Your Inspection Report

27 Clark Street
Toronto, ON M4M 1M5

Wednesday, September 19, 2018

RE: Report No. 2602
27 Clark Street
Toronto, ON
M4M 1M5

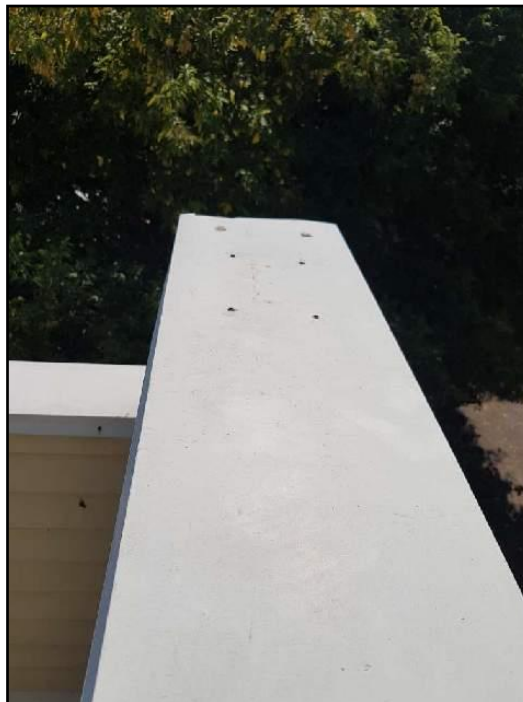
2. **Condition:** • Not sealed.

Location: South Third Floor

3. *Not sealed.*

Seal holes in parapet cap flashing.

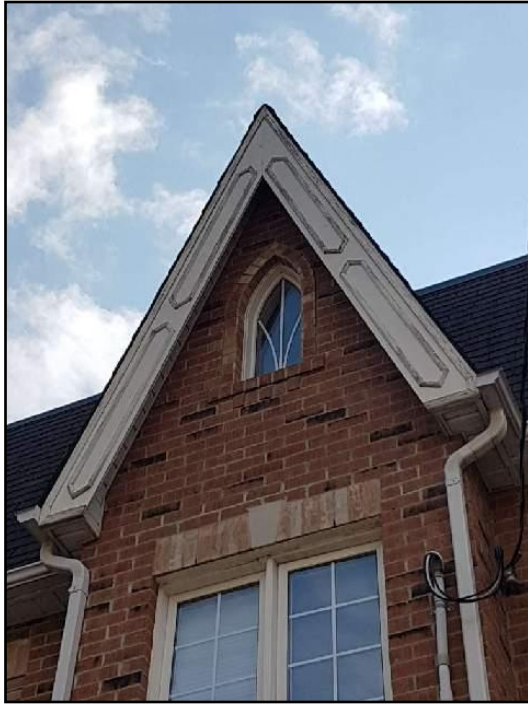
3. Condition: • Paint - deteriorated / missing

Location: North Exterior

4. Paint - deteriorated / missing

Wood trim needs paint maintenance.

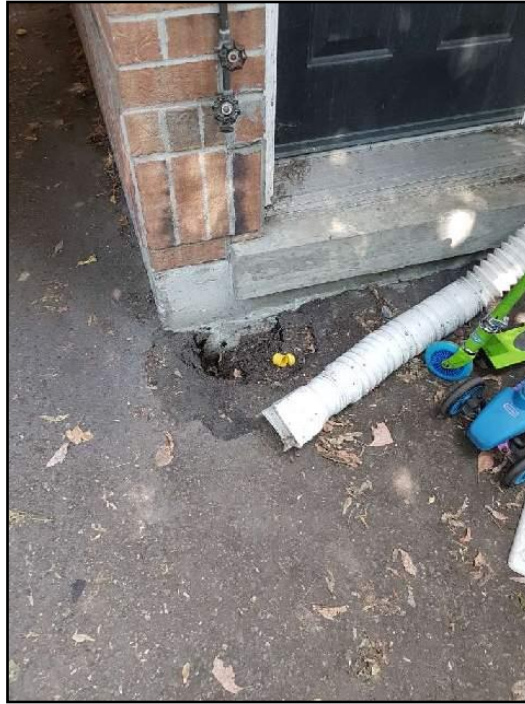
4. Condition: • [Cracked or damaged surfaces](#)

Implication(s): Trip or fall hazard

Location: Southwest Exterior

6. Cracked or damaged surfaces

Fill and seal pothole next to door.

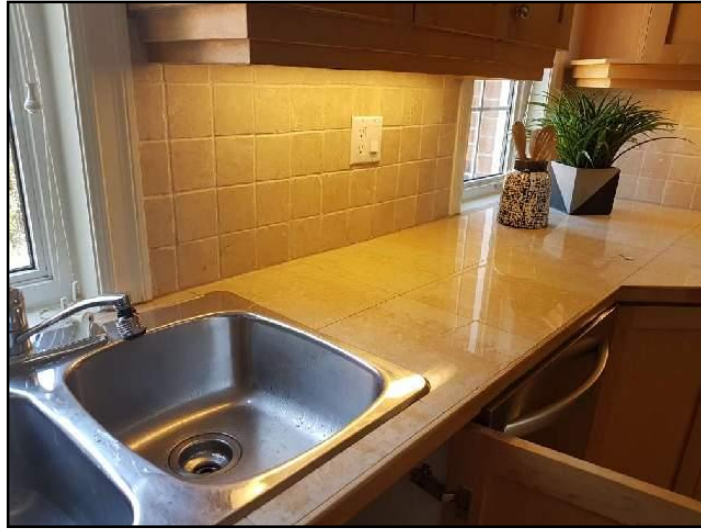
7. Condition: • [GFCI/GFI needed \(Ground Fault Circuit Interrupter\)](#)

Implication(s): Electric shock

Location: Kitchen

7. GFCI/GFI needed (Ground Fault Circuit...

Task: Replace

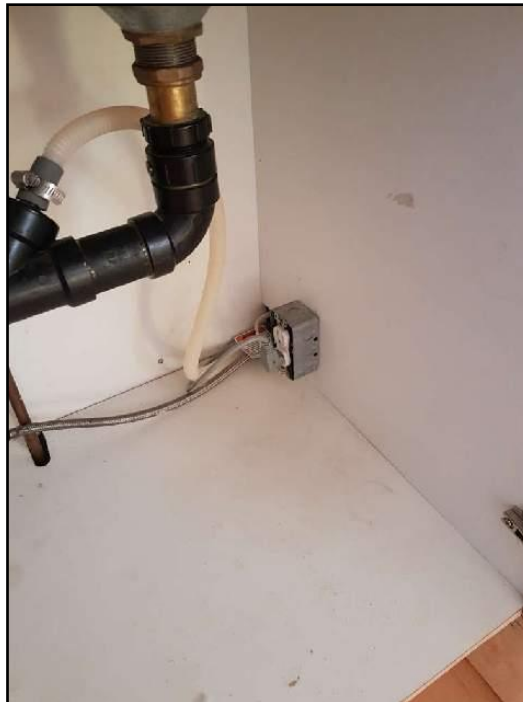
8. Condition: • [Missing](#)

Implication(s): Electric shock

Location: Kitchen

8. Exposed wire

Add coverplate and protect wire with conduit.

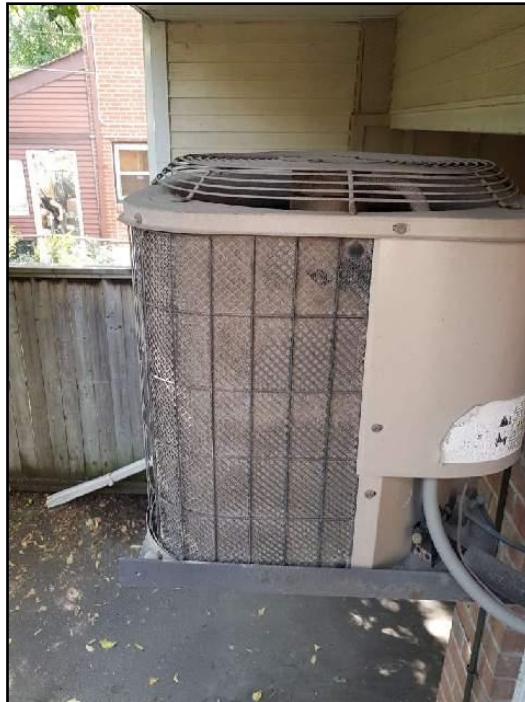
11. Condition: • [Dirty](#)

Implication(s): Reduced system life expectancy | Increased cooling costs | Reduced comfort

Location: South Exterior

10. Dirty

Task: Clean

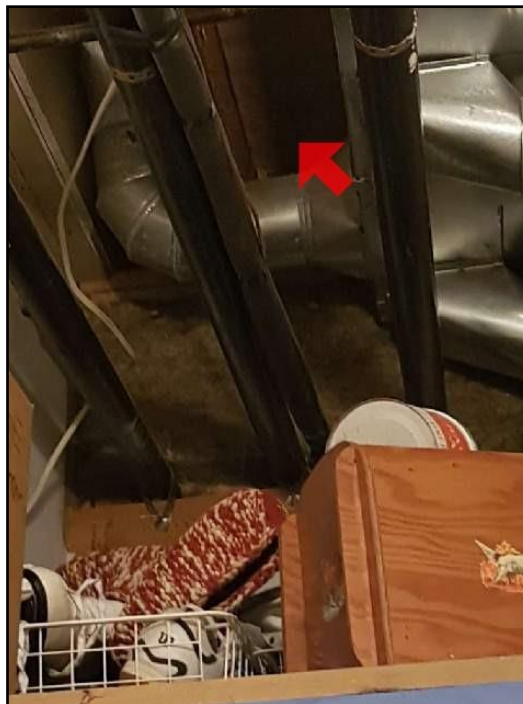
11.

Location: South Furnace Room

12. Condition: • Insulate upper south wall of furnace room.

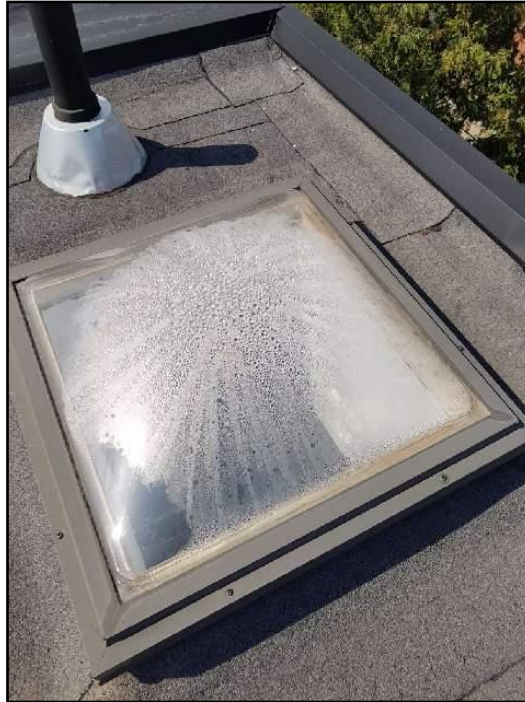
15. Condition: • Lost seal on double glazing.

This issue is primarily cosmetic.

Location: Third floor bathroom

12. Lost seal on double glazing.

Task: Replace
