Your Inspection Report

212 Roselawn Avenue
Toronto, ON M4R 1E9

Friday, May 2, 2025

RE: Report No. 4254
212 Roselawn Avenue
Toronto, ON
M4R 1E9

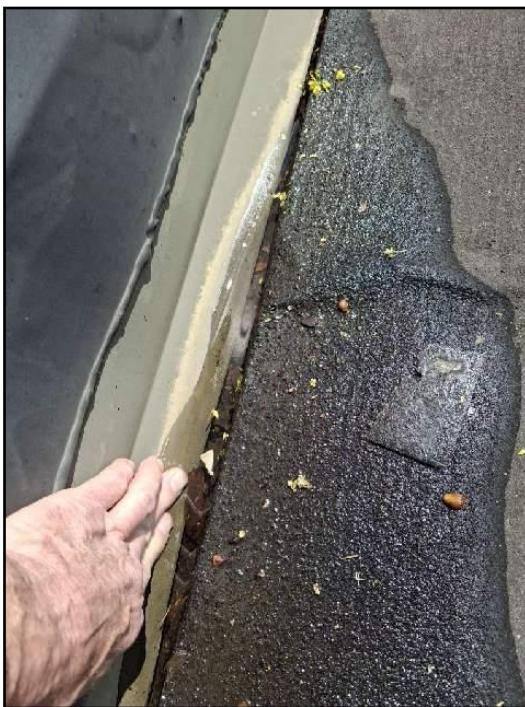
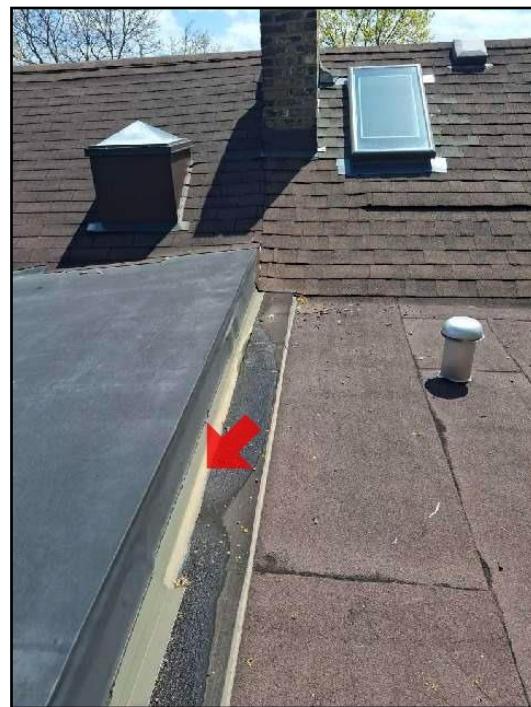
FLAT ROOFING \ General notes

1. Condition: • Poor transition between attached flat roof areas is causing water to collect against west wall of master bedroom. Surface is underlayment only. Create drainage and cap with metal or membrane.

Location: Northwest Exterior

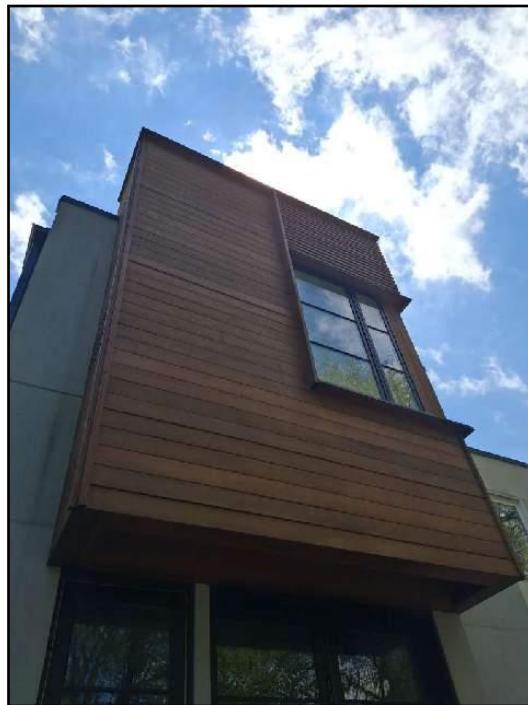
6.

WALLS \ Wood siding

2. Condition: • [Paint or stain - needed](#)

Implication(s): Shortened life expectancy of material

Location: North Exterior

Task: Improve

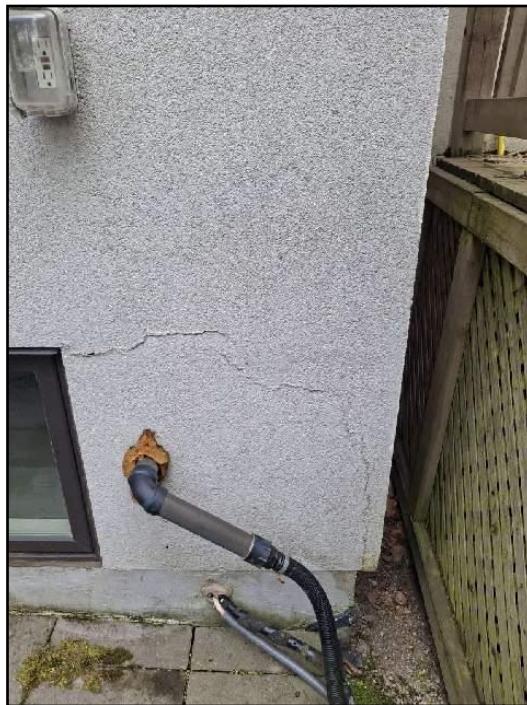
7.

WALLS \ EIFS (Exterior Insulation and Finishing System) and Stucco

3. Condition: • [Minor cracks](#)

Implication(s): Shortened life expectancy of material

Location: Northwest Exterior

Task: Repair

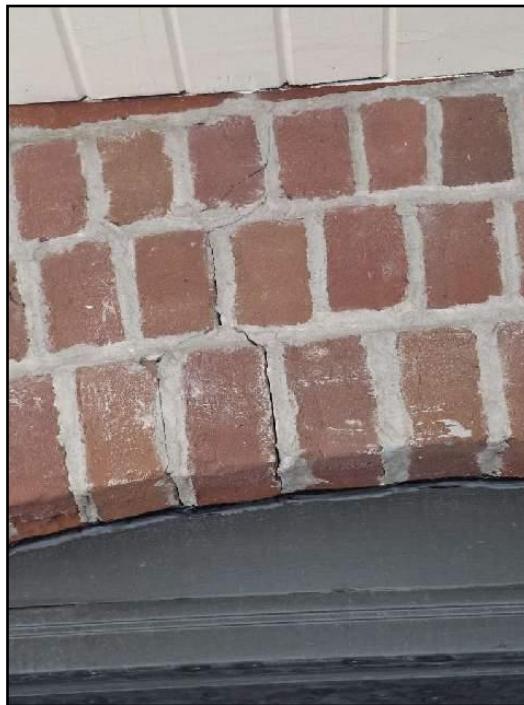
8.

WALLS \ Masonry (brick, stone) and concrete

4. Condition: • Cracked

Implication(s): Chance of water entering building | Weakened structure | Chance of movement

Location: South Exterior

Minor tuckpointing needed.

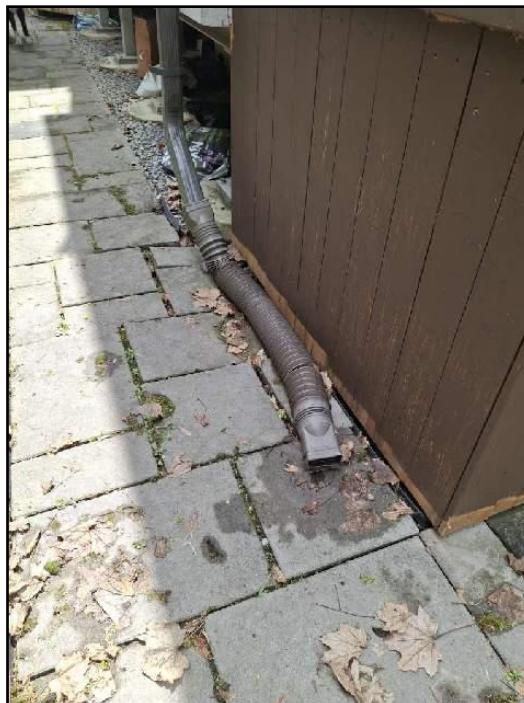
9.

LANDSCAPING \ Walkway

5. Condition: • [Improper slope or drainage](#)

Implication(s): Chance of water damage to structure, finishes and contents

Location: Northeast Exterior

Create drainage slope away from foundation.

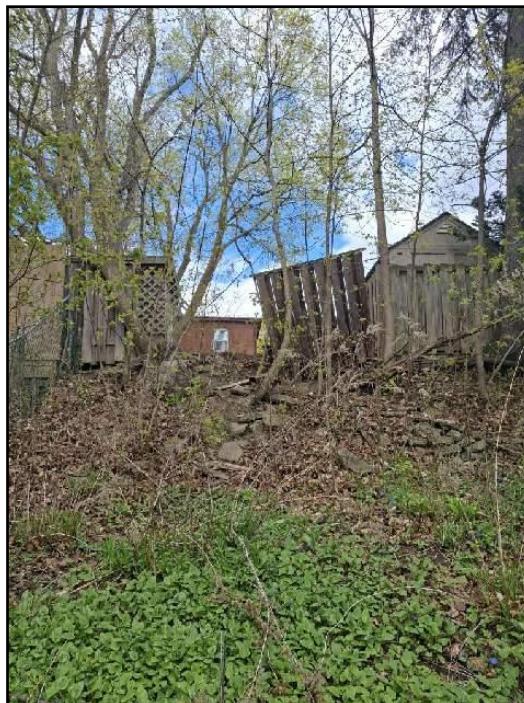
10.

LANDSCAPING \ Fence

6. Condition: • Damage

Implication(s): Material deterioration

Location: North Exterior

Task: Replace

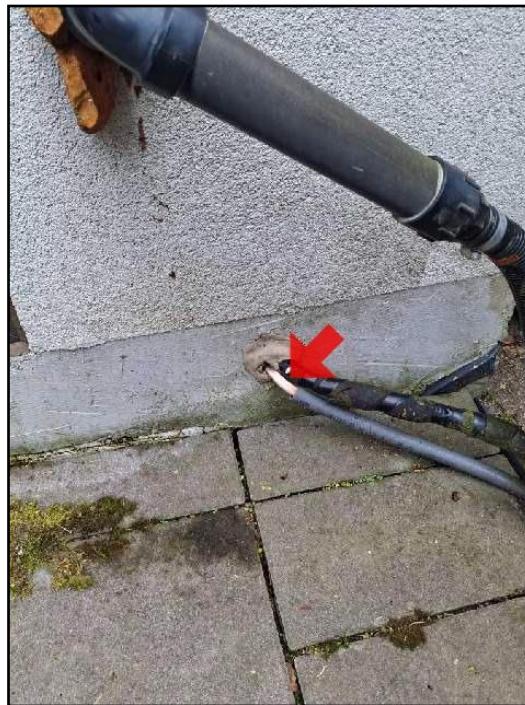
12.

DISTRIBUTION SYSTEM \ Outdoor wiring (wires)

9. Condition: • Protect exposed wiring with conduit.

Location: Northwest Exterior Wall

Protect a/c wiring.

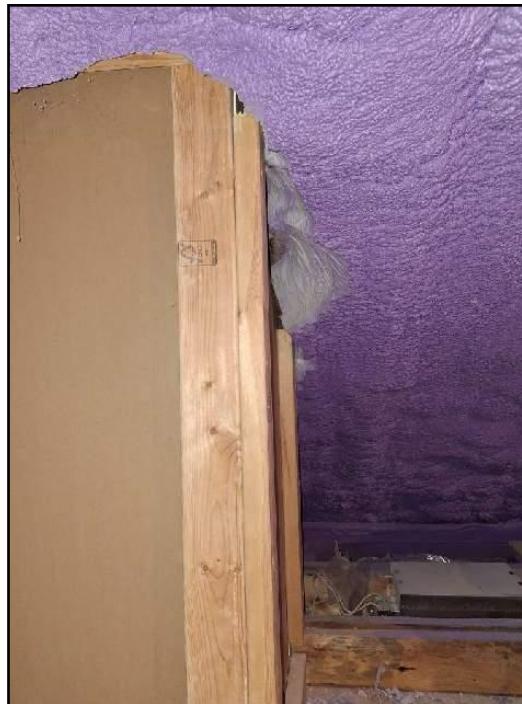
13.

ATTIC/ROOF \ Insulation

12. Condition: • [Gaps or voids](#)

Implication(s): Increased heating and cooling costs | Reduced comfort

Location: Attic

Replace missing sprayfoam at skylight shaft.

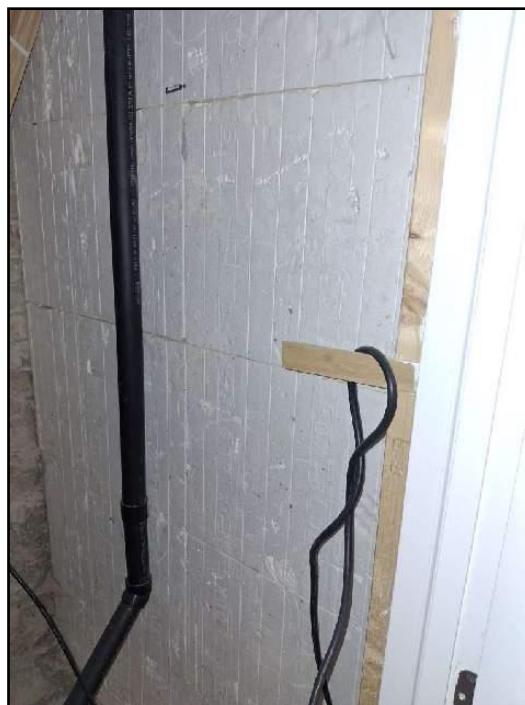
14.

FOUNDATION \ Interior insulation

13. Condition: • [Exposed combustible insulation](#)

Implication(s): Fire hazard

Location: West Basement

Cover exposed styrofoam with drywall.

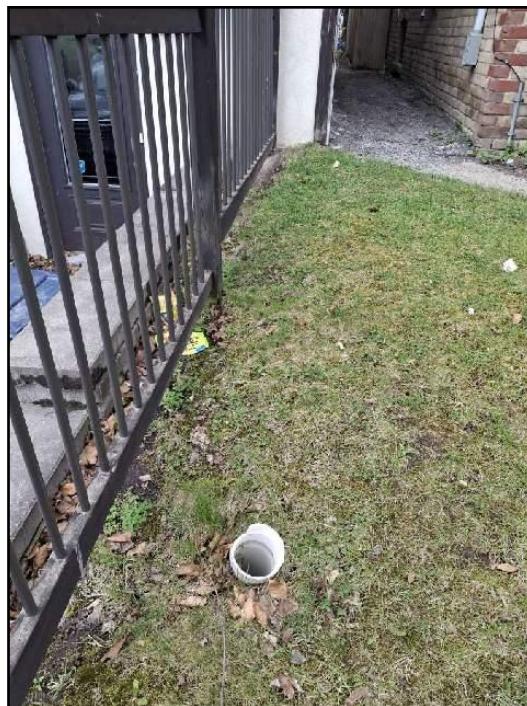
16.

WASTE PLUMBING \ Drain piping - performance

15. Condition: • Replace missing cover at clean out.

Location: Southeast Exterior
