# Your Inspection Report

179 Hallam Street  
Toronto, ON M6H 1X4

**INSPECTION DATE:**  
Wednesday, September 2, 2026

RE: Report No. 9726  
179 Hallam Street  
Toronto, ON  
M6H 1X4

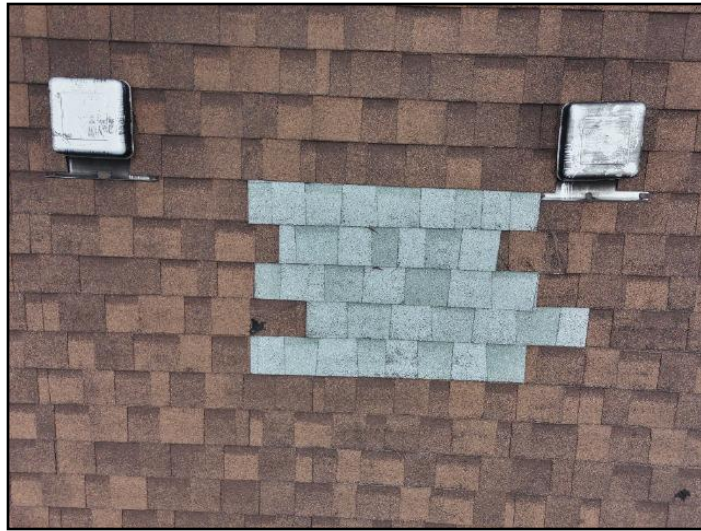
2. Patched

**Condition:** • [Patched](#)

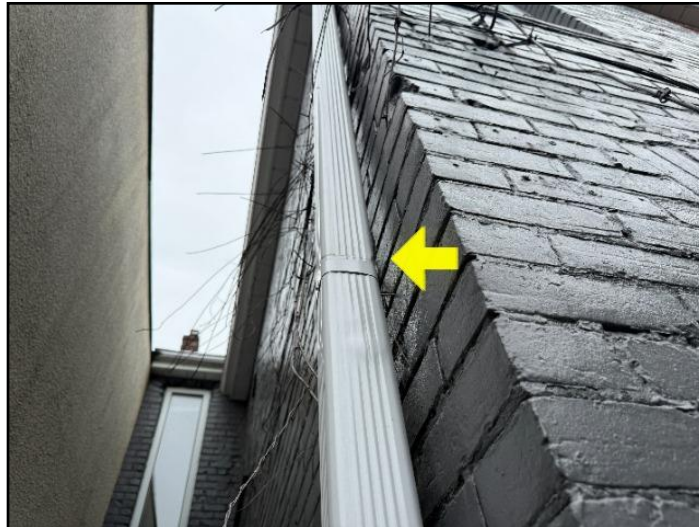
3. Not well secured

**Condition:** • [Not well secured](#)

**Task:** Secure

**Time:** Less than 1 year

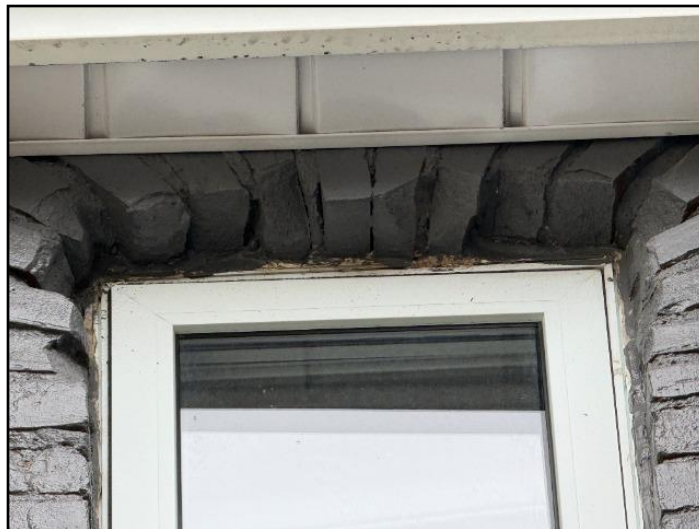
6.

**Condition:** • Irregular/chipped masonry was noted above a window opening with extensive caulking. No significant displacement or other obvious signs of structural movement were observed in visible areas.

**Task:** Maintain seal / Repair as needed

**Time:** Ongoing Regular maintenance

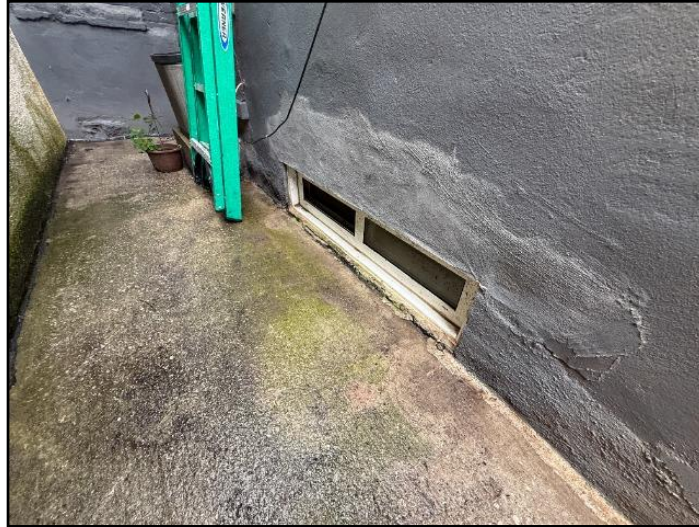
7. Sill - Near or at Grade Level

**Condition:** • Sill - Near or at Grade Level

Basement window at or near grade level. Modern standards recommend that the bottom of the window be at least 6 inches above grade or have a window well installed. Consider adding window well if regrading or when necessary. In the meantime, ensure windows remain well-sealed to prevent water intrusion.

**Task:** Monitor for moisture intrusion / Improve

**Time:** As necessary

**Cost:** If/when upgrading to window wells in the future, \$2000 and up each

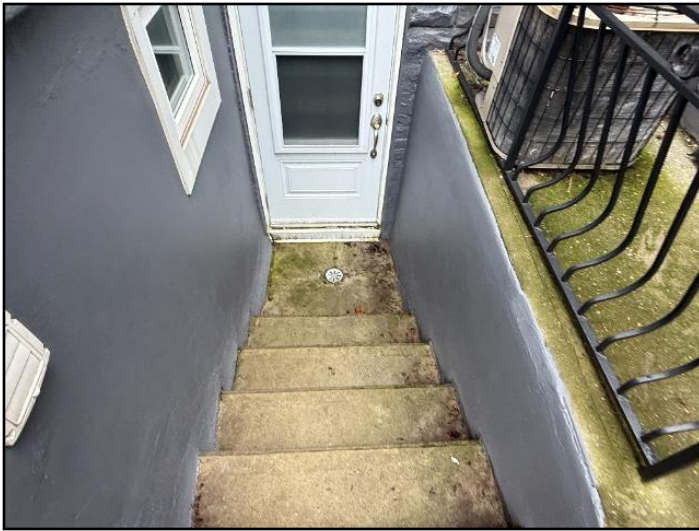
8. Missing handrail

**Condition:** • [Missing](#)

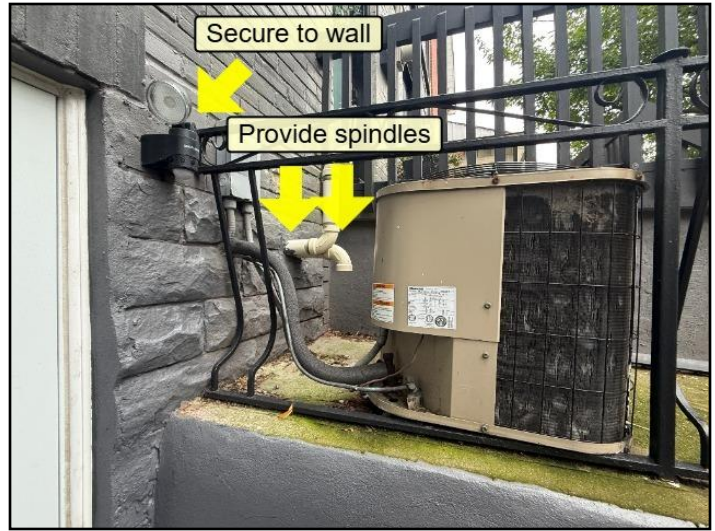
9. Guard

**Condition:** • [Guard and handrail problems](#)

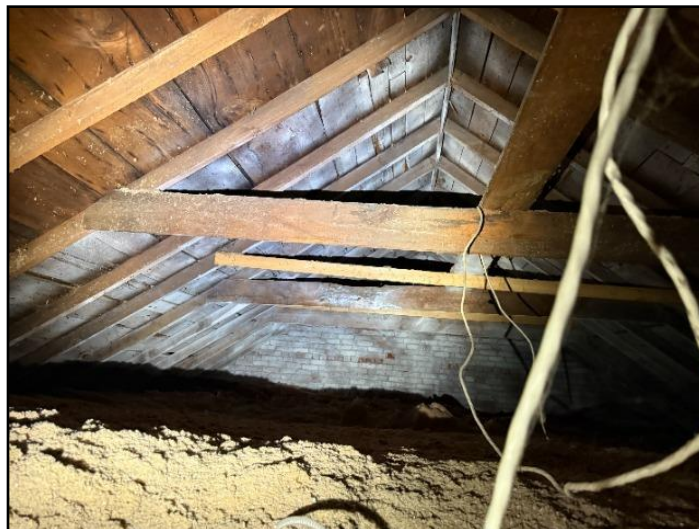
10. example

**Condition:** • FRT Treatment (Fire Retardant Treated)

White fire-retardant-type coating was noted on portions of the attic framing/sheathing. Seller reports there was a fire at the neighbouring property approximately 15 years ago, resulting in insurance remediation.

**Task:** For Your Information / No further action needed

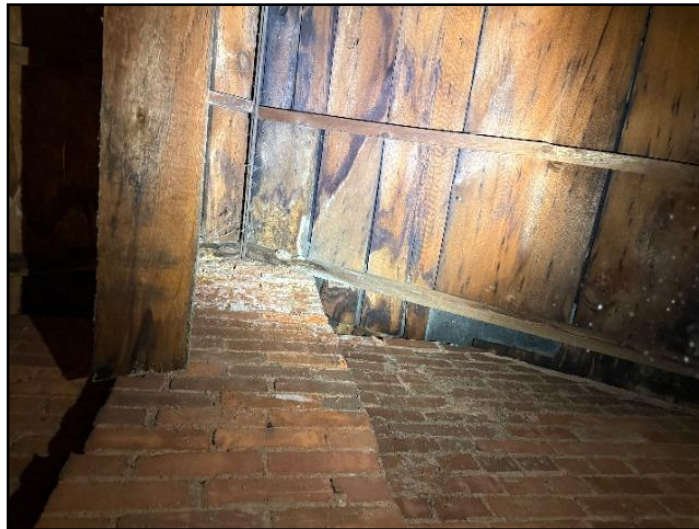
11. Water stains or discoloration - Attic plank...

**Condition:** • Water stains or discoloration - Attic plank boards

Water staining/discoloration was noted on the attic plank sheathing near the chimney, along with efflorescence/staining on the chimney masonry. No visible water entry was observed at the time of inspection. The stained area was not accessible for moisture meter testing. Prior caulking/sealant was noted at the exterior chimney flashing and should be maintained ongoing.

**Task:** Monitor for recurrence / Maintain chimney flashing as needed

**Time:** Ongoing Regular maintenance

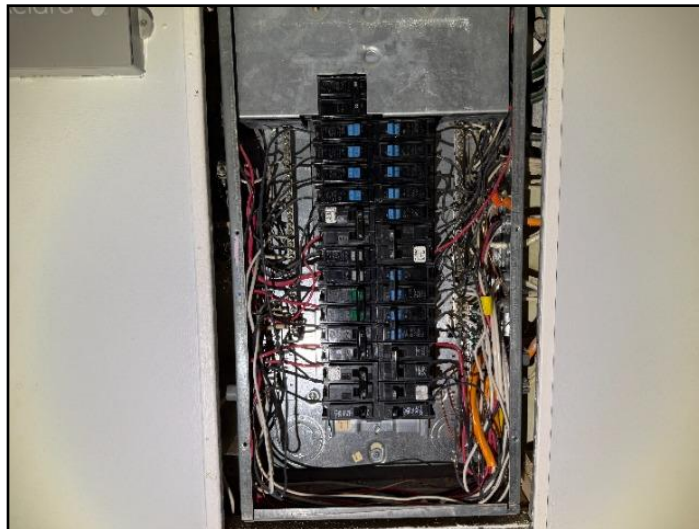
12. Breakers - basement

Good condition overall

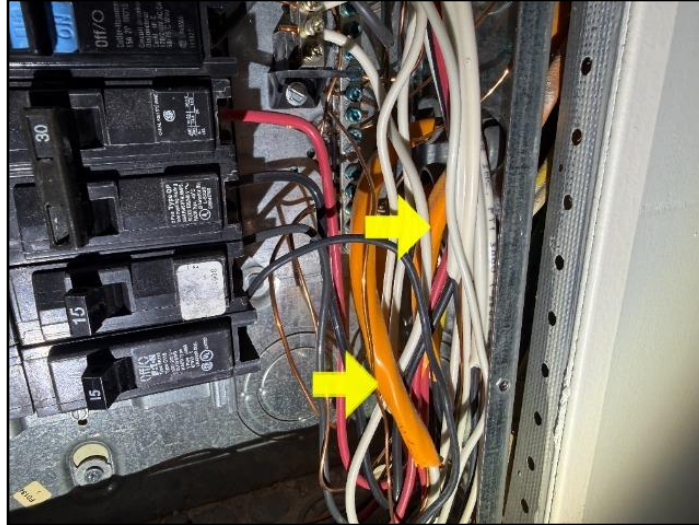
**13.** Sheathing not removed

**Condition:** • [Sheathing not removed](#)

**Time:** Less than 6 months

**Cost:** Minor

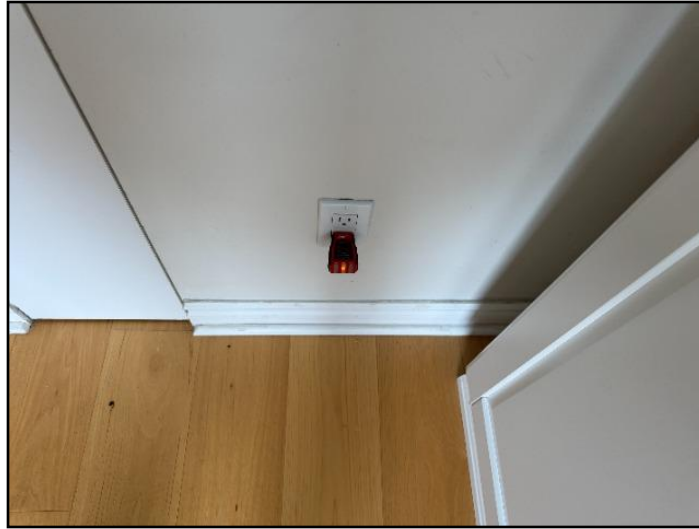
14. Ungrounded

**Condition:** • Ungrounded

A representative number of outlets were tested. This is the only outlet we found to be ungrounded.

**Task:** Replace with GFCI outlet

**Time:** As soon as practical

**Cost:** Minor

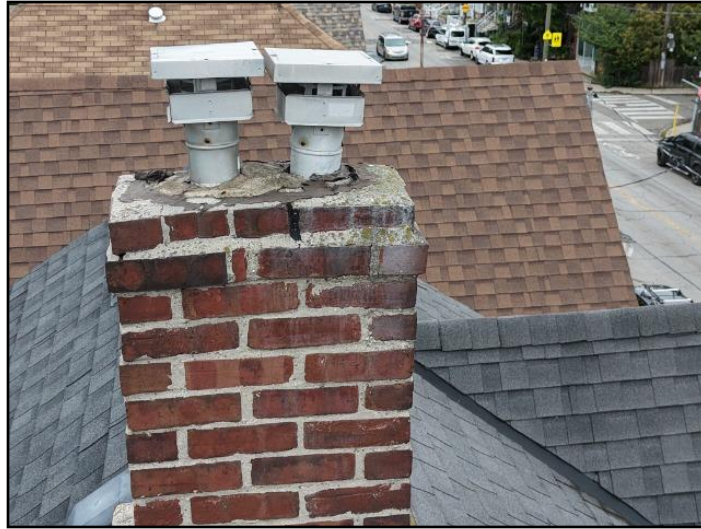
15. No drip edge on cap (crown)

**Condition:** • [No drip edge on cap \(crown\)](#)

Additionally, chimney crown is weathered with localized deterioration/patching and gaps noted around the vent penetrations.

**Implication(s):** Chance of water damage to structure, finishes and contents | Shortened life expectancy of material | Material deterioration

**Task:** Repair / Improve

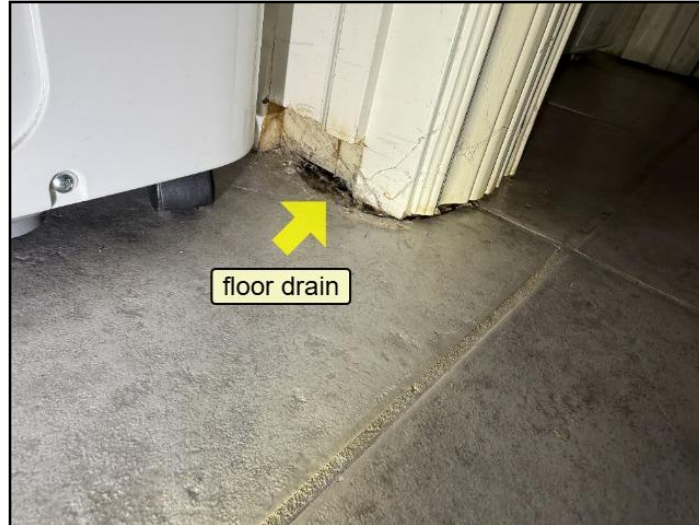
18. Obstructed

**Condition:** • [Obstructed](#)

**Task:** Correct

**Time:** Less than 1 year

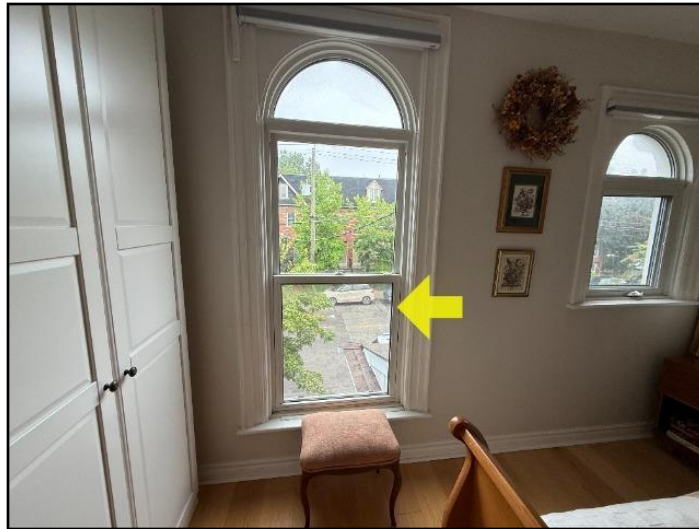
19. Won't stay open

**Condition:** • [Won't stay open](#)

**Task:** Repair or replace

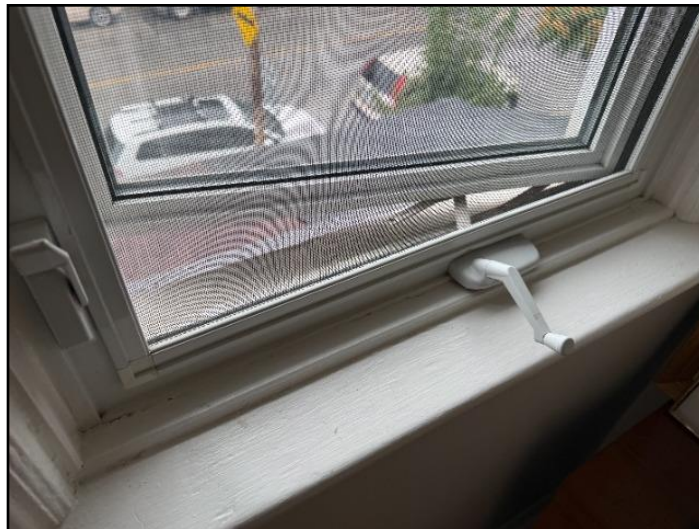
20.

**Condition:** • [Inoperative](#)

Window was found partially open at the time of inspection. The casement arm was detached and the window could not be closed or latched when tested.

**Task:** Repair / Replace hardware

**Time:** As soon as practical

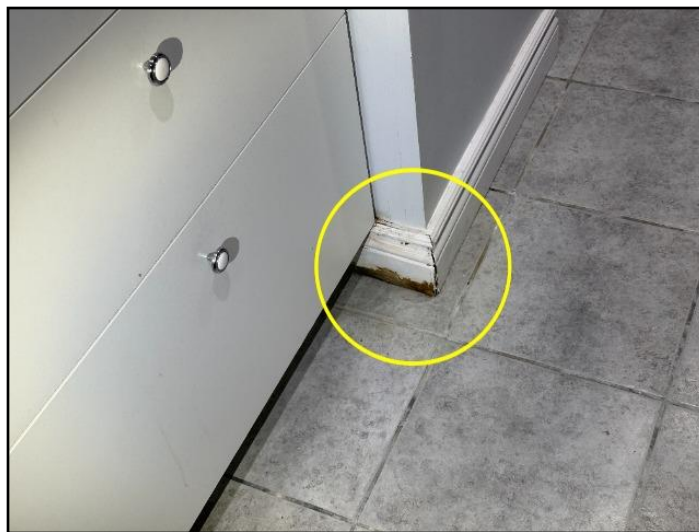
**21.** *Damaged plaster, dry wall or other finished...*

**Condition:** • Damaged plaster, dry wall or other finished surfaces - Wet at time of inspection

Localized wall damage was noted near the basement kitchen. This area tested wet with a moisture meter at the time of inspection. The source of moisture was not determined.

**Task:** Locate source of moisture / Correct

**Time:** As soon as possible

**Cost:** Depends on work needed, consult specialist

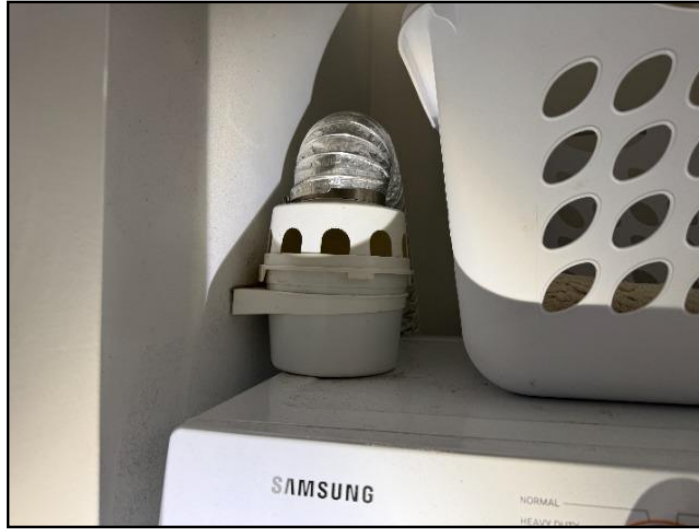
22. one example

**Condition:** • Dryer not vented to exterior

**Time:** As soon as practical

**Cost:** Depends on work needed
