# Your Inspection Report

14 Claude Ave  
Toronto, ON

**INSPECTION DATE:**  
Wednesday, October 12, 2016

RE: Report No. 55624, v.3  
14 Claude Ave  
Toronto, ON

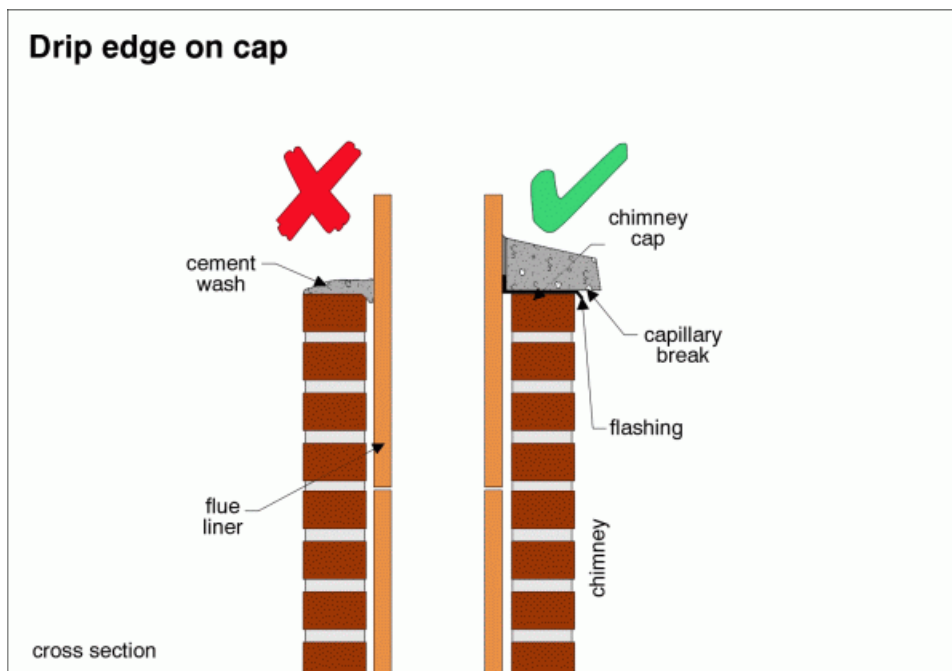
**Condition:** • [Cap - deteriorated/missing](#)

Provide cap to help keep water away from the walls of the chimney where it could infiltrate small cracks in the mortar or masonry and cause damage to these surfaces in cold weather.

Some masonry/mortar deteriorated or missing. Repair as required.

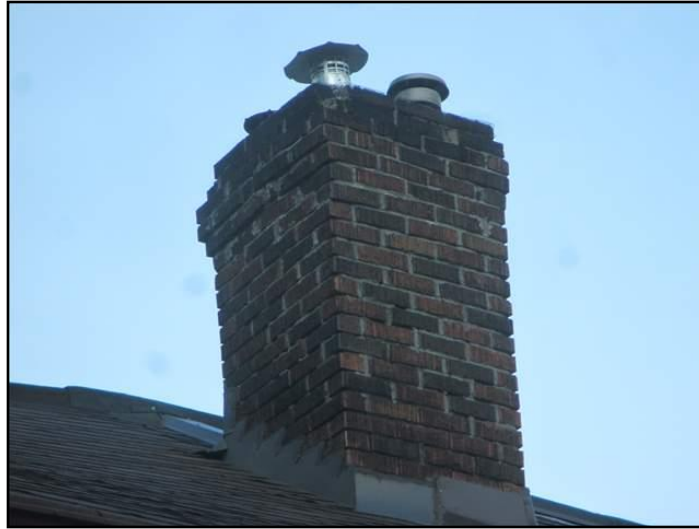
*Cap - missing*

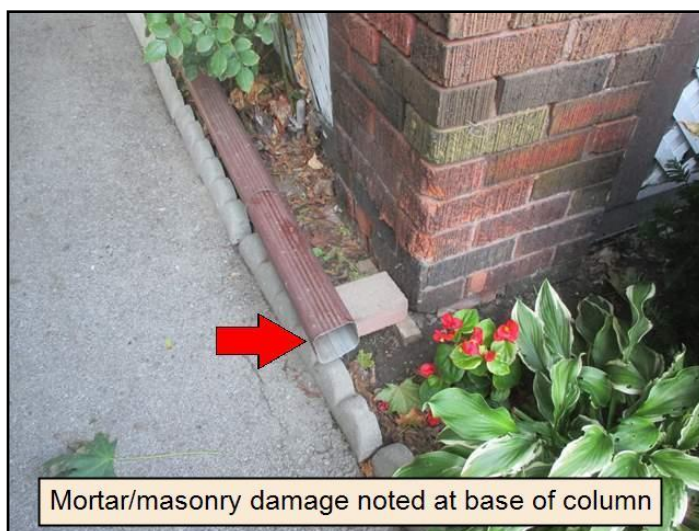
**Condition:** • [Discharge too close to Column / Post \(should discharge at least 2 m / 6 ft away\); provide Downspout Extension](#)

Water discharge causes compression and settlement of surrounding soil. Discharge may cause a slip hazard in cold weather at walk.

*Discharge too close to Column / Post...*

**Task:** Correct

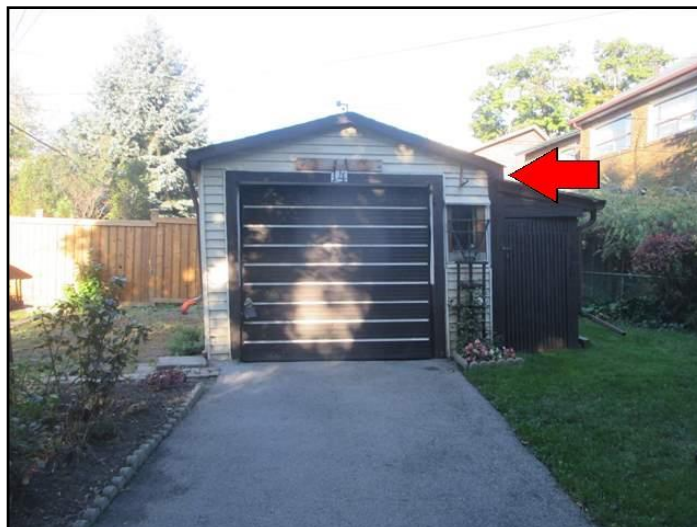
**Condition:** • Structure out of plumb.

*Structure out of plumb*

**Task:** Repair / Replace

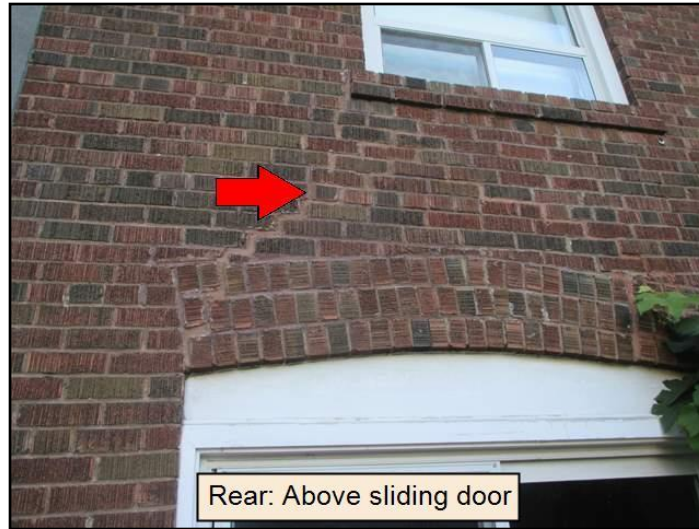
**Condition:** • [Cracks](#)

Gaps/cracks were noted indicating previous movement. Most of these areas have been repaired. It is not possible from a one-time visit to determine whether movement is ongoing, and if so at what rate.

*Example: Cracks/lateral movement*

Monitor window sills, wall surfaces and other mortar areas and repair as necessary.

Keep these areas properly sealed to help prevent damage from water and insects.

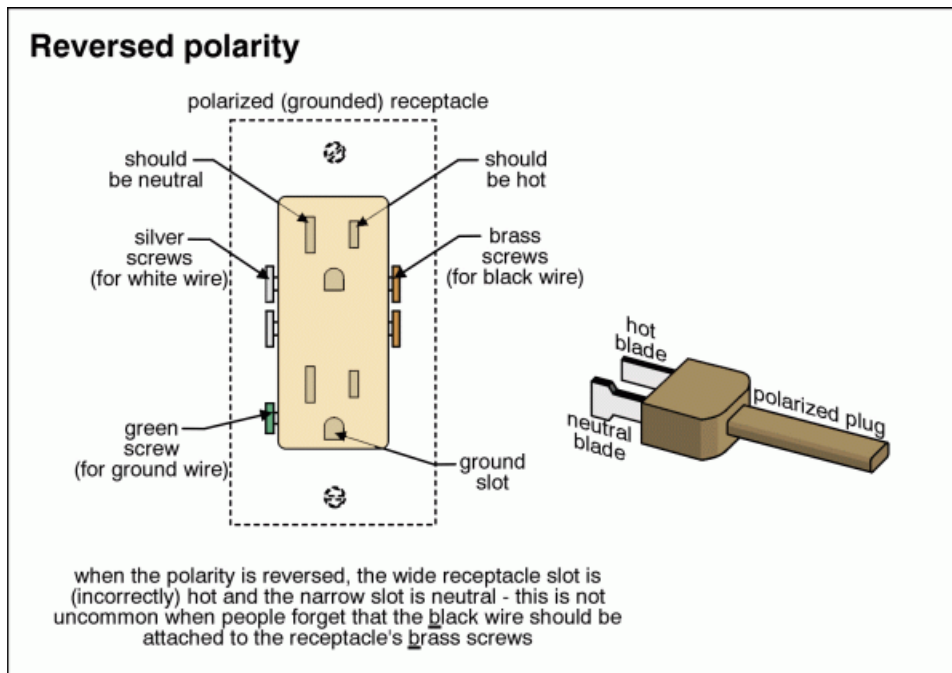
**Location:** Left Side Exterior (above basement window)

**Condition:** • [Reversed polarity \(black / white wires reversed\)](#)

**Task:** Correct

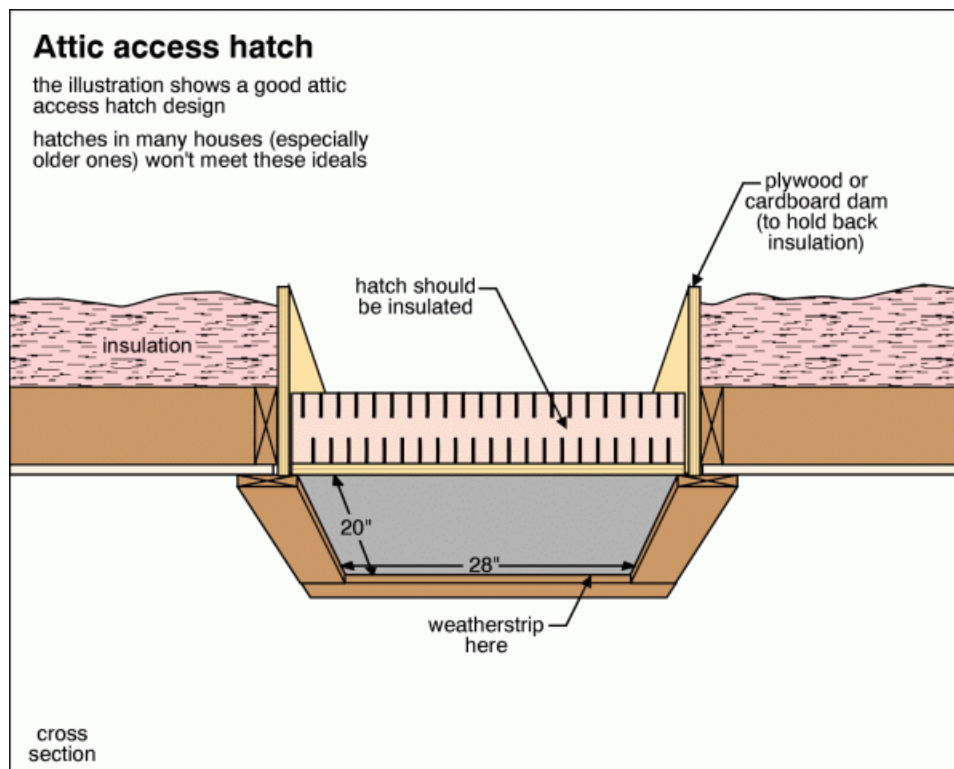
**Condition:** • [Access Hatch: insulation/weatherstripping/fit less than ideal](#)

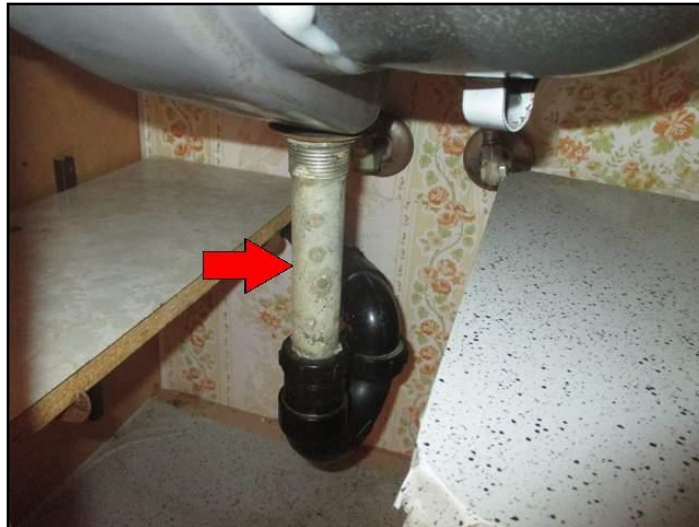
**Condition:** • Tail piece corroded.

*Tail piece corroded*

**Task:** Repair

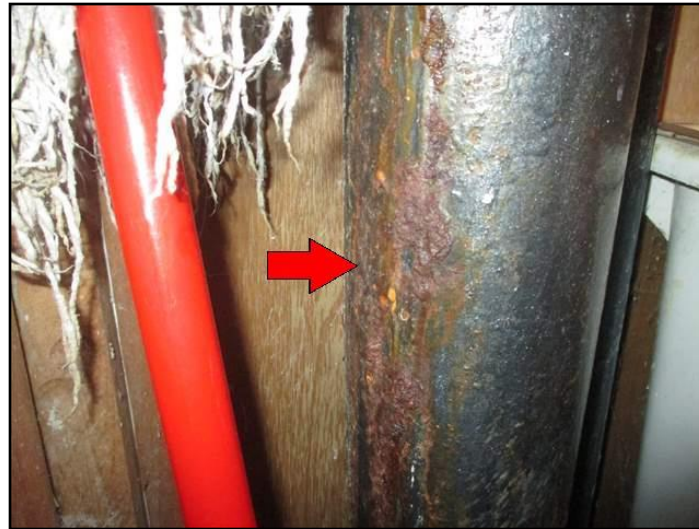
**Condition:** • The cast iron waste piping is near the end of its normal life expectancy and is prone to rusting through or splitting. Replacement may be required in the near future.

Visible damage noted to lower section of waste pipe.

*The cast iron waste piping is near the end...*

\*A video inspection of the waste plumbing is recommended to determine whether there are other obstructions, or damaged pipe. This is common on older properties. This is a great precautionary measure and can help prevent leakage.

**Task:** Replace

**Cost:** \$800 - and up (lower visible section only)
