Your Inspection Report

45 Vernon Street
Toronto, ON M6P 1S9

INSPECTION DATE:
Monday, May 4, 2026

RE: Report No. 9323
45 Vernon Street
Toronto, ON
M6P 1S9

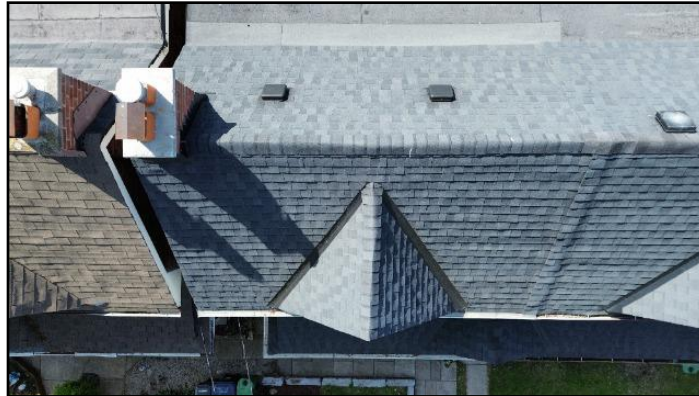
Good condition overall

1. Asphalt shingles

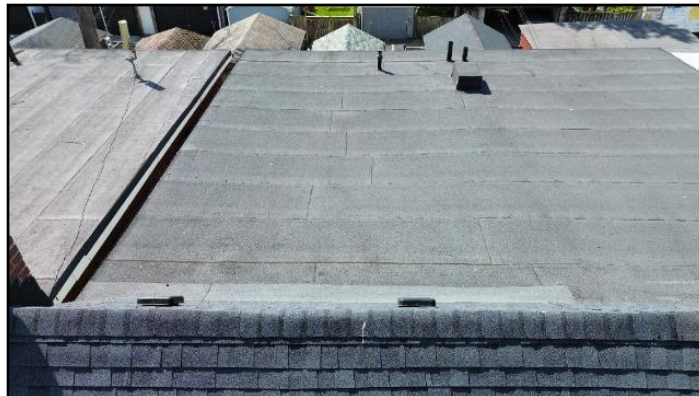
2. Modified bitumen membrane

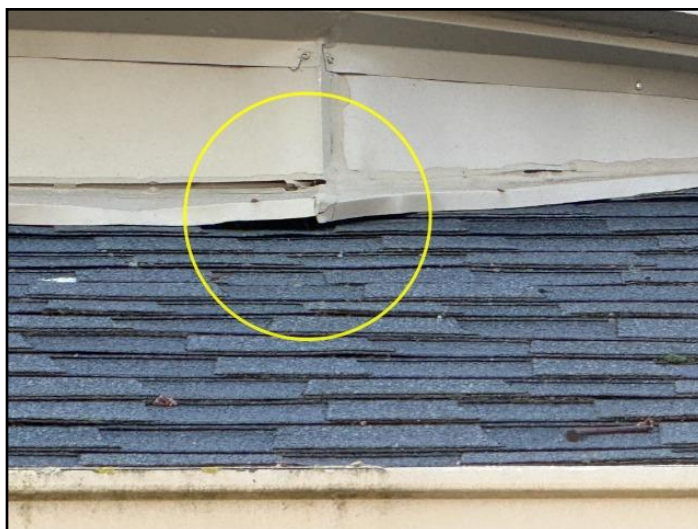
Condition: • [Damage, loose, open seams, patched](#)

3. example

Task: Repair

Time: Less than 1 year / At next annual roof servicing

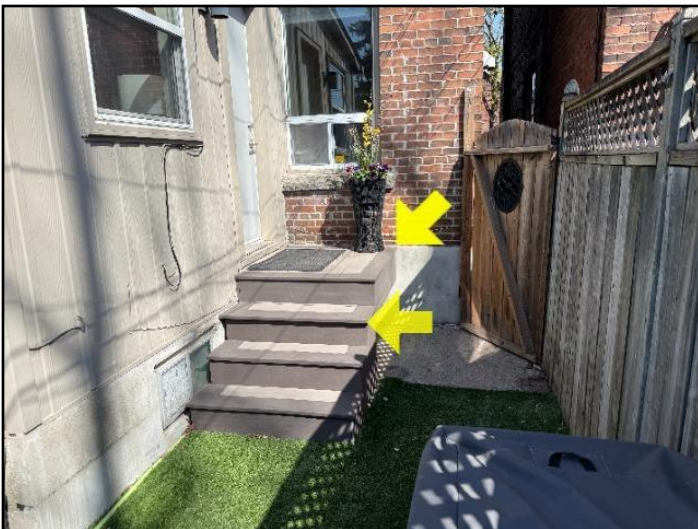
Condition: • [Missing](#)

Implication(s): Fall hazard

4. Missing hand/guard rails

Time: Less than 1 year

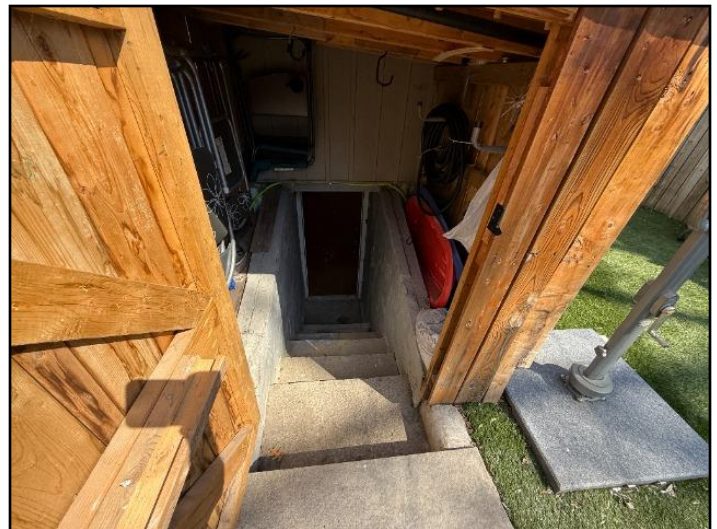
5. Missing handrail

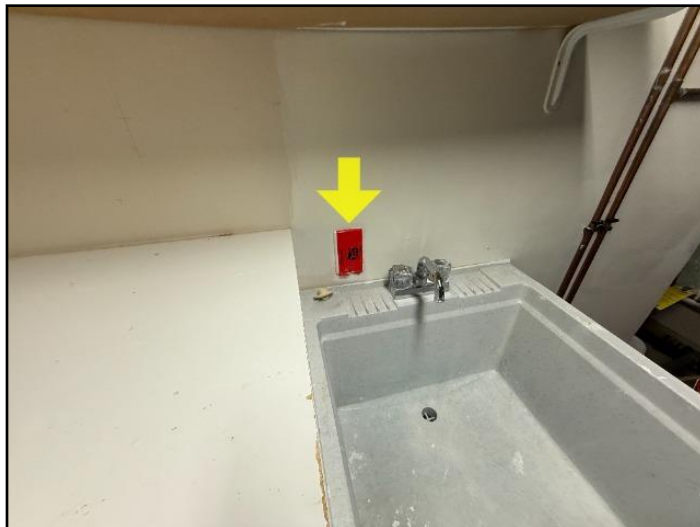
Condition: • [GFCI/GFI needed \(Ground Fault Circuit Interrupter\)](#)

7. GFCI/GFI needed (Ground Fault Circuit...)

Task: Replace with gfi outlet

Time: Before using
