# INSPECTION REPORT

For the Property at:  
**WEST WINDSOR**  
WINDSOR, ON

Prepared for: JOHN SMITH  
Inspection Date: Tuesday, September 4, 2018  
Prepared by: Philip Teasdale

Report No. 1003, v.5

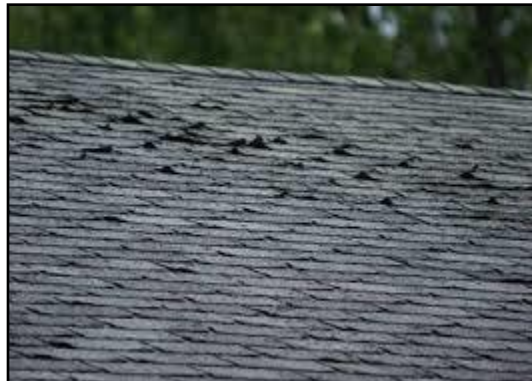
1. Condition: • [Old, worn out](#)

Implication(s): Chance of water damage to contents, finishes and/or structure

Location: West

*Asphalt shingles*

Task: Repair or replace

Time: Less than 1 year

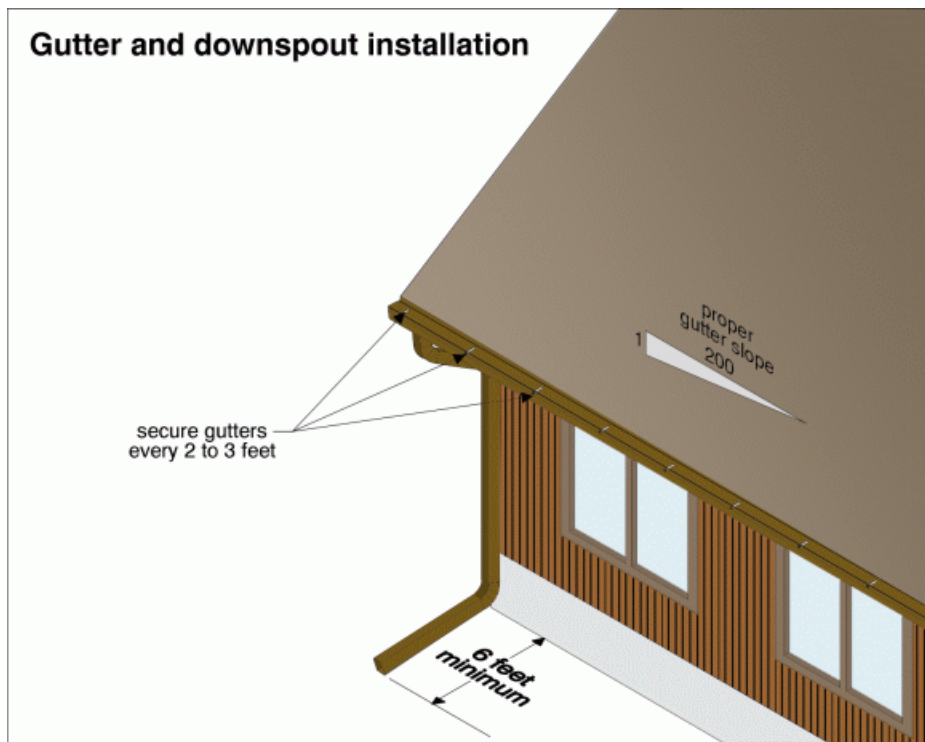
2. Condition: • [Should discharge 6 feet from building](#)

Implication(s): Chance of water damage to contents, finishes and/or structure

Task: Improve

Time: Immediate

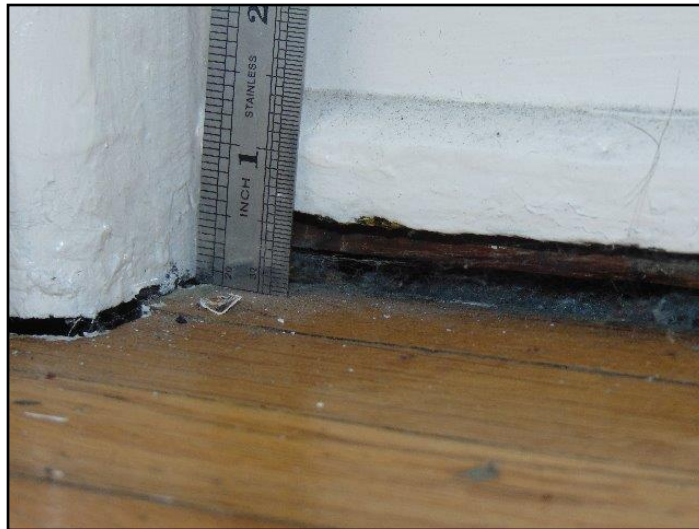
**3. Condition:** • [Slope](#)

One inch gap from wall to floor surface over 3 feet

**Implication(s):** Chance of structural movement

**Location:** Second Floor Master Bathroom

**Task:** Further evaluation

**Time:** Less than 1 year

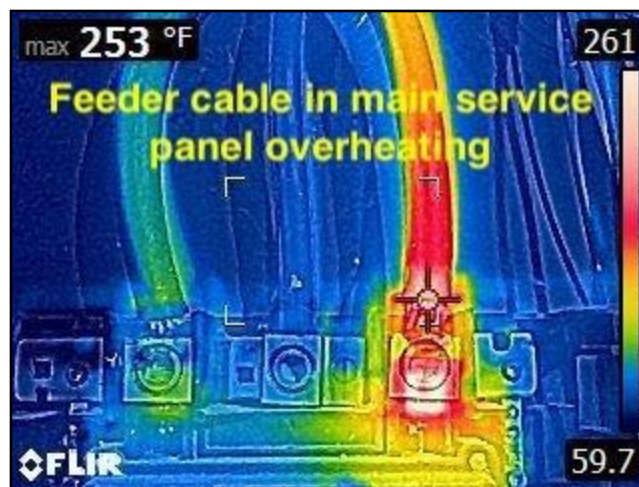
**4. Condition:** • [Poor connections](#)

**Implication(s):** Electric shock | Fire hazard

*Poor connections*

Must be done by a qualified electrical contractor

**Task:** Repair

**Time:** Immediate

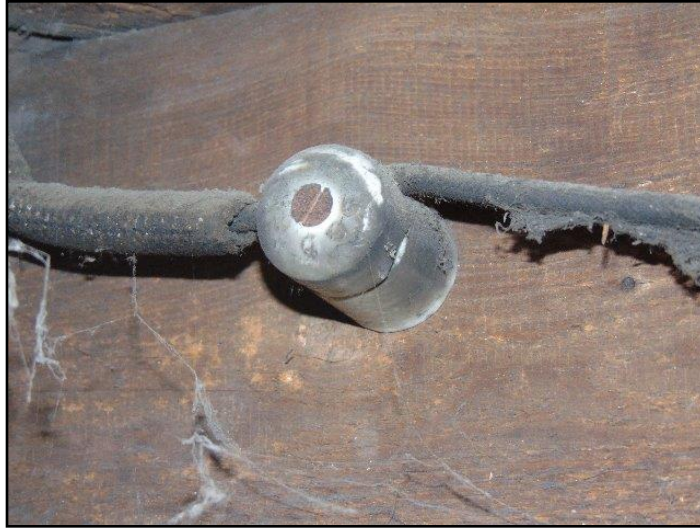
**5. Condition:** • [Damaged or frayed](#)

**Implication(s):** Electric shock | Fire hazard

**Location:** Various Crawl Space

*Copper - knob and tube*

**Task:** Replace

**Time:** At earliest opportunity

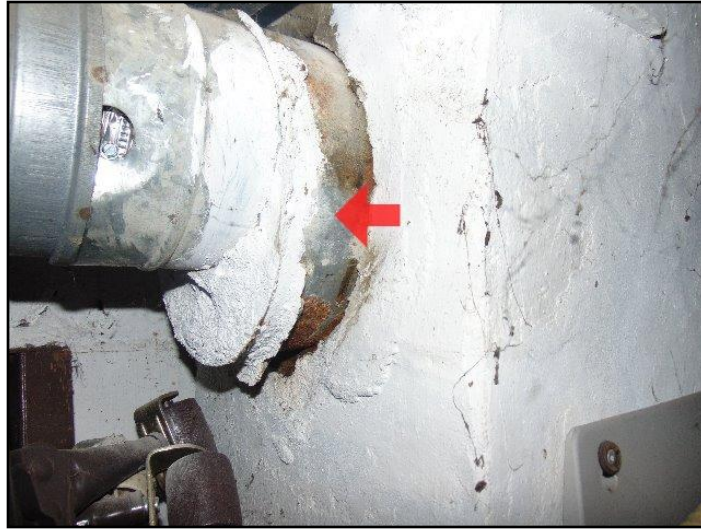
**6. Condition:** • [Poor connections](#)

Poor vent connection into chimney

**Implication(s):** Equipment not operating properly | Hazardous combustion products entering home

**Task:** Repair

**Time:** Immediate

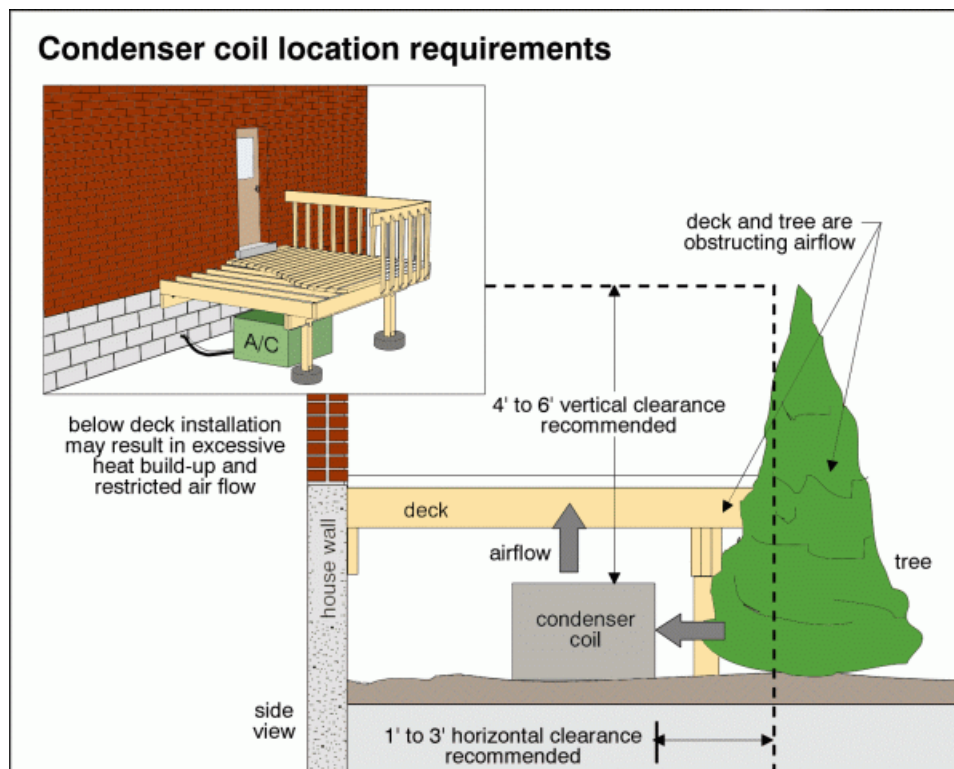
**7. Condition:** • [Obstructed airflow](#)

**Implication(s):** Reduced system life expectancy | Increased cooling costs | Reduced comfort

Cut back shrubs 3 feet

**Task:** Improve

**Time:** Regular maintenance

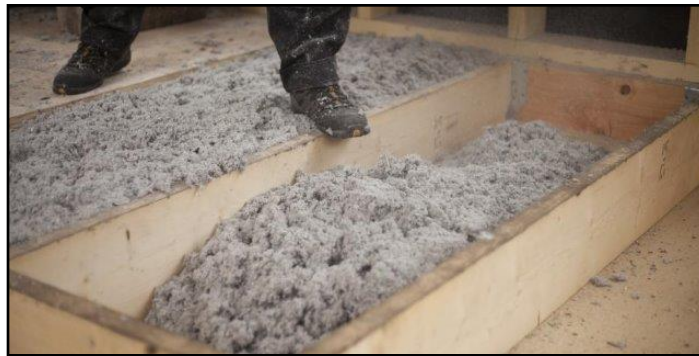
8. Condition: • [Amount inadequate](#)

Implication(s): Increased heating and cooling costs

*Amount inadequate*

Task: Add or replace insulation

Time: At earliest opportunity

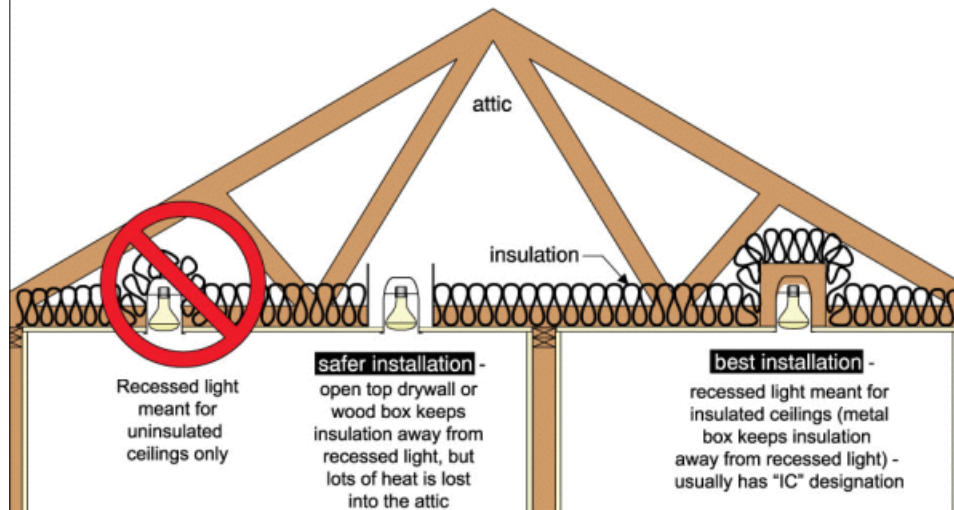
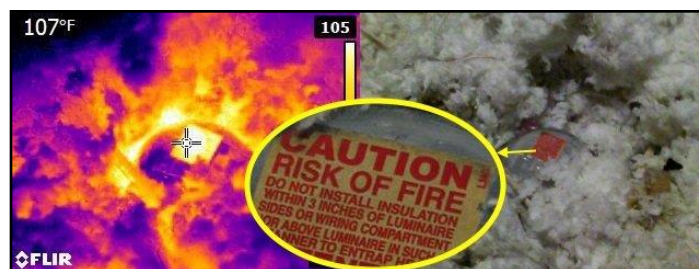
9. Condition: • [Covering recessed lights](#)

Implication(s): Increased fire hazard

Location: Attic

Covering recessed lights

Task: Repair or replace

Time: Immediate

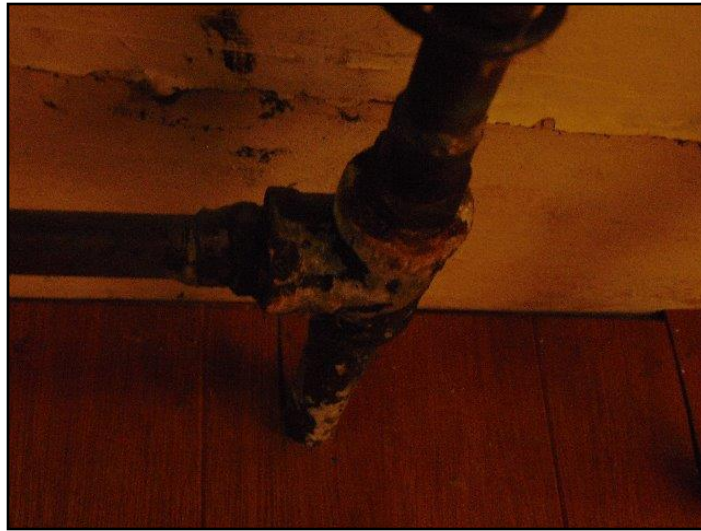
**10. Condition:** • [Galvanized steel](#)

Copper to galvanized pipework rust and leakage

**Implication(s):** Reduced water pressure and volume

*Galvanized steel*

**Task:** Replace

**Time:** Immediate

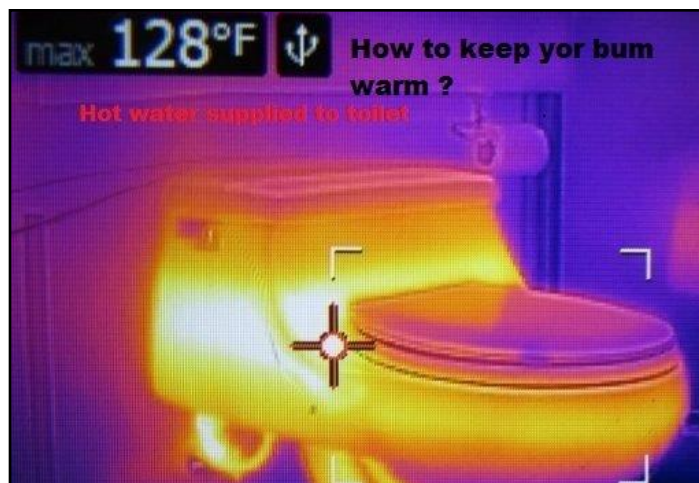
11. Condition: • [Connected to the hot water system](#)

**Implication(s):** Increased hot water consumption | Increased operating costs

*Connected to the hot water system*

**Time:** Immediate

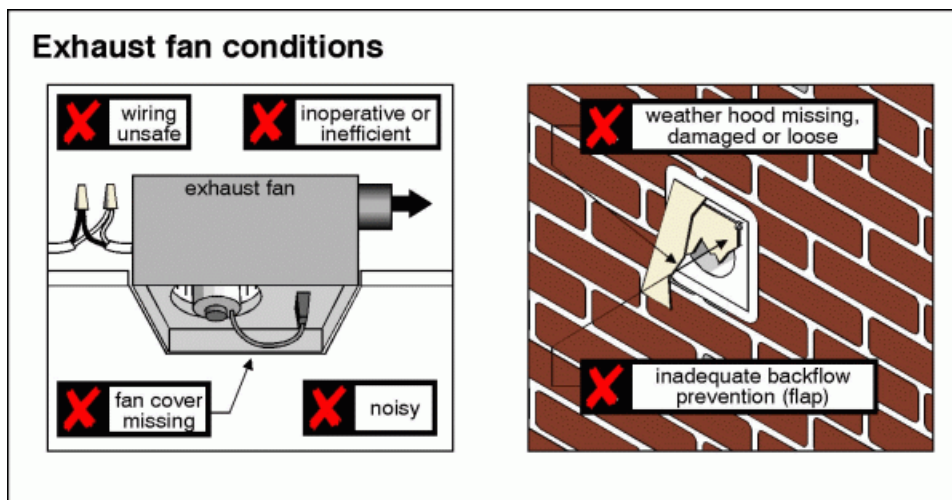
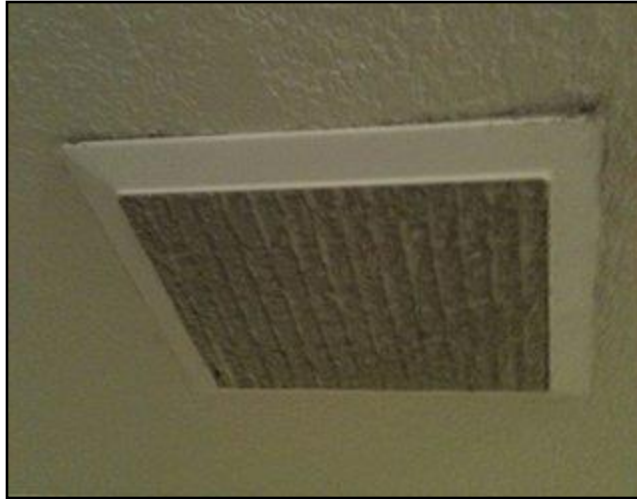
12. Condition: • [Inadequate air movement](#)

Implication(s): Chance of condensation damage to finishes and/or structure

*Inadequate air movement*

Task: Clean

Time: Immediate
