INSPECTION REPORT

KING ST
ANYWHERE, ON

Inspection Date: Tuesday, January 12, 2016

RE: Report No. 1001, v.2
King St
Anywhere, ON

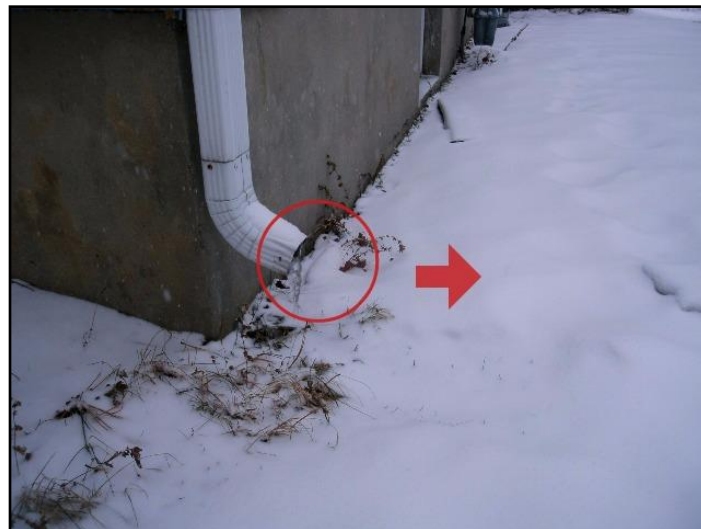
1. Downspouts end too close to building

3. Condition: • [Downspouts end too close to building](#)

Implication(s): Chance of water damage to contents, finishes and/or structure

Location: Various

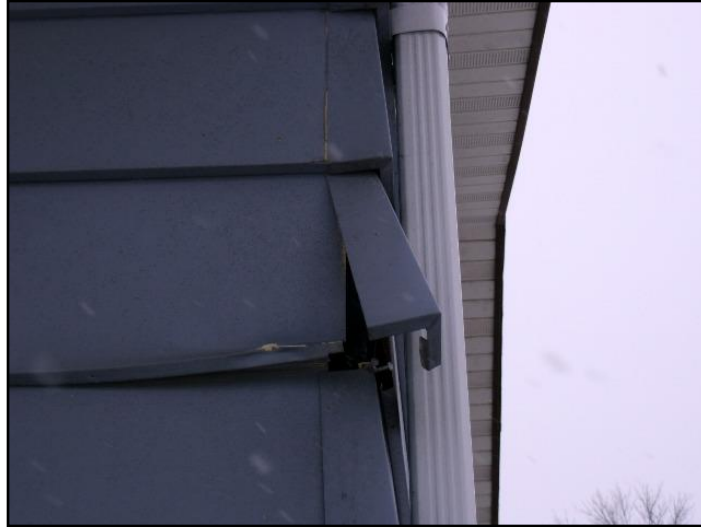
2. Loose

4. Condition: • [Loose](#)

Implication(s): Cosmetic defects | Chance of water damage to contents, finishes and/or structure

Location: Northeast Exterior Wall

Task: Repair

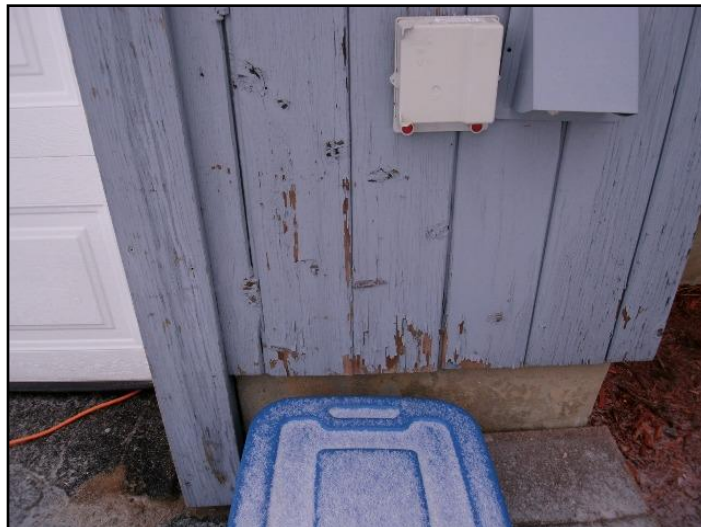
3. Paint or stain - needed

5. Condition: • [Paint or stain - needed](#)

Implication(s): Shortened life expectancy of material

Location: West

Repaint wood boards.

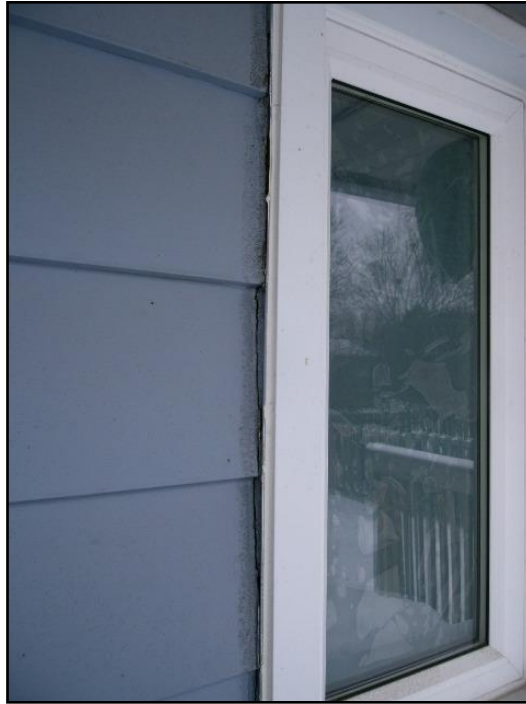
4.

6. Condition: • Calking around window needed.

Location: North Exterior

Task: Repair

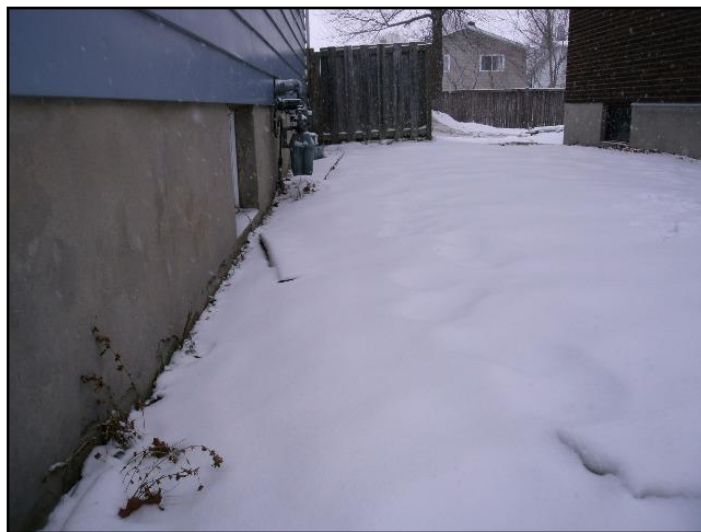
5. Improper slope

8. Condition: • [Improper slope](#)

Implication(s): Chance of water damage to contents, finishes and/or structure

Location: Various

Task: Repair

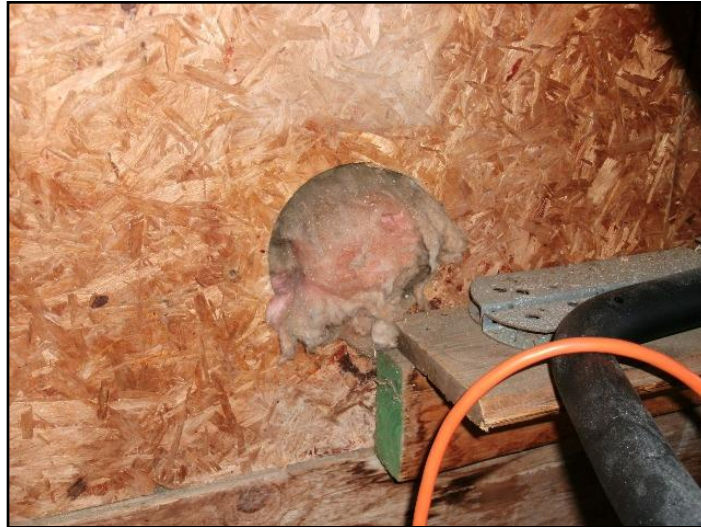
6. Not gastight

9. Condition: • Not gastight

Implication(s): Hazardous combustion products entering home

Location: Interior garage wall

Task: Repair

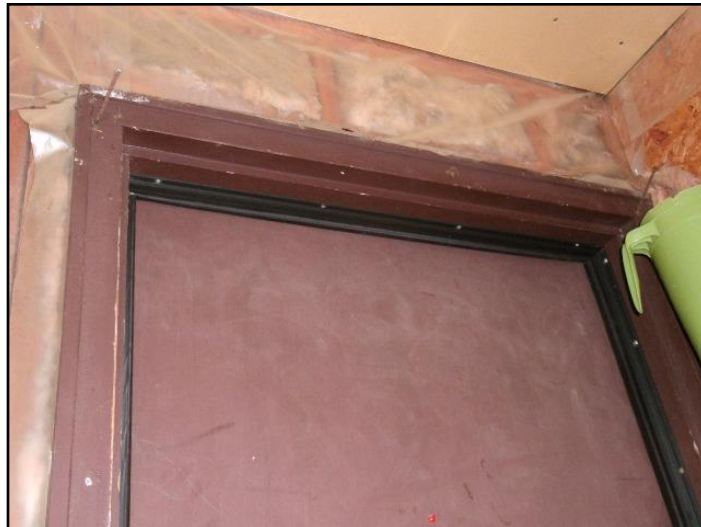
7. No self-closer

10. Condition: • [No self-closer](#)

Implication(s): Hazardous combustion products entering home | Increased fire hazard

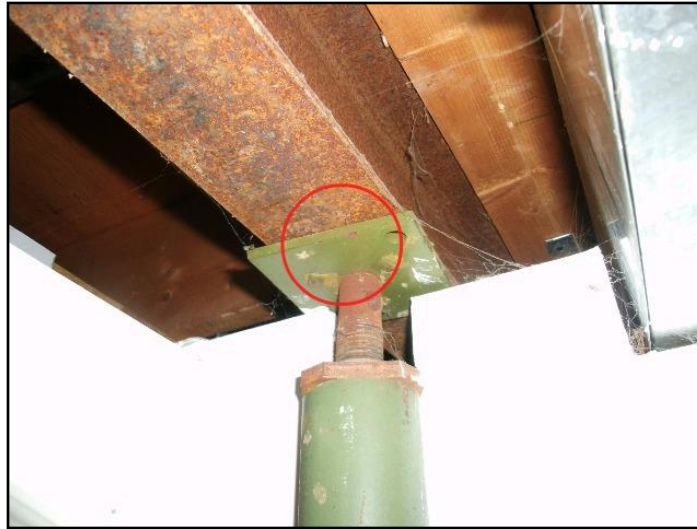
8. Steel beams

Steel beam rusted, and beam is not properly secured to column. Just monitor.

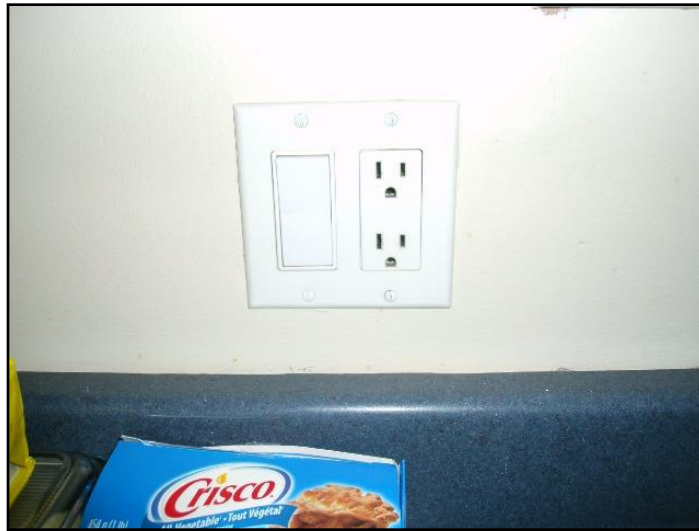
9. No GFCI

• No GFCI

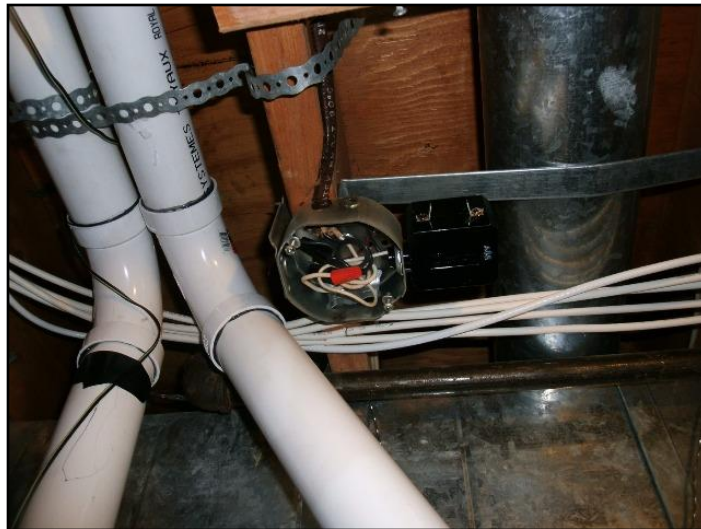
10. Cover loose or missing

11. Condition: • [Cover loose or missing](#)

Implication(s): Electric shock | Fire hazard

Location: Northwest East Basement Furnace Room Garage

Task: Provide

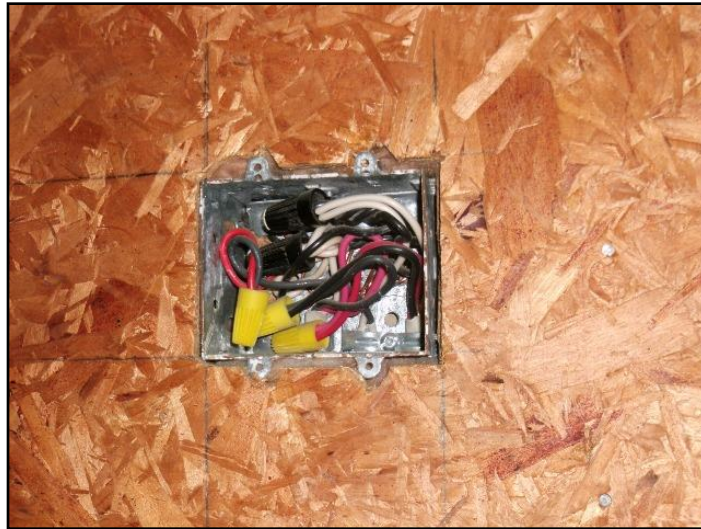
11. Cover loose or missing

12. Condition: • [Cover loose or missing](#)

Implication(s): Electric shock | Fire hazard

Location: Garage

Task: Provide

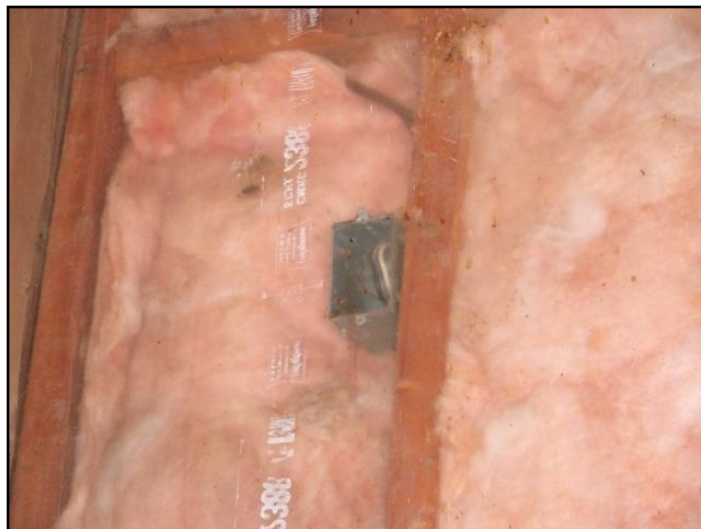
12. Cover loose or missing

13. Condition: • [Cover loose or missing](#)

Implication(s): Electric shock | Fire hazard

Location: Garage

Task: Provide

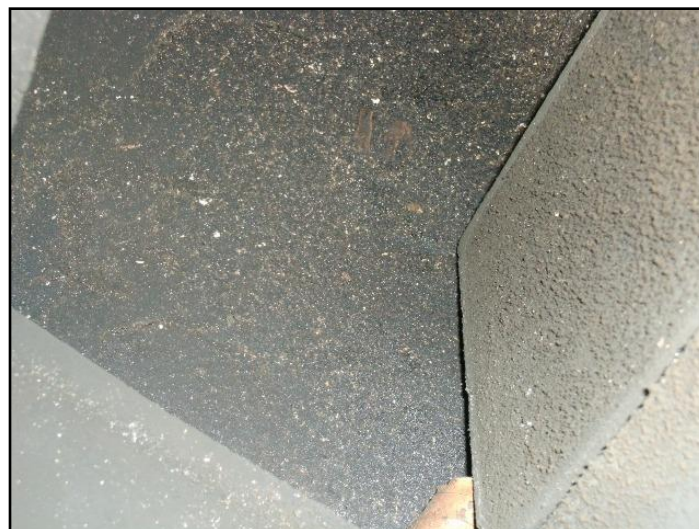
13. Creosote build-up

15. Condition: • [Creosote build-up](#)

Implication(s): Increased fire hazard

Clean before using fireplace.

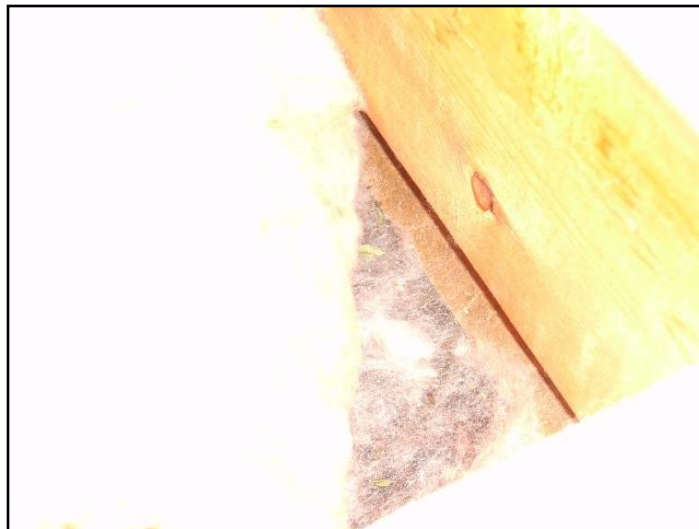
14. Amount less than current standards

16. Condition: • [Amount less than current standards](#)

Implication(s): Increased heating and cooling costs

Location: Attic

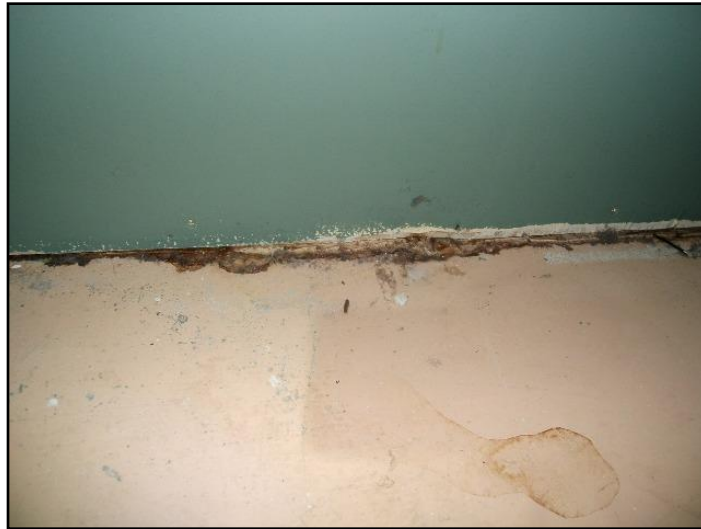
15. *Stains*

19. Condition: • [Stains](#)

Implication(s): Cosmetic defects | Chance of water damage to contents, finishes and/or structure

Location: Southeast Basement

Task: Monitor
