# INSPECTION REPORT

For the Property at:  
**374 ADELAIDE AVE WEST**  
OSHAWA, ON L1J 2R6

Prepared for: X X  
Inspection Date: Saturday, September 12, 2020  
Prepared by: Paul Christensen RHI, NCI

Report No. 1785

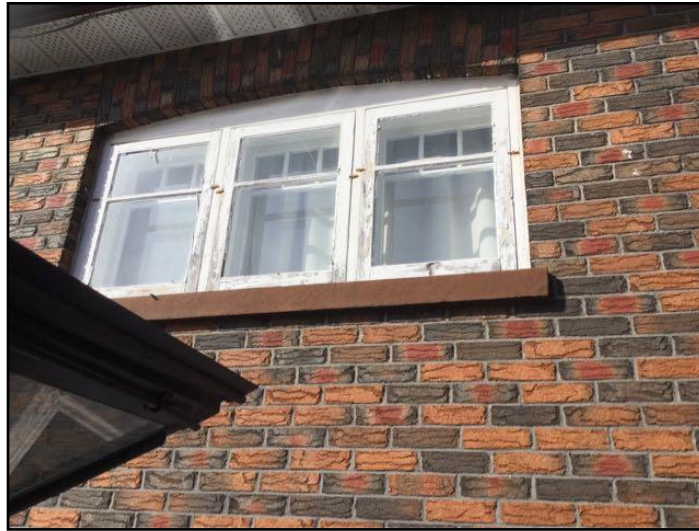
1. *Paint or stain needed*

**2. Condition:** • Paint or stain needed

**Implication(s):** Material deterioration

**Location:** East Exterior

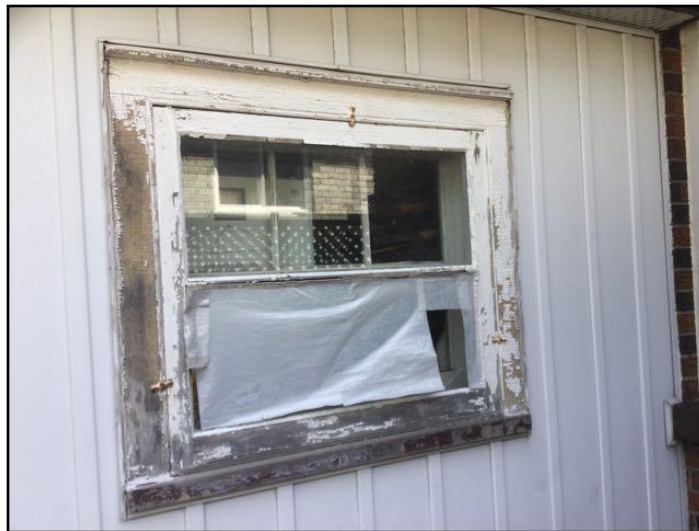
2. *Paint or stain needed*

**3. Condition:** • Paint or stain needed

**Implication(s):** Material deterioration

**Location:** Rear Exterior

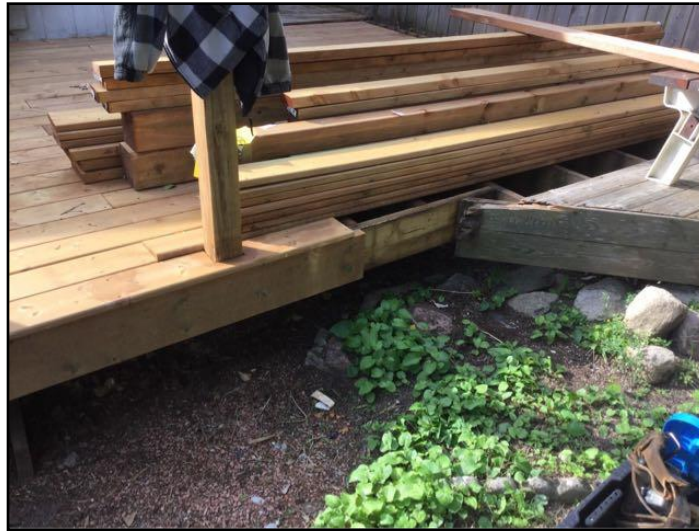
3.

**4. Condition:** • Under repair

**Location:** Rear Yard

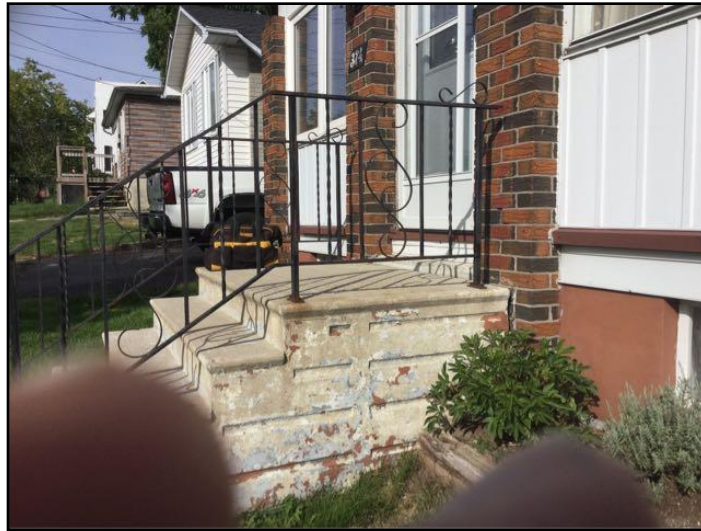
5. Condition: • Ineffective

Implication(s): Fall hazard

Location: Front

4. Ineffective

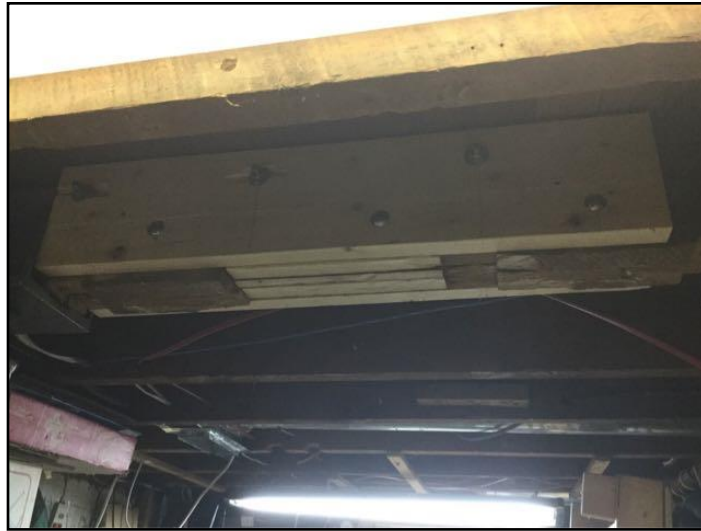
**6. Condition:** • Prior repairs

**Implication(s):** Weakened structure | Chance of structural movement

**Location:** Basement

5. Prior repairs

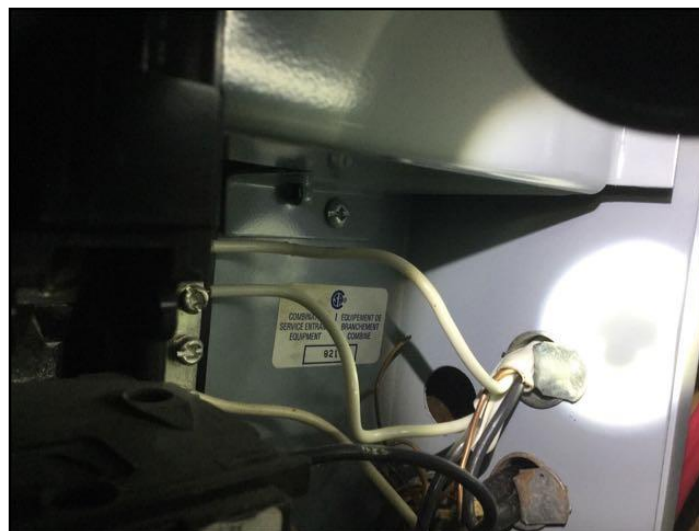
**8. Condition:** • Openings in panel

**Implication(s):** Electric shock | Fire hazard

**Location:** Basement Front

6. Openings in panel

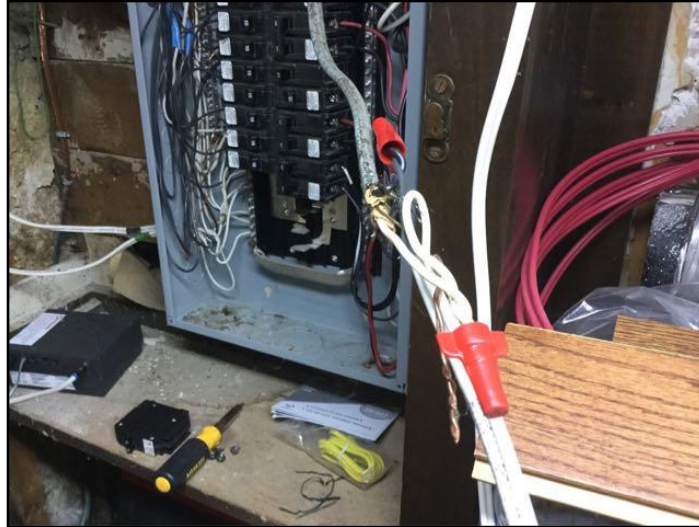
**9. Condition:** • Open splices

**Implication(s):** Electric shock | Fire hazard

**Location:** Southwest Basement

7. Open splices

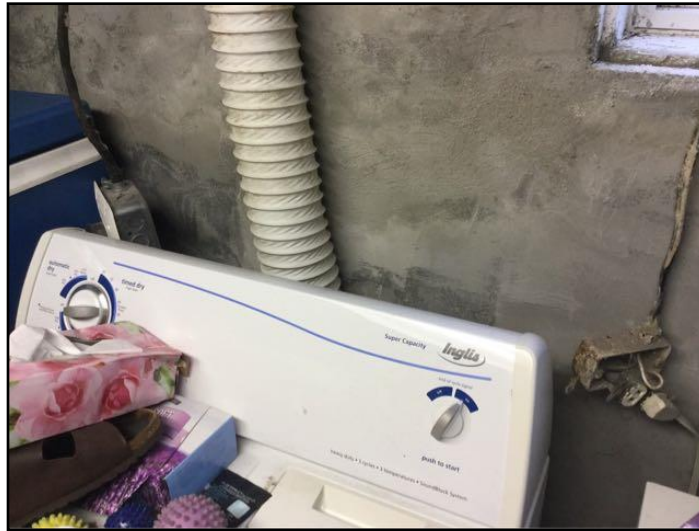
**10. Condition:** • Not well secured

**Implication(s):** Electric shock | Fire hazard

**Location:** West Basement Laundry Area

8. Not well secured

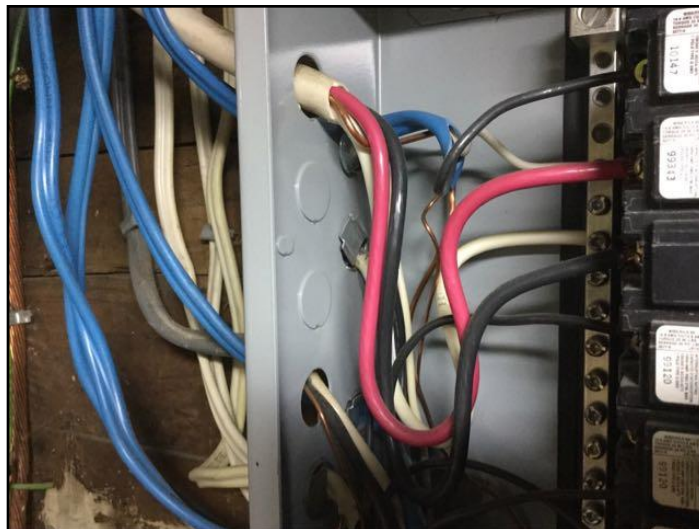
**11. Condition:** • Missing or Improper cable clamp used.

Implications: Fire Hazard / Electric Shock

**Location:** Front Basement

9. Missing or Improper cable clamp...

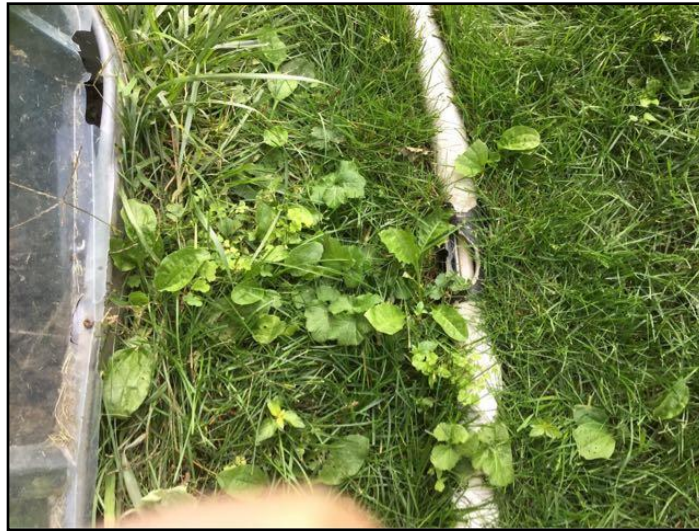
**12. Condition:** • Damaged Conduct Implications Electric shock

**Location:** West Yard

10. Damaged Conduct Implications Electric shock

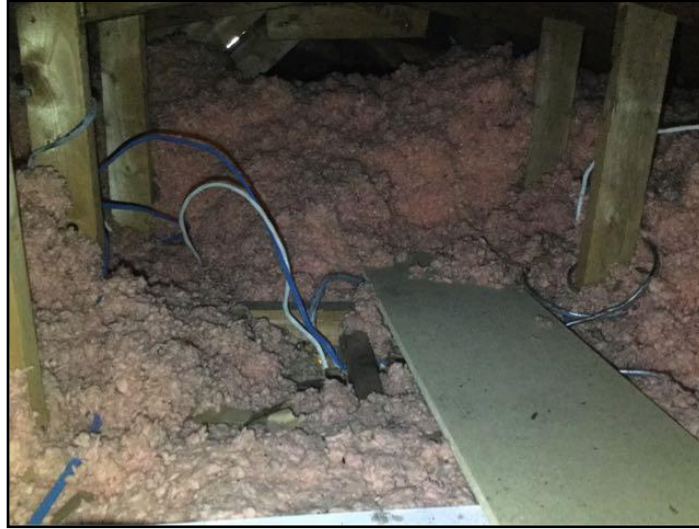
**19. Condition:** • Gaps or voids

No insulation over hall light area

**Implication(s):** Increased heating and cooling costs | Reduced comfort

**Location:** Attic

11. *Gaps or voids*

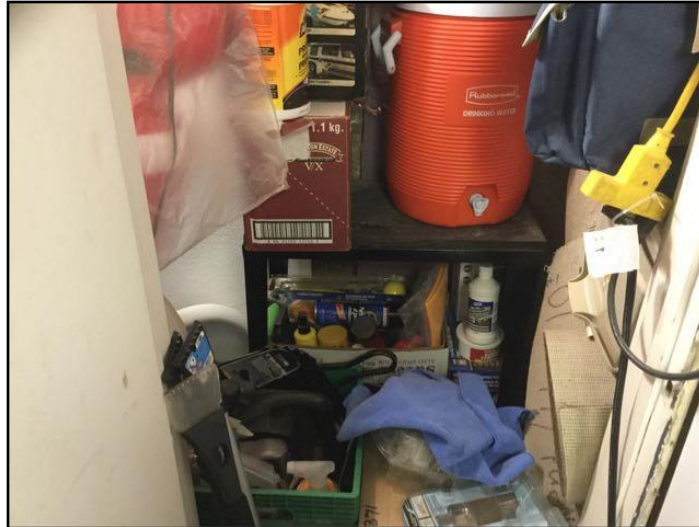
12.

**20. Condition:** • 2 piece bathroom not in use

**Location:** Basement

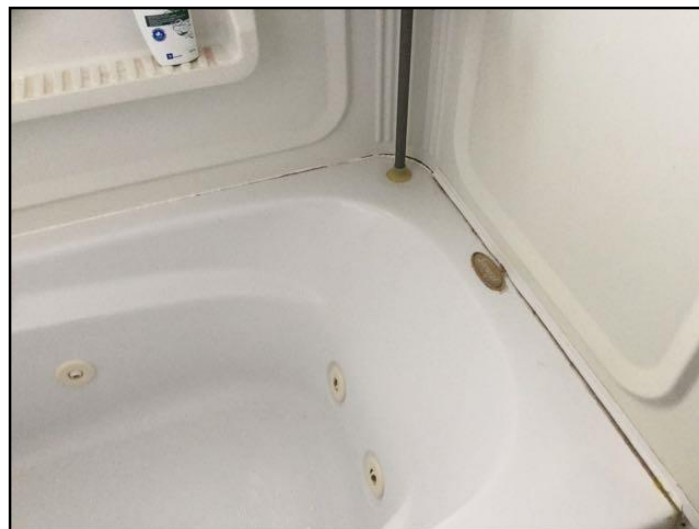
**25. Condition:** • Caulking loose, missing or deteriorated

**Implication(s):** Chance of water damage to structure, finishes and contents

**Location:** Second Floor Bathroom

13. Caulking loose, missing or deteriorated

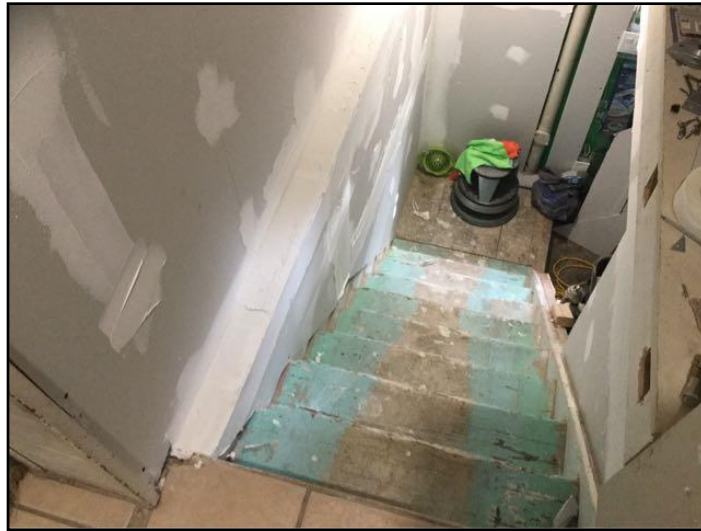
**28. Condition:** • Missing

Missing, under construction

**Implication(s):** Fall hazard

**Location:** Basement

14. Missing

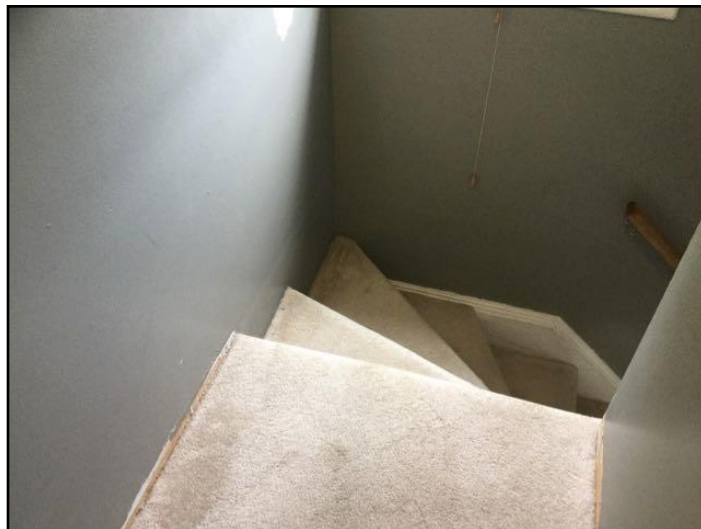
29. Condition: • Missing

Implication(s): Fall hazard

Location: Second Floor

15. Missing

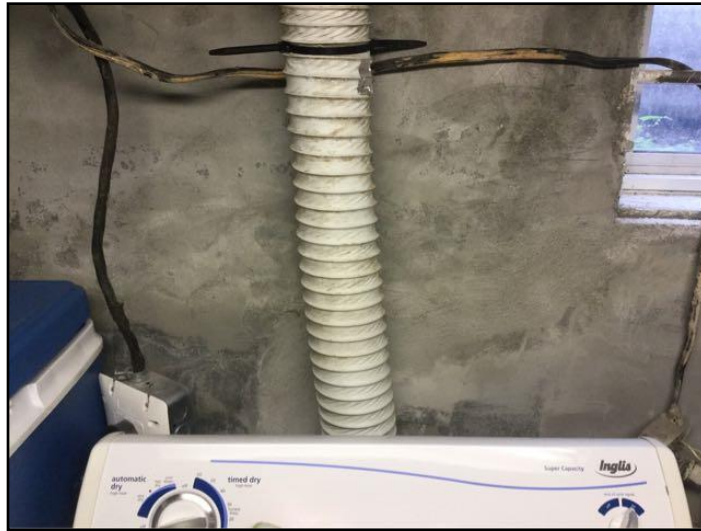
30. Condition: • Plastic dryer vent

Implication(s): Equipment ineffective | Fire hazard

Location: Basement Laundry Area

16. Plastic dryer vent
