# YOUR INSPECTION REPORT

27 St Johns Road  
Toronto, ON M6P 1T7

INSPECTION DATE:  
Thursday, August 13, 2020

RE: Report No. 2705, v.2  
27 St Johns Road  
Toronto, ON  
M6P 1T7

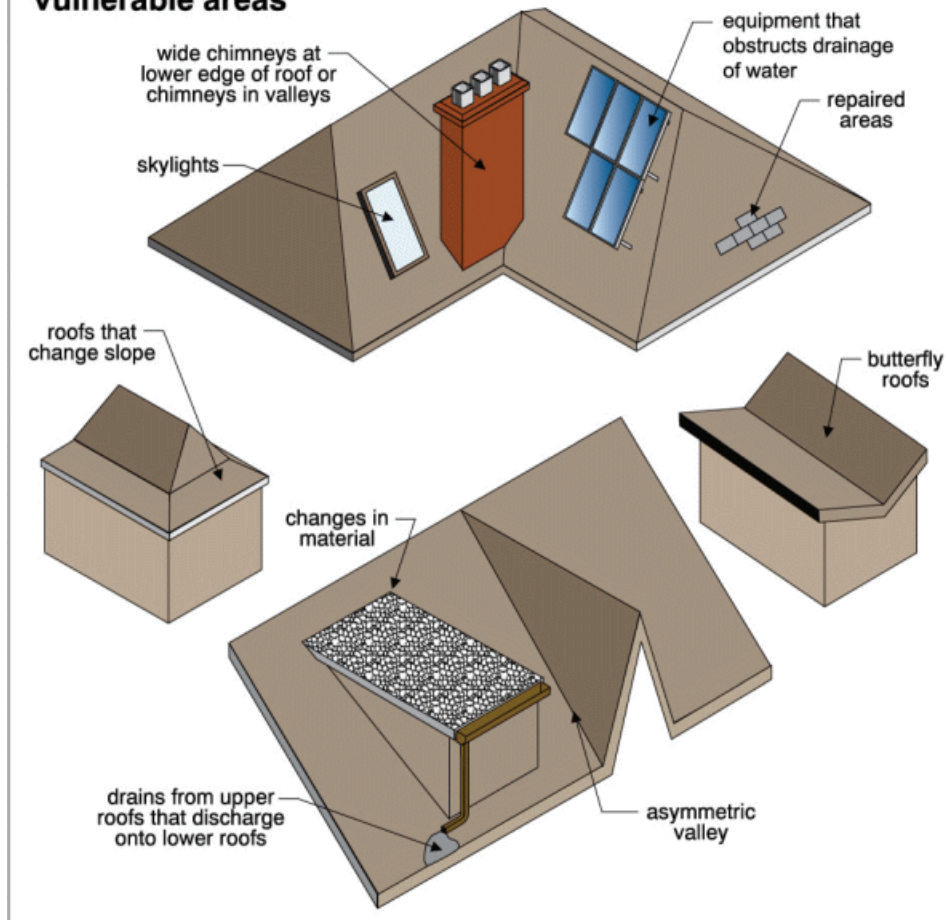
## Vulnerable areas

skylights are vulnerable areas on all roofs. Monitor regularly

**Implication(s):** Chance of water damage to contents, finishes and/or structure

**Task:** Inspect annually

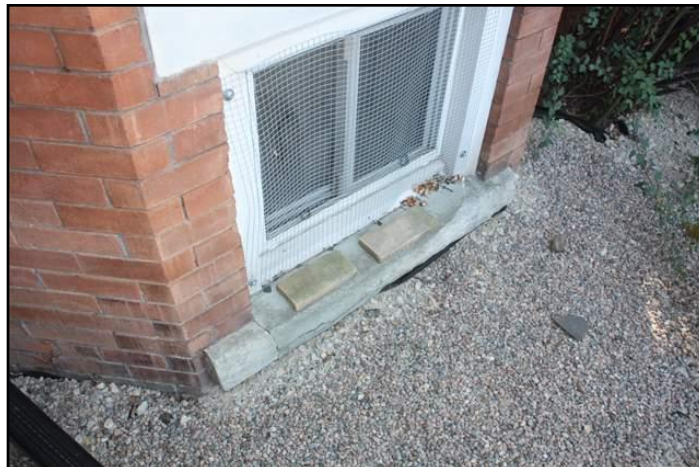
4. Sill deteriorated

**Condition:** • [Sill deteriorated](#)

Minor cracks of parging at sill. Patch to prevent further damage. Typical Maintenance

**Implication(s):** Material deterioration

**Location:** Front Exterior

**Task:** Patch /Parge

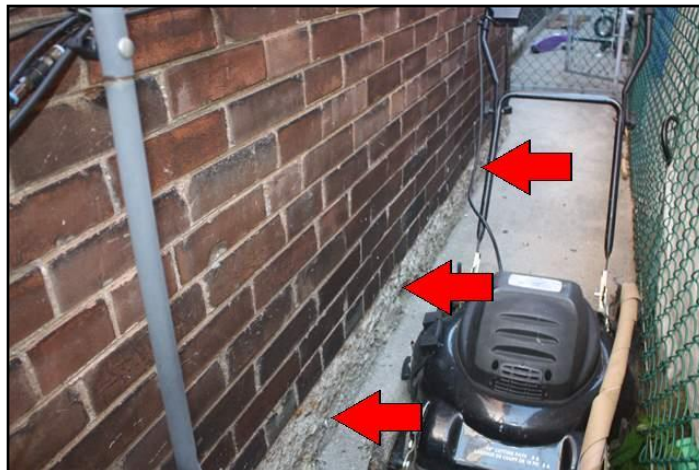
5. Parging damaged or missing

**Condition:** • [Parging damaged or missing](#)

**Location:** Left Exterior Wall

**Task:** Provide parging

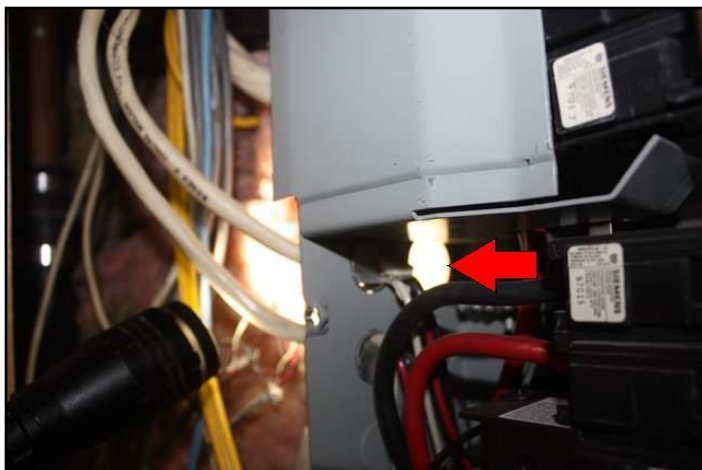
9. First panel on left

**Condition:** • [Openings in panel](#)

**Implication(s):** Electric shock | Fire hazard

**Location:** Various Basement Panel

**Task:** Correct

any exposed panel openings (that would allow access to the inside of the panel) should be fitted with secure covers

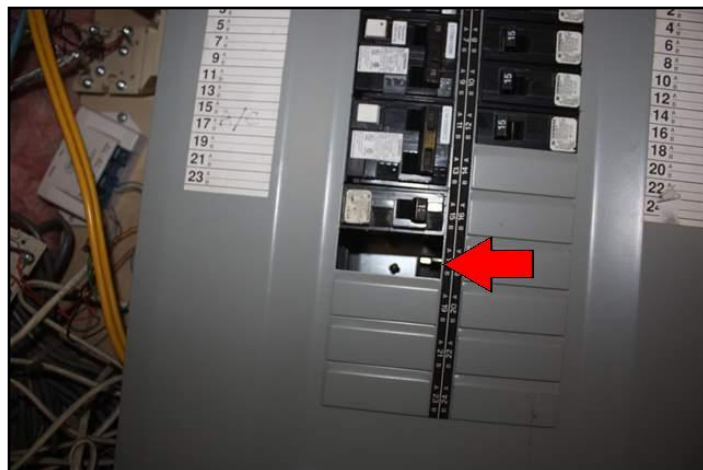
10. Openings in panel

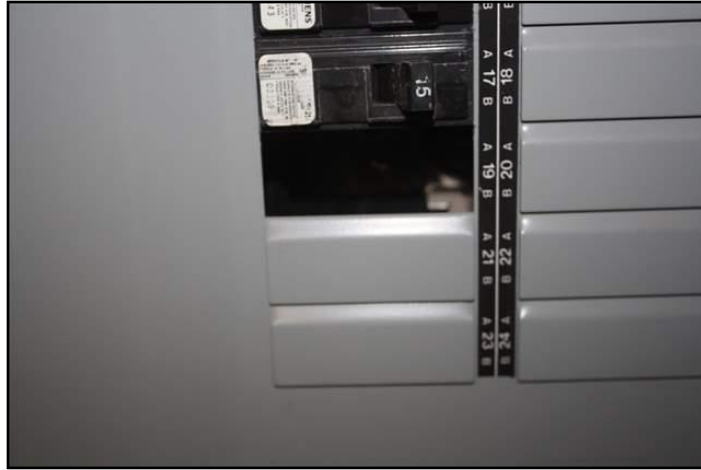
11. Openings in panel

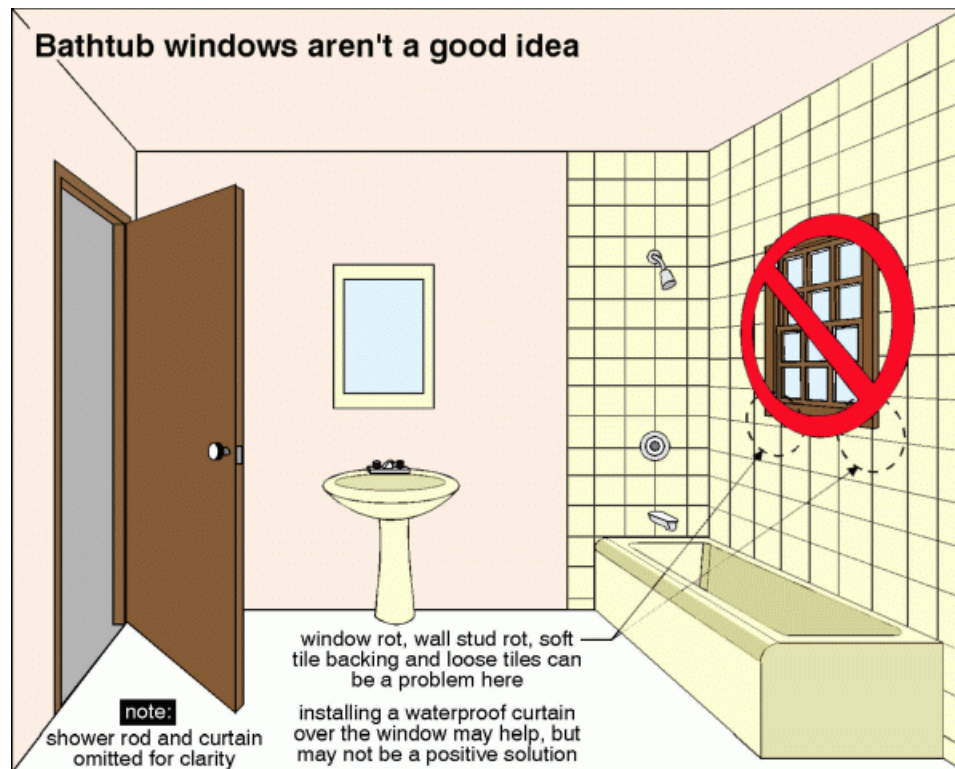
**Condition:** • [Unprotected window](#)

**Implication(s):** Chance of damage to finishes and structure

**Task:** Improve

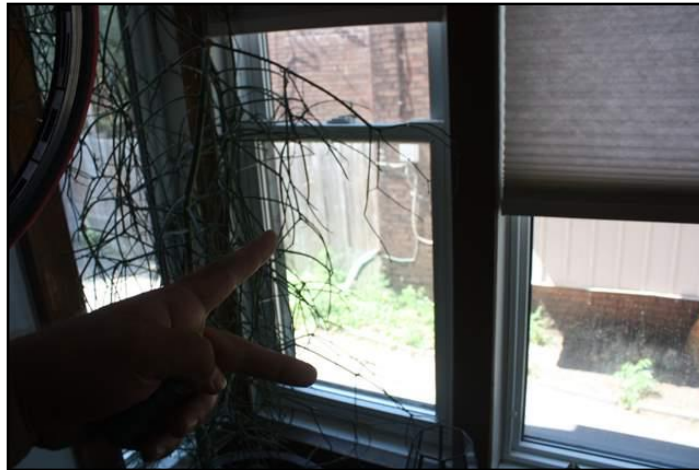
**Condition:** • Painted shut

13. Painted shut

**Task:** Correct

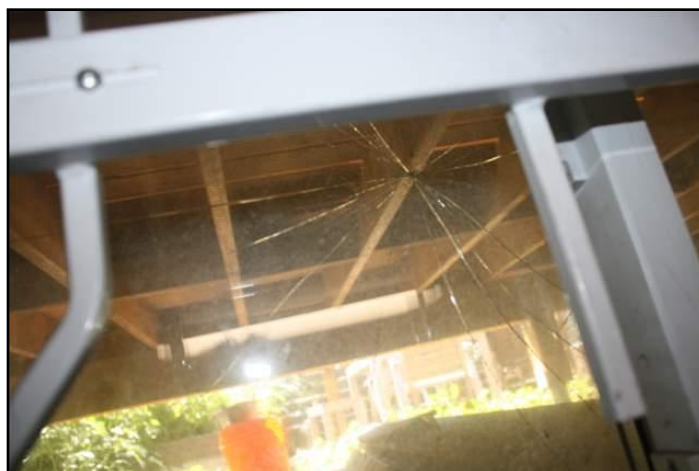
**Condition:** • [Cracked](#)

14. Cracked

**Task:** Replace

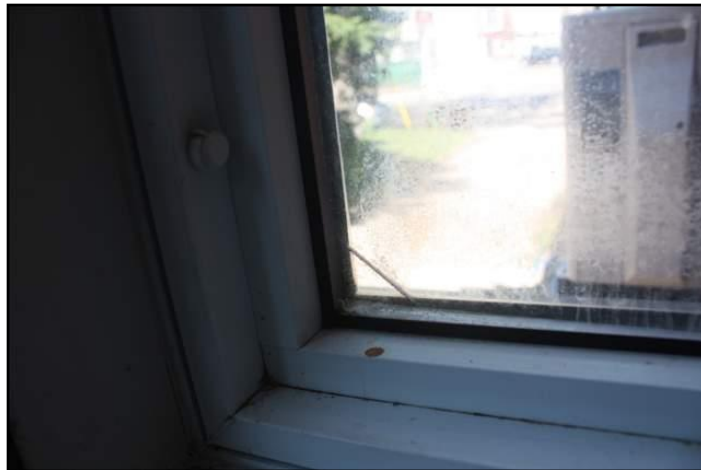
**Condition:** • [Cracked](#)

15. Cracked

**Task:** Replace

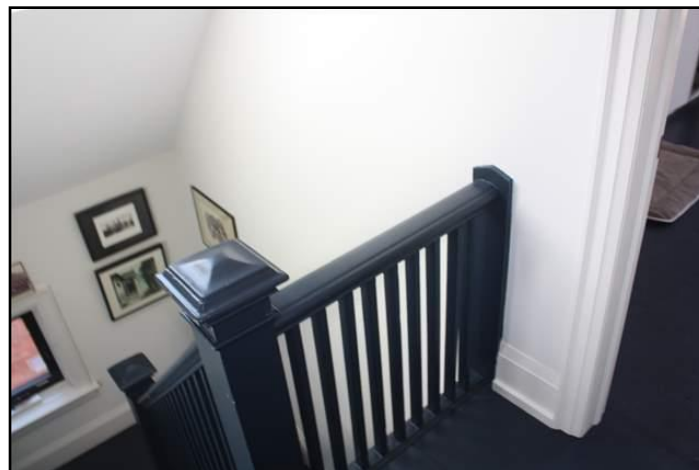
**Condition:** • [Too low](#)

**Implication(s):** Fall hazard

16. Too low

**Task:** Upgrade

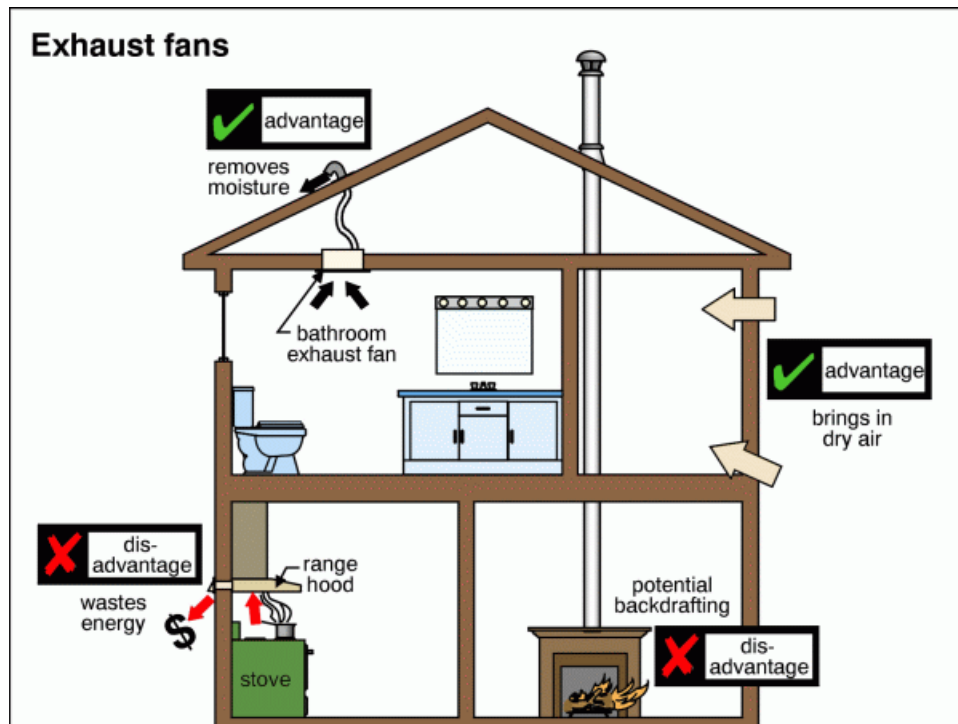
**Condition:** • [Missing](#)

**Implication(s):** Chance of condensation damage to finishes and/or structure

**Task:** Upgrade
