YOUR INSPECTION REPORT

FOR THE PROPERTY AT:
2 Forfar Court
Toronto, ON M9A 2C8

INSPECTION DATE:
Tuesday, April 30, 2019

RE: Report No. 2446
2 Forfar Court
Toronto, ON
M9A 2C8

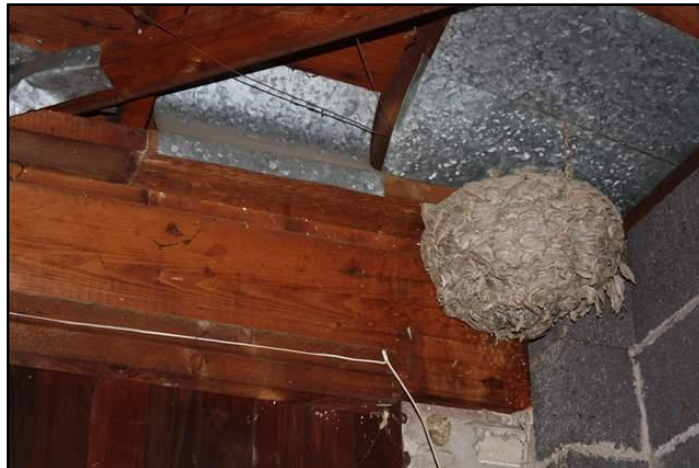
4.

• inactive wasp nest. Homeowner had nest treated.

Location: Garage

Task: Remove old nest

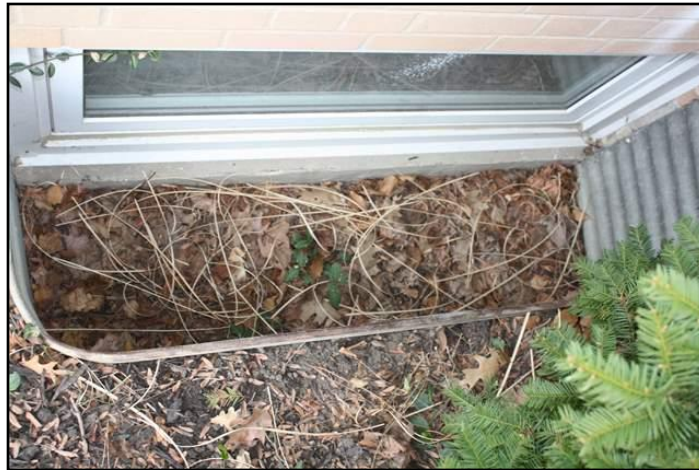
5. Example

Condition: • [Obstructed/clogged](#)

Location: Various Exterior

Task: Clean

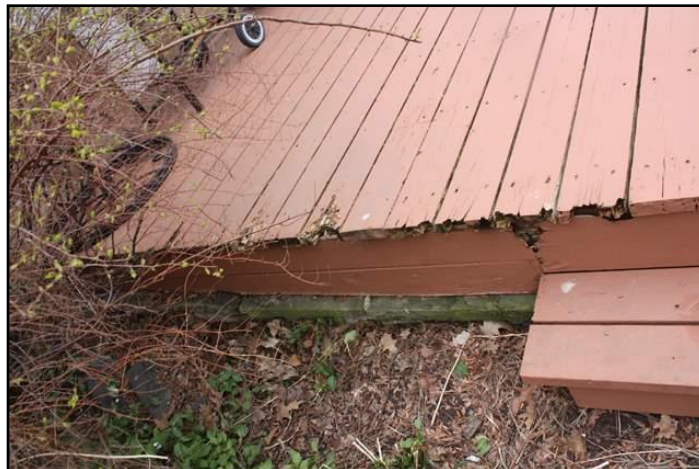
Condition: • [Rot](#)

Implication(s): Weakened structure

Location: Various Rear Exterior Deck

6. Rot example

Task: Repair / Replace

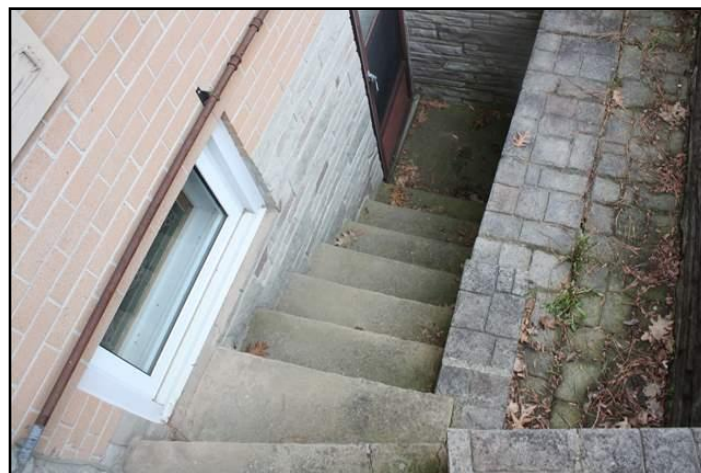
Condition: • [Guard and handrail problems](#)

Implication(s): Fall hazard

Location: Rear Exterior

7. Guard and handrail problems

Task: Provide Handrails

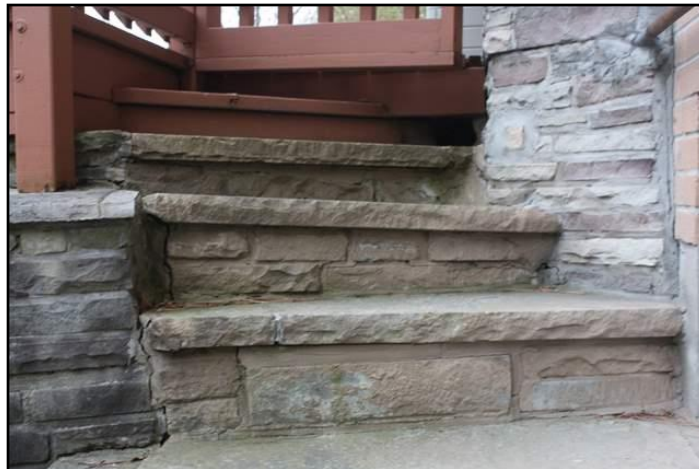
Condition: • [Step and landing problems](#)

Settlement.

Location: Rear Exterior

8. Step and landing problems

Task: Repair / Replace

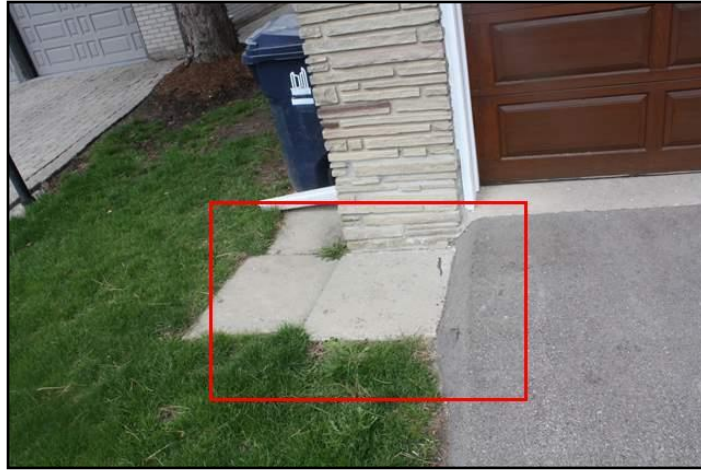
Condition: • [Improper slope or drainage](#)

Implication(s): Chance of water damage to contents, finishes and/or structure

Location: Exterior

9. Improper slope or drainage

Task: Improve

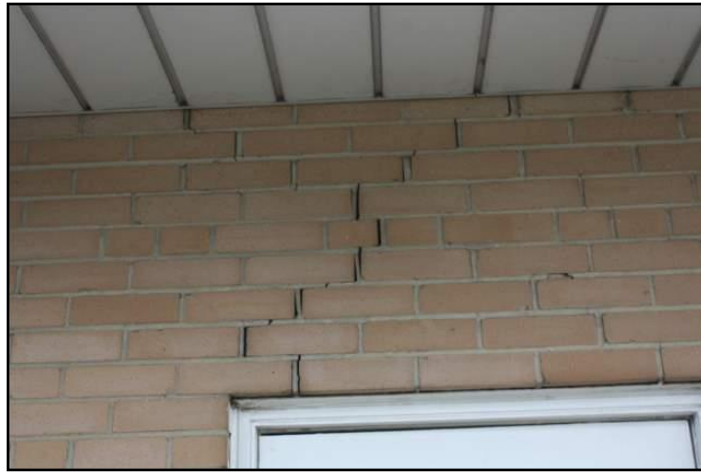
Condition: • [Cracked](#)

Settlement Cracks noted at wall. These are common above and below windows and doors. Our recommendation is to repair the cracks (Tuckpoint mortar and patch bricks) to prevent water entry and/or further damage. Note the date, and monitor for activity. Crack repairs / maintenance can be expected with most homes of this age.

10. Cracked

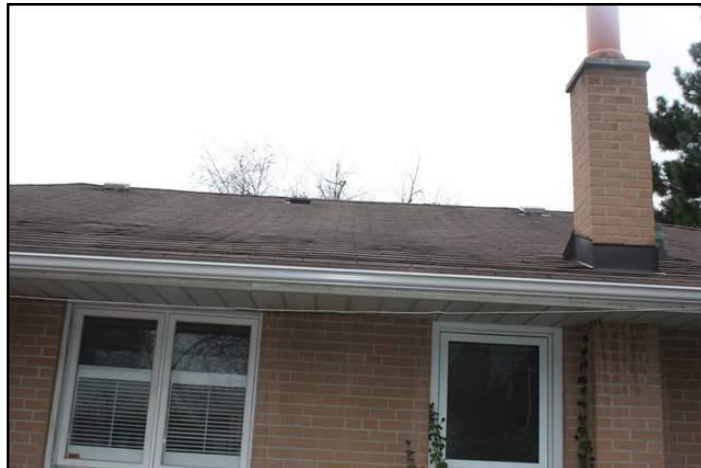
Condition: • [Sagging](#)

Sagging noted. This is common with homes of this era when a thinner 3/8 inch sheathing were used. We recommend that you replace parts of the roof sheathing when replacing the roof covering.

11. Sagging

Task: Replace various sheathing

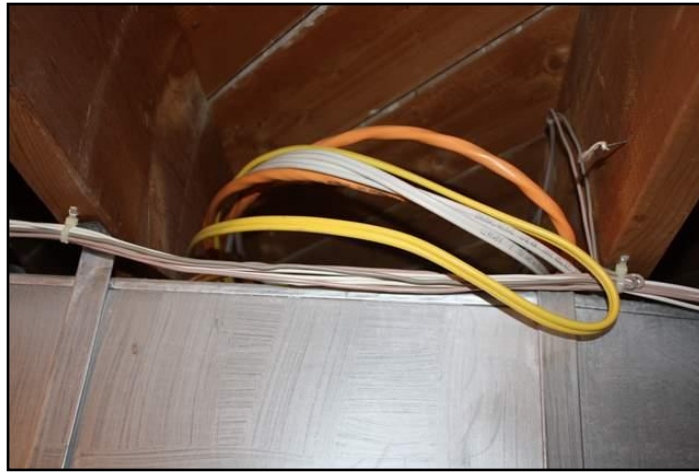
Condition: • [Too close to duct, pipe, vent or chimney](#)

Implication(s): Electric shock | Fire hazard

12. Too close to duct, pipe, vent or chimney

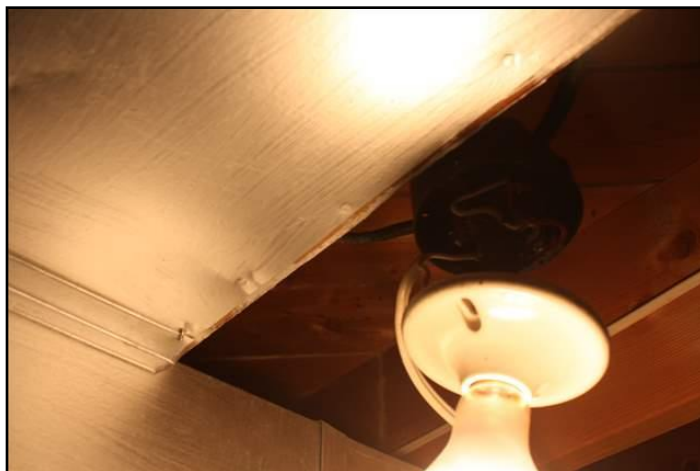
Condition: • [Damage](#)

Implication(s): Electric shock | Fire hazard

13. Damage

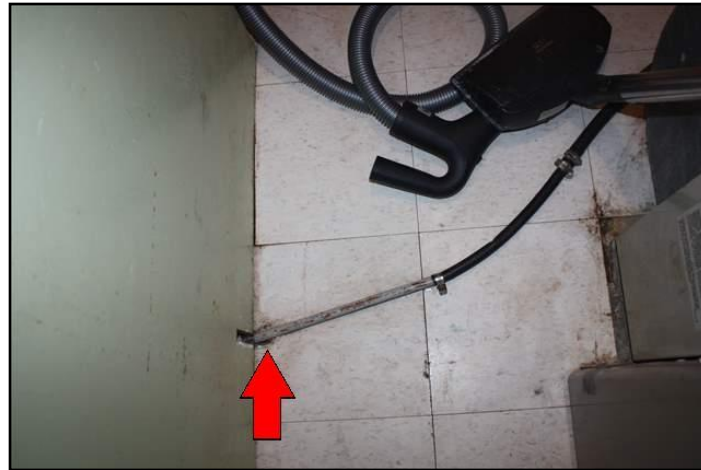
Condition: • [Condensate problems](#)

Minor condensate leak and condensate tube. Service by HVAC technician required.

Implication(s): Chance of water damage to contents, finishes and/or structure | Reduced system life expectancy

14. Condensate problems

Task: Repair

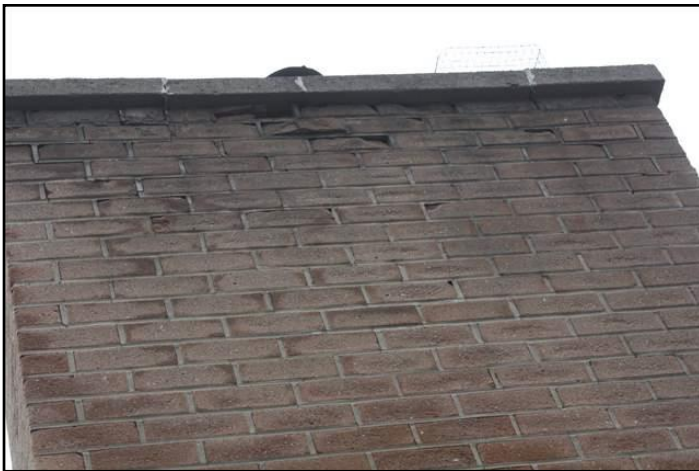
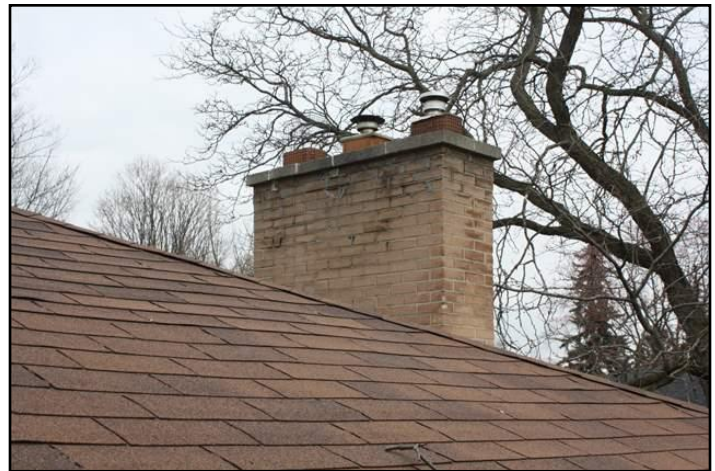
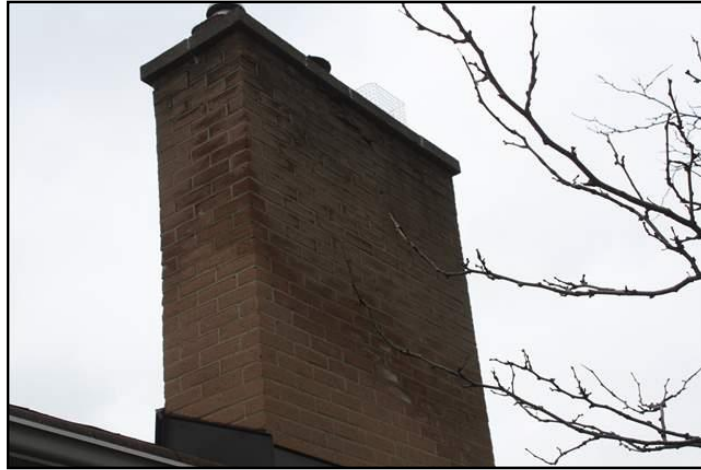
Condition: • [Loose, missing or deteriorated masonry](#)

Implication(s): Material deterioration

15. Loose, missing or deteriorated masonry

16. Loose, missing or deteriorated masonry

17. Loose, missing or deteriorated masonry

Task: Repair

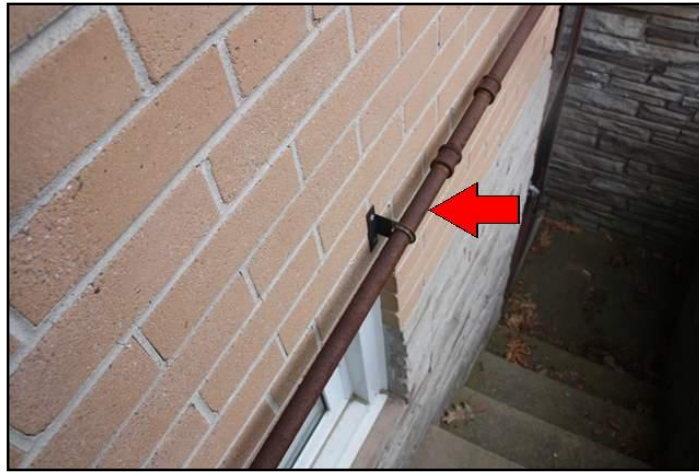
Condition: • [Rust](#)

19. Rust

Task: Further evaluation / Replace

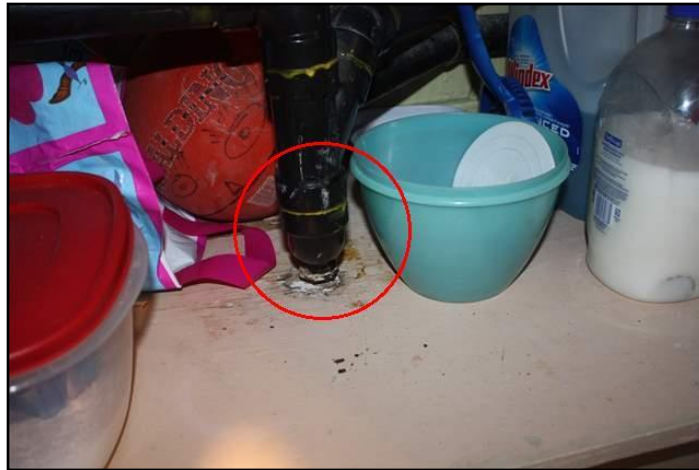
20.

Condition: • Prior repair.

Task: Repair / Replace
