# Your Inspection Report

9 Sandcliff Rd  
Toronto, ON M6N 2M4

RE: Report No. 61620  
9 Sandcliff Rd  
Toronto, ON  
M6N 2M4

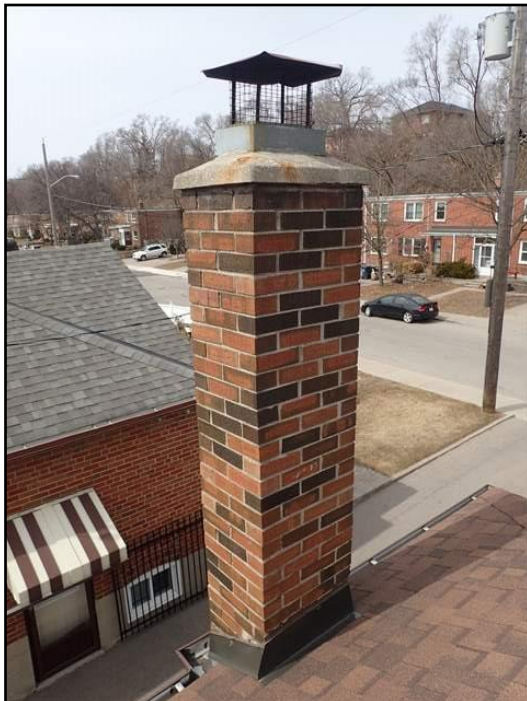
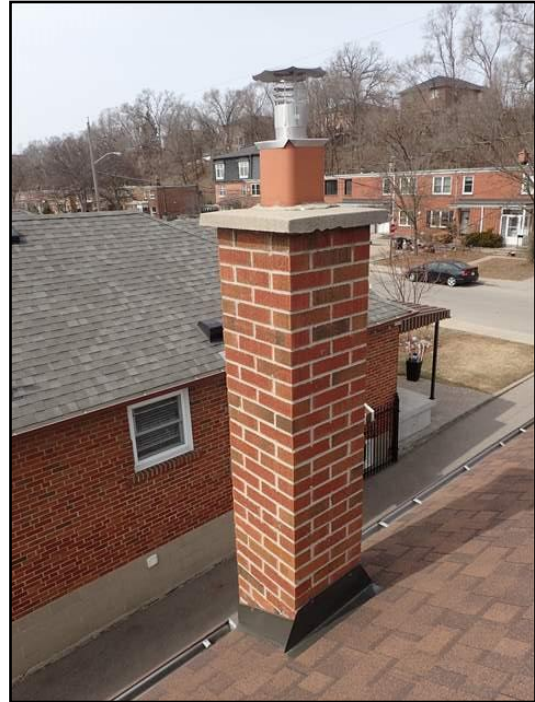
*Chimneys are in good condition*

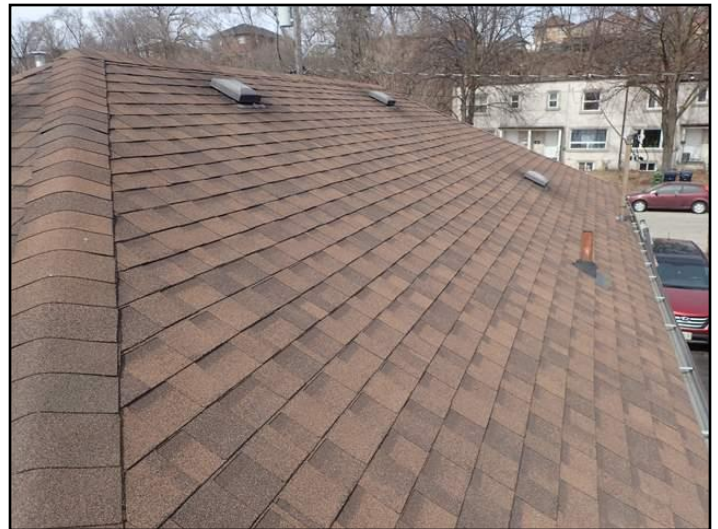
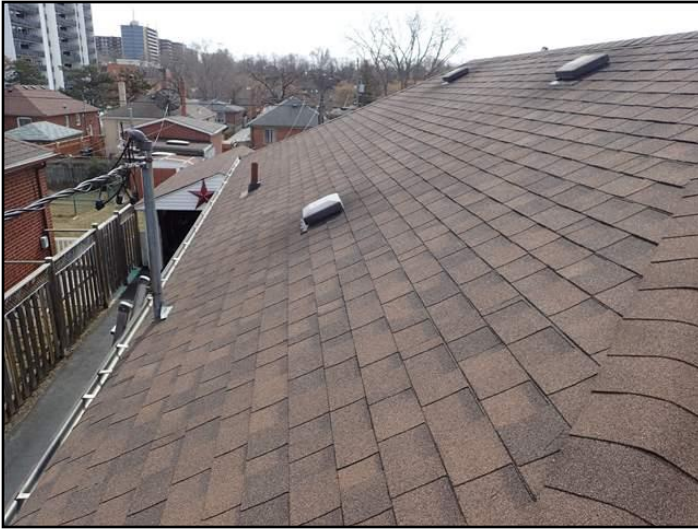
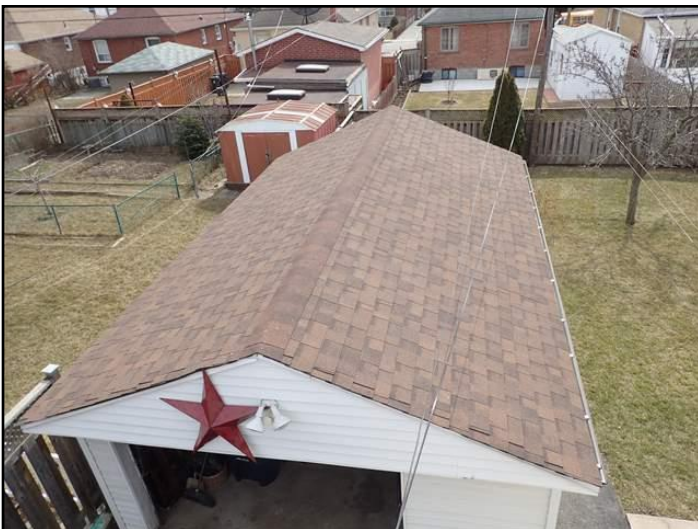
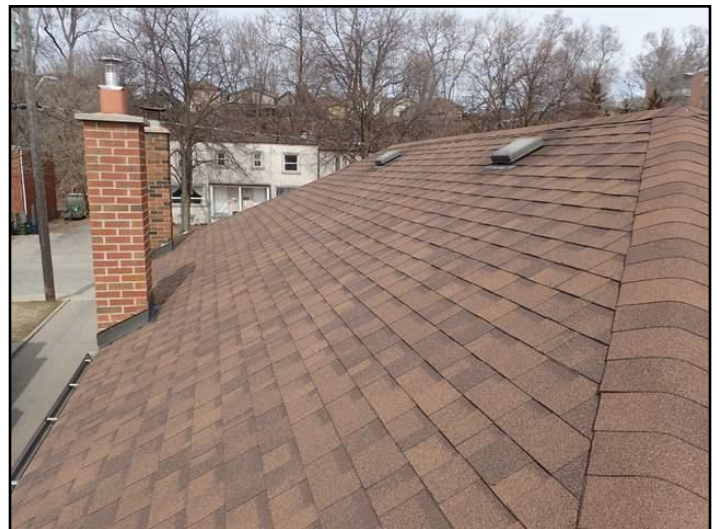
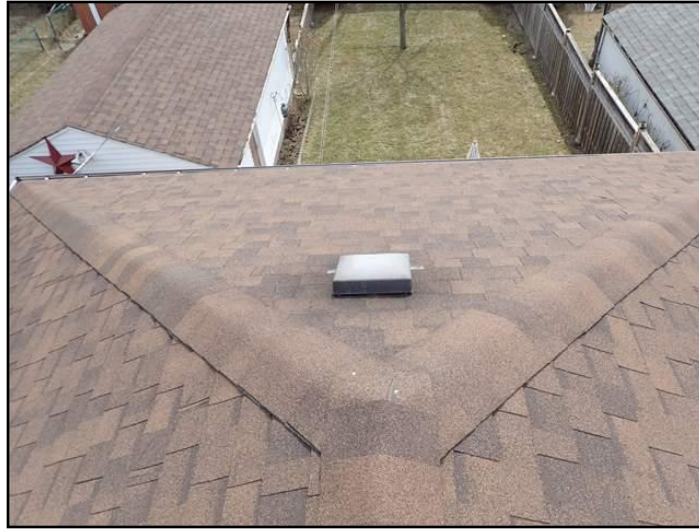
- The roof shingles look relatively young and they are in good condition.

They are a premium grade and while warranties may range 30 years and up, a more realistic expectation is usually closer to 20-25 years.

*Shingles are in good condition*

Annual inspections are recommended (on any roof) to take care of any damage and/or regular maintenance items (flashings/caulking).

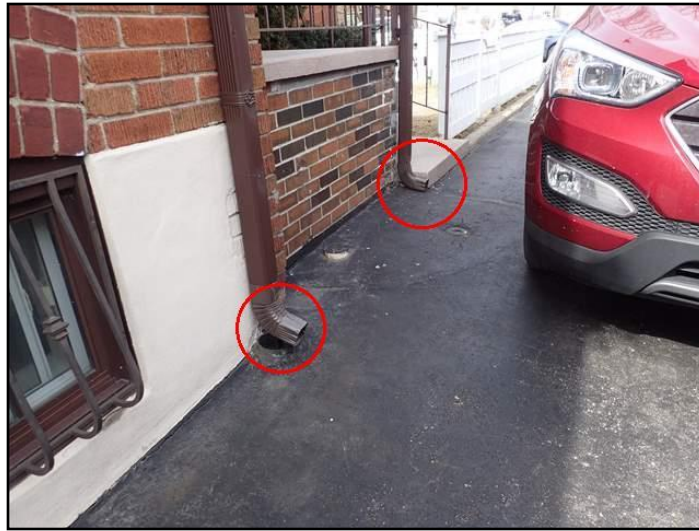
**Condition:** • Less-than-ideal downspout location

*Less-than-ideal downspout location*

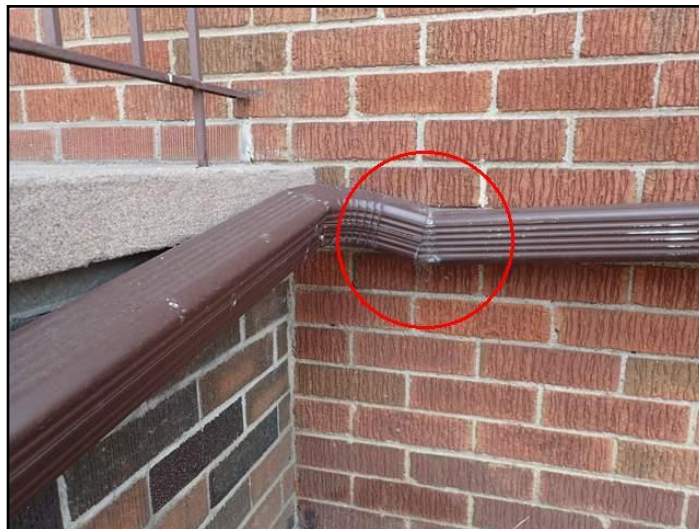
**Condition:** • [Connections loose](#)

*Connections loose*

**Task:** Improve

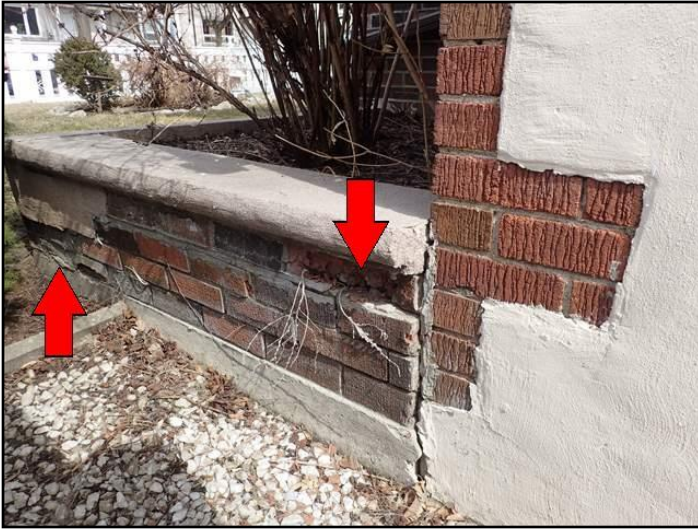
**Condition:** • [Masonry deterioration](#)

Some brick doesn't handle water very well (it will absorb moisture and deteriorate).

Masonry deterioration

Parging can be applied as a sacrificial material and/or the grades should be sloped away to minimize future damage.

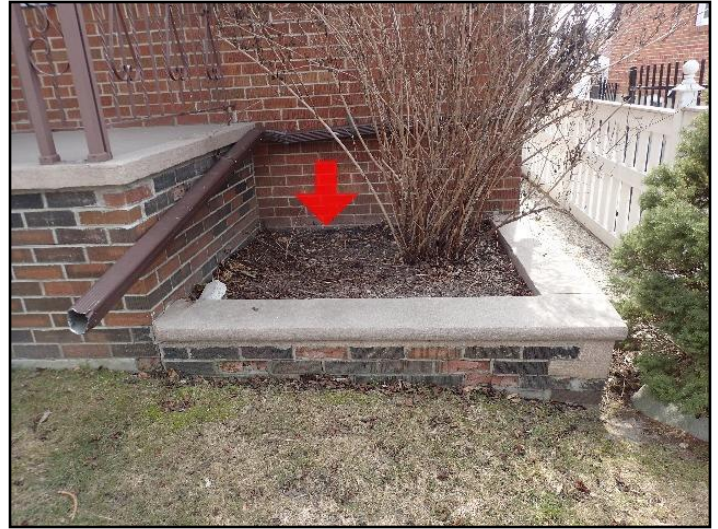
Brick at grade is more vulnerable

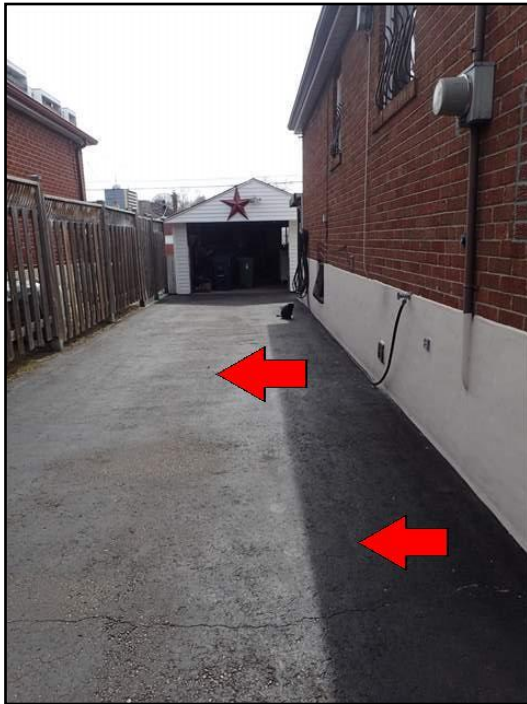
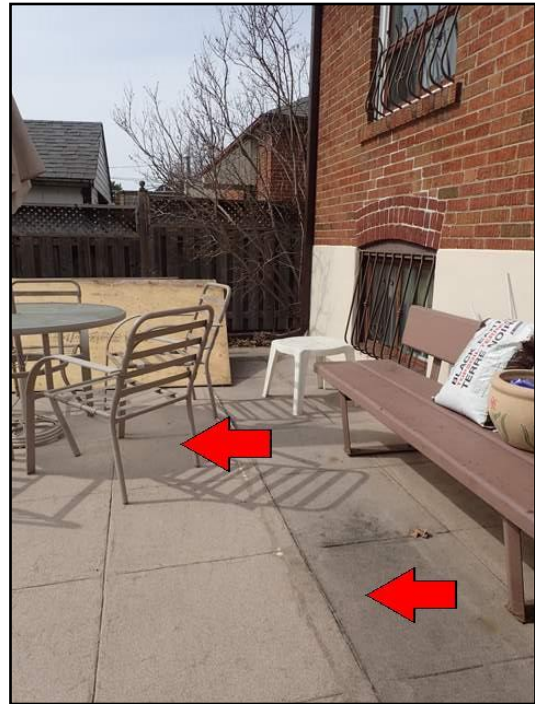
**Condition:** • Lot grading

**Implication(s):** When trying to minimize basement leakage, it is always best to be proactive and slope the grades away from the house.

Maintain slope away from house

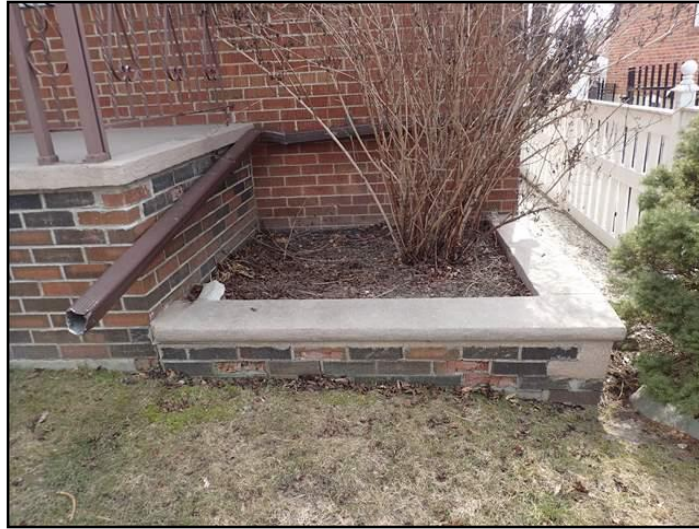
## Condition: • [Planters and gardens against walls](#)

Gardens and planters (and sprinklers) next to the house increase the risk of moisture problems in the basement, especially if they are watered regularly.

*Watch gardens next to house*

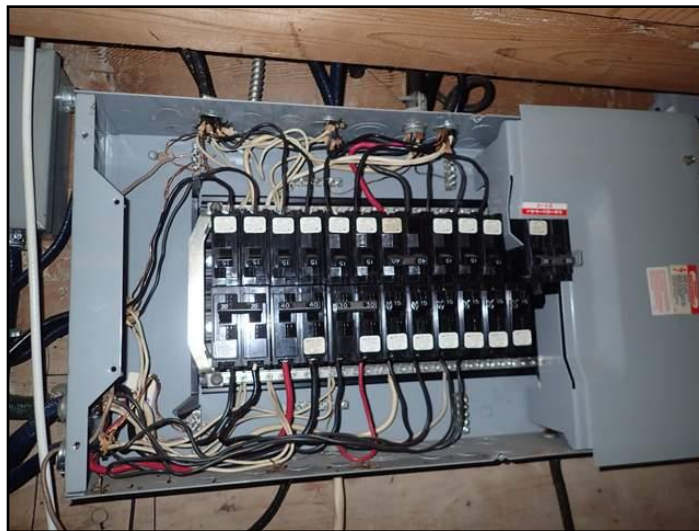
- The panel and the panel wires look professionally organized and well put together.

*Panel and wiring are in good condition*

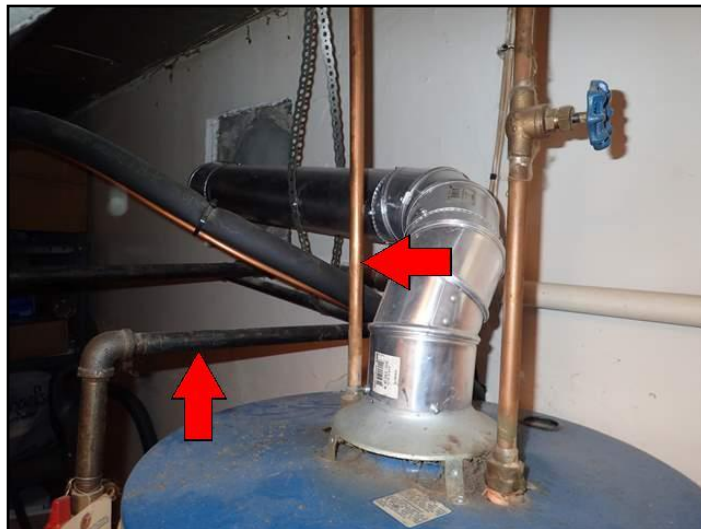
**Condition:** • Bonding (for Gas Piping) - missing

*Bonding (for Gas Piping) - missing*

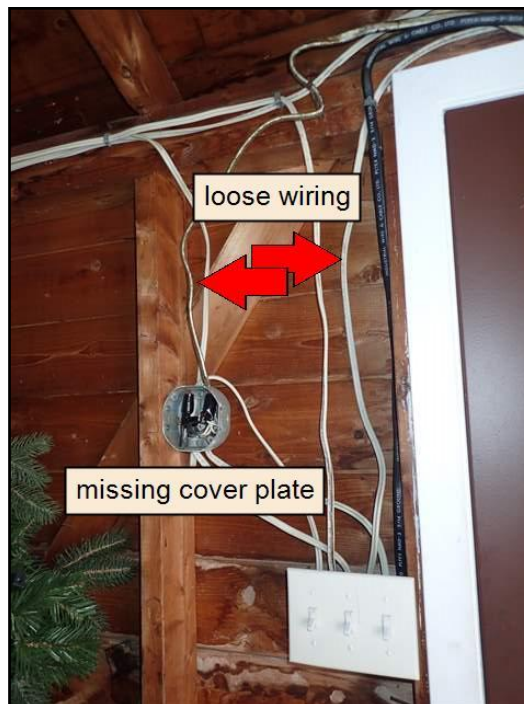
**Condition:** • [Missing](#)

*Missing*

Any missing cover plates should be replaced and, at the same time, any loose wiring should be improved.

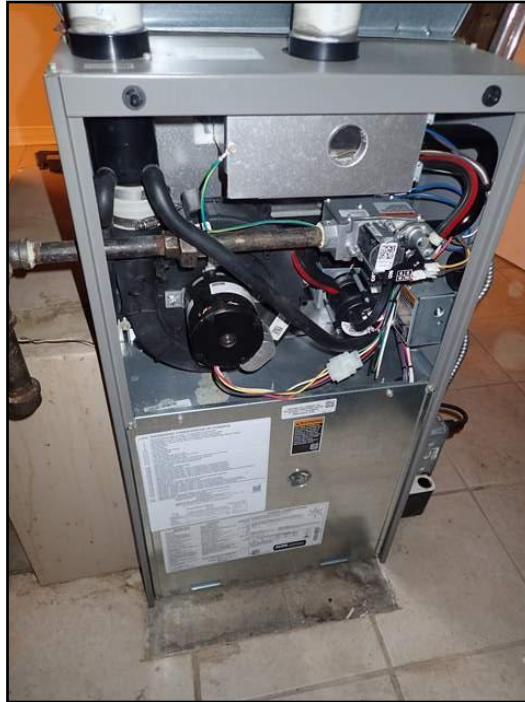
*Furnace cabinet is in good condition*

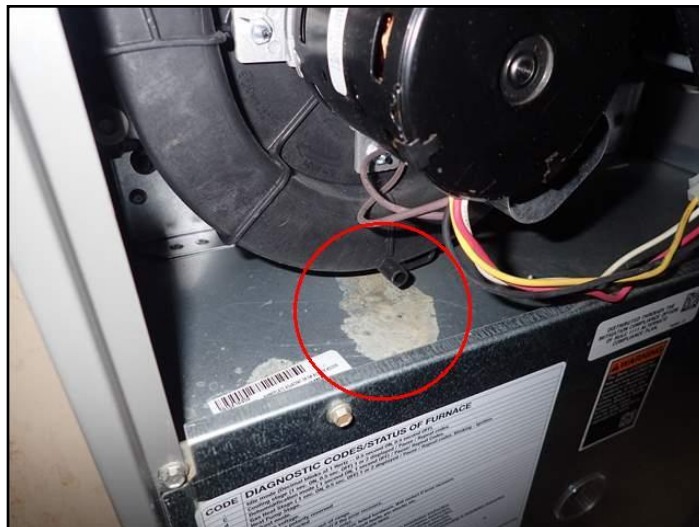
**Condition:** • Water stains in cabinet (dry at inspection)

Usual cause is a leaky induced draft fan or a blocked condensate drain.

*Water stains in cabinet (dry at inspection)*

Watch for leaks when furnace is running for an extended period.

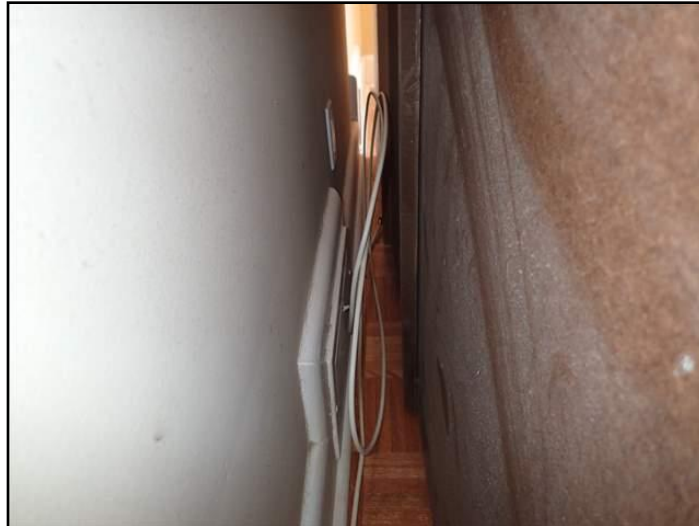
**Condition:** • Ductwork - layout typical of older houses

*Less-than-ideal register layout*

supply air vents can make achieving an even air flow/distribution more of a challenge.  
Contact an HVAC specialist for further evaluation/improvement if needed

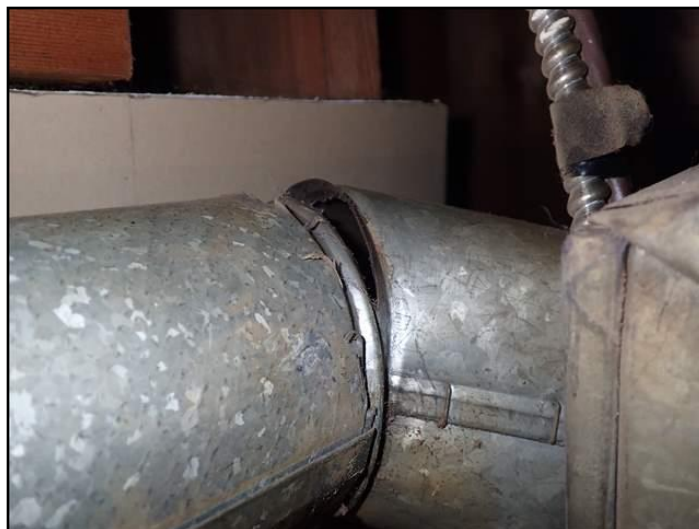
**Condition:** • [Leaky joints](#)

*Leaky joints*

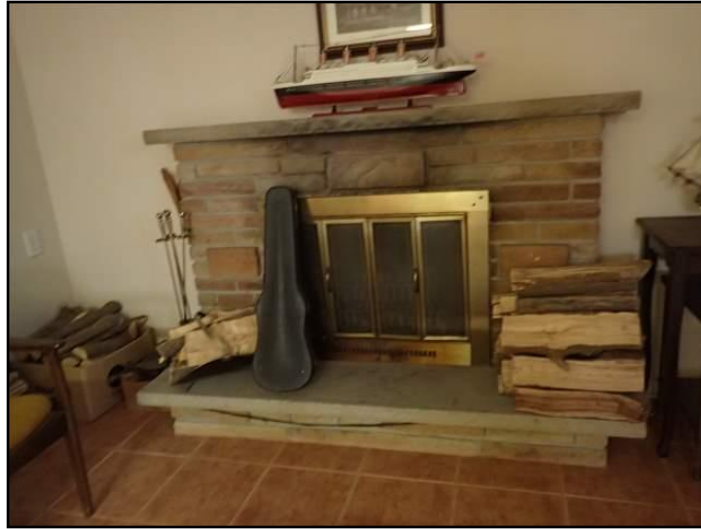
*Inspect, sweep fireplace before using*

**Condition:** • The fireplace, flue and chimney should be inspected and swept as needed by a WETT certified technician and any recommended repairs completed before the unit is used. (WETT - Wood Energy Technology Transfer Inc. is a non-profit training and education association)

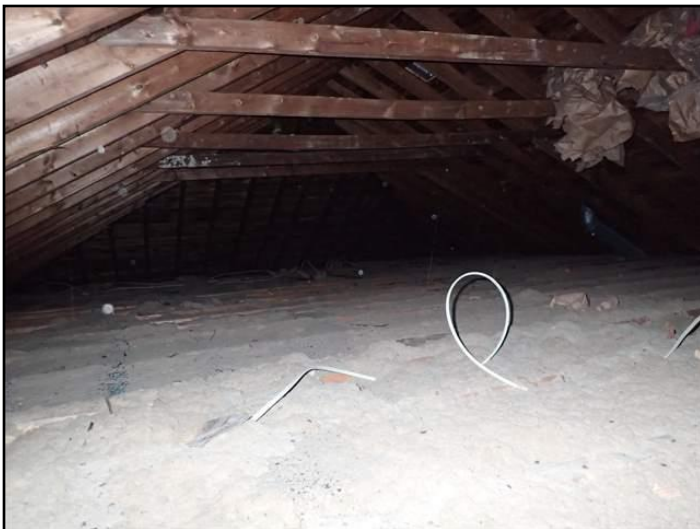
Condition: • [Amount less than current standards](#)

*Insulation level less than current standards*

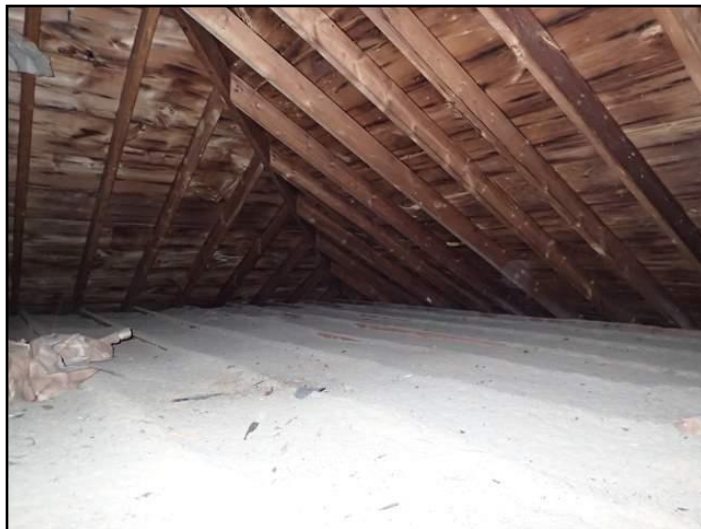
Otherwise, the insulation is evenly distributed and the roof sheathing is in good condition.

*Insulation is evenly distributed*

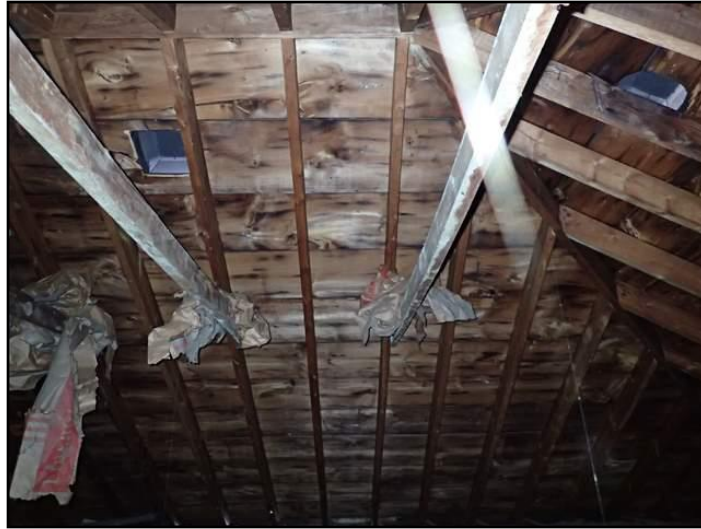
*Roof sheathing is in good condition*

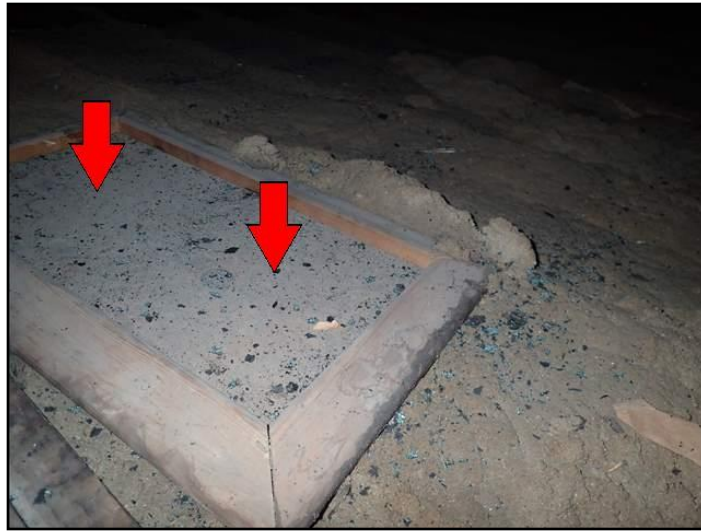
**Condition:** • Not insulated

*Attic access hatch not insulated*

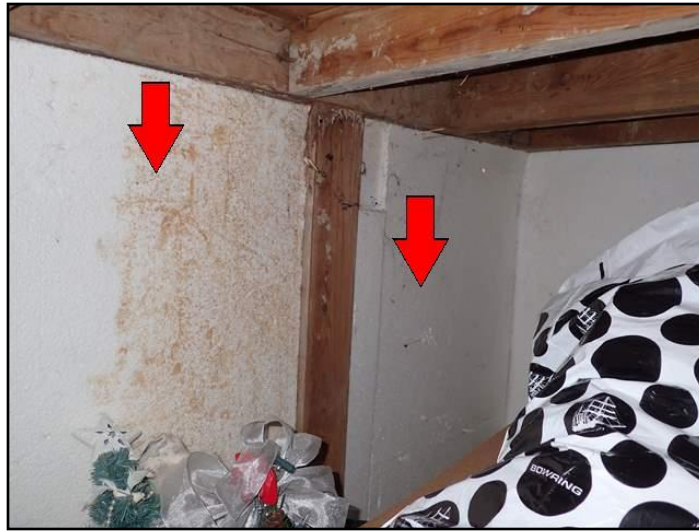
**Condition:** • [Exposed combustible insulation](#)

*Exposed combustible insulation*

The usual recommendation is to cover it with something non-combustible (e.g. drywall) or remove it.

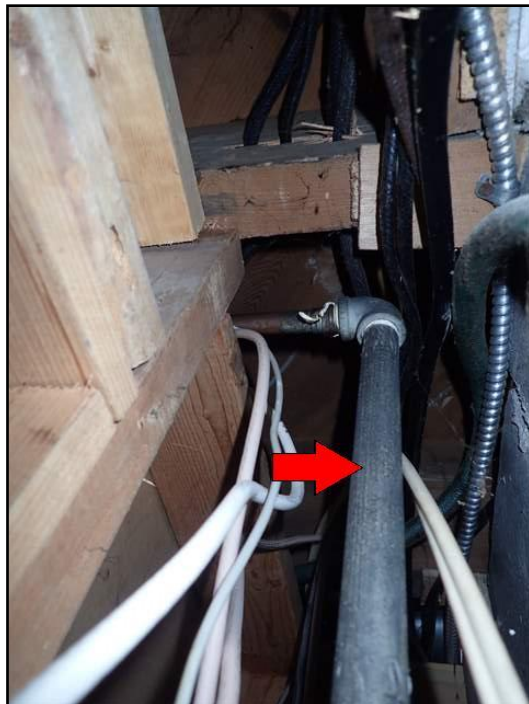
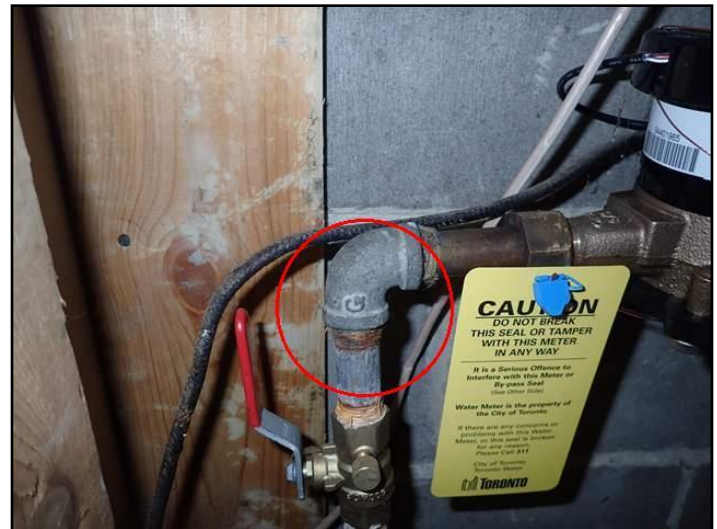
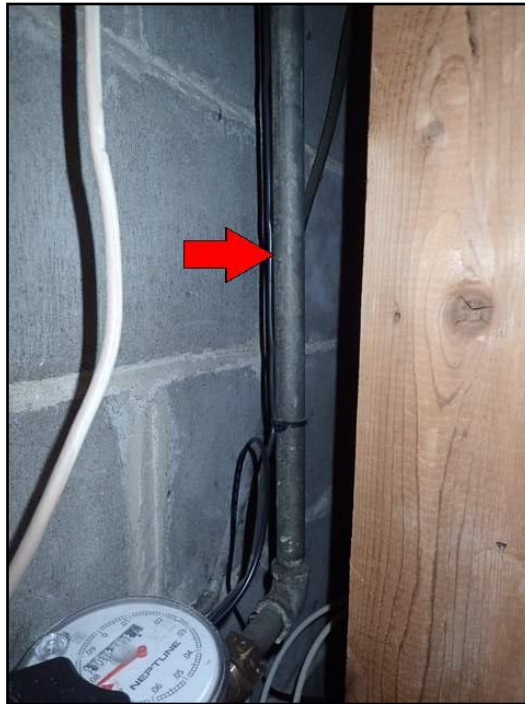
**Condition:** • [Galvanized steel](#)

Steel piping rusts from the inside out and will eventually leak.

Galvanized steel by water meter

*Galvanized steel by water meter*

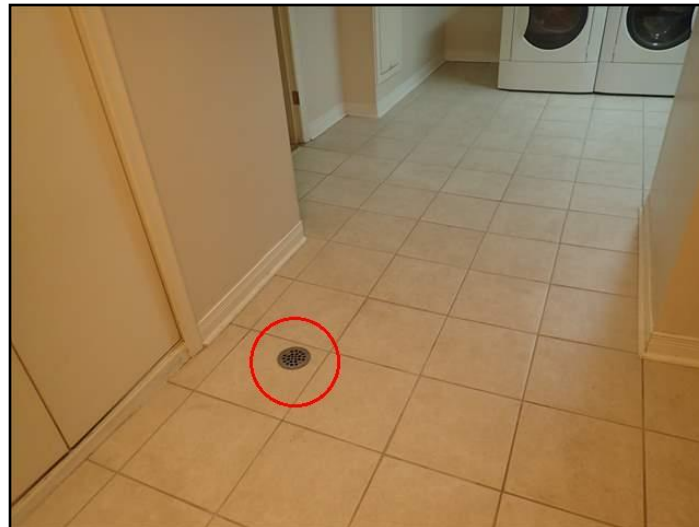
**Condition:** • Dry floor drain

*Keep water in basement trap*

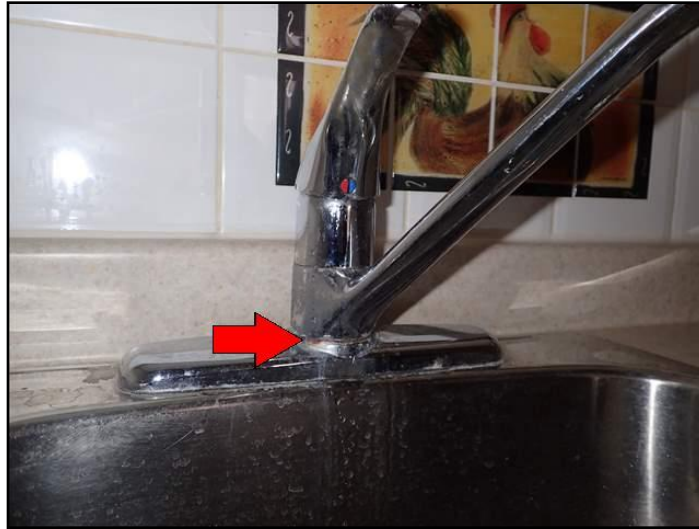
**Condition:** • Leaky faucet

*Leaky faucet*

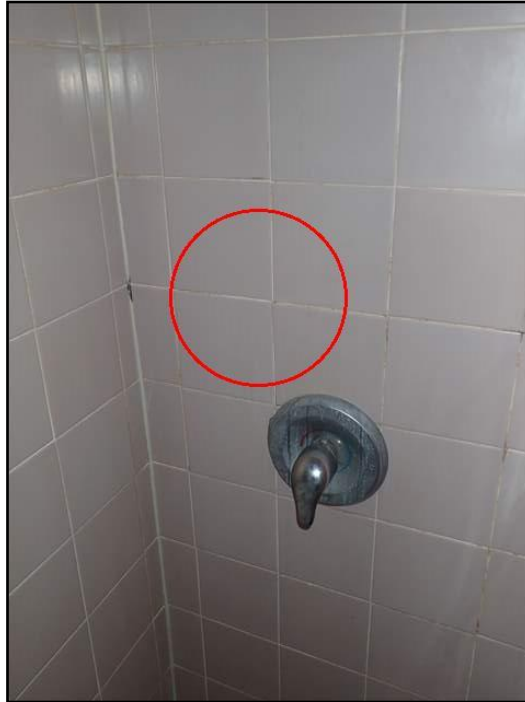
**Condition:** • [Tile loose, broken or missing tile](#)

*Loose, displaced tile in Basement shower*

Spot repairs could be done.

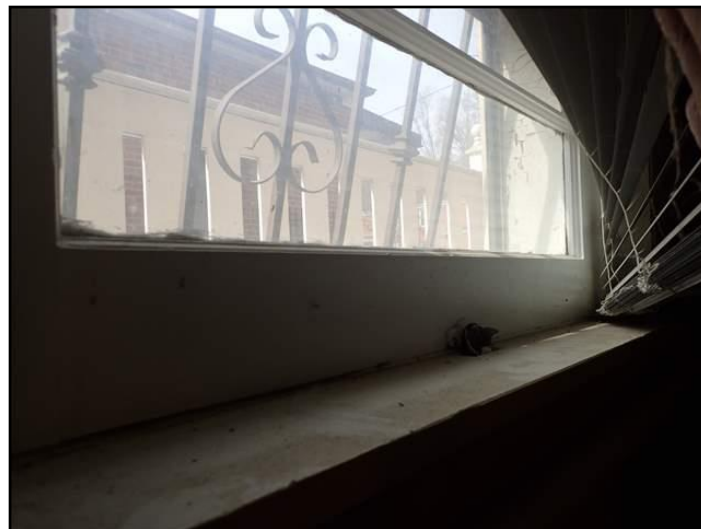
*Window painted shut in Basement*
