# YOUR INSPECTION REPORT

FOR THE PROPERTY AT:  
235 Indian Grove  
Toronto, ON M6P 2H4

INSPECTION DATE:  
Tuesday, September 12, 2017

RE: Report No. 2162, v.2  
235 Indian Grove  
Toronto, ON  
M6P 2H4

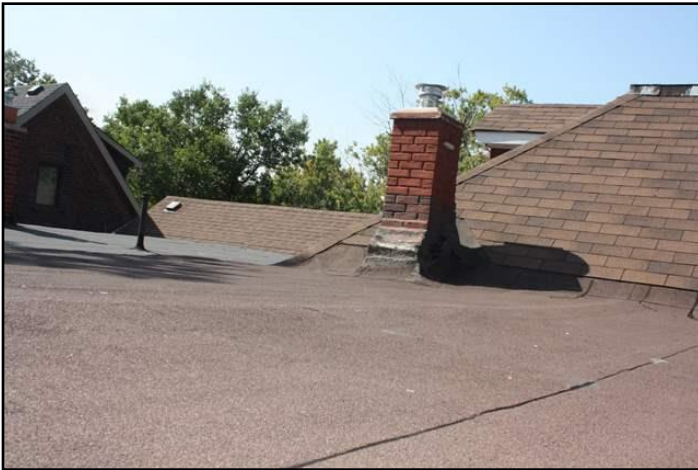
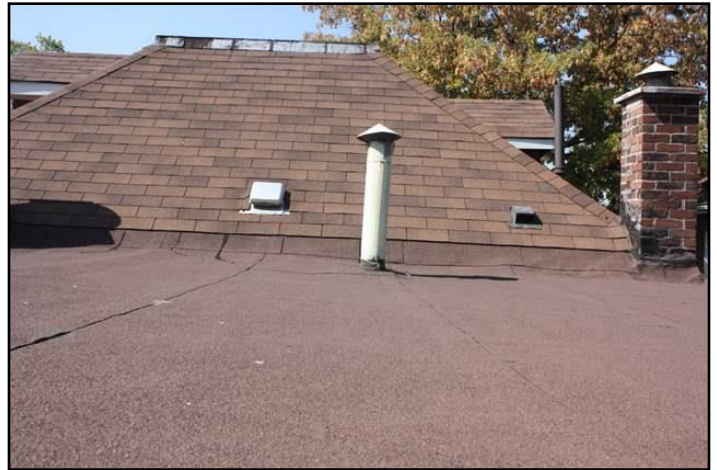
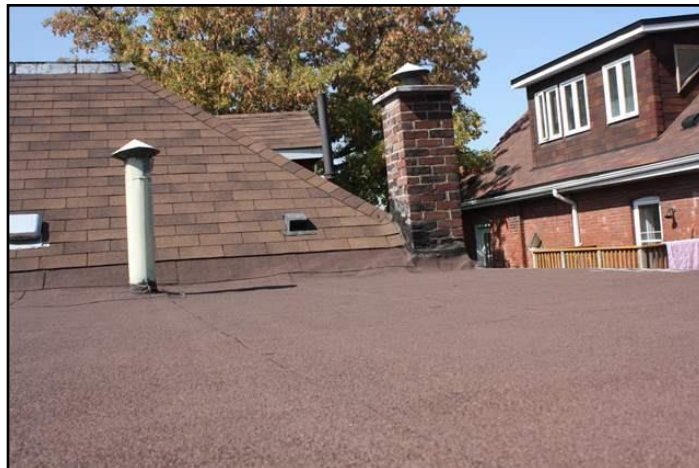
Flat roof at rear is in good condition overall

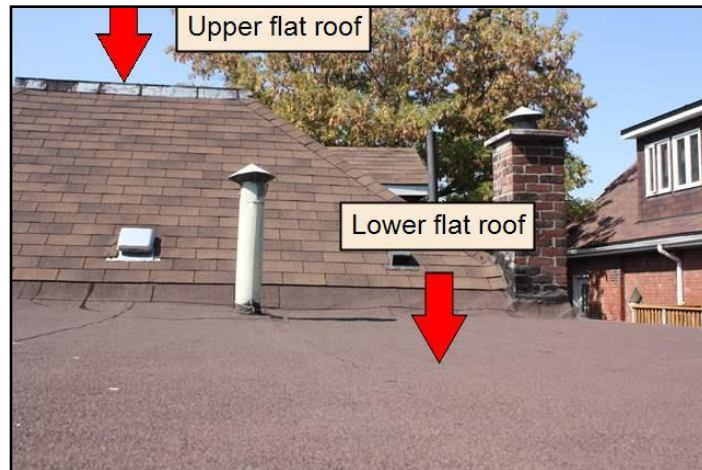
4. Lack of access (too high/steep)

No access was gained to the uppermost flat roof. A full evaluation by a specialist is recommended to provide more information about the condition of the roof.

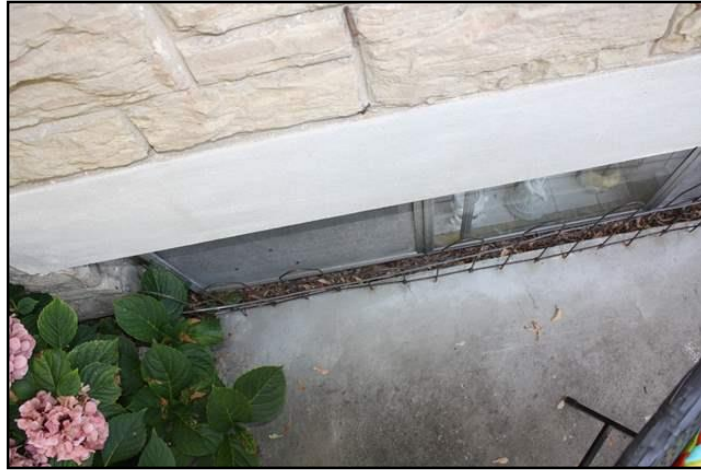
6. Sill - Near or at Grade Level

**Condition:** • Sill - Near or at Grade Level

Front basement window is vulnerable for leakage.

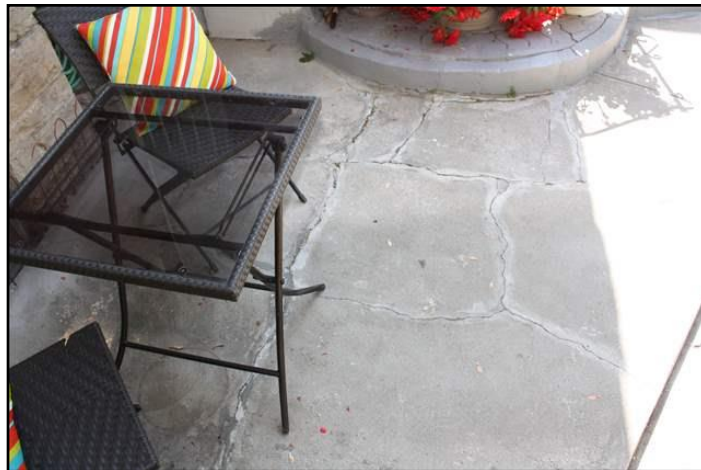
7. Cracked or damaged surfaces

**Condition:** • [Cracked or damaged surfaces](#)

**Implication(s):** Trip or fall hazard

**Task:** Repair or replace

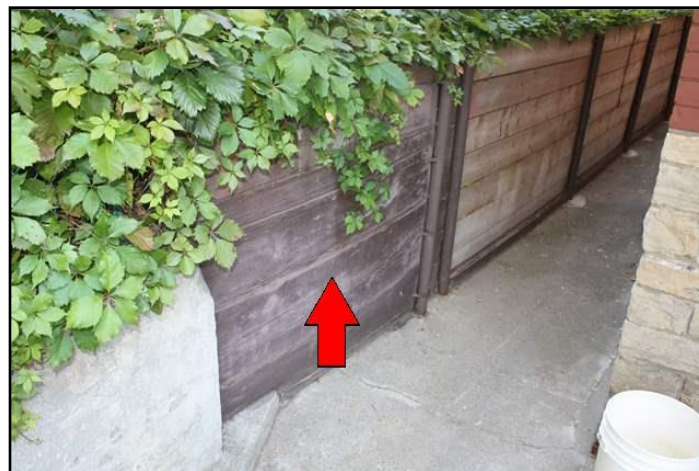
8. Bowing or bulging

**Condition:** • [Bowing or bulging](#)

**Task:** Repair

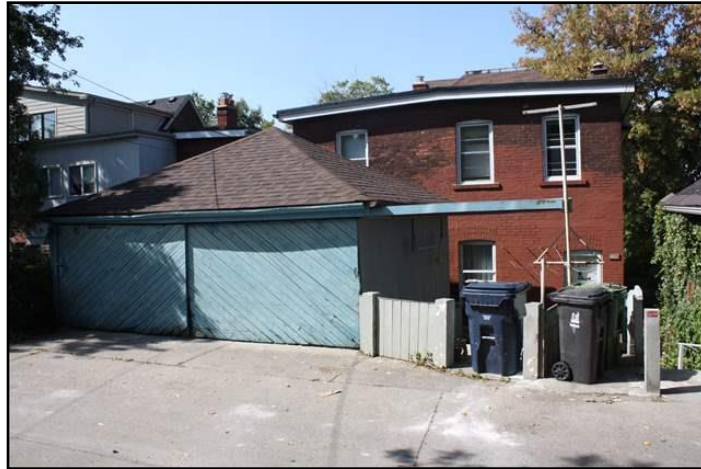
9. Typical old Toronto Garage

**Condition:** • Typical low quality structure

WE DID NOT ACCESS THE INTERIOR OF THE GARAGE DUE TO LOCKS. From the exterior, this appears to be a typical Toronto old garage that needs ongoing work. The roof covering is in good condition. The metal cladding is worn and leaning/bulging in various areas. Due to the lack of access we could not determine if the interior wall is leaning. Also there was a beam going across the front of the garage out jetted out approximately 8 feet. We could not determine if this

was intended as structural support. Overall, extensive repairs would be needed to bring it up to modern standards. Replacement of garages are expensive, \$20,000 and up, therefore most people choose to repair the garage ongoing as needed.

**Task:** Repair

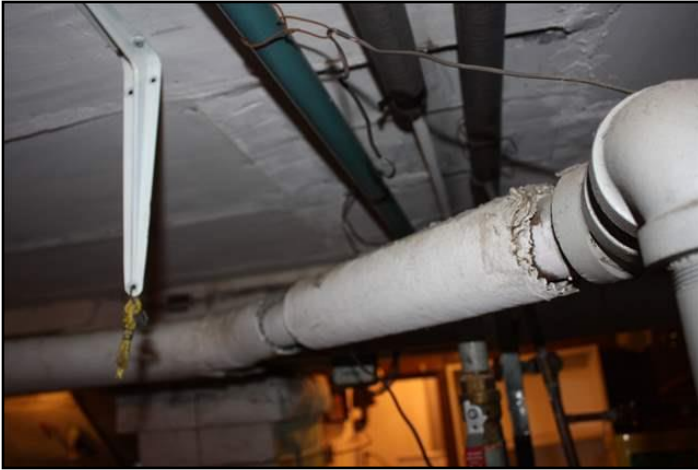
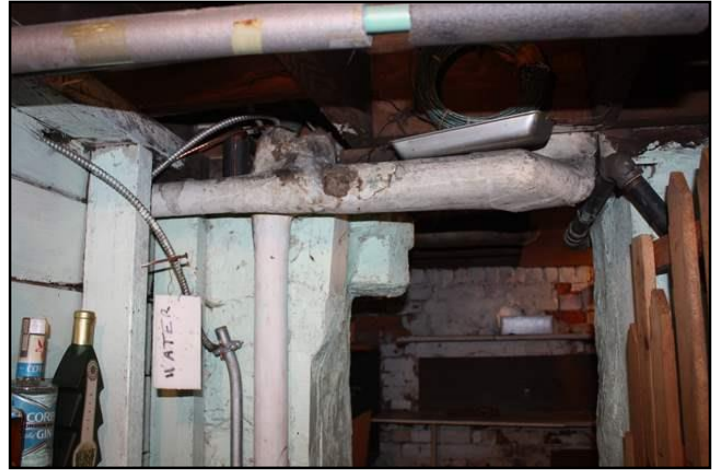
**Condition:** • The insulation on the boiler or heating pipes may contain asbestos. Health Canada recommends the insulation be left in place undisturbed. If the insulation is damaged or is to be disturbed, and if it contains asbestos (confirm with Laboratory test), precautions should be taken that asbestos fibers are not released into the house air during the work. Please see the Asbestos article in the Supplementary section of the text.

**Time:** Immediate

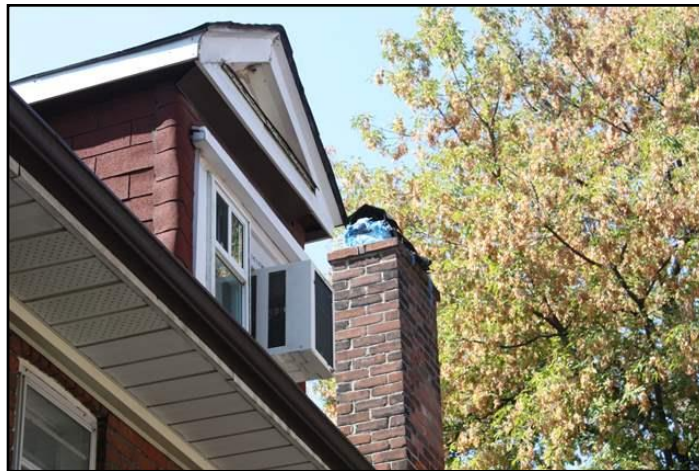
12. Loose, missing or deteriorated masonry

**Condition:** • [Loose, missing or deteriorated masonry](#)

Appears to be an abandoned chimney. Rather than repair, you may consider removing the chimney altogether

**Implication(s):** Material deterioration

**Task:** Remove

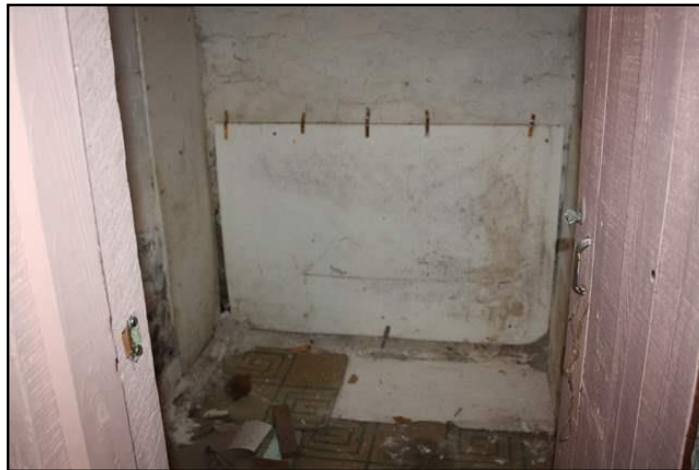
13. *Exposed combustible insulation*

**Condition:** • [Exposed combustible insulation](#)

**Implication(s):** Increased fire hazard

**Task:** Remove

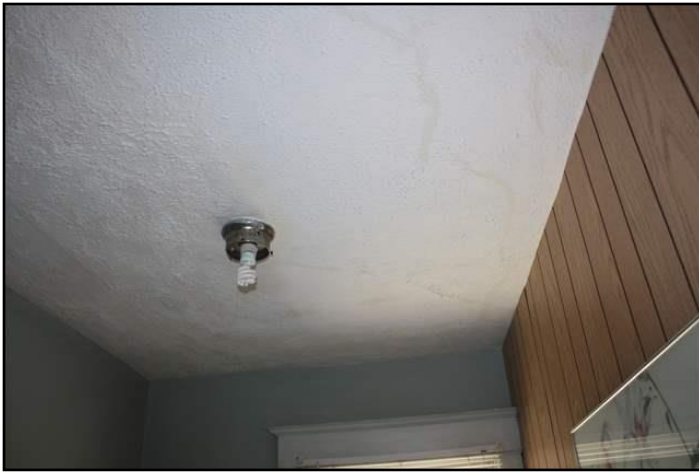
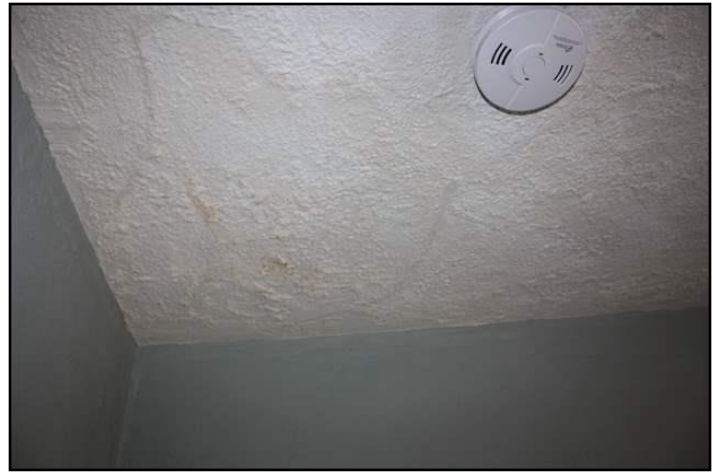
**Condition:** • Stains

Multiple water stains noted. All stains that were accessible were tested with a Moisture meter. Dry at time of home inspection.

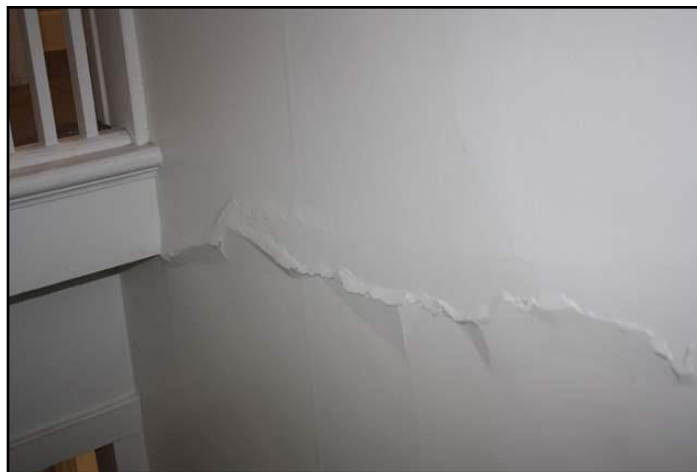
16. Damage example

**Condition:** • Damage

**Implication(s):** Damage or physical injury due to falling materials

**Task:** Repair

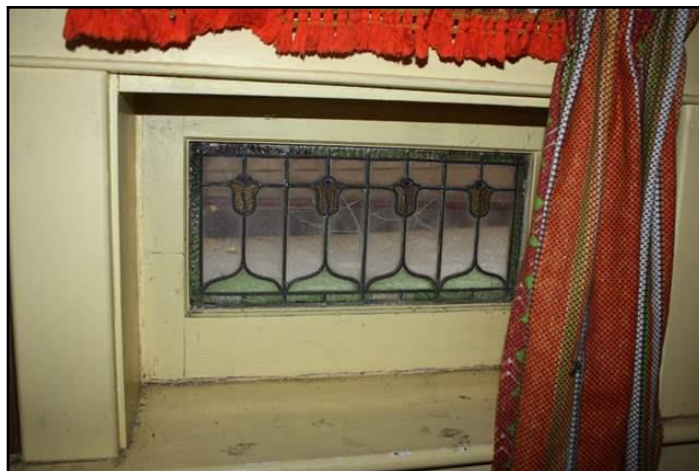
17. Example

**Condition:** • [Cracked](#)

**Task:** Replace

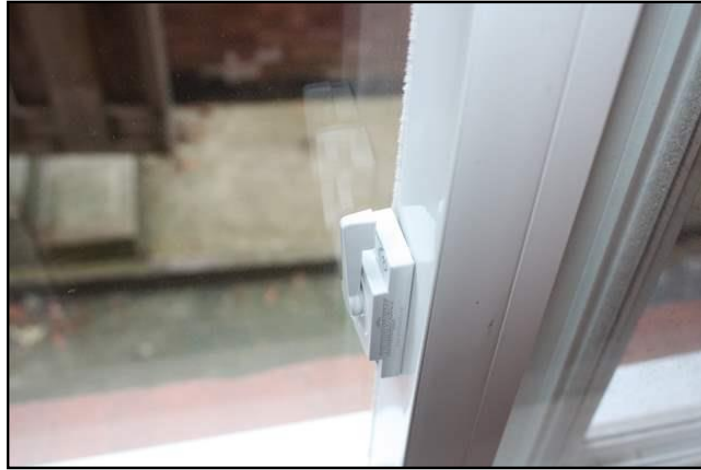
18. Broken

**Condition:** • [Broken](#)

**Task:** Repair or replace

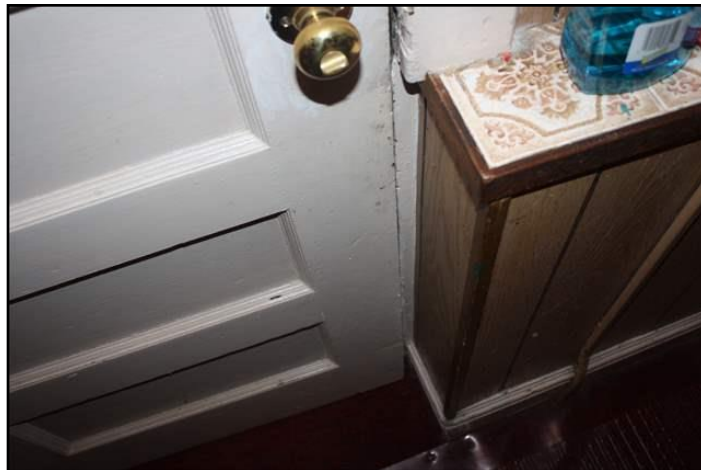
19. Loose or poor fit

**Condition:** • [Loose or poor fit](#)

**Implication(s):** Chance of damage to finishes and structure

**Task:** Adjust

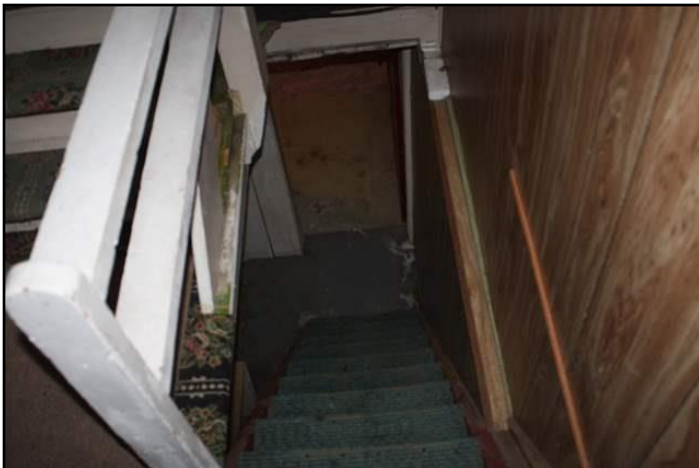
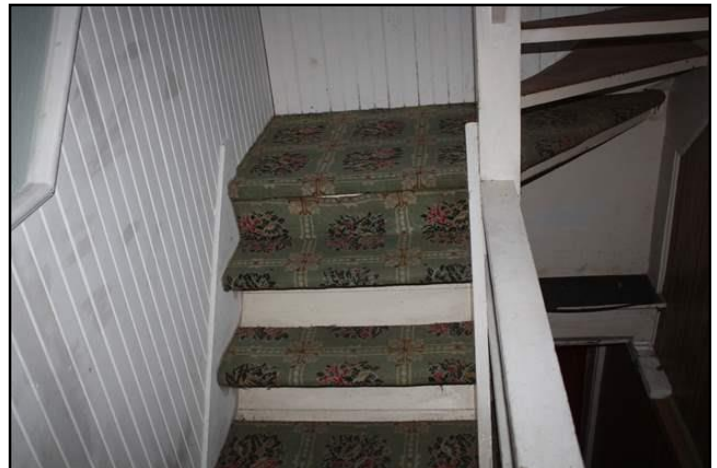
**Condition:** • [Missing](#)

**Implication(s):** Fall hazard

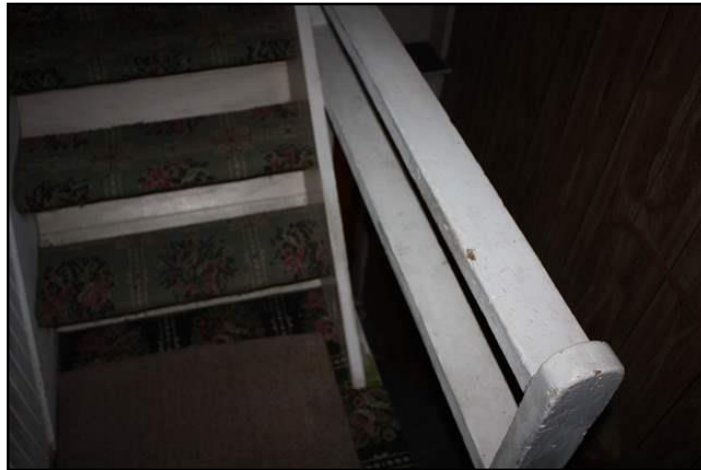
22. Too far apart

Condition: • [Too far apart](#)

Implication(s): Fall hazard

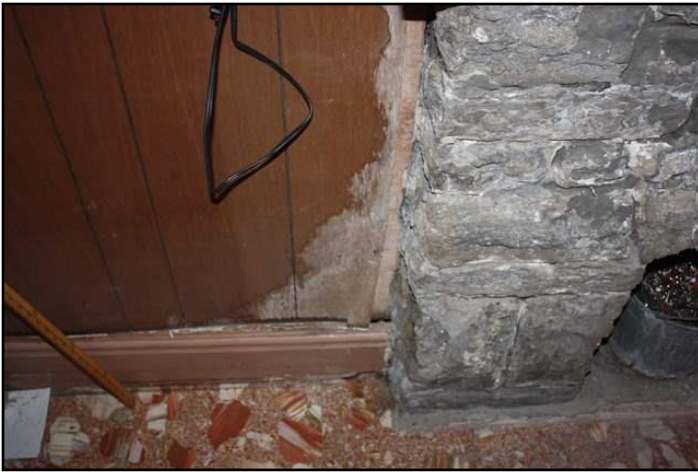
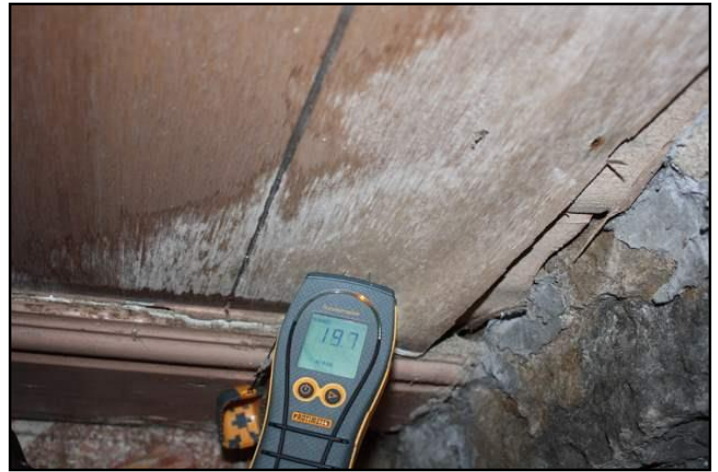
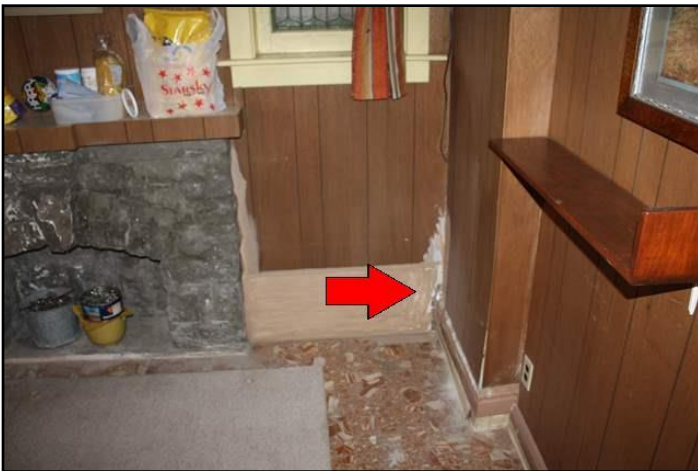
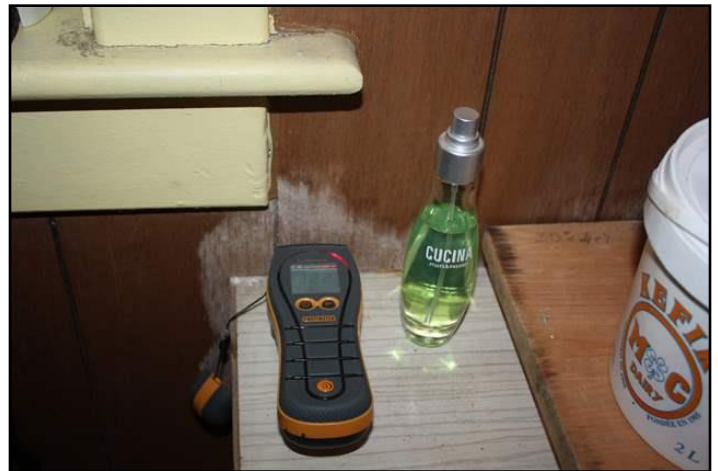
**Condition:** • [Dampness on floor or walls](#)

**Implication(s):** Chance of water damage to contents, finishes and/or structure | Material deterioration

**Task:** Repair
