# INSPECTION REPORT

For the Property at:  
**1234 ROLLING CREEK RIVER**  
ANY CITY, IL

Prepared for: HAPPY BUYER  
Inspection Date: Thursday, April 14, 2016  
Prepared by: Jeff Walters

RE: Report No. 1004, v.4  
1234 Rolling Creek River  
any city, IL

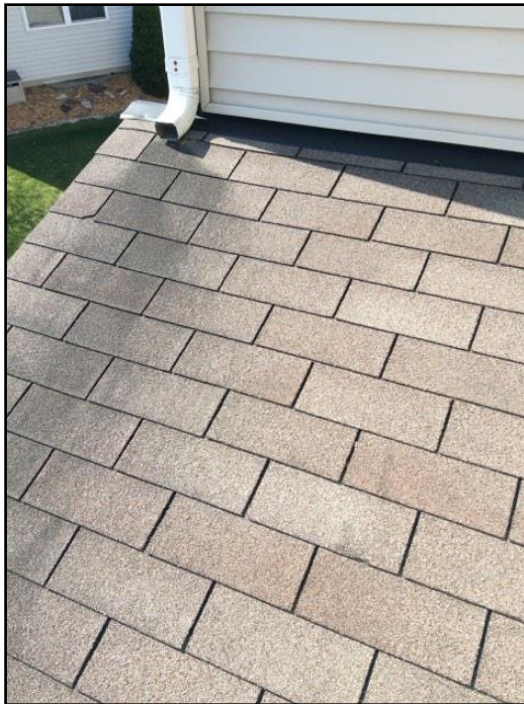
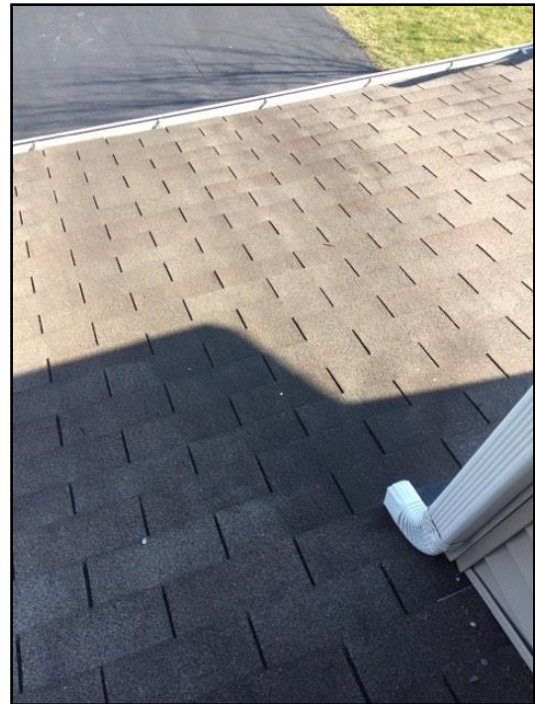
**1. Condition:** • [Downspouts discharging onto roofs](#)

## Downspout running across roof

installing a downspout (from the secondary roof to the main gutter below) helps prevent localized roof wear

7. Downspouts discharging onto roofs

8. Downspouts discharging onto roofs

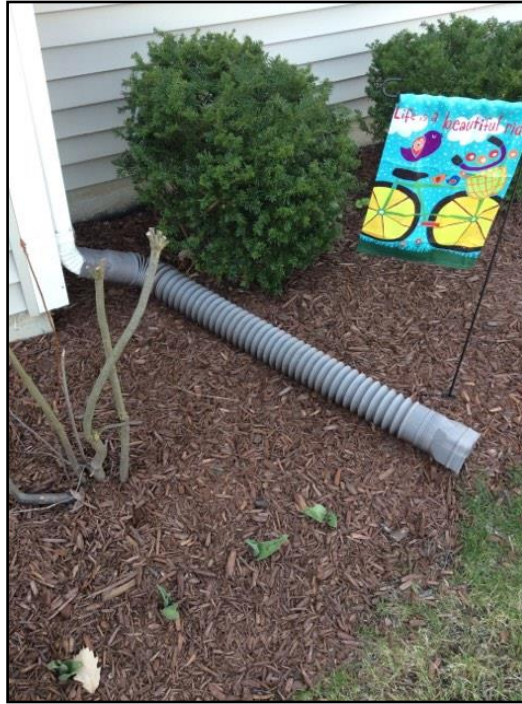
2. Condition: • [Should discharge 6 feet from building](#)

9. Should discharge 6 feet from building

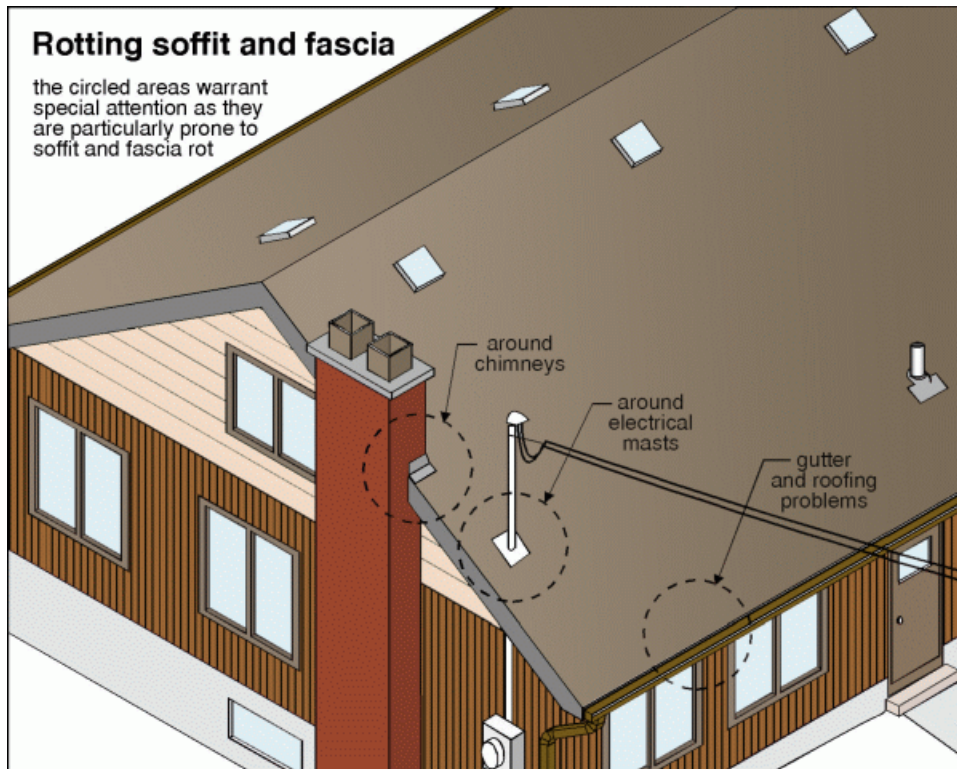
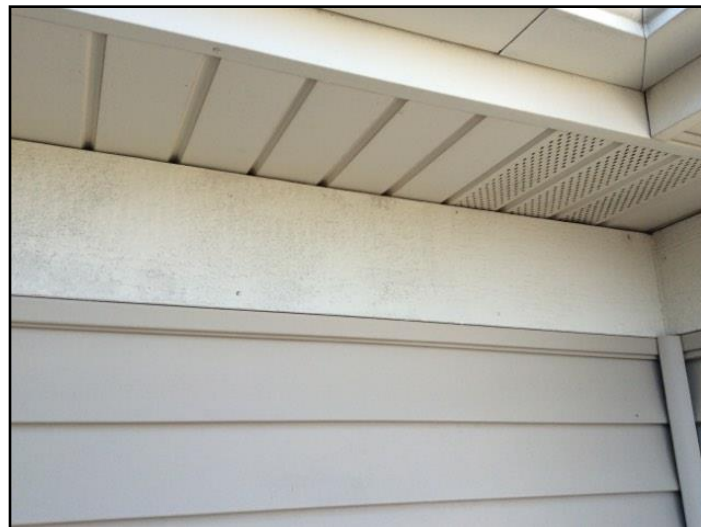
**3. Condition:** • [Paint or stain needed](#)

**Task:** Correct

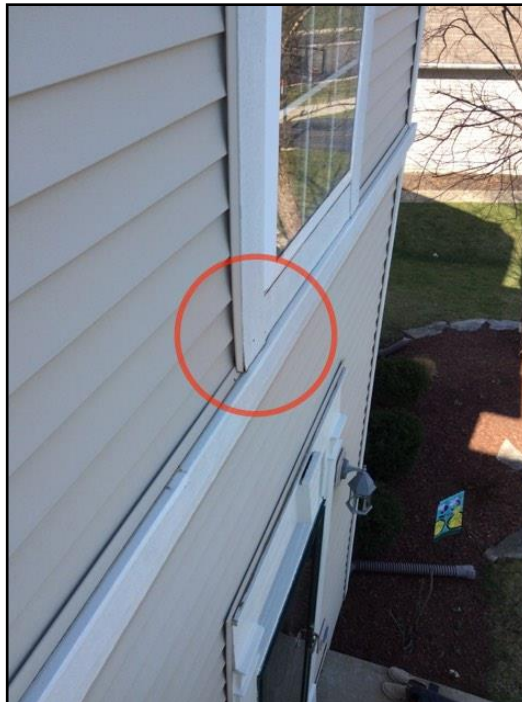
**7. Condition:** • [Caulking missing or ineffective](#)

Window over front door trim needs paint and caulk

11. *Caulking missing or ineffective*

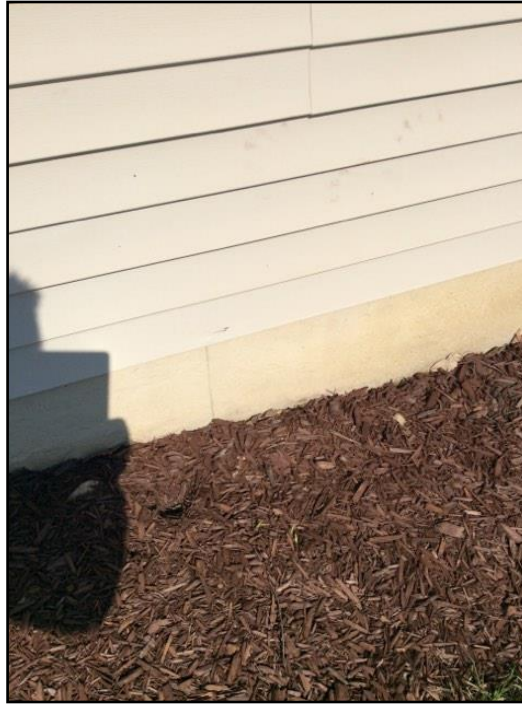
**8. Condition:** • [Loose or missing pieces](#)

12. Loose or missing pieces

**Task:** Repair Monitor

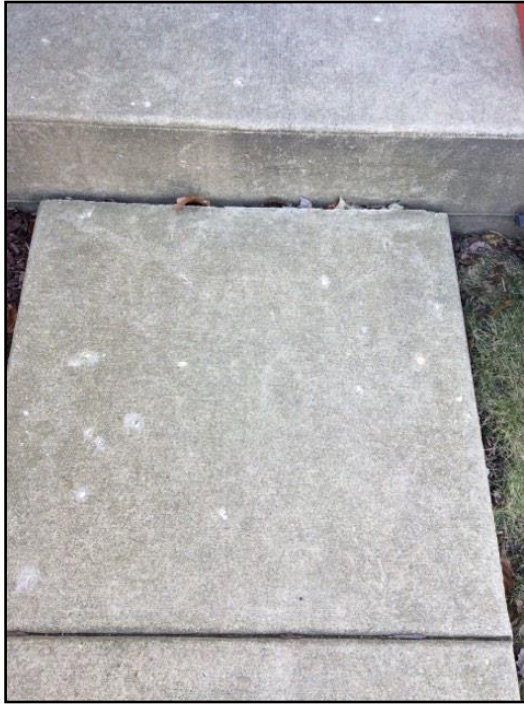
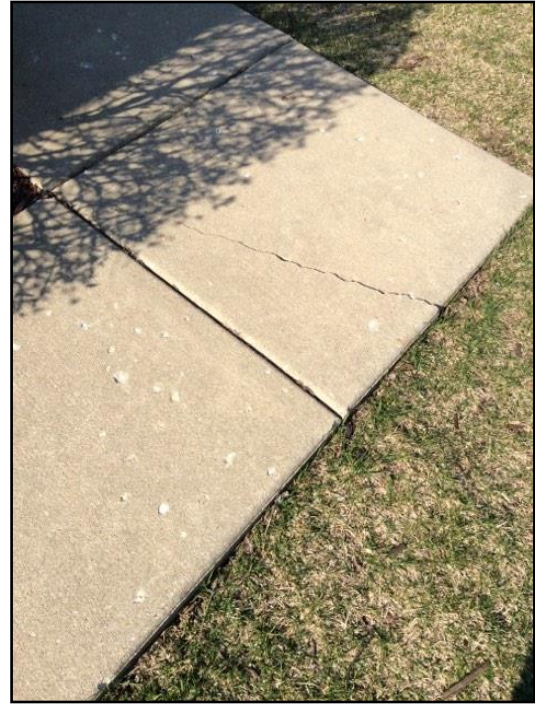
10. Condition: • [Unsealed gap at building](#)

13. Unsealed gap at building

14. Unsealed gap at building

Task: Repair or replace

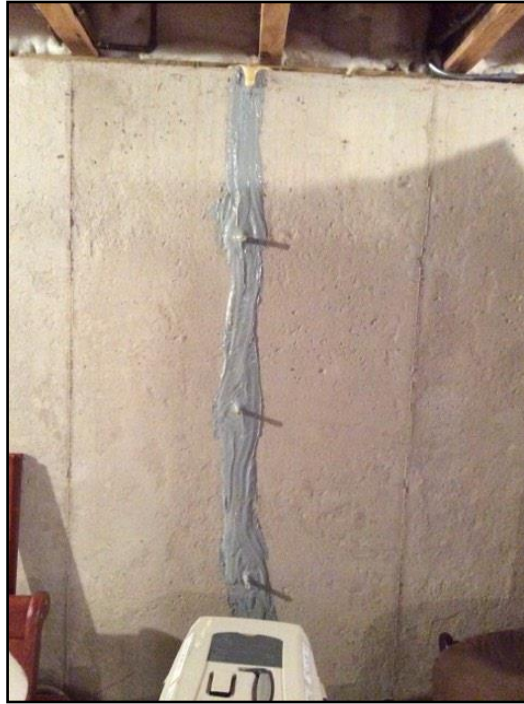
A repair has been made to stop water leakage

16. Basement

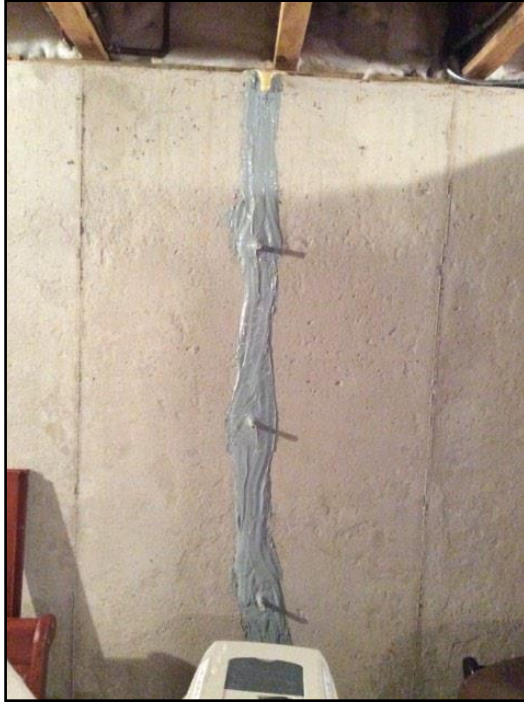
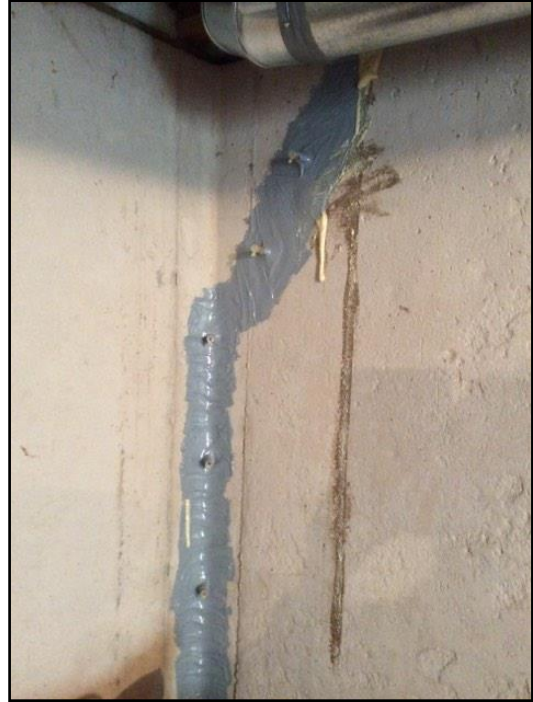
**15. Condition:** • [Prior repairs](#)

**21.** *Prior repairs*

**22.** *Prior repairs*

**Task:** Monitor

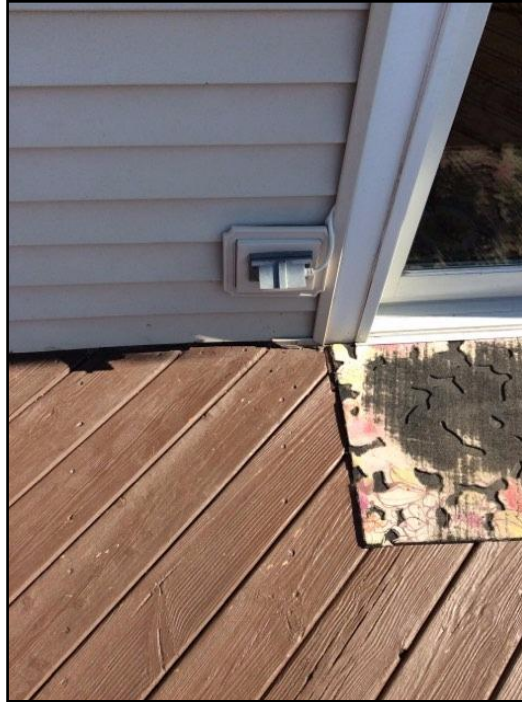
Rear gfi did not trip when tested

26. GFCI - outside

**16. Condition:** • [Test faulty on Ground Fault Circuit Interrupter \(GFCI\)](#)

**Task:** Repair

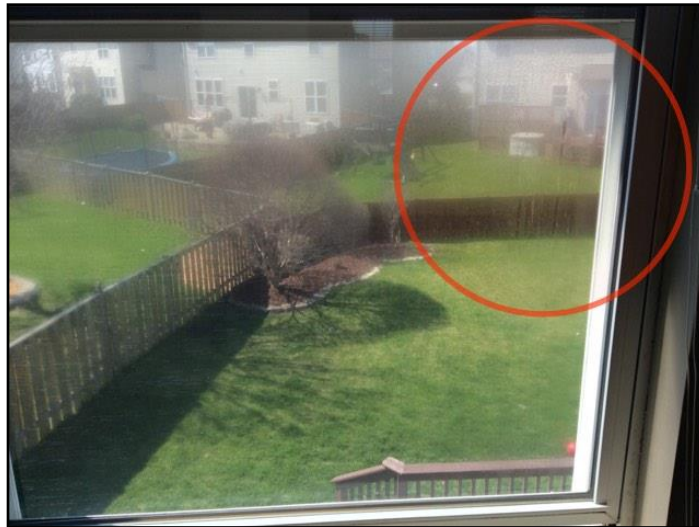
Window in master bath has lost its seal

32. *Single/double hung*

**23. Condition:** • [Lost seal on double or triple glazing](#)

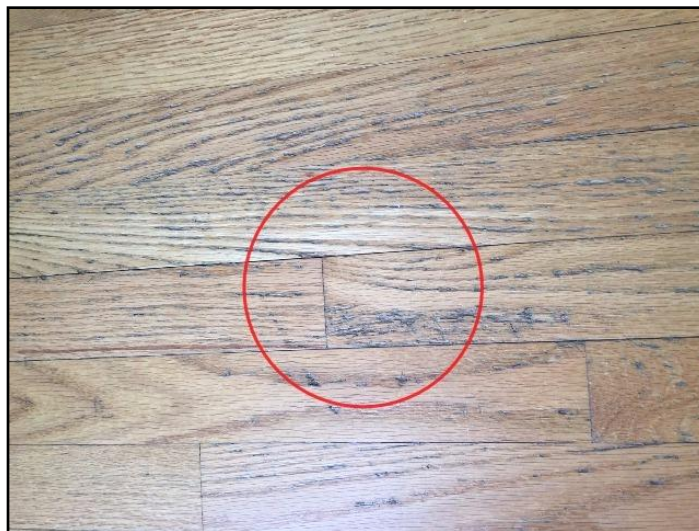
**21. Condition:** • Typical flaws

33. Hardwood

**Task:** Repair
