Your Inspection Report

30 Humber Trail
Toronto, ON

INSPECTION DATE:
Friday, April 14, 2017

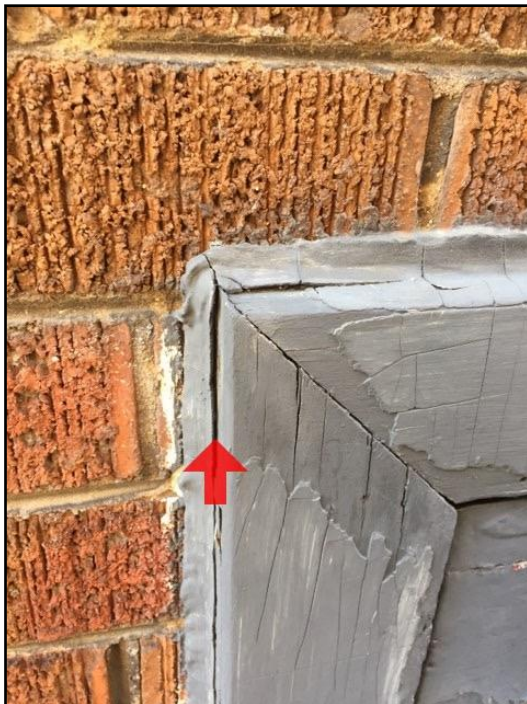
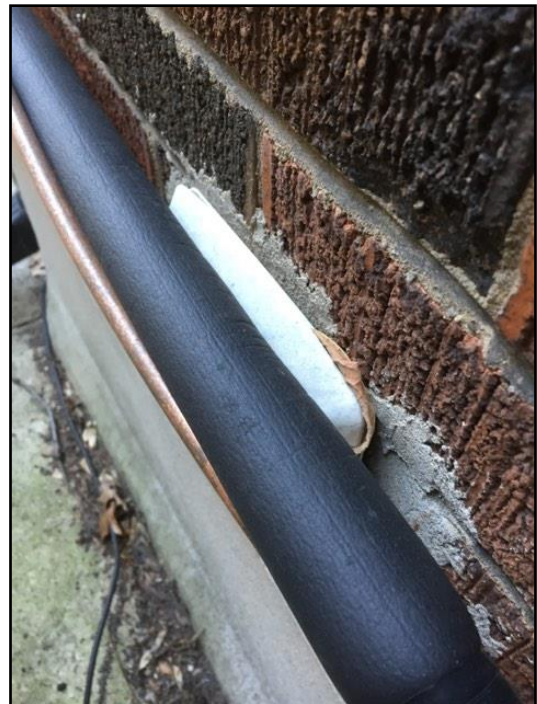
Condition: • [Caulking missing or deteriorated](#)

Implication(s): Chance of water damage to contents, finishes and/or structure | Material deterioration

Location: North, Southwest

Caulking missing or deteriorated

Task: Repair

Time: Less than 1 year

Cost: Minor

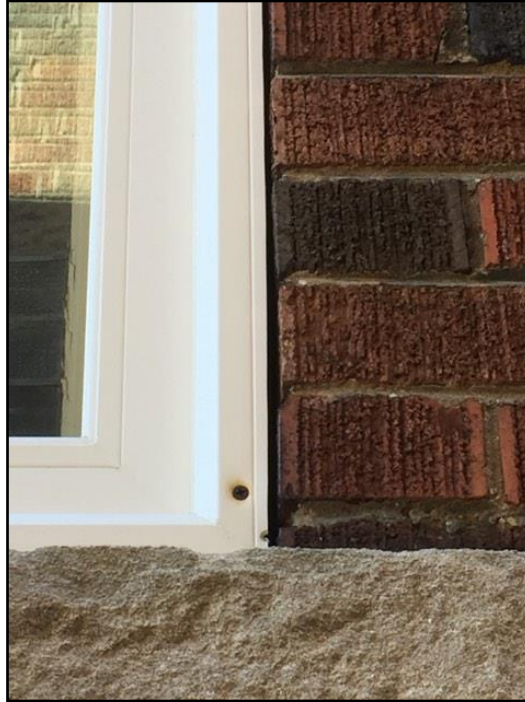
Condition: • [Caulking missing, loose or deteriorated](#)

Implication(s): Chance of water damage to contents, finishes and/or structure

Location: North

Caulking missing, loose or deteriorated

Task: Provide

Time: Less than 1 year

Cost: Minor

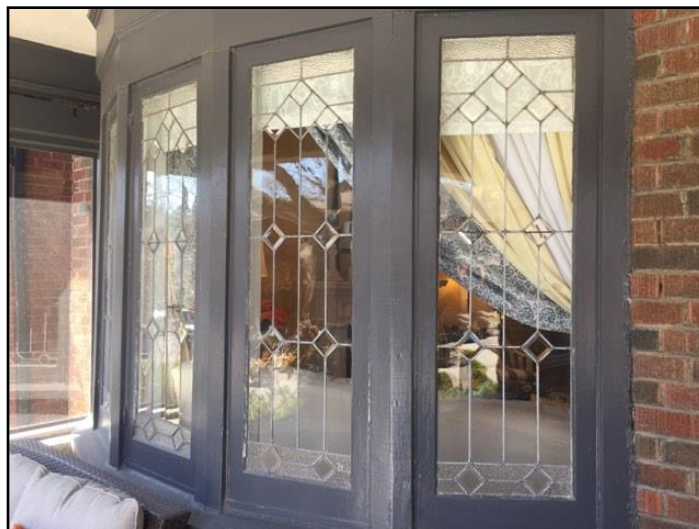
Condition: • [Missing](#)

Implication(s): Increased heating and cooling costs | Reduced comfort

Location: Front

Missing storms

Task: Repair

Time: Discretionary

Cost: \$1,000 - \$2,000

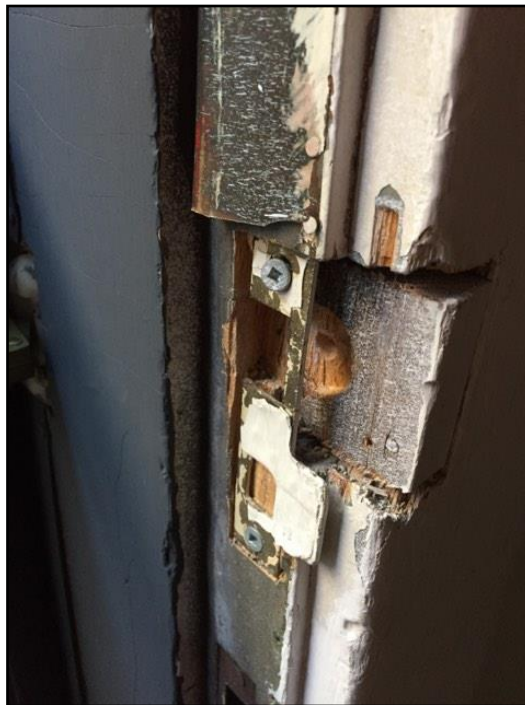
Condition: • Lock not effective on exterior door

Implication(s): Poor security

Location: Side Door

Lock not effective on exterior door

Task: Repair

Time: Immediate

Cost: \$100 - \$300

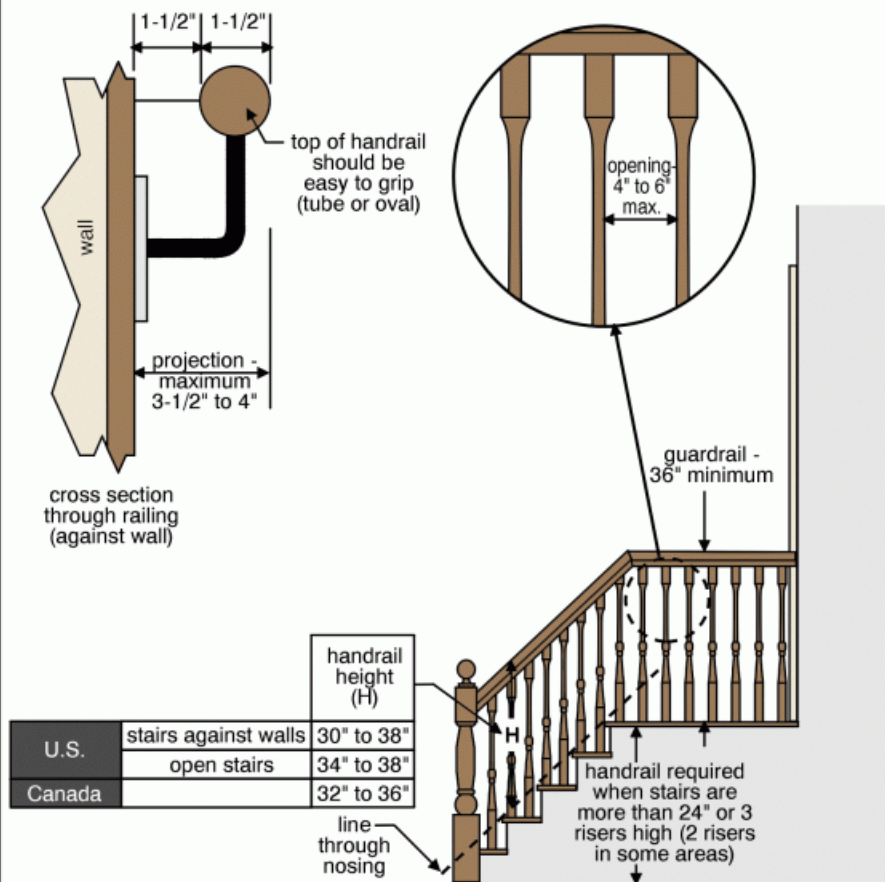
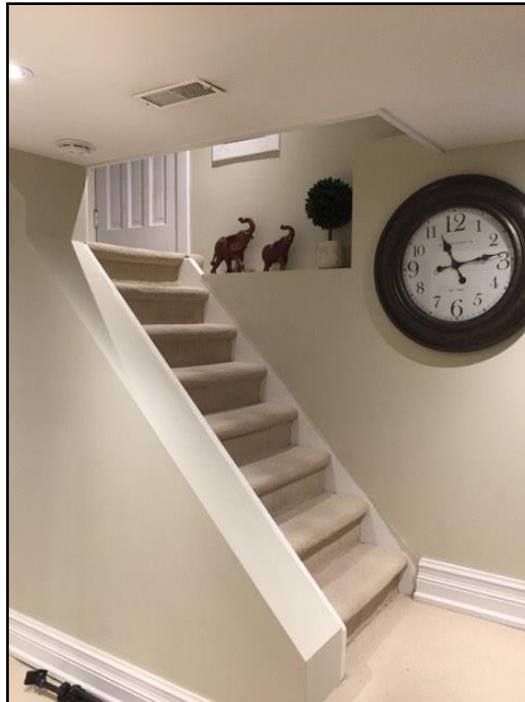
Condition: • [Missing](#)

Implication(s): Fall hazard

Location: Basement Staircase

Missing guardrail

Task: Provide

Time: Immediate

Cost: Depends on approach
