Your Inspection Report

35 Kilmarnock Ave
Toronto, ON M1K 1Y5

INSPECTION DATE:
Thursday, July 26, 2018

RE: Report No. 63421
35 Kilmarnock Ave
Toronto, ON
M1K 1Y5

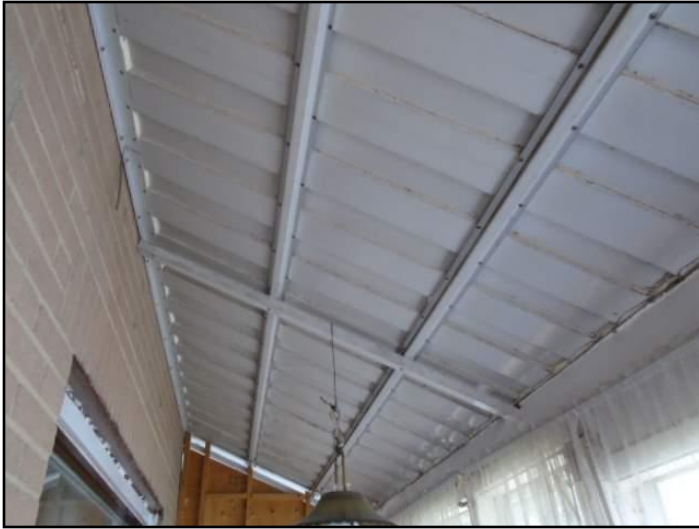
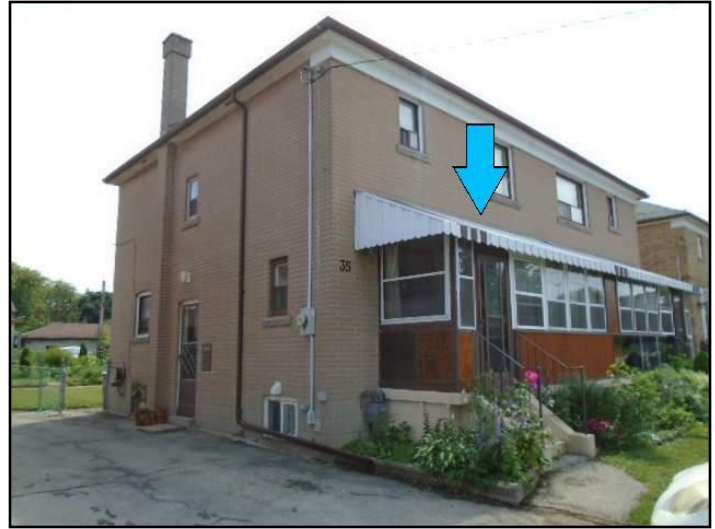
Metal

SLOPED ROOF FLASHINGS \ General

Condition: • Inspect & repair, as needed.

Implication(s): Chance of water damage to contents, finishes and/or structure

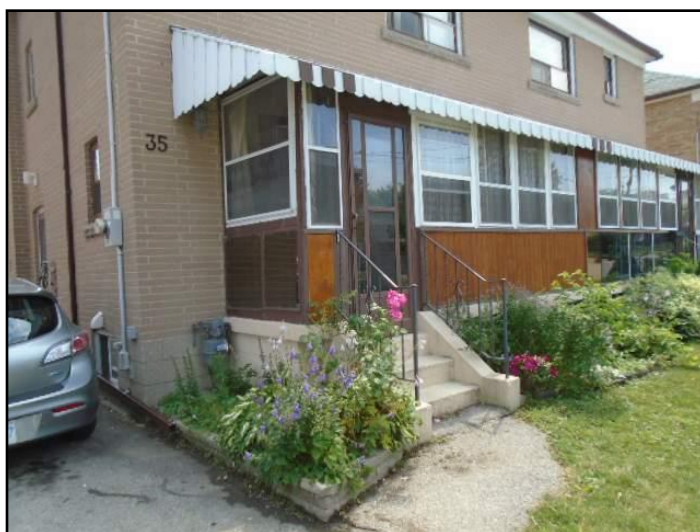
Wood

Condition: • The gap at the wall should be well sealed.

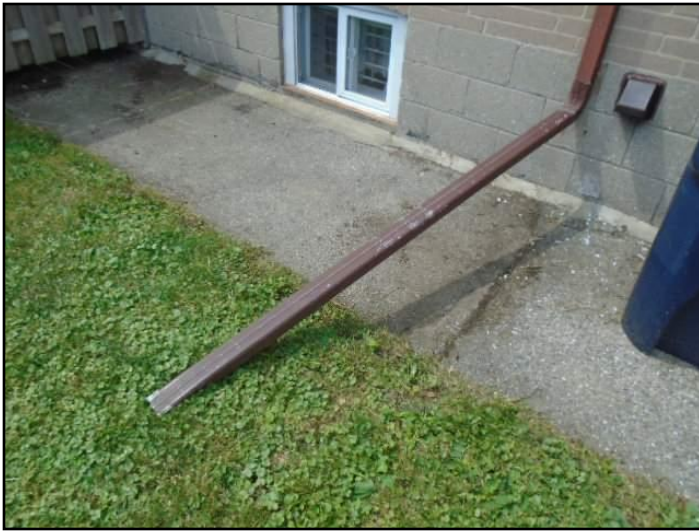
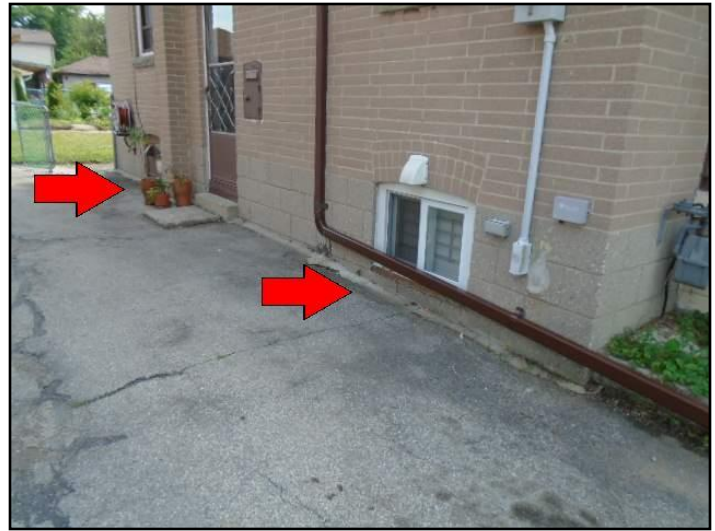
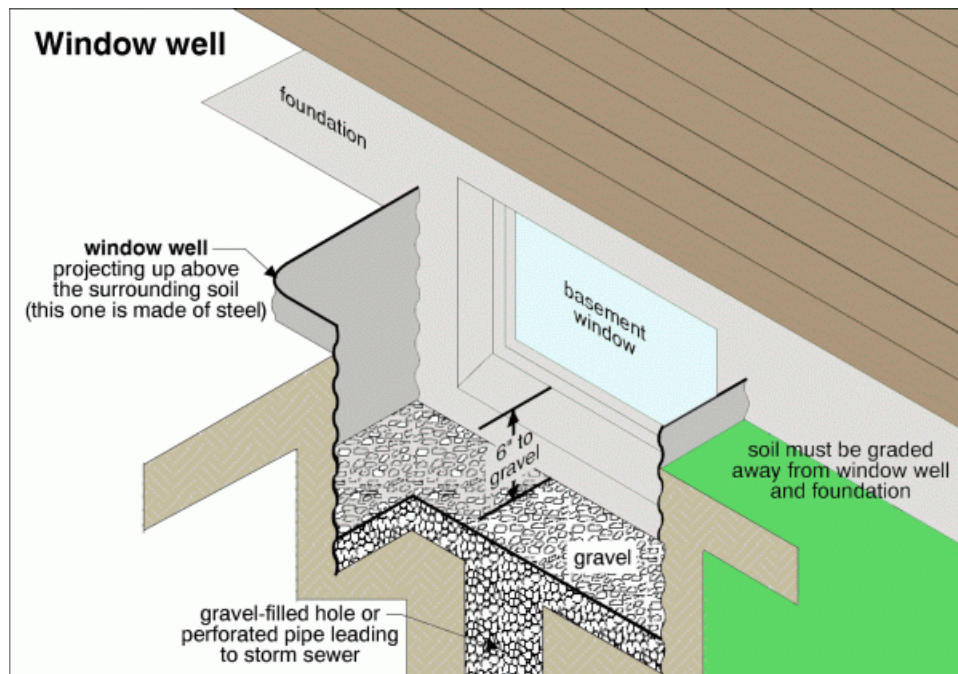
EXTERIOR GLASS/WINDOWS \ Window wells

Condition: • [Missing](#)

Implication(s): Material deterioration | Chance of water damage to contents, finishes and/or structure

Task: Monitor after heavy storms

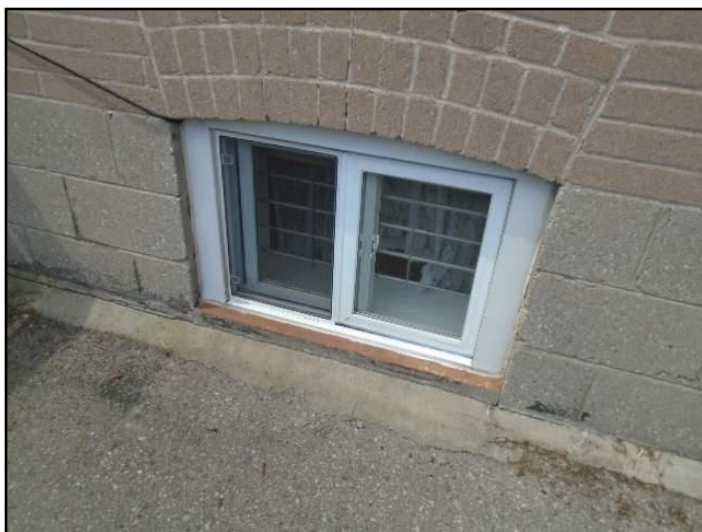
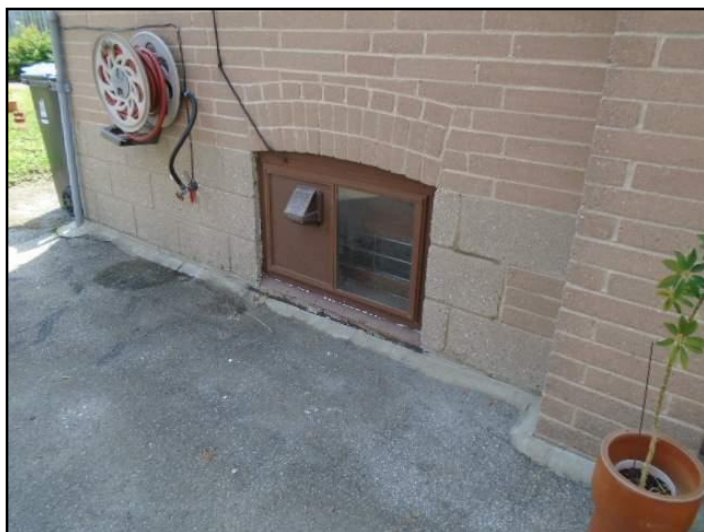
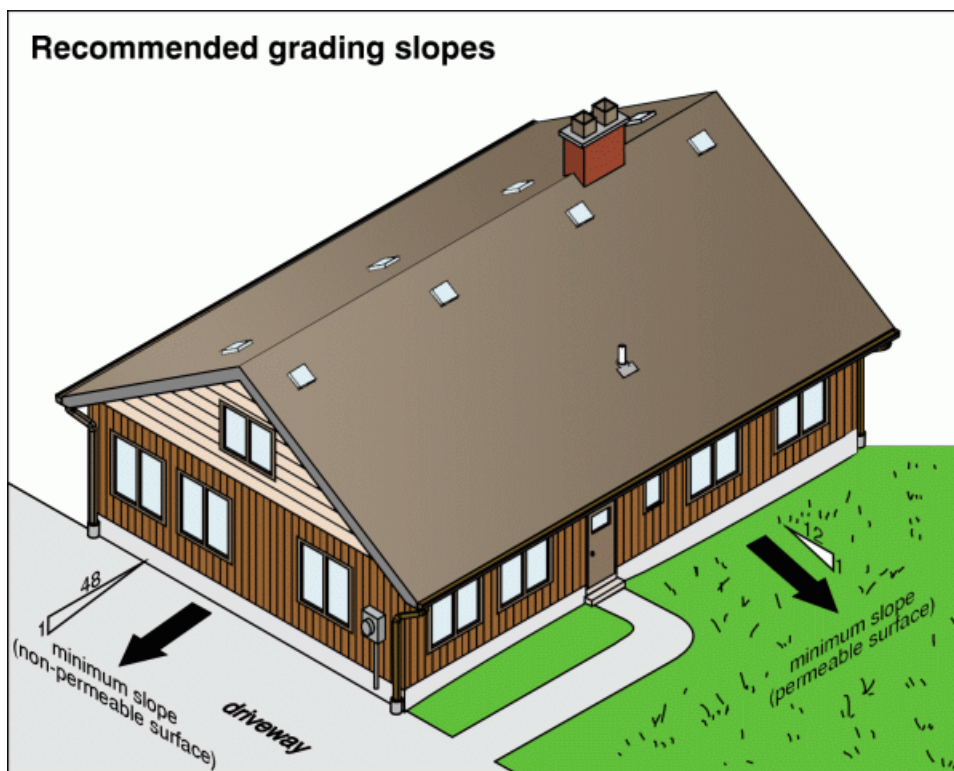
LANDSCAPING \ Lot grading

Condition: • The grading around portions of the house is relatively neutral

Implication(s): When trying to minimize basement leakage, it is always best to be proactive and slope the grades away from the house. Maintain slope away from house

Task: Monitor/Improve

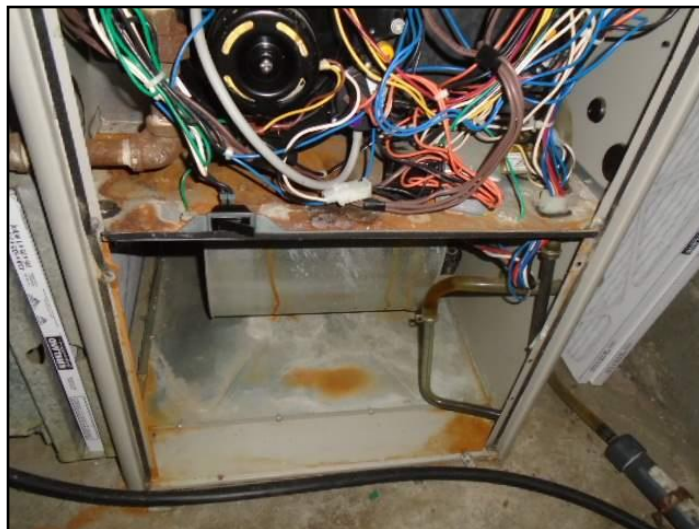
Rust

Condition: • [Rust](#)

Implication(s): Reduced system life expectancy | Material deterioration

Task: Monitor/Improve

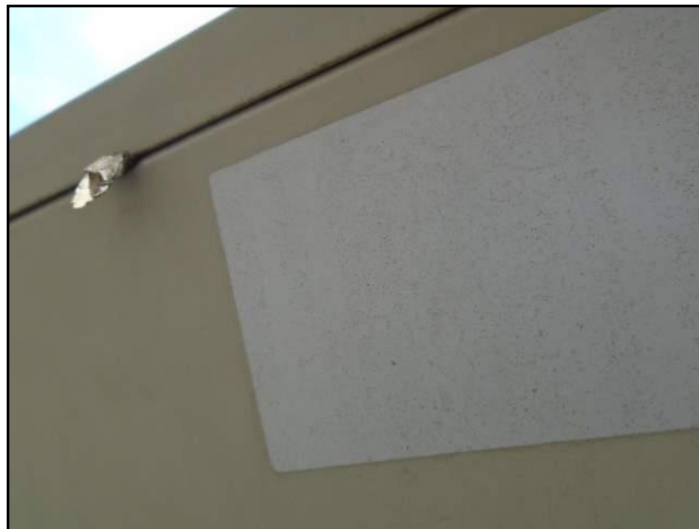
The data plate is illegible...

Compressor approximate age: • More than 20 years

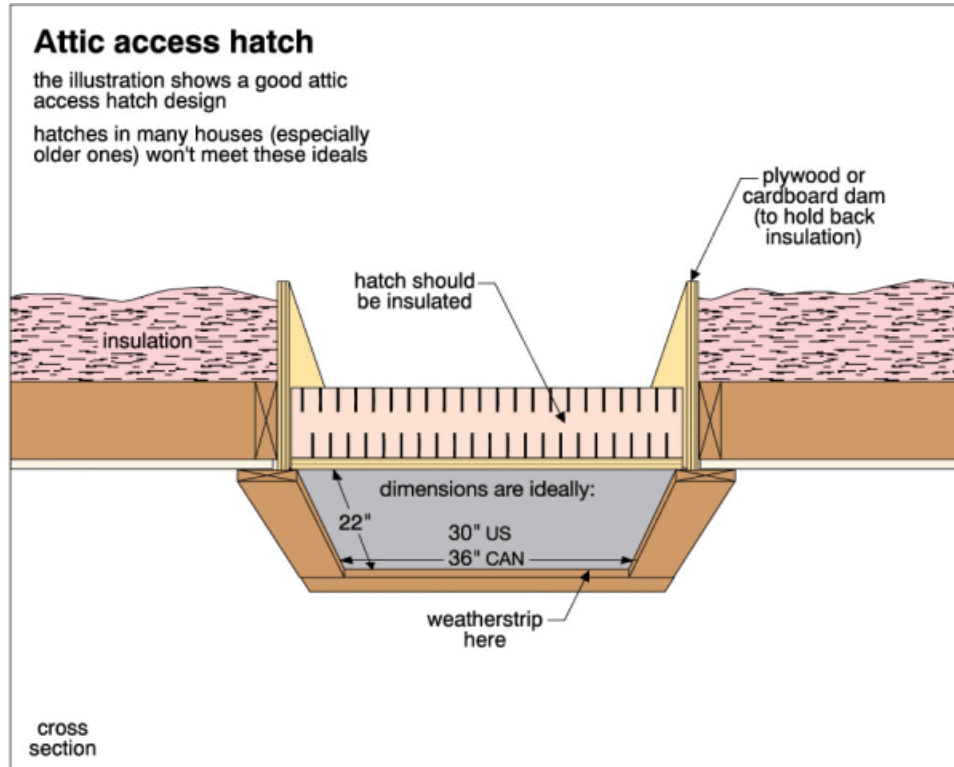
Condition: • [Not insulated and not weatherstripped](#)

Implication(s): Increased heating and cooling costs | Reduced comfort | Chance of condensation damage to finishes and/or structure

Task: Improve
Time: As required
Cost: Minor

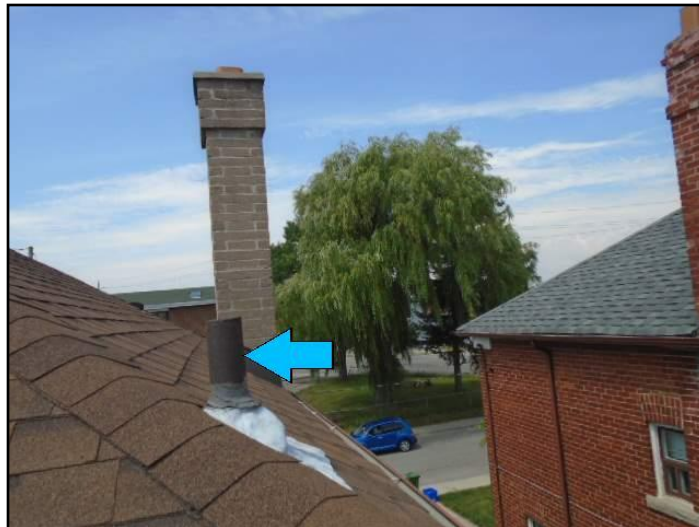
Cast Iron

Condition: • The cast iron waste piping is near the end of its normal life expectancy and is prone to rusting through or splitting. Replacement may be required in the near future.

Task: Further evaluation Replace

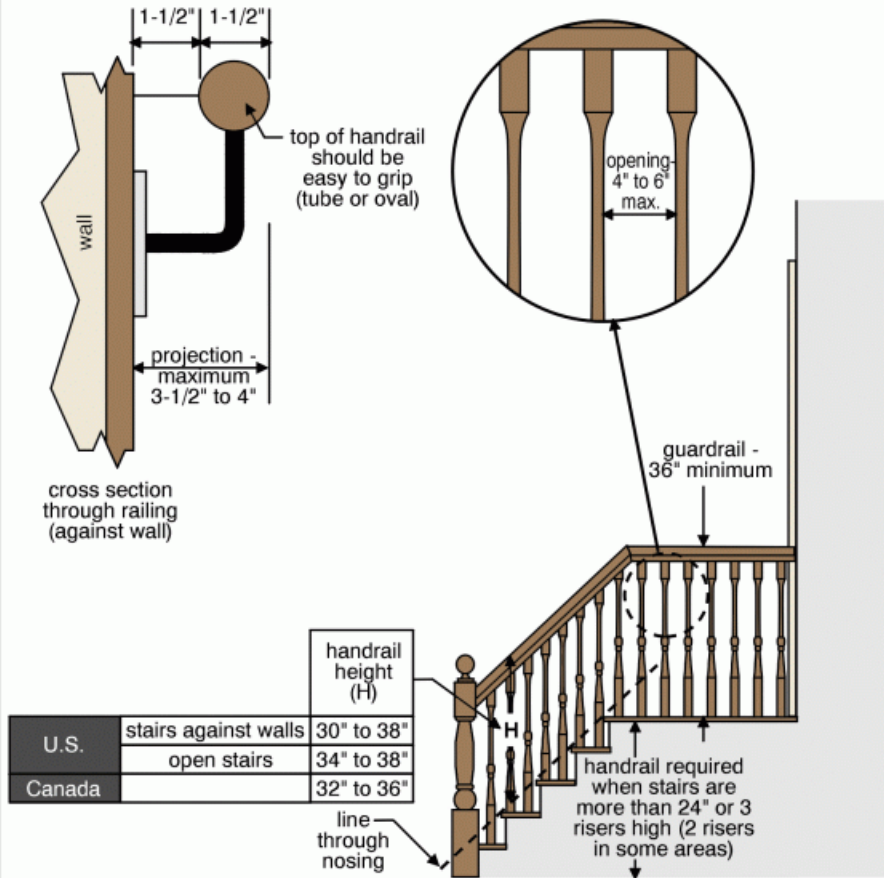
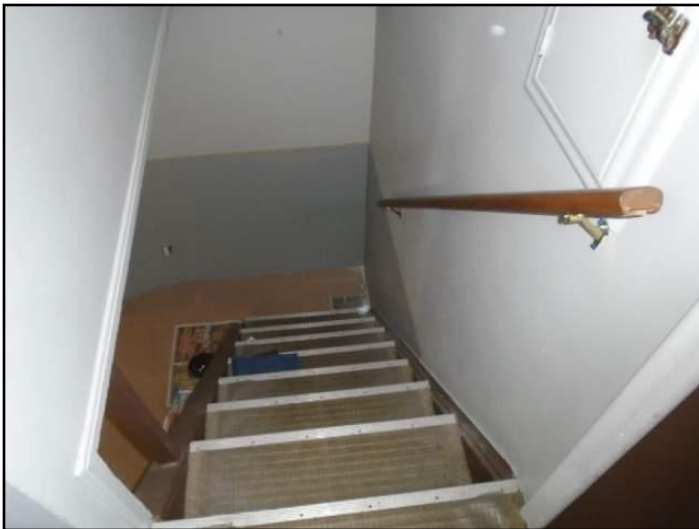
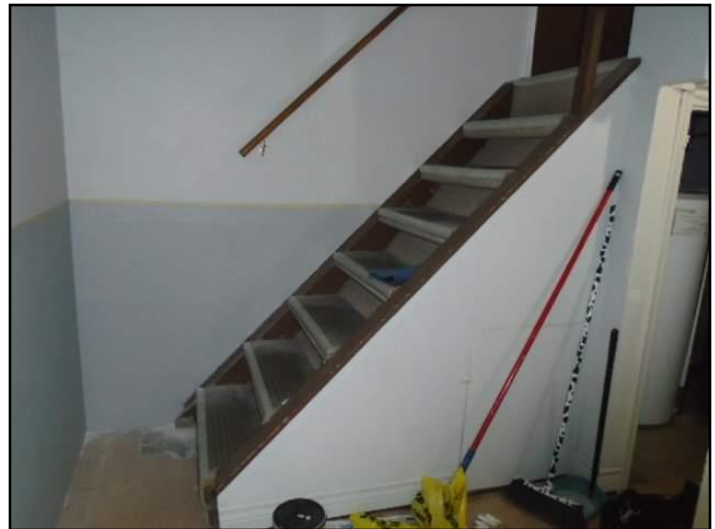
Handrails and guards

Condition: • [Missing](#)

Missing at the inboard side, a fall arrest issue...

Implication(s): Fall hazard

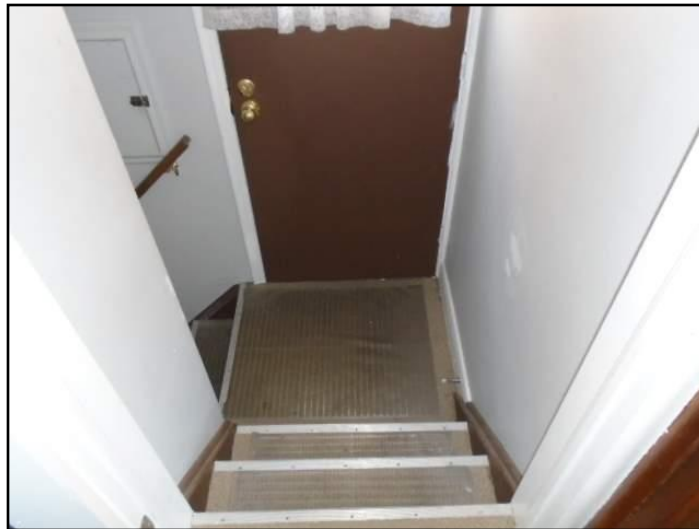
Condition: • [Missing](#)

Implication(s): Fall hazard

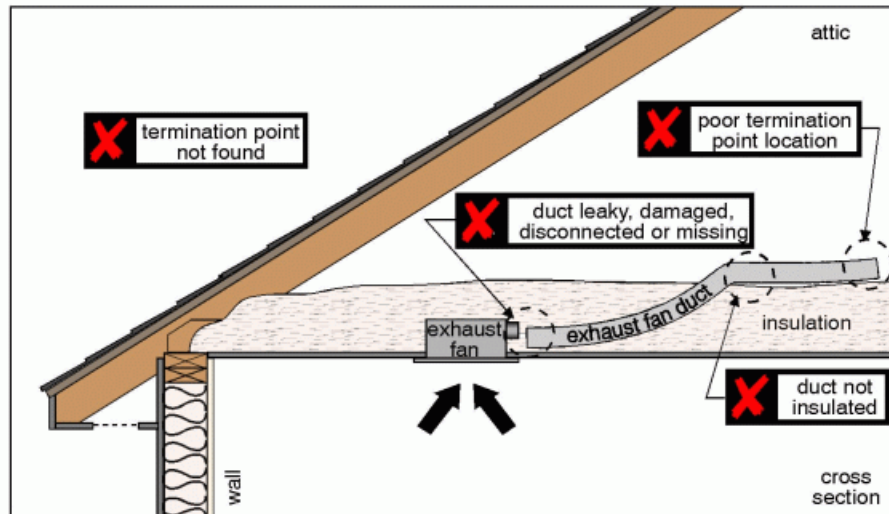
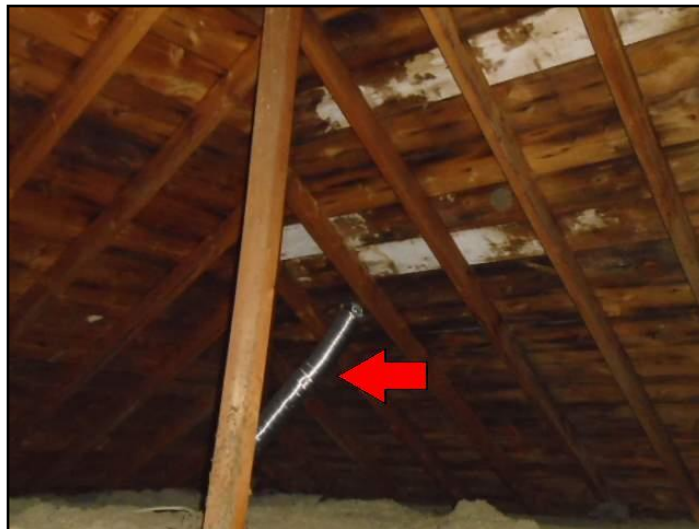
Exhaust fan conditions

EXHAUST FANS \ Duct

Condition: • [Not insulated in unconditioned space](#)

Implication(s): Chance of condensation damage to finishes and/or structure
