Your Inspection Report

1 Sample St., Suite A,B,C,&D
Sacramento, CA 95820

INSPECTION DATE:
Tuesday, August 23, 2016

RE: Report No. 1036, v.4
1 Sample St., A,B,C,&D
Sacramento, CA
95820

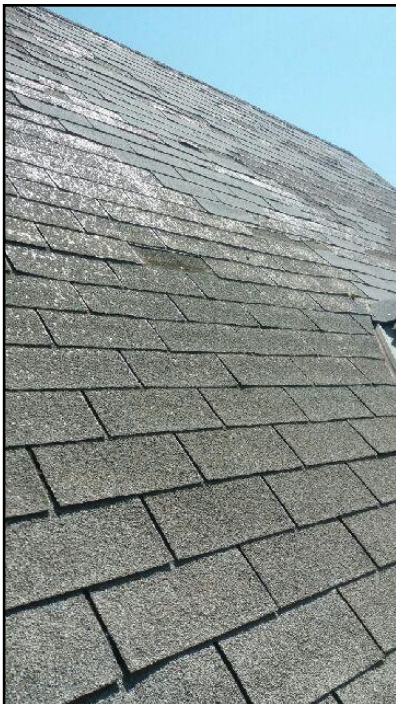
The roofs over Units C&D are old and in poor condition with significant granule loss observed and patches and missing shingles were observed at different locations (see picture and illustrations). Although no evidence of obvious leaks were observed from the attic at the time of the inspection, the buyer should be aware that these roofs will need to be replaced in the very near future.

1. Old, worn out

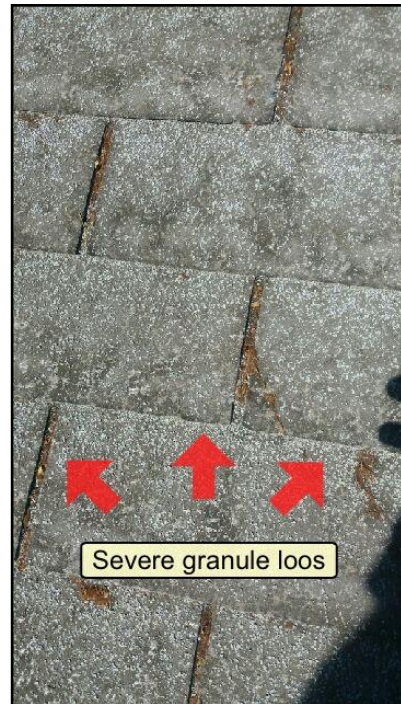
2. Old, worn out

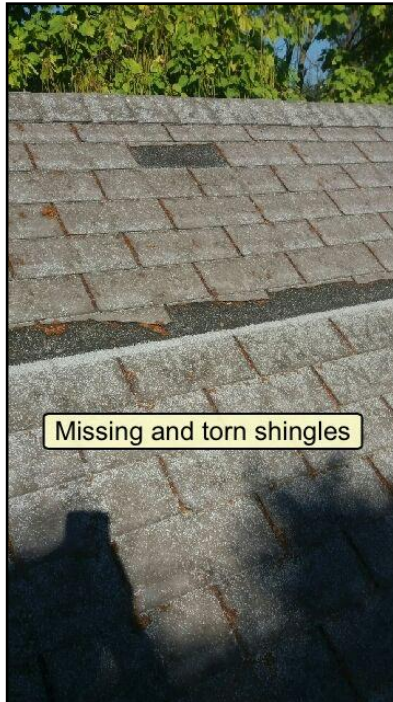
3. Old, worn out

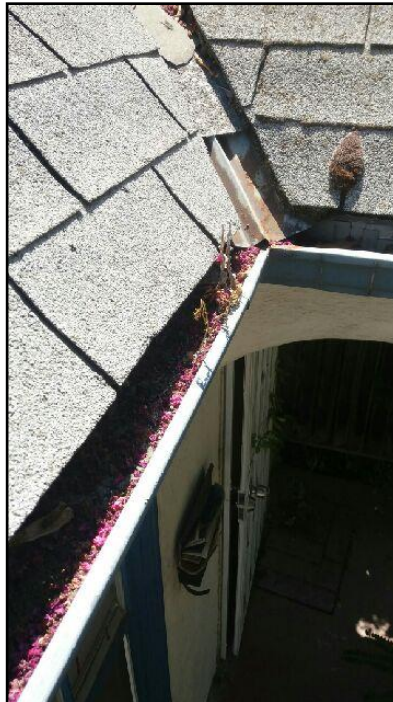
Clogged gutters were observed at several locations (see picture and illustration). This condition may result in water damage to finishes and/ or the structure. Clean gutters ASAP and as a regular maintenance in order to maintain a functional water removal system and hence to reduce the probability of water damage.

13. Clogged gutters

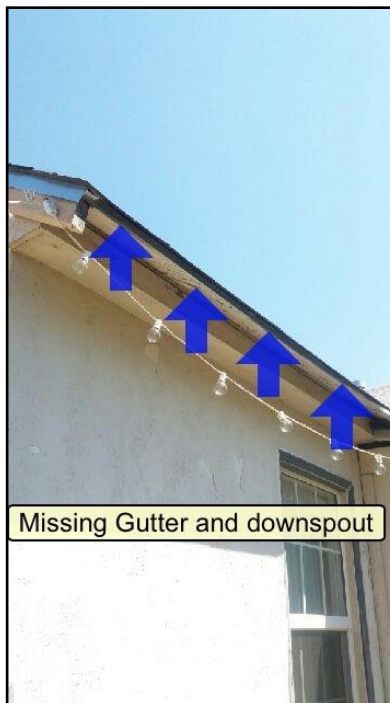
Several of the gutters and downspouts are missing. A good rain removal system is very important in order to maintain the structural integrity of the structure. The discharge of rain water along the house/ foundation may result in saturated soil; saturated soil reduces the capability of the soil to resist load/ pressure which will increase the probability of unwanted foundation movement. Installation of an effective rain water removal system is highly recommended to reduce the probability of foundation movement.

14. Missing gutter and downspout

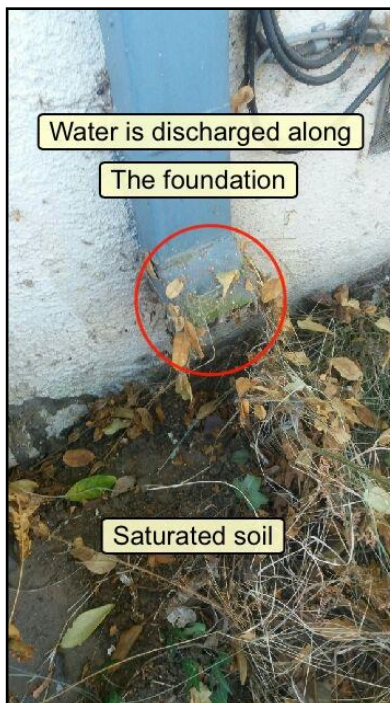
Several of the downspouts on this property discharge water close to the house/ foundation. This condition may result in saturated soil; saturated soil reduces the capability of the soil to resist load/ pressure which will increase the probability of unwanted foundation movement. It is highly recommended to extend the downspout in such a way that all water will be charged away from the foundation.

15. Downspouts end too close to building

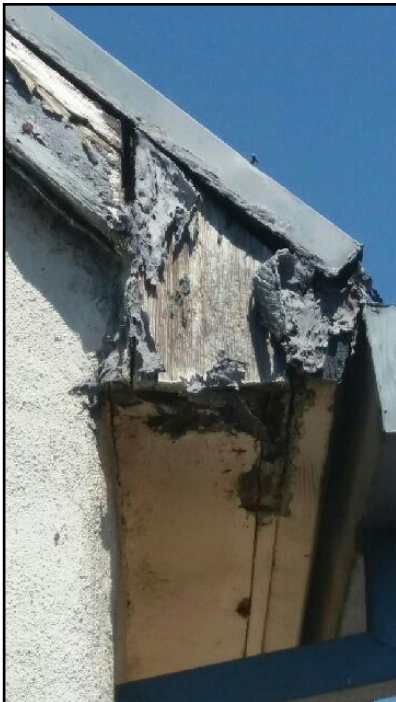
Damaged and rotted wood pieces/trim/ wall boards were observed on this property (see pictures). Also, several gaps

16. Fascia needs protection

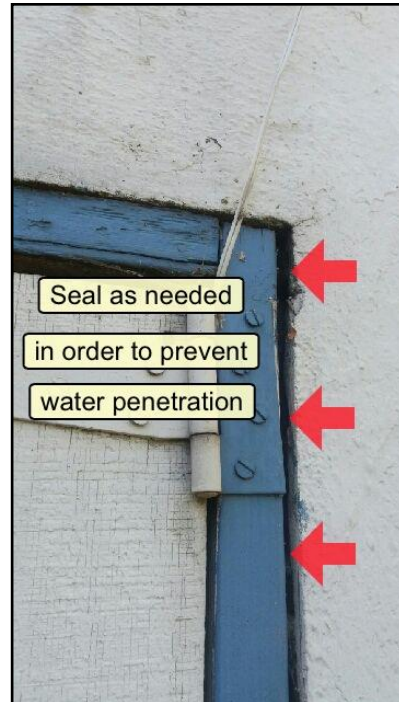
17. Gap needs to be sealed

between trim and wall were observed where water can penetrate and damage the structure. Replace/repair/protect/seal as needed.

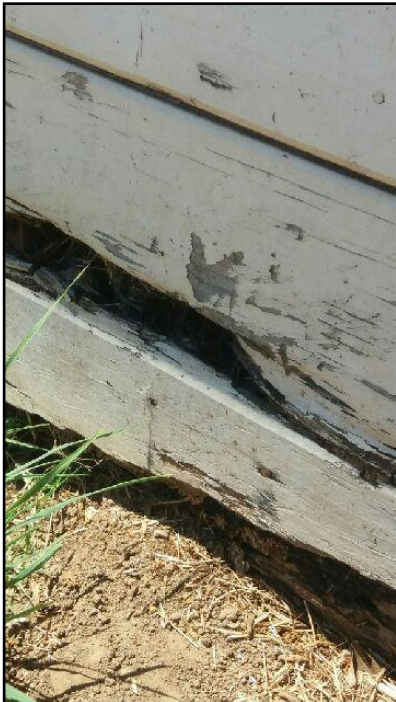
18. Damaged ood boards, Unit D

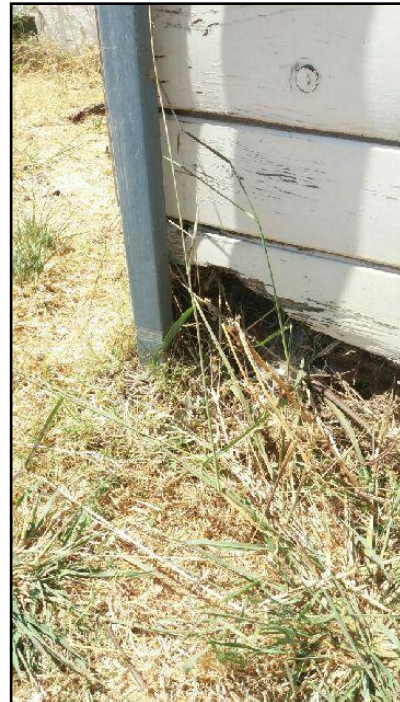
19. Damaged boards; Unit D

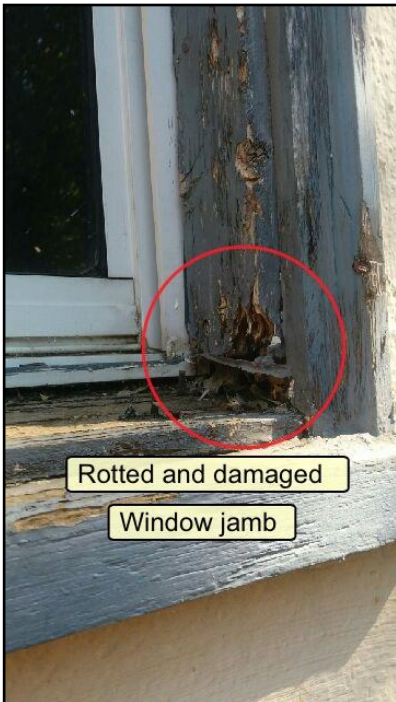
20. Damaged wood

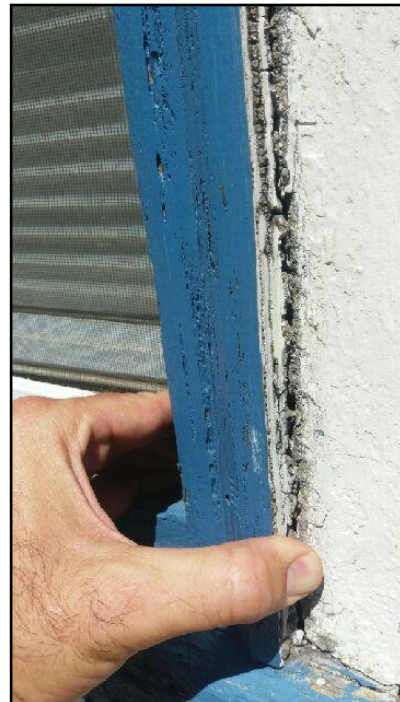
21. Gap needs to be sealed

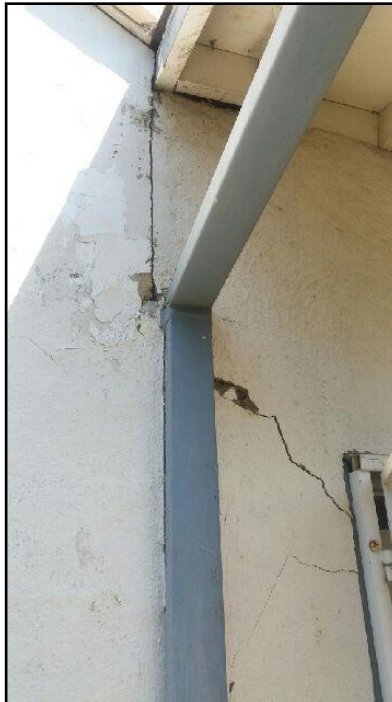
Although the exterior Stucco was in good condition, several cracks/gaps in the exterior Stucco were observed at several locations (see pictures). Have all cracks sealed/patched in order to prevent water penetration and possibly damage to the structure.

22. *Stucco crack*

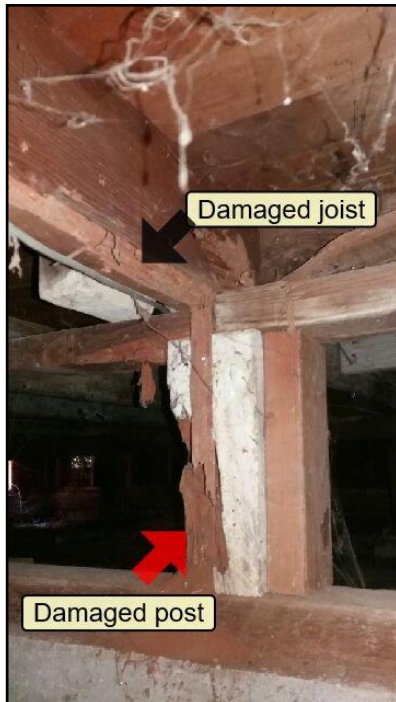
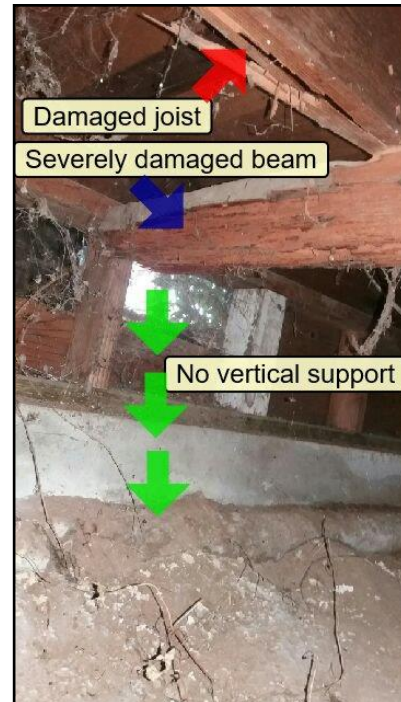
25. Unit A

7. Condition: • Some termite damage was observed, in the crawl space of Unit A, to several structural elements, see pictures. Have a professional contractor inspect and repair all damaged structural elements in order to maintain a sound and safe structure for years to come.

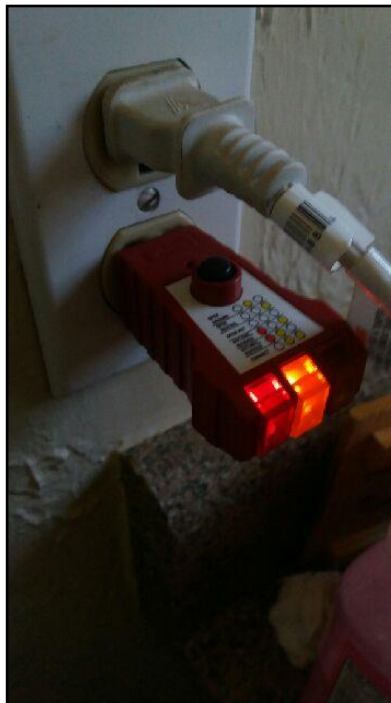
Reversed Polarity condition was detected at the kitchen of Unit D; see illustration and click the blue link above for more information.

Although minor and an easy fix, this condition is considered a safety hazard and should be corrected by an Electrician.

34. Reversed polarity

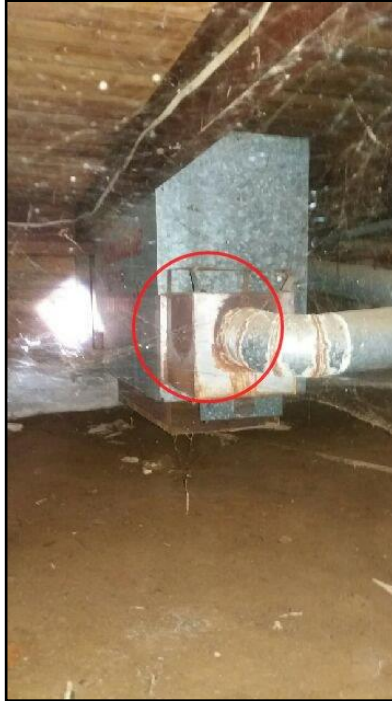
11. • All gas heating units (Units A,C, and D) were operational at the time of the inspection and provided heat. However, the unit in Unit C is very old and rust was observed on the unit which is located in the crawl space. The buyer should be aware that this unit may need to be replaced in the near future.

40. Rust on heating unit, Unit C

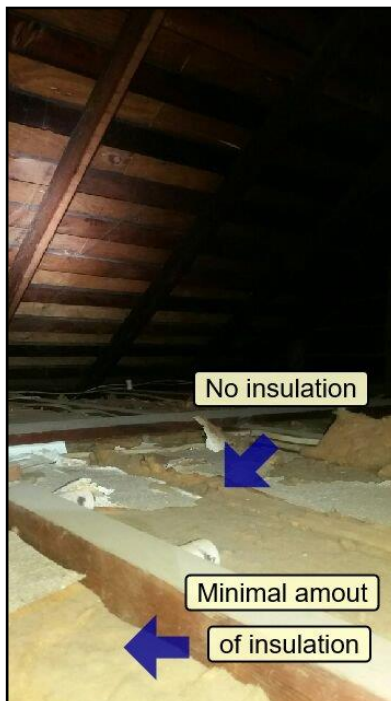
Minimal amount of insulation (2 to 3 inches) in the attic was observed and there was no insulation in some areas. Adding more insulation will help maintain the desired temperature in the units and may reduced heating/ cooling costs.

41. Amount less than current standards

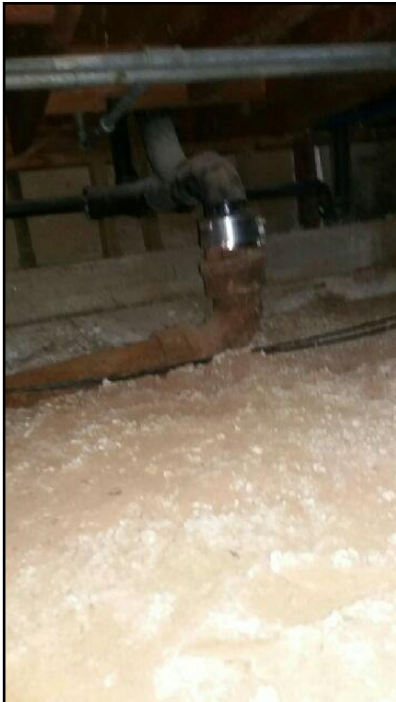
General: • FYI. The plumbing system, including the supply pipes and waste pipes, is very old and has not been upgraded.

42. Old plumbing

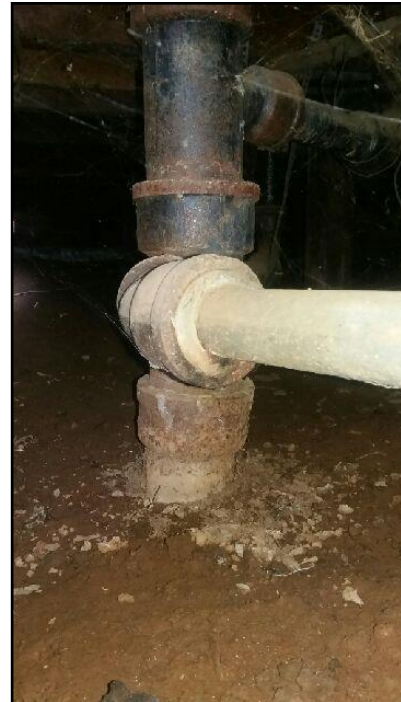
43. Old original waste pipes

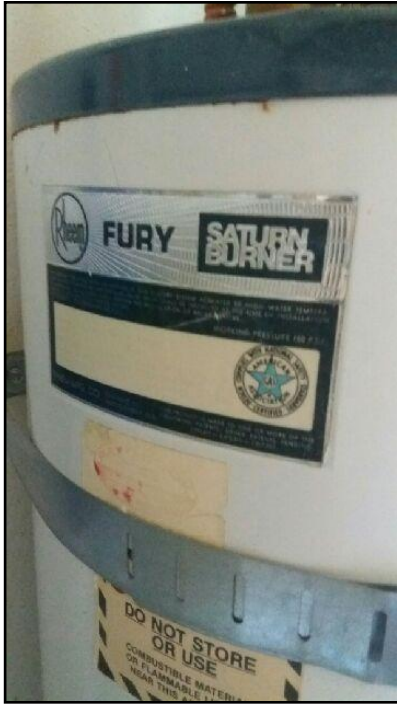
Very old unit, age could not be determined

47. Data plate not legible

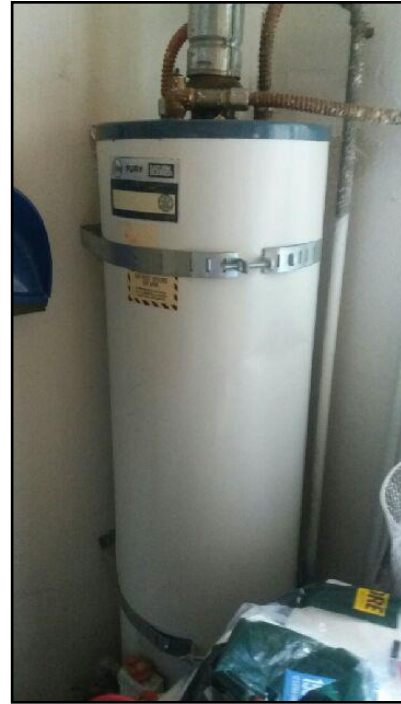
48. Unit A water heater

Although Unit A water heater was functional and no combustible gases or Carbon Monoxide were detected, this unit is very old and has high probability of failure. Also, it is very noisy while operating (most likely due to mineral built up). This unit will have to be replaced in the very near future.

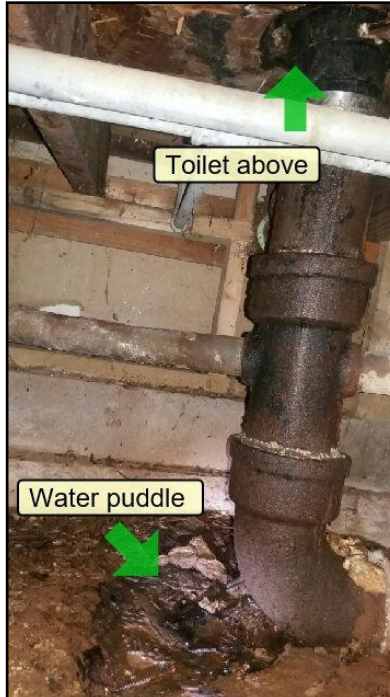
An active leak was observed in the crawl space of Unit A under the toilet (see picture of puddle next to the pipe). Have a plumber inspect and repair as needed.

50. Active plumbing leak

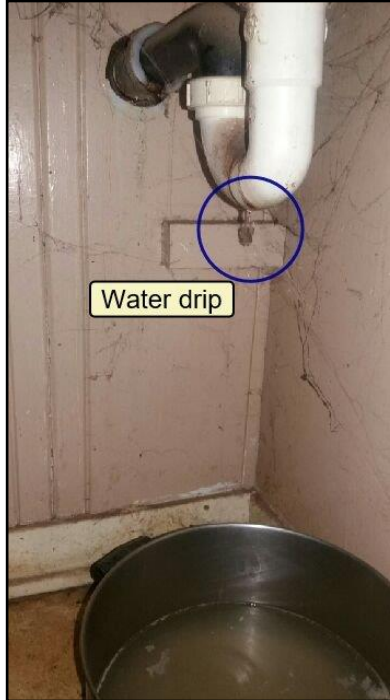
An active leak under the kitchen sink of Unit C was observed (see picture). Have the leak repaired as needed.

51. Active leak

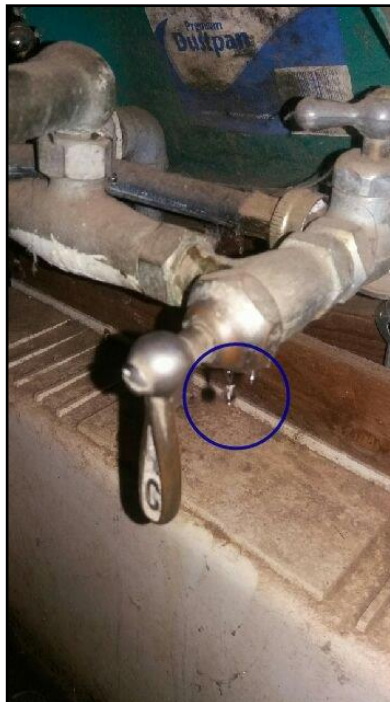
A leak was observed at the Unit C laundry faucet (see picture). Improve/ fix as needed.

52. Leaky faucet

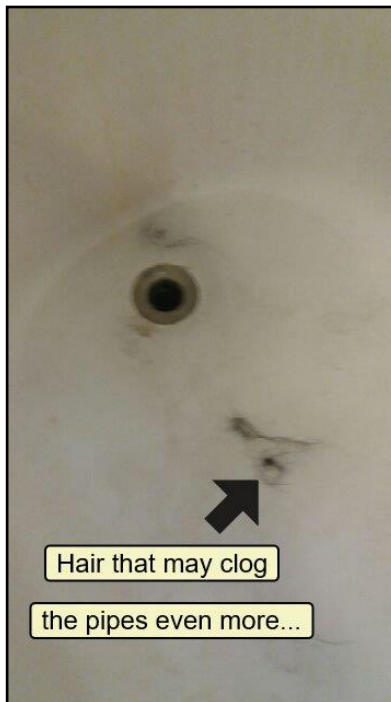
Very slow drain at the unit D tub. Repair/improve as needed.

53. Slow drain

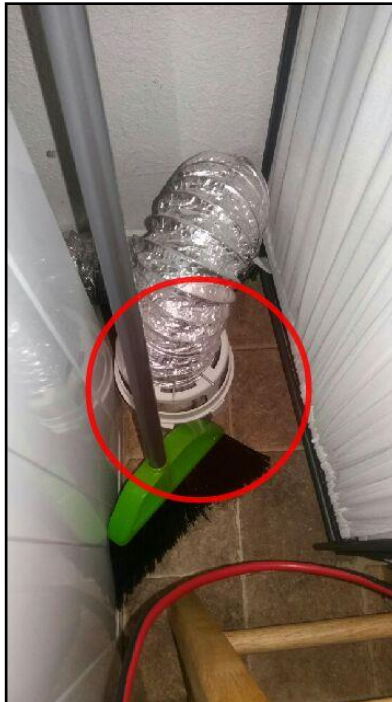
The Unit A dryer is vented inside with a filter designed for this purpose; however, it is recommended to have the dryer vent outside if possible.

56. *Dryer not vented to exterior*
