INSPECTION REPORT

For the Property at:
1234 HOME
CENTRAL POINT, OR 97502

Prepared for: EXAMPLE REPORT
Inspection Date: Tuesday, May 16, 2017
Prepared by: Zach Macormic

Apex Home Inspection & Construction
120 Meadowbrook Dr
Central Point, OR 97502
541-821-3473

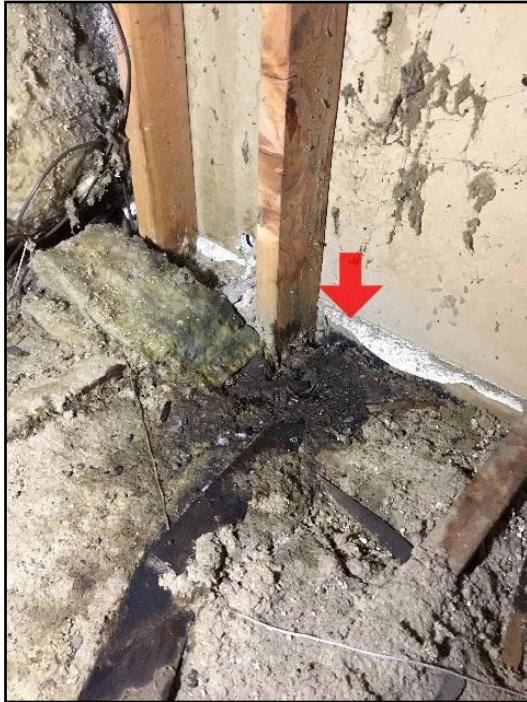
Implication(s): A Leak was found just past the entrance into the attic on the right. It appears to be a considerable leak and was dripping at the time of inspection. The insulation was wet and the the water appears to be flowing down into the wall below. The garage has a noticeable wet spot in the middle of the wall. I recommend having a professional roofer patch the roof immediately to prevent damage to the interior of the home and possible mold problems.

1. Leak

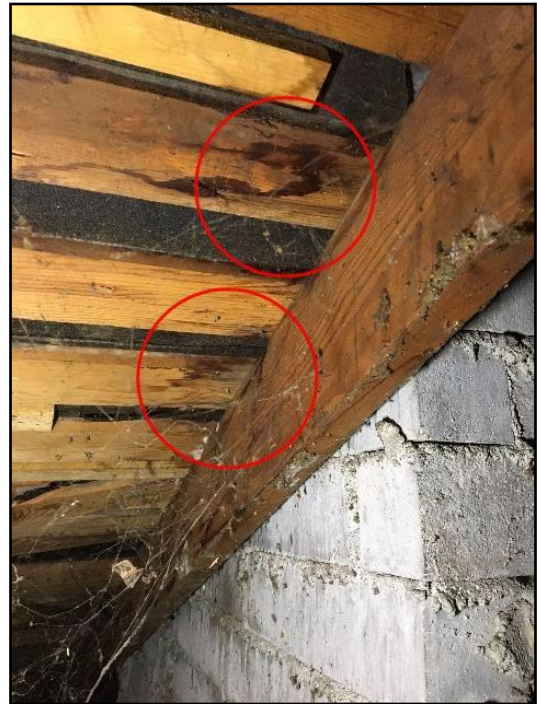
5. Evidence of past leakage under chimney

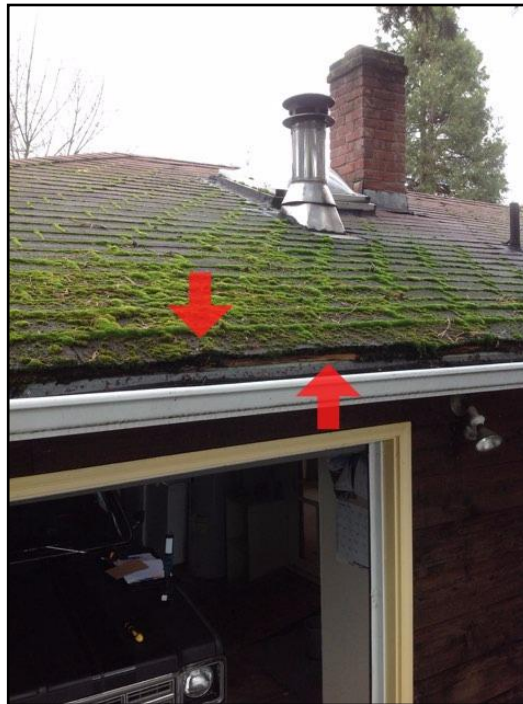
I noted no drip edges on the eave of the roof. While it is common for a roof to not have a drip edge, no drip edge allows the eventual rotting of the sub-roofing material. There are several areas on the perimeter of the home where I noted have some evidence of rot because of this. I recommend installation of a drip edge to prevent further deterioration by a qualified roofer.

6. Missing drip edge flashing

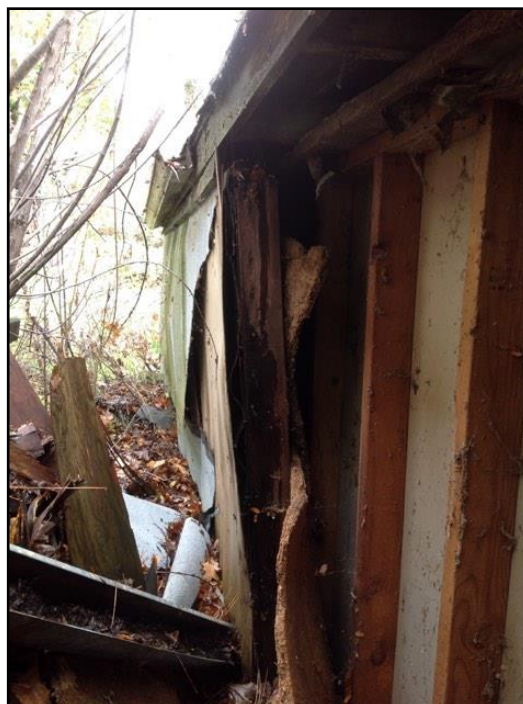
The North side of the detached storage room is severely deteriorated. This is due to improper roofing installation which allowed water to drip down the wall and rot the particle board away. This is the cause of the water intrusion and mold inside inside the storage room. I recommend consulting a qualified contractor for proper remedy.

9. Rot damage

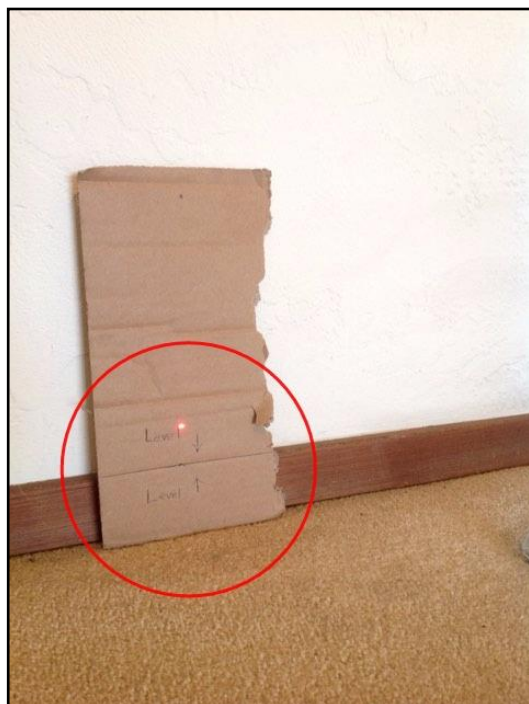
- The entry way has some obvious settling. The ceiling is cracked substantially and the door reveal shows about a 1/2" variance. From North to South, the floor drops about 1.5" in about 3 feet.

10. 1.5" lower on the west side of entry.

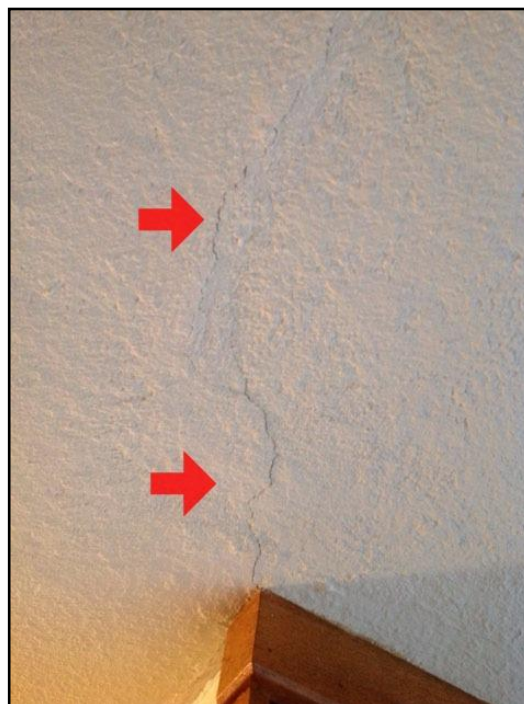
11. Crack above fireplace

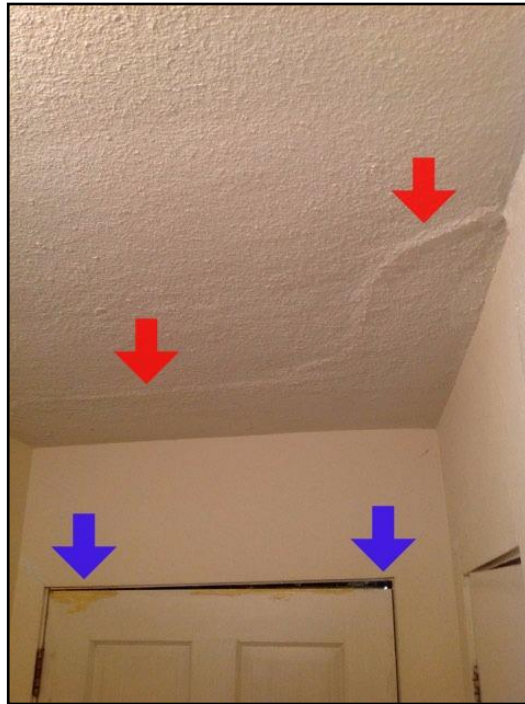
12. Crack and door reveal

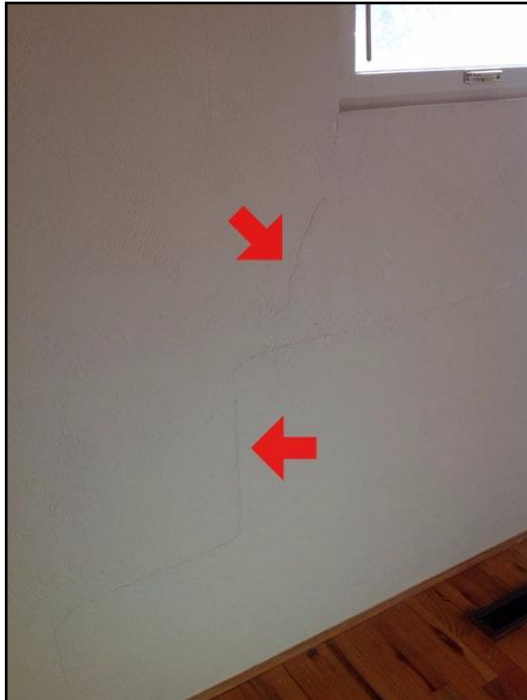
Implication(s): Chance of structural movement

13. Settled

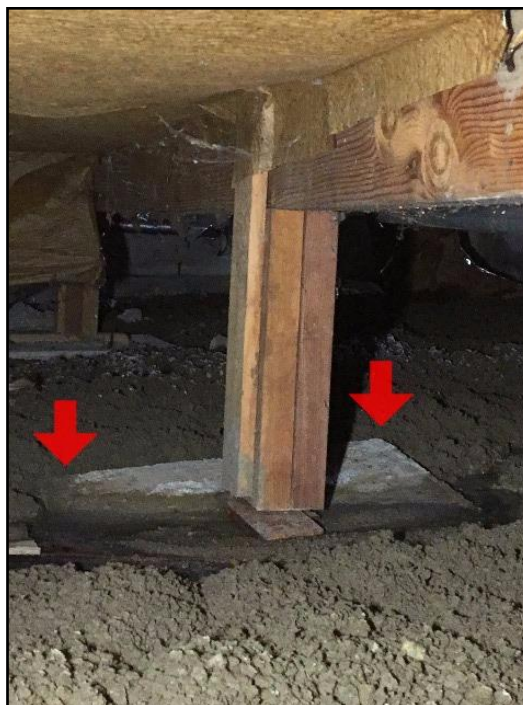
17. Footing movement and standing water

Crack in corner and standing water.

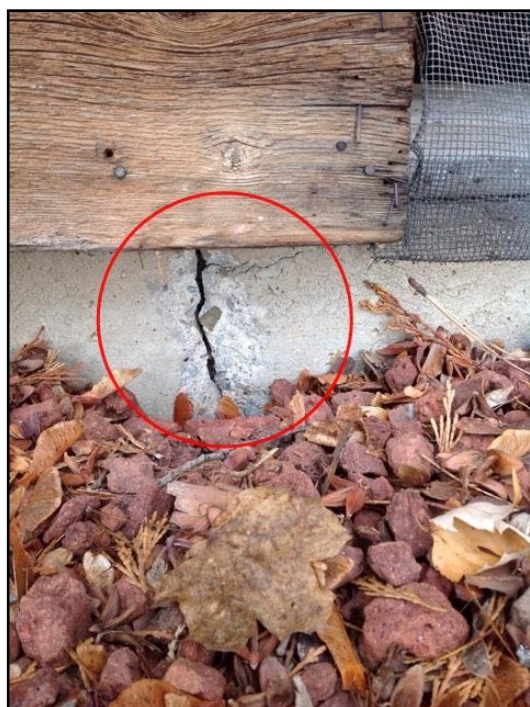
18. Cracked

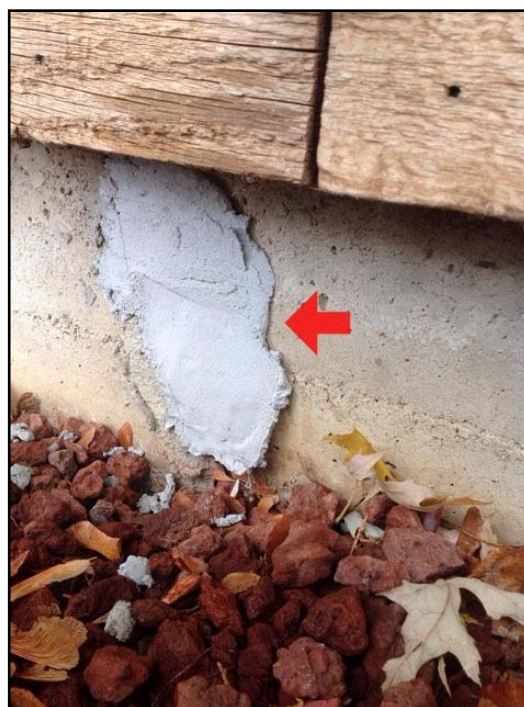
19. Typical minor cracks

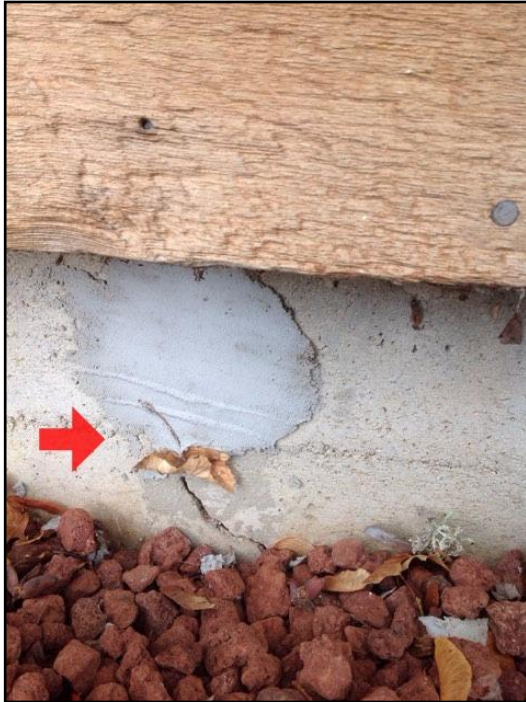
20. Typical minor cracks

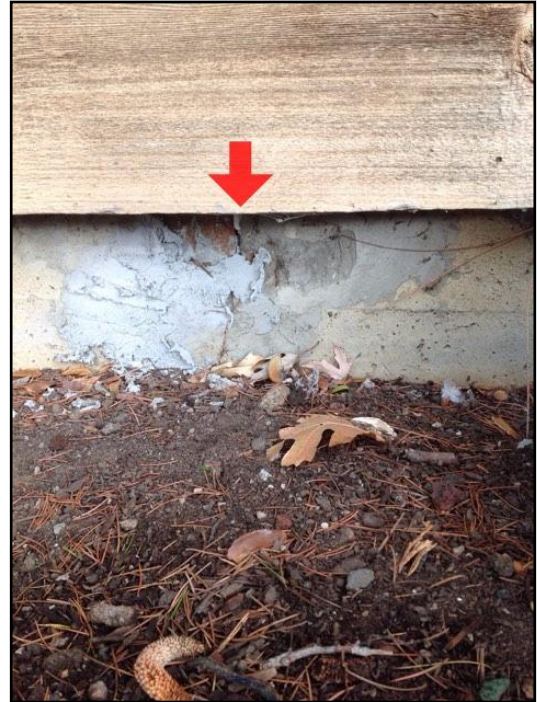
21. Cracked

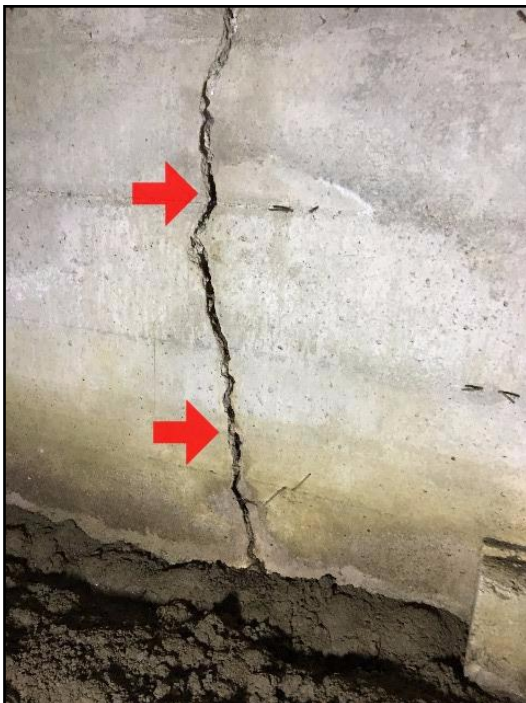
22. Cracked

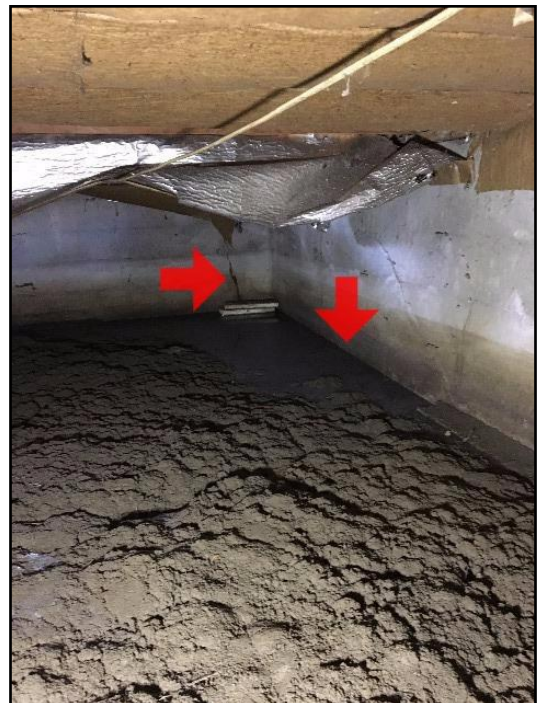
23. Cracked

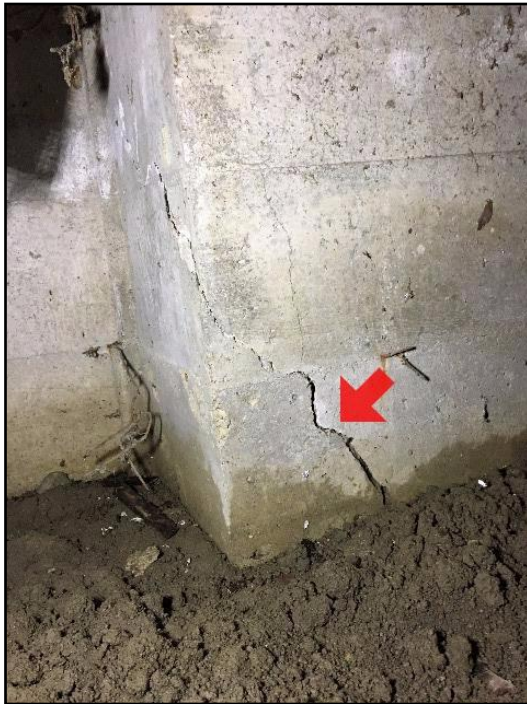
24. Cracked

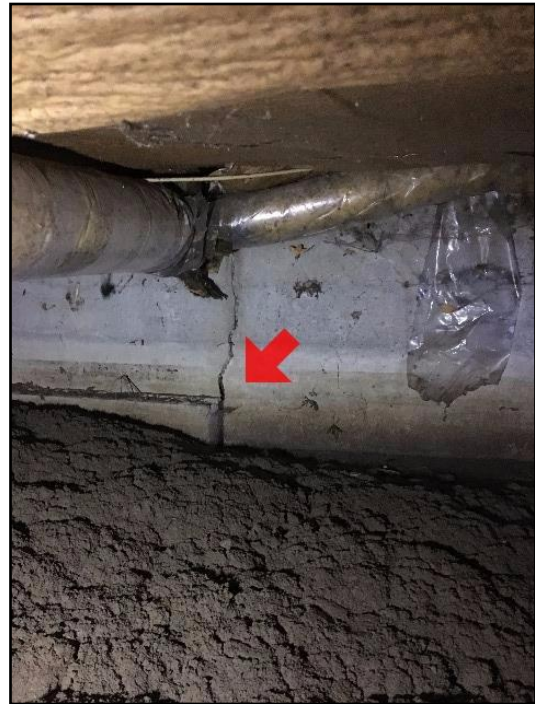
25. Cracked

The foundation shows many signs of obvious settling. The foundation appears to have been poured directly on top of expansive soil. The 60 years of the soil expanding and contracting over the seasons has caused several substantial cracks throughout the foundation by allowing the foundation to sink. Water has been allowed to exist under the home, this allows the soil to be soft and expand. I recommend prevention of water intrusion into the crawlspace and installation of a sump pump as soon as possible.

I recommend further consultation from a qualified foundation expert to discuss severity and remedy.

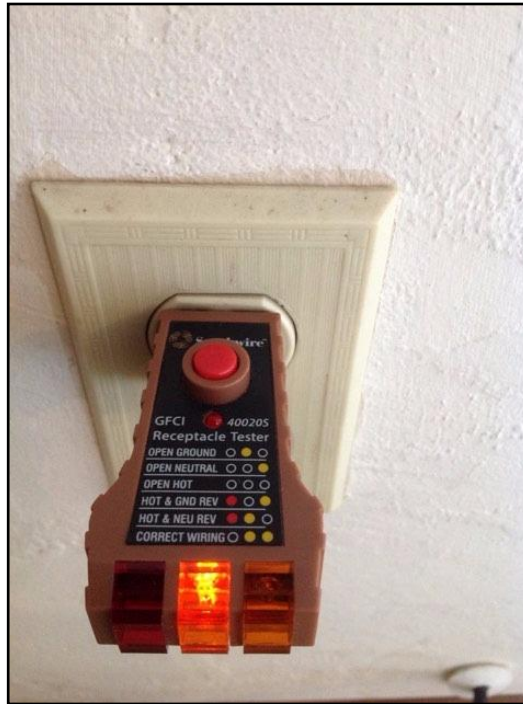
26.

All the outlets I found in the home are ungrounded. This is a normal construction practice for the time this home was built, however I recommend a qualified electrician replace the recepticals with Ground Fault Circuit Interrupter outlets to prevent a possible shock hazard.

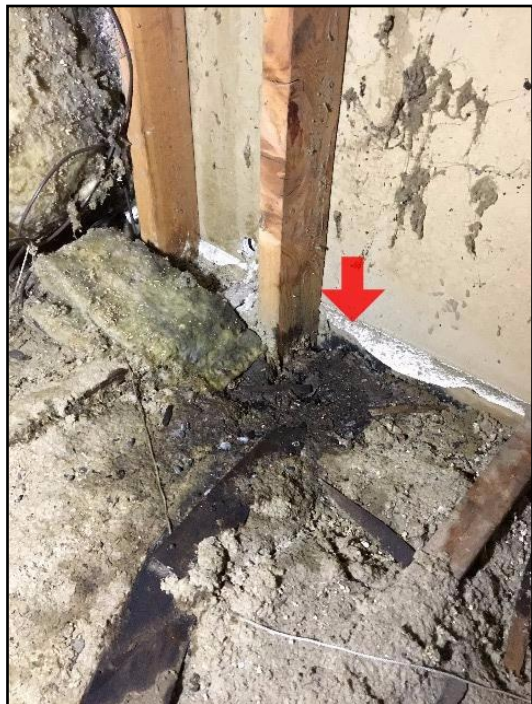
Implication(s): A Leak was found just past the entrance into the attic on the right. It appears to be a considerable leak and was dripping at the time of inspection. The insulation was wet and the the water appears to be flowing down into the wall below. The garage has a noticeable wet spot in the middle of the wall. I recommend having a professional roofer patch the roof immediately to prevent damage to the interior of the home and possible mold problems.

36. Leak

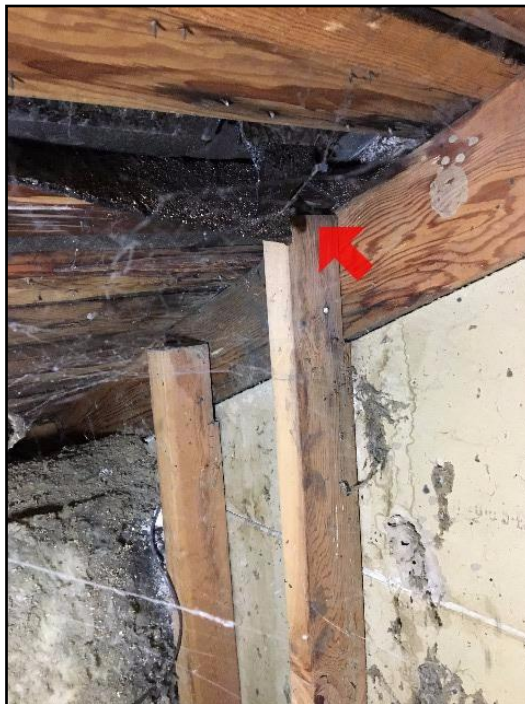
37. Leak

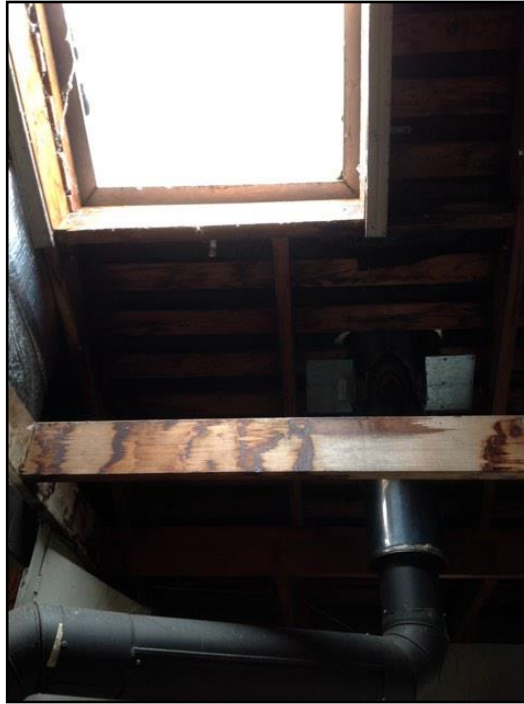
38.

A leak was found in the garage coming from the skylight. This appears to be from skylight flashing failure. I recommend re-flashing the skylight to prevent any further water penetration.

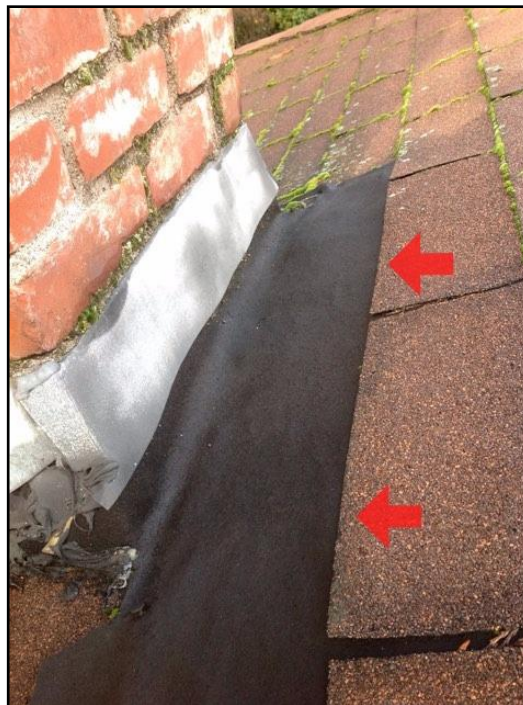
The upper side of the chimney flashing is installed improperly. It has been flashed using a piece of tar paper and it needs a material capable of withstanding the elements for long term use. I recommend having a qualified roofer install new flashing properly.

41. Missing top, bottom, side flashings

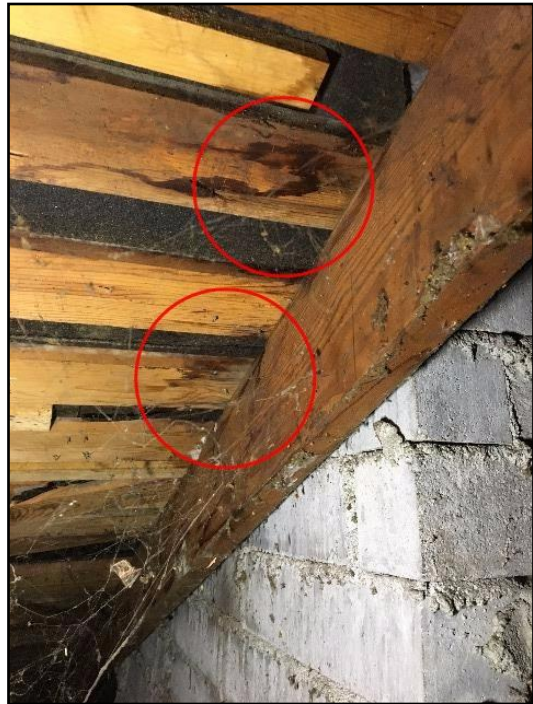
43. Evidence of past leakage under chimney

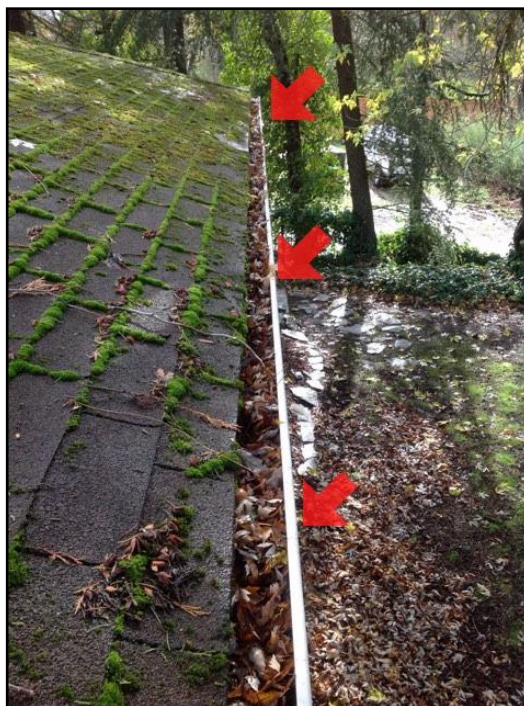
Much of the gutters were full of leaves. I recommend cleaning them to allow properer water drainage.

46. Clogged Gutters

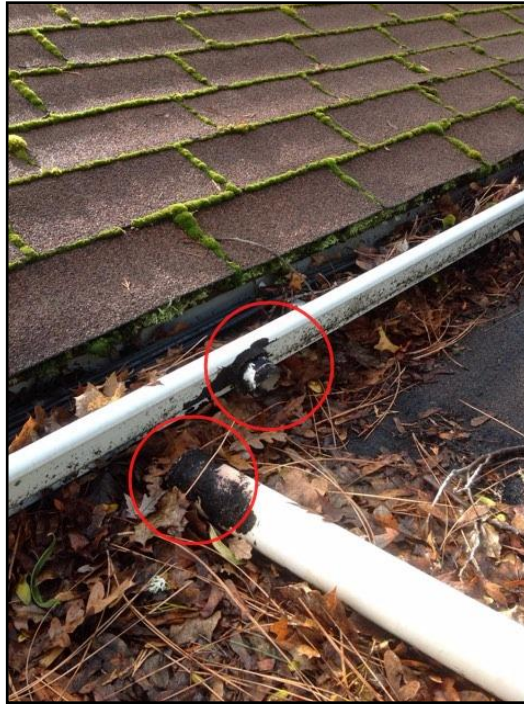
The gutter over the carport has a failed connection which allows excessive water onto the carport roof. I recommend

47. Discharging onto roof

re-installing the drain pipe for proper water drainage.

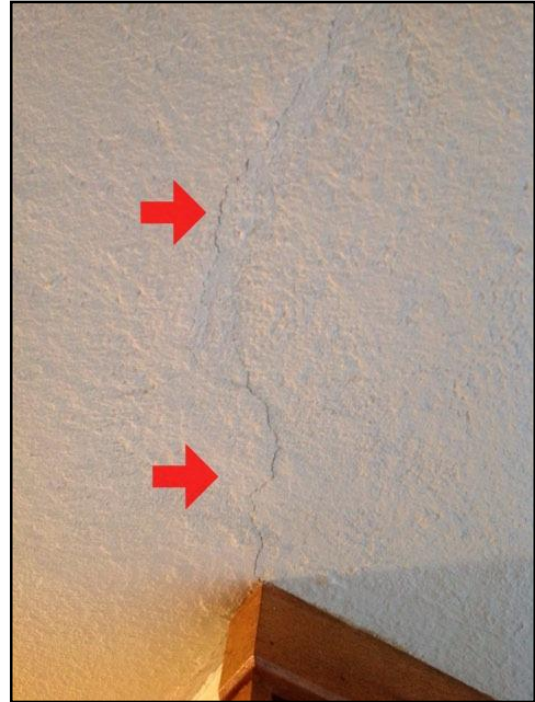
54. Crack above fireplace

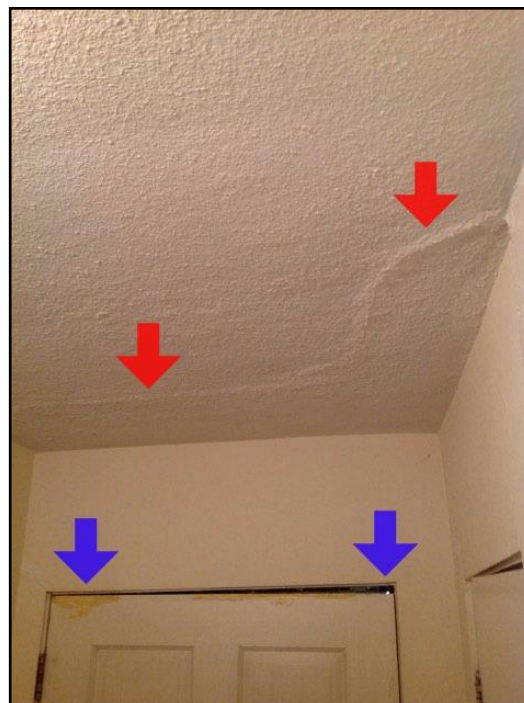
16. • The entry way has some obvious settling. The ceiling is cracked substantially and the door reveal shows about a 1/2" variance. From North to South, the floor drops about 1.5" in about 3 feet.

55. Crack and door reveal

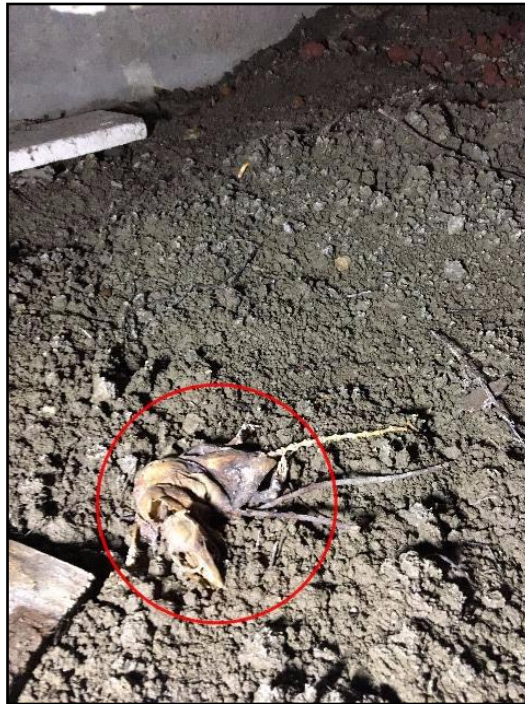
17. • I noted some evidence of past rodent activity. I did not see any evidence of wood boring pests or current rodent activity.

56. Evidence of past rodent activity

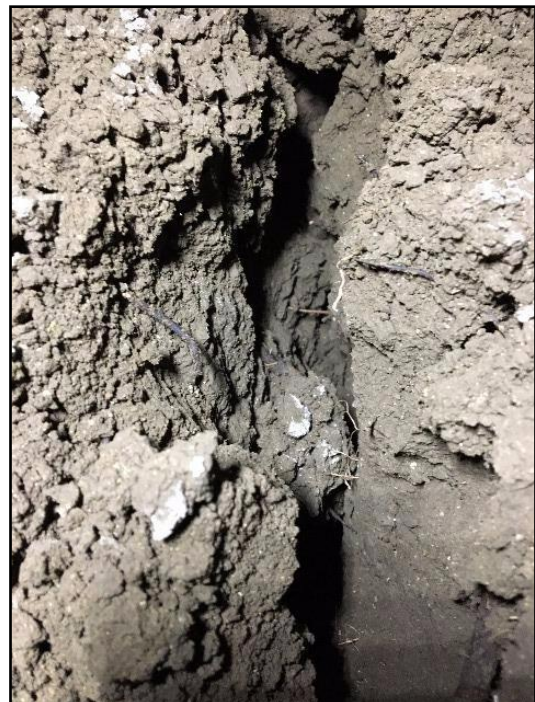
58. Expansive Soil - large crack found under home

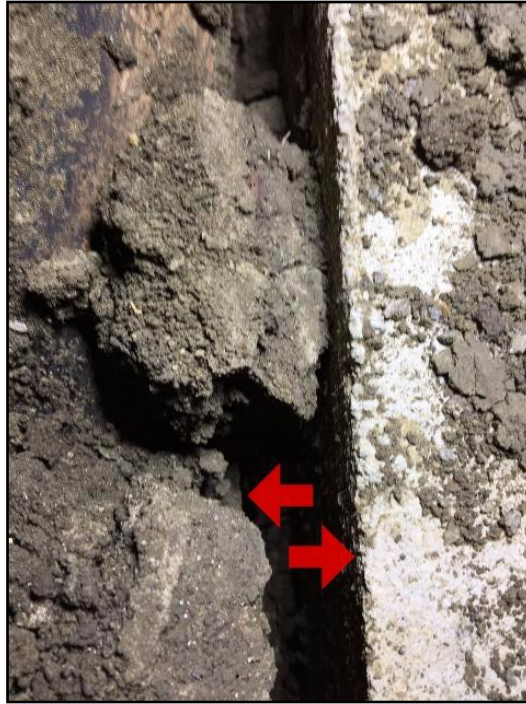
59. Evidence of movement - gap

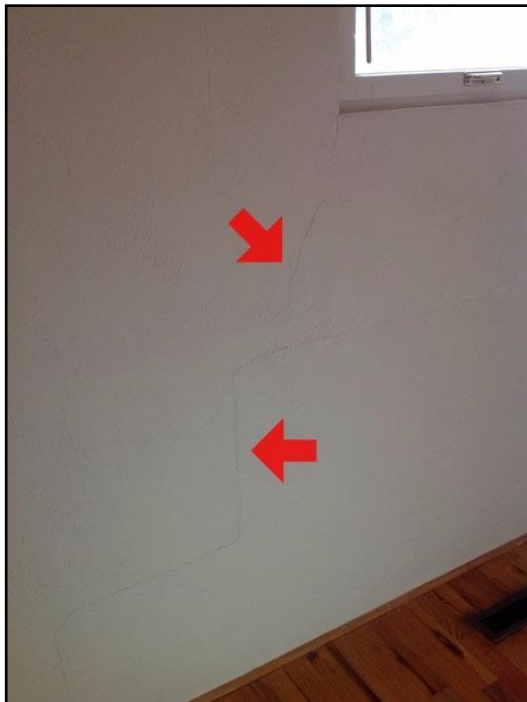
Implication(s): Chance of structural movement

60. Settled

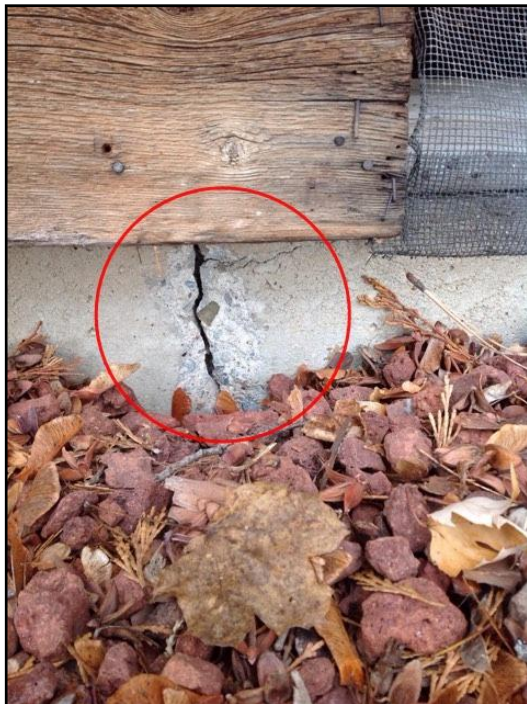
65. Cracked

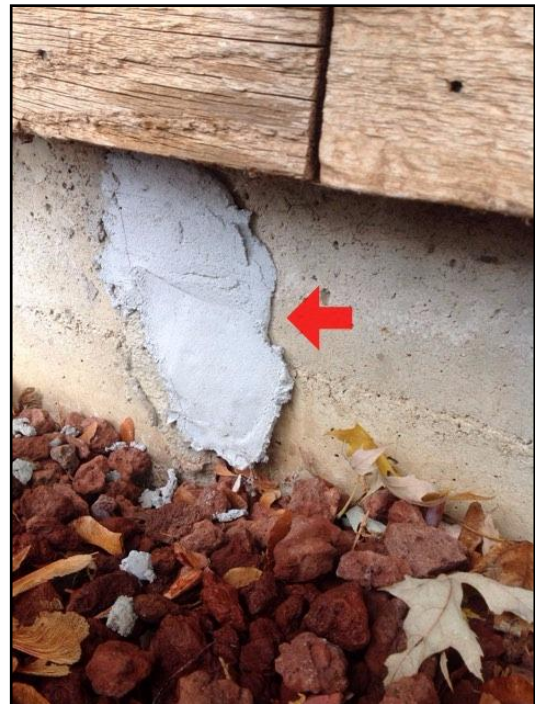
66. Typical minor cracks

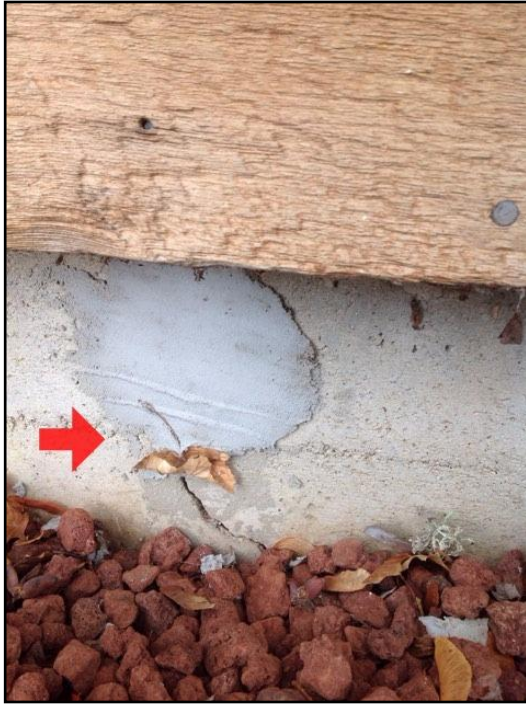
67. Typical minor cracks

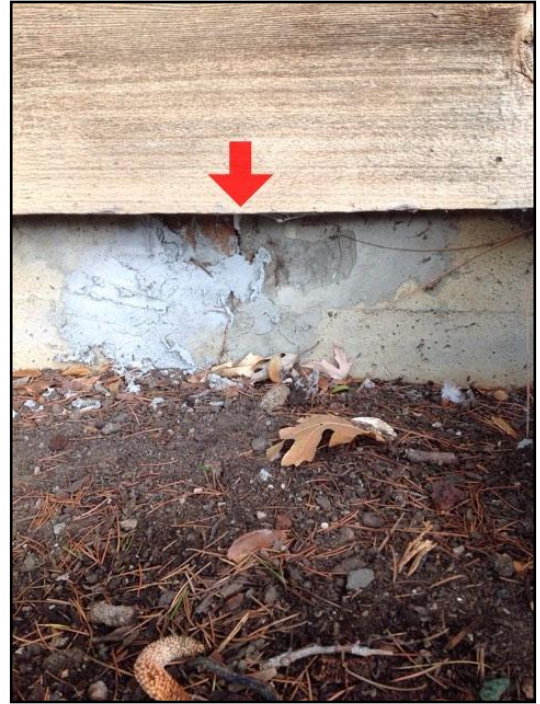
68. Cracked

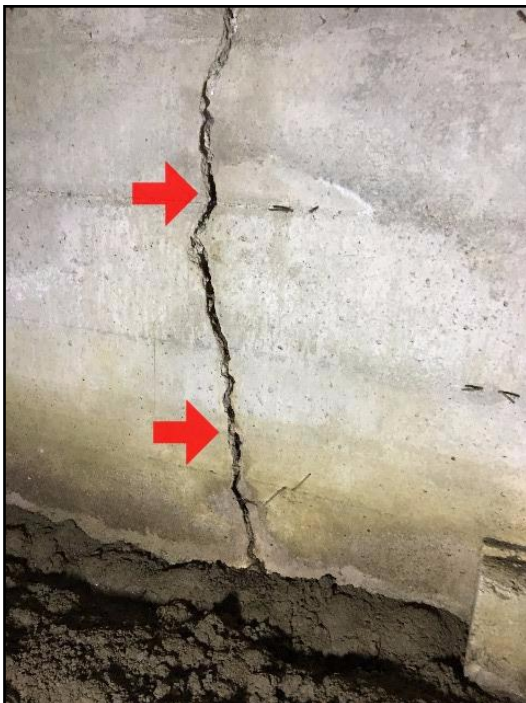
69. Cracked

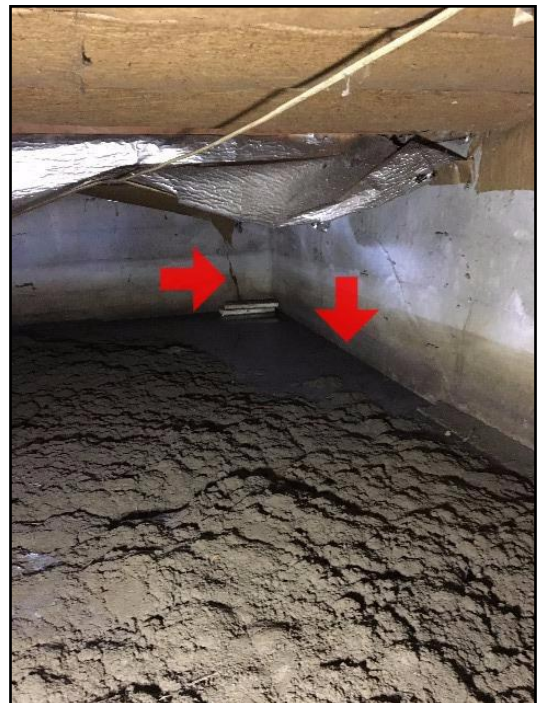
70. Cracked

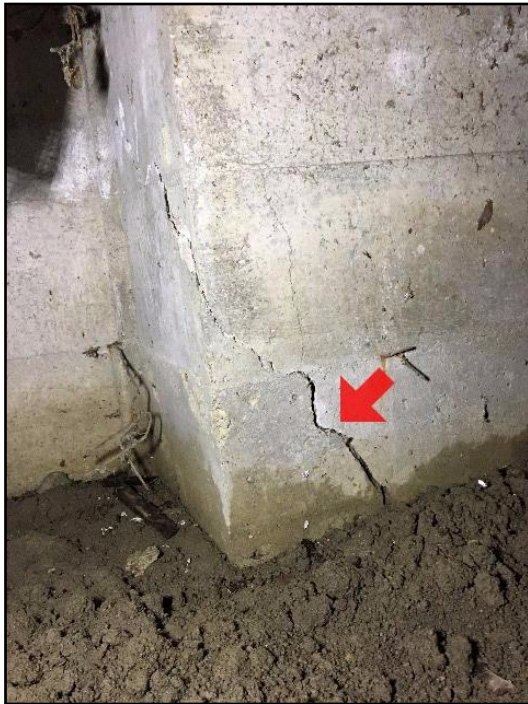
71. Cracked

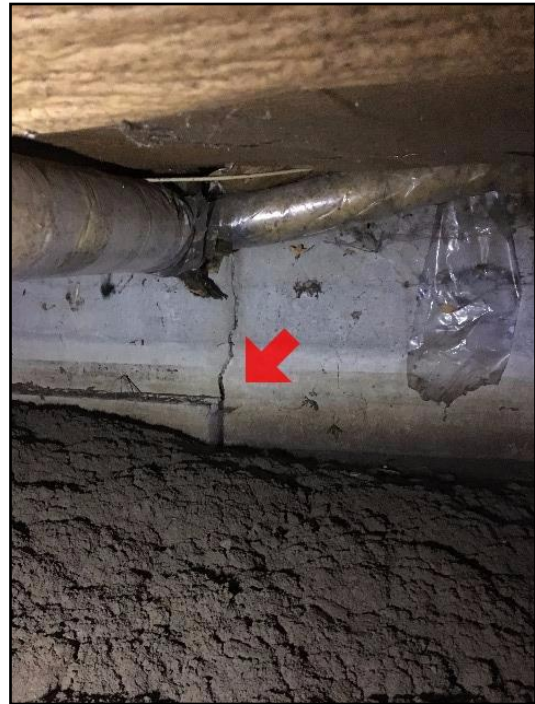
72. Cracked

The foundation shows many signs of obvious settling. The foundation appears to have been poured directly on top of expansive soil. The 60 years of the soil expanding and contracting over the seasons has caused several substantial cracks throughout the foundation by allowing the foundation to sink. Water has been allowed to exist under the home, this allows the soil to be soft and expand. I recommend prevention of water intrusion into the crawlspace and installation of a sump pump as soon as possible.

I recommend further consultation from a qualified foundation expert to discuss severity and remedy.

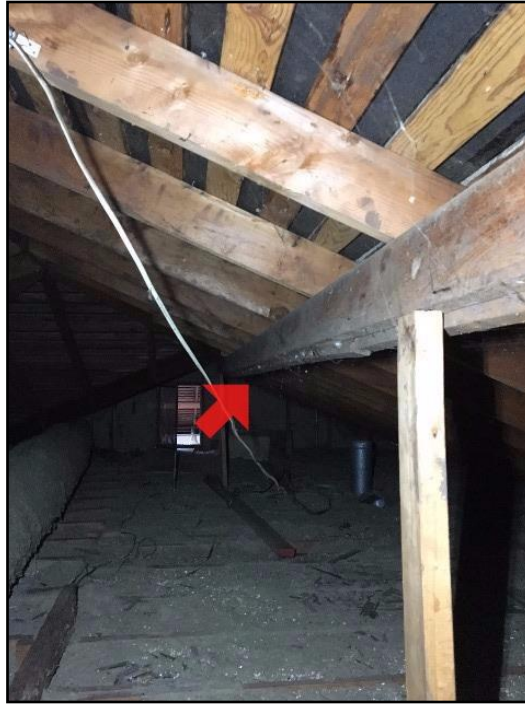
This purlin is over span, though it does not appear to be excessively deflected. I recommend adding another support in the middle, to help guard against roof sagging.

73. Purlins sagging

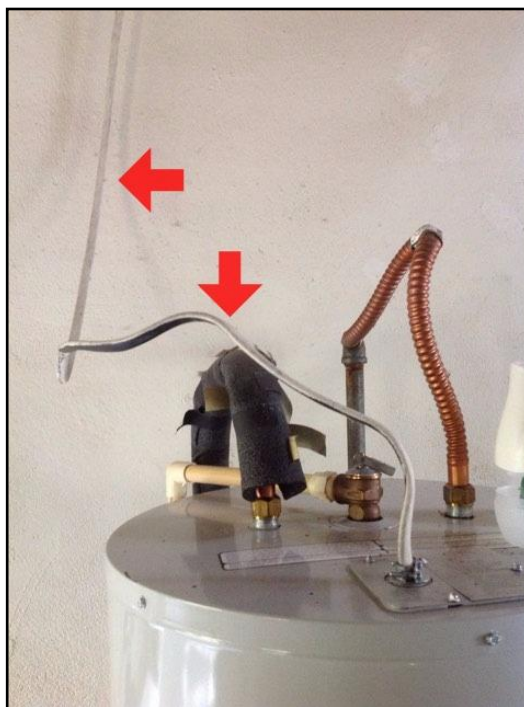
I recommend this electrical wire to the water heater be protected by an approved conduit to prevent possible damage and consequently electric shock.

80. Exposed on walls or ceilings

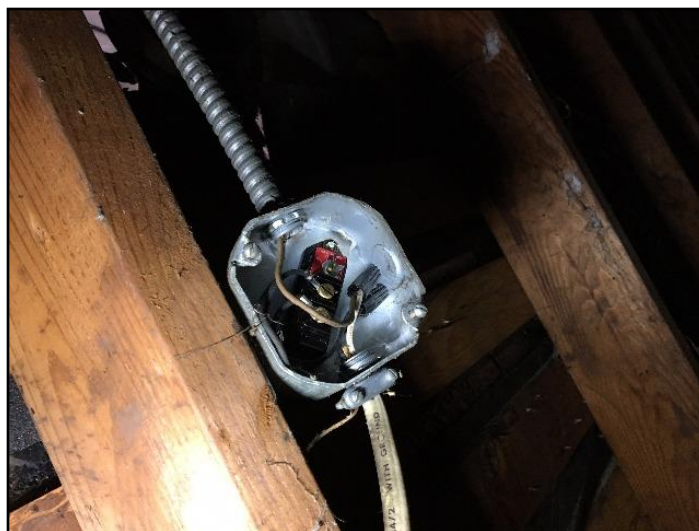
83. Missing cover

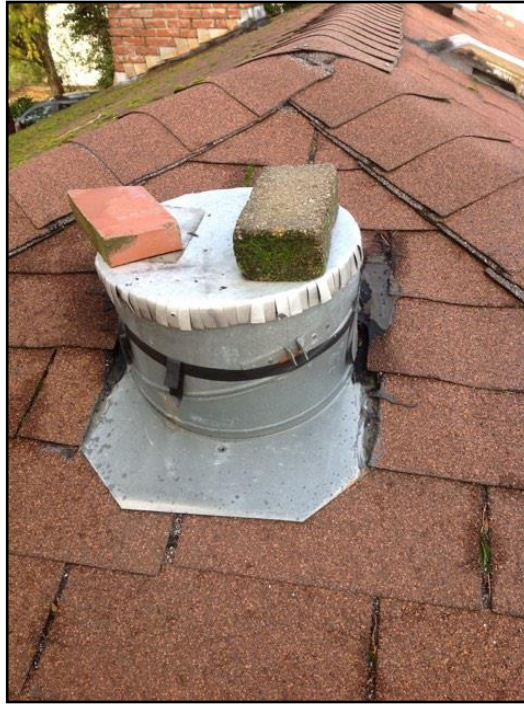
I noted to turbine style vents that were on the roof but not installed in their respective roof vents. I recommend proper re-installation to allow proper airflow to reduce energy costs and moisture.

91. Missing Vents

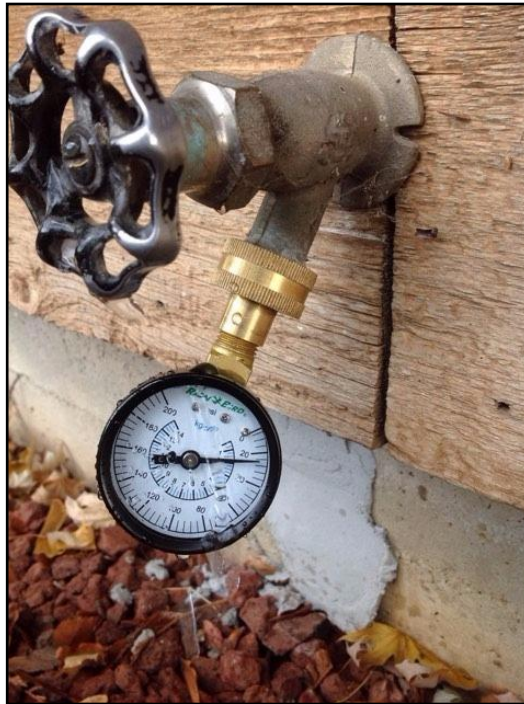
I found the water pressure to be about only 27psi. This is well below average, I recommend having a qualified plumber evaluate the condition and recommend a possible remedy.

93. Only 27 PSI

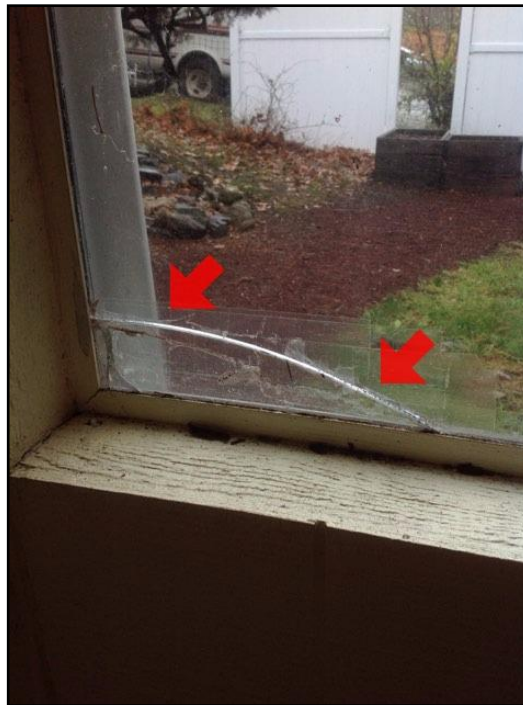
98. Cracked

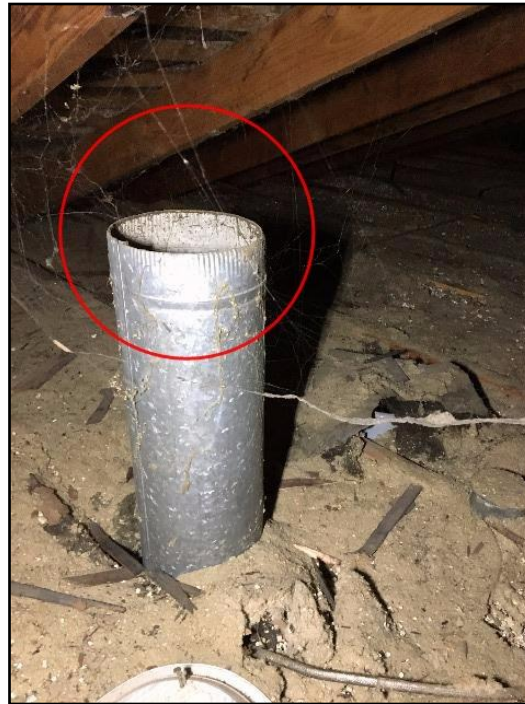
102. Not vented to exterior

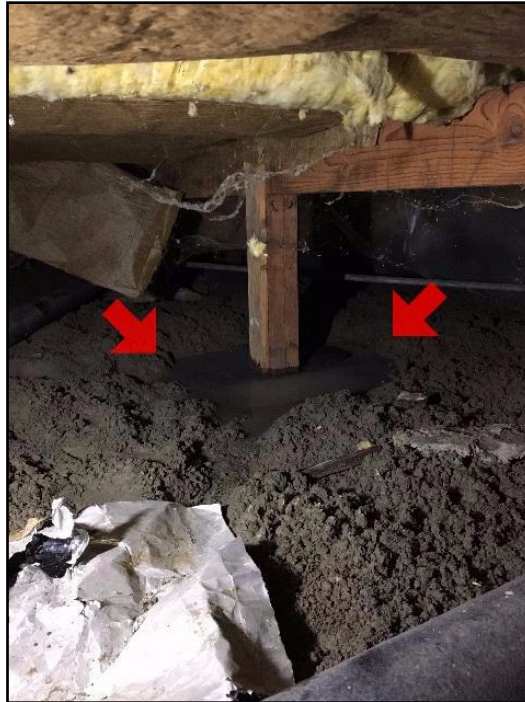
I noted standing water in the crawlspace. The entire floor was wet and muddy at the time of the inspection. The majority of the water pooled up at the South West corner of the home. I highly recommend the installation of a sump pump to remove the excessive water intrusion.

103. Settled
