INSPECTION REPORT

For the Property at:
12345 MAIN ST
PLAINWELL, WA 12345

Prepared for: JOHN AND JOAN EXAMPLE
Inspection Date: Thursday, February 8, 2024
Prepared by: Corby Whiddon

RE: Report No. 1394, v.3
12345 Main St
Plainwell, WA
12345

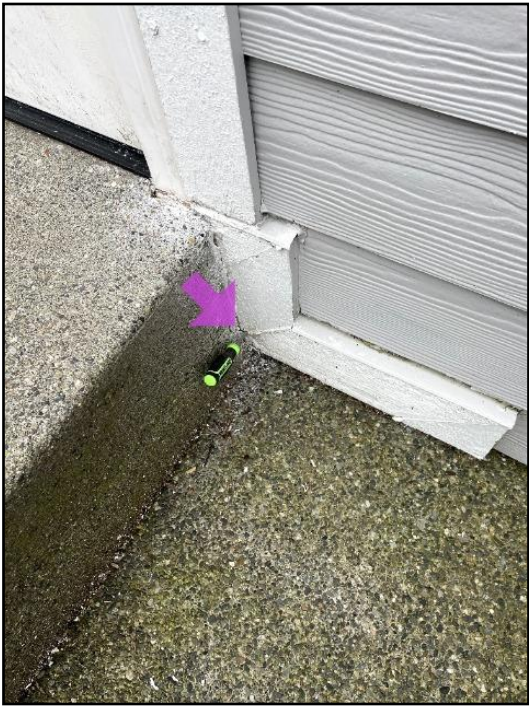
6. Wood

Several areas of trim appear to have levels of water intrusion and caulking deterioration. Recommend all seams where materials meet are properly sealed. Damaged wood repaired/replaced.

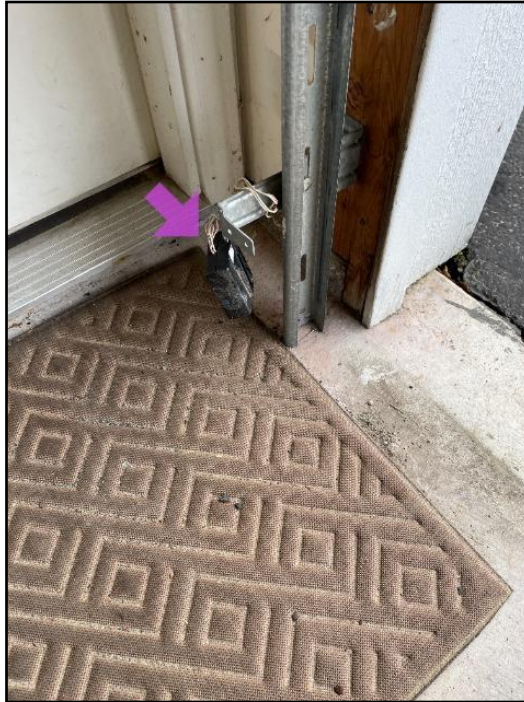
Condition: • Sensors damaged

Garage door sensor appears to be broken. Sensors are not lining up requiring the operator button to be fully pressed at all times to close door.

Implication(s): Physical injury

7. Sensors damaged

Task: Improve

Time: Discretionary
