Your Inspection Report

1234 Place Nearyou St
Cobble Hill , BC

INSPECTION DATE:
Wednesday, May 18, 2016

RE: Report No. 1226, v.2
1234 Place Nearyou St
Cobble Hill , BC

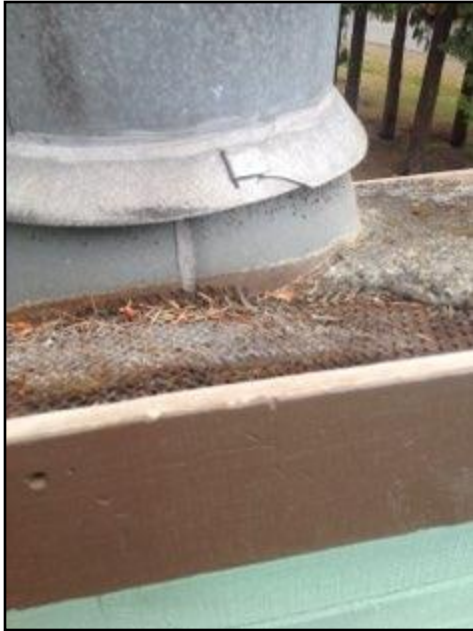
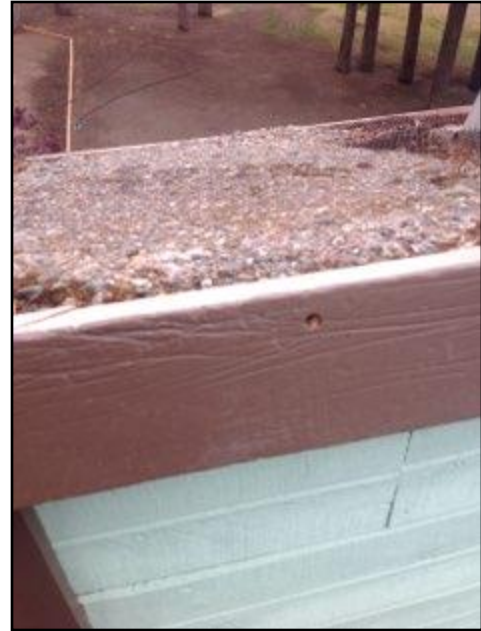
2. **Condition:** • Other

Rock roof cover on chimney box has deteriorated recommend repairs or metal can installed. Chance of water leakage to chimney chase.

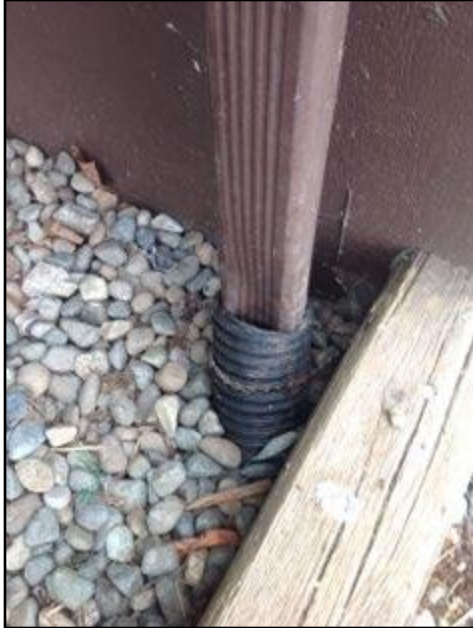
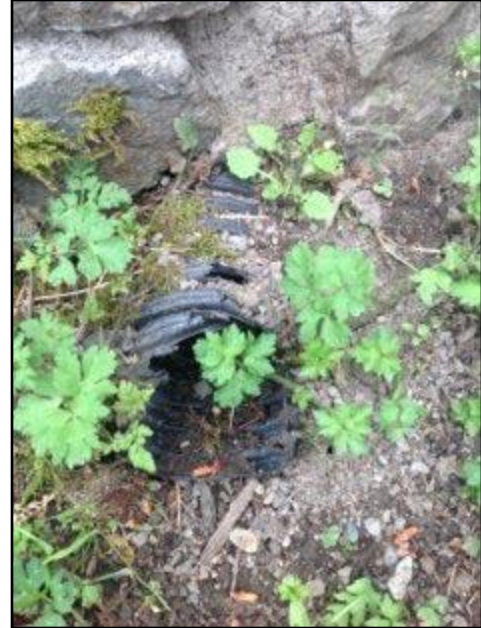
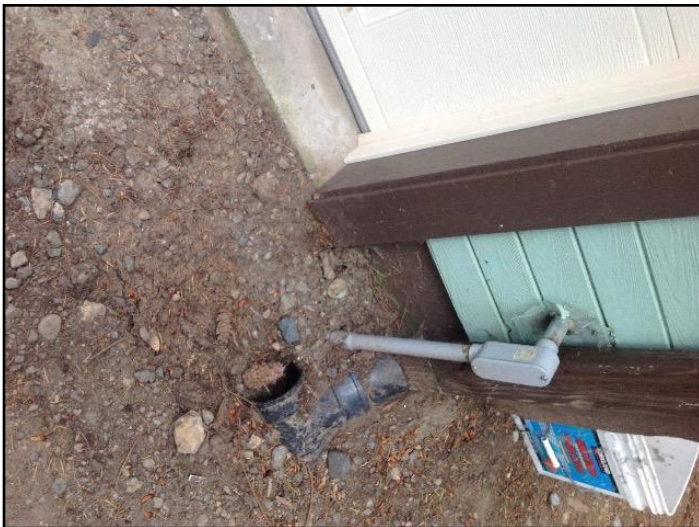
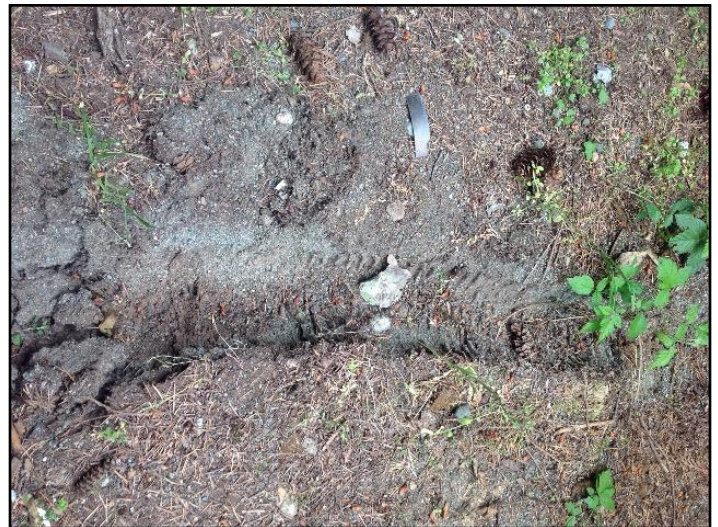
3. • Appears perimeter drainage has been removed in sections of house. Remainder of house is Big O which is considered obsolete. All perimeter drainage should go into a rock drainage pit or storm. Recommend upgrading perimeters this is a high risk concern that could cause water entry into basement and crawl space. See also notes in interior section of report.

Implication(s): Water damage to structure or contents.

5. Cut / diconected

6. Removed

7. Removed from drain pit

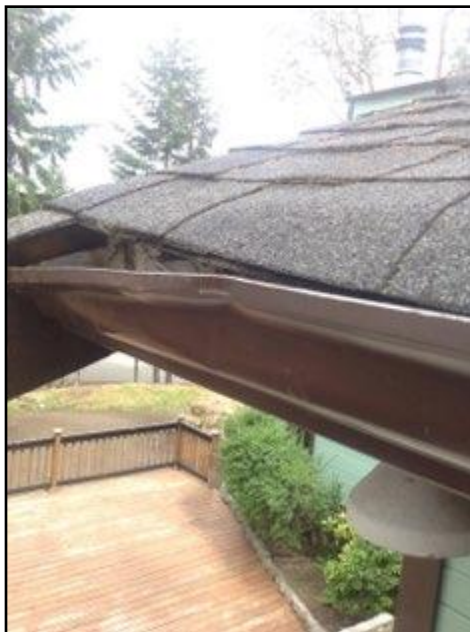
8. Loose or damaged

4. **Condition:** • [Loose or damaged](#)

Implication(s): Chance of water damage to contents, finishes and/or structure

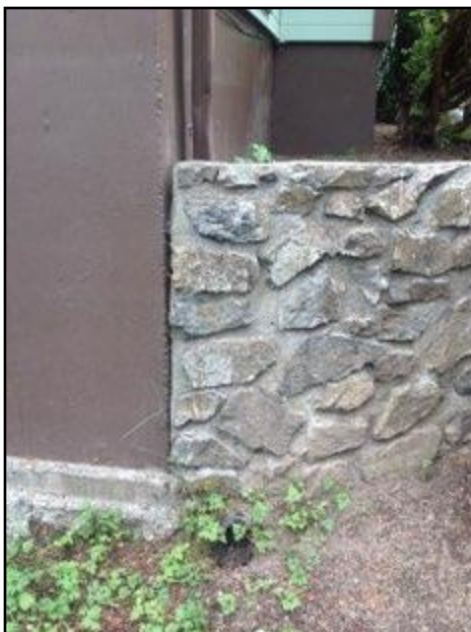
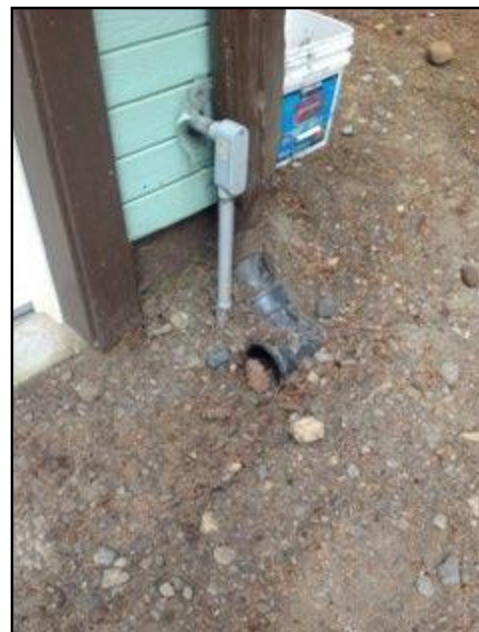
9. Downspouts end too close to building

5. Condition: • [Downspouts end too close to building](#)

Above grade downspout drainage should be diverted 6 ft from foundation walls.

Implication(s): Chance of water damage to contents, finishes and/or structure

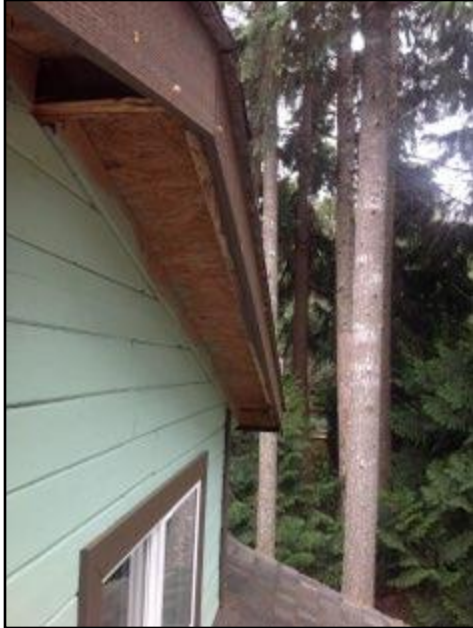
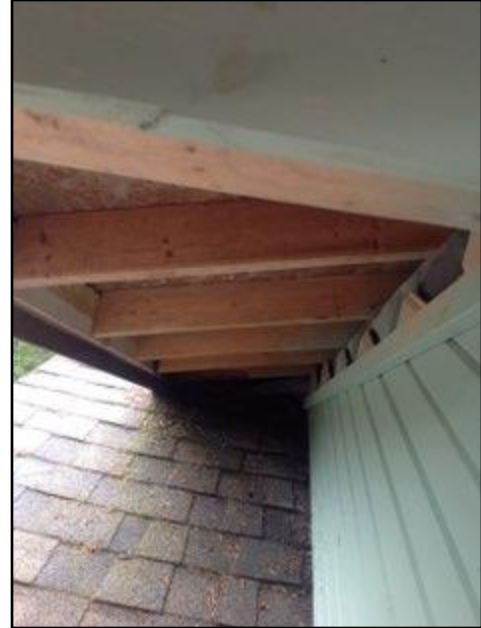
11. Loose or missing pieces

6. Condition: • [Loose or missing pieces](#)

Soffit missing over garage recommend installing immediately to prevent insects from entering attic space.

Implication(s): Chance of water damage to contents, finishes and/or structure | Chance of pests entering building

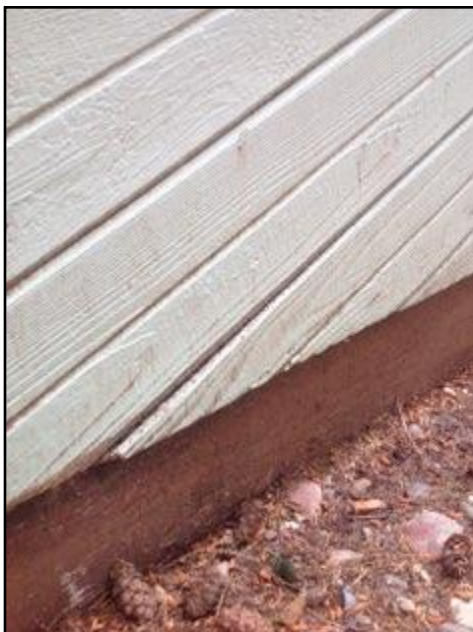
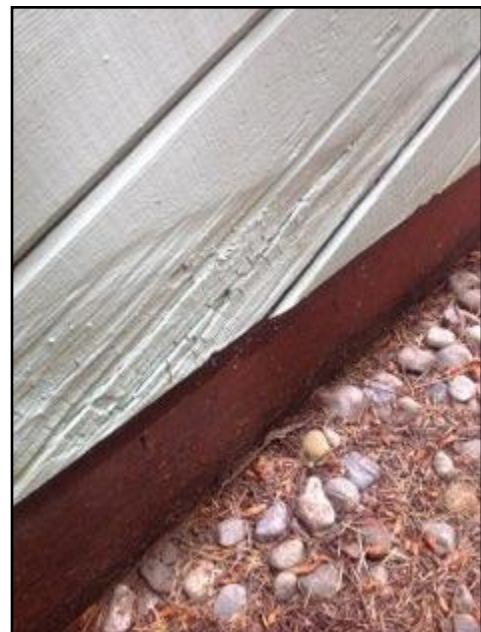
13. Loose

7. Condition: • [Loose](#)

Bottom of siding on right side loose recommend fastening. Some rot and minor deterioration.

Implication(s): Chance of water damage to contents, finishes and/or structure

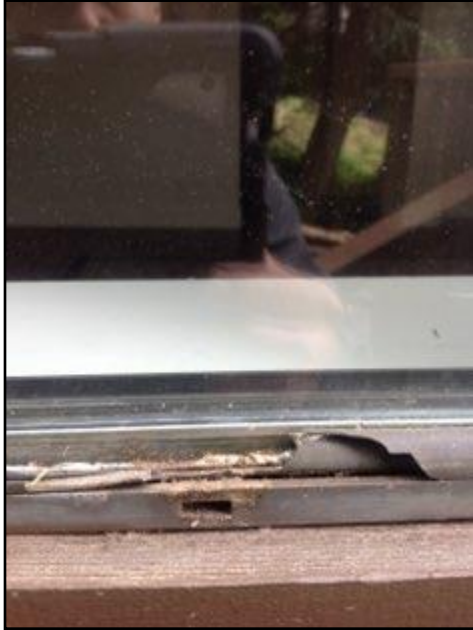
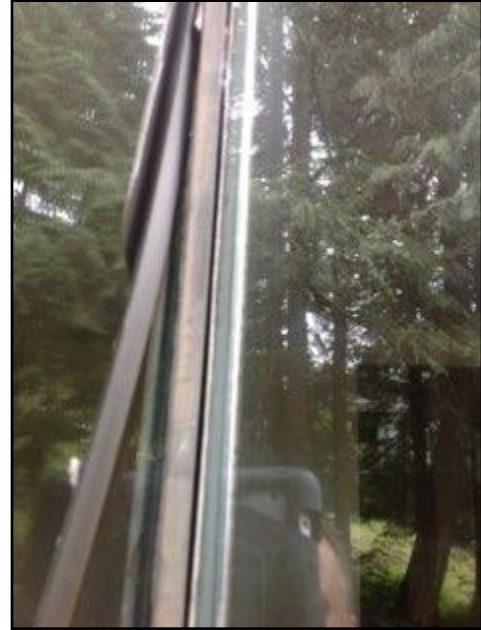
15.

8. Condition: • Window plastic trim mouldings have deteriorated recommend repairs and replacing.

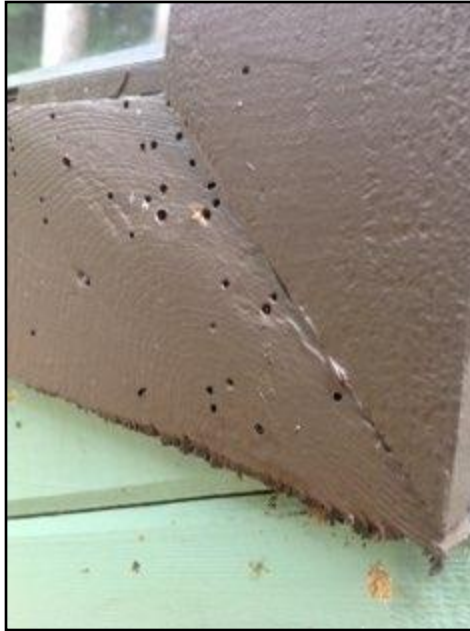
17. Insect damage

9. Condition: • Insect damage

Exterior garage side window trim has insect damage. Recommend replacing board and evaluating any hidden damage.

Implication(s): Material deterioration

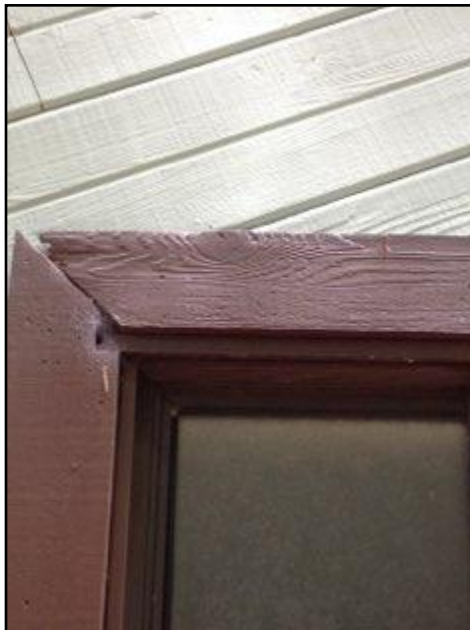
18. Rot

10. Condition: • [Rot](#)

Recommend replacing at time of window upgrades in future.

Implication(s): Chance of water damage to contents, finishes and/or structure | Material deterioration

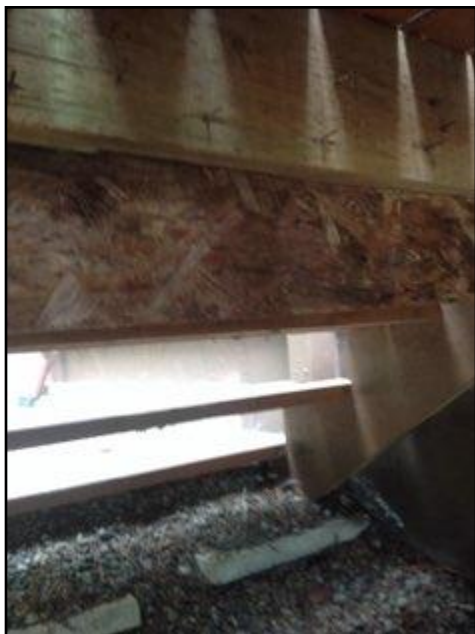
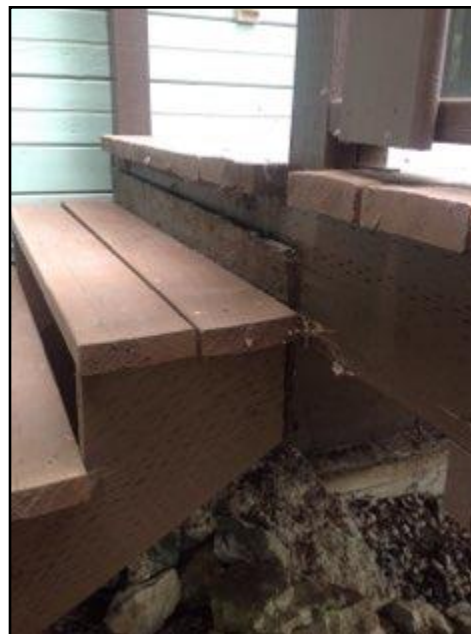
11. Condition: • Rear stairs have OSB backing board support which is inadequate and has deteriorated. Recommend

treated plyboard or solid wood. Contact carpenter to repair.

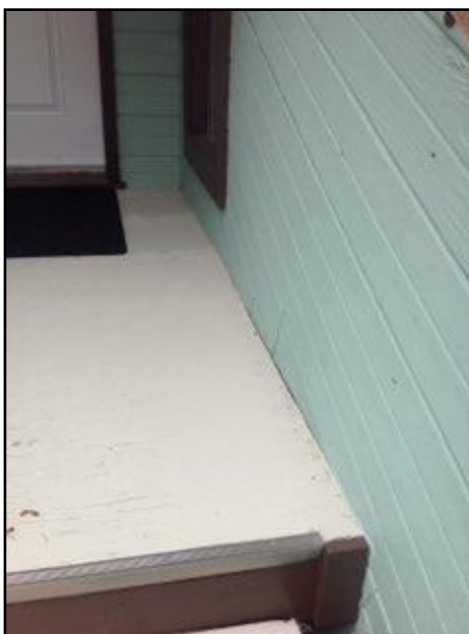
21.

12. Condition: • Front entrance floor painted plywood this is a high maintenance area. Recommend front entrance landing covered with vinyl this should be flashed 4 inches up wall.

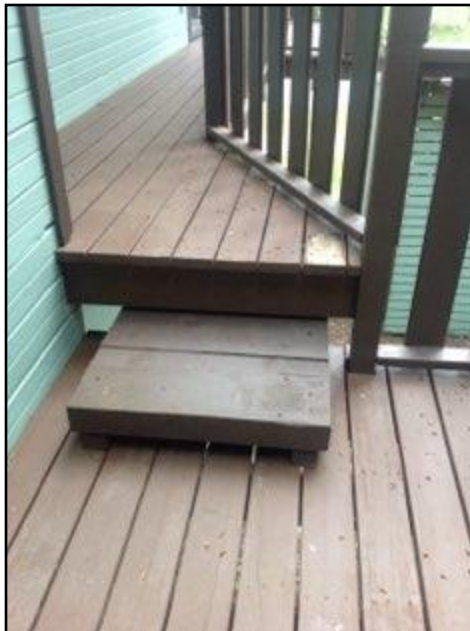
22. Stair rise too big or not uniform

13. Condition: • [Stair rise too big or not uniform](#)

Step rise to high to upper deck recommend improving immediately, this is a trip hazard

Implication(s): Trip or fall hazard

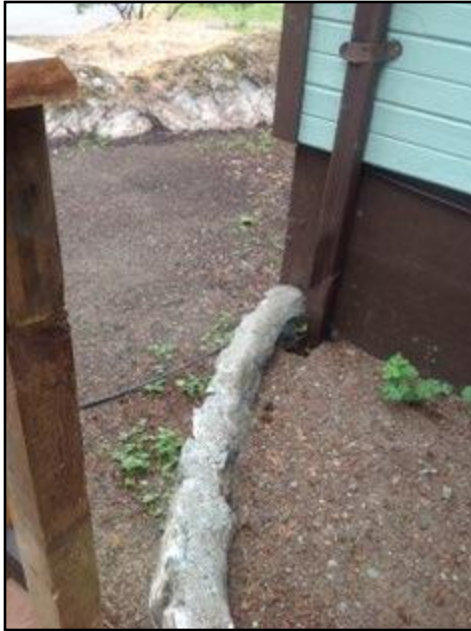
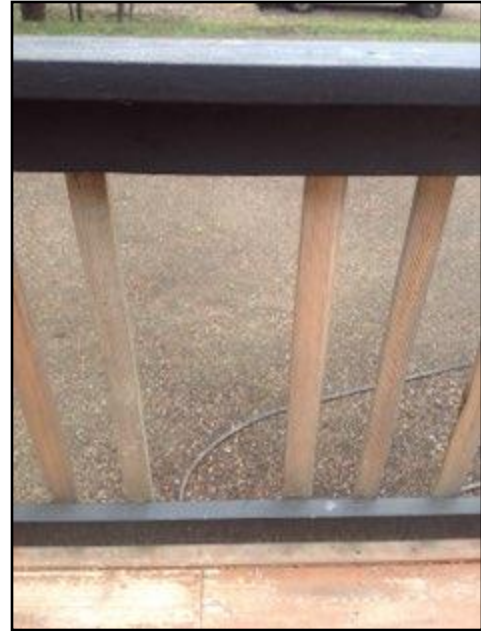
14. Condition: • [Missing](#)

Missing spindle on front deck , as a safety upgrade recommend extending rail to house.

Implication(s): Fall hazard

23. Missing extend rail

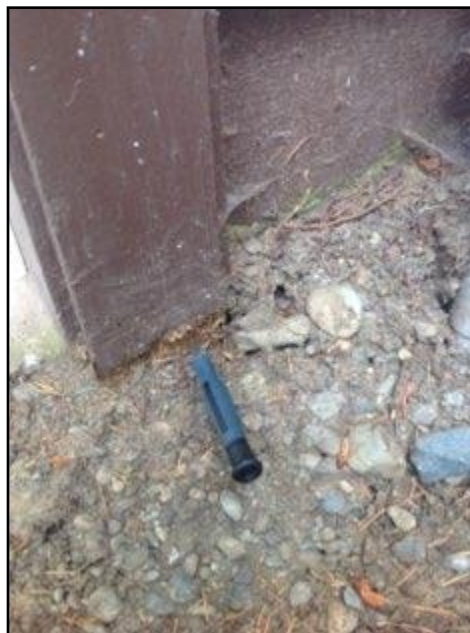
25. Rot

15. Condition: • Rot

Bottom of garage door trim board has small amount of rot recommend repairs.

Implication(s): Material deterioration

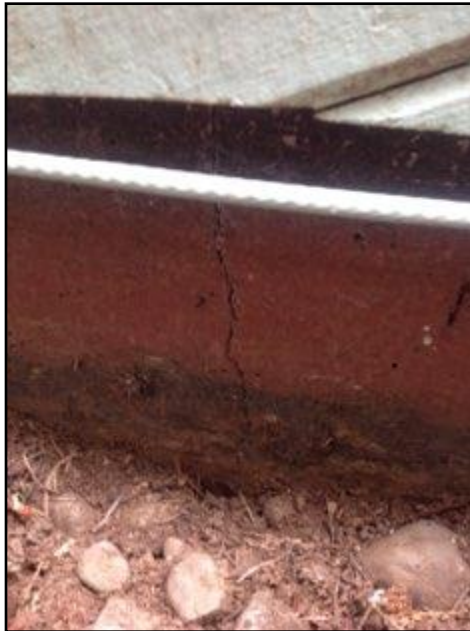
27. Typical minor settlement

16. Condition: • [Typical minor settlement](#)

3 minor foundation cracks on right side of house recommend epoxy repair.

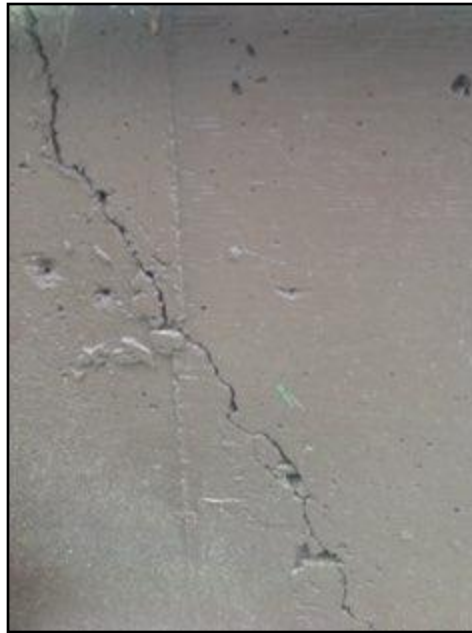
28. Typical minor settlement

17. Condition: • [Typical minor settlement](#)

Minor settlement crack in foundation on left side of garage recommend repairs.

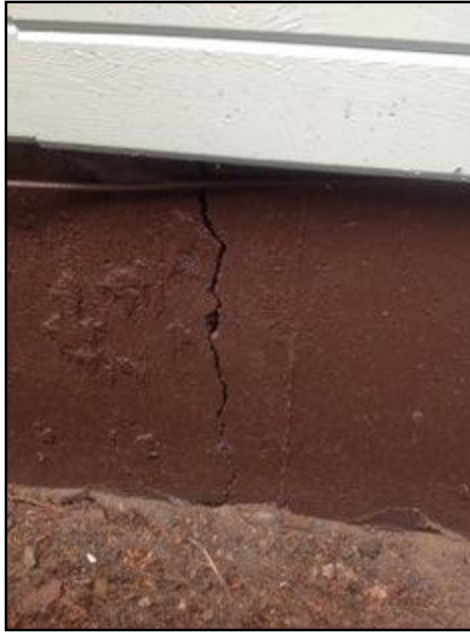
29. Cracked

18. Condition: • [Cracked](#)

Significant foundation crack at front of house recommend immediate repairs. This is a possible water entry risk.

Implication(s): Chance of water damage to contents, finishes and/or structure | Weakened structure

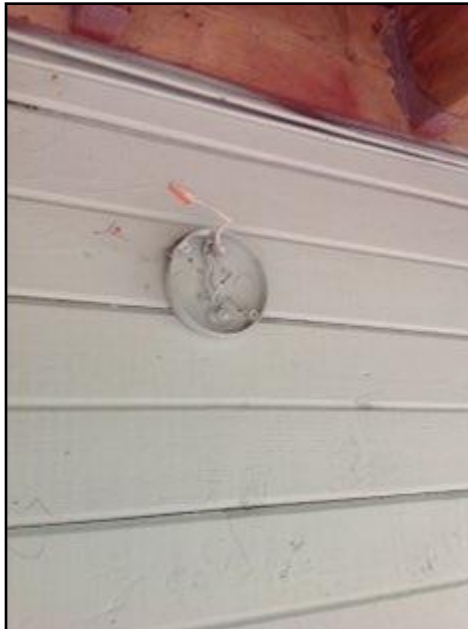
31. Missing

24. Condition: • [Missing](#)

Rear exterior light fixture missing recommend installing.

Implication(s): Inadequate lighting

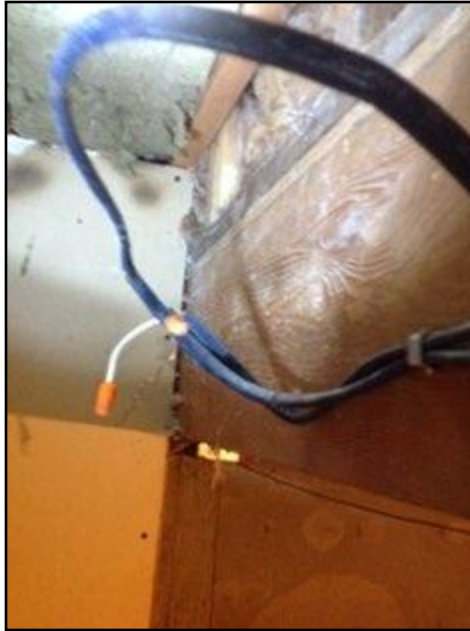
32. Missing, loose

25. Condition: • [Missing, loose](#)

Implication(s): Electric shock | Fire hazard

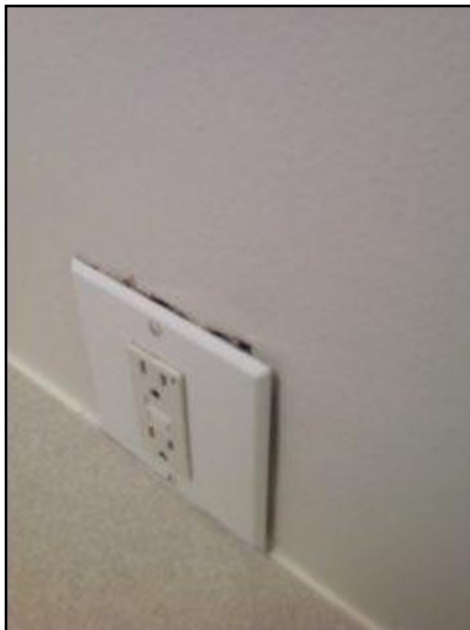
33. Loose

26. Condition: • [Loose](#)

Bathroom counter plug outlet loose recommend repairs.

Implication(s): Electric shock | Fire hazard

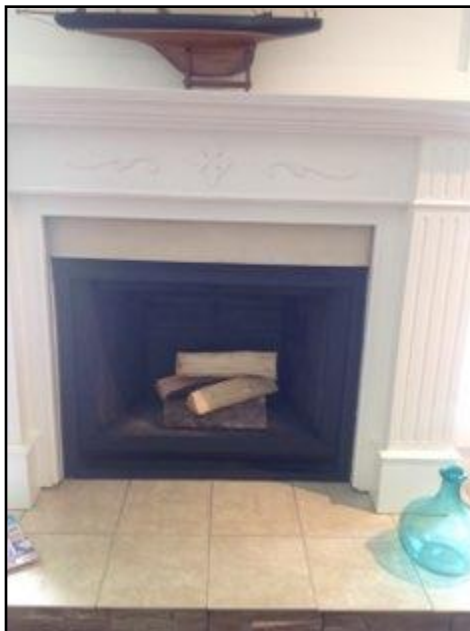
34. Inadequate clearance from combustibles

27. Condition: • [Inadequate clearance from combustibles](#)

Fire place mantel to close to combustibles, not safe to use. Recommend further evaluation and correction.

Implication(s): Fire hazard

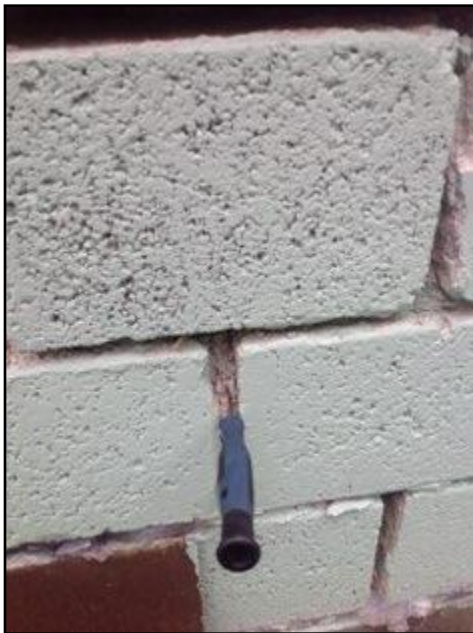
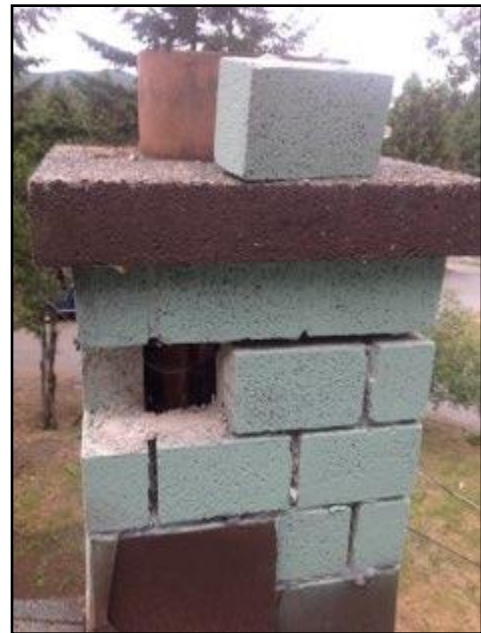
35. Loose, missing or deteriorated masonry

29. Condition: • [Loose, missing or deteriorated masonry](#)

Wood stove is not useable until chimney is replaced or repaired . Top 1/3 of chimenys mortar has blown out this could indicate a past chimney fire. The other concern is the wood wall side of chimney is not visible for inspection and mortar could also be deteriorated. The interior of chimney should be scoped to deter ain't full condition. This is a fire hazard do not use.

Implication(s): Material deterioration

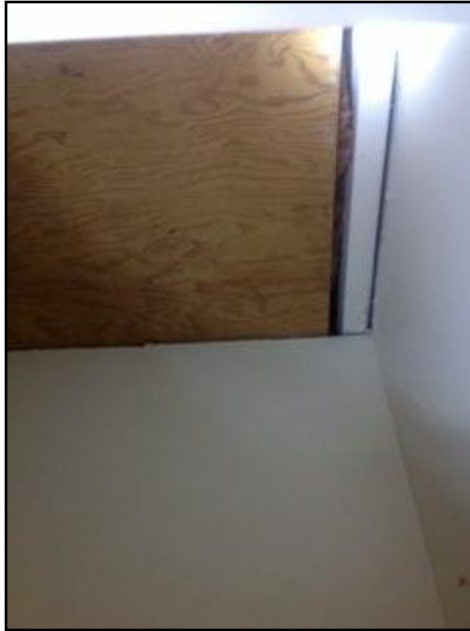
38. Not weatherstripped

31. Condition: • [Not weatherstripped](#)

Attic hatch does not seal has gaps recommend improving this is a high heat loss area.

Implication(s): Chance of condensation damage to finishes and/or structure | Increased heating and cooling costs

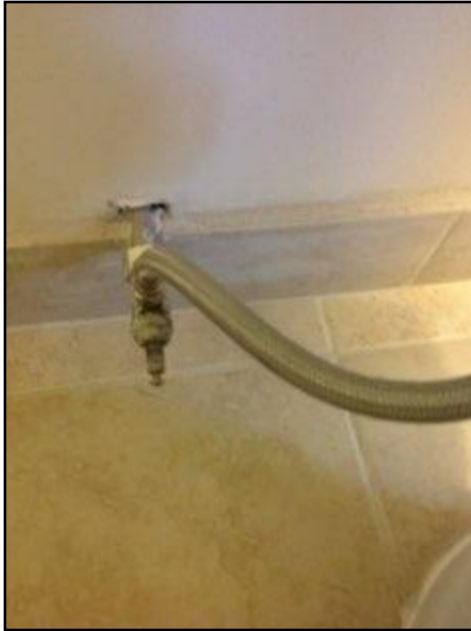
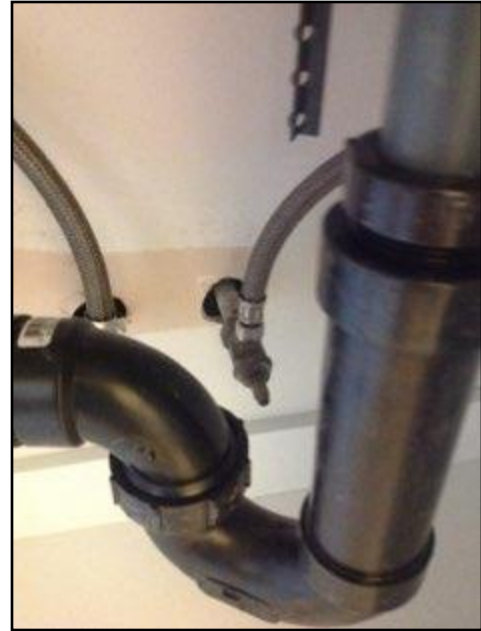
33. Condition: • Missing pressure regulator if city pressure rises it could do damage to washing machines and plumbing. Recommend installing as a precaution.

34. Condition: • Shut off handles for supply faucets and toilet missing recommend installing.

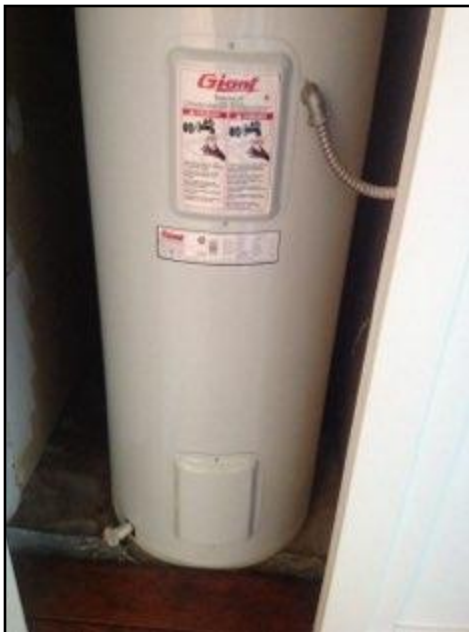
41. Near end of life expectancy

35. Condition: • [Near end of life expectancy](#)

Hot water tank is 10 years old typically they last 8 to 10 years before leakage. The tank has no safety drain pan a leak would do damage to new flooring. Recommend replacement and safety drain pan installed, a better place is to relocate new tank to crawl space.

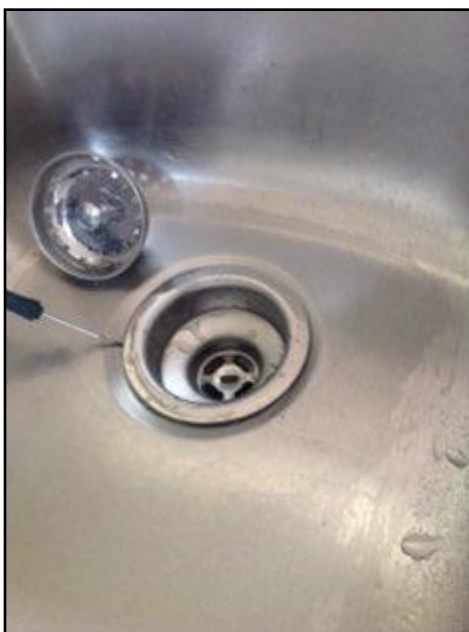
42.

37. Condition: • Kitchen drain baskets incorrectly installed the rubber gasket is for the underside of drain. Top seal should be plumbers putty. Recommend plumber to correct immediately .

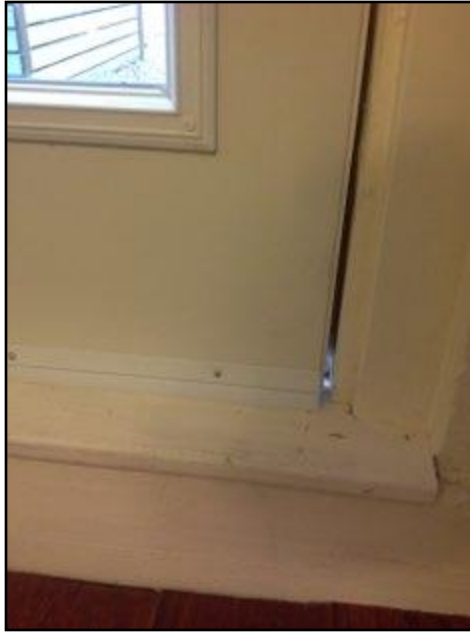
43. Weatherstripping missing or ineffective

38. Condition: • [Weatherstripping missing or ineffective](#)

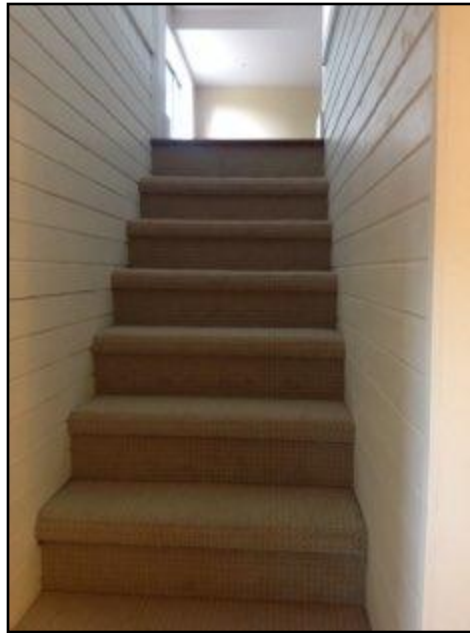
44. Missing

39. Condition: • [Missing](#)

Recommend installing hand rail this is a fall hazard .

Implication(s): Fall hazard

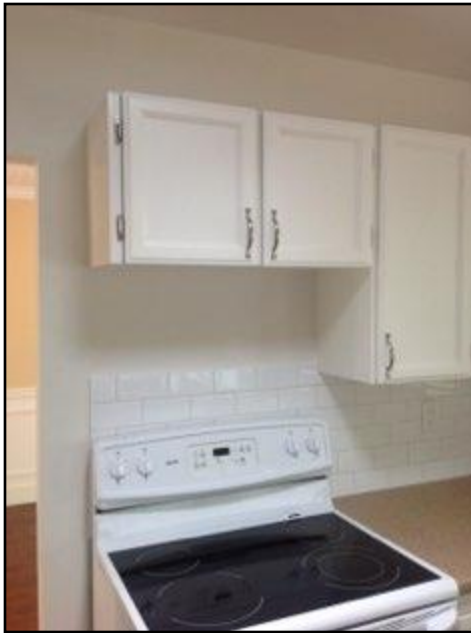
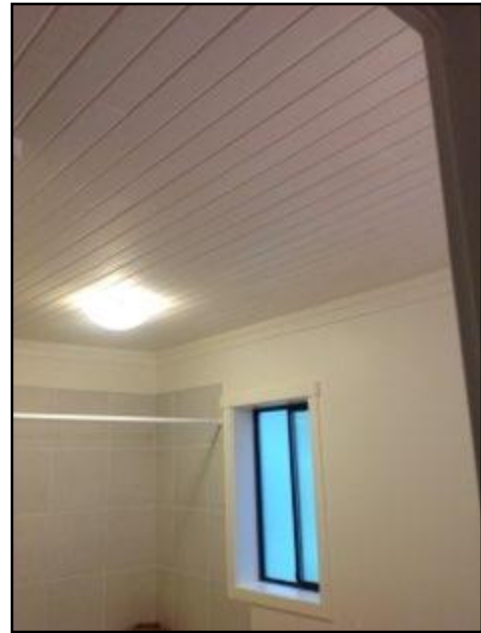
40. Condition: • [Missing](#)

Recommend installing bath fans in bathrooms and range hood in kitchen. Contact ventilation company for estimate.

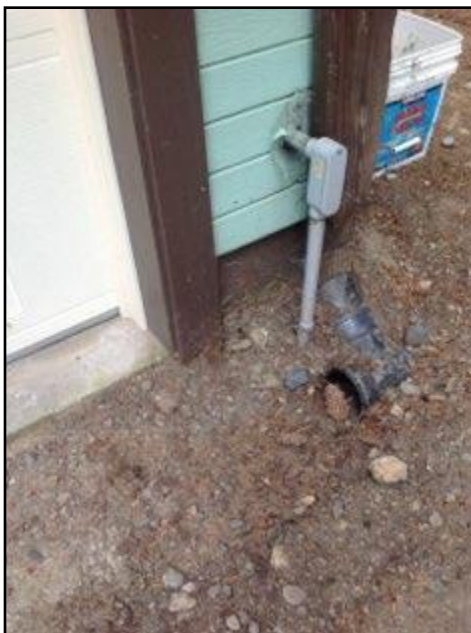
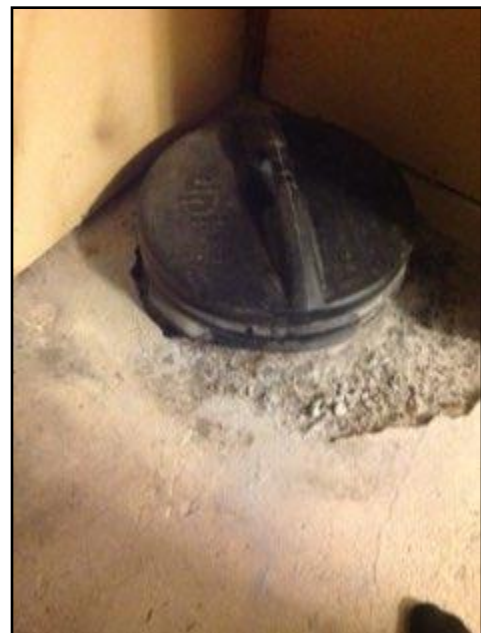
Condition: • Perimeters damaged and missing in areas around house, drain tile exposed , lack of drain rock. . Sump bucket added in crawl. Crawl and basement considered high risk for damp or wet basement. Recommend all perimeters upgraded contact drainage specialist .

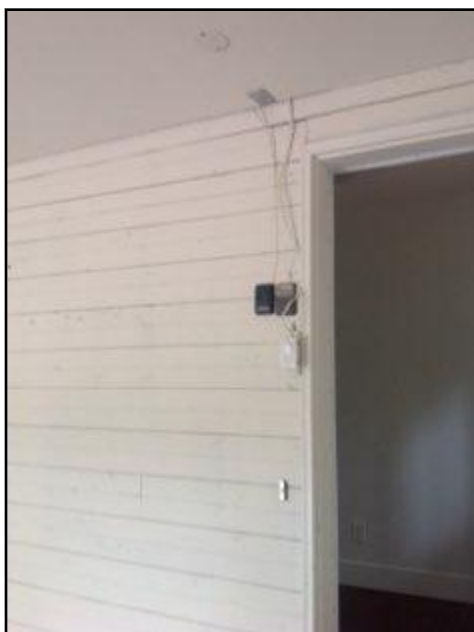
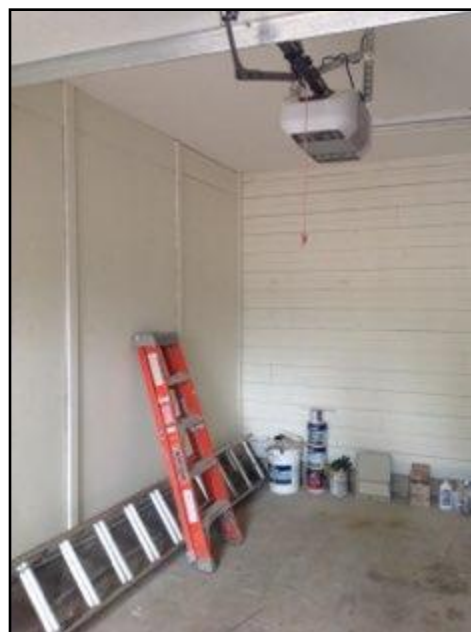
Implication(s): Fire hazard

51. Fire separation between garage and living...

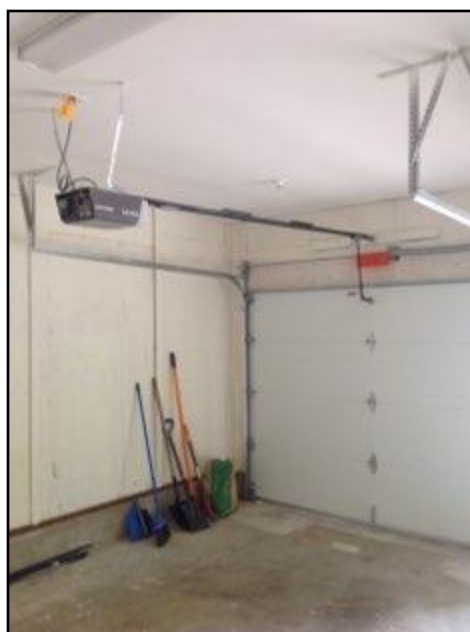
53. Inoperative

Right side garage door opener fails to open recommend repairs by a garage door company.
