# Your Inspection Report

330 Willard Avenue  
Toronto, ON M6S 3R2

RE: Report No. 9725, v.4  
330 Willard Avenue  
Toronto, ON  
M6S 3R2

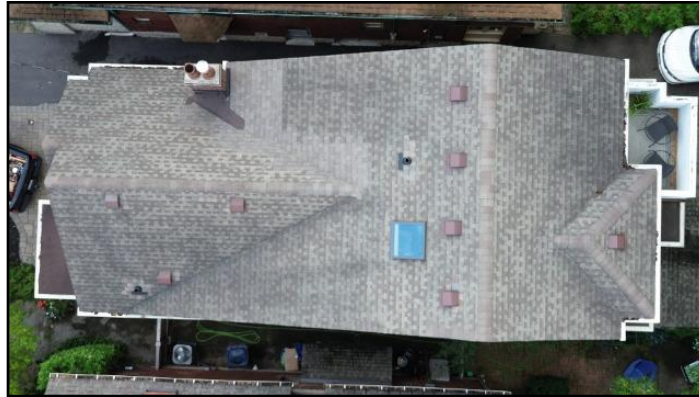
1. Asphalt shingles

**Sloped roofing material:** • Sloped roofing appears aging and remaining service life cannot be predicted.

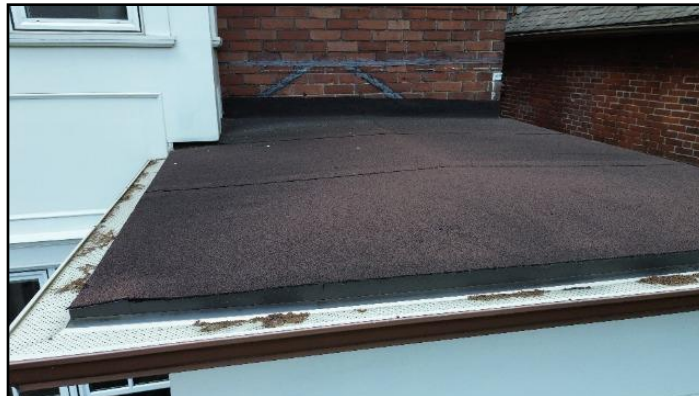
2. Modified bitumen membrane

**Approximate age:** • Flat roof approximate age: 15-20 years

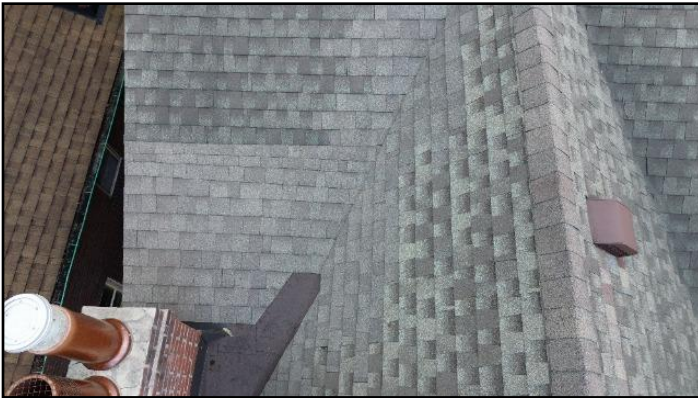
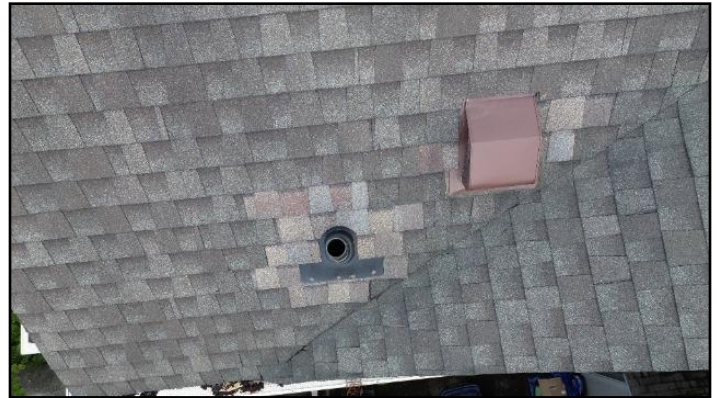
**Condition:** • [Patched](#)

3. Patched examples

4. Patched examples

**Task:** For Your Information / Inspect annually

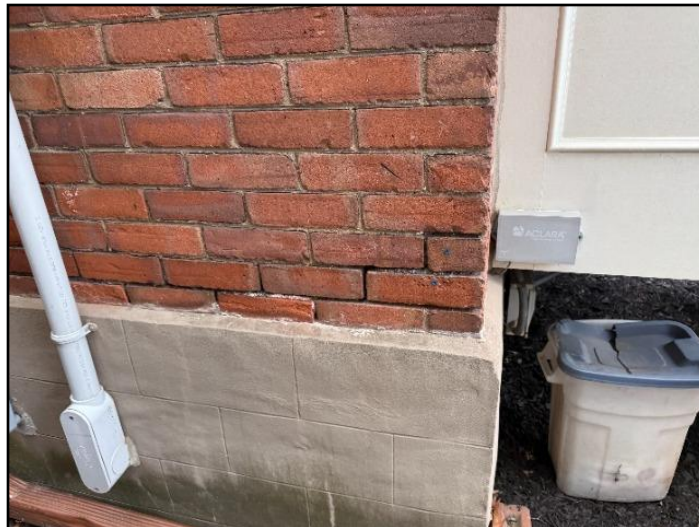
5. one example

**Condition:** • [Mortar deterioration](#)

**Task:** Repair

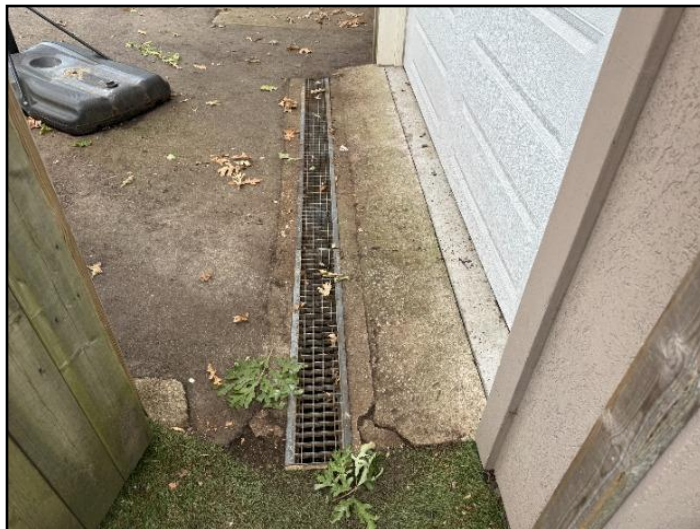
**Condition:** • Debris Accumulation or Clogged catch basin

6. Debris Accumulation or Clogged catch basin

**Task:** Clean / Correct

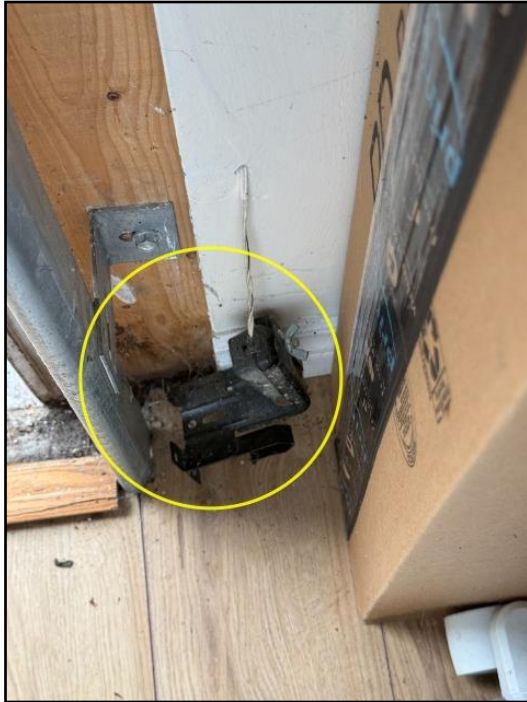
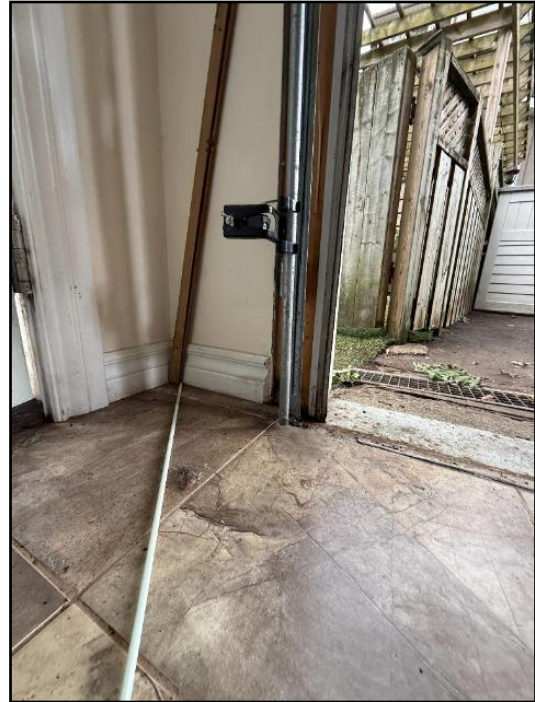
**Condition:** • Sensors poorly located

7. Sensors poorly located

8. Photoelectric sensor more than 6 inches...

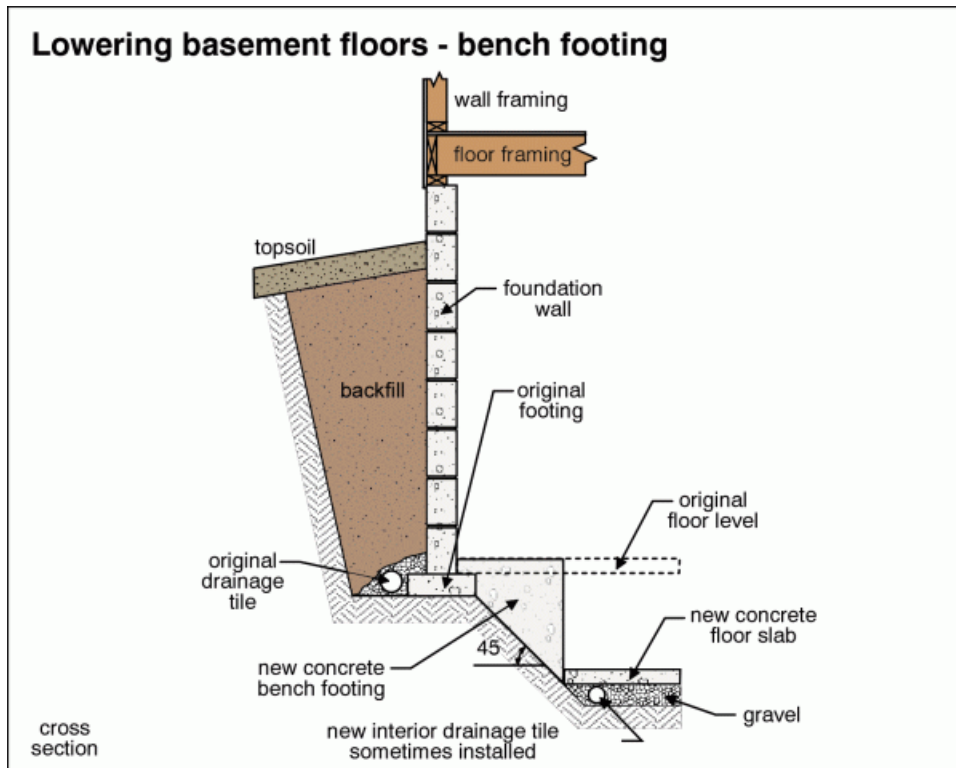
**Condition:** • [Basement lowered](#)

**Task:** For Your Information

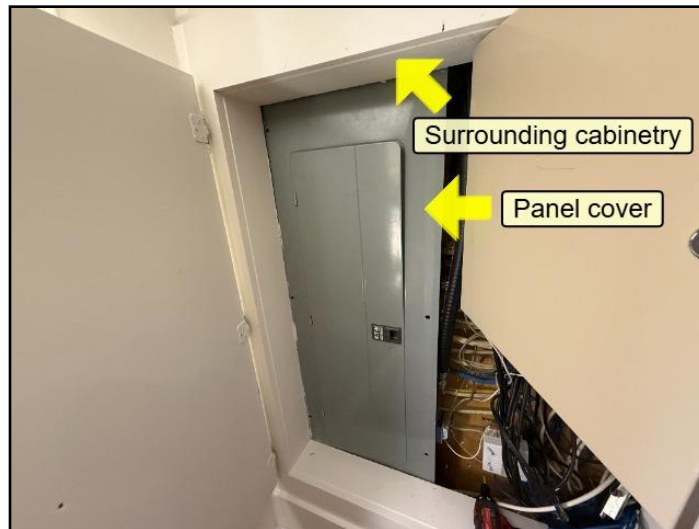
10. Basement panel

**Condition:** • Panel interior not accessible for inspection

**Task:** Provide access and inspect panel interior

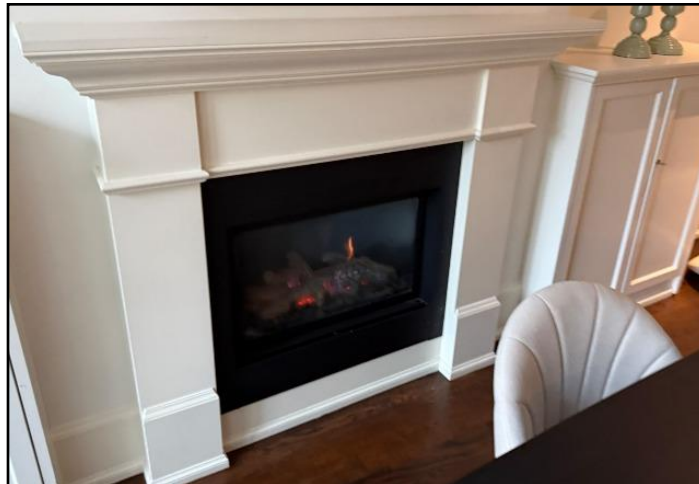
**Fireplace/stove:** • Two gas fireplaces were present on the main floor. The living room fireplace functioned when tested. The family room fireplace did not operate during the inspection. Seller later advised that the pilot was manually lit with a match and provided video showing the fireplace operating with the pilot already lit.

11. Gas fireplace in living room operating

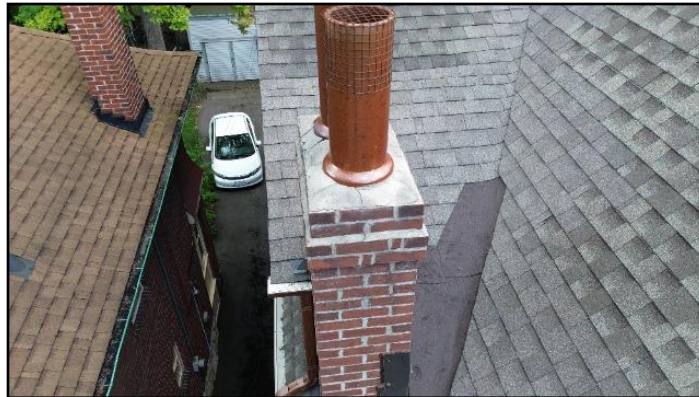
**Condition:** • [No drip edge on cap \(crown\)](#)

12. No drip edge on cap (crown)

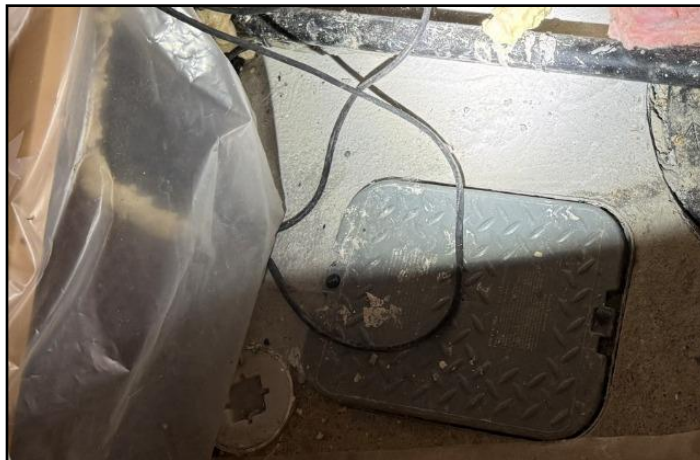
16. Backwater valve

- Backwater valve is present.

These valves help prevent sewer backup. Many insurance companies insist these be installed before they will offer a sewer backup endorsement, which we strongly recommend you obtain.

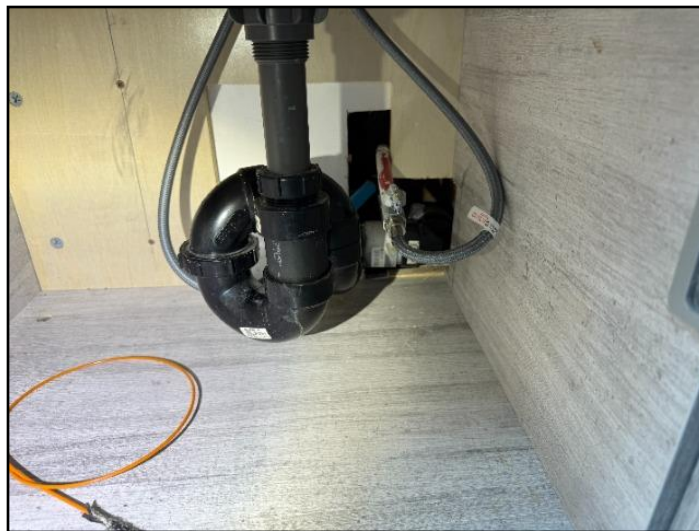
**Condition:** • Nonstandard shape or material

17. Nonstandard shape

**Task:** Monitor for siphoning or slow draining and Improve if necessary

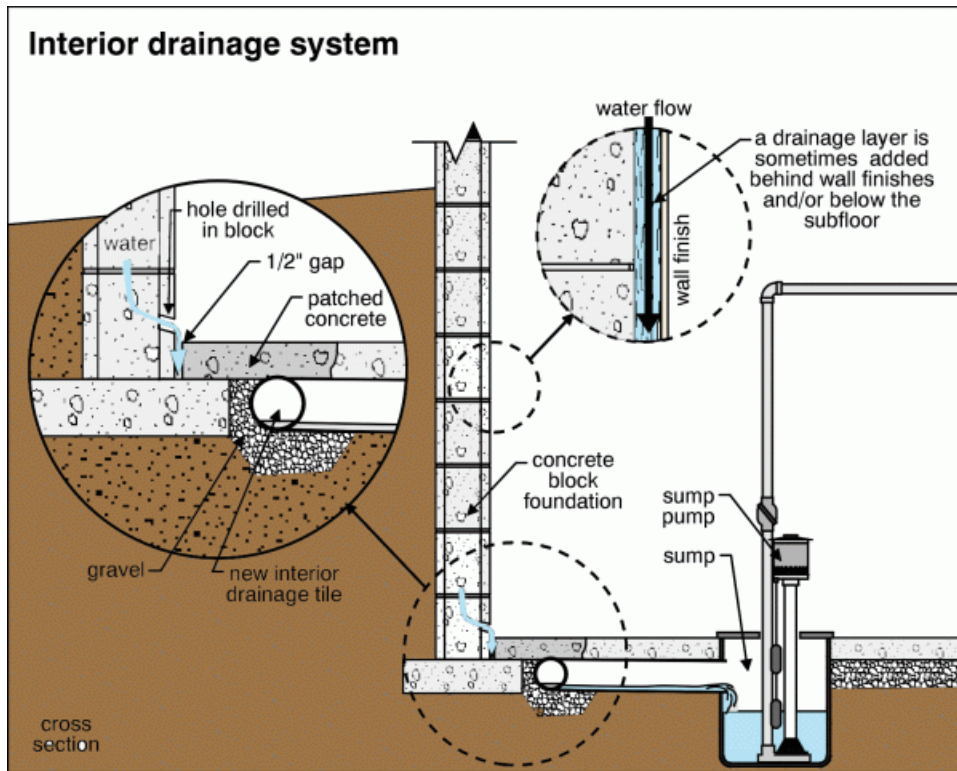
**Condition:** • [Interior drainage system](#)

An interior drainage membrane was visible at a limited area of the basement foundation, and two sump pumps were present. The extent of the system could not be determined. Consult seller / agent if further information is desired.

**Task:** For Your Information
