# Your Inspection Report

276 Durie Street  
Toronto, ON M6S 3G3

RE: Report No. 9836, v.4  
276 Durie Street  
Toronto, ON  
M6S 3G3

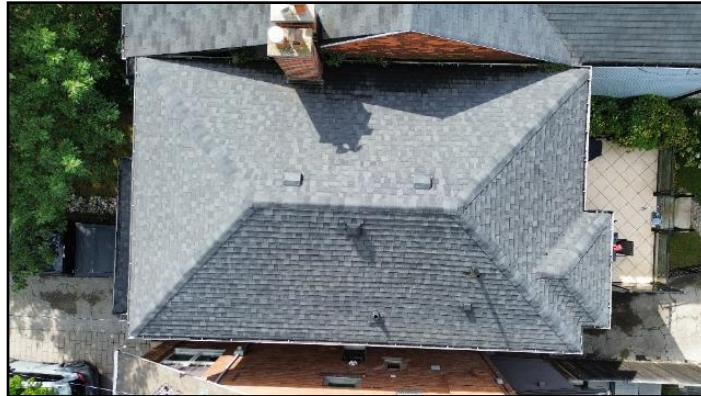
1. Asphalt shingles

Good condition overall

**Approximate age:** • 8-10 years old

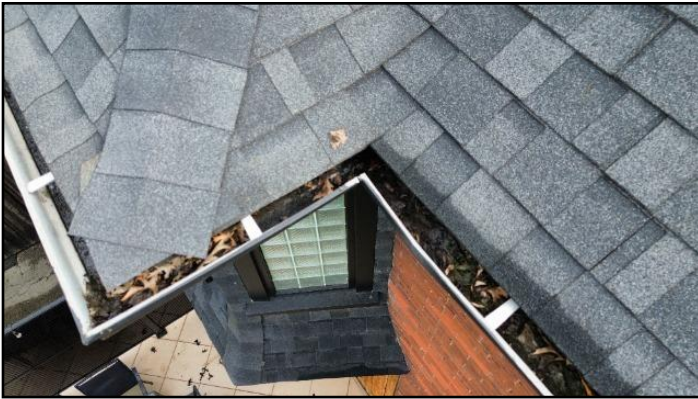
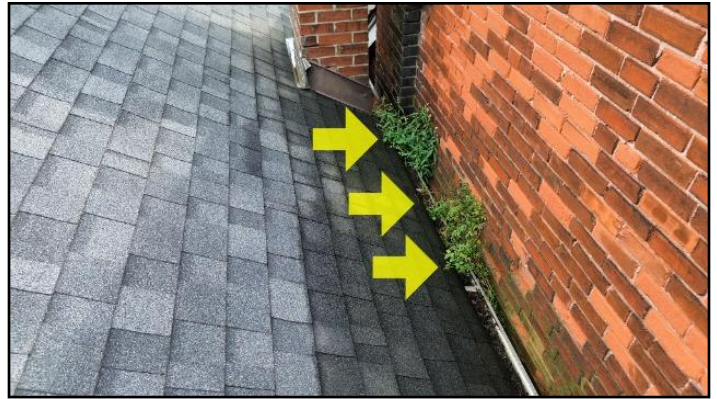
**Condition:** • Dirty/debris

2. Dirty/debris example

3. Dirty/debris example

**Task:** Clean

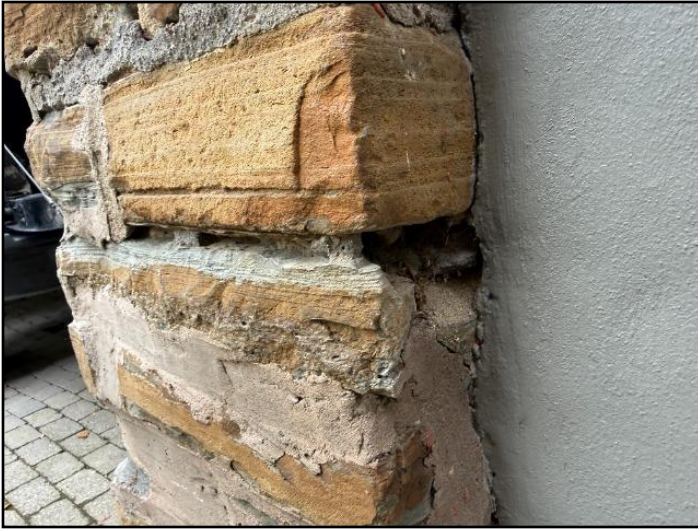
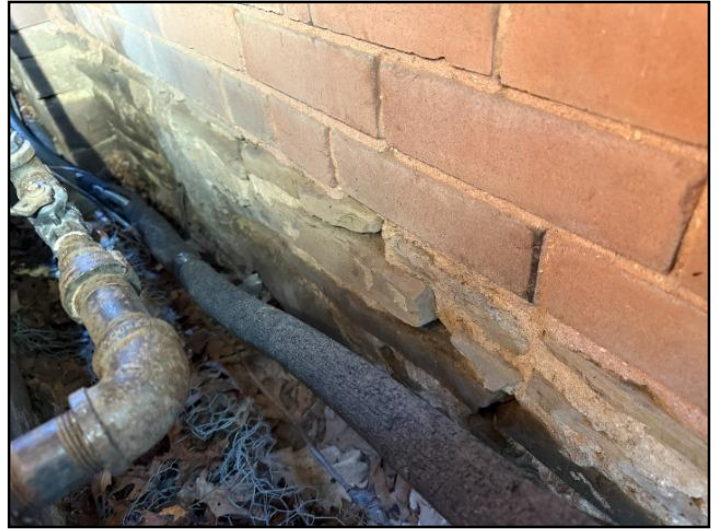
**Condition:** • Masonry and/or mortar deterioration

4. example near front

5. One example from left side foundation

Tuckpoint / Repoint mortar and patch/repair spalled masonry. This is typical maintenance for a home of this age.

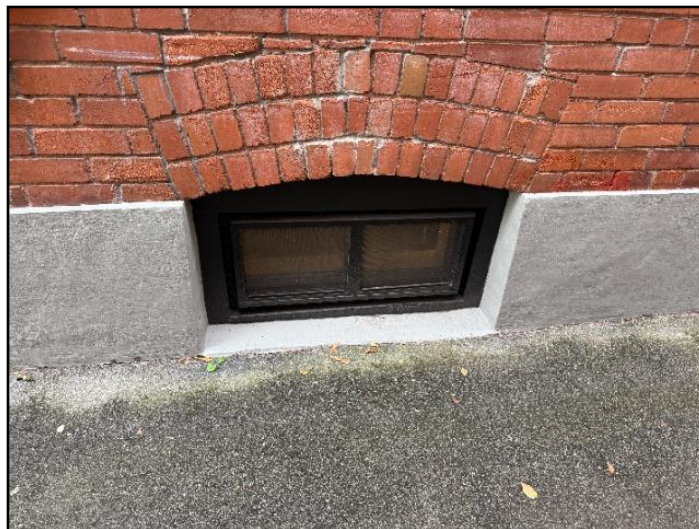
**Condition:** • Sill - Near or at Grade Level

Basement window at or near grade level. Modern standards recommend that the bottom of the window be at least 6 inches above grade or have a window well installed. Consider adding window well if regrading or when necessary. In the meantime, ensure windows remain well-sealed to prevent water intrusion.

6. Sill - Near or at Grade Level

**Task:** Monitor for moisture intrusion / Improve

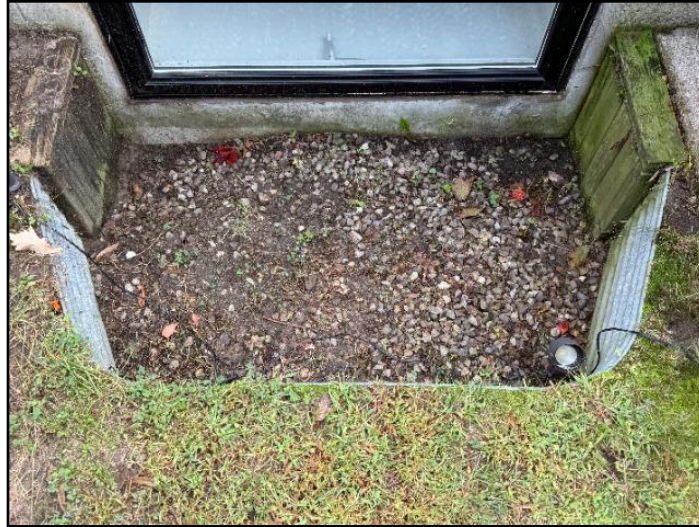
**Condition:** • Drain not visible / presence not confirmed

No window well drain was visible at the time of inspection. The presence or configuration of any concealed drainage could not be confirmed. No evidence of moisture intrusion was observed at the corresponding interior area.

7. one example

**Task:** Confirm drainage provision / Improve if necessary

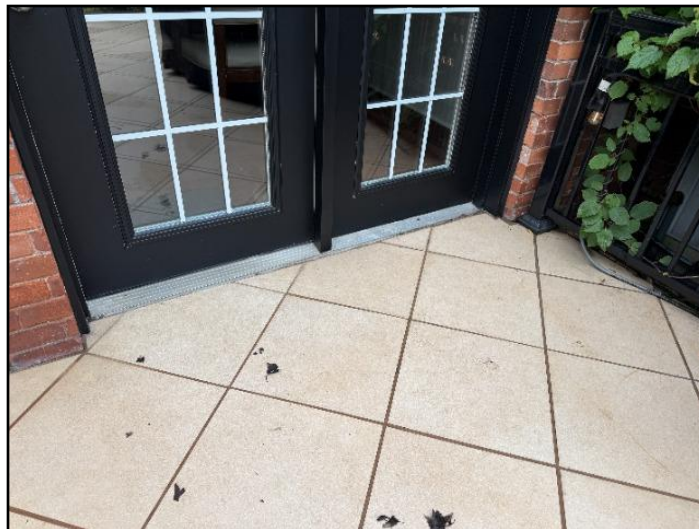
**Condition:** • Threshold too low

Having a minimal step makes the inside/outside transition easier. On the other hand, it also makes it more prone to snow buildup/leakage. While it is probably not practical to improve the current situation, it will be important to keep any weatherstripping/caulking in good condition.

8. Threshold too low

**Task:** Monitor for moisture intrusion / Improve

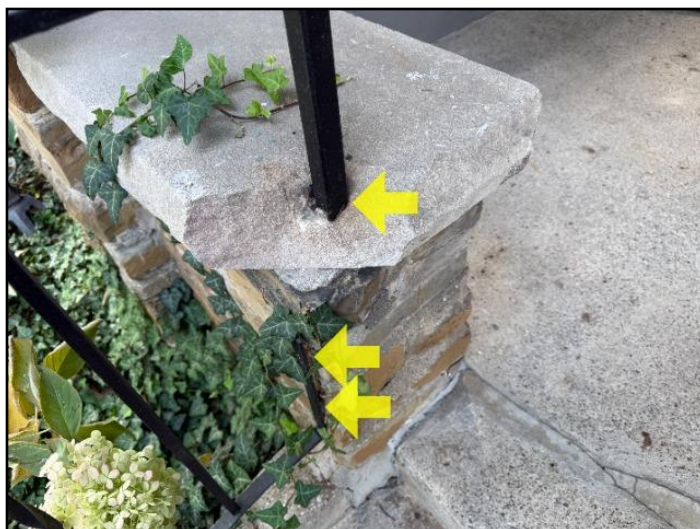
**Condition:** • [Loose](#)

9. Loose

**Task:** Repair or replace

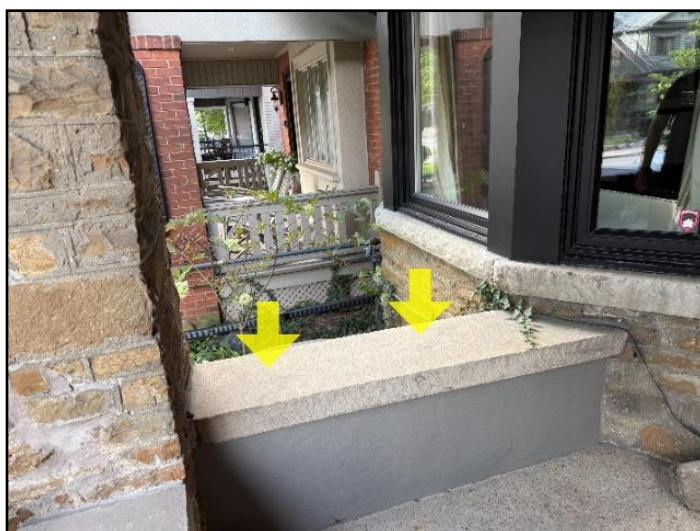
10. example

**Condition:** • [Too low](#)

**Task:** Upgrade

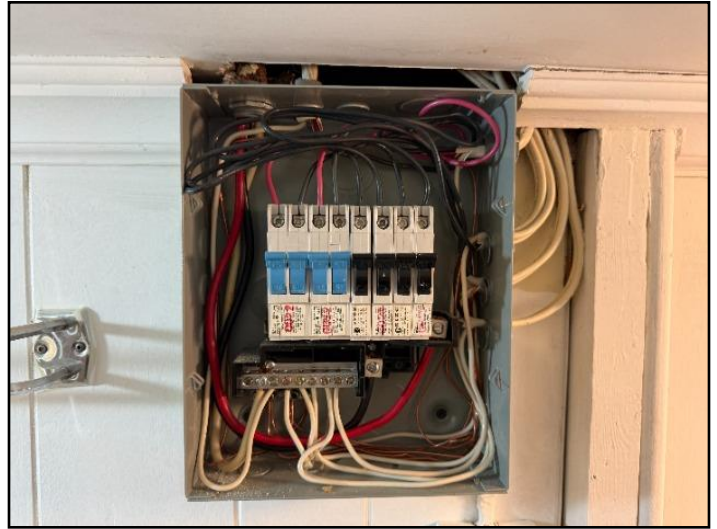
12. Breakers - sub panel

**Condition:** • A Federal Pacific or Pioneer Stab-Lok sub panel is installed. There have been reported problems with these

Due to the potential risks, it is strongly recommended to have the sub panel inspected by a licensed electrician familiar with Stab-Lok panels. The electrician can assess the panel's condition, identify any specific issues, and recommend appropriate actions, which may include replacing certain breakers or the entire sub panel.

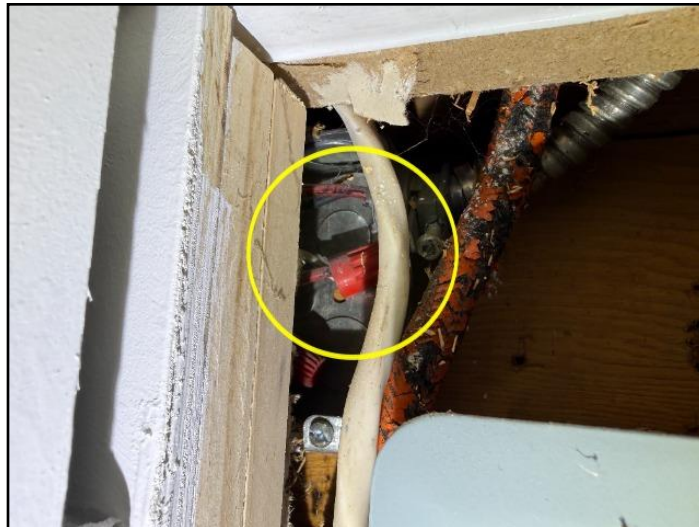
**Condition:** • Cover missing

13. Cover missing

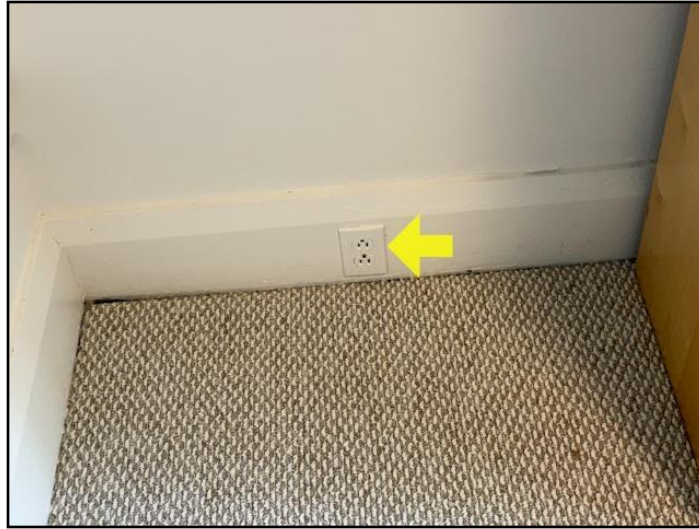
**Condition:** • [Inoperative](#)

14. Inoperative

**Task:** Repair / Replace / Remove

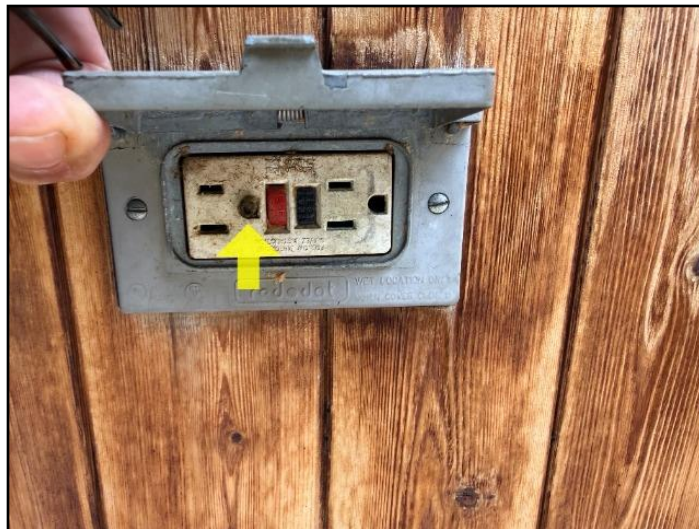
**Condition:** • [Test faulty on GFCI/GFI \(Ground Fault Circuit Interrupter\)](#)

Additionally, broken pin in ground slot

15. Test faulty on GFCI/GFI (Ground Fault...

**Task:** Replace

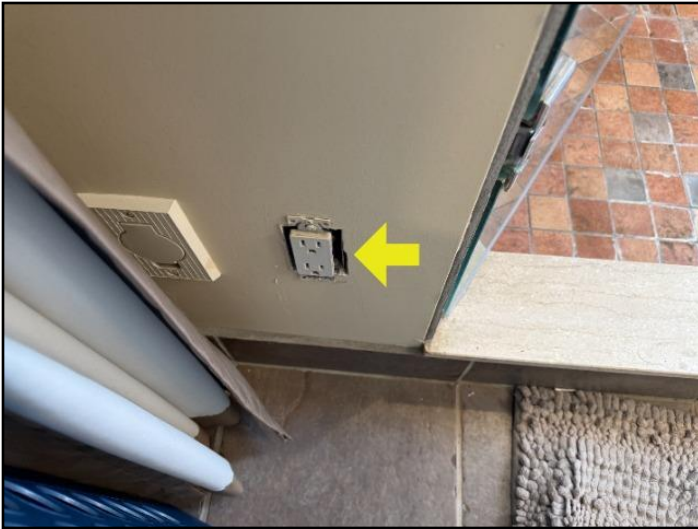
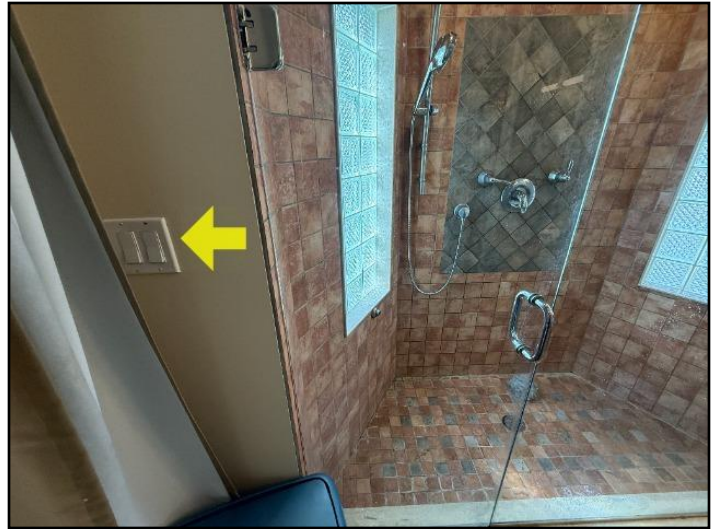
**Condition:** • [Too close to bathtub or shower](#)

Both outlet and switch. Additionally, outlet is missing cover plate.

16. Too close to bathtub or shower

17. Too close to bathtub or shower

**Task:** Relocate

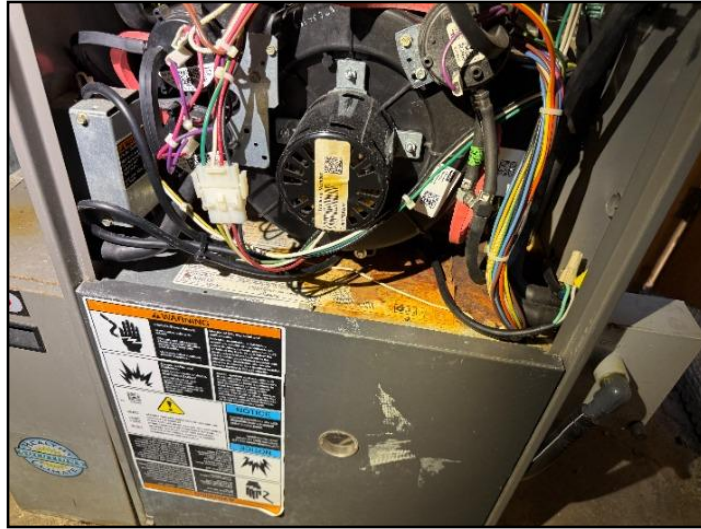
**Condition:** • Condensate prior issues and/or rust

Various areas of rust and evidence of prior condensate leak noted inside furnace cabinet. Dry at time of inspection. Unknown if issue is resolved, active or intermittent. Have HVAC technician service the unit and check all interior components at next annual servicing.

18. Condensate prior issues and/or rust

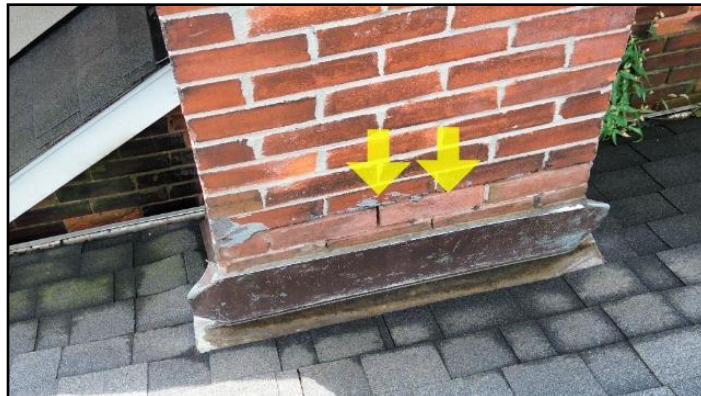
19. example

**Condition:** • [Loose, missing or deteriorated mortar](#)

**Task:** Repair

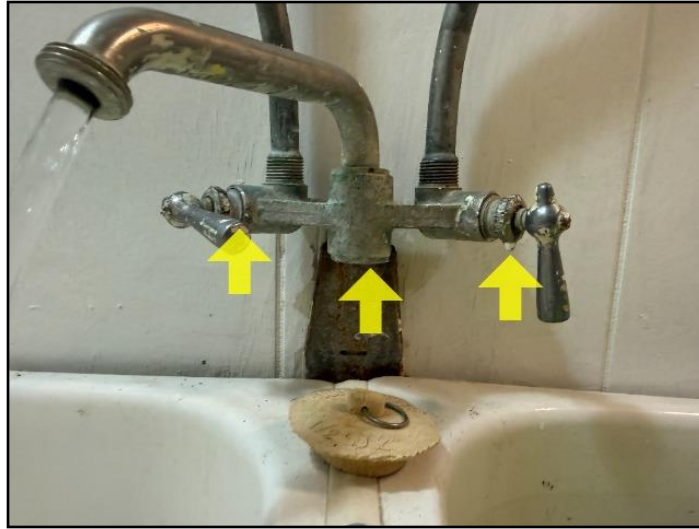
**Condition:** • [Drip, leak](#)

Leakage was noted at both faucet handles and the faucet body/spout area during testing, with water dripping onto the floor behind the tub.

22. leak

**Task:** Repair / Replace

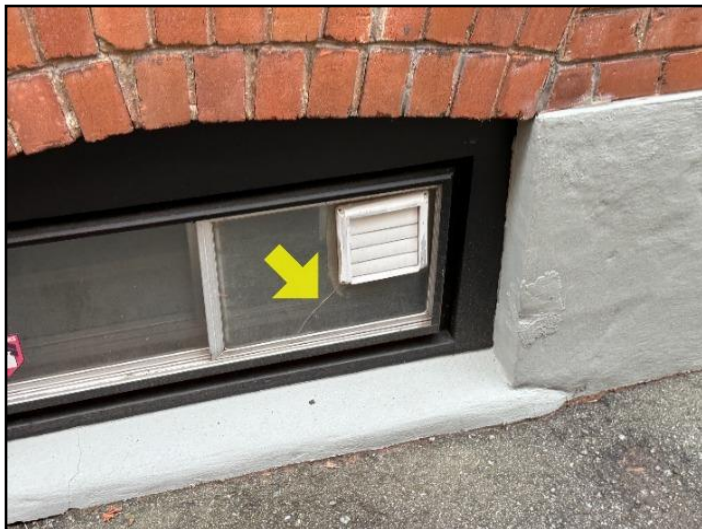
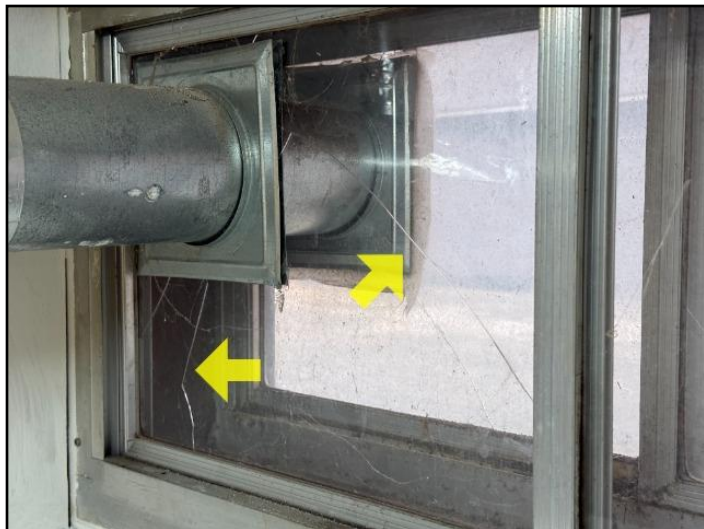
**Condition:** • [Cracked](#)

23. Cracked

24. Cracked

**Task:** Replace

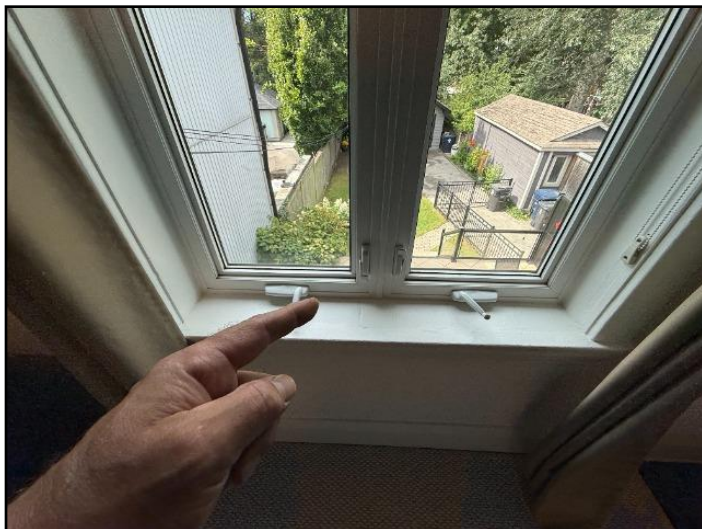
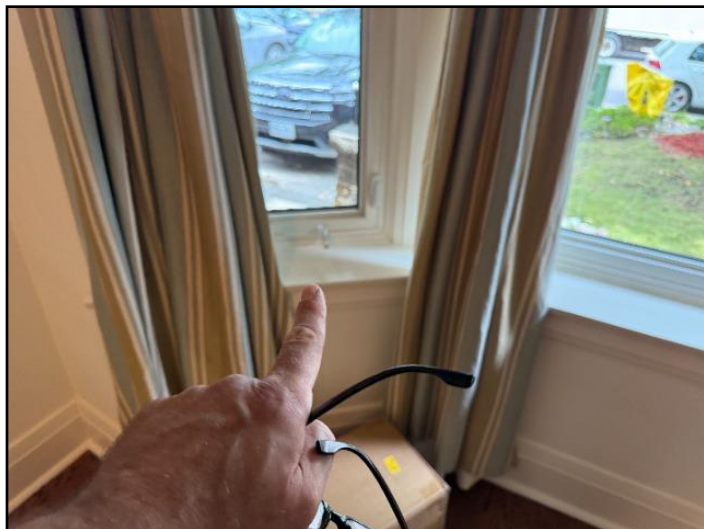
Condition: • [Inoperative](#)

25. Inoperative

26. Inoperative

Task: Repair / Replace operator hardware

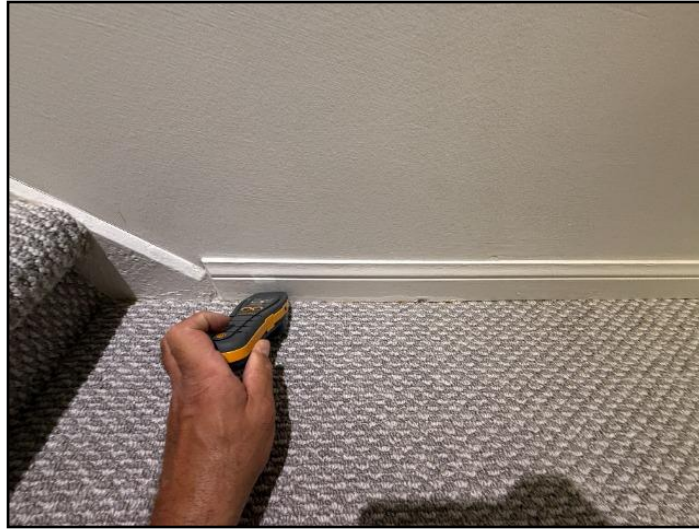
Condition: • Water damage and/or stains

Localized staining noted at baseboard. Area was dry when tested with a moisture meter.

27. Water damage and/or stains, tested dry
