# INSPECTION REPORT

For the Property at:  
**2222 REAL , St**  
ARLINGTON, VA 22207

Prepared for: TIM TAYLOR  
Inspection Date: Monday, May 8, 2017  
Prepared by: Johnny Short

RE: Report No. 1013, v.4  
2222 Real , St  
Arlington, VA  
22207

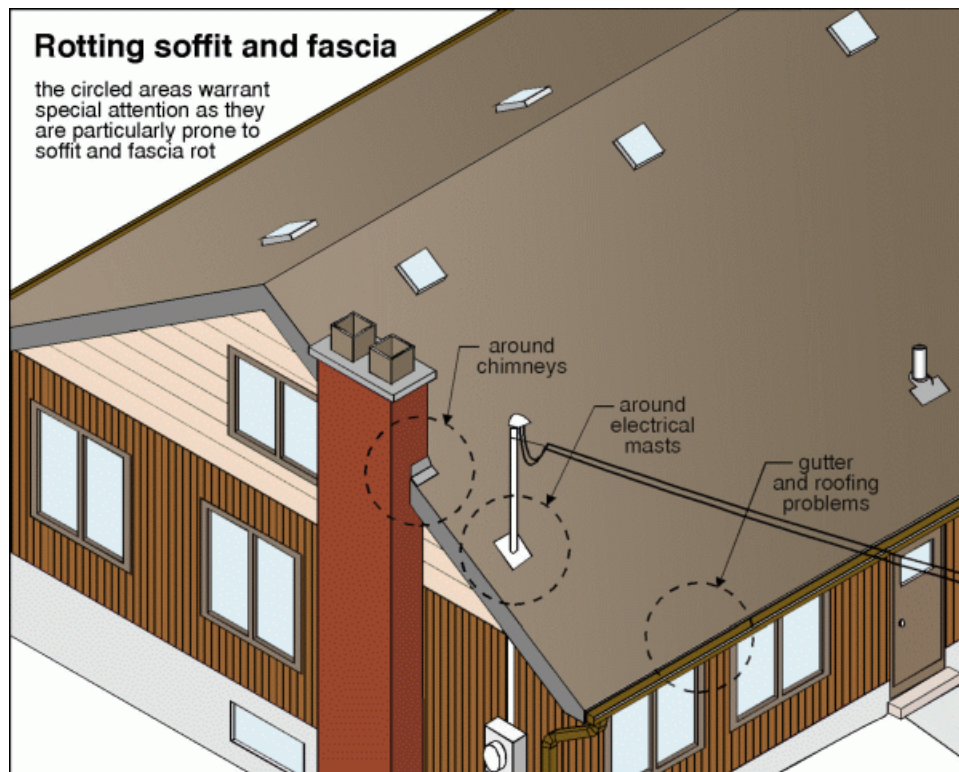
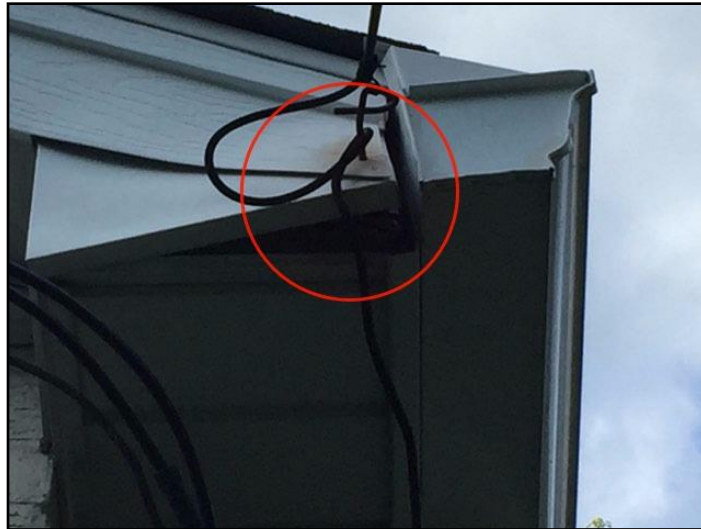
**Location:** Right Side

**Condition:** • Loose or missing pieces

**Implication(s):** Chance of water damage to contents, finishes and/or structure | Chance of pests entering building

*Loose or missing pieces*

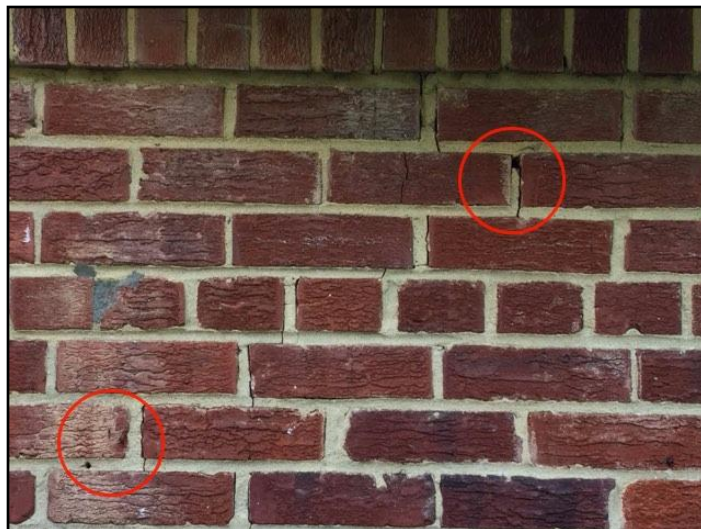
**Location:** Front

**Condition:** • Cracked

Step cracks in mortar joints

**Implication(s):** Chance of water entering building | Weakened structure | Chance of movement

*Cracked*

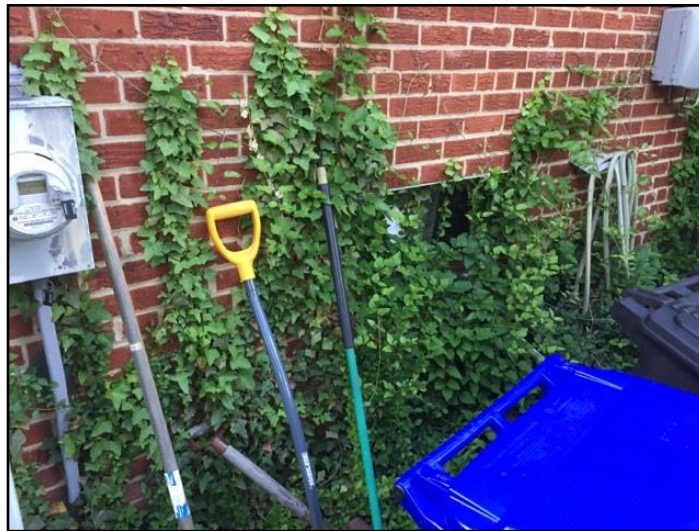
**Location:** Right Side

**Condition:** • Planters and gardens against walls

**Implication(s):** Chance of water entering building | Chance of damage to structure | Chance of structural movement

*Planters and gardens against walls*

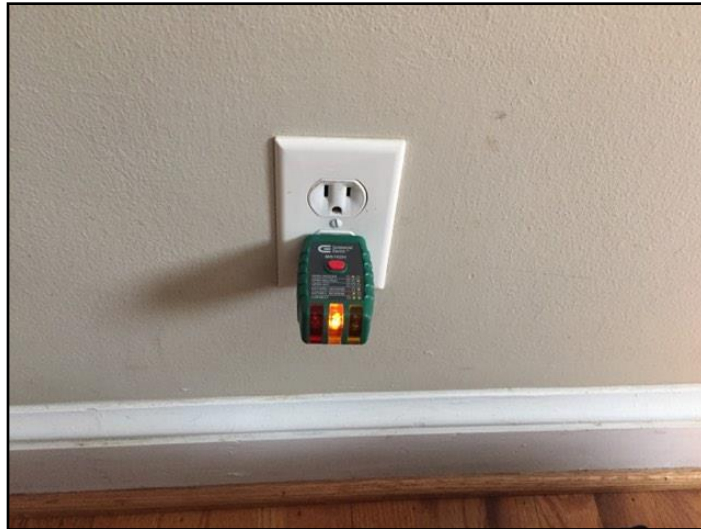
**Location:** First Floor Living Room

**Condition:** • Ungrounded

**Implication(s):** Electric shock

*Ungrounded*

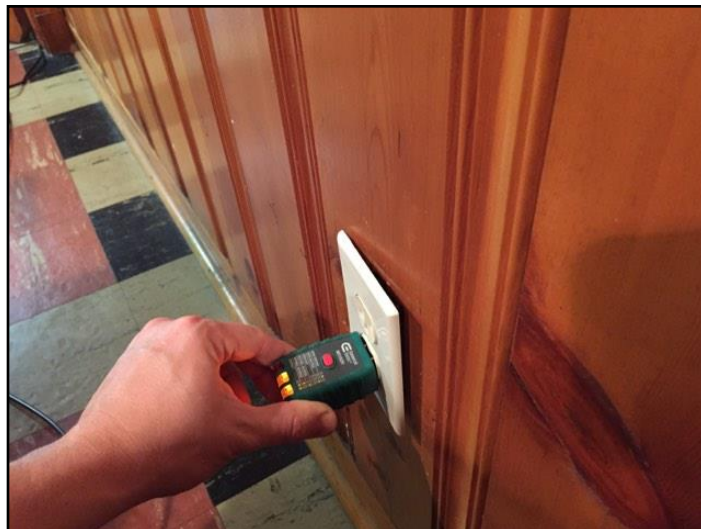
**Location:** Left Side Basement

**Condition:** • Loose

**Implication(s):** Electric shock | Fire hazard

*Loose*

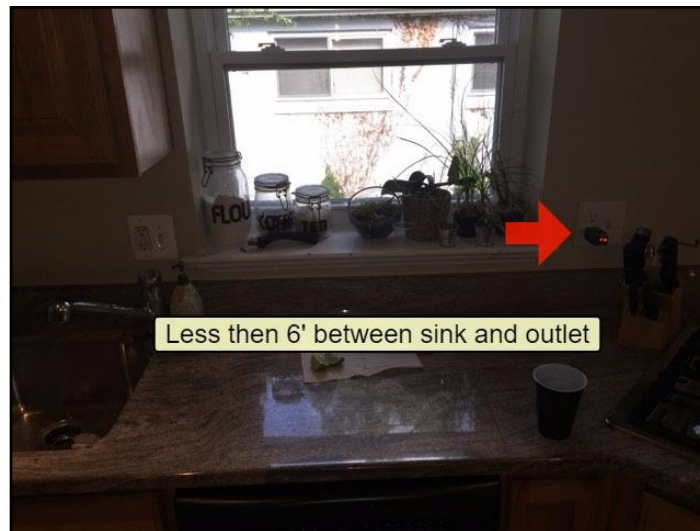
**Location:** First Floor Kitchen

**Condition:** • No GFCI/GFI (Ground Fault Circuit Interrupter)

Less then 6' from kitchen sink

**Implication(s):** Electric shock

No GFCI/GFI (Ground Fault Circuit...

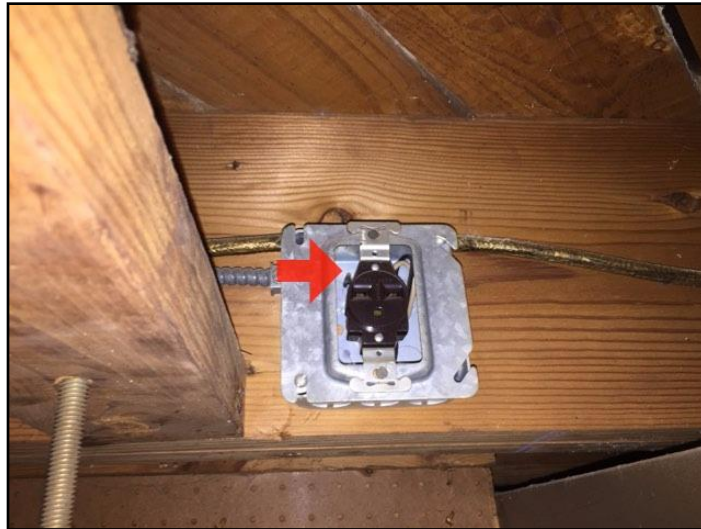
**Location:** Basement Utility Room

**Condition:** • Missing

**Implication(s):** Electric shock

*Missing*

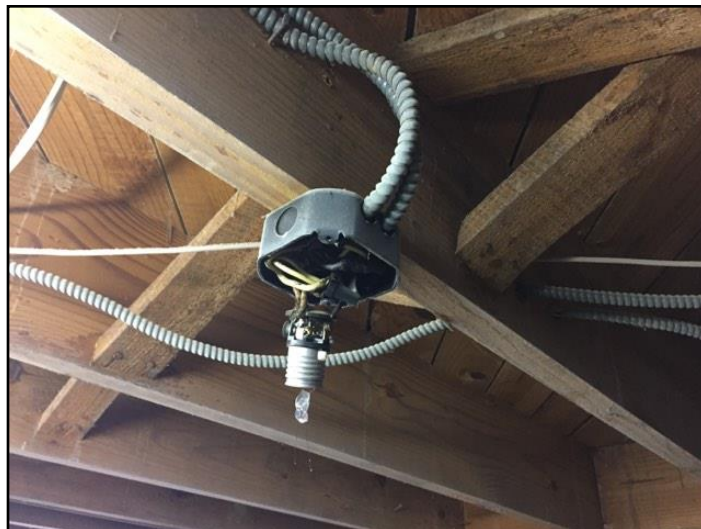
**Location:** Basement

**Condition:** • Missing

**Implication(s):** Electric shock

*Missing*

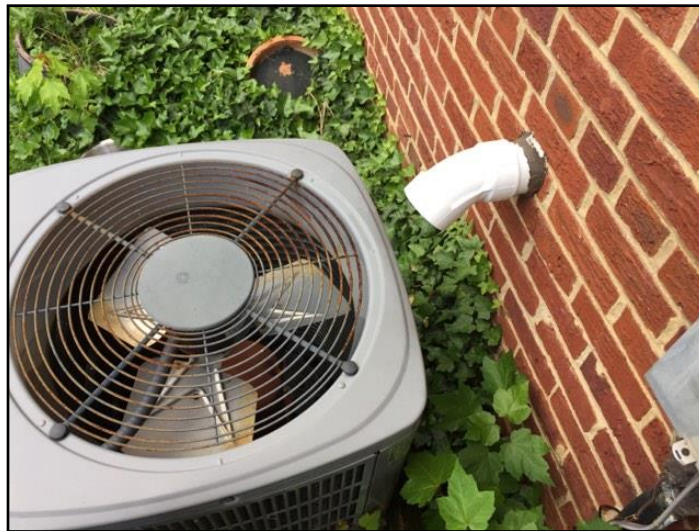
**Location:** Left Side Exterior

**Condition:** • Poor vent location, arrangement

Hi efficient gas furnace exhausting directly on air cooled AC unit

**Implication(s):** Equipment not operating properly | Equipment inoperative | Hazardous combustion products entering home

Poor vent location, arrangement

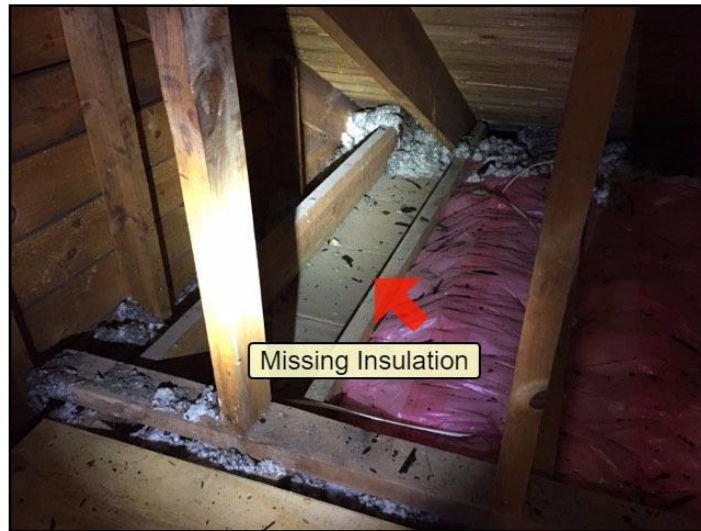
**Location:** Attic Throughout

**Condition:** • Gaps or voids

**Implication(s):** Increased heating and cooling costs | Reduced comfort

*Gaps or voids*

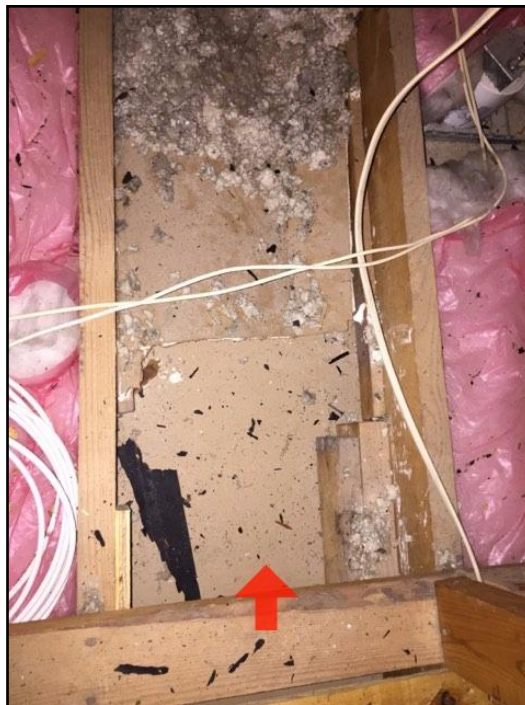
**Location:** Attic

**Condition:** • Gaps or voids

**Implication(s):** Increased heating and cooling costs | Reduced comfort

*Gaps or voids*

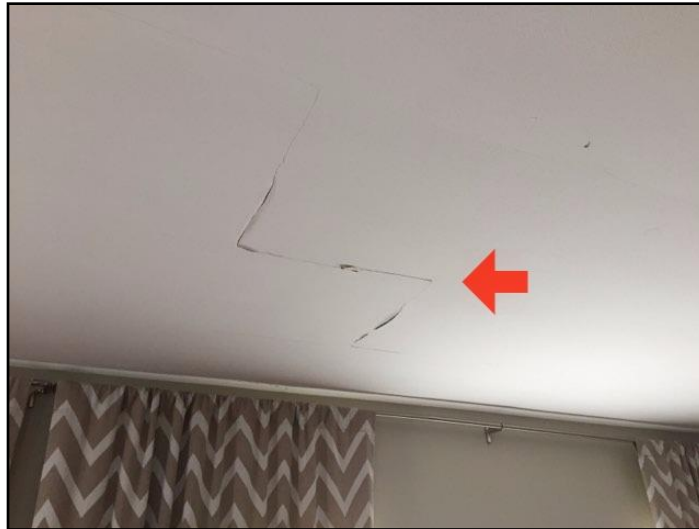
**Location:** First Floor Living Room

**Condition:** • Cracks

**Implication(s):** Damage or physical injury due to falling materials

*Cracks*

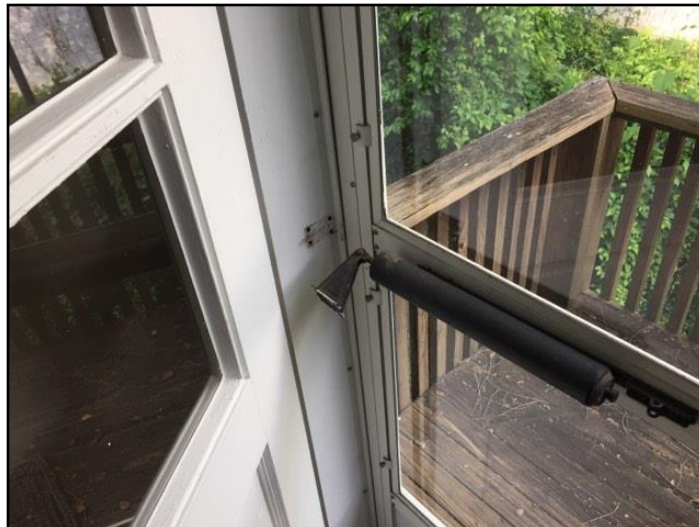
**Location:** First Floor Kitchen

**Condition:** • Inoperable

Broken storm door shock holder

**Implication(s):** System inoperative or difficult to operate

*Inoperable*

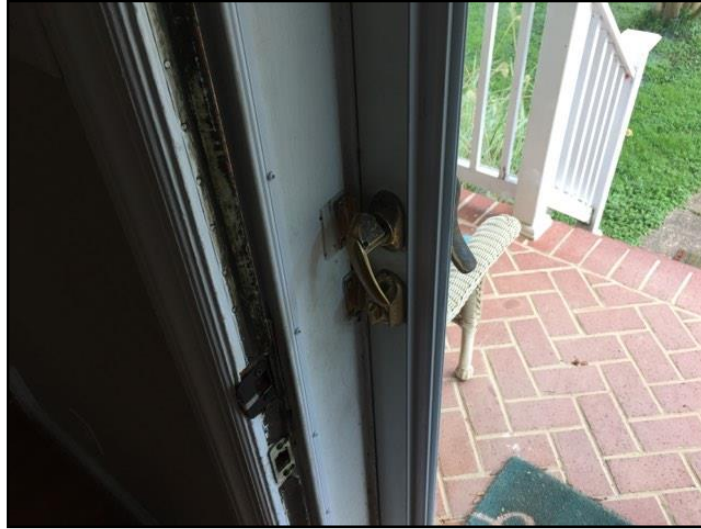
**Location:** First Floor Living Room

**Condition:** • Inoperable

**Implication(s):** System inoperative or difficult to operate

*Inoperable*

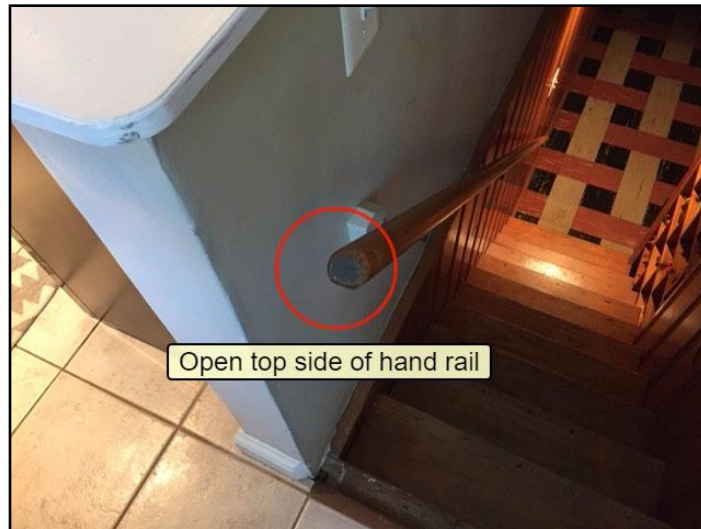
**Location:** Kitchen

**Condition:** • Stair rails should have downward movement opening closed off to prevent snagging of clothes

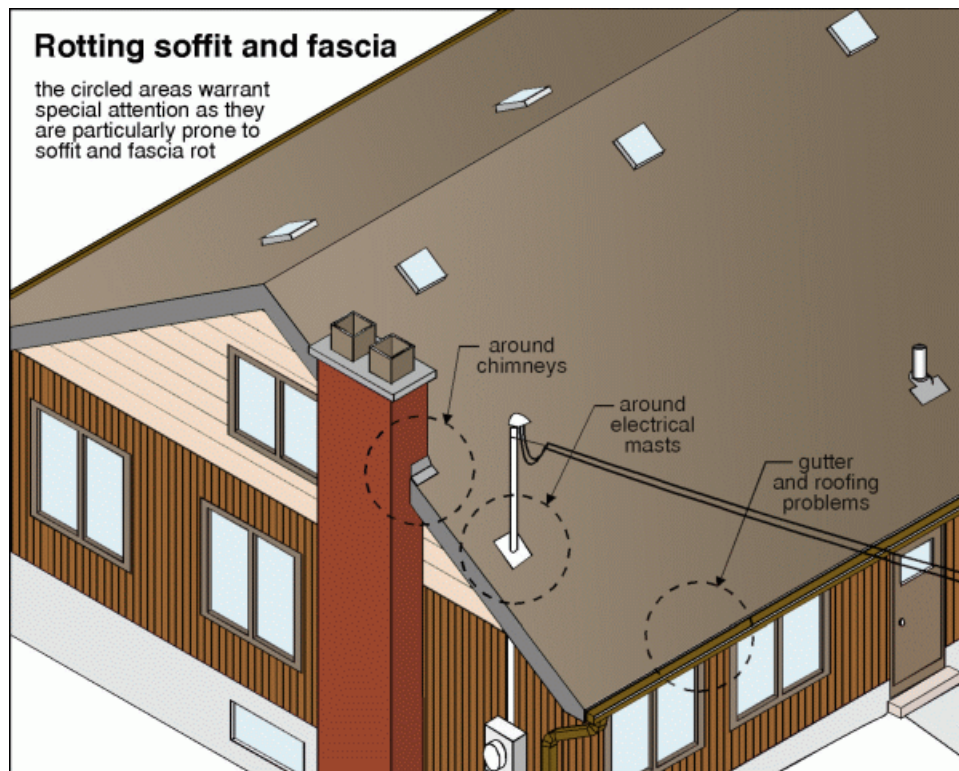
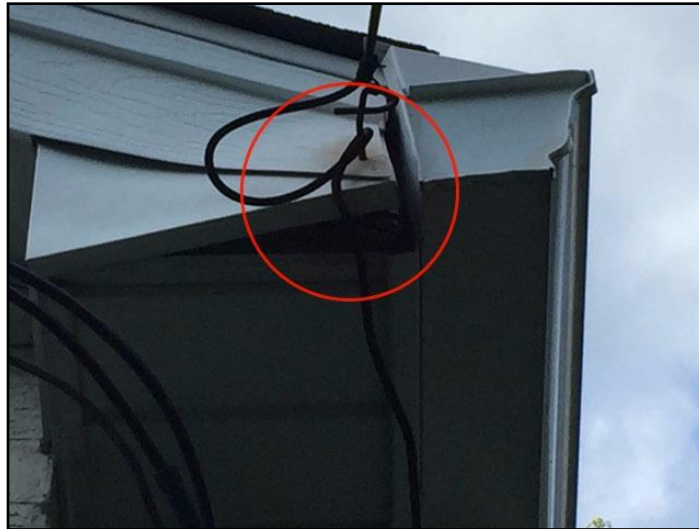
**Location:** Right Side

**1. Condition:** • Loose or missing pieces

**Implication(s):** Chance of water damage to contents, finishes and/or structure | Chance of pests entering building

*Loose or missing pieces*

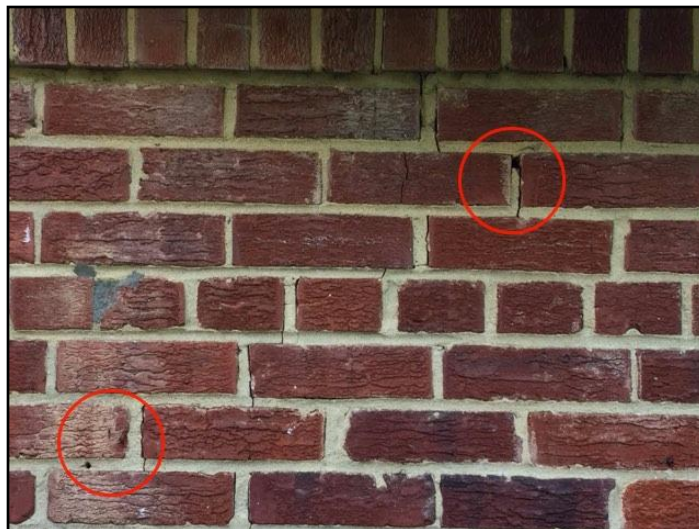
**Location:** Front

### **2. Condition:** • Cracked

Step cracks in mortar joints

**Implication(s):** Chance of water entering building | Weakened structure | Chance of movement

*Cracked*

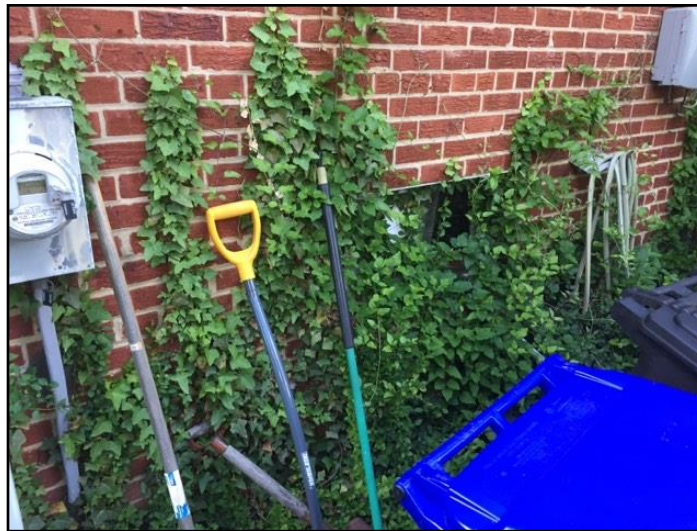
**Location:** Right Side

### **4. Condition:** • Planters and gardens against walls

**Implication(s):** Chance of water entering building | Chance of damage to structure | Chance of structural movement

*Planters and gardens against walls*

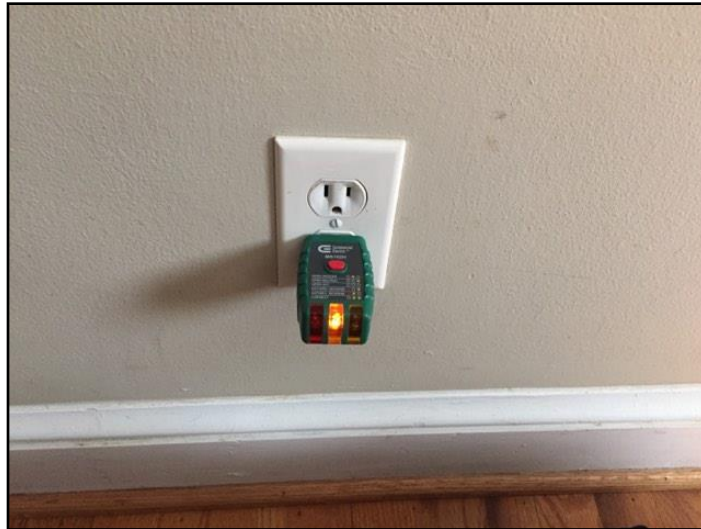
**Location:** First Floor Living Room

**5. Condition:** • Ungrounded

**Implication(s):** Electric shock

*Ungrounded*

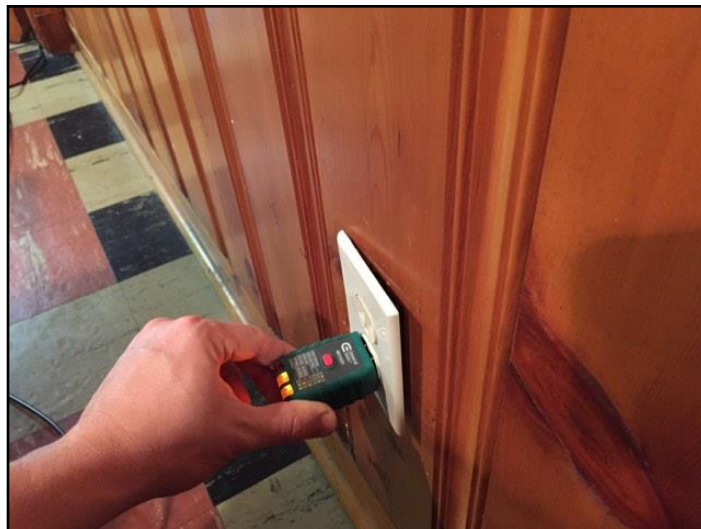
**Location:** Left Side Basement

**6. Condition:** • Loose

**Implication(s):** Electric shock | Fire hazard

*Loose*

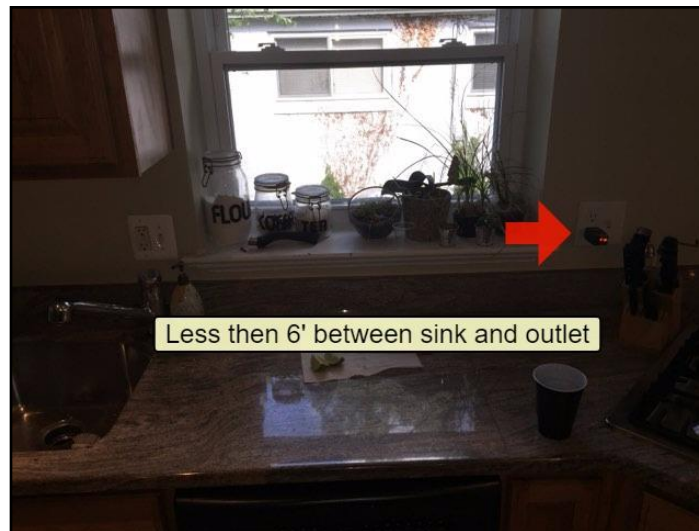
**Location:** First Floor Kitchen

**7. Condition:** • No GFCI/GFI (Ground Fault Circuit Interrupter)

Less then 6' from kitchen sink

**Implication(s):** Electric shock

No GFCI/GFI (Ground Fault Circuit...

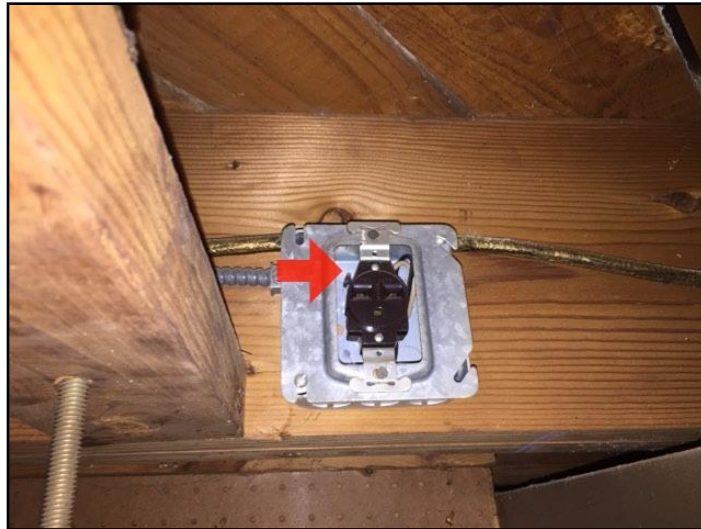
Location: Basement Utility Room

8. Condition: • Missing

Implication(s): Electric shock

*Missing*

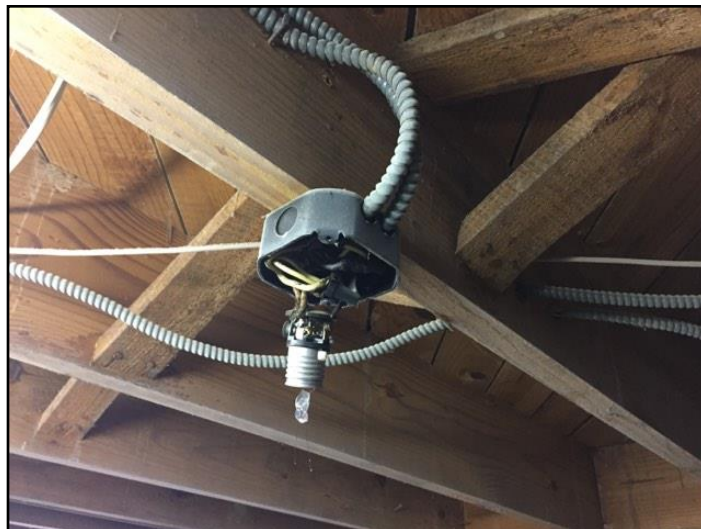
**Location:** Basement

**9. Condition:** • Missing

**Implication(s):** Electric shock

*Missing*

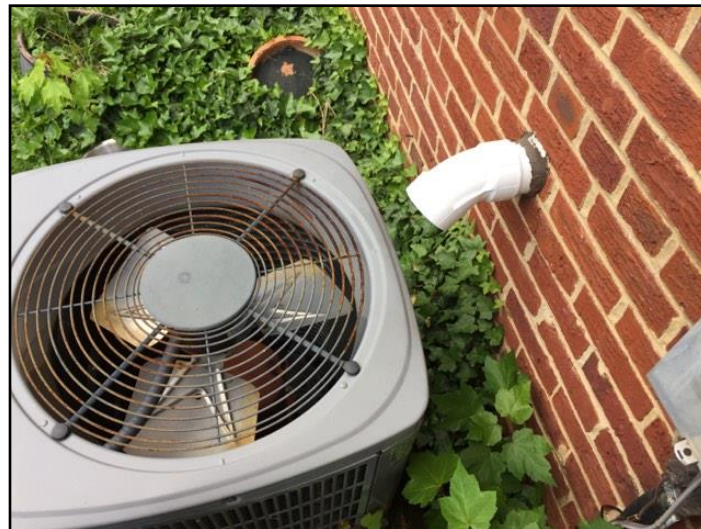
**Location:** Left Side Exterior

**10. Condition:** • Poor vent location, arrangement

Hi efficient gas furnace exhausting directly on air cooled AC unit

**Implication(s):** Equipment not operating properly | Equipment inoperative | Hazardous combustion products entering home

Poor vent location, arrangement

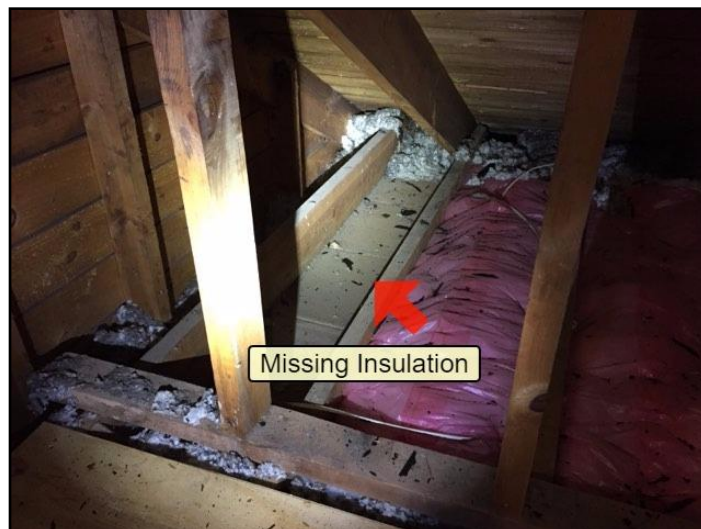
**Location:** Attic Throughout

**11. Condition:** • Gaps or voids

**Implication(s):** Increased heating and cooling costs | Reduced comfort

*Gaps or voids*

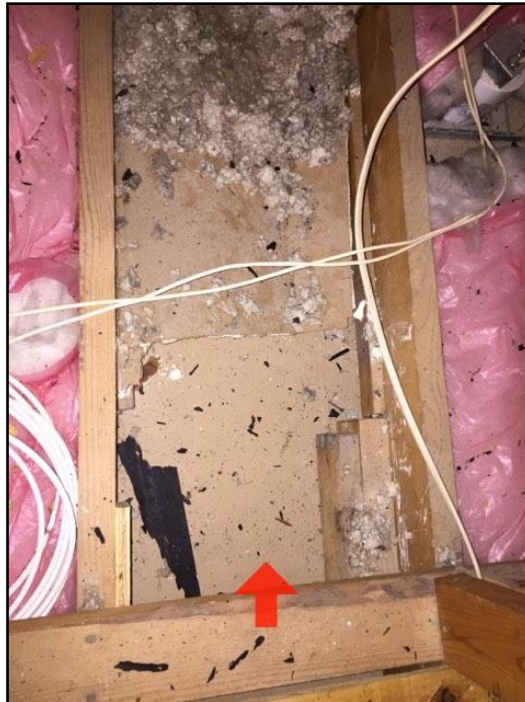
**Location:** Attic

**12. Condition:** • Gaps or voids

**Implication(s):** Increased heating and cooling costs | Reduced comfort

*Gaps or voids*

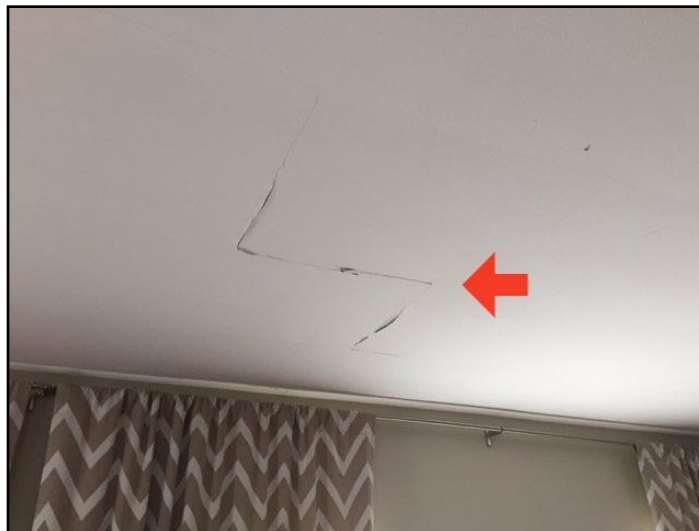
**Location:** First Floor Living Room

**13. Condition:** • Cracks

**Implication(s):** Damage or physical injury due to falling materials

Cracks

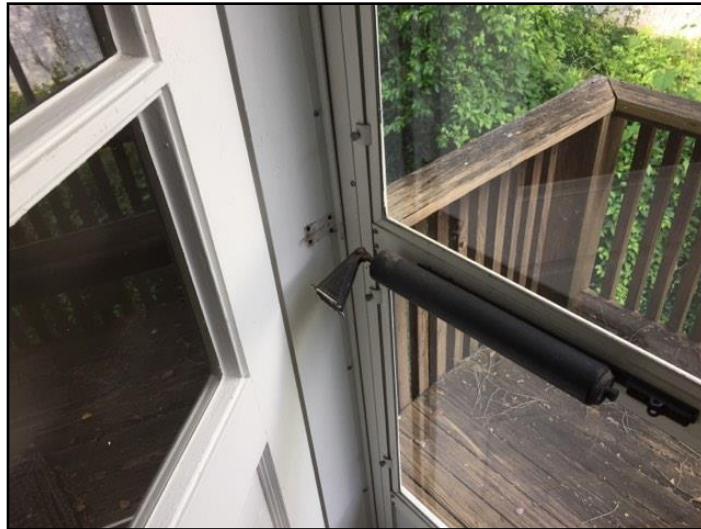
**Location:** First Floor Kitchen

**14. Condition:** • Inoperable

Broken storm door shock holder

**Implication(s):** System inoperative or difficult to operate

*Inoperable*

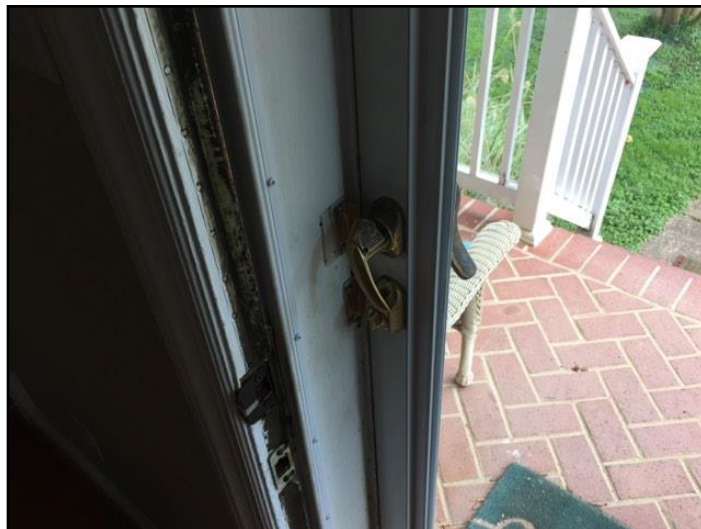
**Location:** First Floor Living Room

**15. Condition:** • Inoperable

**Implication(s):** System inoperative or difficult to operate

*Inoperable*

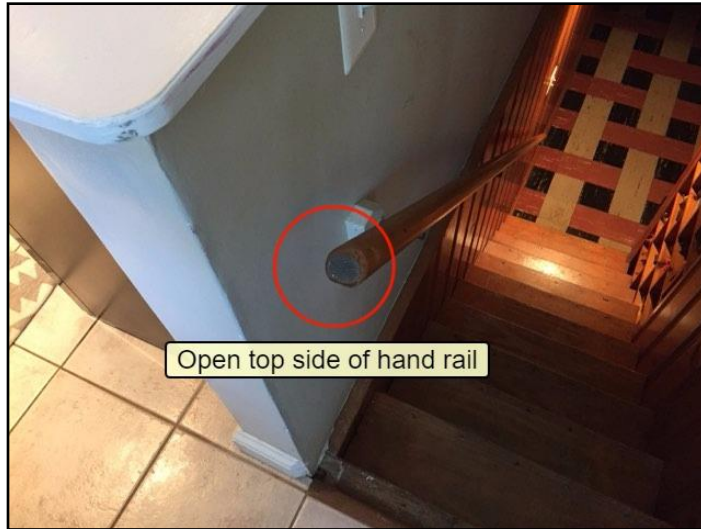
**16. Condition:** • Stair rails should have downward movement opening closed off to prevent snagging of clothes
