# YOUR INSPECTION REPORT

FOR THE PROPERTY AT:  
245 Indian Grove  
Toronto, ON M6P 2H4

INSPECTION DATE:  
Friday, September 8, 2023

RE: Report No. 7267, v.3  
245 Indian Grove  
Toronto, ON  
M6P 2H4

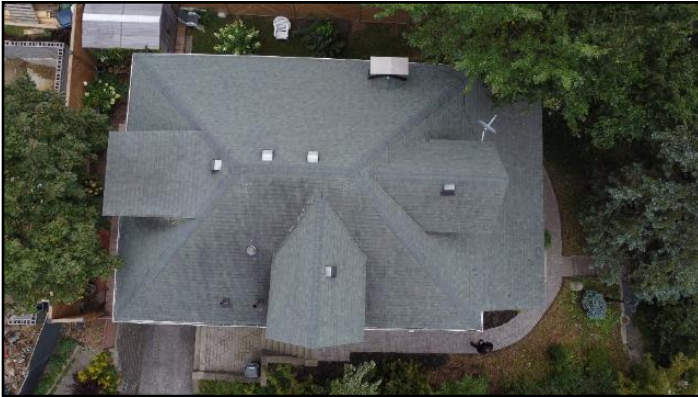
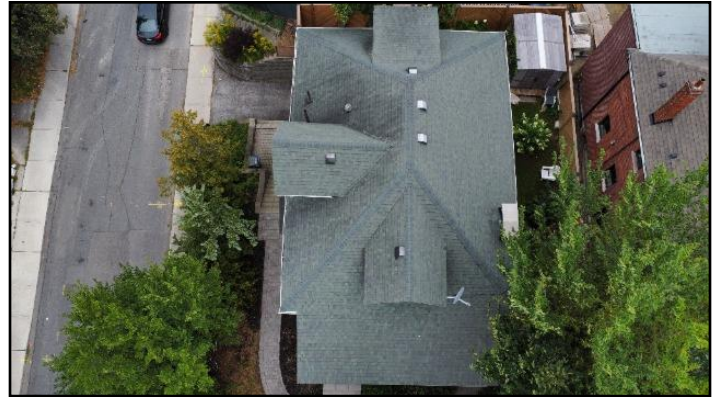
1. Asphalt shingles

2. Asphalt shingles

**Condition:** • Aging

This type of asphalt shingle, often sold as a 25-year shingle will typically last around 18-20 years in Canadian climates. The current roof is nearing the end of its lifespan and is aging with typical wear - Minor cracks, granule loss, small tears and discoloration. Inspect annually and plan to replace within the next few years.

**Task:** Inspect annually and Replace within next few years based on roofing contractor recommendation

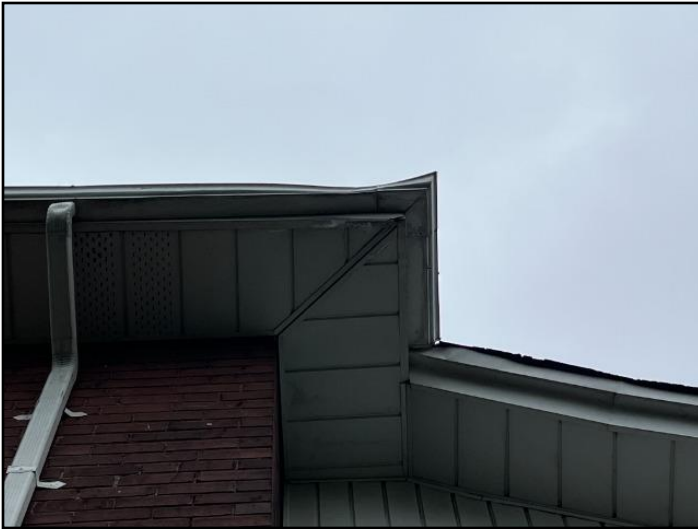
**Condition:** • Damage

3. Damage

**Task:** Repair / Replace

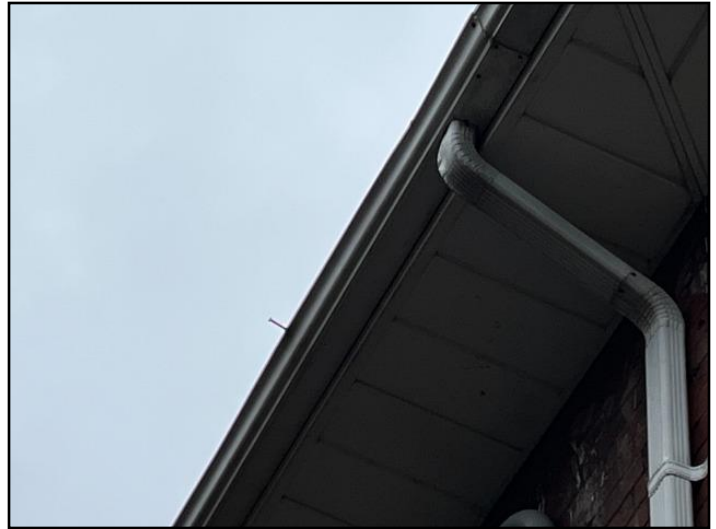
Also loose fasteners in some areas

4. loose fastener

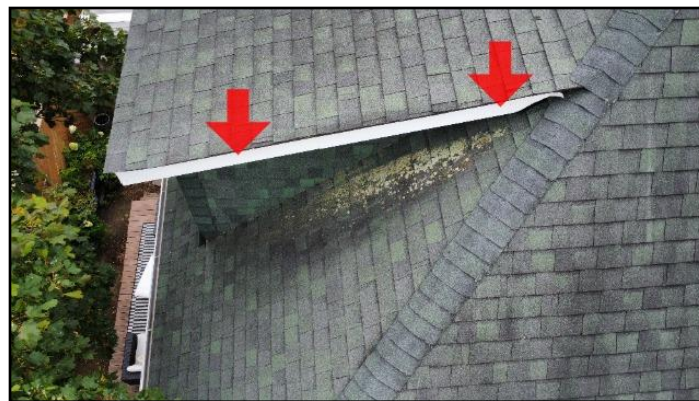
**Condition:** • [Missing](#)

5. Missing

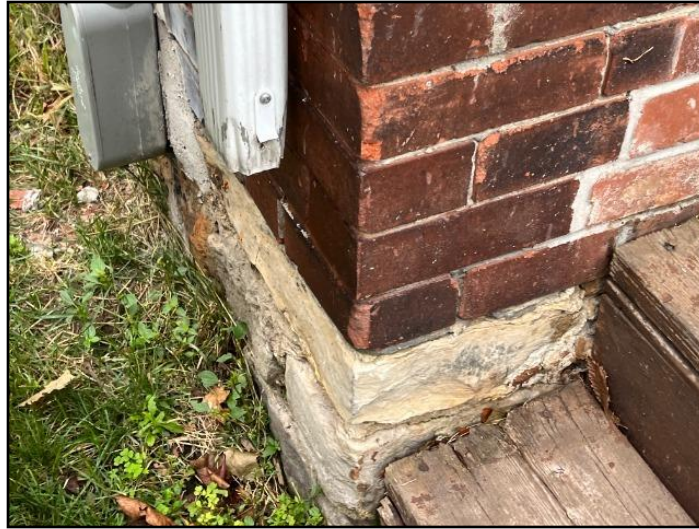
**Condition:** • [Discharge too close to building](#)

6. Discharge too close to building

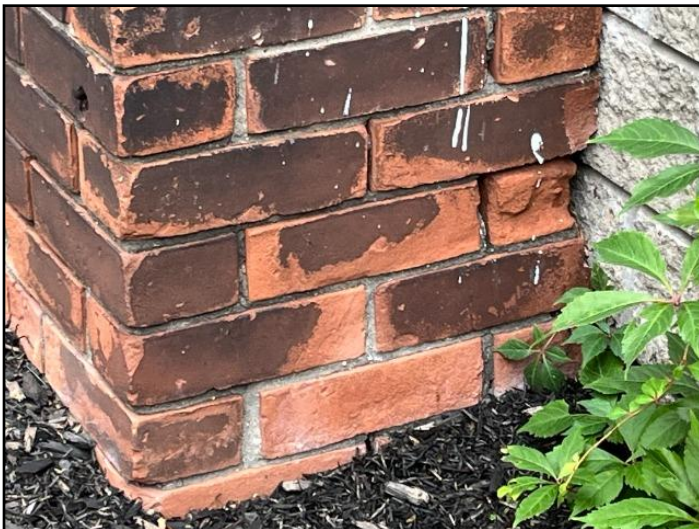
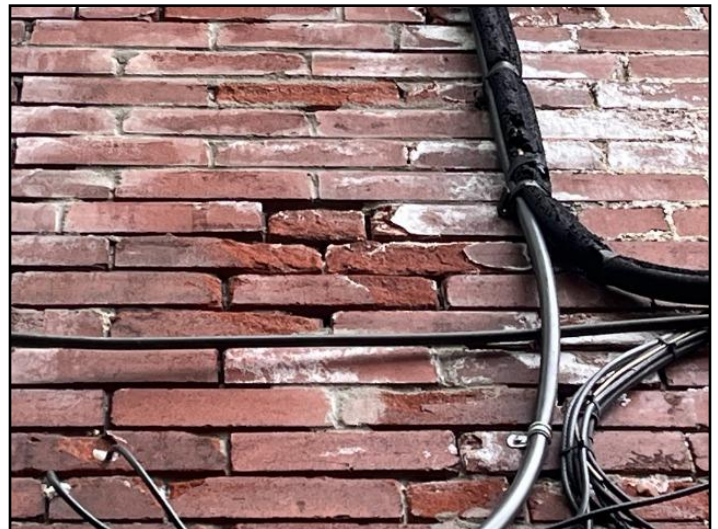
**Condition:** • [Spalling](#)

A few localized spalled bricks were noted as is common with all older homes. Masonry will require routine maintenance from time to time.

8. Spalling example

**Task:** Replace / Repair

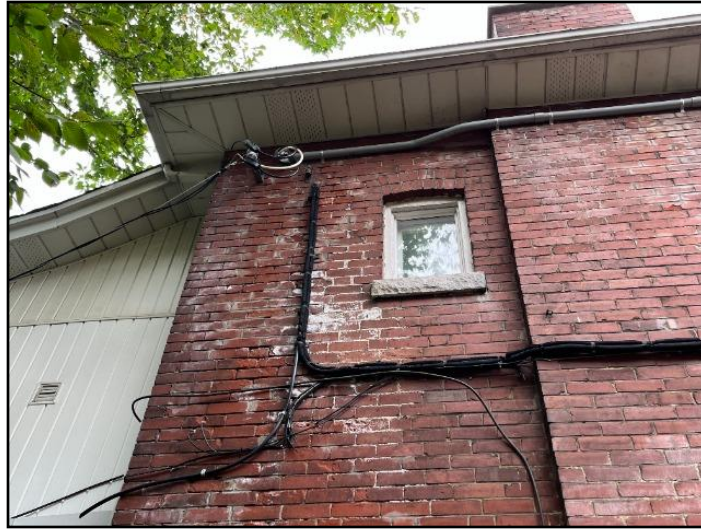
Condition: • [Efflorescence](#)

9. Efflorescence

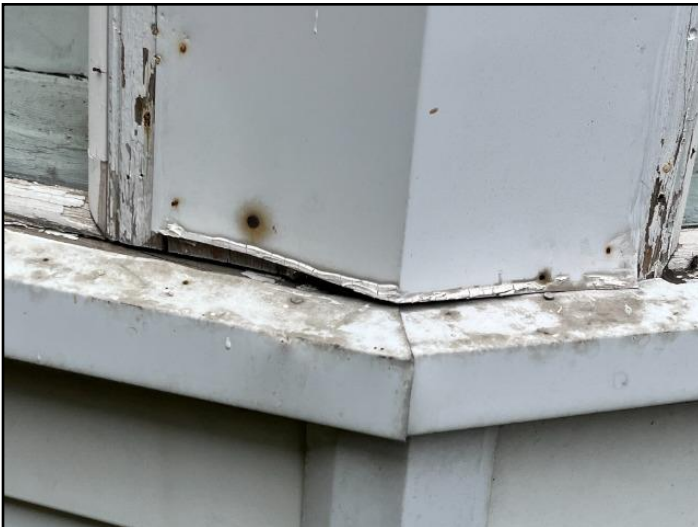
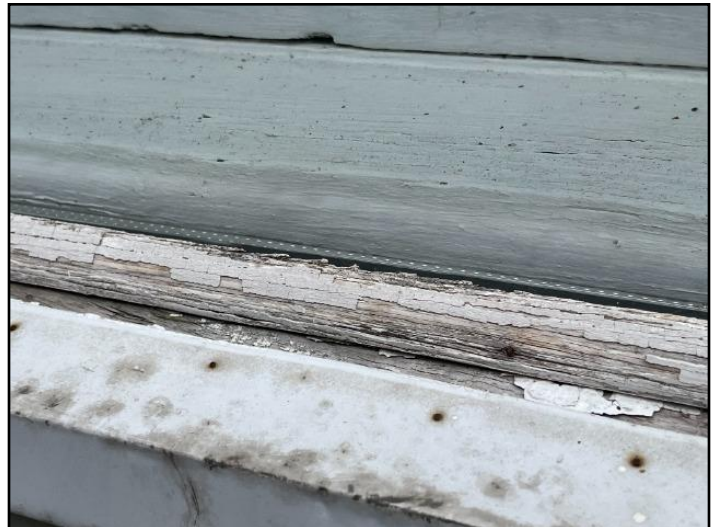
**Condition:** • Paint and Caulking - deteriorated / missing

10. Paint and Caulking - deteriorated / missing

11. Paint and Caulking - deteriorated / missing

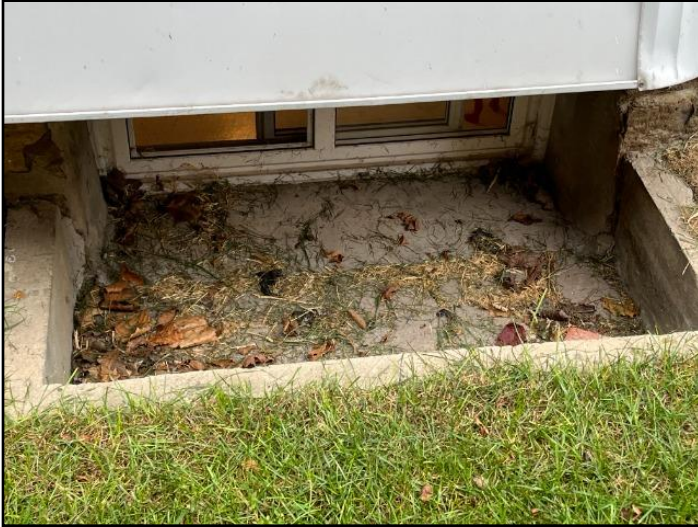
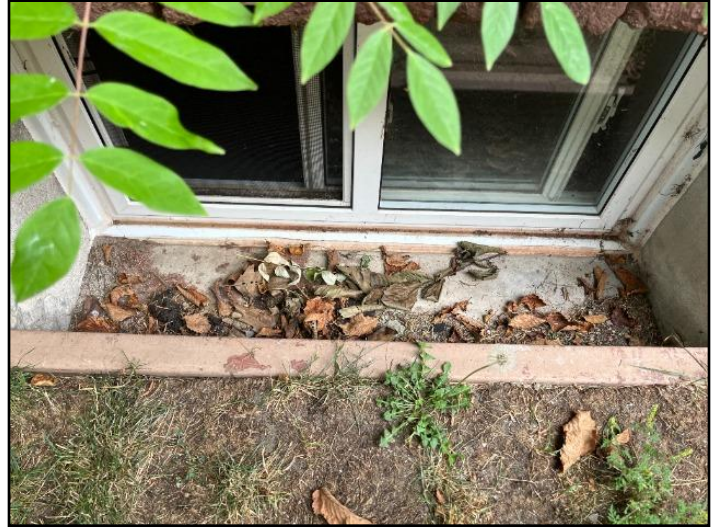
**Condition:** • [Missing](#)

12. Missing

13. Missing

**Task:** Monitor / Improve

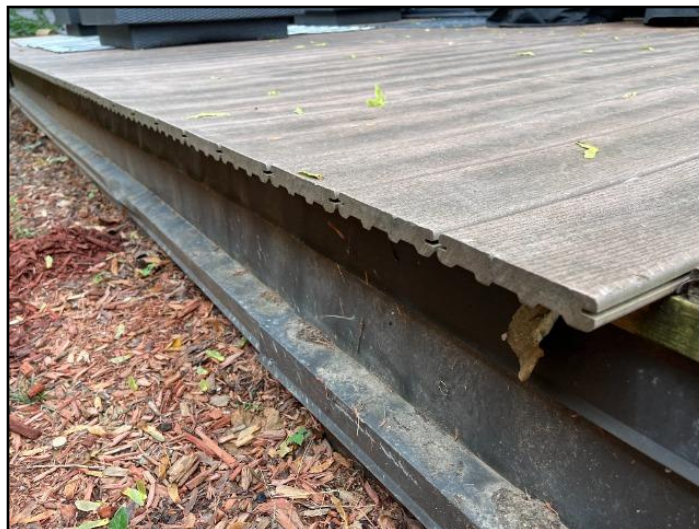
14.

**Condition:** • Floor boards overhang not supported

**Task:** Improve

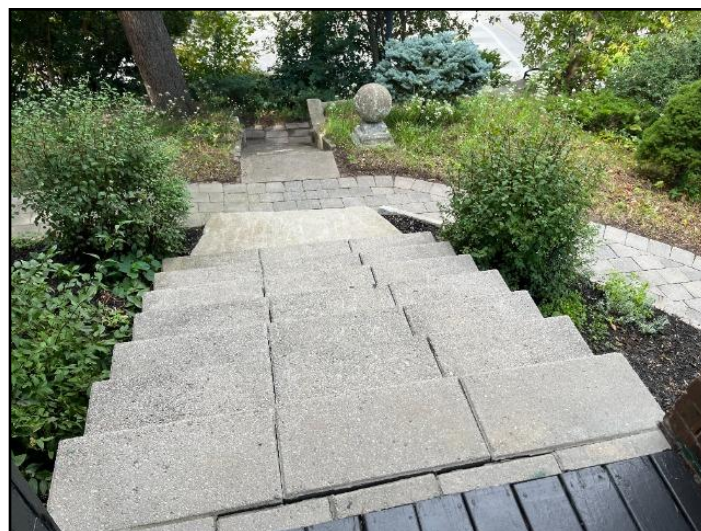
Condition: • [Missing](#)

15. Missing

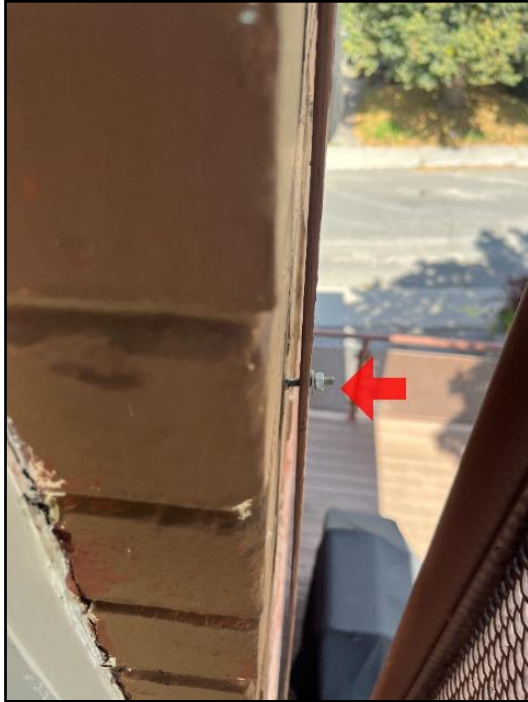
## Condition: • [Loose](#)

Railing fasteners on either side where attached to wall are loose or poorly fastened.

Fall hazard.

16. Loose

**Task:** Repair

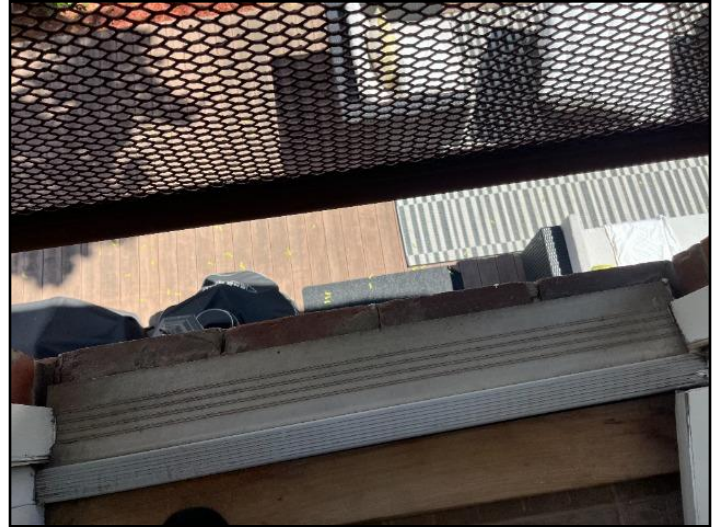
17. opening at bottom too large

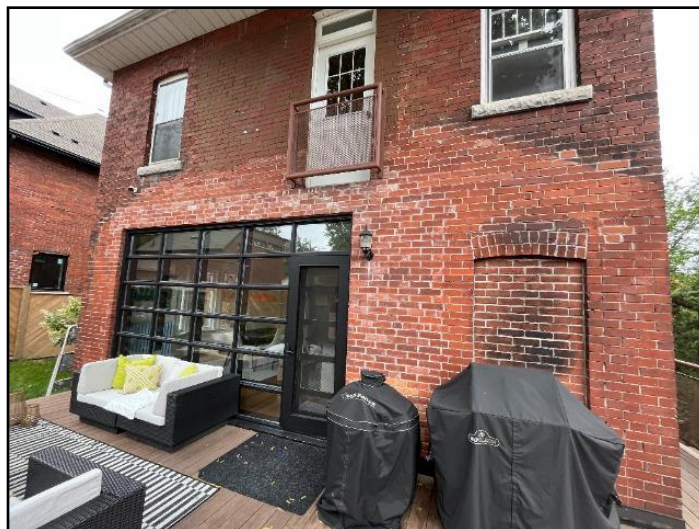
**Condition:** • [Prior repairs](#)

It is common to find a multitude of wall repairs on homes of this age (including prior window removals or new door/window installations)

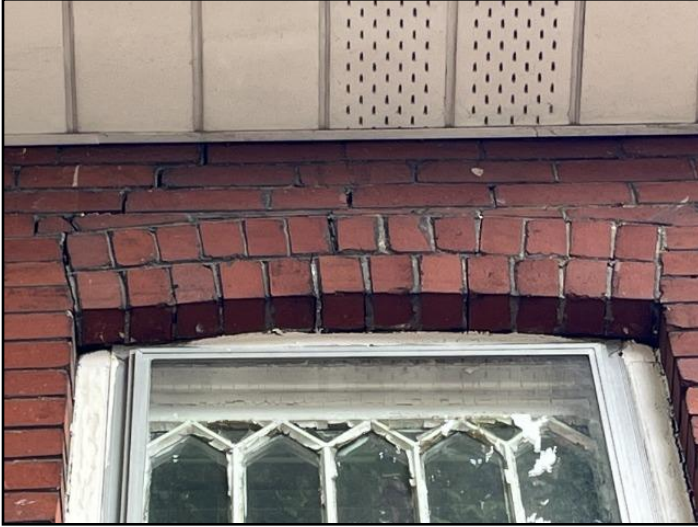
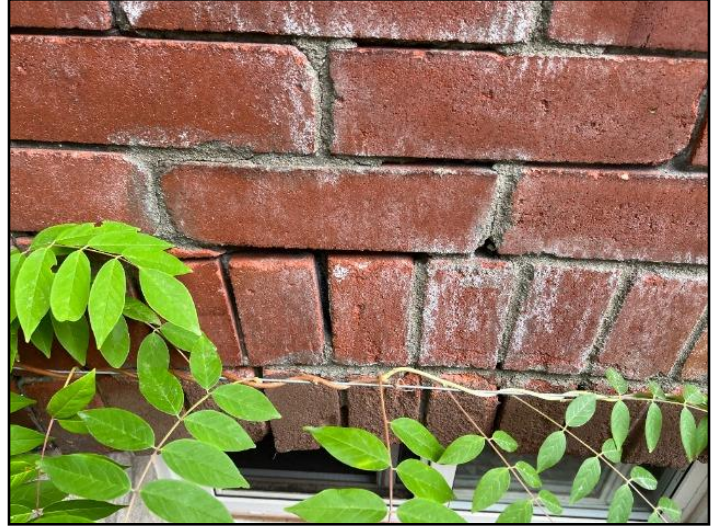
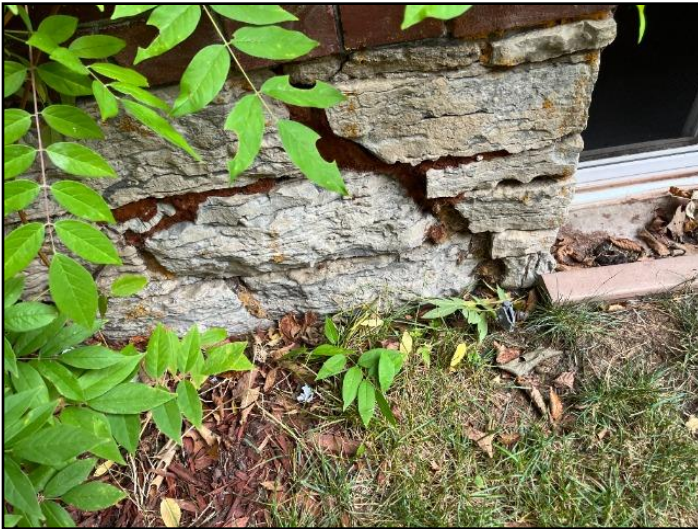
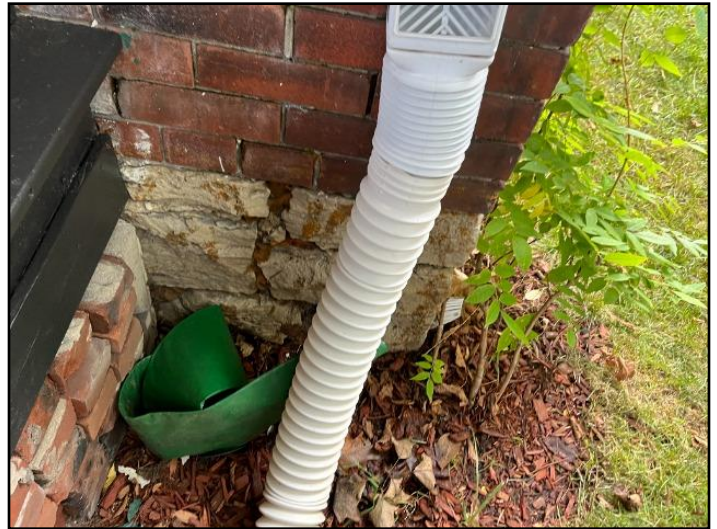
## Condition: • [Mortar deteriorating](#)

Repointing / Tuck-Pointing of mortar required. This is COMMON MAINTENANCE for all homes of this age. Overall brick and mortar is in good condition. photos show a sampling

**Task:** Repair

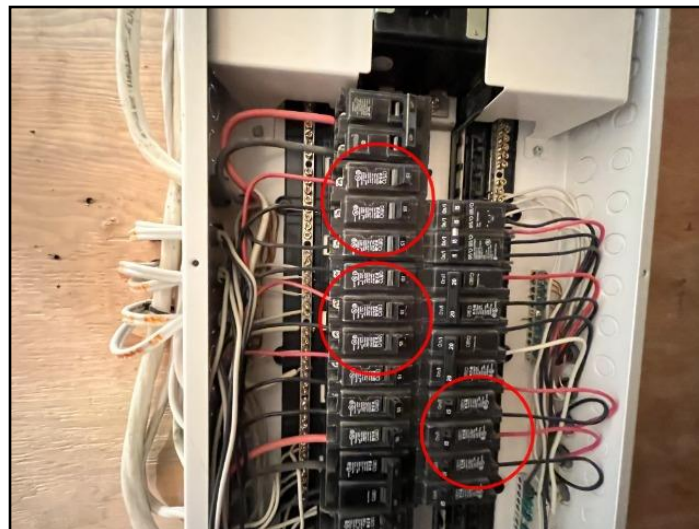
**Condition:** • [No links for multi-wire circuits](#)

Possible missing links. Have electrician confirm if distribution lines (see photo) are multi-wire 240V circuits. Provide handle ties if necessary.

25. No links for multi-wire circuits

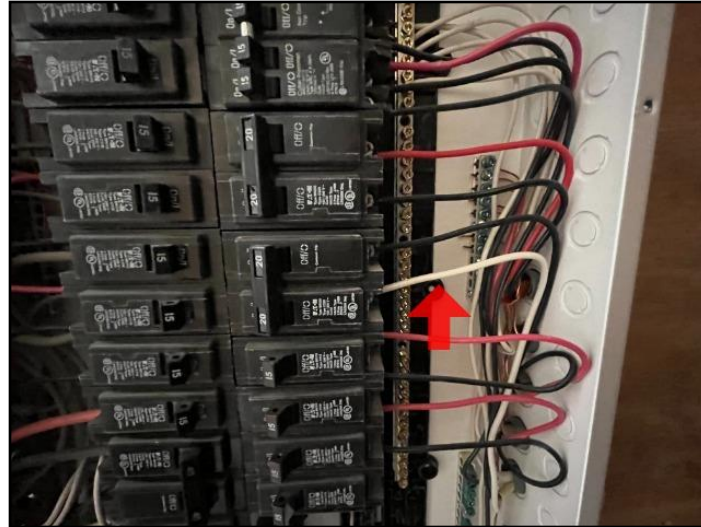
**Condition:** • White wires connected to breakers not identified as hot/live/ungrounded  
White wire used as hot wire not marked

26. White wires connected to breakers not...

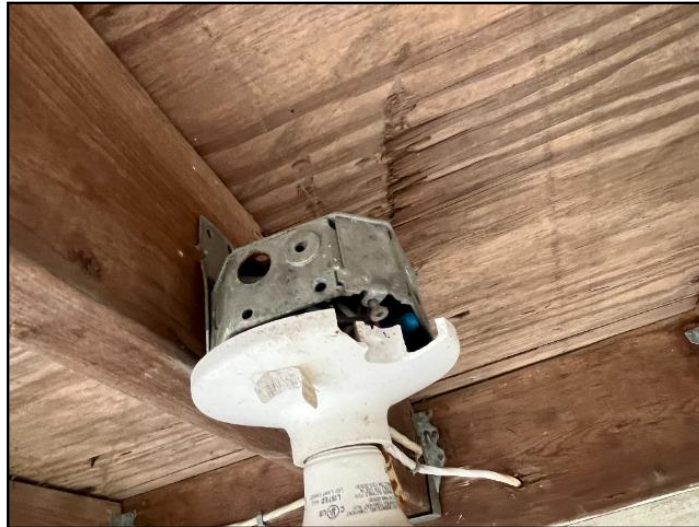
**Condition:** • [Damage](#)

27. Damage

**Task:** Replace

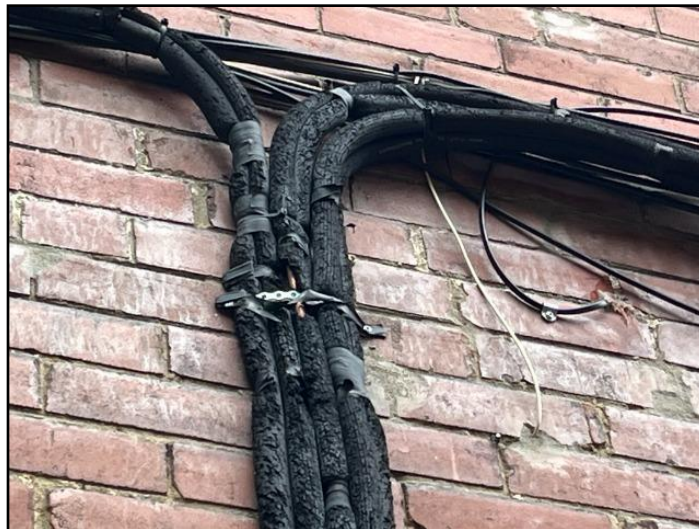
**Condition:** • Refrigerant insulation deteriorating or missing in some areas.

**Task:** Provide

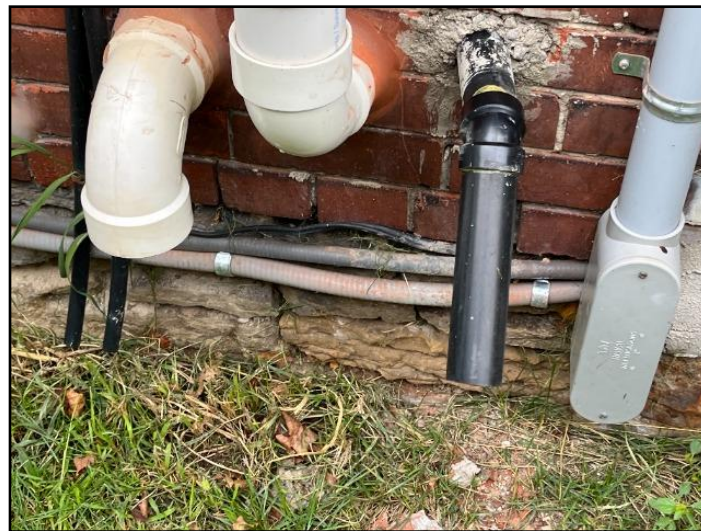
**Condition:** • [Discharges less than 6 feet from home](#)

30. Discharges less than 6 feet from home

**Task:** Correct

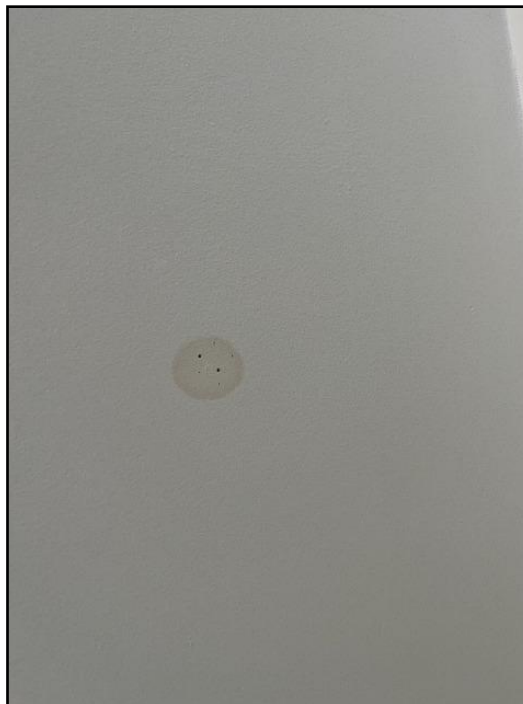
**Condition:** • Water stains

Small stain. Tested with moisture meter and was dry.

31. Water stain

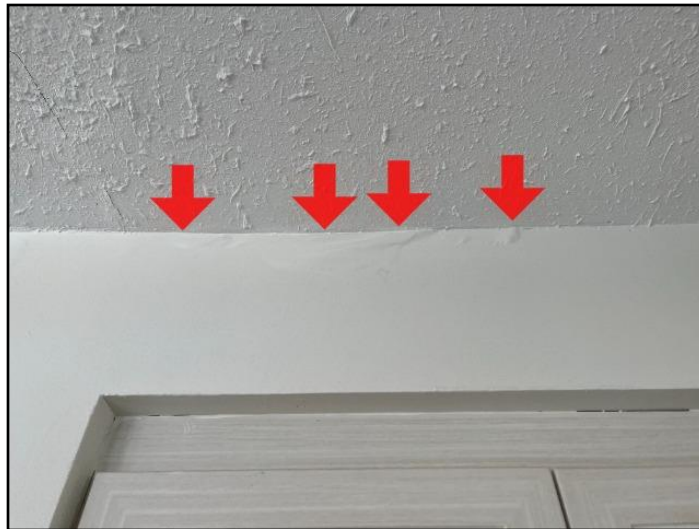
**Condition:** • [Water damage](#)

Small area is blistered. No stains present and area tested dry.

32. Water damage

**Task:** Repair

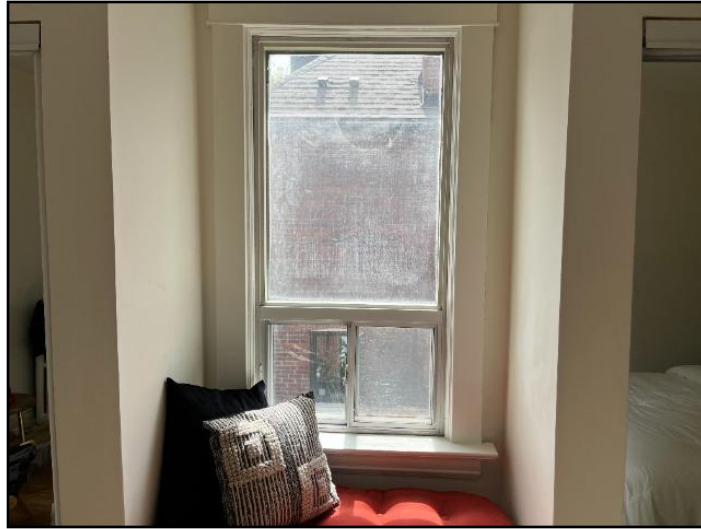
**Condition:** • [Lost seal on double or triple glazing](#)

**33.** *Lost seal on double or triple glazing*

**Task:** Replace

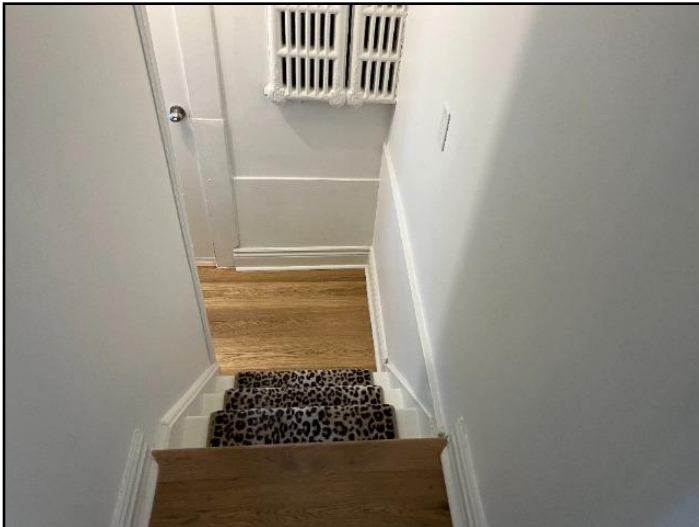
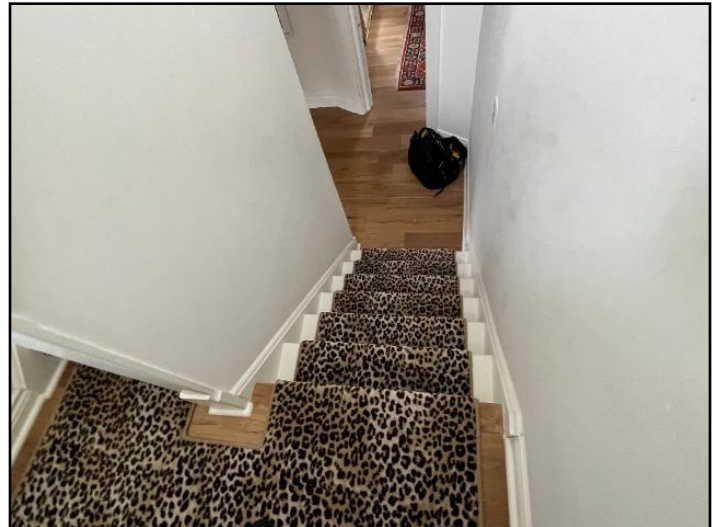
**Condition:** • [Missing](#)

34. Missing

35. Missing
