INSPECTION REPORT

For the Property at:
123 YOUR STREET
NEW ORLEANS, LA 70118

Prepared for: SAMPLE COTTAGE
Inspection Date: Tuesday, November 28, 2023
Prepared by: Turk Schexnayder LHI Lic.10679

RE: Report No. 2572, v.3
123 Your Street
New Orleans, LA
70118

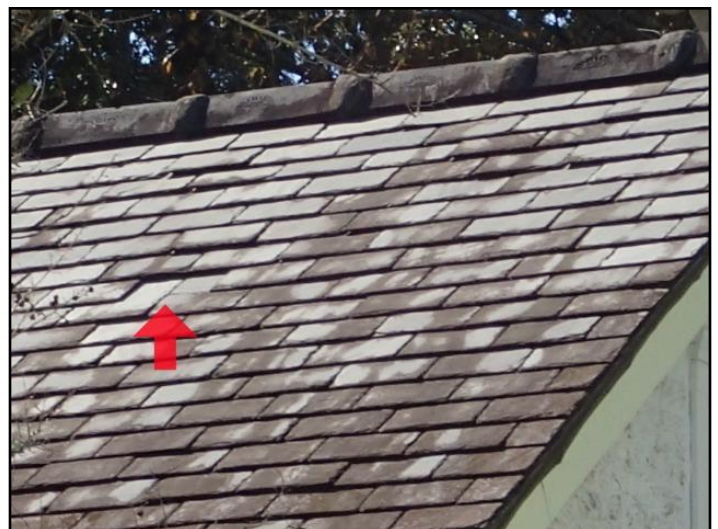
2. Condition: • The slate roof appeared mostly functional at the time of inspection with general maintenance recommended. Prior repairs and/or slipped slates were noted. The slate roof should be checked at least twice annually by a qualified roofing contractor and regular maintenance performed as needed to extend roof life and prevent leakage. The photos taken are intended to describe the roof issues and do not point out every deficiency.

Items noted at time of inspection were but are not limited to: Chipped/Slipped/Missing slate; Prior repairs and moss on roof noted; Torn or missing underlayment noted in attic; Plastic sheet secured to rafters on under side of roof. Broken deck plank noted. Prior repairs to other decking noted.

3. Missing slate

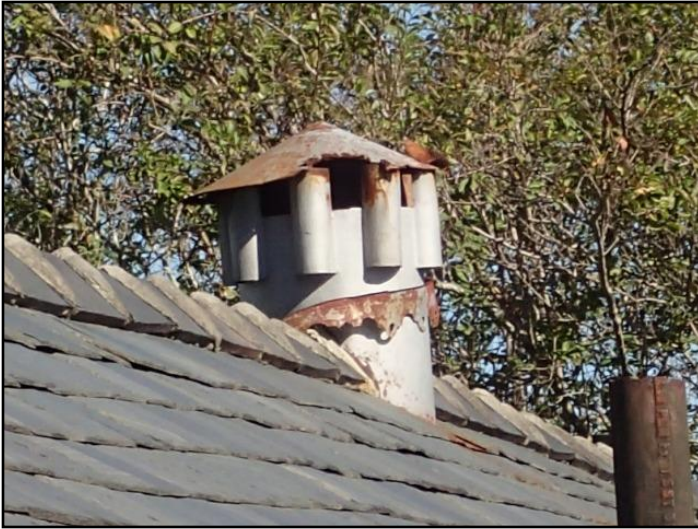
4. Rusted roof vent

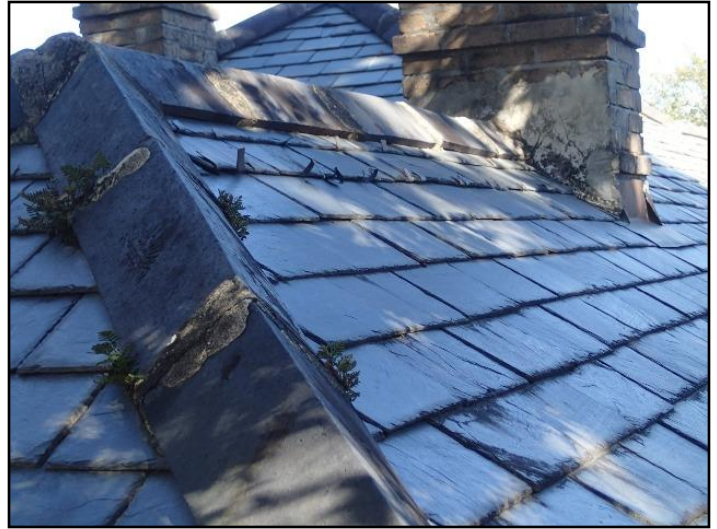
5. Prior repairs and moss/plant growth

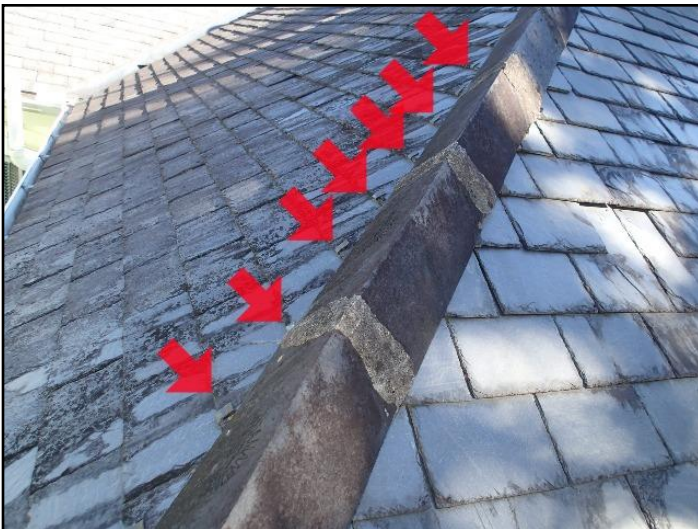
6. Prior repairs

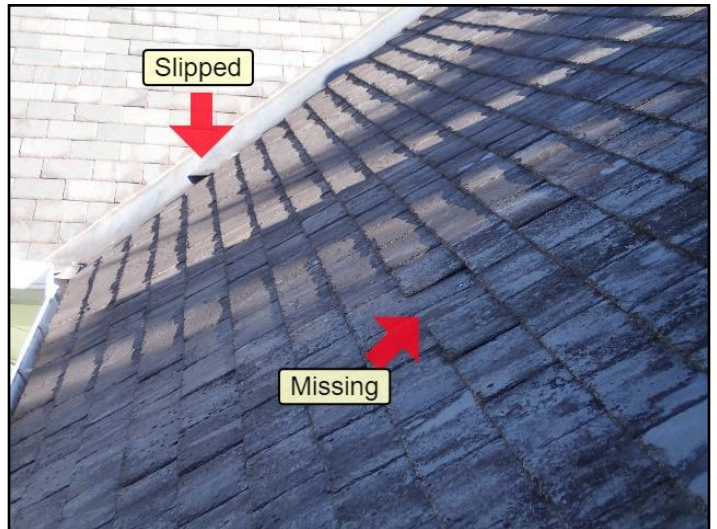
7. Missing tile & slipped tile

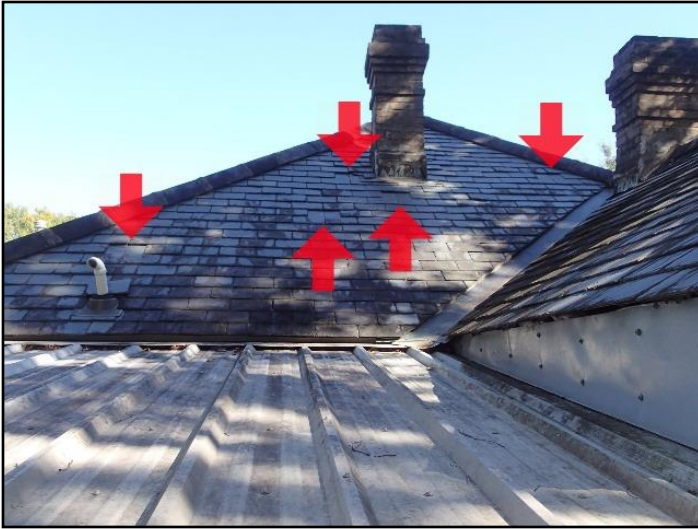
8. Slipped/missing tile

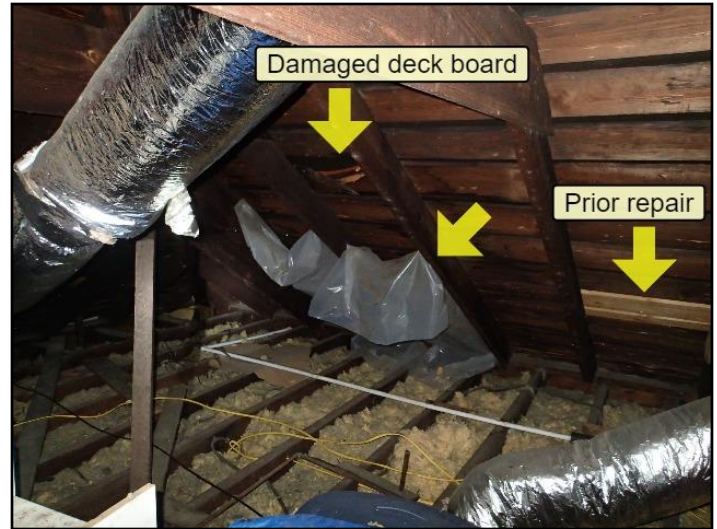
9. Plastic secured to rafters

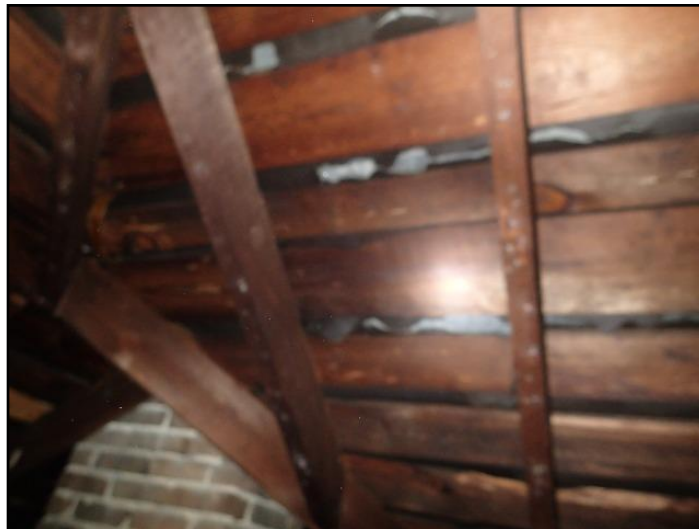
10. Torn / missing underlayment

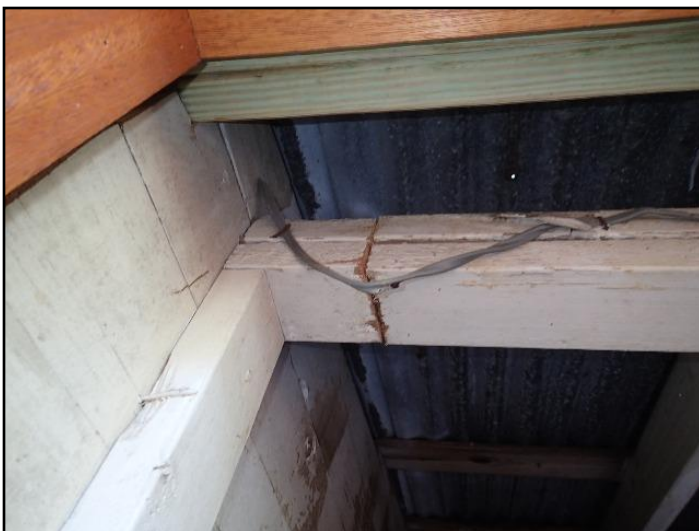
It is my opinion the rear shed had some minor issues. The trees growing behind the shed on the neighbors property is having a negative impact on the shed. The base of the trees and/or roots are cracking the concrete flooring and raising the framing. Cut framing at front above right side door should be repaired. There is a section of the roof on right that has a hole. Items on left side were draped in a tarp indicating the roof may be leaking. Personal items and / or storage prevented access to most areas inside shed. The water and gas lines into the shed should have been wrapped or sleeved to allow separation between pipes and concrete.

14. Cut framing

Task: Repair as needed.

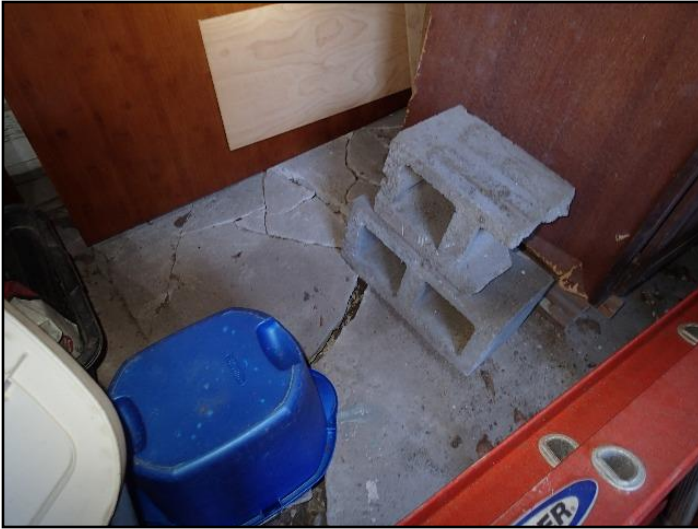
16. Broken concrete/Raised floor

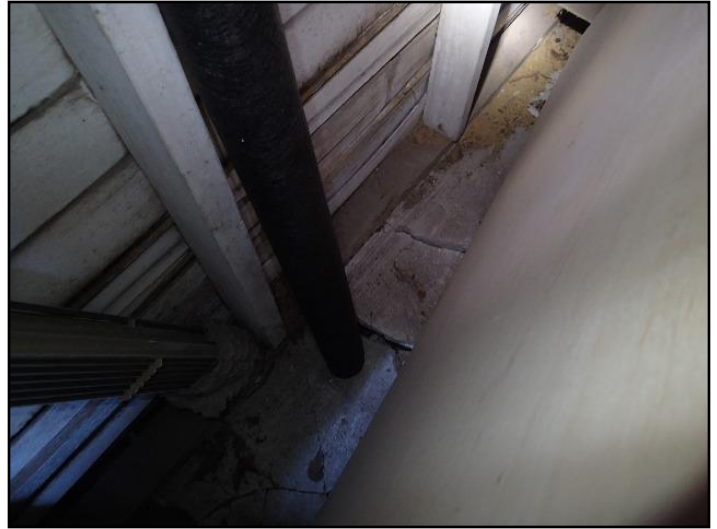
17. Broken concrete/Raised floor

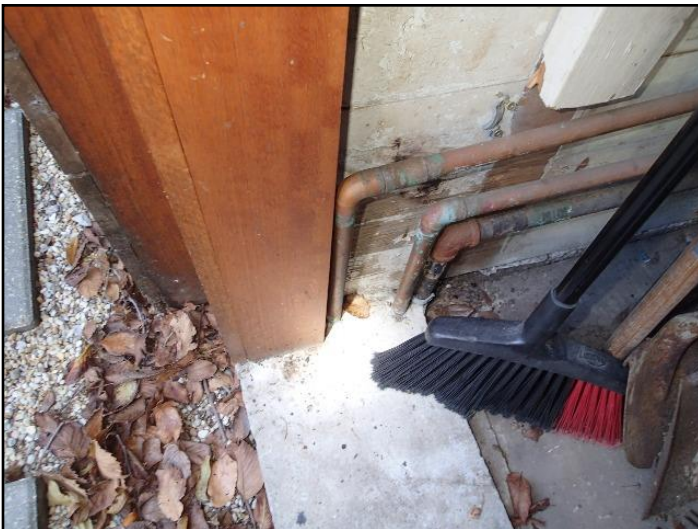
3. Condition: • Exterior shed.

18. Exterior shed.

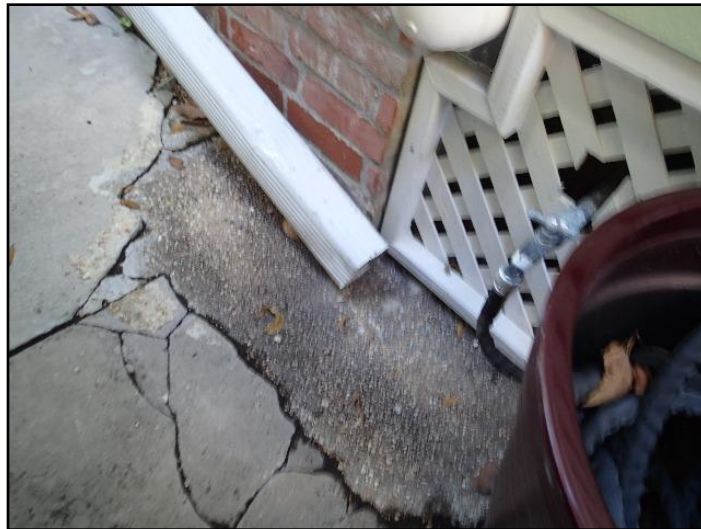
4. **Condition:** • Downspout discharge ends too close to building or foundation.

25. Downspout discharge ends too close to...

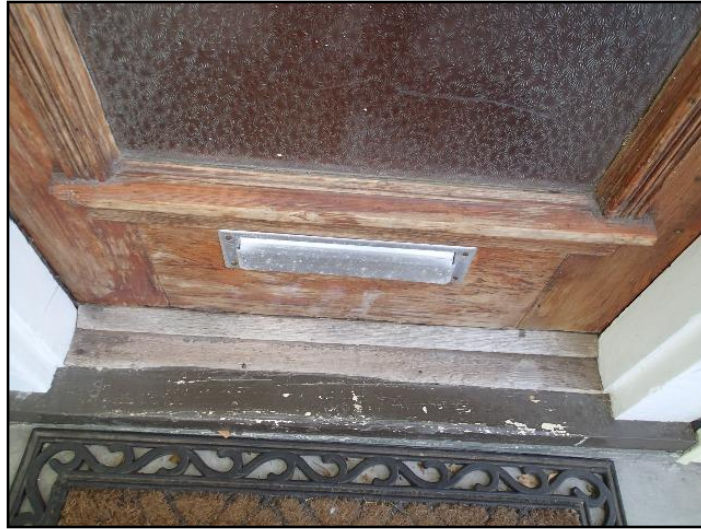
6. Condition: • Paint or stain - needed

Implication(s): Material deterioration

29. Paint or stain - needed

Task: Paint/Stain as needed.

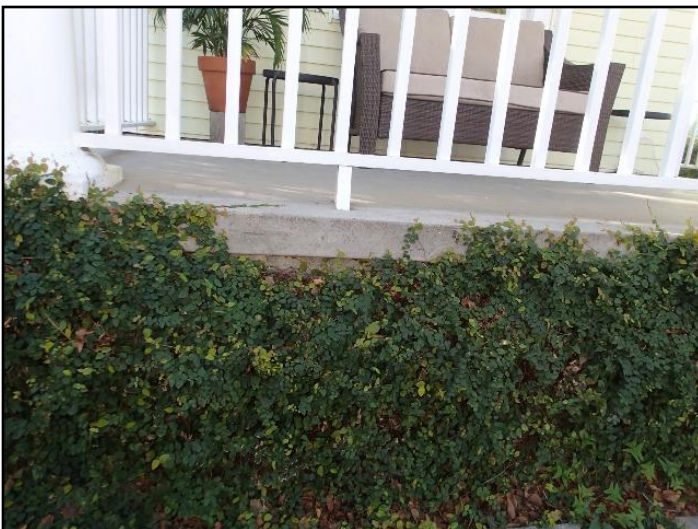
7. Condition: • [Vines](#)

Vines on exterior masonry or wood. While masonry walls are more tolerant of vine damage than wood or siding, vines will facilitate insect and pest entry and moisture damage due to slow drying. Damage to mortar can also occur. Roots create the most serious mechanical damage. Wood trim is especially susceptible to rot caused by vines. Some people are prepared to live with the disadvantage of the plants due to the cosmetic effect, but the removal of vines on any exterior surface is recommended.

Implication(s): Chance of damage to finishes

30. Vines

Task: Remove vines to prevent material deterioration

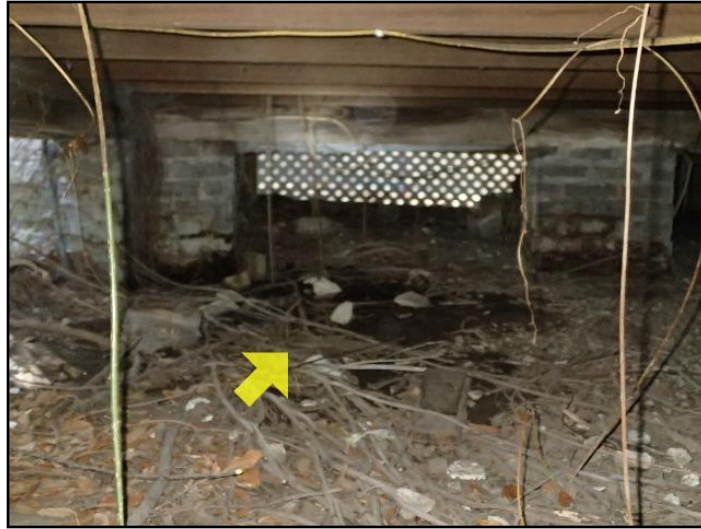
8. Condition: • [Improper slope or drainage](#)

Implication(s): Chance of water damage to structure, finishes and contents

34. Improper slope or drainage

Task: Improve drainage to direct water away from foundation.

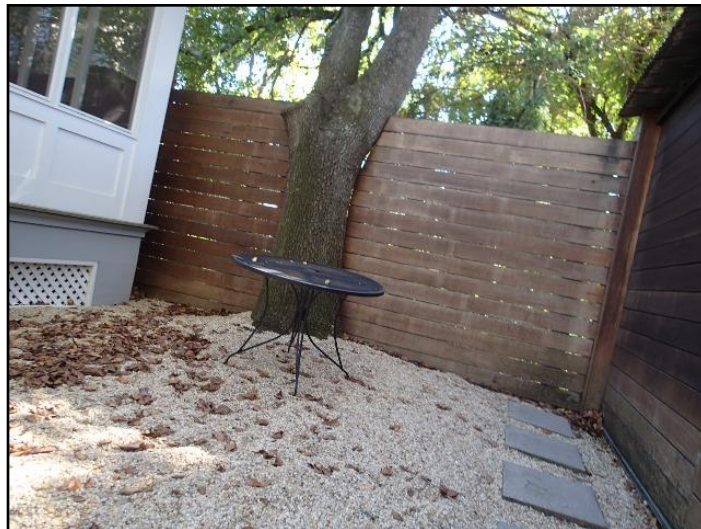
9. Condition: • Lot slopes toward house near tree.

35. Slopes toward house

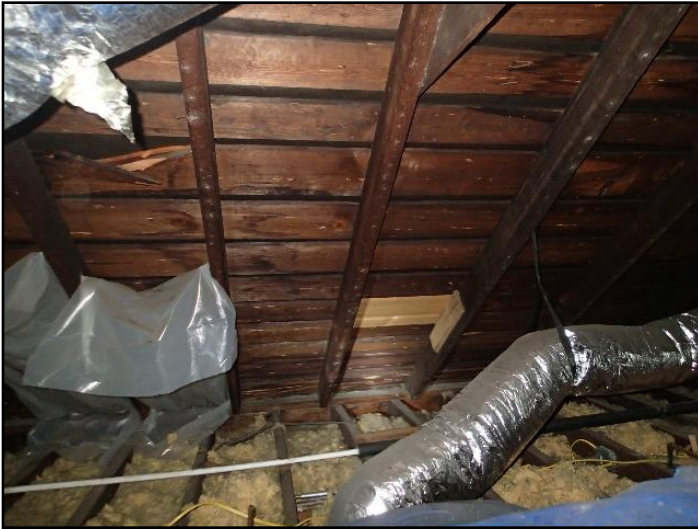
37. Prior repair to roof decking

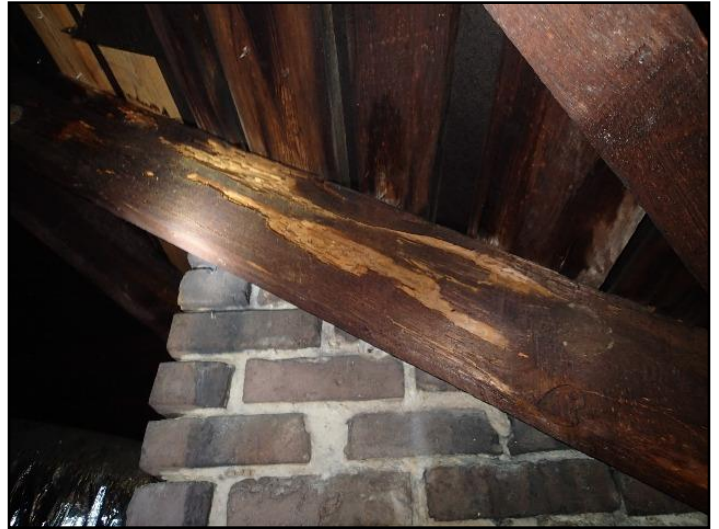
38. Damaged rafter

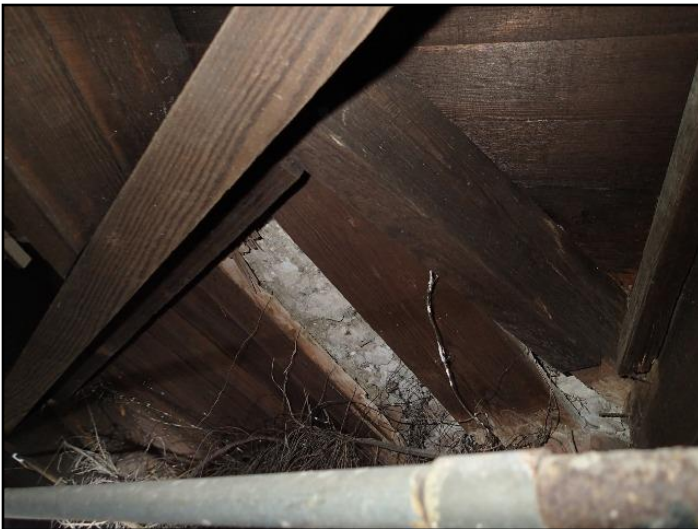
11. Condition: • Prior repairs noted from below in crawl space. Damaged flooring under fireplace hearth in crawl space. Crack in hearth noted from above. Several piers had missing mortar and should be repointed or encapsulated, only one is pictured as an example.

39. Damaged subfloor under fireplace

Task: Further evaluation by a qualified contractor is recommended.

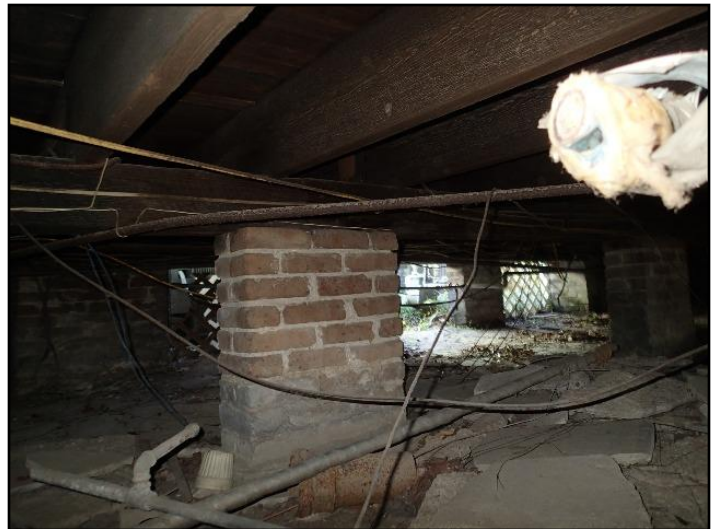
40. Missing mortar on piers.

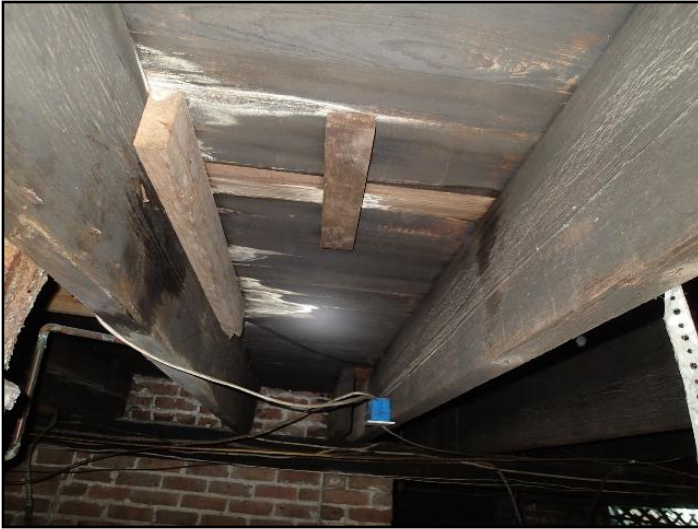
41. Prior repair from below

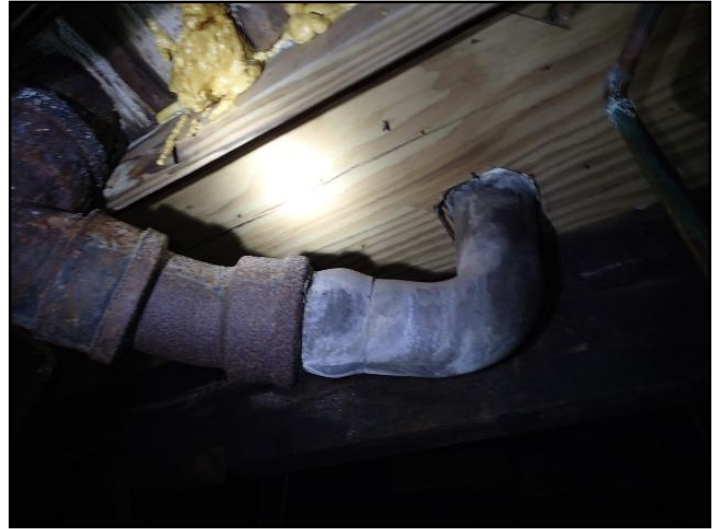
42. Prior repair from below

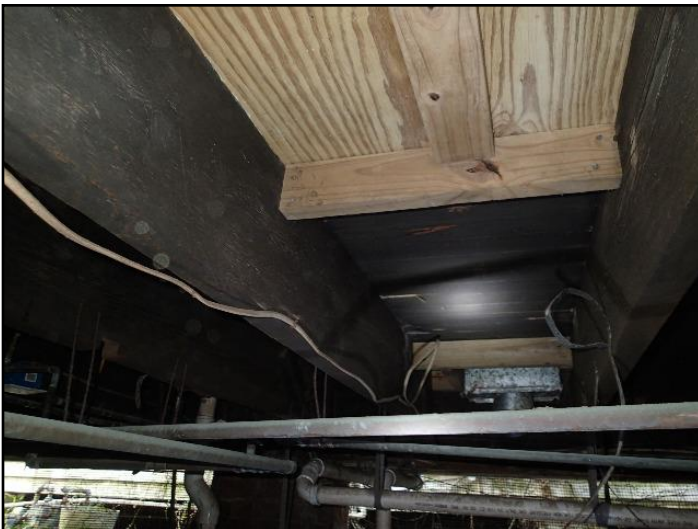
43. Prior repair from below.

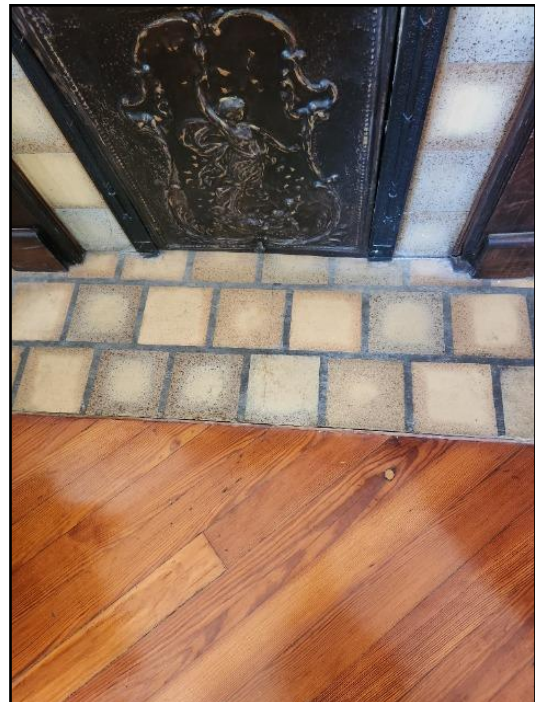
44. Crack in hearth

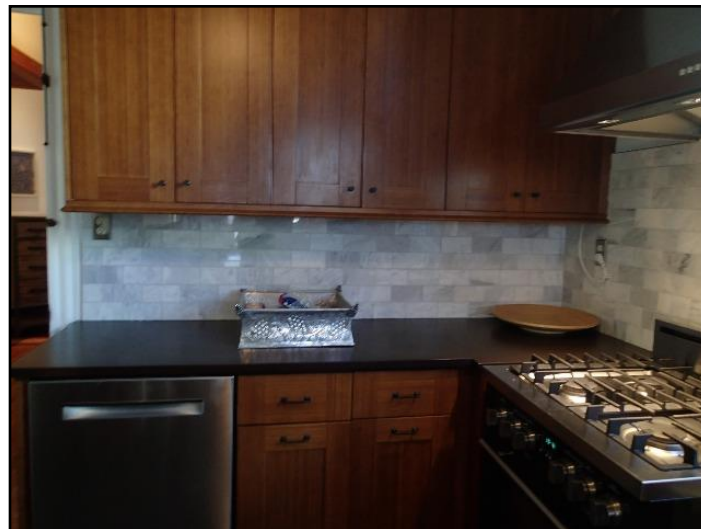
13. Condition: • GFCI/GFI recommended (Ground Fault Circuit Interrupter)

While not required at time of construction, for safety, it is recommended that GFCI protection be installed in ALL kitchen counter, bath, and exterior outlets. (wet areas) GFCI outlets were installed bathrooms only.

Implication(s): Electric shock

47. GFCI/GFI recommended

Location: Kitchen**Task:** Repair / Improvement by a licensed electrician

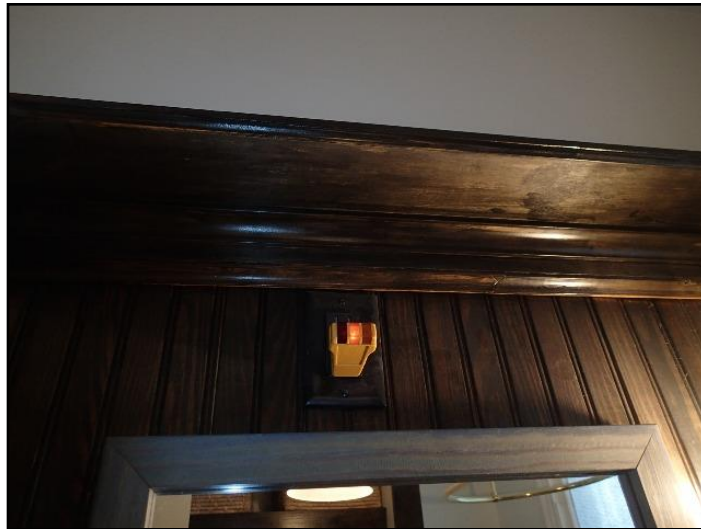
14. Condition: • A ground fault circuit interrupter (GFCI) on an ungrounded circuit will improve the safety of the system. Many electrical authorities will now accept ground fault circuit interrupters as an alternative to grounding in existing homes. GFCIs can be installed at the panel or as GFCI receptacles. If ungrounded GFCI outlets are installed they shall be marked "No Equipment Ground". While GFCI outlet may protect a life, it may not protect appliances or electronics. Some authorities may not accept ungrounded GFCI receptacles. Check your local jurisdiction for requirements.

48. Ungrounded GFCI outlet

Task: Improve

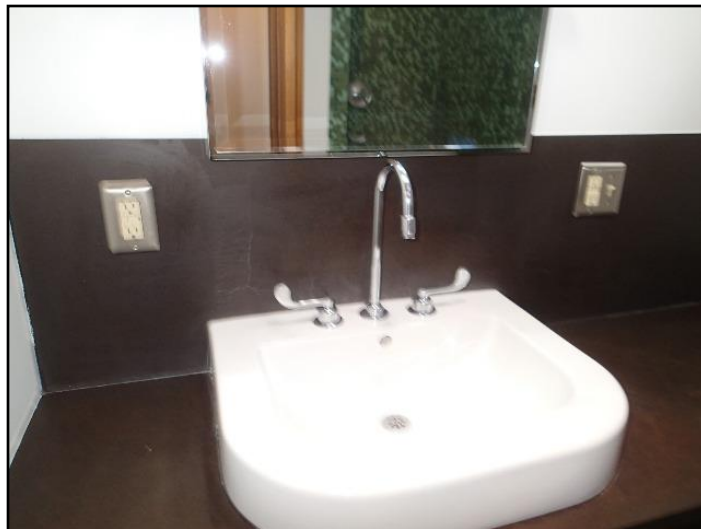
15. Condition: • GFCI outlet on same circuit downstream of GFCI outlet. When GFCI outlet is downstream of another GFCI outlet it trips both. In order to reset the outlet, the one upstream has to be reset first before the one downstream can be reset. This type of installation is inconvenient.

49. GFCI outlet on same circuit downstream of...

Task: Repair by a licensed electrician

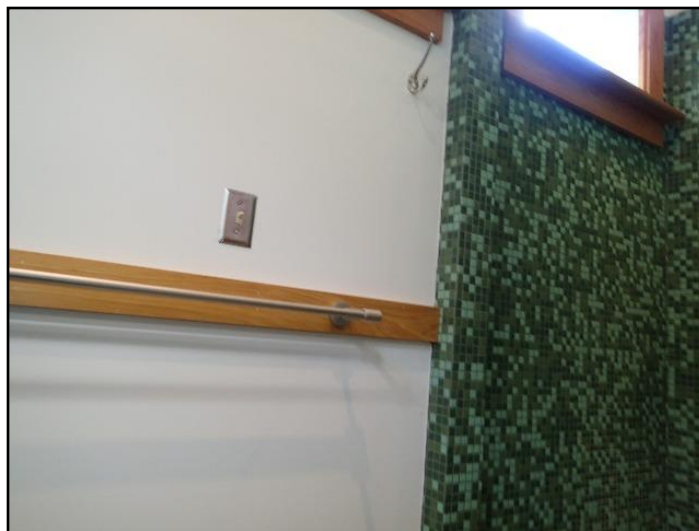
16. Condition: • [Location poor \(near Bathtub or Shower Stall\)](#)

50. Location poor (near Shower Stall)

Task: Repair by a licensed electrician

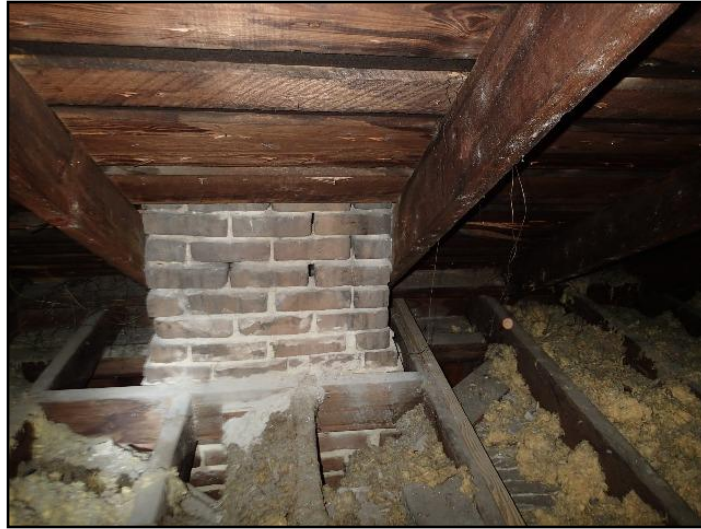
23. Condition: • [Loose, missing or deteriorated masonry](#)

Missing mortar on chimneys. Only one is pictured as an example.

Implication(s): Material deterioration

56. *Missing or deteriorated masonry*

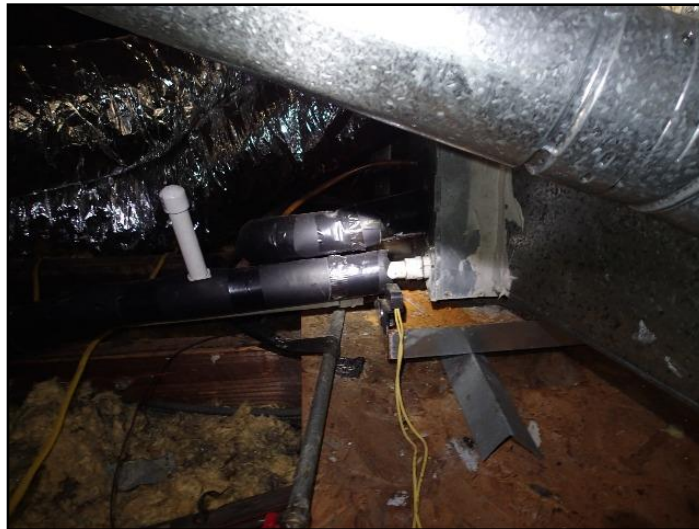
26. Condition: • Float switch in pan. The condensate pan has a float switch which turns off the cooling system if the pan fills with water. This may prevent ceiling damage from overflow if the drain line gets clogged. If the cooling system does not come on, check this first. Ask your HVAC technician about this. The float switch was not checked to determine if functioning or fastened properly, this is beyond the scope of a home inspection.

59. Float switch in pan.

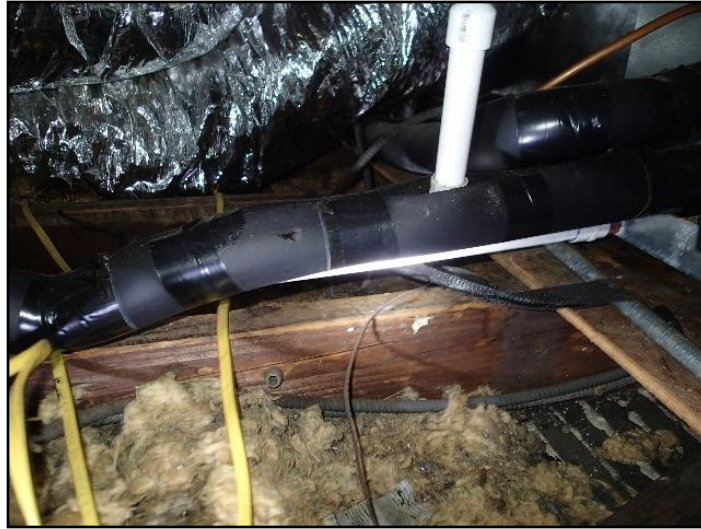
27. Condition: • The condensate drain line has no float switch which turns off the cooling system if the line clogs and fills with water. This may prevent damage from overflow of the drain line. Ask your HVAC technician about this.

60. The condensate drain line has no float switch

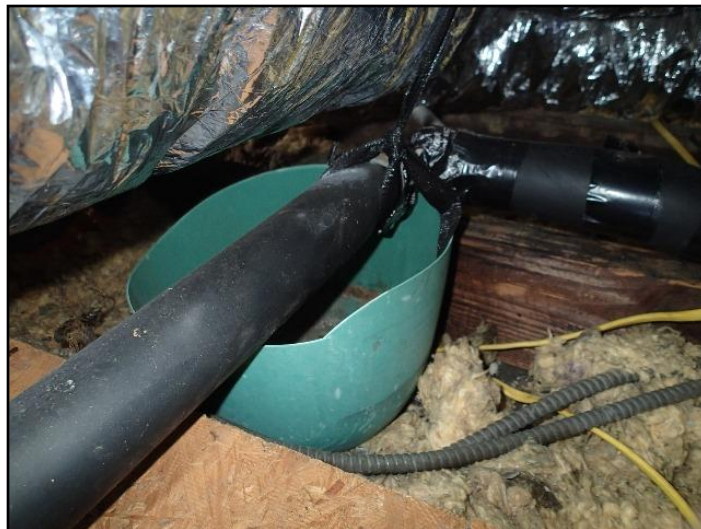
28. Condition: • [Leak](#)

Possible leak at joint in condensate drain line noted in attic. A container was located below likely to catch moisture. Staining on joist below condensate drain line noted.

Implication(s): Chance of water damage to structure, finishes and contents | Damage to equipment

61. Possible leak

Task: Check/Correct when servicing.

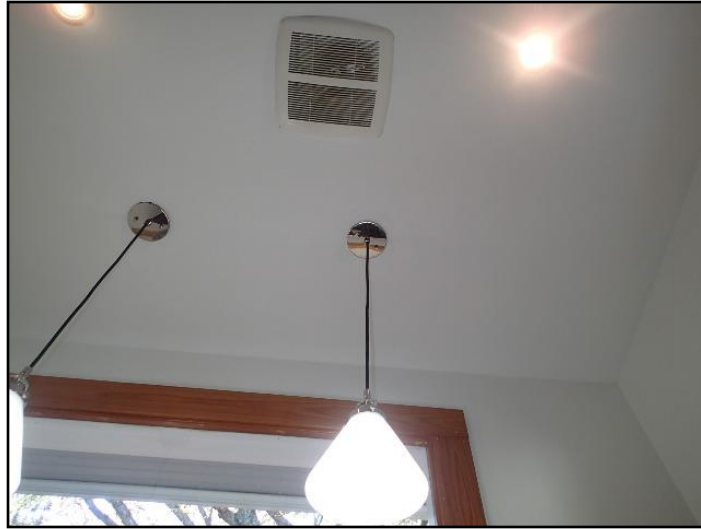
29. Condition: • [Missing](#)

No AC register noted in primary bathroom. Lack of air exchange can lead to mold and/or mildew issues.

62. Missing AC register

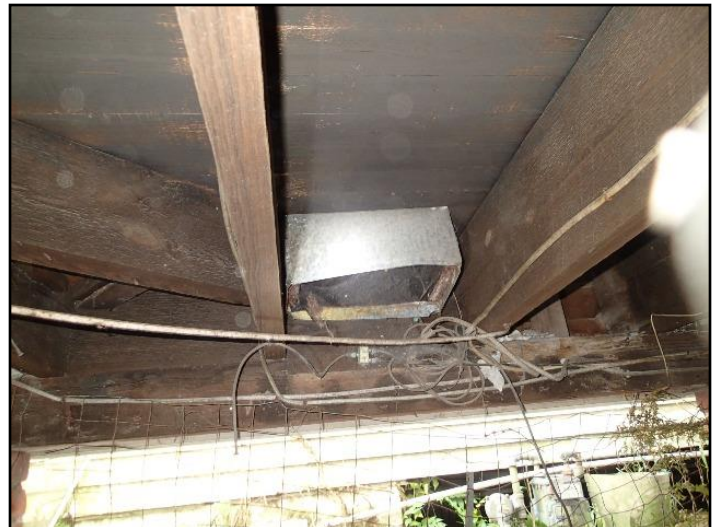
31. Condition: • Abandoned

64. Abandoned register

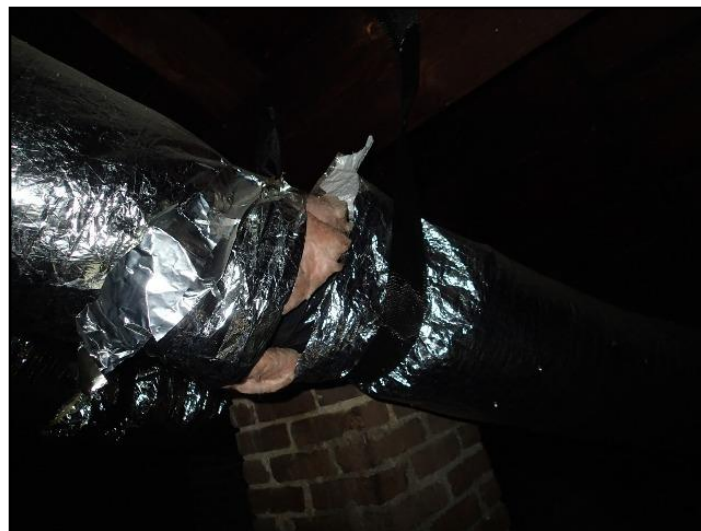
32. Condition: • [Incomplete](#)

Missing insulation and/or tears in insulation on ducts in attic. This can reduce efficiency and cause condensation. Insulation should completely cover duct from air handler to register.

Implication(s): Chance of condensation damage to finishes and/or structure | Increased heating and cooling costs | Reduced comfort

65. Incomplete

Task: Repair

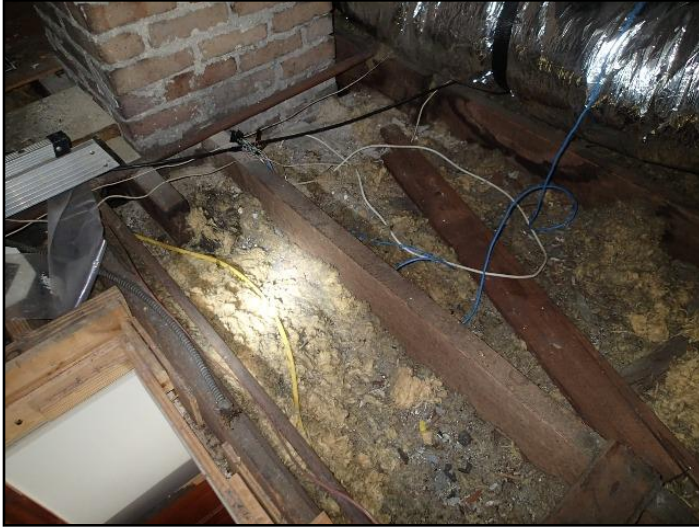
33. Condition: • [Gaps or voids](#)

Isolated sections of insulation was missing leaving gaps or voids. Only two photos are included as examples. All gaps or voids may not be pictured.

Implication(s): Increased heating and cooling costs | Reduced comfort

69. *Gaps or voids*

Task: Replace insulation where needed.

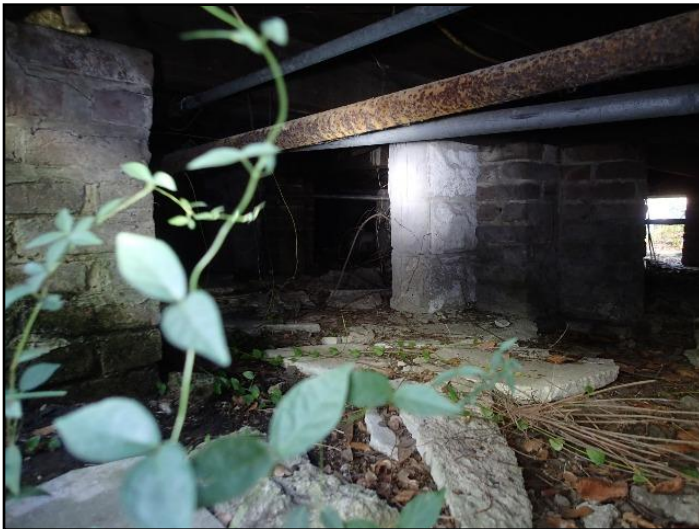
35. Condition: • [Rust](#)

Rust noted on gas lines in crawl space. This should be checked and monitored for leaks prior to purchase.

Implication(s): Material deterioration | Fire hazard

75. Rust

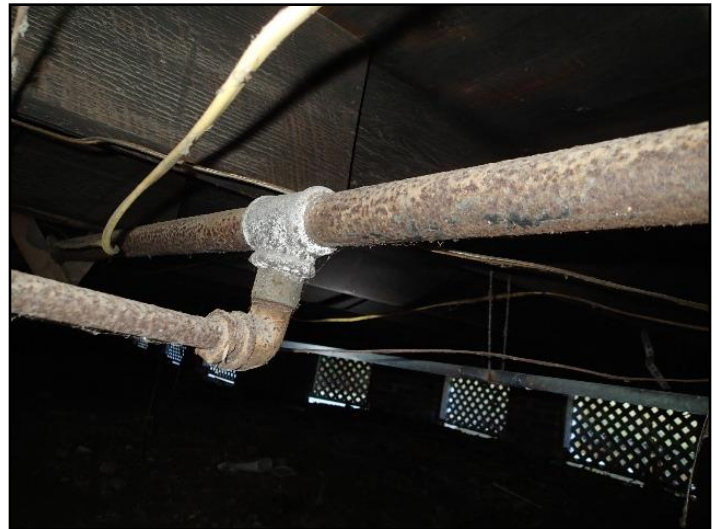
76. Rust

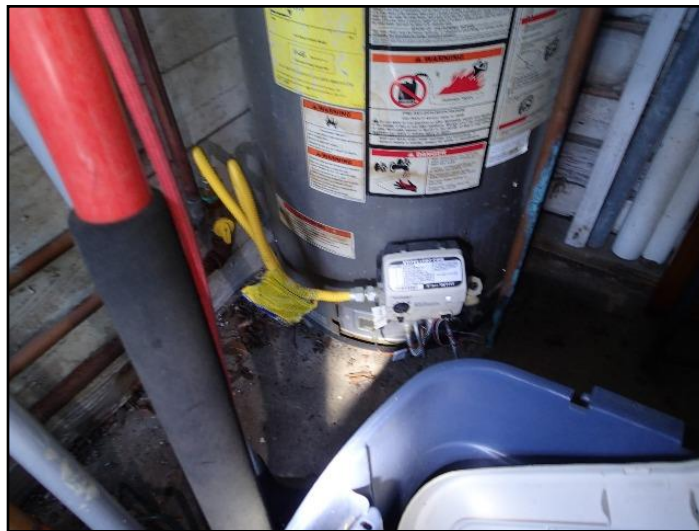
36. Condition: • [Missing](#)

Implication(s): Fire or explosion

77. Missing

Task: Replace cover

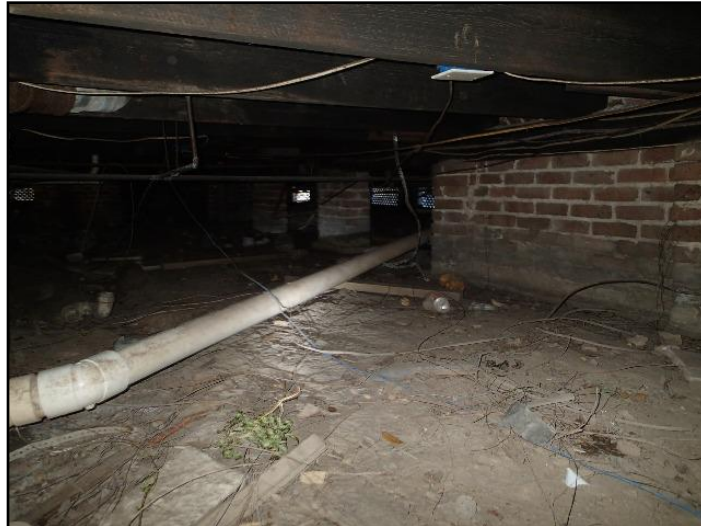
37. Condition: • [Poor support](#)

Implication(s): Chance of water damage to structure, finishes and contents | Sewage entering the building

78. Poor support

Task: Repair by a licensed plumber

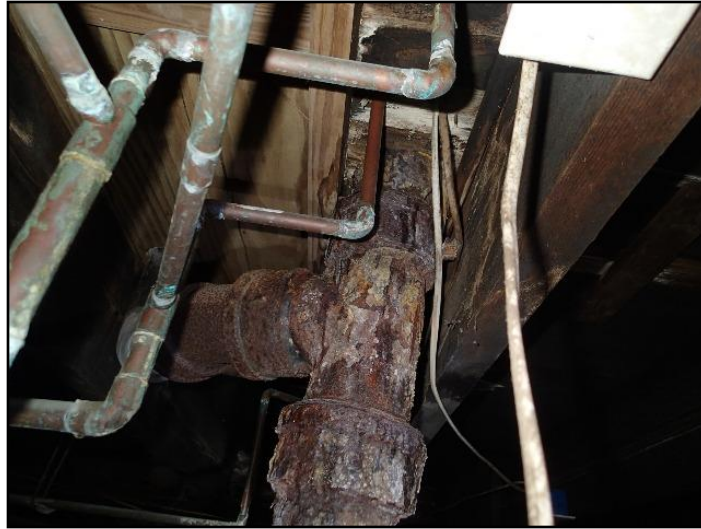
38. Condition: • [Rust](#)

Older cast iron waste line in crawl space was rusted and flaking.

79. Rust

Task: Replacement recommended.

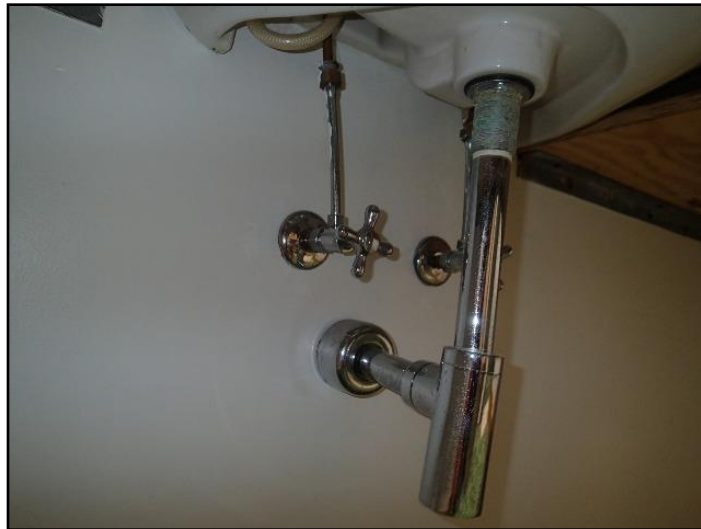
39. Condition: • Bottle trap. Drain pipes should be passable with a snake or mechanical device. Bottle traps have an internal partition which can fail allowing sewer gases into the home. Some municipalities do not accept or allow bottle traps. Check with your local jurisdiction to determine if this type of trap is allowed.

Implication(s): Sewer gasses entering home.

80. Bottle trap. Primary bathroom

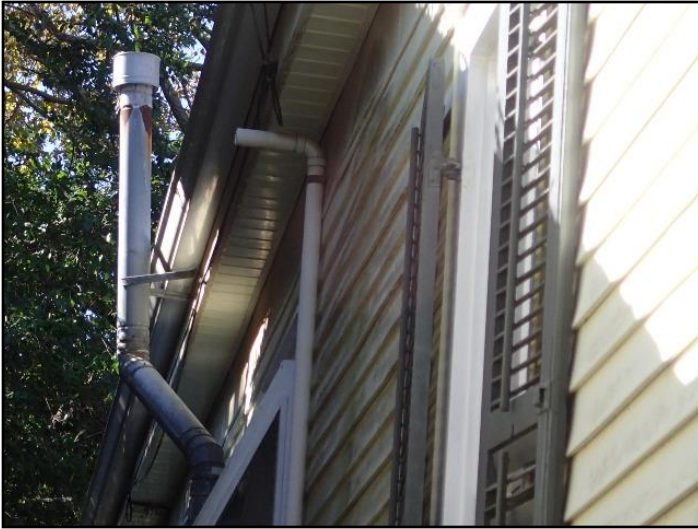
40. Condition: • [Vent termination problems](#)

Implication(s): Reduced operability | Sewer gases entering the building

81. Does not extend above roof line

Task: Repair by a licensed plumber

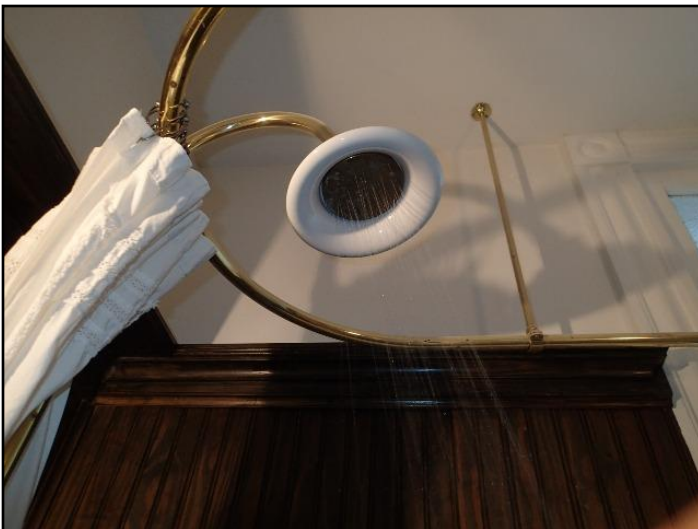
41. Condition: • [Shower diverter inoperative or defective](#)

Implication(s): Equipment failure

83. Shower diverter inoperative or defective

Task: Repair by a licensed plumber

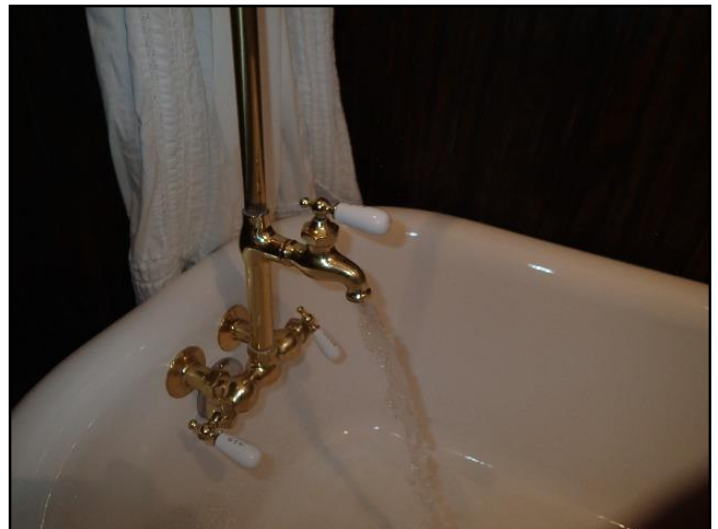
84. Shower diverter inoperative or defective

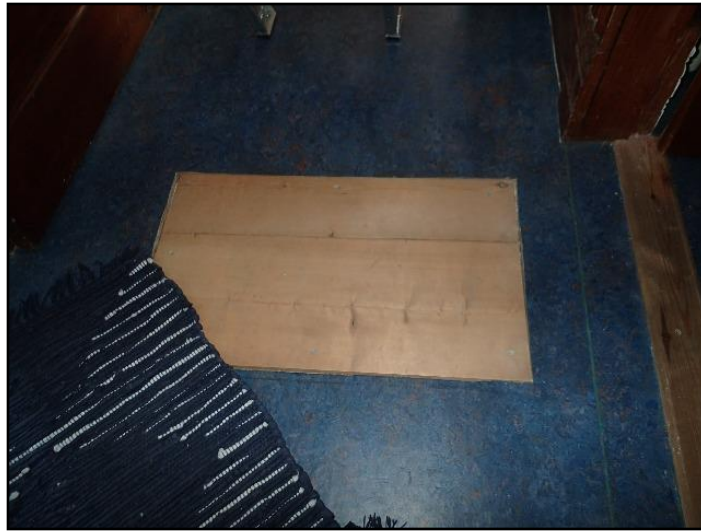
42. Condition: • Missing flooring in hall.

86. Missing floor covering.

Task: Install missing flooring.

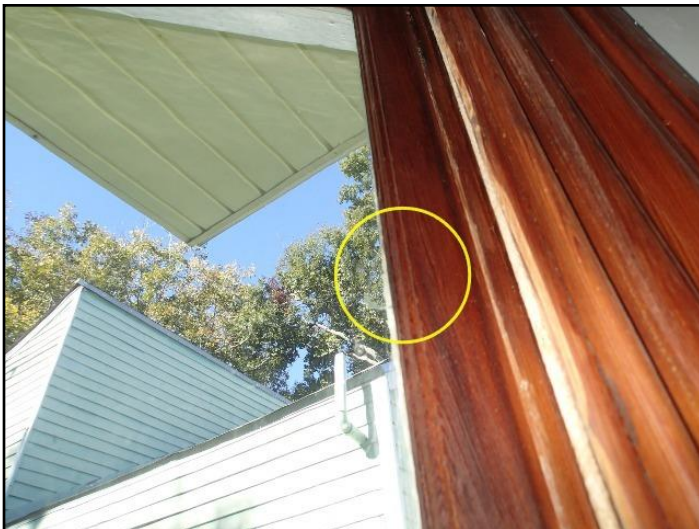
43. Condition: • [Cracked](#)

A cracked window pane noted. The photo is an example of the broken glass found.

Implication(s): Physical injury

87. Cracked

Task: Replace broken glass where needed.

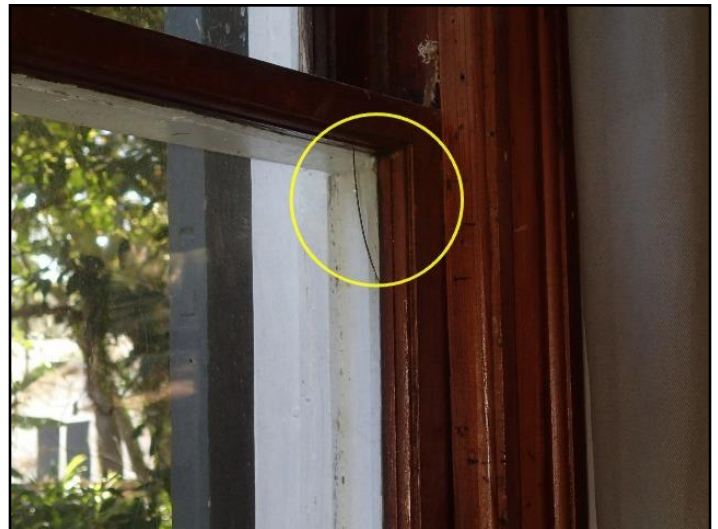
88. Cracked

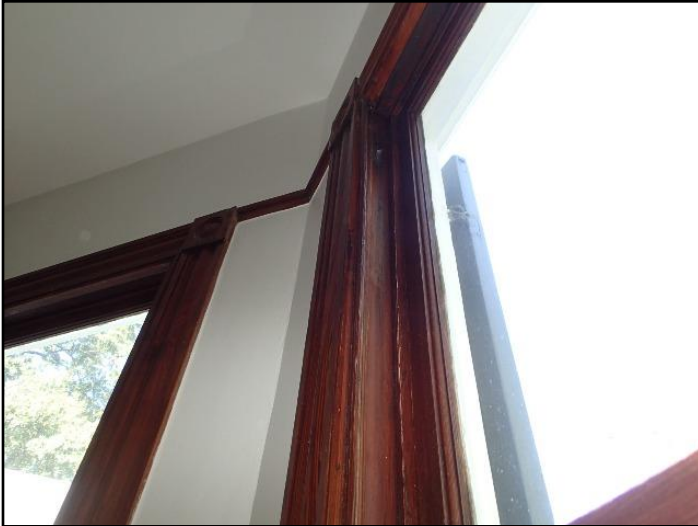
44. Condition: • Broken / Missing sash cord/spring

While some windows had sash cords in place some were missing. Only two are pictured as examples.

Implication(s): Nuisance | Reduced operability

89. Broken / Missing sash cord/spring

Task: Repair or replace sash cords where needed.

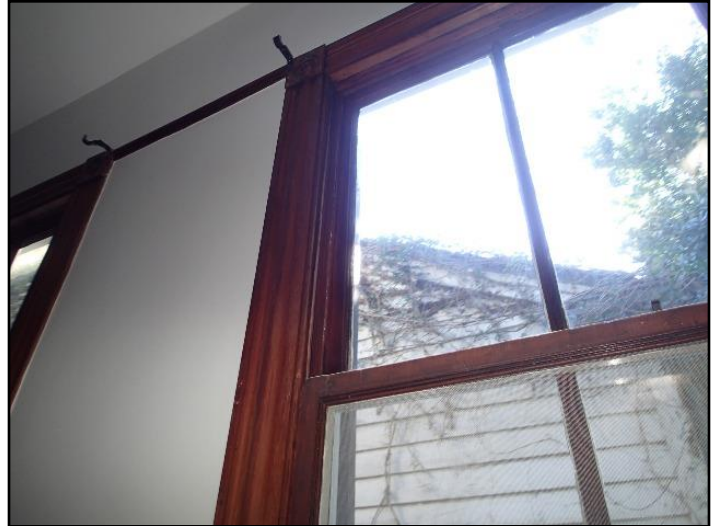
90. Broken / Missing sash cord/spring

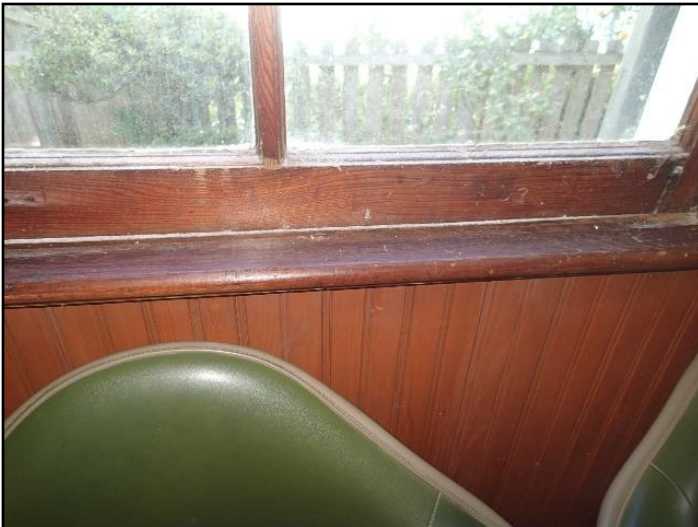
45. Condition: • [Missing](#)

Missing insert on some windows make it difficult to operate.

Implication(s): System inoperative or difficult to operate

91. Insert Missing

Task: Install inserts on bottom of window.

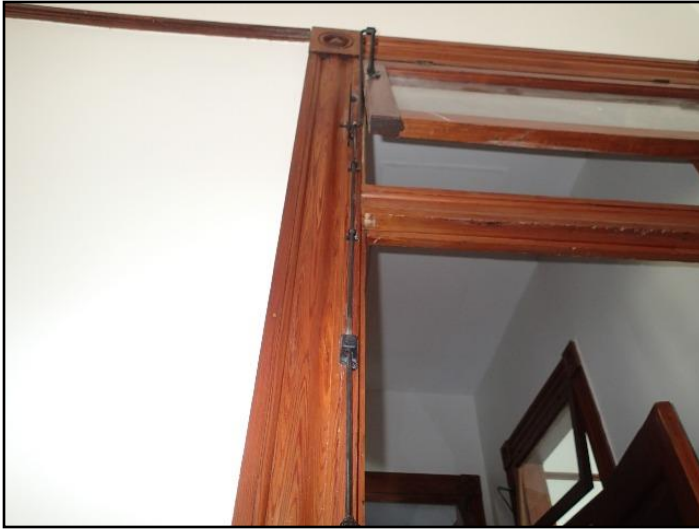
46. Condition: • Transom hardware missing latching piece on bottom to hold window in place. Transom hardware is not adjustable the way it is installed. Transom above front door was screwed in place.

93. Missing latching hardware

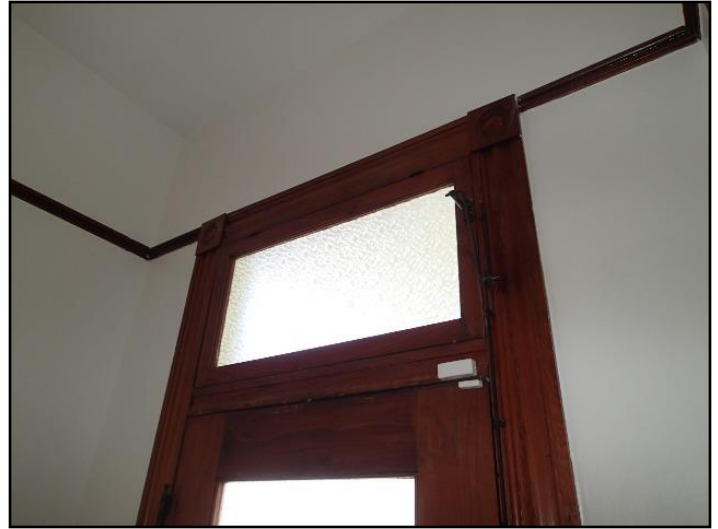
94. Screwed in place
