INSPECTION REPORT

For the Property at:
123 YOUR STREET
NEW ORLEANS, LA 70118

Prepared for: SAMPLE COTTAGE
Inspection Date: Tuesday, November 28, 2023
Prepared by: Turk Schexnayder LHI Lic.10679

RE: Report No. 2572, v.3
123 Your Street
New Orleans, LA
70118

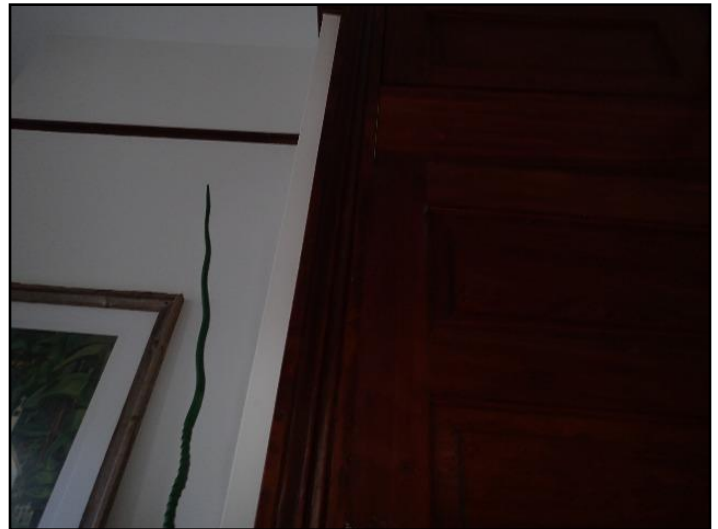
47. Condition: • Stiff / Poor fit / Unable to open or close

96. Stiff / Poor fit / Unable to open or close

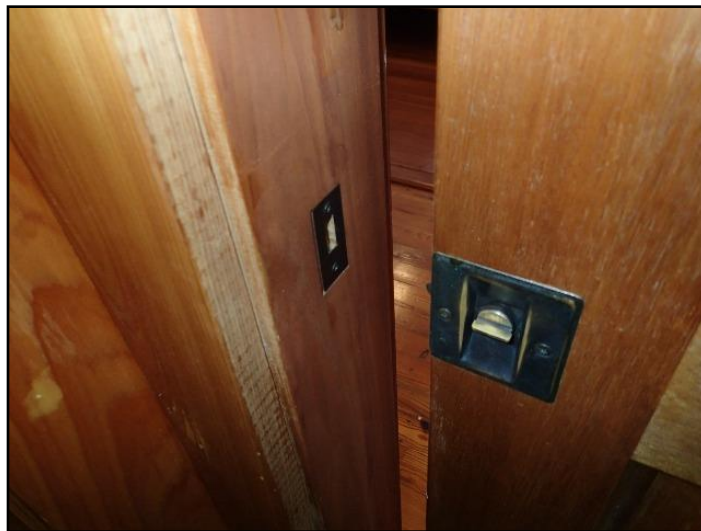
49. Condition: • [Ineffective](#)

98. Ineffective

Task: Repair Adjust

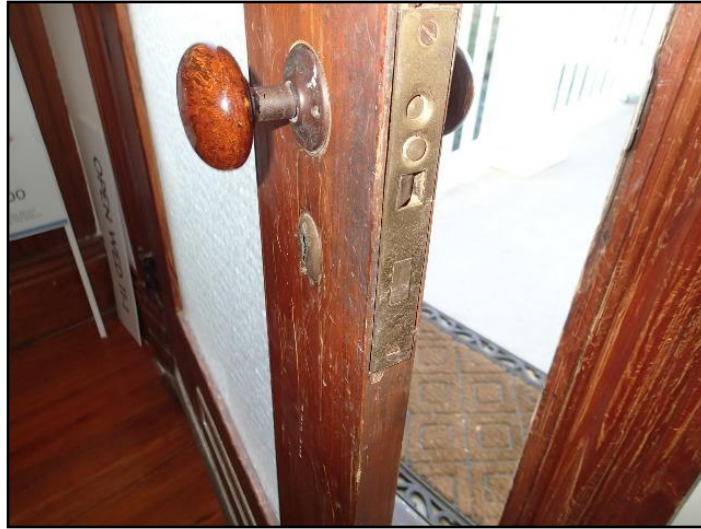
50. Condition: • Latch not effective on exterior door

Implication(s): Poor security

99. Latch not effective on exterior door

Task: Repair or replace

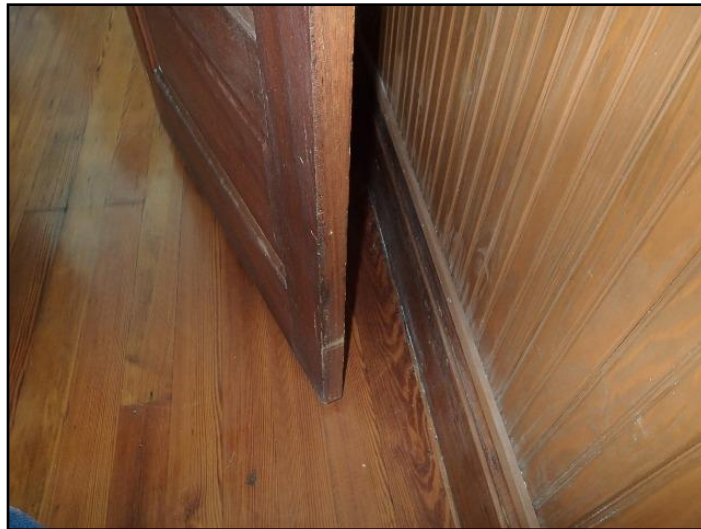
51. Condition: • Door stop missing.

While some doors had door stops, some did not. Installing door stops may prevent wall damage from door hardware.

100. Door stop missing.
