Your Inspection Report

83 Muriel Ave
Toronto, ON M4J 2Y3

INSPECTION DATE:
Monday, June 18, 2018

RE: Report No. 62955
83 Muriel Ave
Toronto, ON
M4J 2Y3

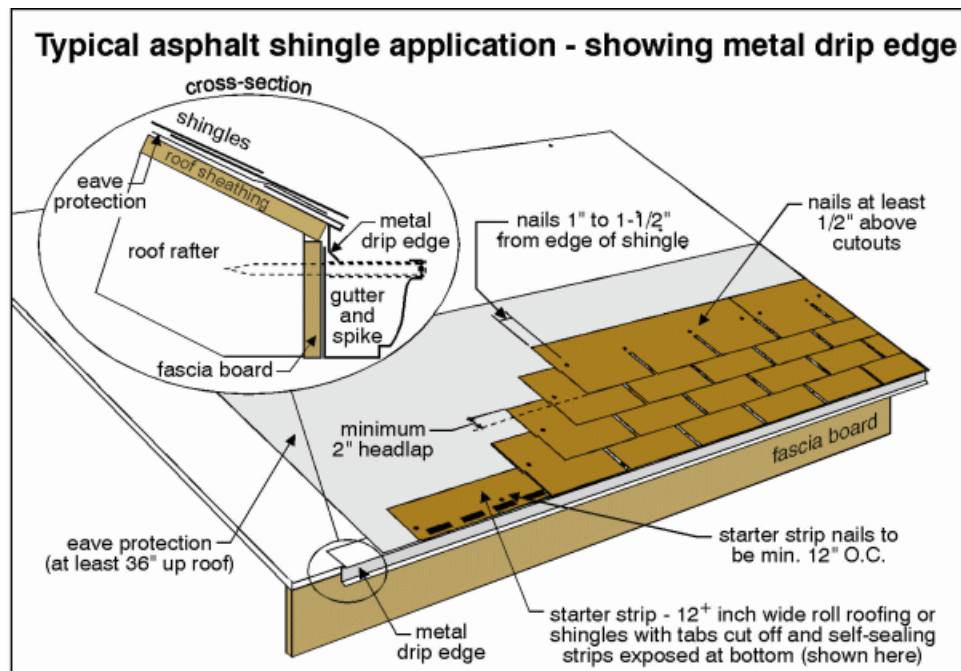
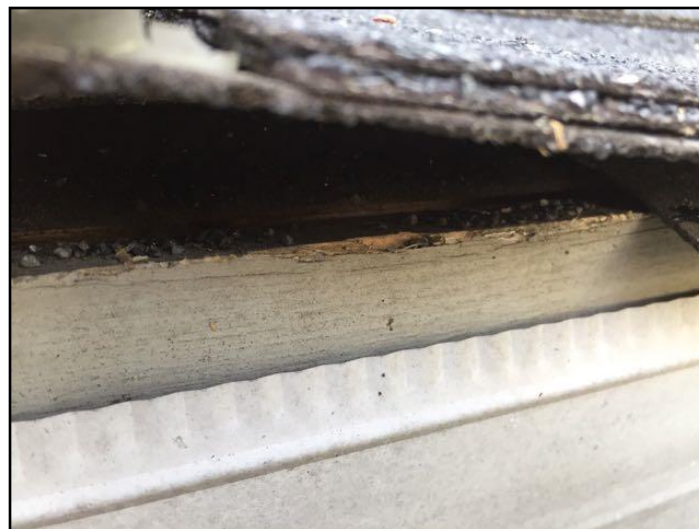
Condition: • [Missing](#)

Implication(s): Chance of water damage to contents, finishes and/or structure

Missing drip edge

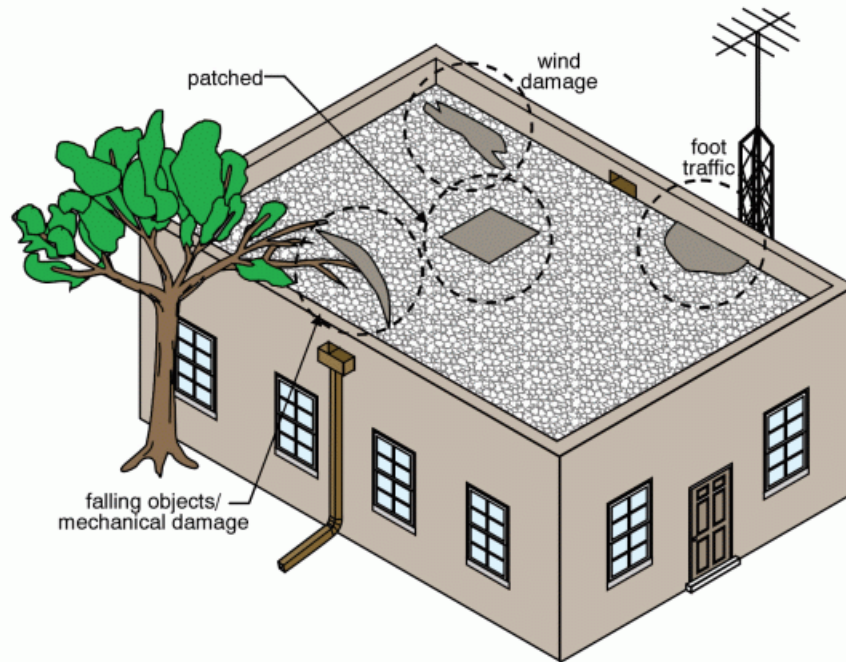
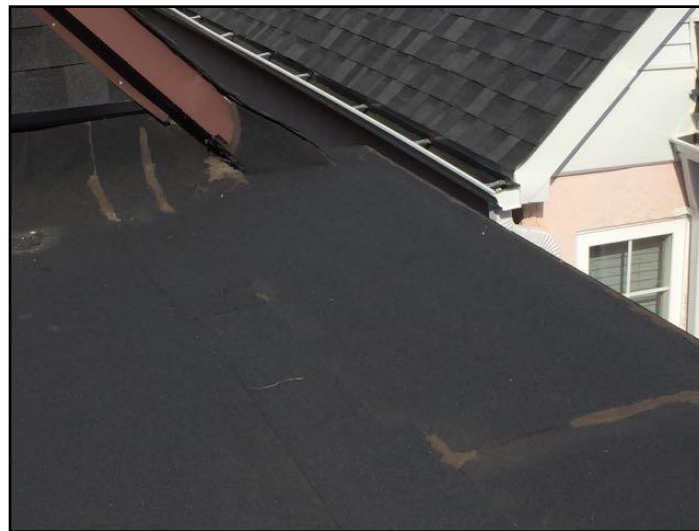
Condition: • [Patched](#)

Implication(s): Chance of water damage to contents, finishes and/or structure

Damaged and patched flat roofs

Patched

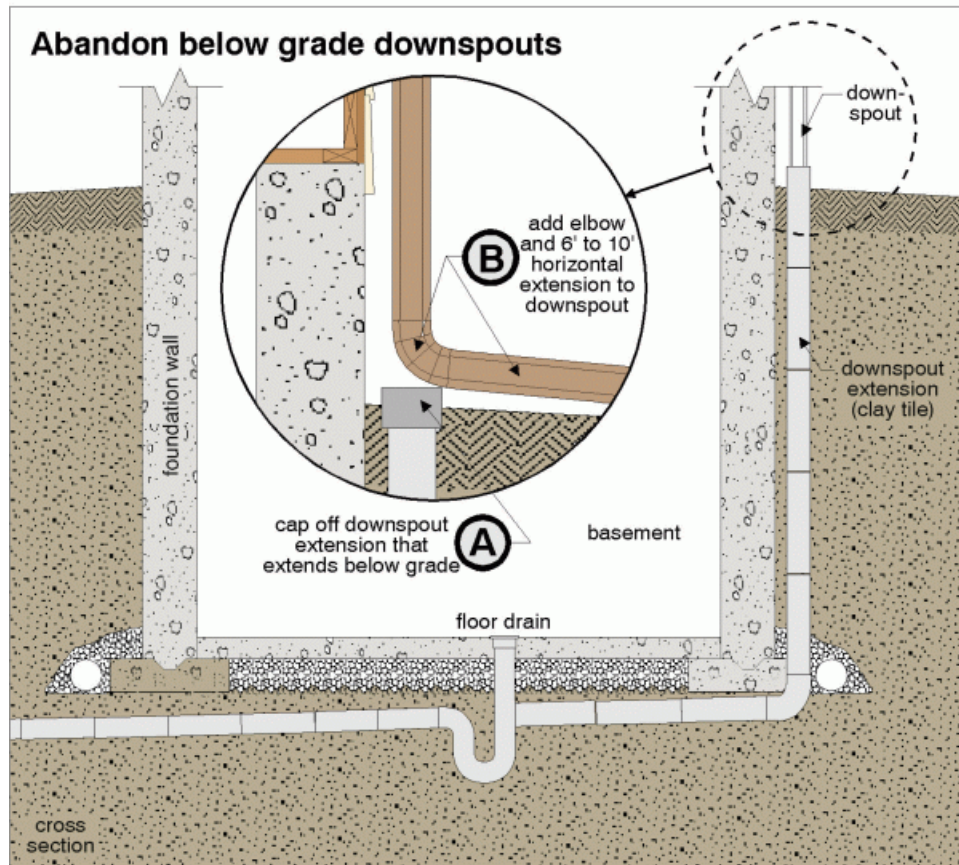
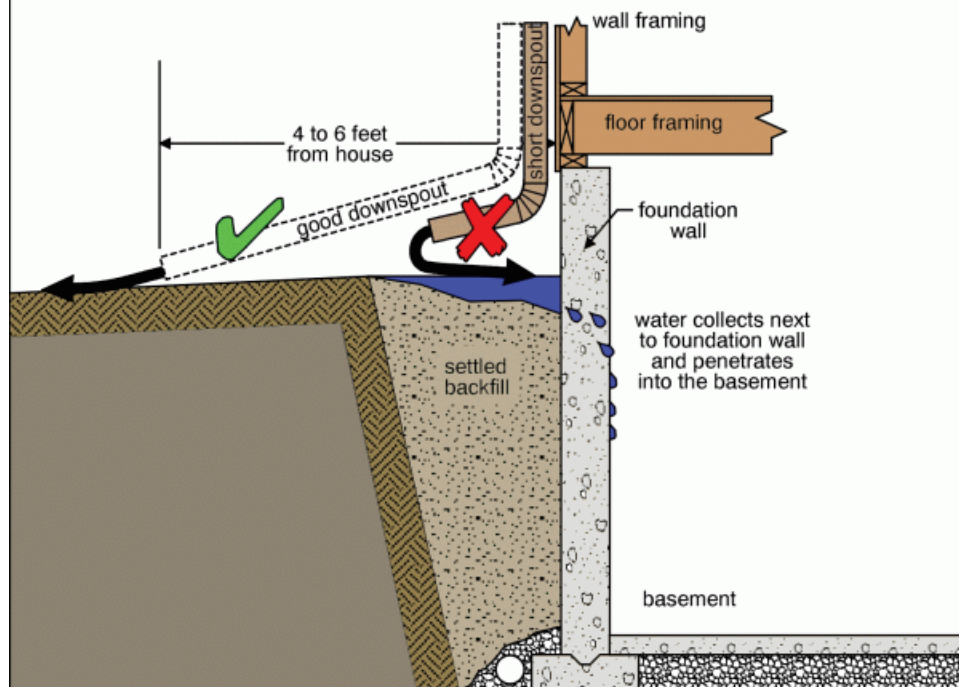
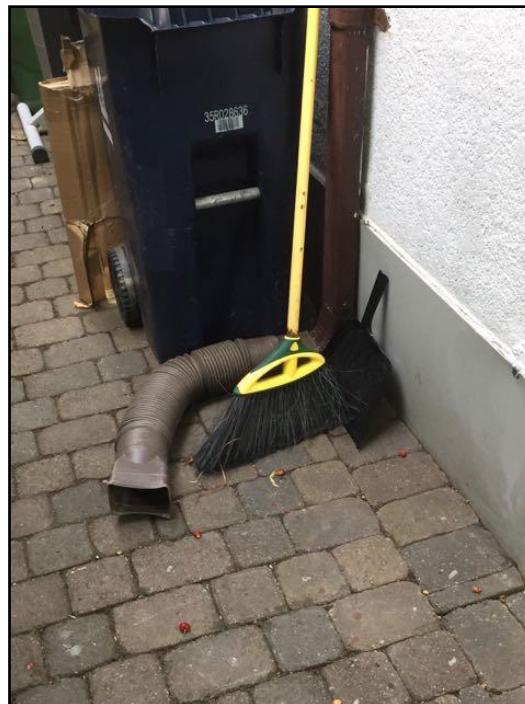
Condition: • [Should discharge 6 feet from building](#)

Implication(s): Chance of water damage to contents, finishes and/or structure

Downspout extension too short

Should discharge 6 feet from building

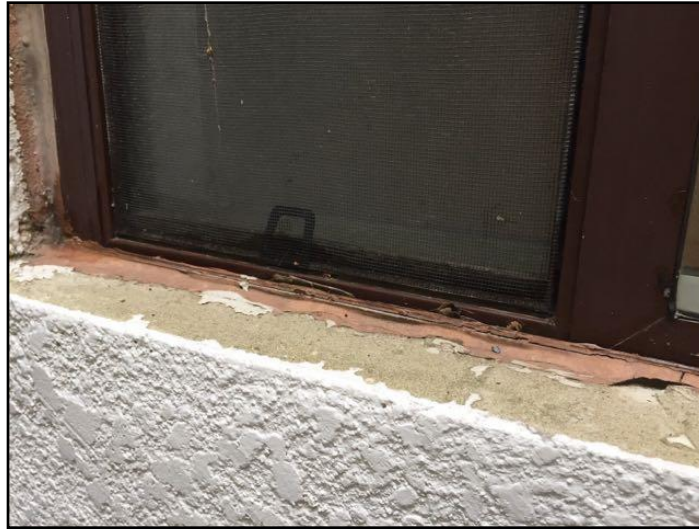
Condition: • [Caulking missing, loose or deteriorated](#)

Caulking deteriorated

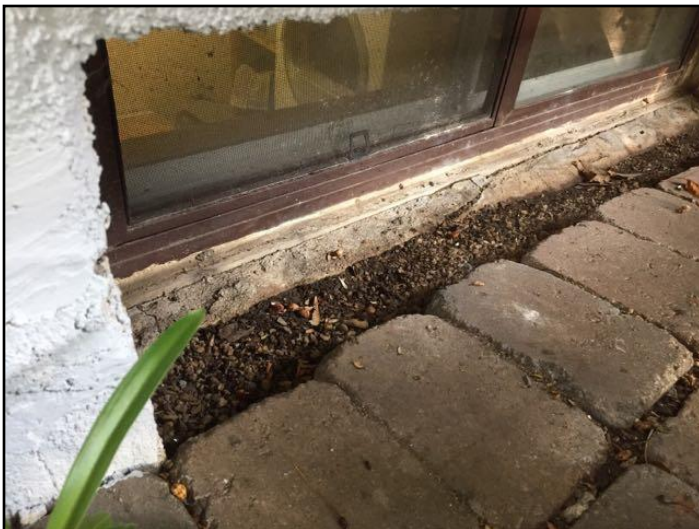
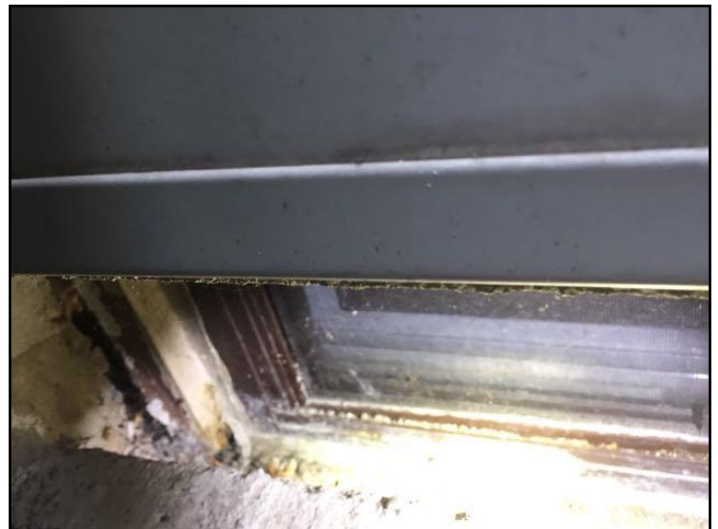
Condition: • Window close to grade in well.
Increase threshold height by lowering well depth.

Window close to grade in well. Increase...

Window close to grade in well

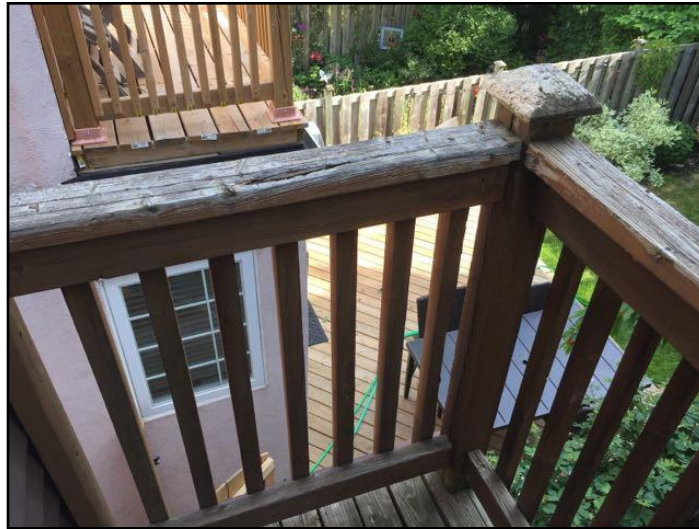
Condition: • [Weak](#)

Implication(s): Fall hazard

Weak railing

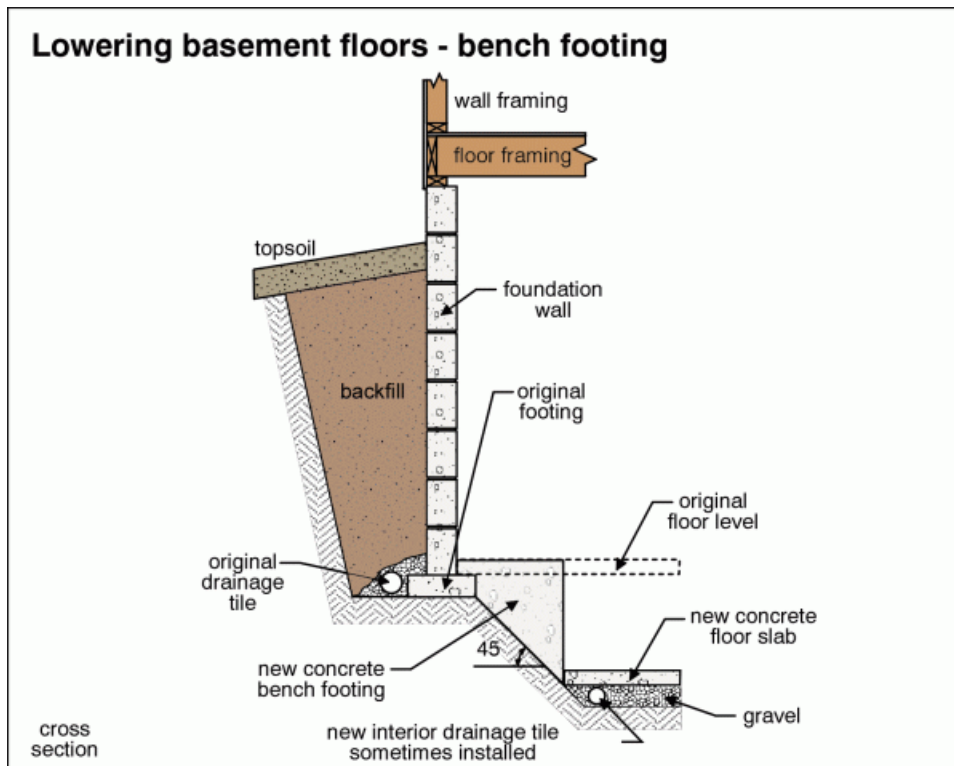
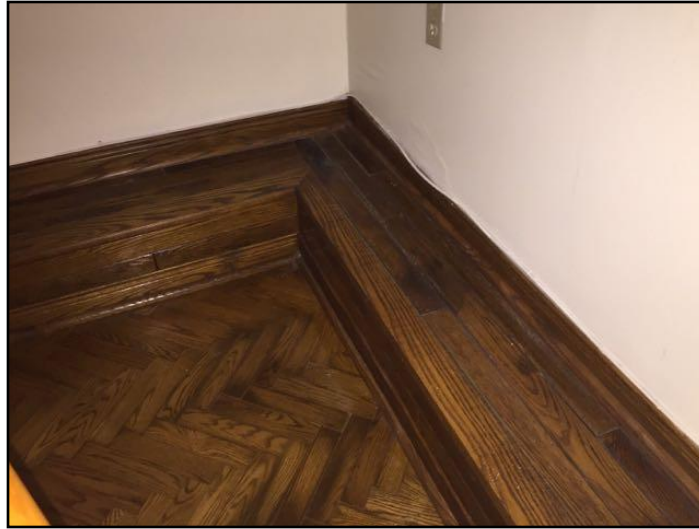
Condition: • [Basement lowered](#)

Implication(s): Chance of structural movement

Basement lowered

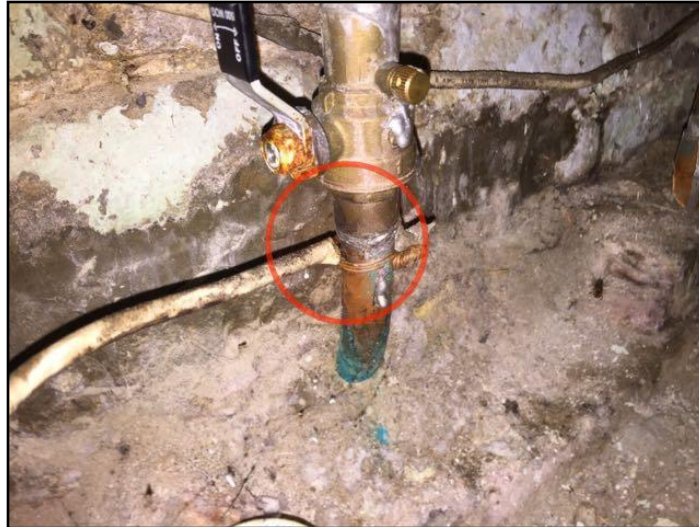
Condition: • [Poor connections](#)

Poor connections/clamp missing

Task: Provide clamp

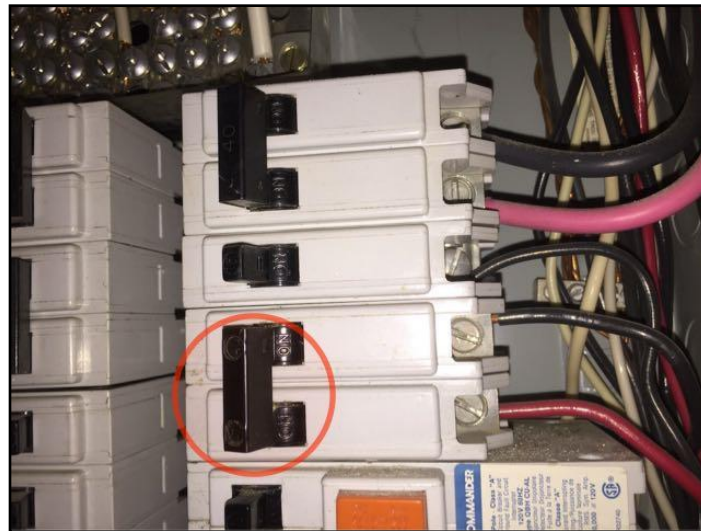
Condition: • [Fuses or breakers too big](#)

Implication(s): Fire hazard | Equipment overheating

breaker too big

Task: Correct

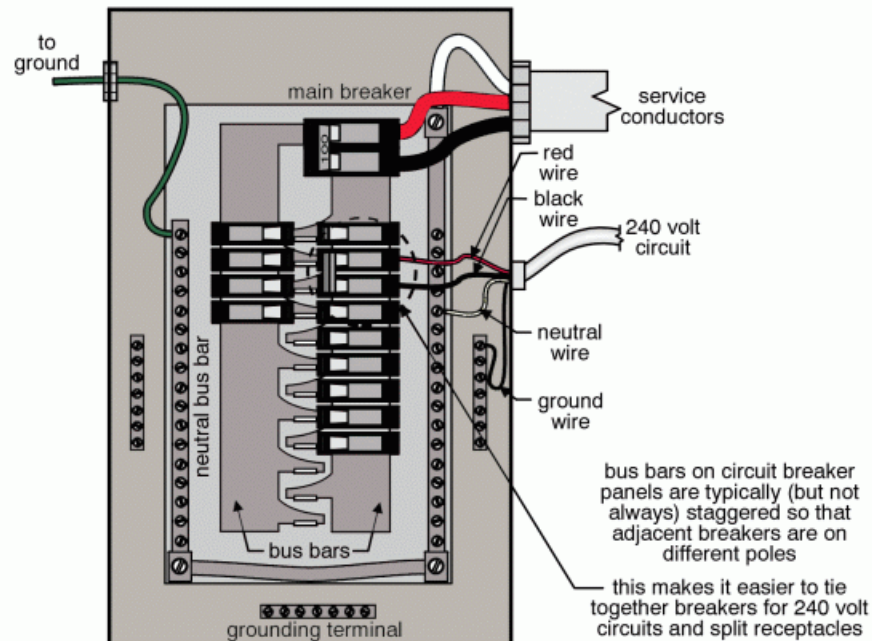
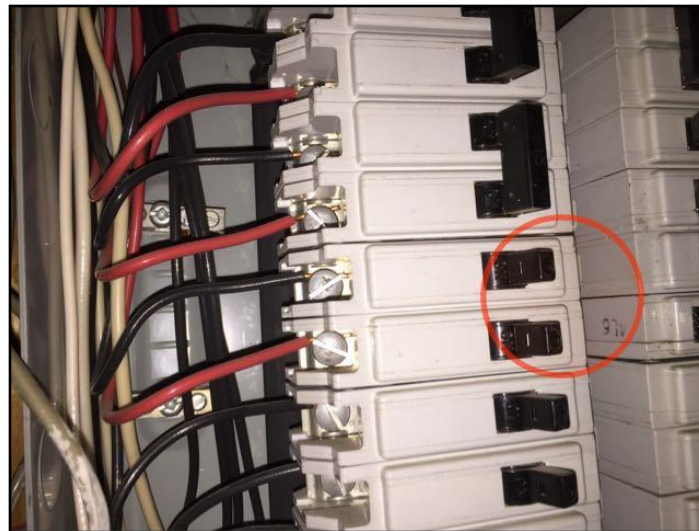
Condition: • [No links for multi-wire circuits](#)

No links for multi-wire circuits

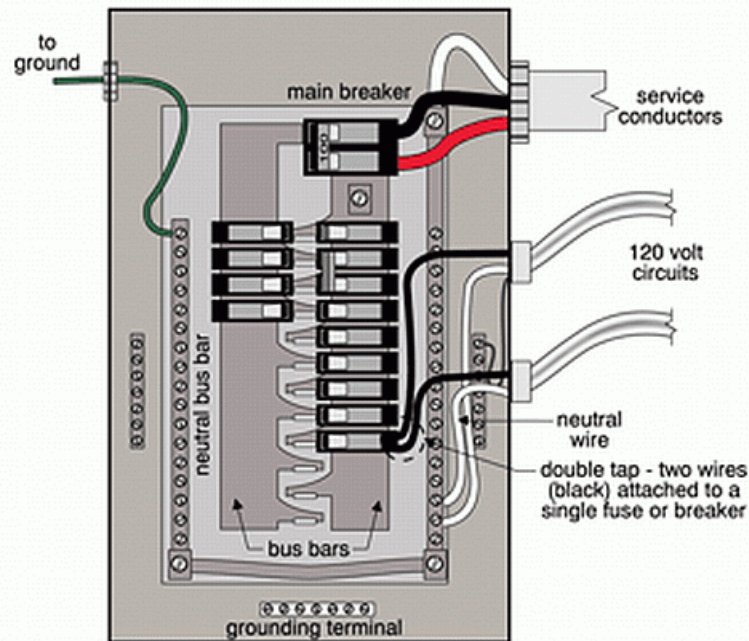
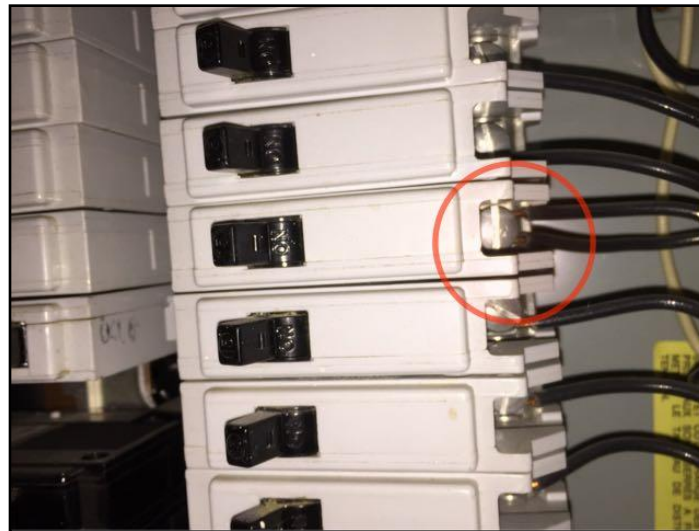
Condition: • [Double taps](#)

Implication(s): Fire hazard

*Double taps***DISTRIBUTION SYSTEM \ Knob-and-tube wiring**

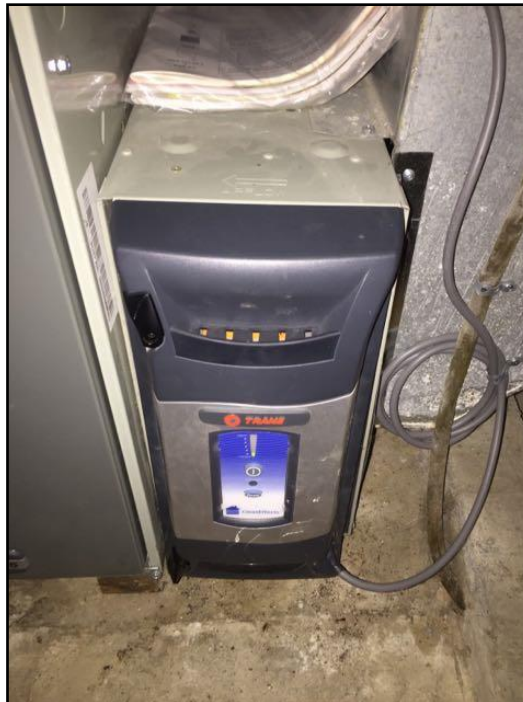
Condition: • Dirty Filter

Dirty Filter

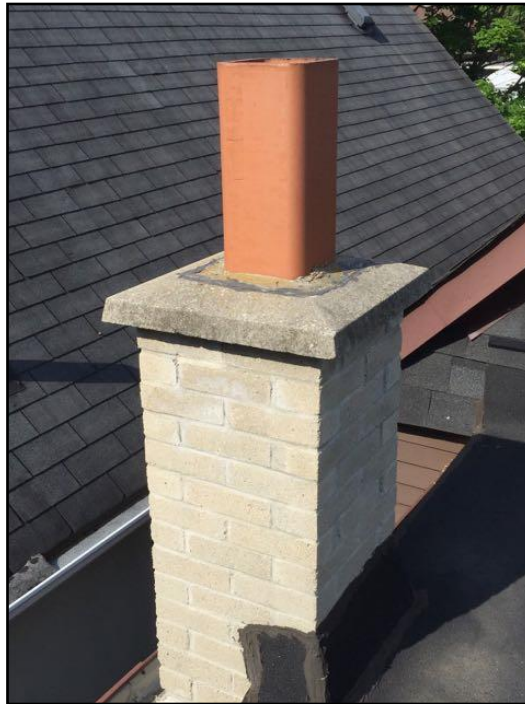
Condition: • Abandoned (vulnerable area for leaks)

Abandoned

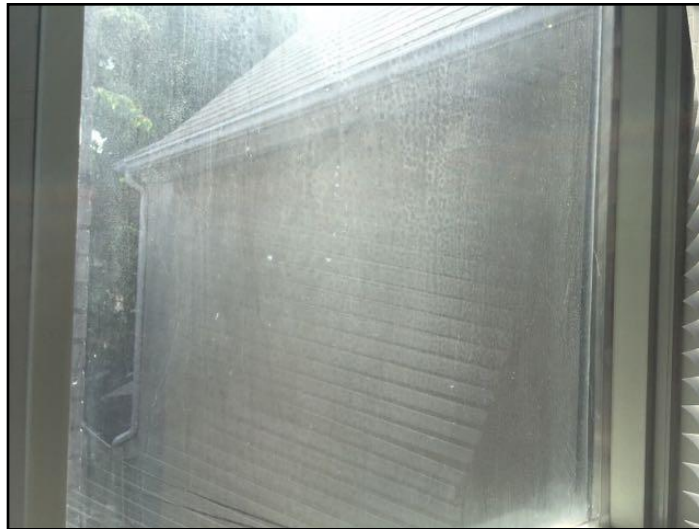
Condition: • [Lost seal on double or triple glazing](#)

Lost seal on double or triple glazing

Task: Repair / Replace

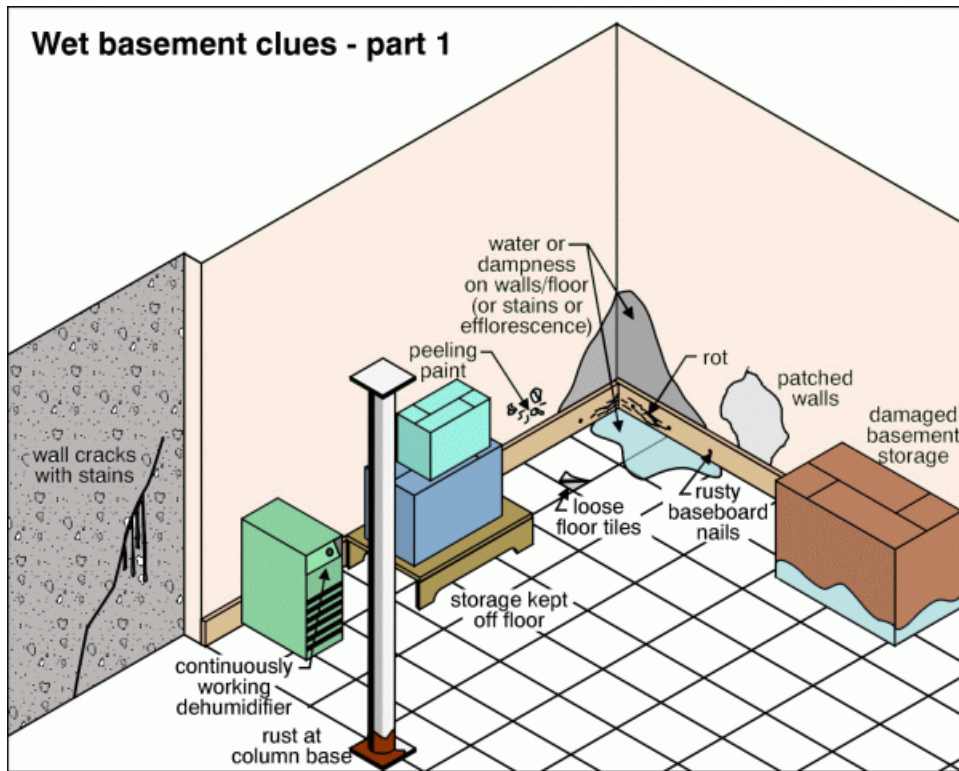
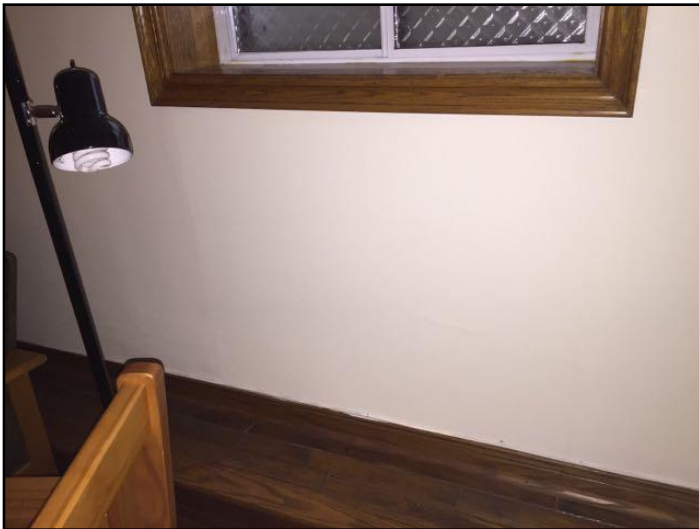
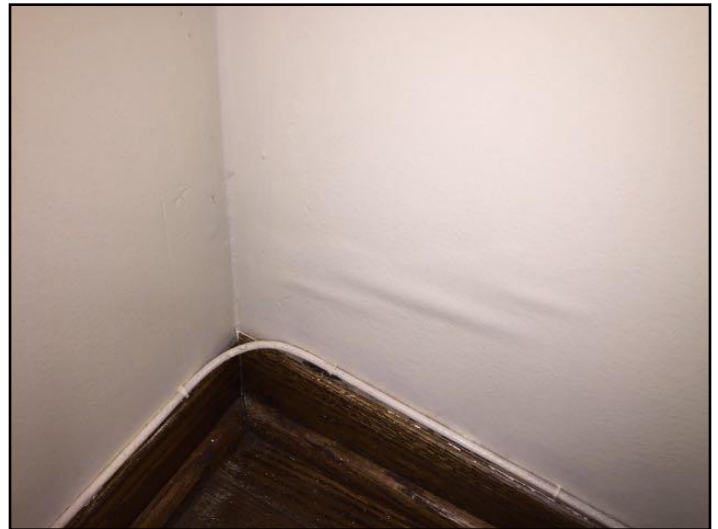
Condition: • [Dampness on floor or walls](#)

Various walls tested wet with moisture meter, (mostly west and south walls).

Implication(s): Chance of water damage to contents, finishes and/or structure | Material deterioration

Dampness on walls

Dampness walls

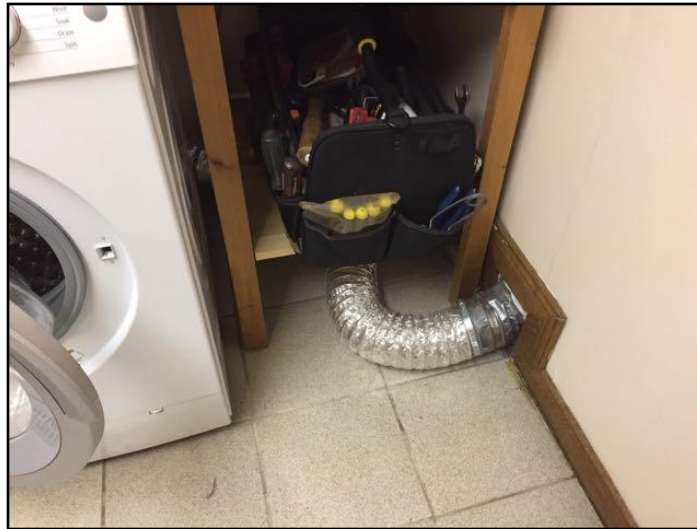
Condition: • We recommend smooth walled metal ductwork to be used instead of corrugated plastic pipe.

We recommend smooth walled metal ductwork t...
