YOUR INSPECTION REPORT

FOR THE PROPERTY AT:
127 Emerson Avenue
Toronto, ON M6H 3S7

INSPECTION DATE:
Thursday, September 11, 2025

RE: Report No. 8551, v.3
127 Emerson Avenue
Toronto, ON
M6H 3S7

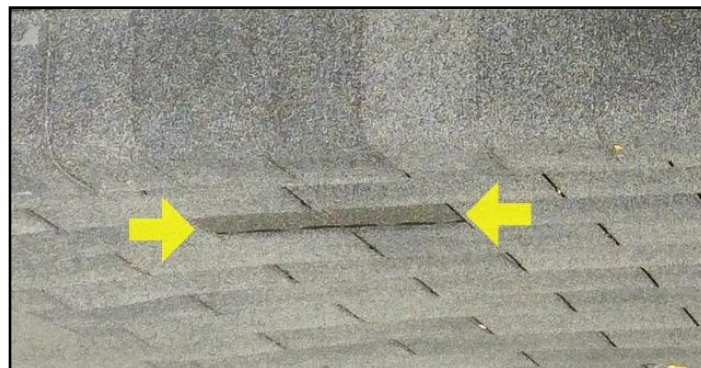
Condition: • [Missing, loose or torn](#)

5. Missing, loose or torn

Task: Repair (one shingle)

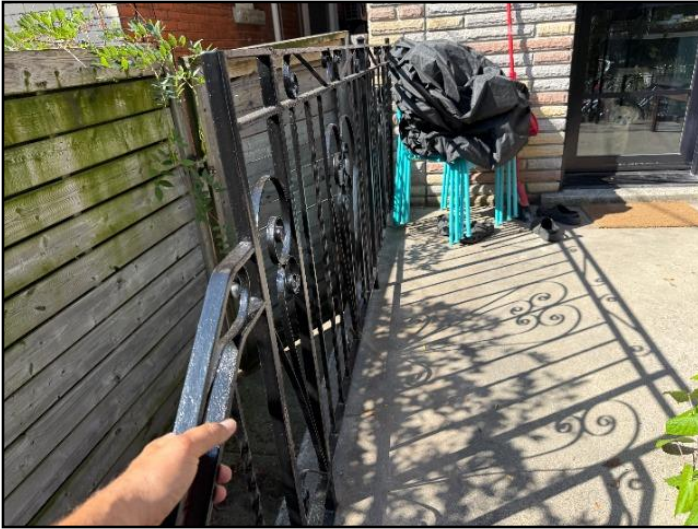
- Railing at side of patio loose
- Railing not secured to wall
- Guard rail at walkout loose - not properly fastened to ground
- Openings at guard and hand rails larger than modern requirements. Improve when practical
- Handrail missing at basement walkout - provide handrail

6. loose

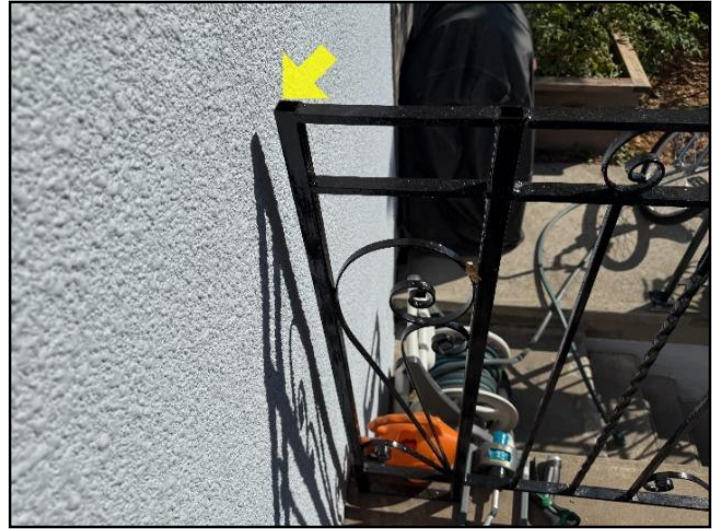
7. Not secured to wall

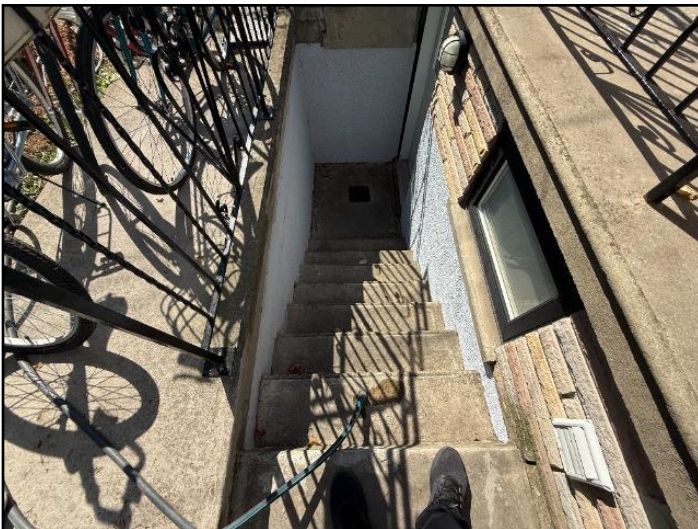
8. missing handrail

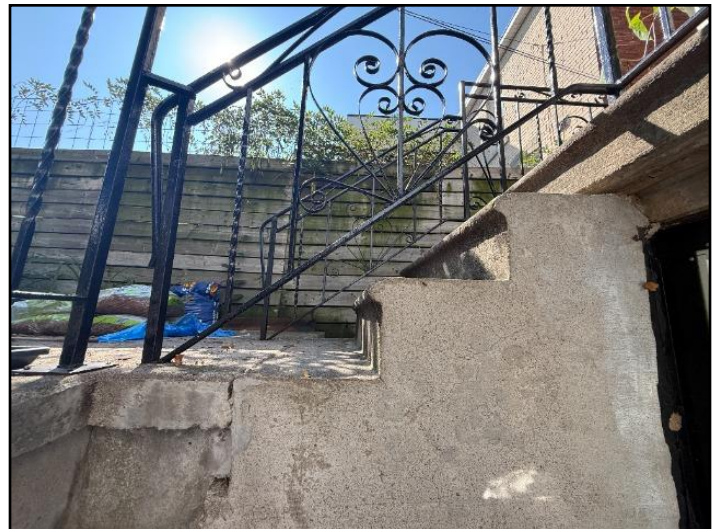
9. large openings

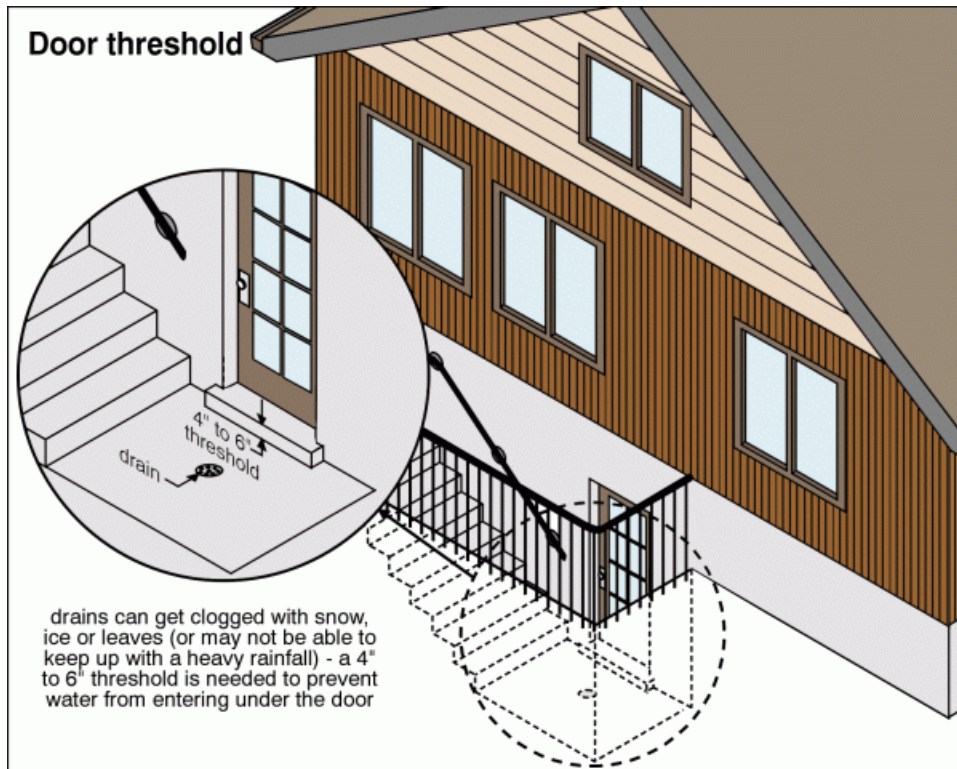
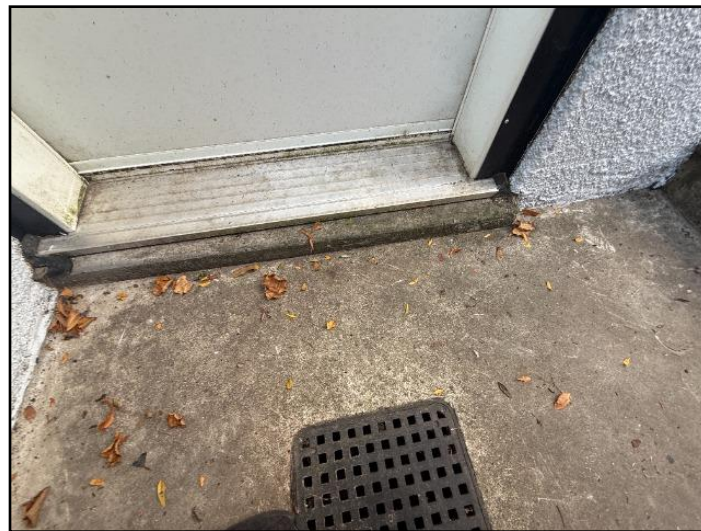
Condition: • [Door threshold missing, too low, not watertight](#)

10. Door threshold too low

Task: Monitor for moisture / water intrusion and improve when necessary

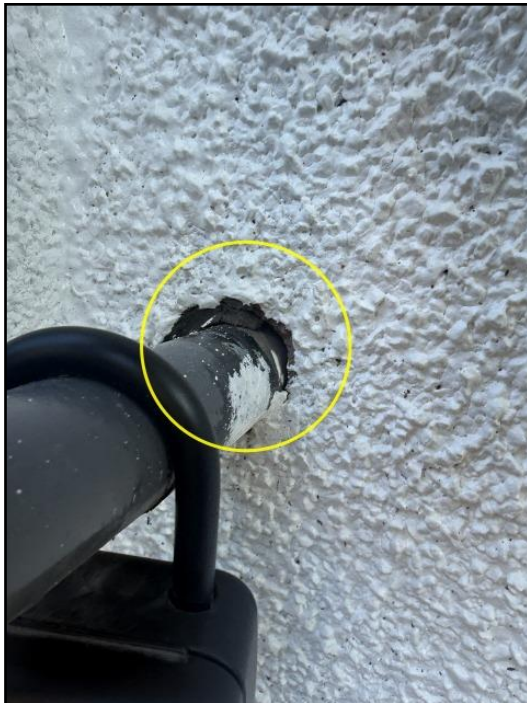
- Keep tree branches trimmed back 3 feet from roof line.
- Gutters - debris in some areas - clean as part of routine maintenance.
- Vent damaged - right side - replace as part of routine maintenance
- Gap - where gas meter enters from wall - seal with caulking
- Window sill minor cracks or mortar missing - Rear second floor exterior window sill - Patch

11. Seal gap

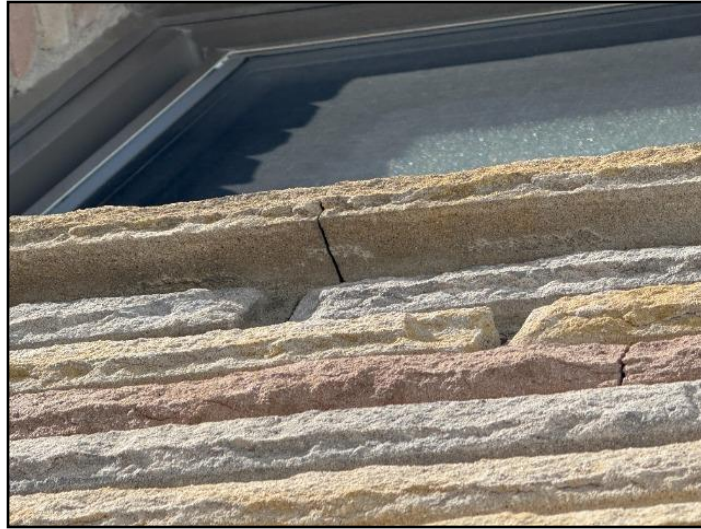
13. Patch sill cracks

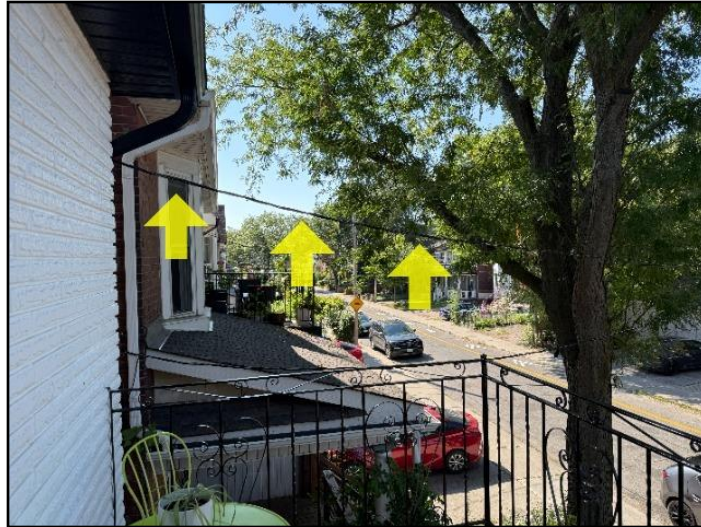
Condition: • [Height over balcony](#)

15. Height over balcony

Task: Further evaluation / Correct

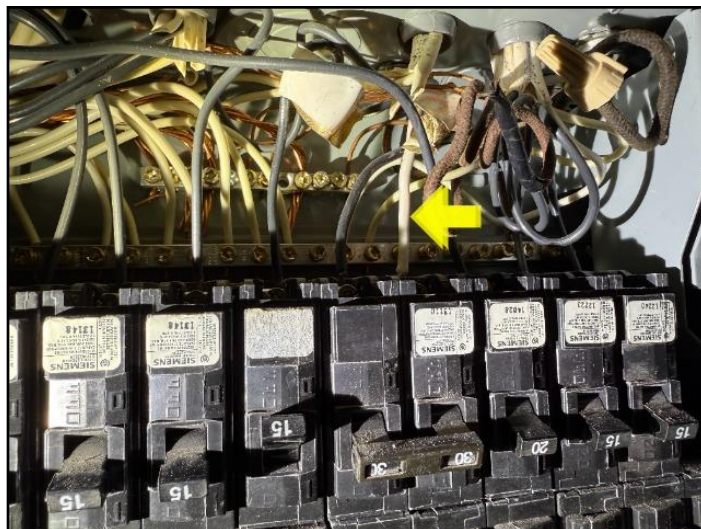
Condition: • White wires connected to breakers not identified as hot/live/ungrounded

16. White wires connected to breakers not...

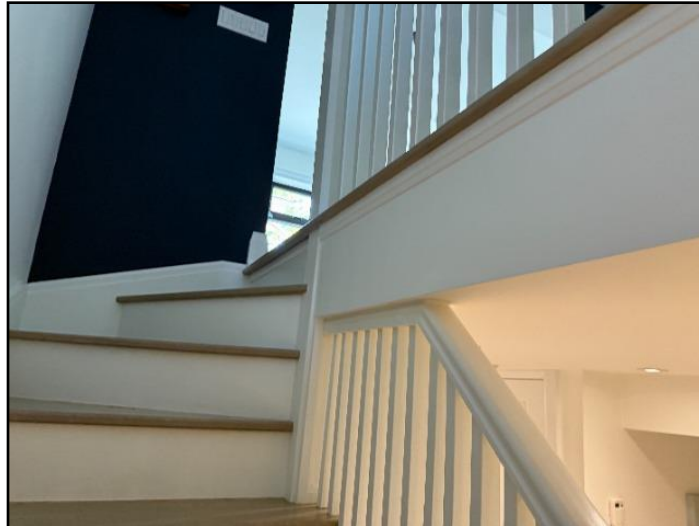
Condition: • [Missing](#)

Implication(s): Fall hazard

19. one example

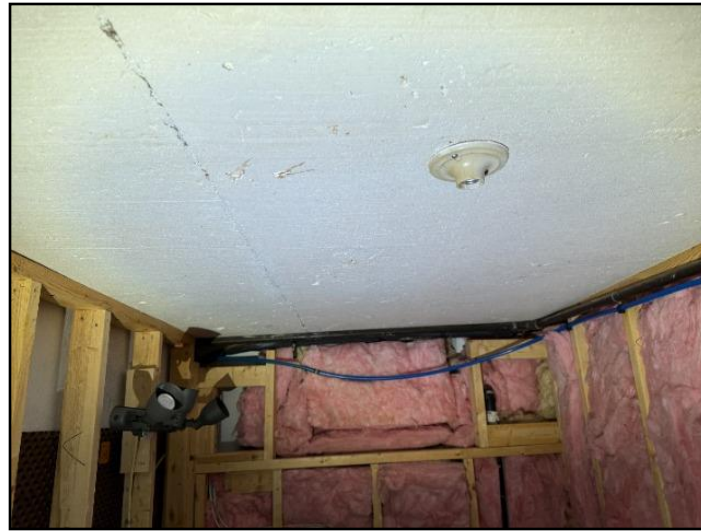
Condition: • Combustible insulation exposed

Implication(s): Increased fire hazard

20. Combustible insulation exposed

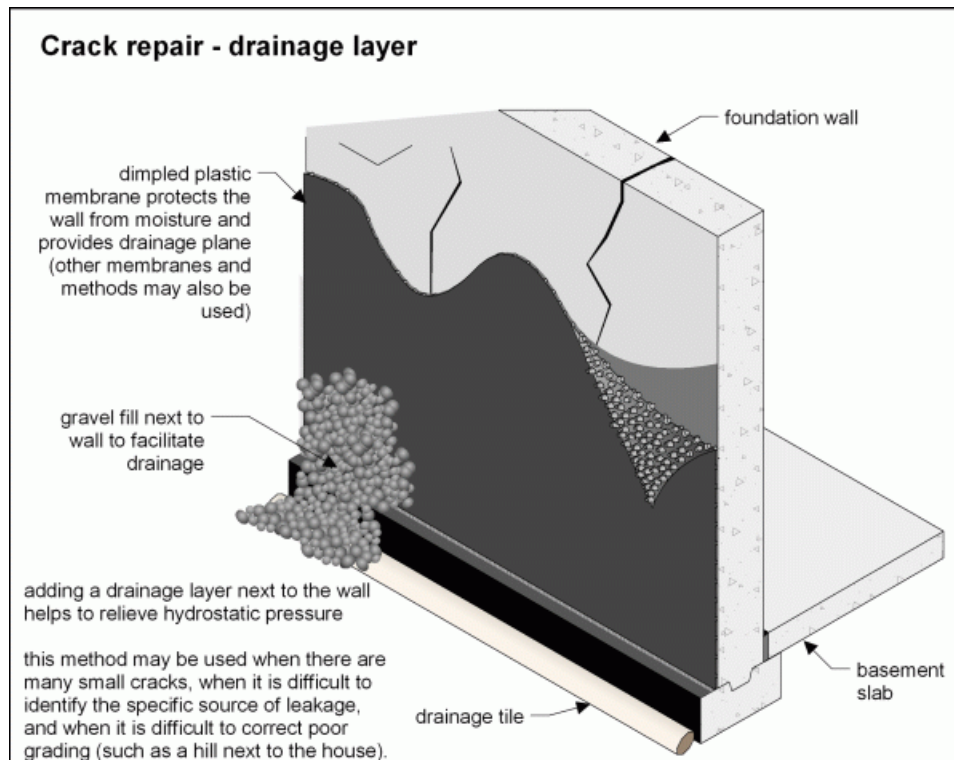
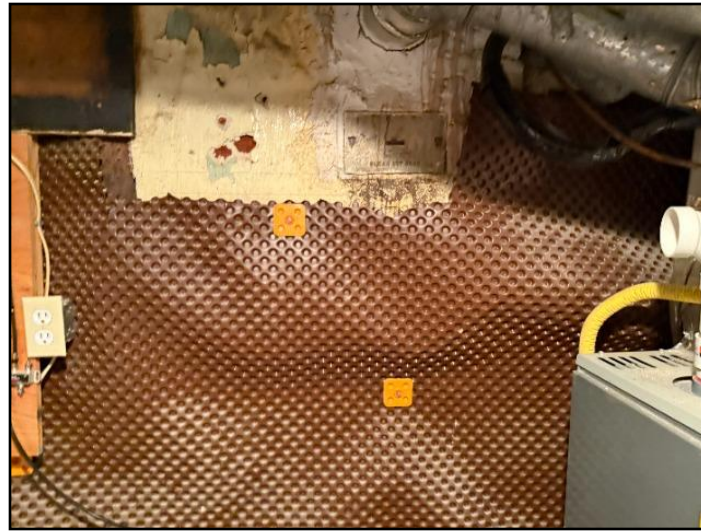
Seller reported that the foundation was excavated and waterproofed on the exterior, and that an interior drainage membrane (dimple board) and sump pump system were installed. These are considered positive waterproofing upgrades that can help reduce the risk of future water infiltration.

21. Interior dimple drainage membrane
