YOUR Inspection Report

123 Address Ave.
Your town, MA 01519

Tuesday, February 26, 2019

RE: Report No. 1056, v.2
123 Address Ave.
Your town, MA
01519

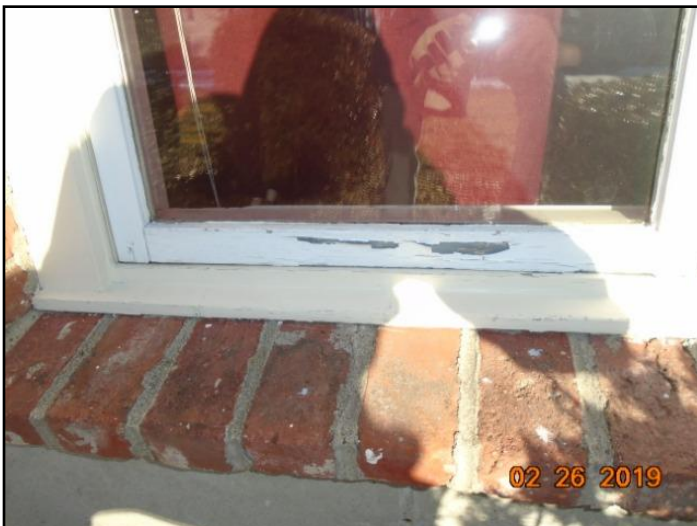
8. Scrape, prime, and paint

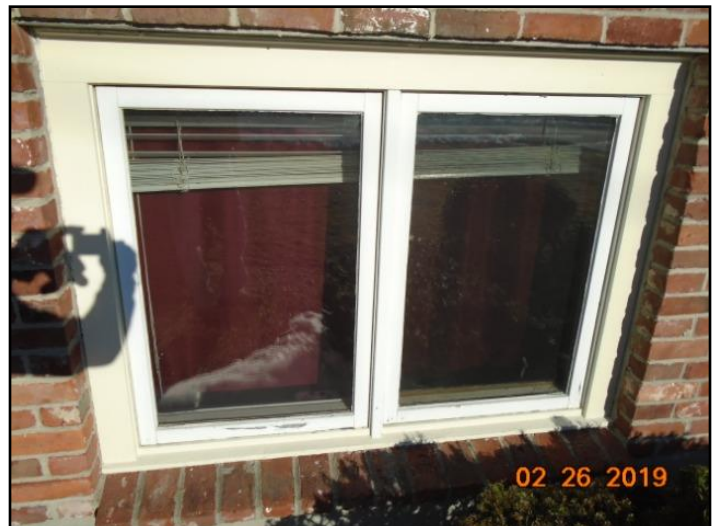
12. Condition: • Paint and Caulking - deteriorated / missing
Basement casement windows have deteriorated, flaking paint.

9. Paint and Caulking - deteriorated / missing

Task: Repair or replace

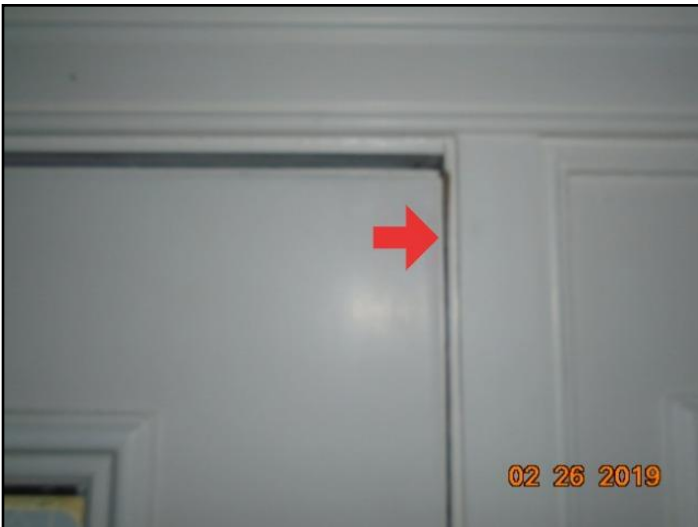
10. Door rubs at top

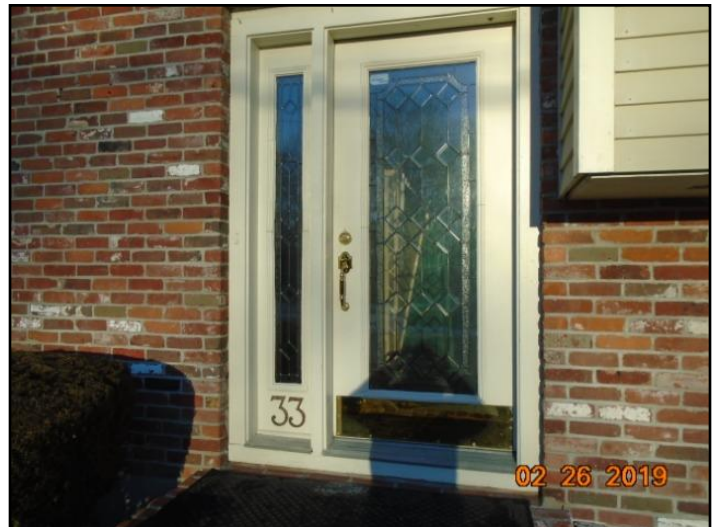
11. Front door

Front exterior door is missing the strike plate for the door to close and latch properly, also the trim around the glass outside has become loose. The double french doors leading to the deck needs an adjustment on the strike plate to seal properly. The door from the kitchen leading to the back deck is taped shut leaving it unable to inspect properly. Final note is that all doors need new weatherstripping to seal properly, the existing weatherstrip is either deteriorated, dry, or just not sealing.

Task: Repair or replace

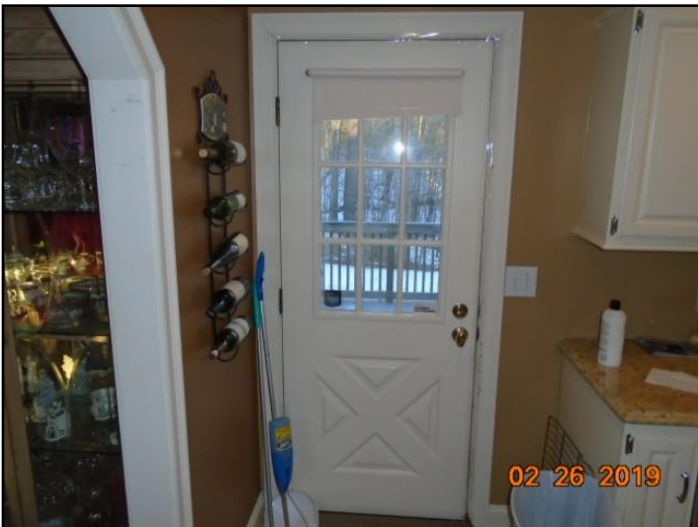
12. Air leaks/Back door in kitchen taped close

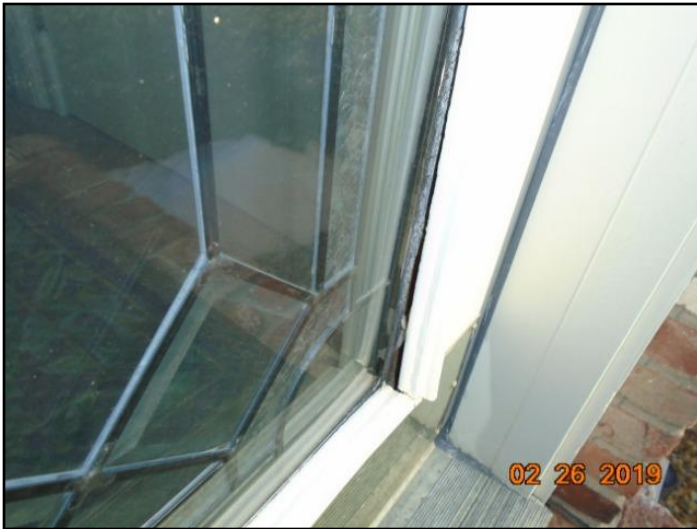
14. Air leaks/trim loose around glass

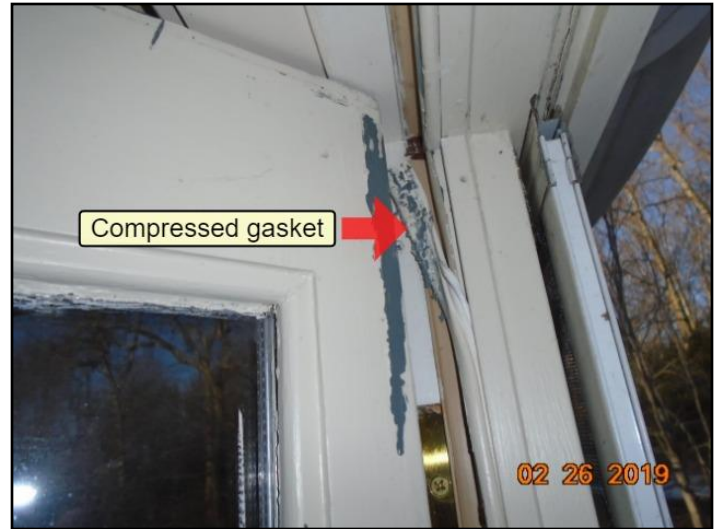
15. Air leaks/Back double door

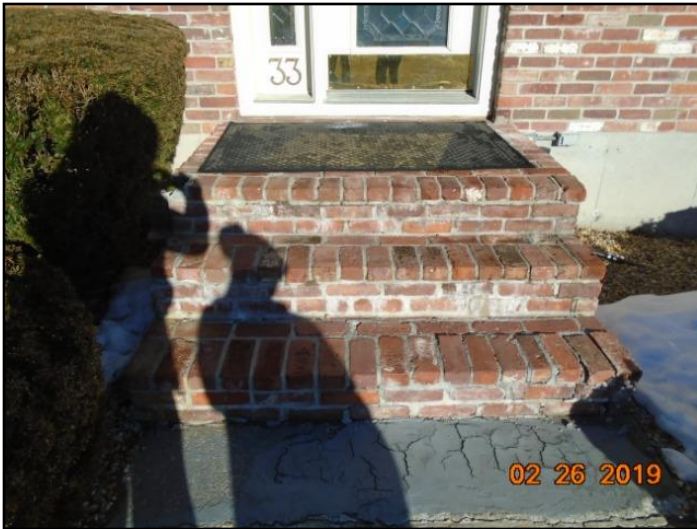
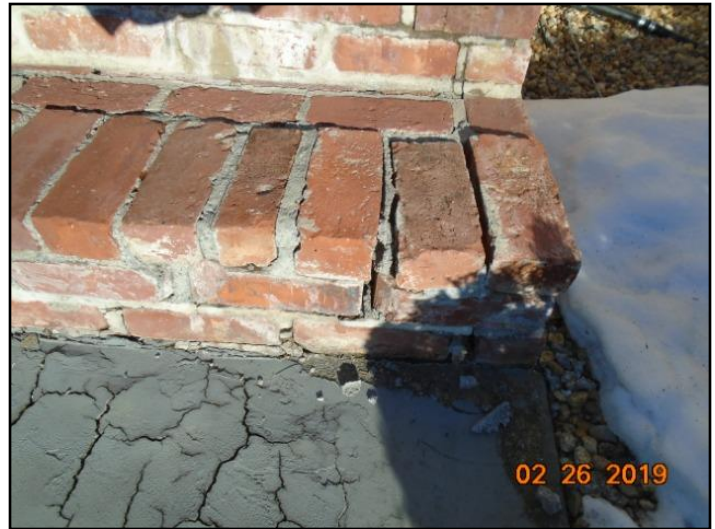
17. Condition: • Front steps have loose or missing bricks that can become a tripping hazard. Recommend licensed mason to repair/replace.

17. Repair loose bricks

18. Repair loose bricks

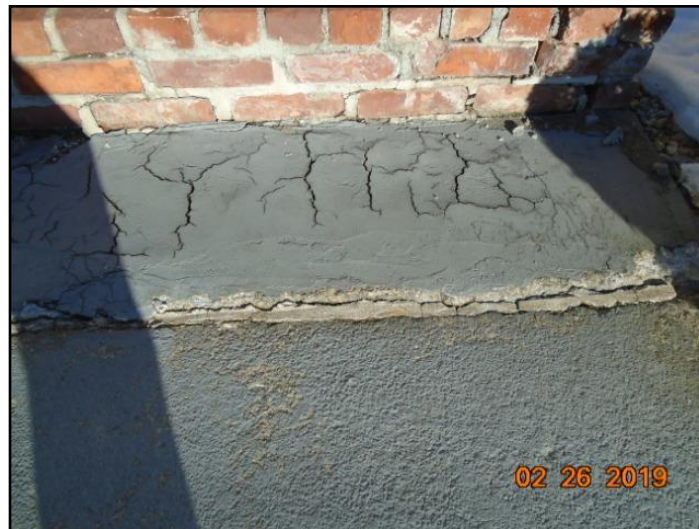
The walkway has some spots that could use some patching to maintain good condition.

23. Cracked or damaged surfaces

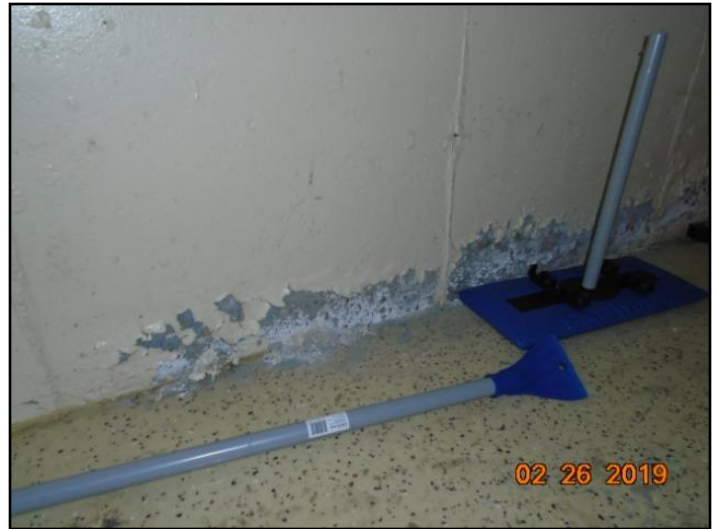
22. Condition: • Damage to concrete possibly by washing salt off cars in garage.

28. Salt damage to concrete

27. Scrape, prime, and seal concrete

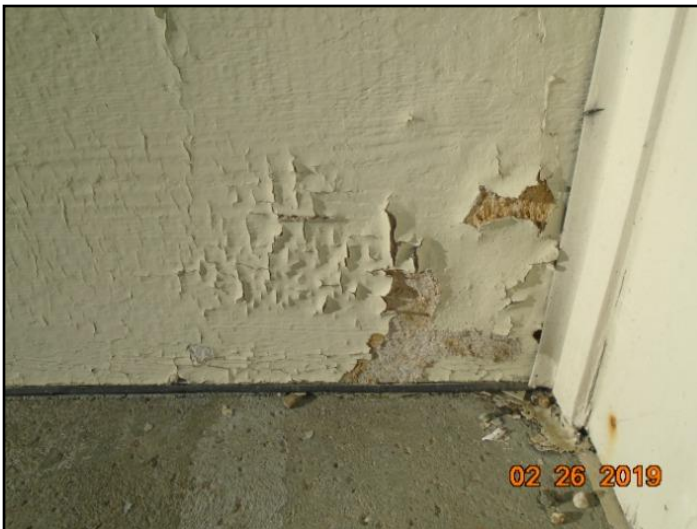
23. Condition: • Paint or stain needed

29. Scrape, prime and paint

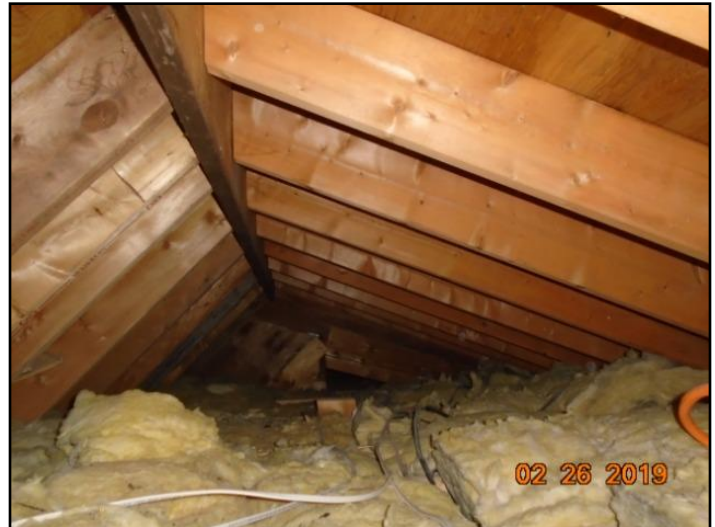
31. Condition: • Minimal amount of roof framing exposed.

32. Minimal amount of roof framing exposed.

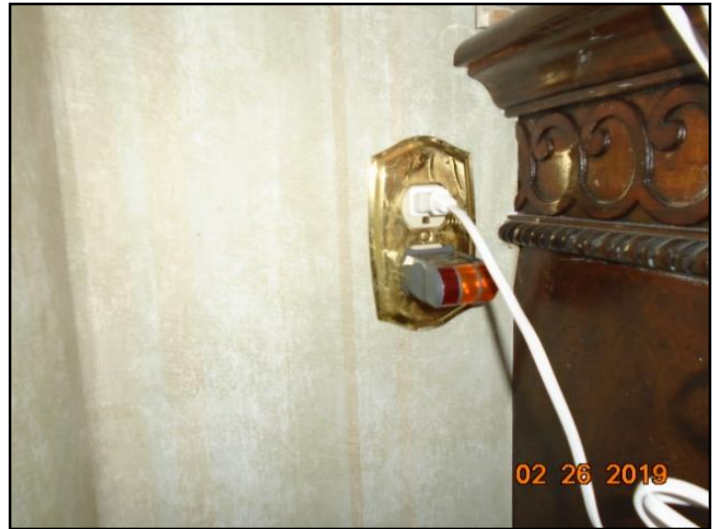
36. Condition: • Exterior and bathroom plugs should be on a dedicated ground fault circuit interrupter. With the amount of circuits throughout the house it was undetermined to the location of the main circuit disconnect whether it is in the panel which has GFCI breakers or a receptacle in the field.

36. No GFCI location determined

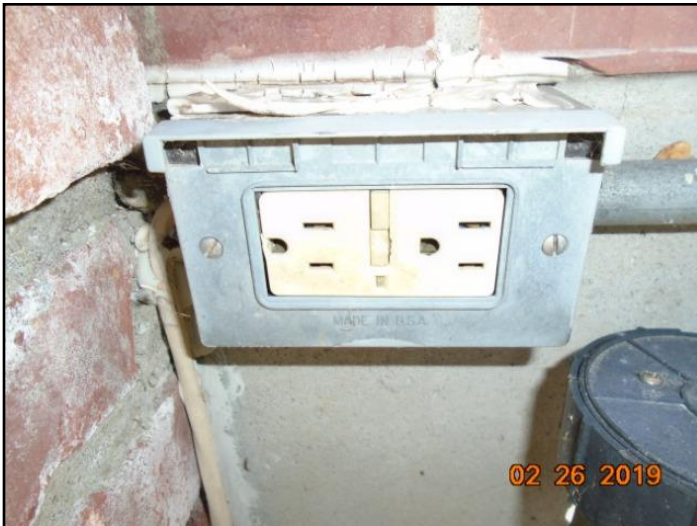
39. **Condition:** • [Missing](#)

37. Missing cover/exterior

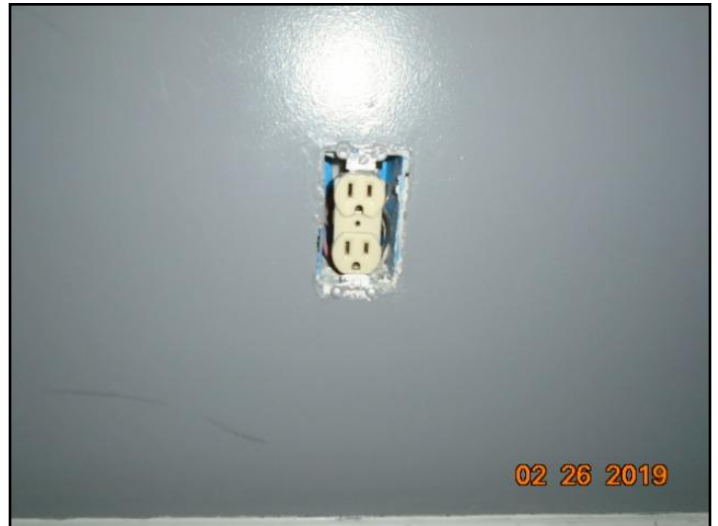
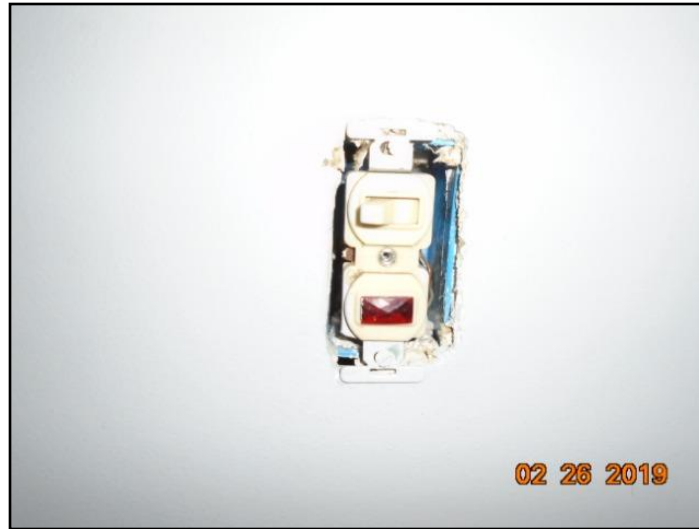
38. Missing cover plate

39. Missing cover plate

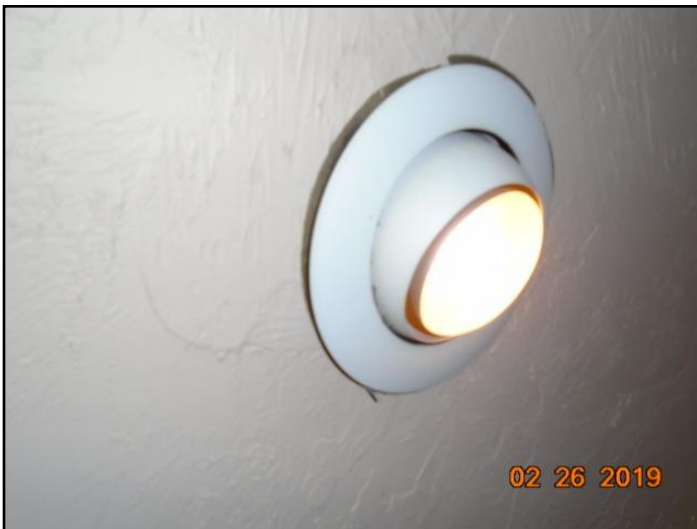
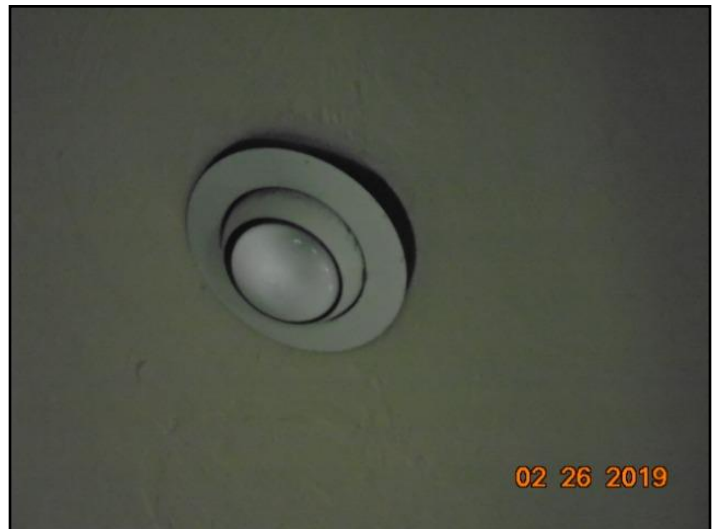
A couple of the recessed lights are loose in there mount.

40. Loose trim

41. Loose trim

Task: Repair or replace Improve

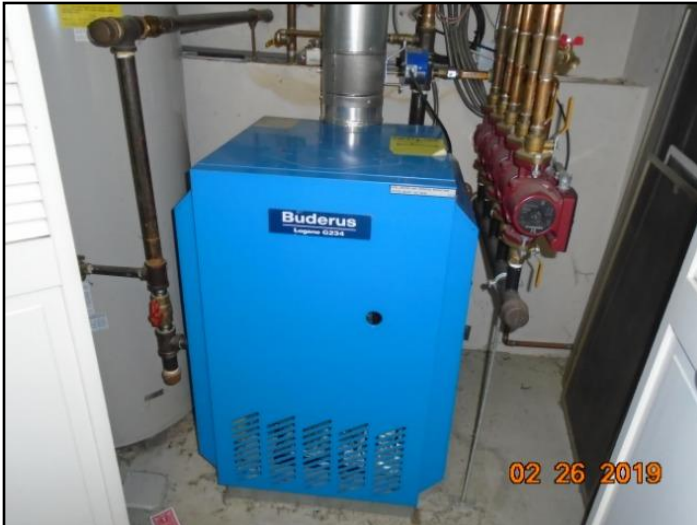
42. Condition: • Gas boilers and furnaces should be serviced every 6-8 years for proper efficiency.

44. Service regularly for maximum efficiency

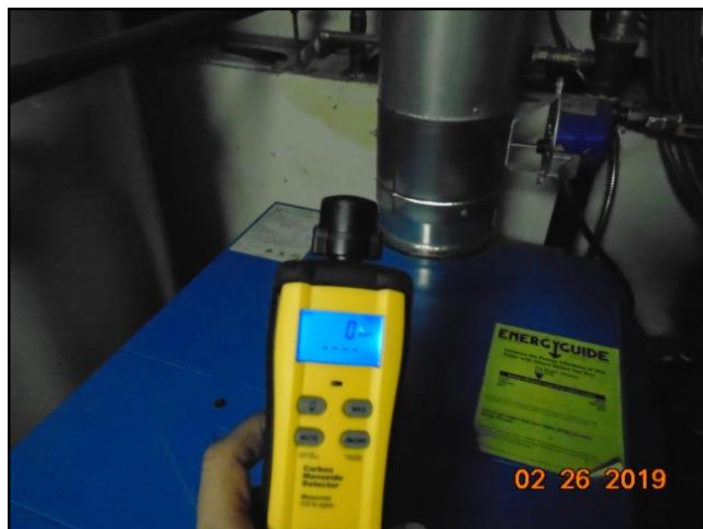
A carbon monoxide sniffer was used while the boiler was running and produced zero readings.

49. Carbon monoxide test

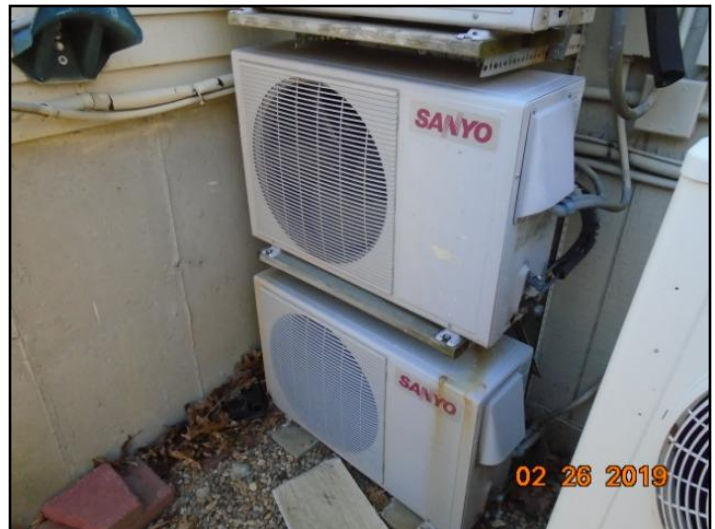
57. 2000-2001

Compressor approximate age: • 2000-2001 Making the units 19 years old.

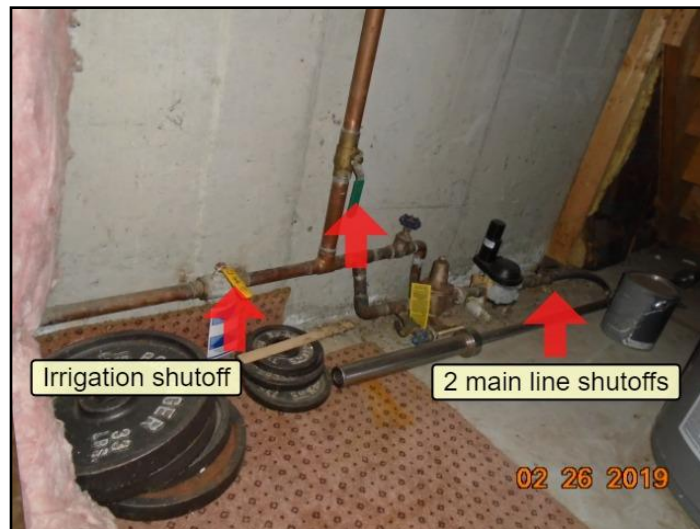
58. Under stairs in basement

54. Condition: • Main water shutoff location

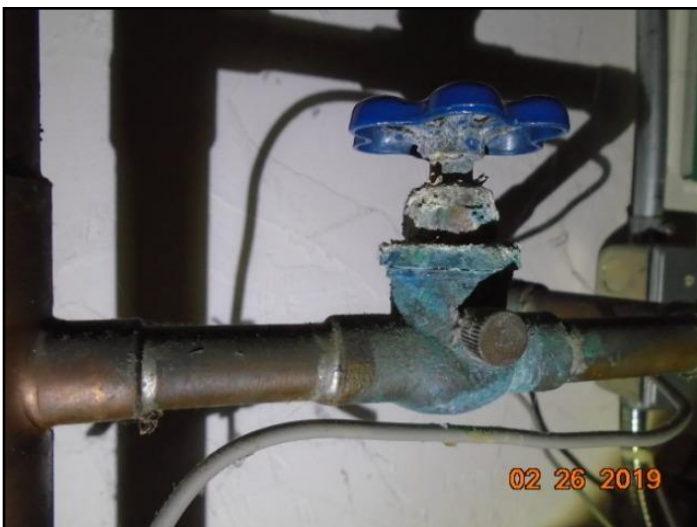
2 visible valves, one above the boiler and one in the area of the main water line entering the home have a small amount of corrosion/ mineral deposits. Recommend repair/replace by licensed plumber.

59. Corrosion/above boiler

Task: Repair or replace Further evaluation

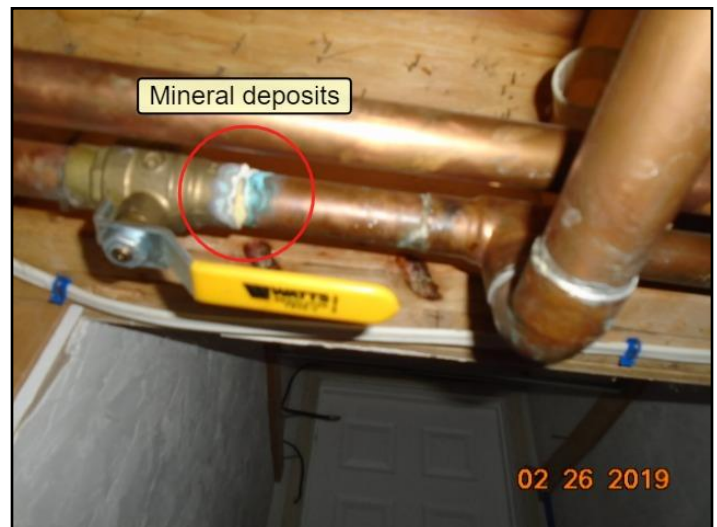
60. Corrosion/under stairs

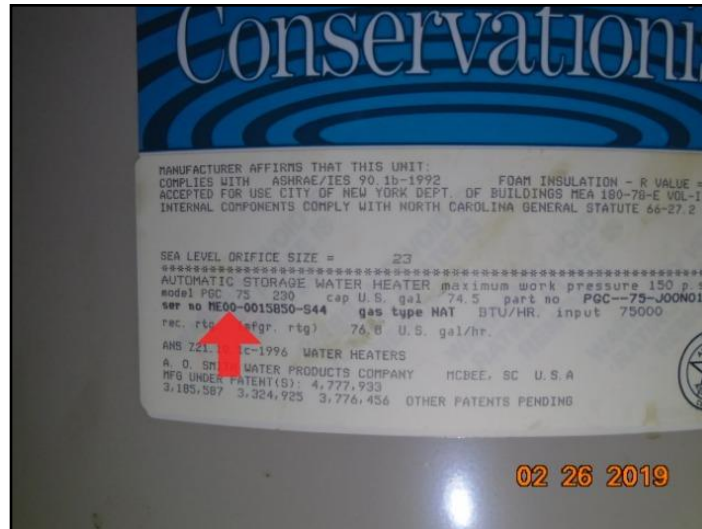
56. Condition: • The hot water tank is manufactured in 2000 making the tank 19 years old. Average life expectancy is 8-12 years.

61. Manufacture date 2000

Task: Monitor

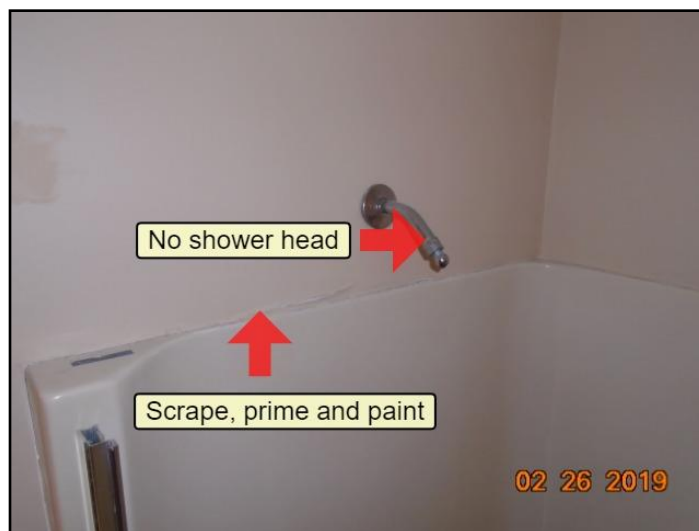
61. Condition: • [Caulking loose, missing or deteriorated](#)

64. Basement shower

Task: Repair or replace

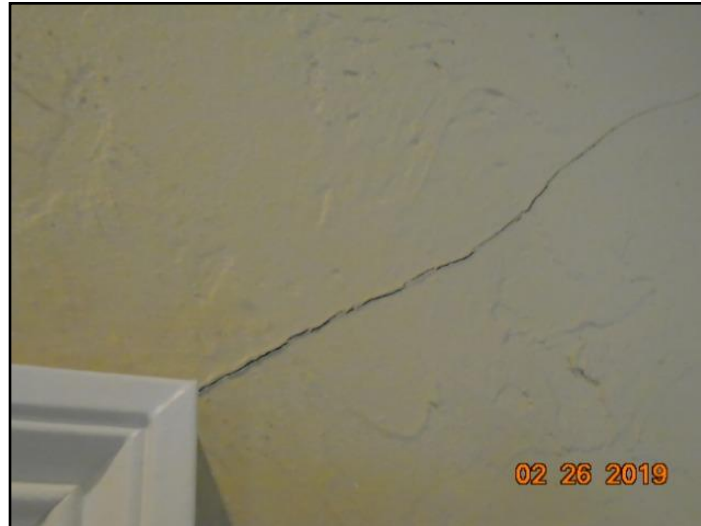
66. Small crack at doorway

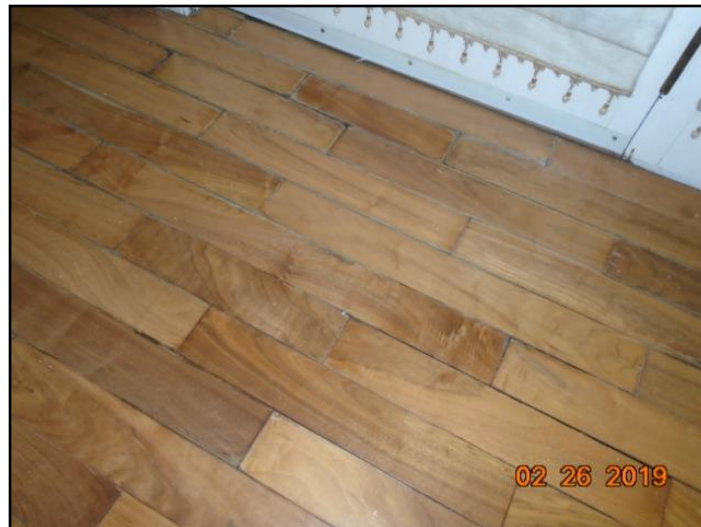
67. Water damage/2nd floor bedroom

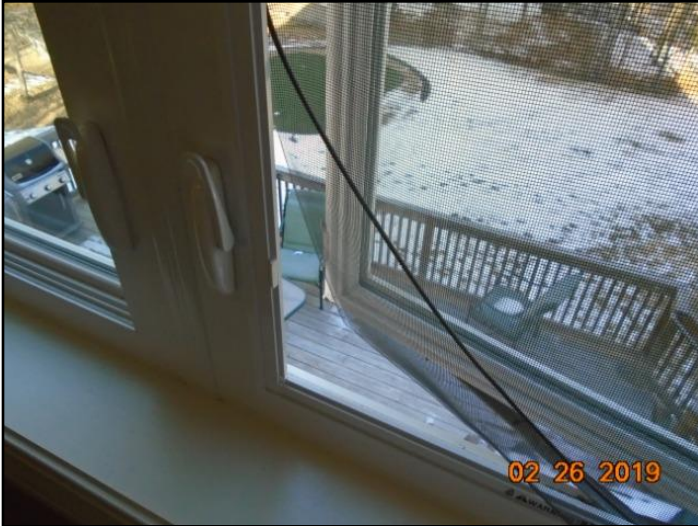
68. Left screen missing/right screen damaged

Task: Repair or replace

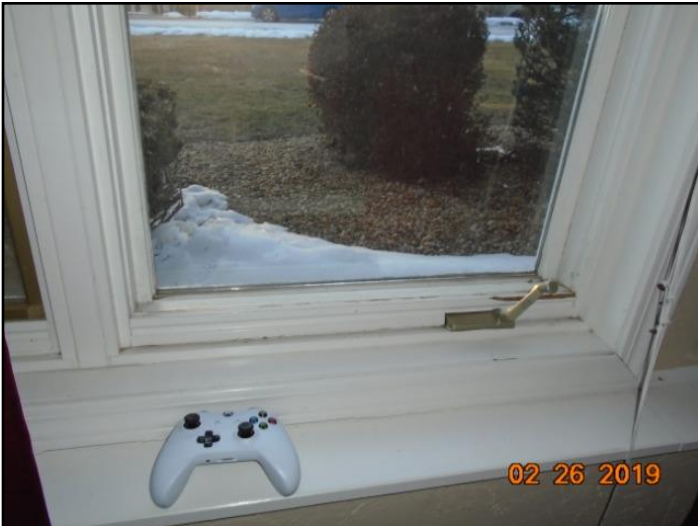
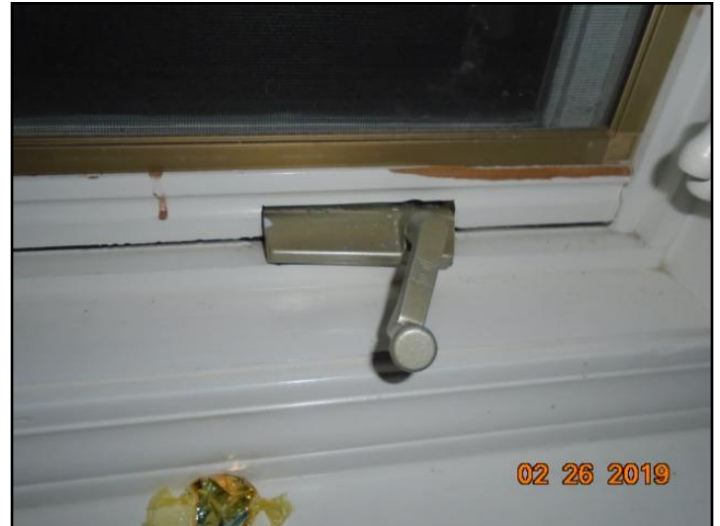
The older casement windows in the basement need attention. Two of the windows inspected the cranks did not operate.

70. Inoperative/window doesn't open

71. Inoperative/crank broke

Task: Repair or replace

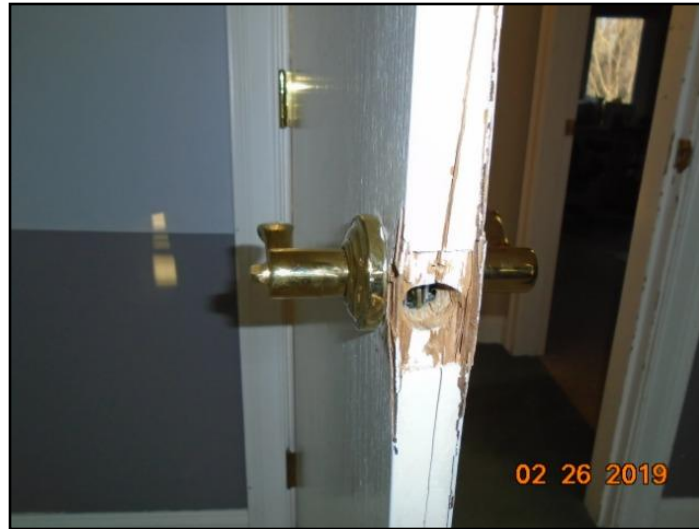
Door to 1st floor room latch damaged.

72. Damage

Task: Repair or replace

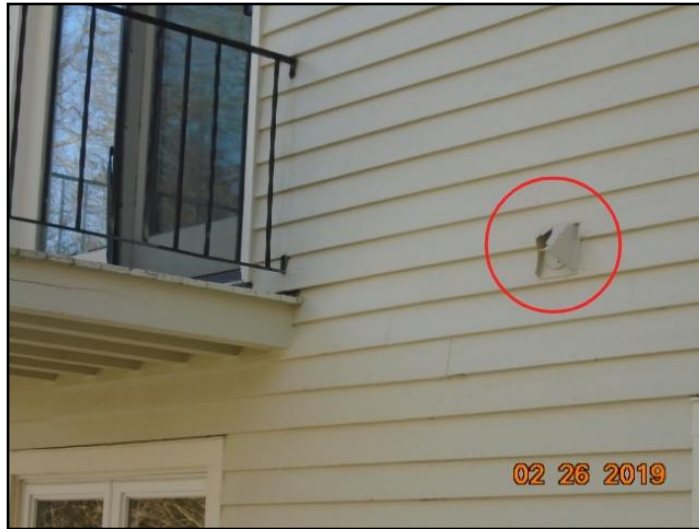
75. Condition: • [Damage](#)

80. Damage/vent cover

Task: Repair or replace

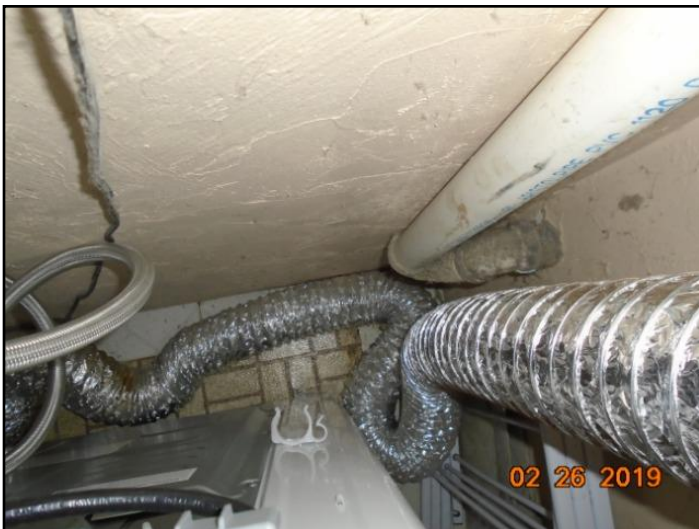
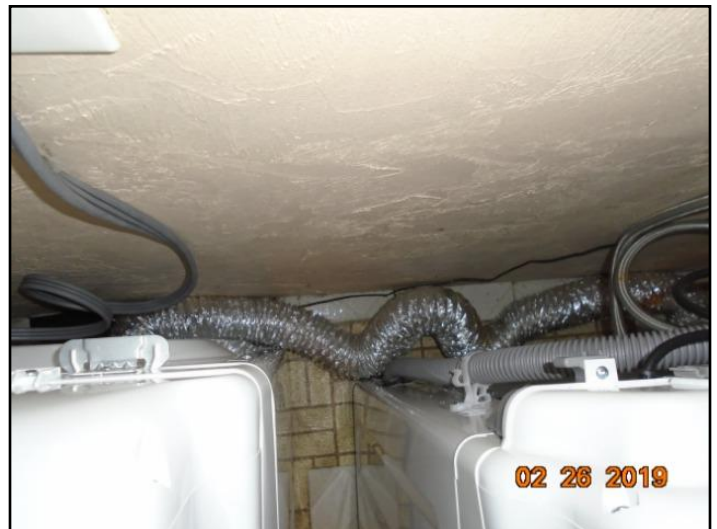
The flexible dryer hose has too many turns that can collect lint and become a fire hazard. Replace with metal pipe.

81. Dryer vent material not smooth wall

82. Too many turns in pipe

Task: Replace
