# Your Inspection Report

554 Runnymede Road  
Toronto, ON M6S 2Z7

RE: Report No. 9745  
554 Runnymede Road  
Toronto, ON  
M6S 2Z7

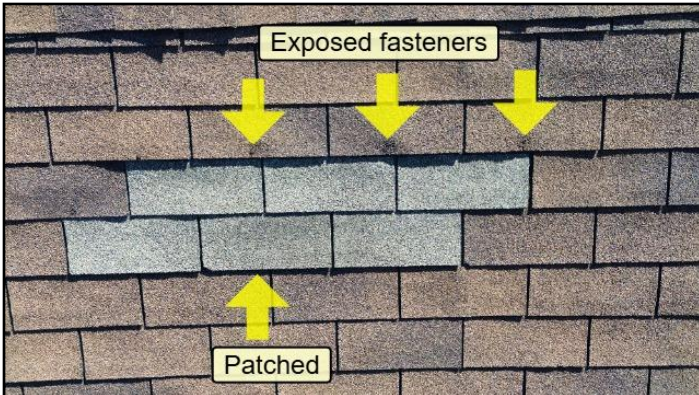
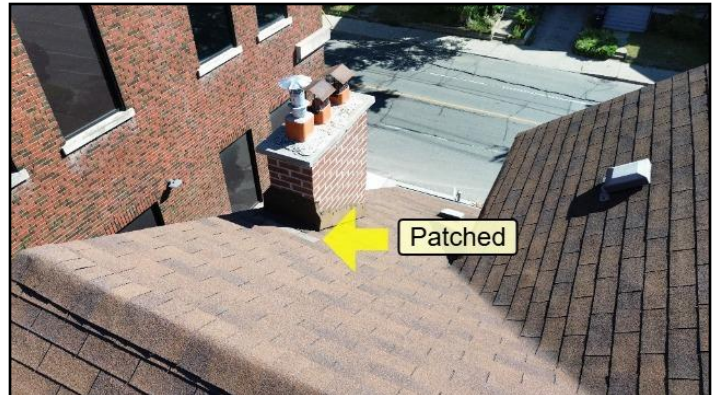
**Condition:** • [Patched](#)

Additionally, exposed fasteners were noted and were not sealed.

2. Patched

3. Patched

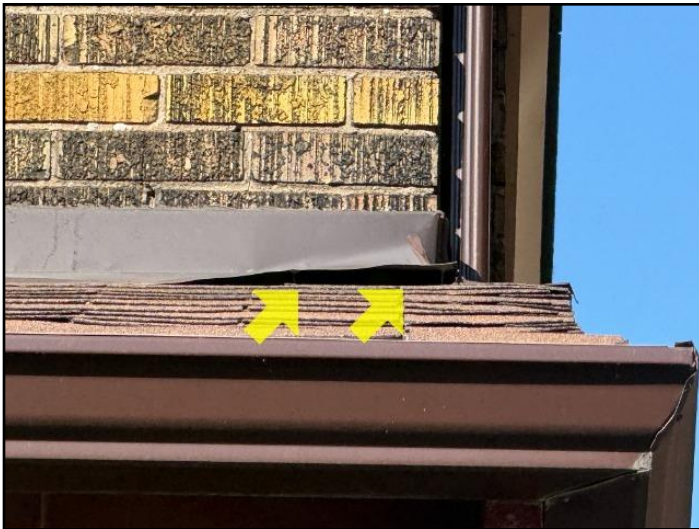
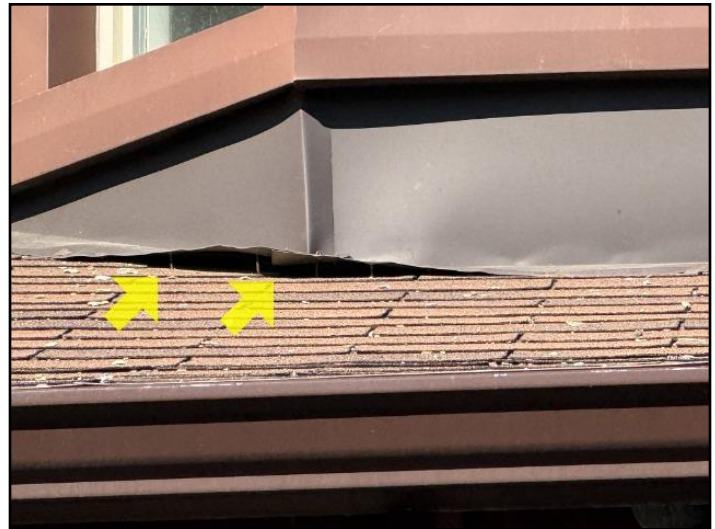
**Condition:** • [Damage, loose, open seams, patched](#)

**Task:** Repair

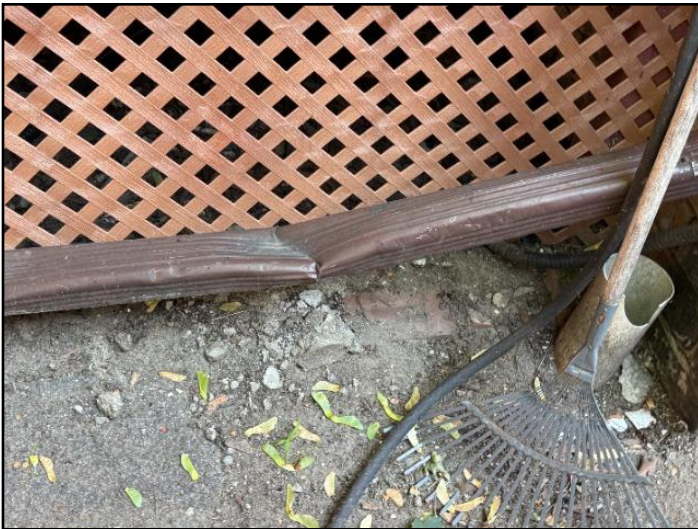
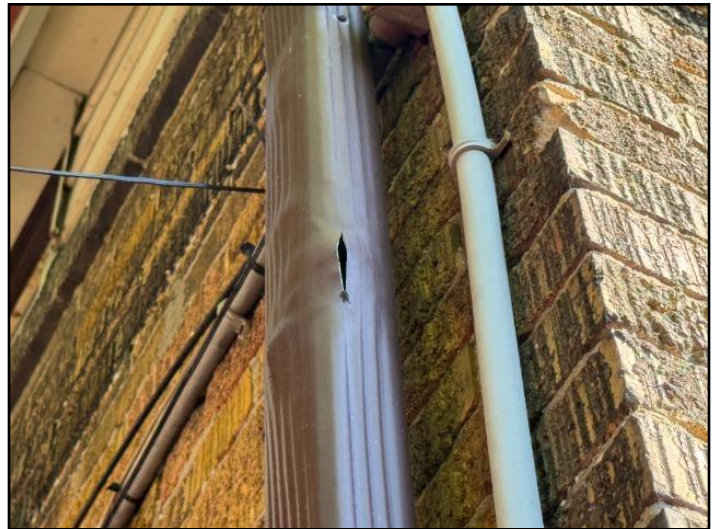
**Condition:** • Aging or Old

Various damaged downspout sections and split seams were noted. Repair or replace deteriorated sections and plan for replacement

6. example of damage

7. one example of split area

**Task:** Replace

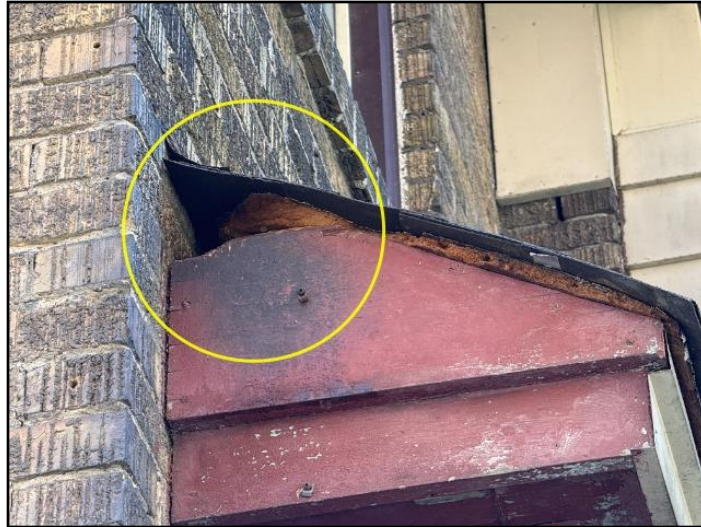
**Condition:** • [Flashings missing](#)

Open gap noted at upper portion of boxed bay window.

8. Flashings missing

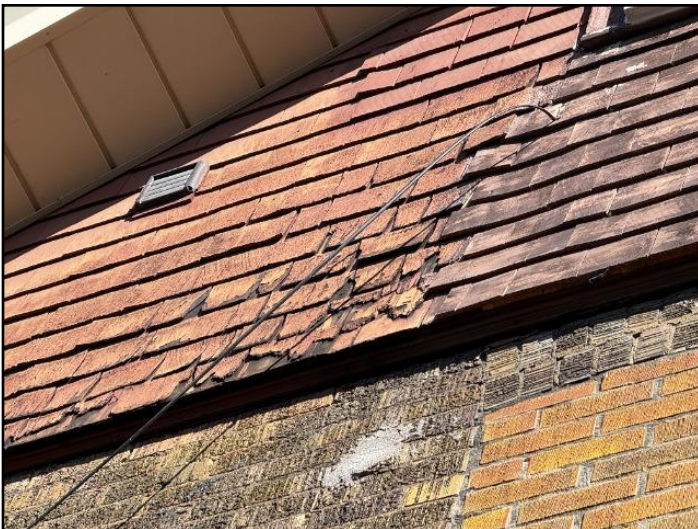
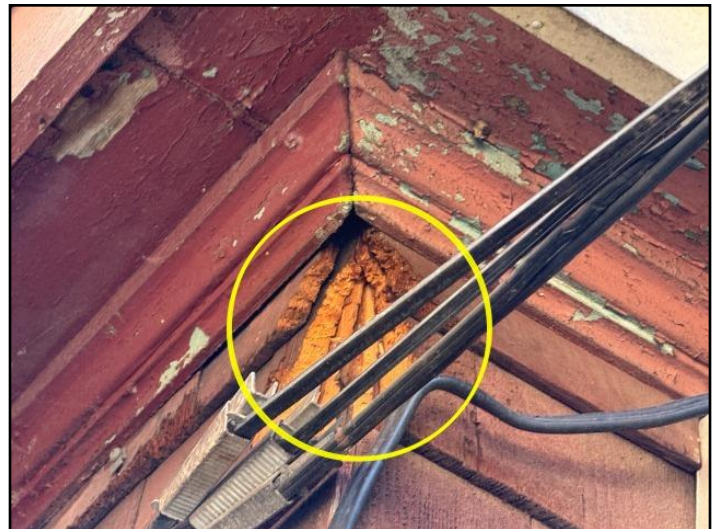
**Condition:** • [Cracked, split or broken](#)

Additionally, prior replacement of localized sections was noted.

9. one example at left side

10. one example at rear

**Task:** Replace

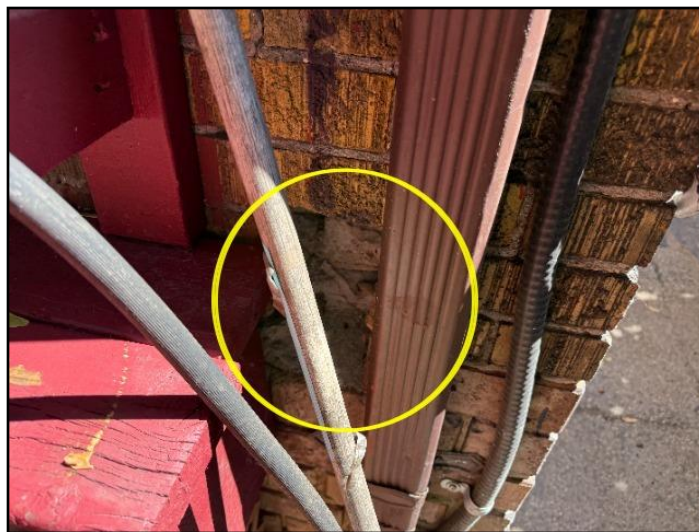
**Condition:** • Gap or Hole at wall

**11.** Gap or Hole at wall

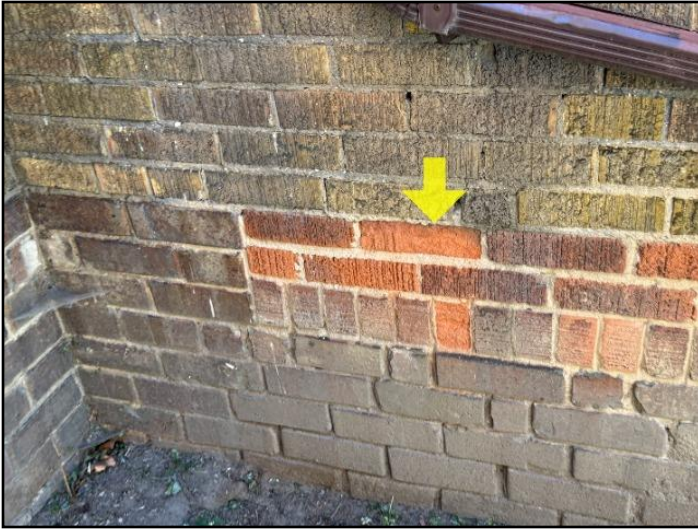
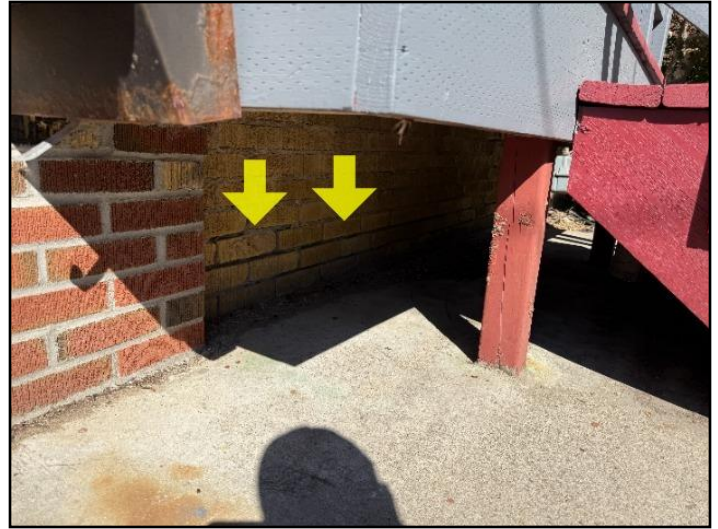
**Condition:** • Masonry and/or mortar deterioration

Tuckpoint / Repoint mortar and patch/repair spalled masonry. This is typical maintenance for a home of this age. Photos show representative examples.

12. example of spalling

13. one example at front

**Task:** Repair

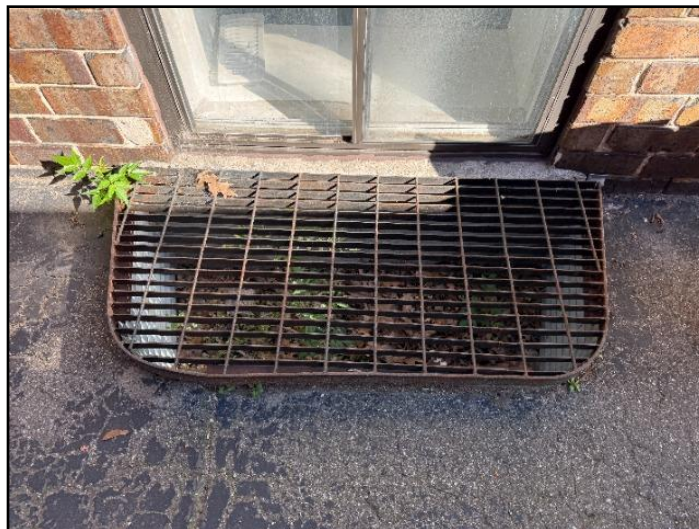
**Condition:** • Debris/Dirty

14. Debris/Dirty

**Task:** Clean

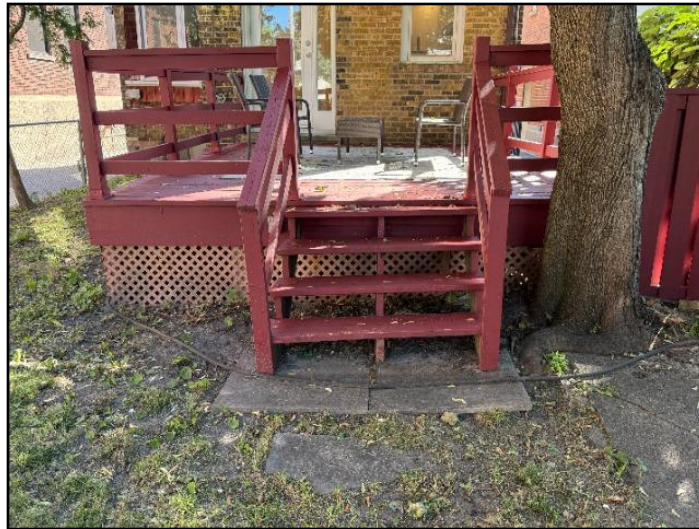
**Condition:** • [Steps slope](#)

15. Steps slope

**Task:** Repair

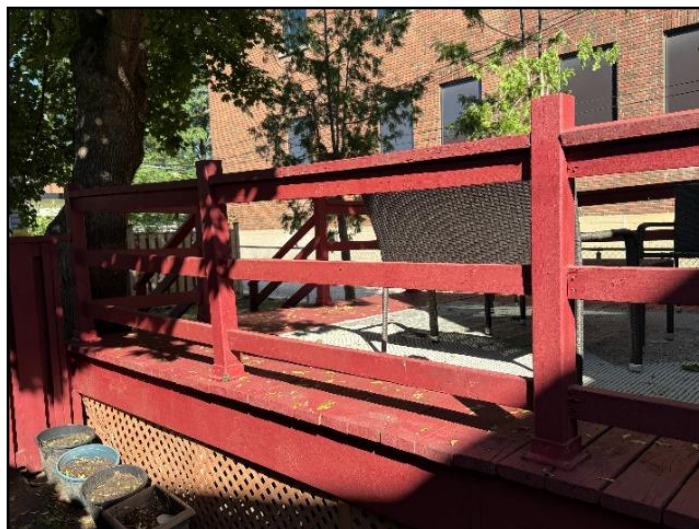
**Condition:** • [Spindles \(balusters\) climbable](#)

16. one example

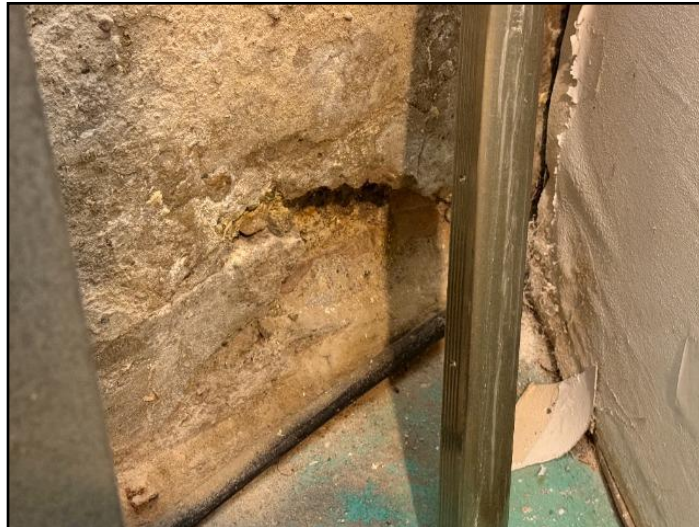
**Condition:** • Spalling, crumbling or broken material

17. one example

**Task:** Patch / Repair

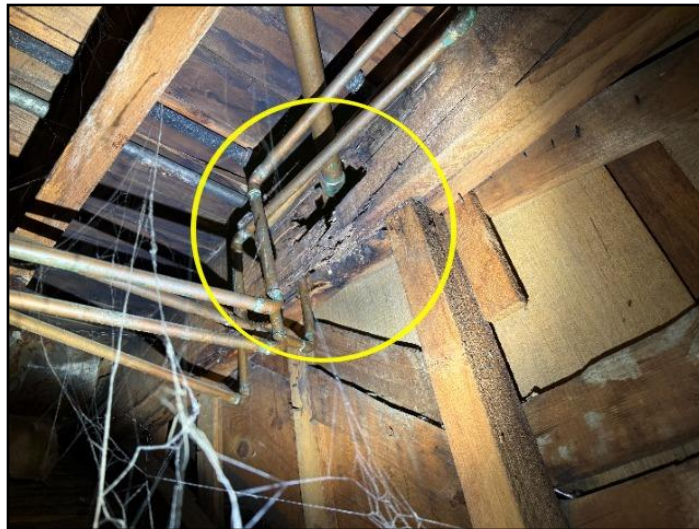
**Condition:** • [Rot](#)

Localized rot/deterioration was noted at structural wood framing above the basement stairwell. The full extent and configuration could not be determined due to limited access.

18. Rot

**Task:** Further evaluation and repair / replace

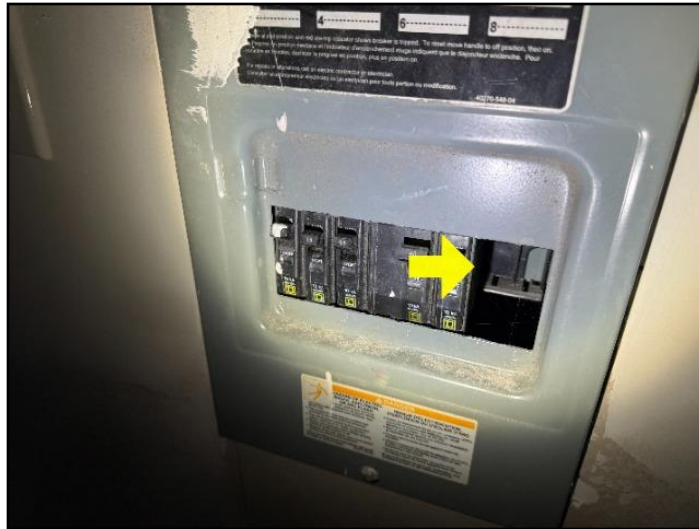
**Condition:** • Unprotected Opening(s)

22. Unprotected Opening(s)

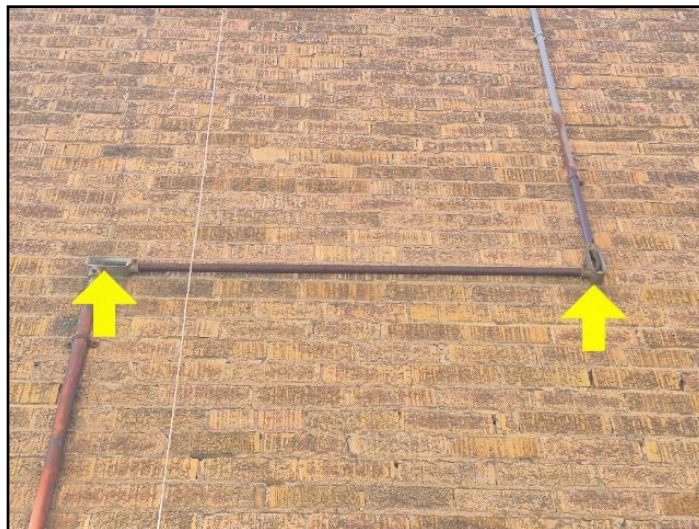
**Condition:** • Conduit missing cover plates

23. Example

**Task:** Correct

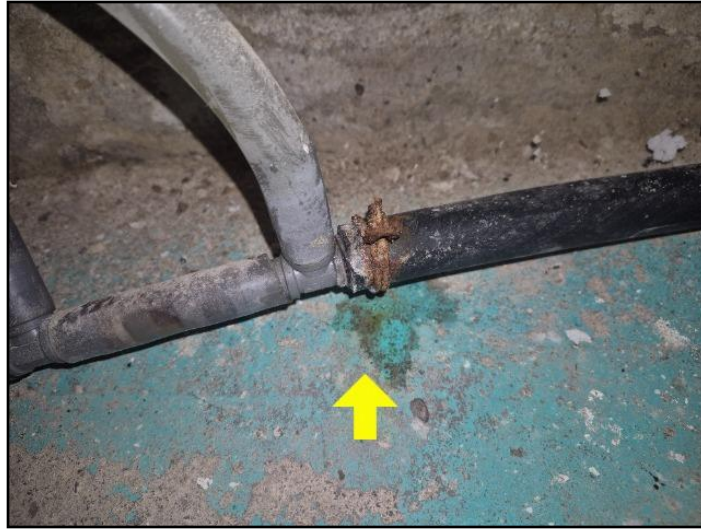
**Condition:** • Condensate drain line problems

Minor leak at condensate drain line noted at time of inspection.

24. Example

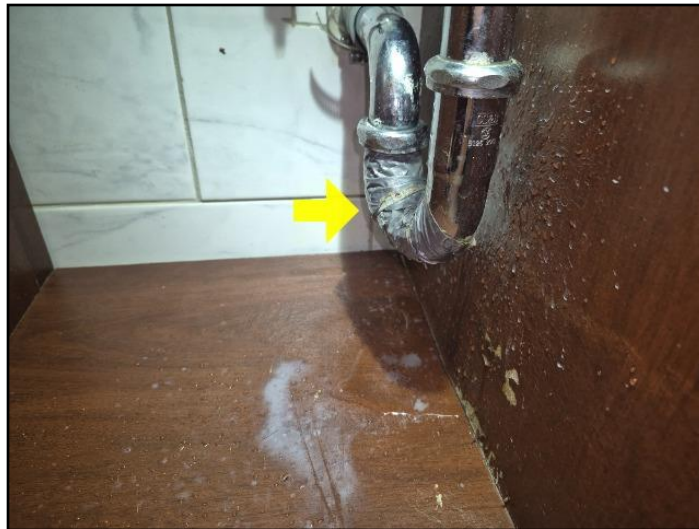
**Condition:** • [Leak](#)

27. Leak

**Task:** Correct

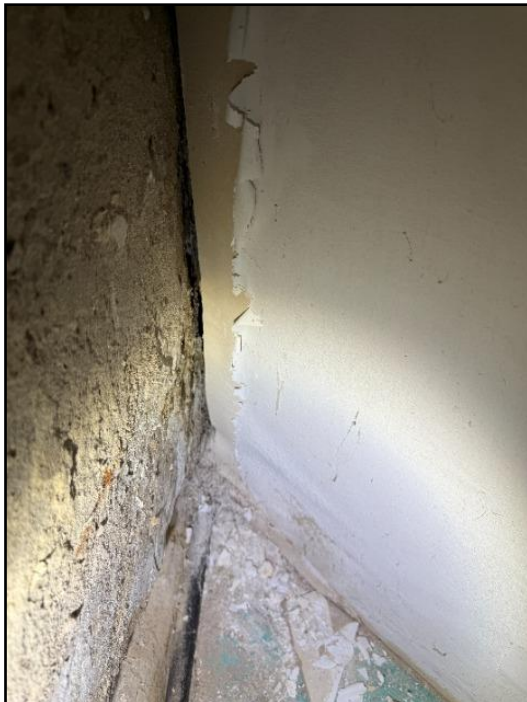
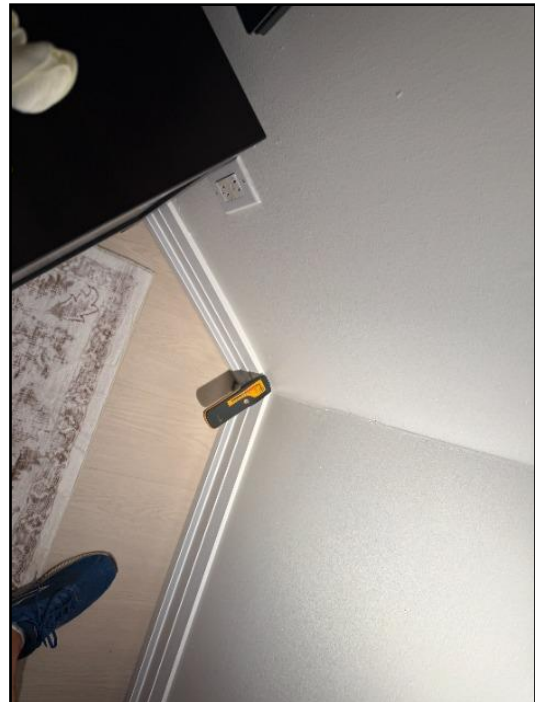
**Condition:** • [Water damage](#)

Moisture was detected at the lower portion of the partition wall in the furnace room and on the opposite side of the wall. The source was not determined.

28. Water damage and wet

29. Opposite side of wall wet

**Task:** Locate source / Correct

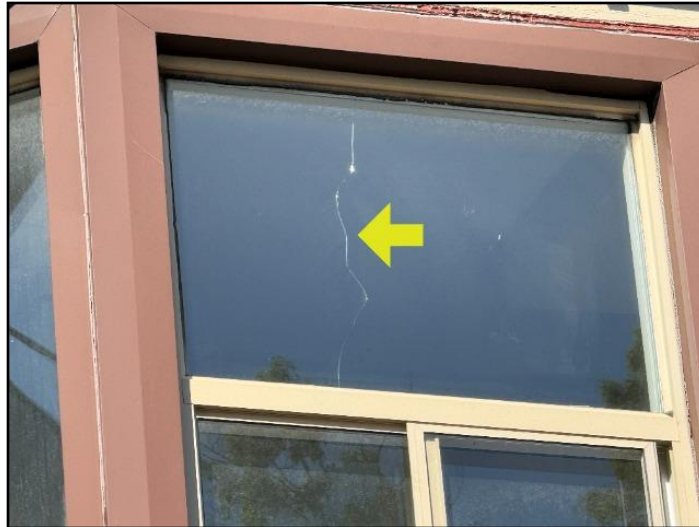
**Condition:** • [Cracked](#)

30. Cracked

**Task:** Replace

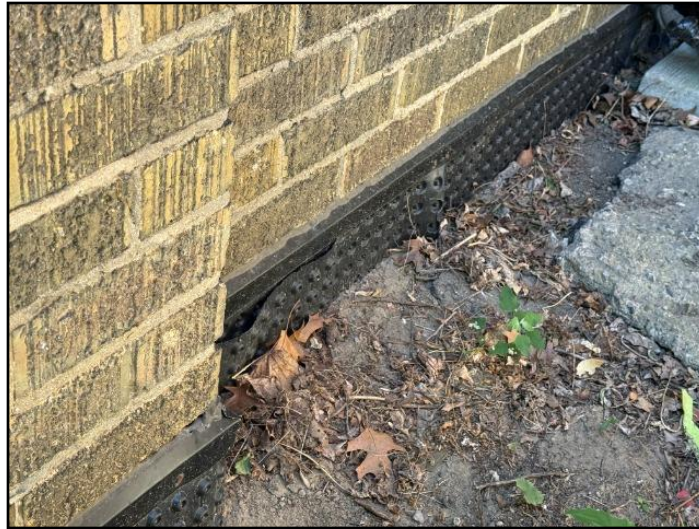
**Condition:** • [New dampproofing material](#)

**Location:** Front Right Exterior

**31.** *New dampproofing material*
