PROPERTY CONDITION ASSESSMENT REPORT

FOR THE PROPERTY AT:
123 Main Street
Medicine Hat, AB T1A 5P6

INSPECTION DATE:
Friday, January 1, 2021

RE: Report No. 1082, v.5
123 Main Street
Medicine Hat, AB
T1A 5P6

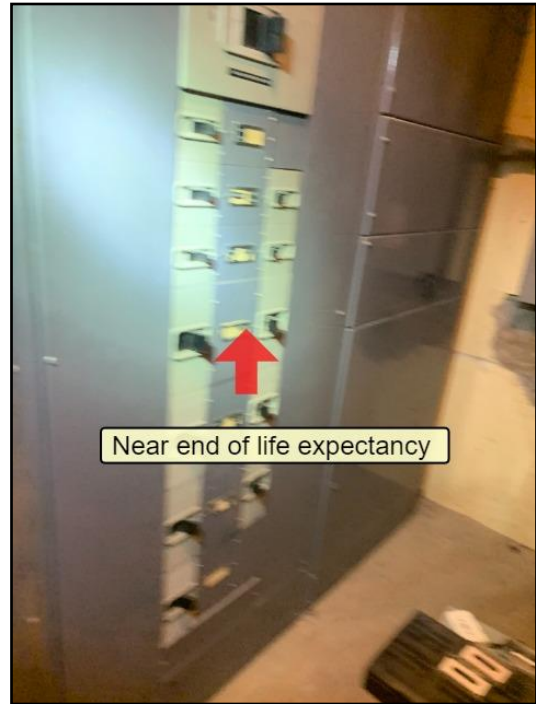
16. Near end of life expectancy

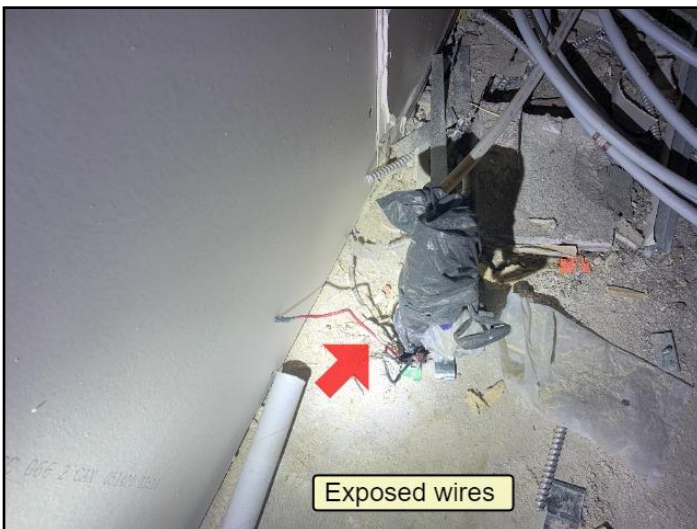
17. Minor deficiencies noted

Cost: \$4,000 - \$6,000

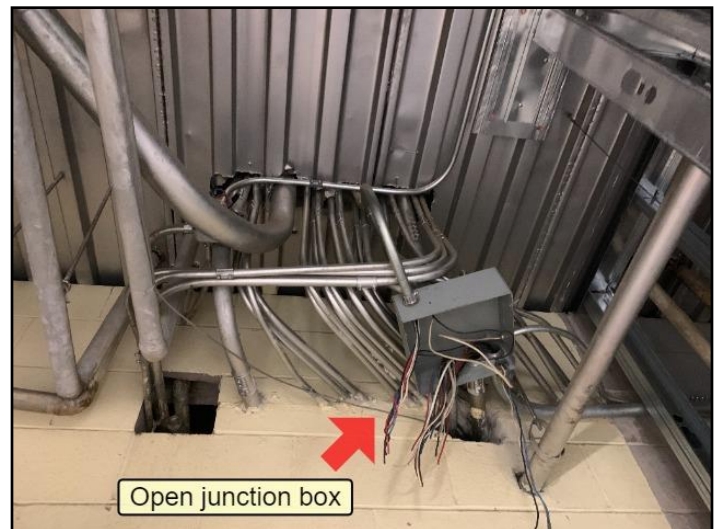
18. Minor deficiencies noted

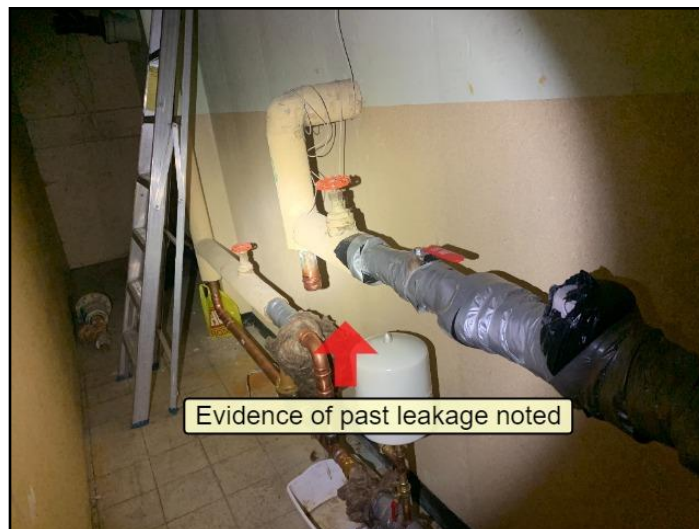
39. Evidence of past leakage noted

Cost: Further investigation \$3,000 | Replac \$20,000 - \$30,000

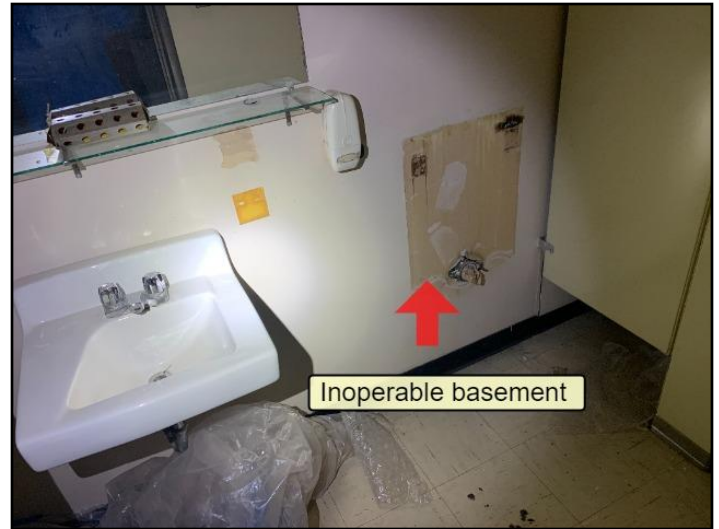
57. Inoperable basement

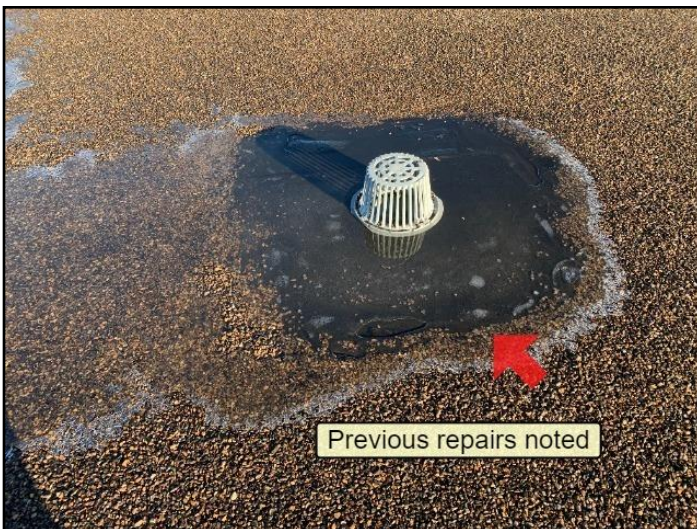
70. *Previous repairs noted*

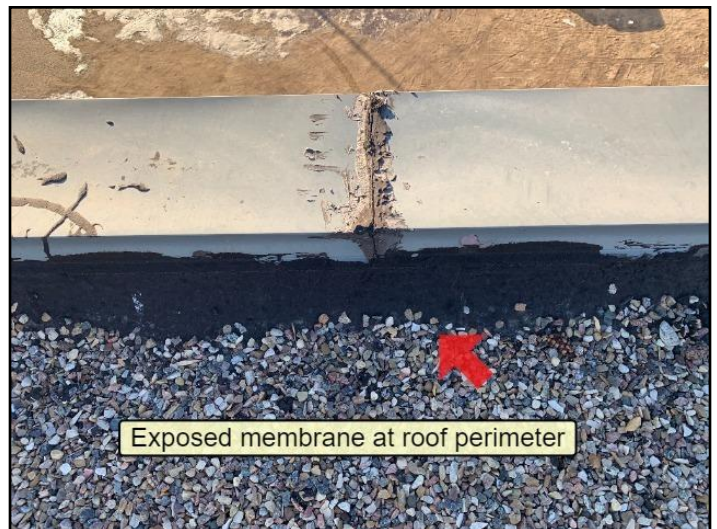
71. *Exposed membrane at roof perimeter*

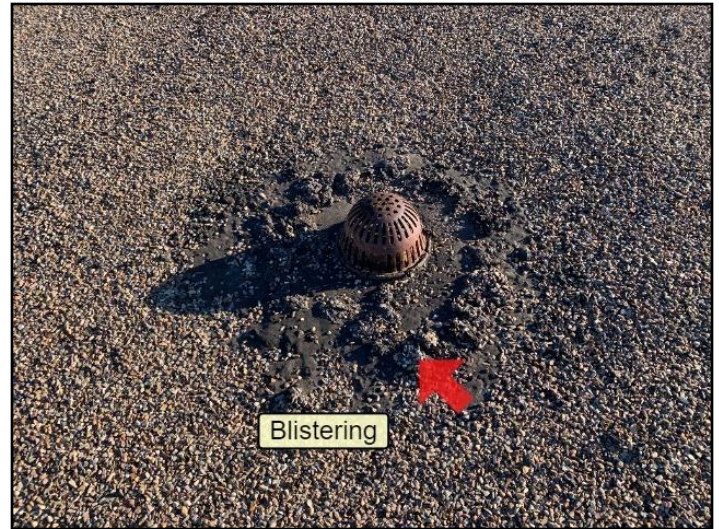
73. Blistering

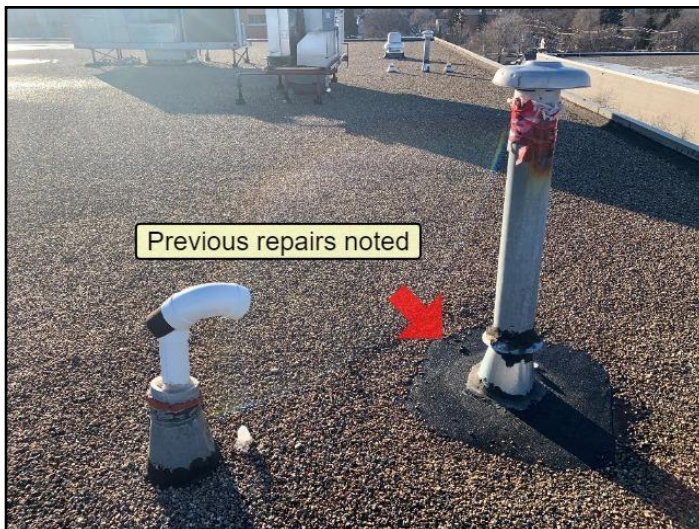
74. Previous repairs noted

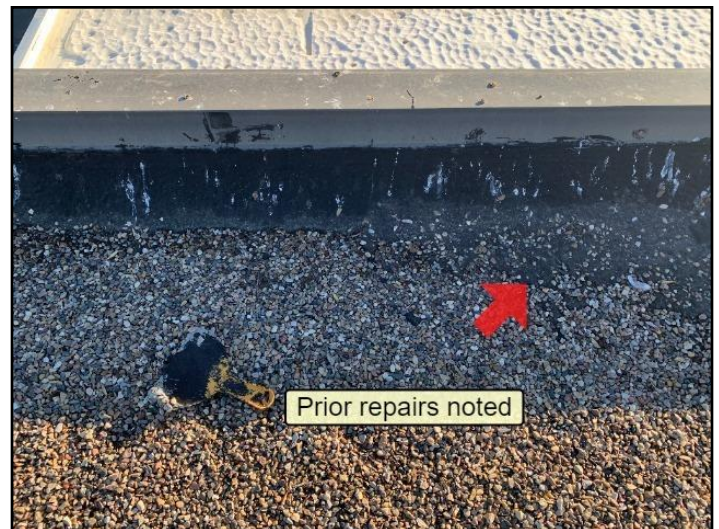
75. Prior repairs noted

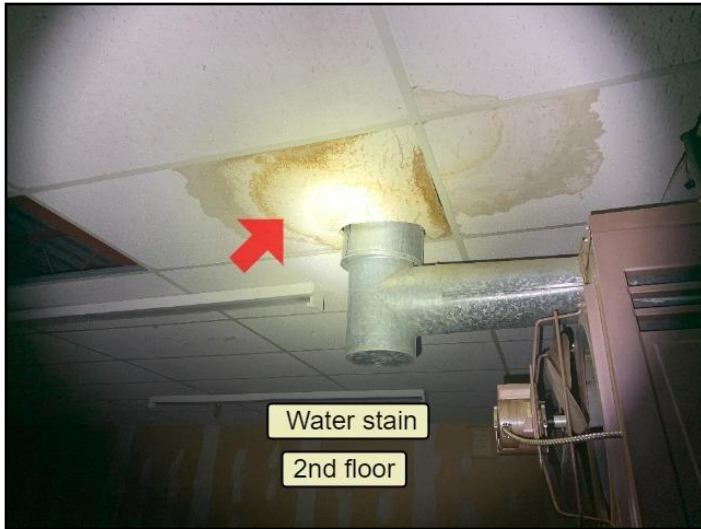
83. Water stain

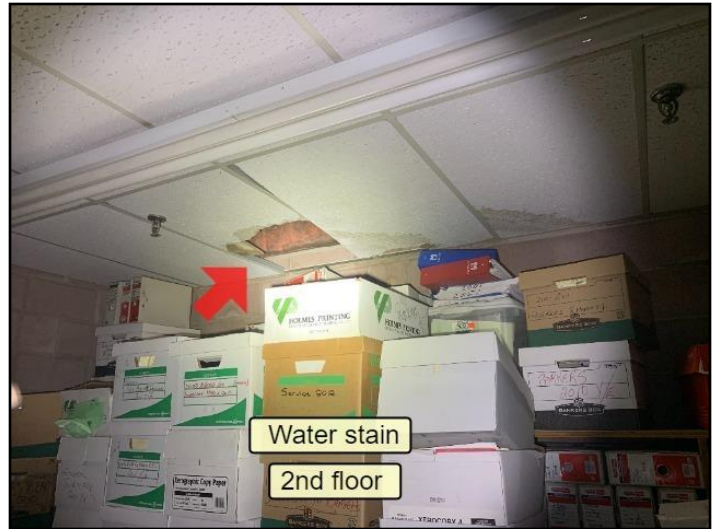
84. Water stain

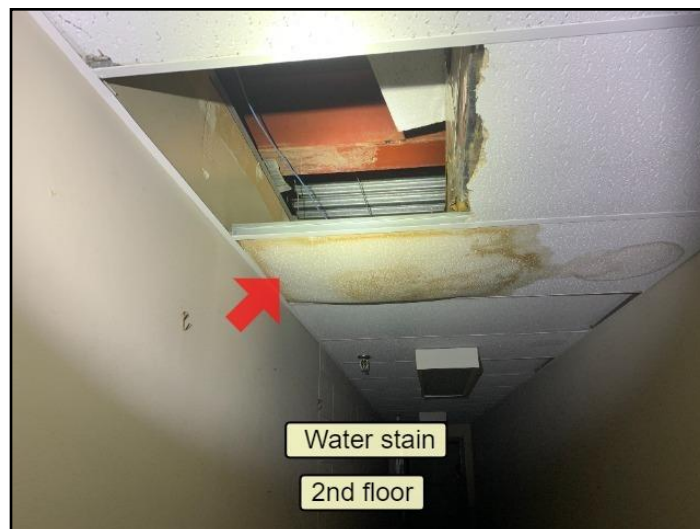
85. Water stain

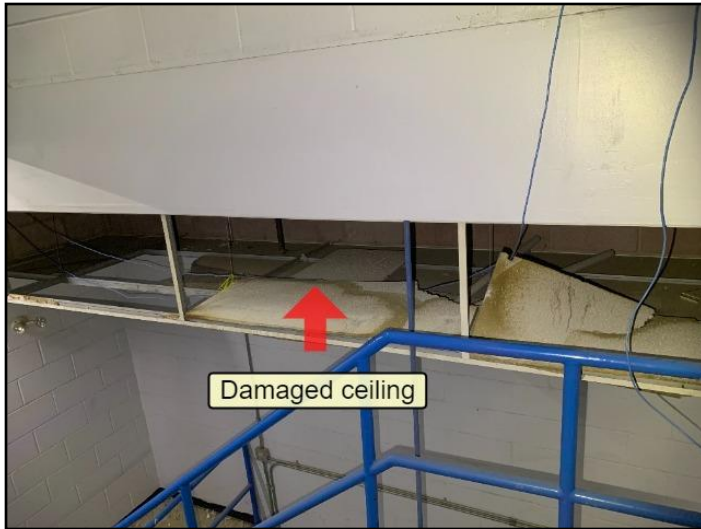
86. Damaged ceiling

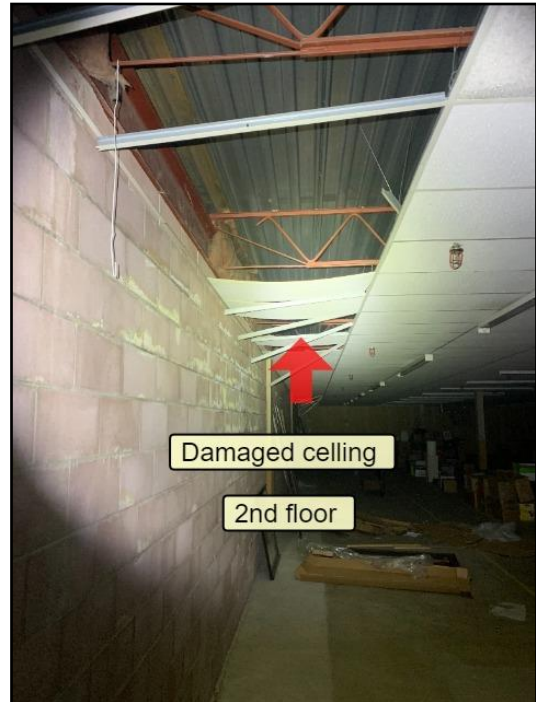
87. Damaged ceiling

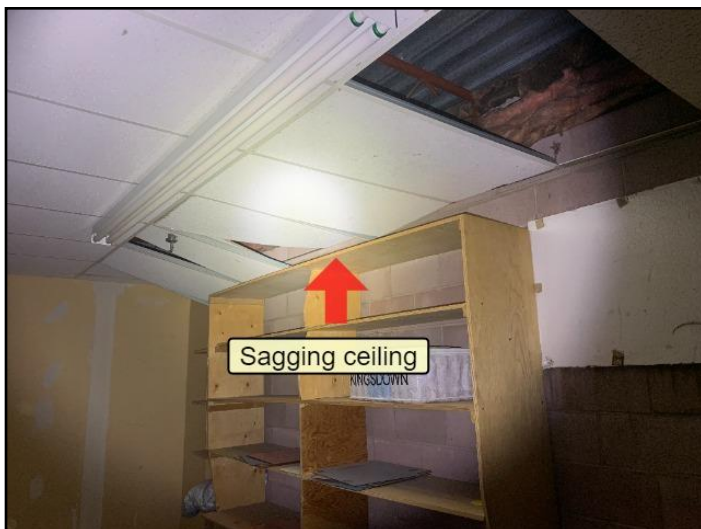
88. Sagging ceiling

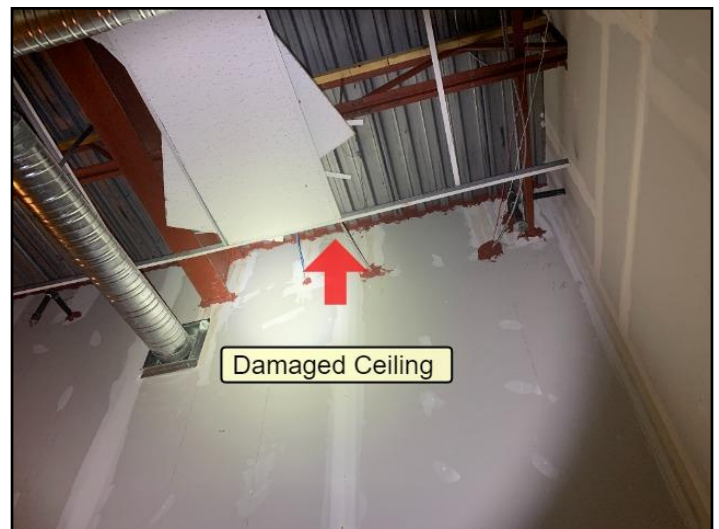
89. Damaged Ceiling

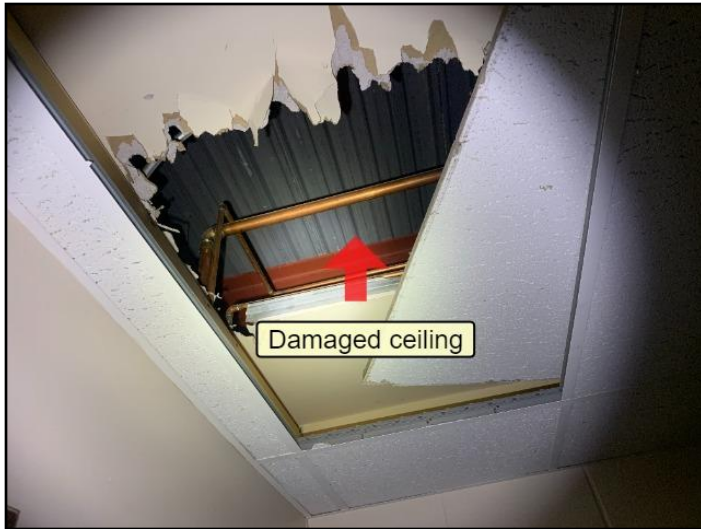
90. Damaged ceiling

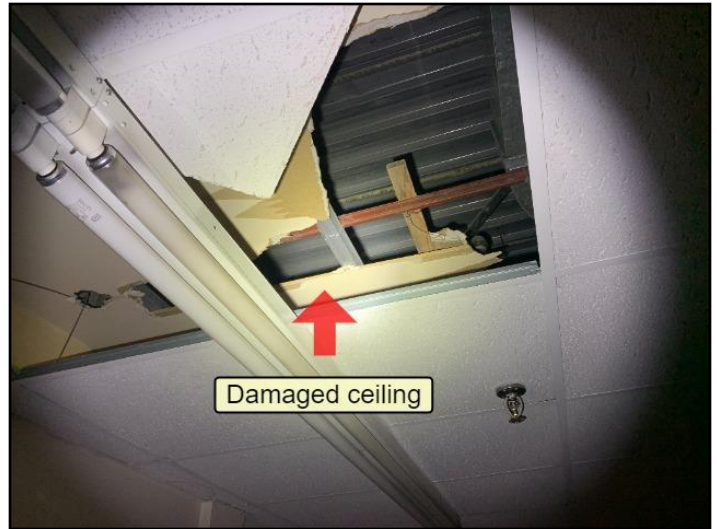
91. Damaged ceiling

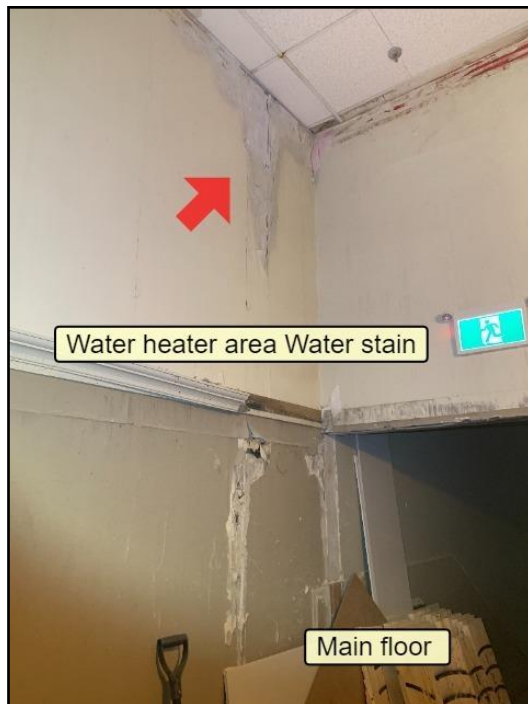
92. Water heater area Water stain

Cost: \$3,000 - \$5,000

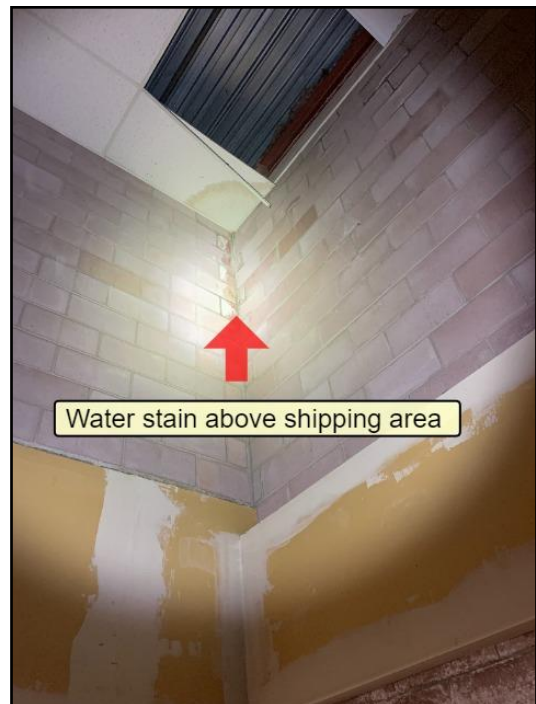
93. Water stain above shipping area

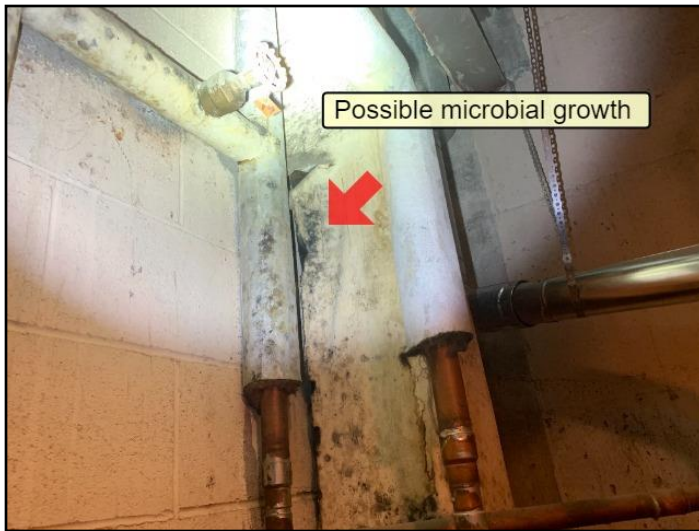
94. Water stain

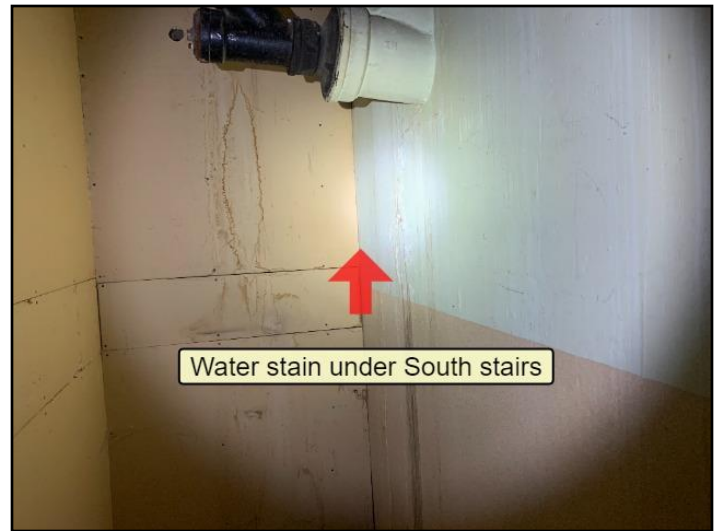
95. Water stain under South stairs

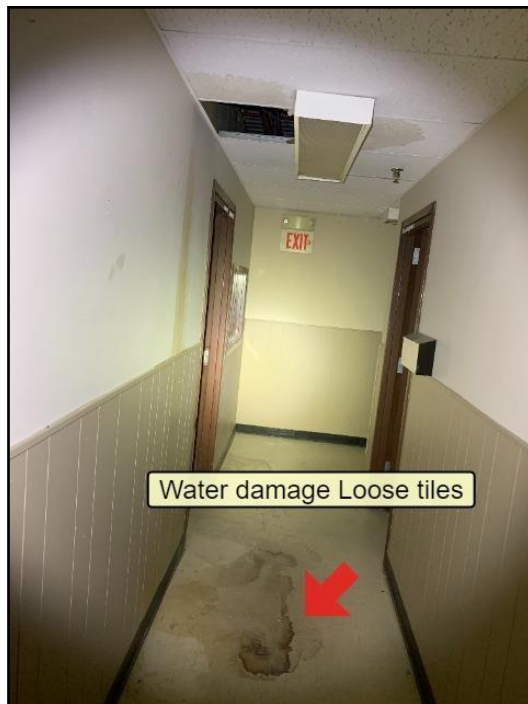
96. Water damage Loose tiles

Cost: \$4,000 - \$6,000

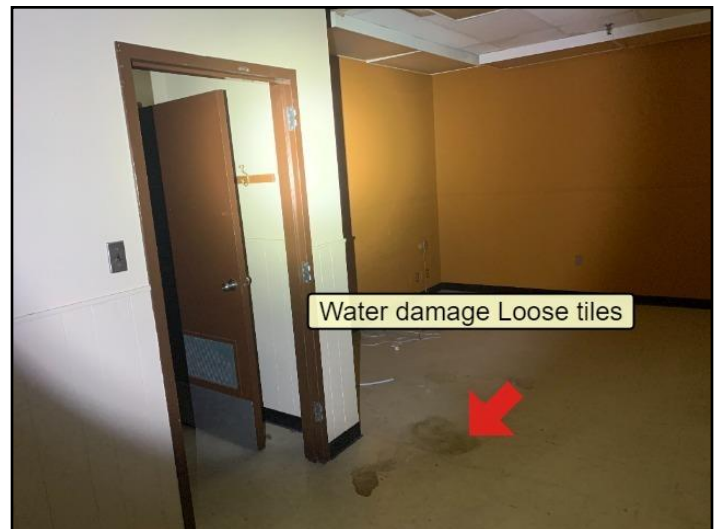
97. Water damage Loose tiles

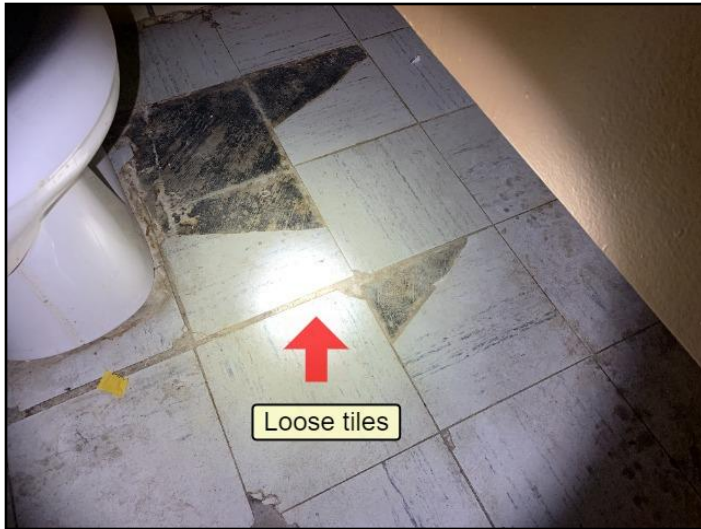
98. Loose tiles

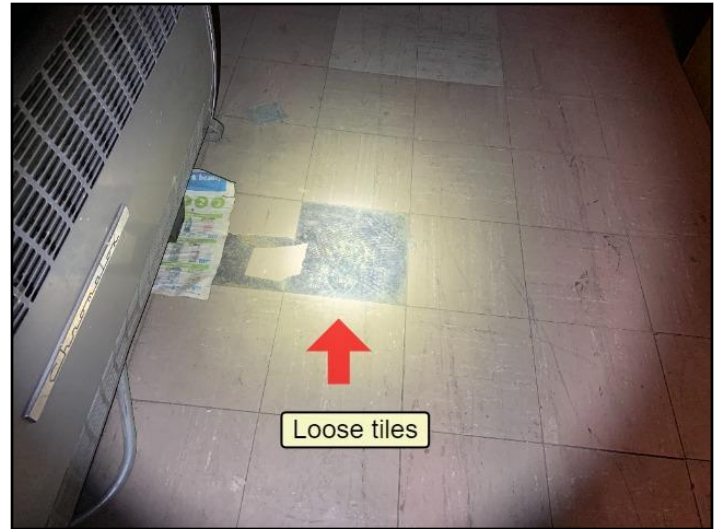
99. Loose tiles

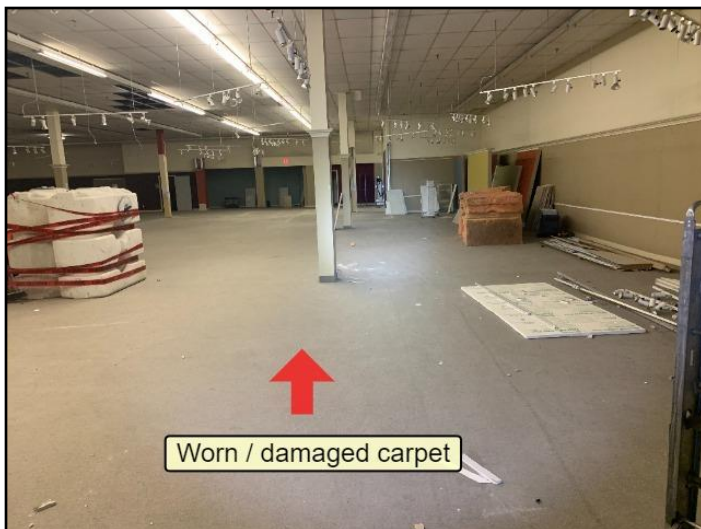
69. Condition: • Worn carpet

100. Worn / damaged carpet

Cost: \$50,000 - \$54,000

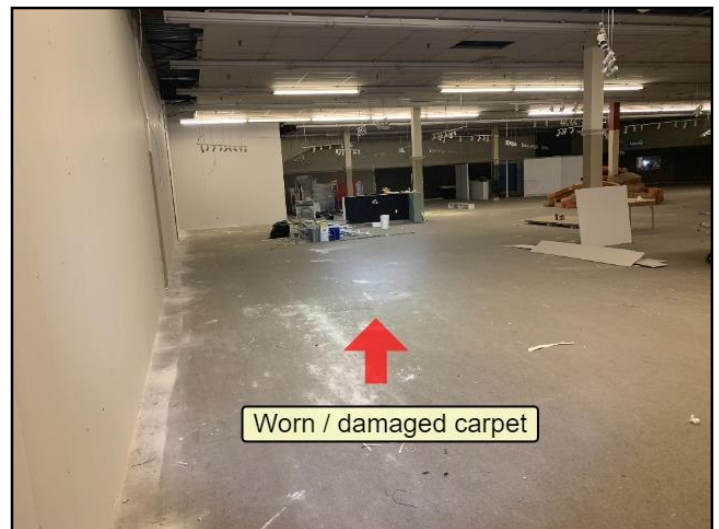
101. Worn / damaged carpet

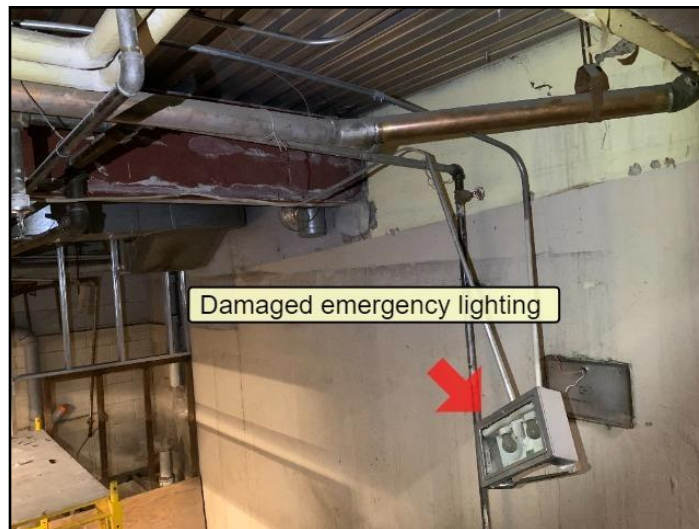
105. Damaged emergency lighting

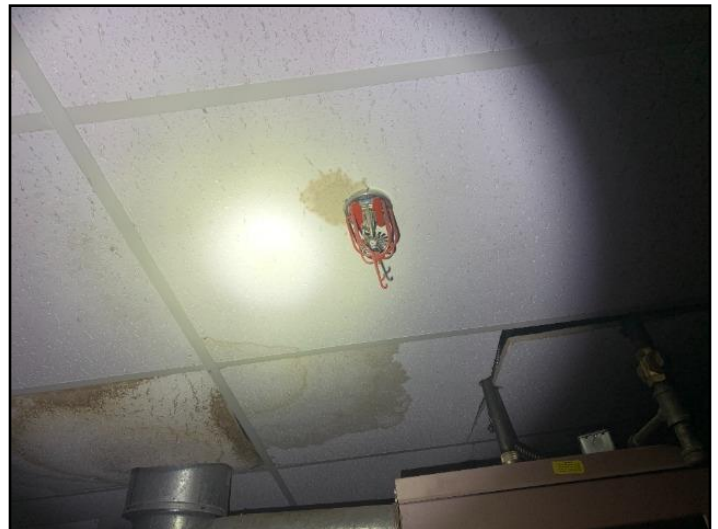
123. Old Fire Alarm system

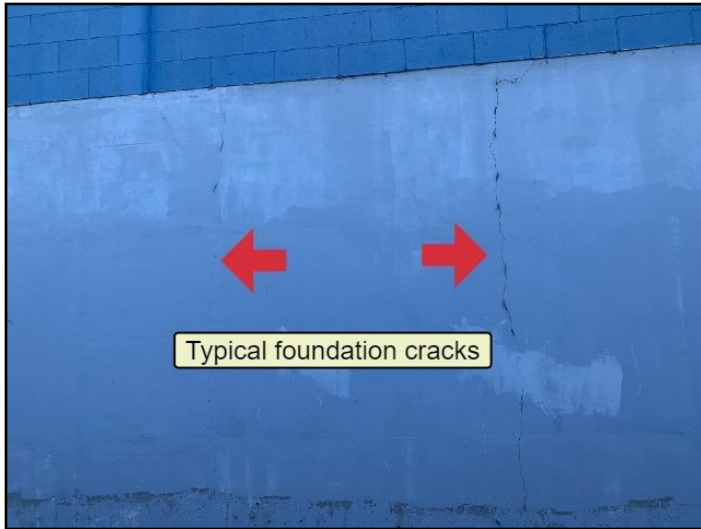
130. Typical foundation cracks

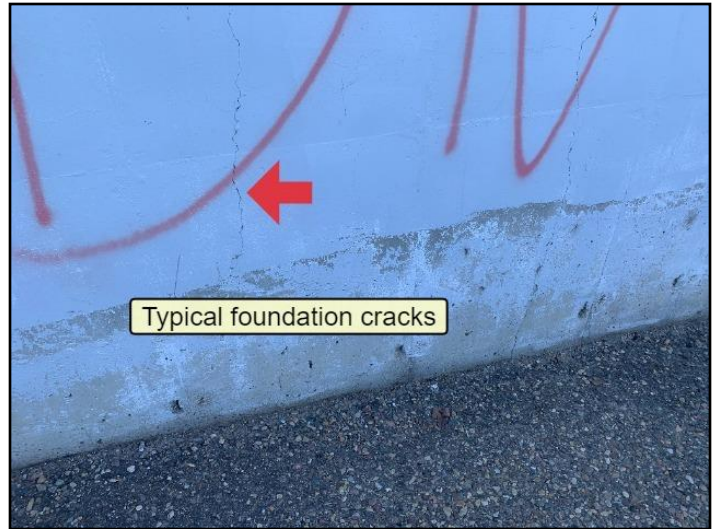
131. Typical foundation cracks

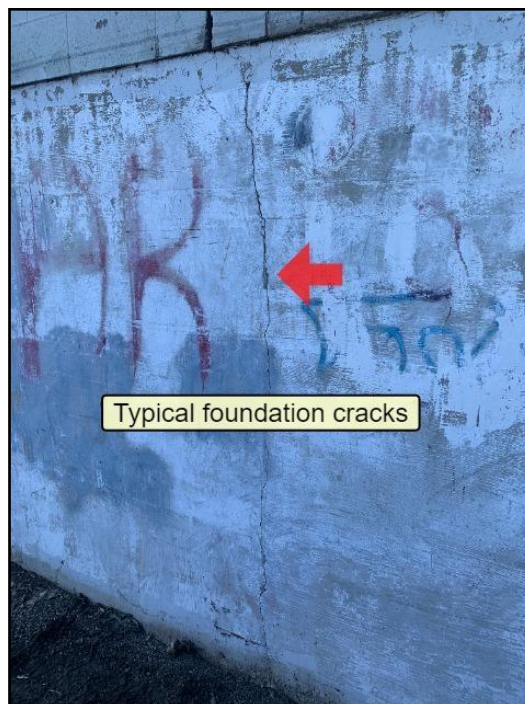
132. Typical foundation cracks

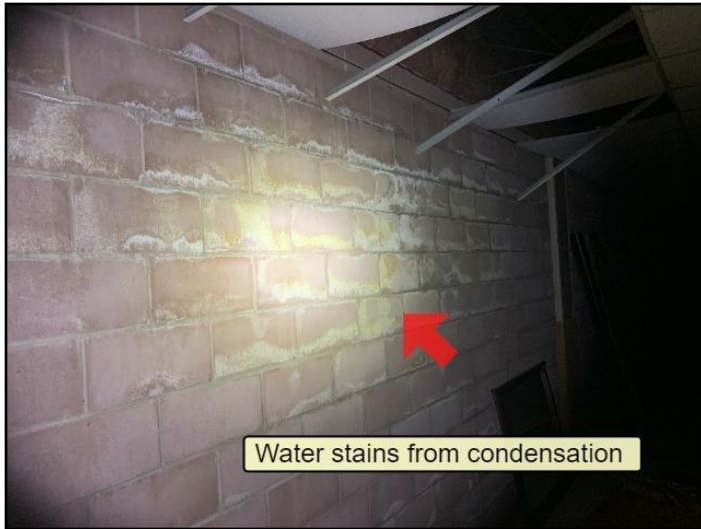
133. Water stains

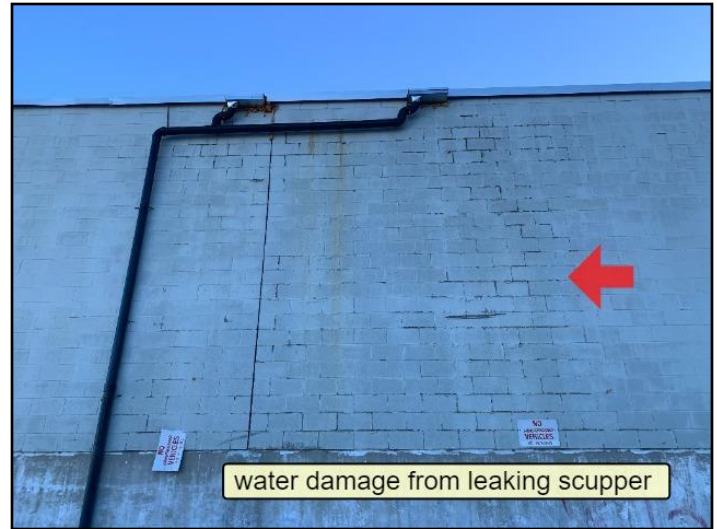
134. Water stains

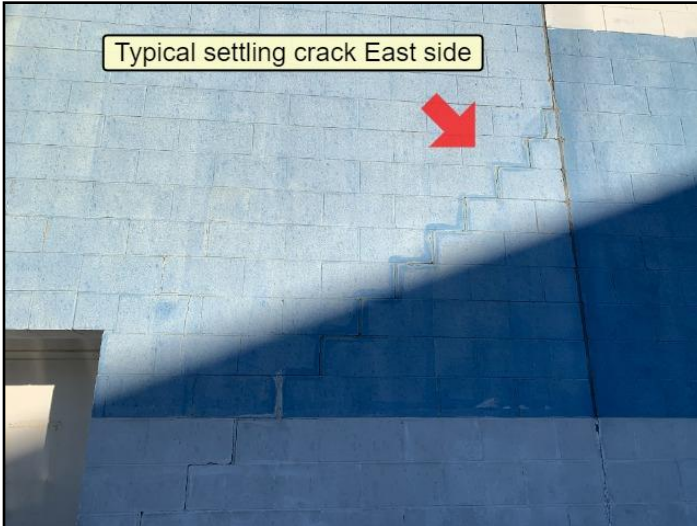
145. Typical settling cracks

Cost: \$4,000 - \$6,000

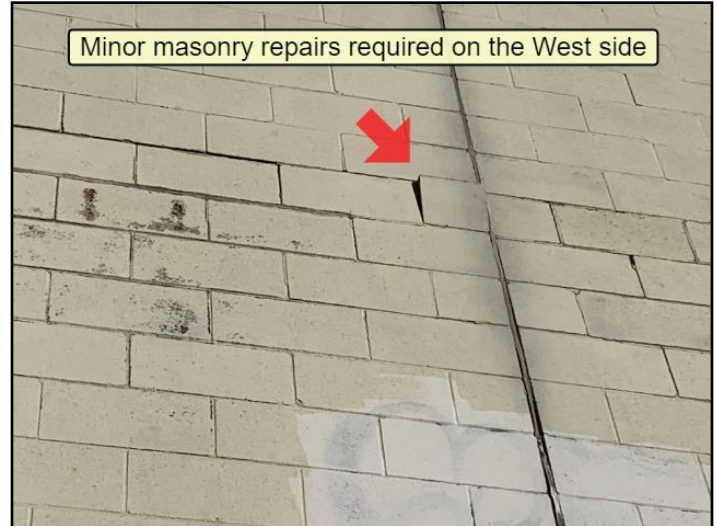
146. Typical settling cracks

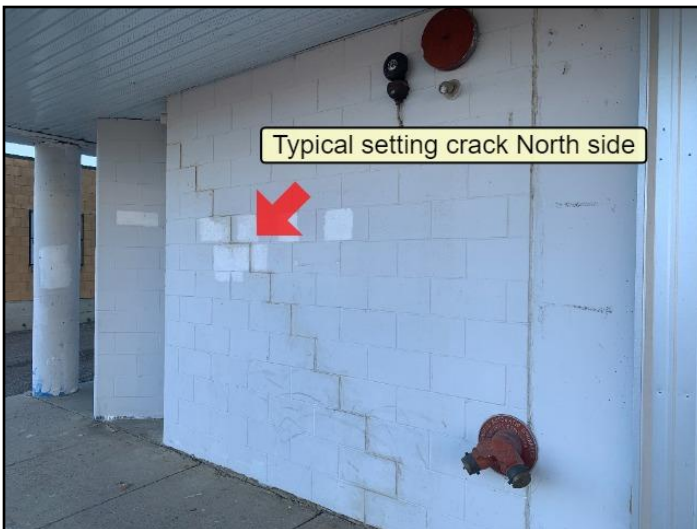
147. Typical settling cracks

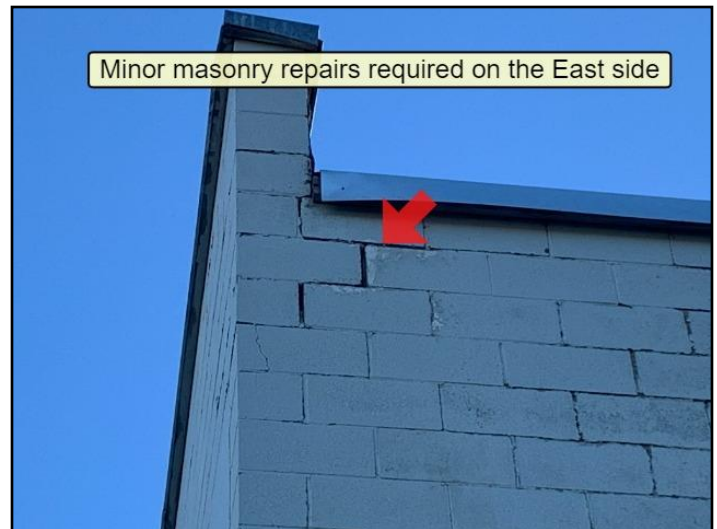
148. Typical settling cracks

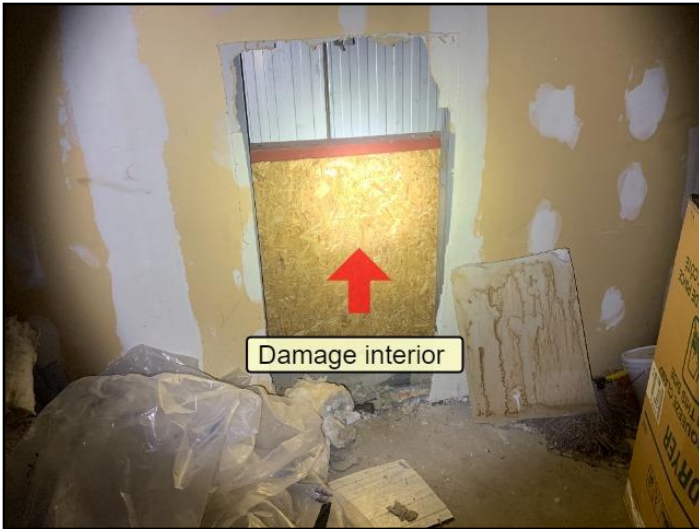
Damage interior

149. Damage interior

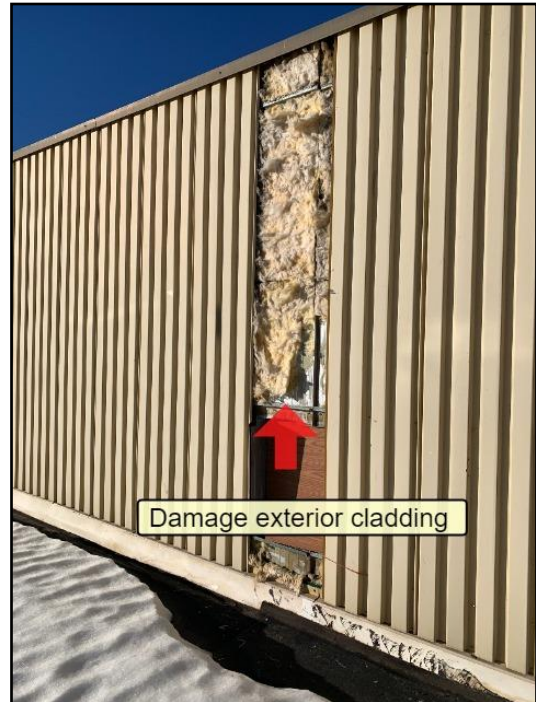
Damage exterior cladding

150. Damage exterior

\$3,000 Repair damaged exterior cladding

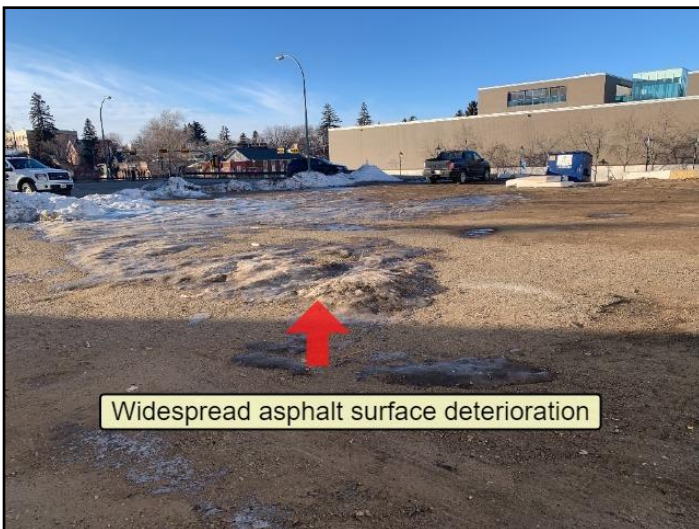
Widespread asphalt surface deterioration

151. Widespread surface deterioration

Cost: \$40,000.00 to \$60,000

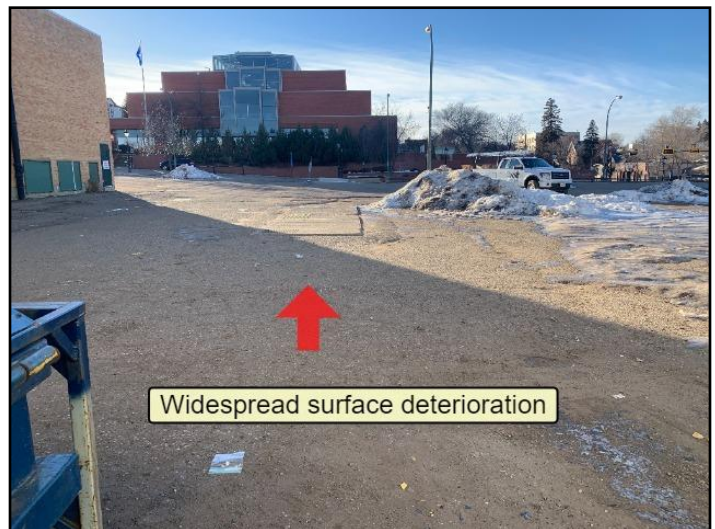
Widespread surface deterioration

152. Widespread surface deterioration
