YOUR INSPECTION REPORT

FOR THE PROPERTY AT:
10 Seaforth Avenue
Toronto, ON M6K 1N5

INSPECTION DATE:
Tuesday, March 23, 2021

RE: Report No. 2860, v.2
10 Seaforth Avenue
Toronto, ON
M6K 1N5

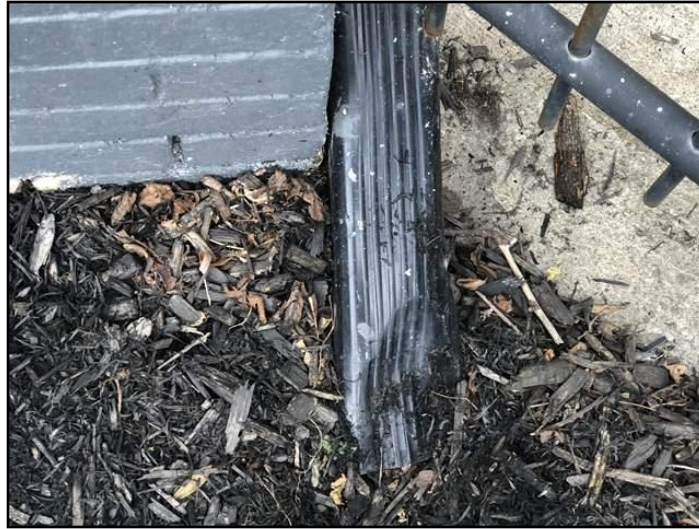
Condition: • [Damage](#)

3. Damage

Task: Repair and extend further away from column

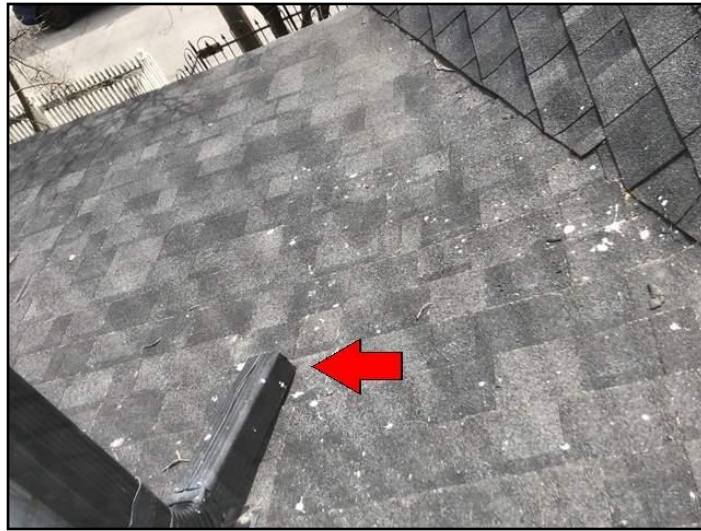
Condition: • [Discharge onto roofs](#)

4. Discharge onto roofs

Improvement recommendation. Extend Downspout to lower gutter to protect roof from premature wear.

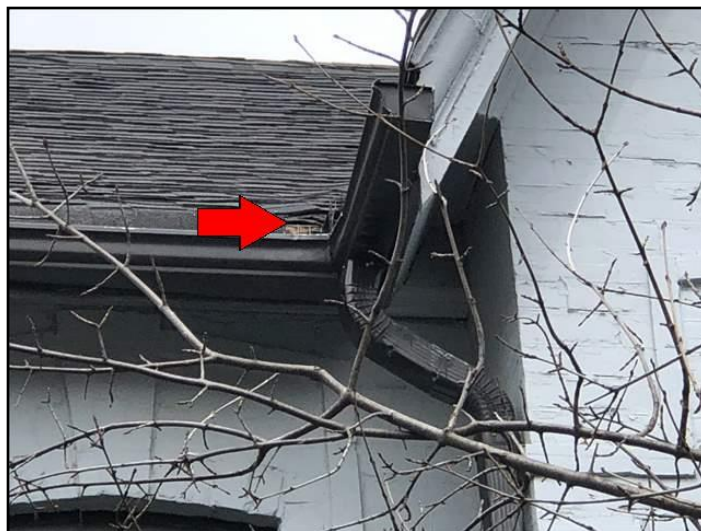
Condition: • Animal Activity

Prior repairs made to prevent animal entry. These types of steel mesh repairs are quite common in Toronto

5. Animal Activity

Task: Monitor

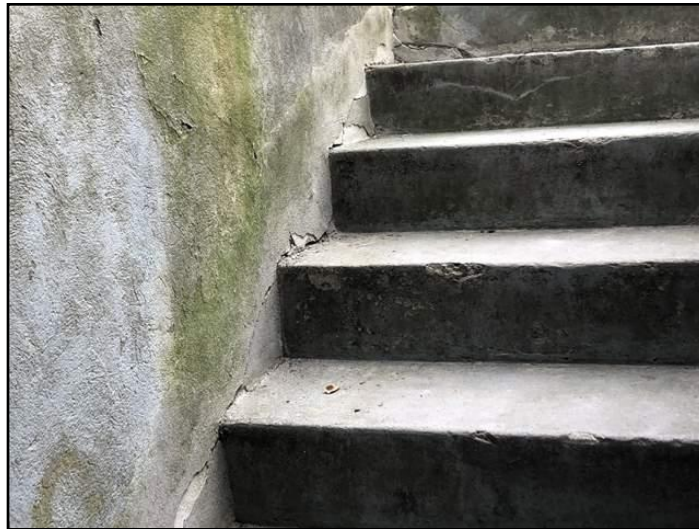
Condition: • [Parging damaged or missing](#)

6. Parging damaged or missing

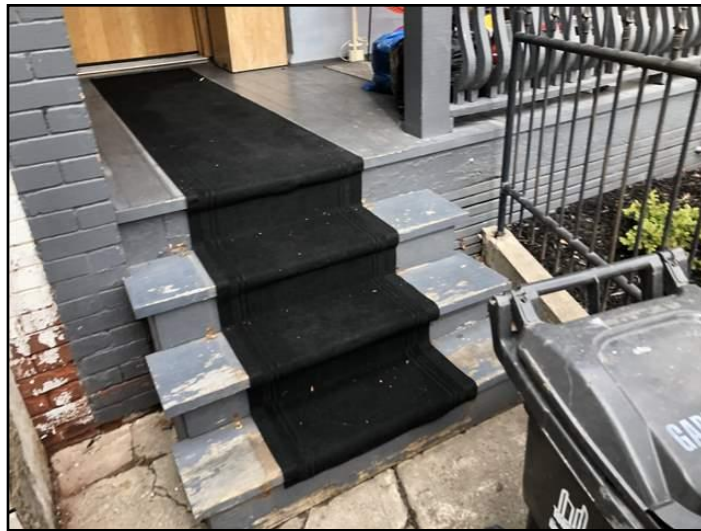
Condition: • [Missing](#)

7. Missing

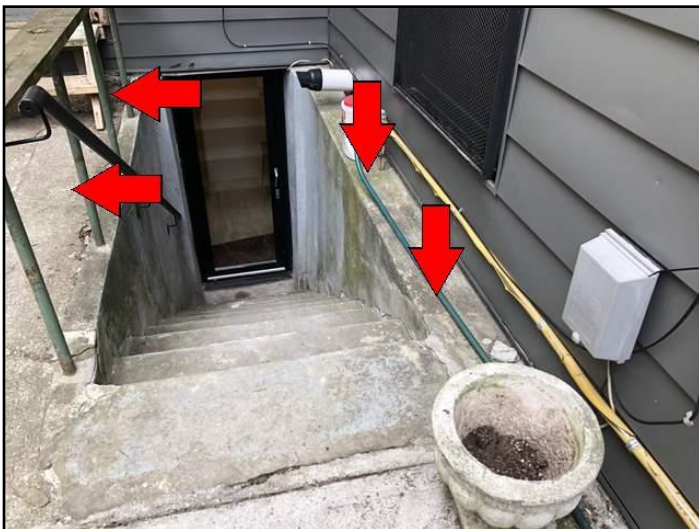
Condition: • [Guard and handrail problems](#)

8. Guard and handrail problems

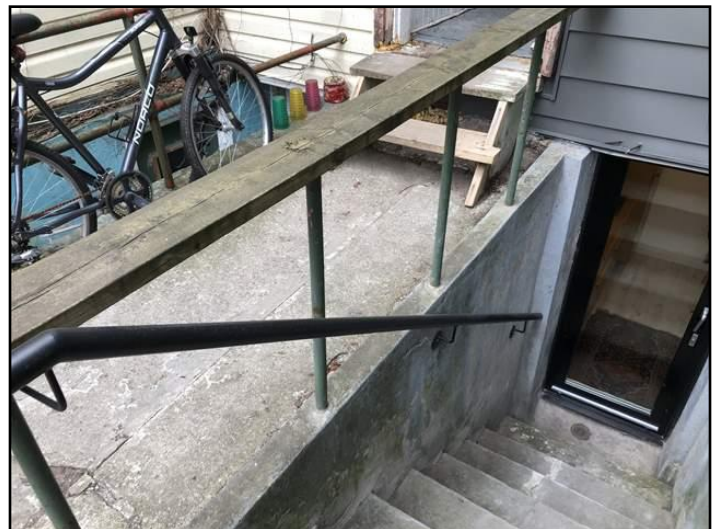
9. Spindles too far apart

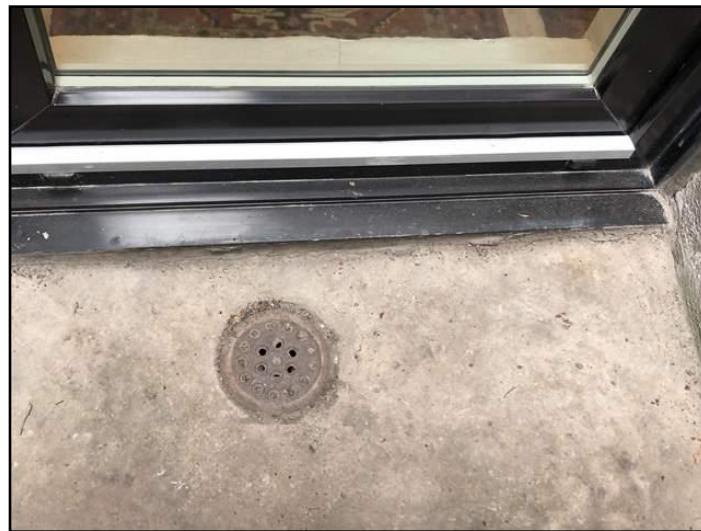
Condition: • [Door threshold missing, too low, not watertight](#)

10. Door threshold missing, too low, not...

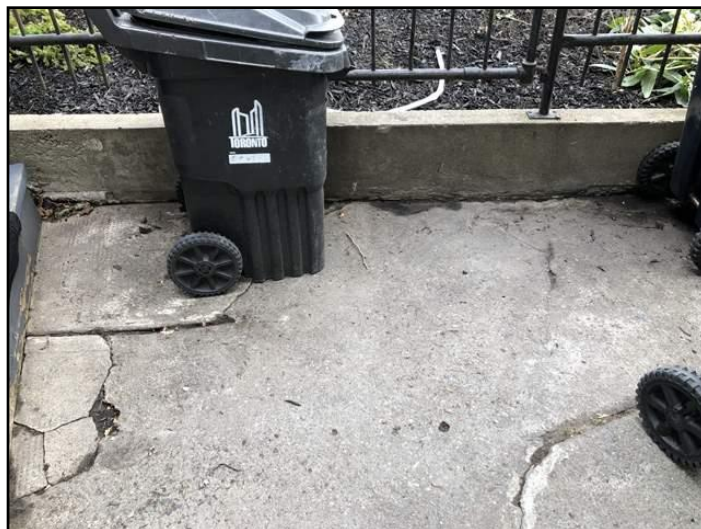
Condition: • [Improper slope or drainage](#)

Walk/patio sloping towards house

11. Improper slope or drainage

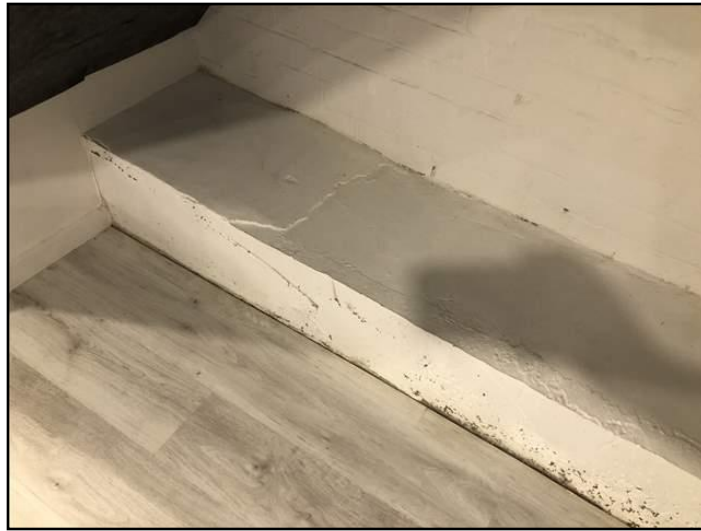
Condition: • [Basement lowered](#)

This is noted for your information only. Bench Footing noted, which is one of the common methods used to lower basements.

12. Bench footing

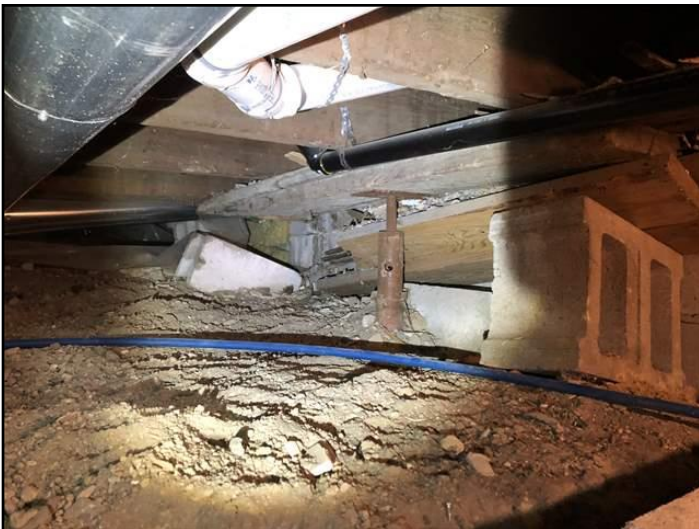
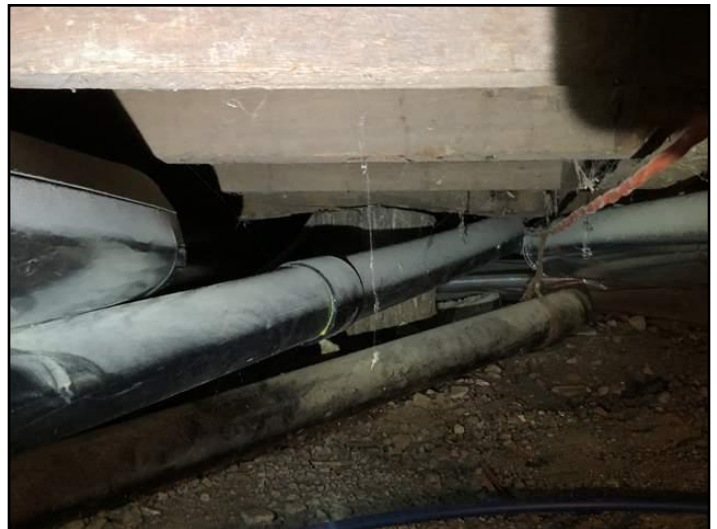
Condition: • [Prior repairs](#)

Temporary columns, A.K.A. jack post was observed in crawlspace These are intended for short term use. Modifications should be made to provide posts for long term use. Have contractor evaluate and advise. Also various material such as concrete blocks and tree stumps were used in various areas to level floors. At some point in near future, have contractor review crawlspace supports/structure and update as needed.

13. Prior repairs

14. Prior repairs

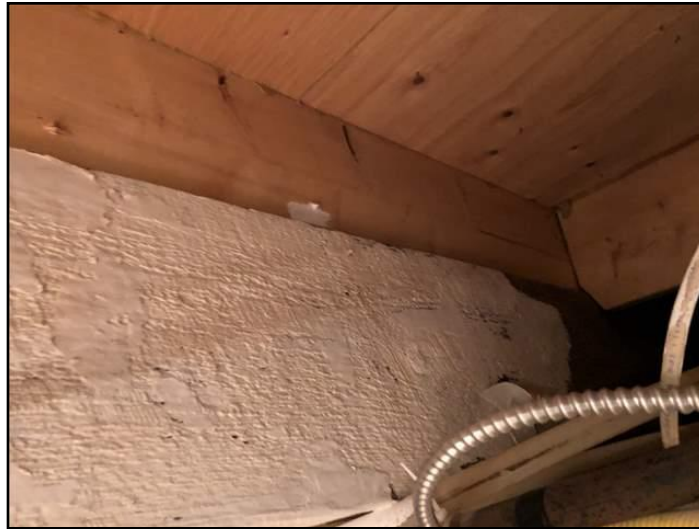
Condition: • [Prior repairs](#)

Major repairs of joists observed in some areas. Seller noted that repairs/modifications were made during major renovations.

15. example

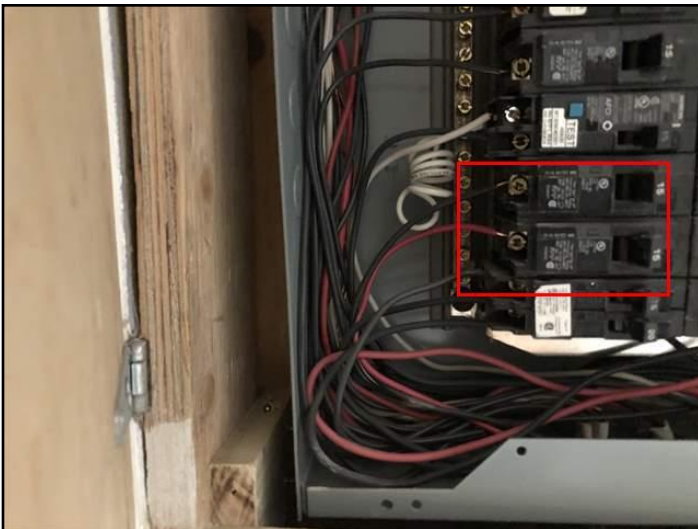
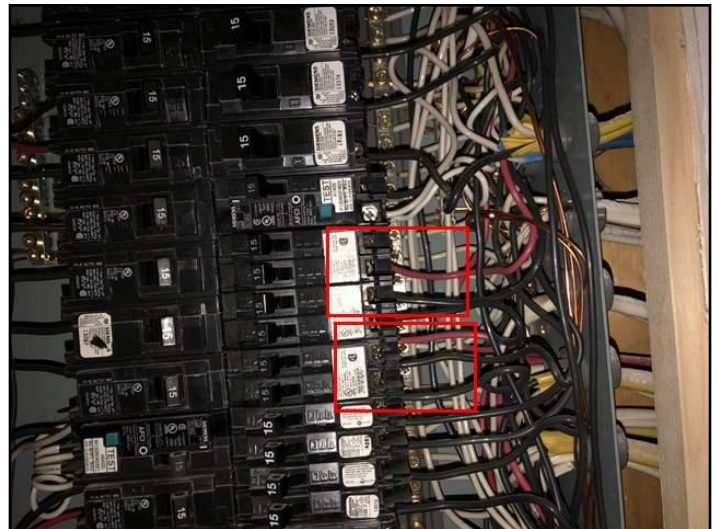
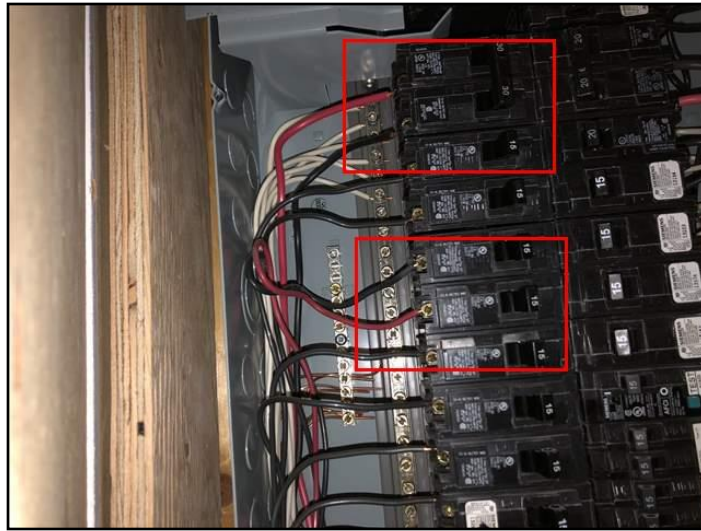
Condition: • [No links for multi-wire circuits](#)

**17.** No links for multi-wire circuits

**18.** No links for multi-wire circuits

19. No links for multi-wire circuits

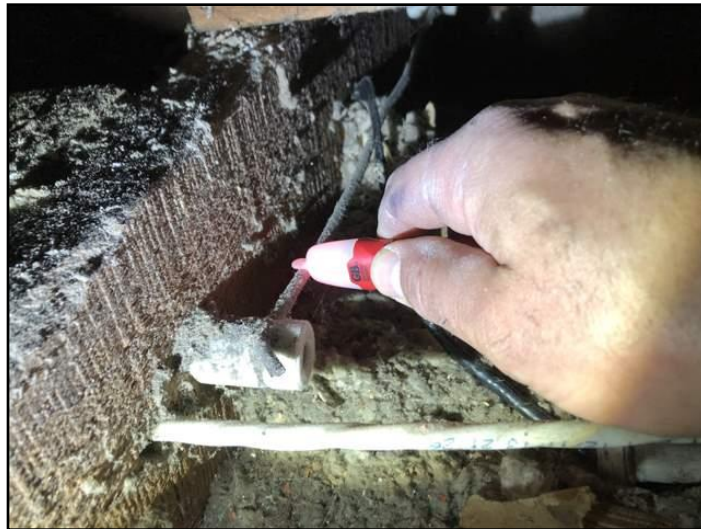
20.

Condition: • The home has undergone renovations and wiring upgrades throughout. The panel contains modern wiring. All the outlets we tested were grounded. We found one line of knob and tube near the attic hatch that was live. Verifying if the amount of knob tube present is outside the scope of work.

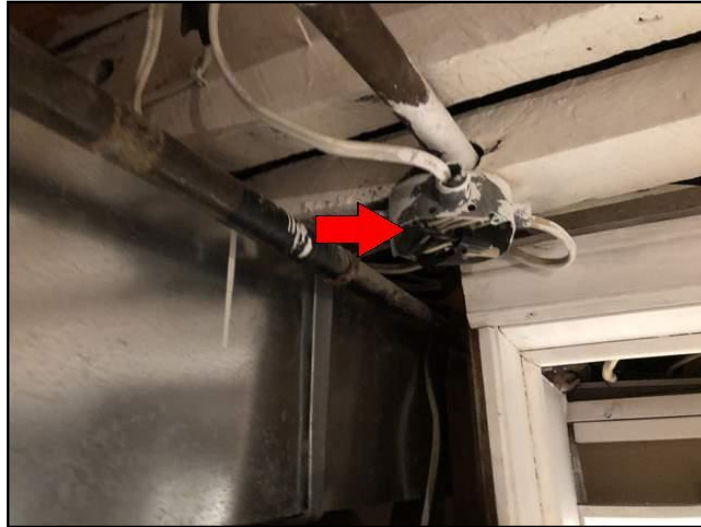
Condition: • [Cover loose or missing](#)

21. Cover missing

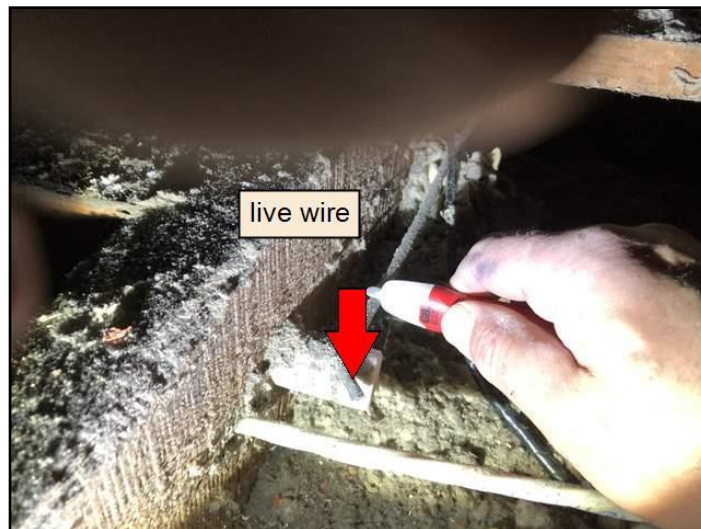
Condition: • [Missing](#)

22. Missing

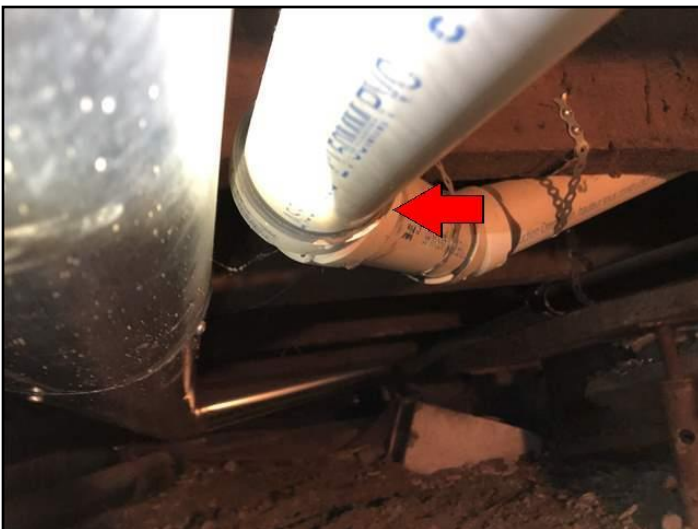
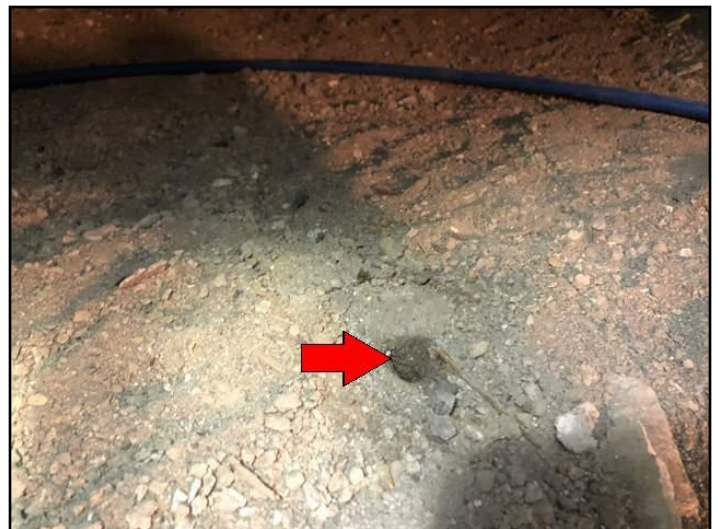
Condition: • [Poor connections](#)

Minor leak of exhaust condensation noted at vent connector. See photo.

23. Poor connections, minor drip from exhaust

24. Poor connections

Task: Repair connection

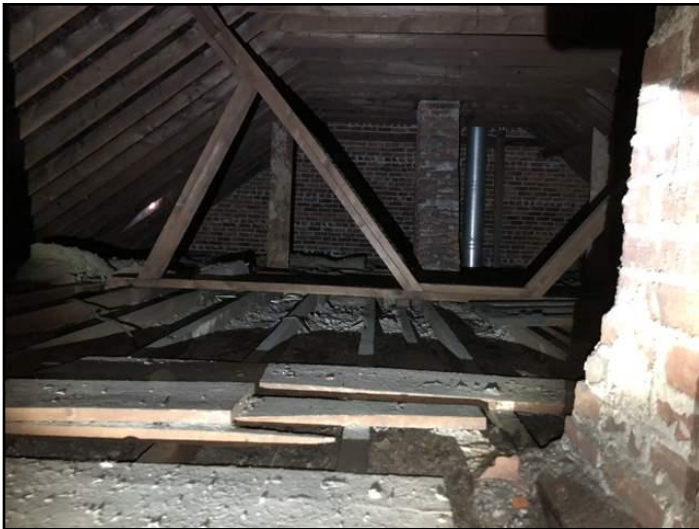
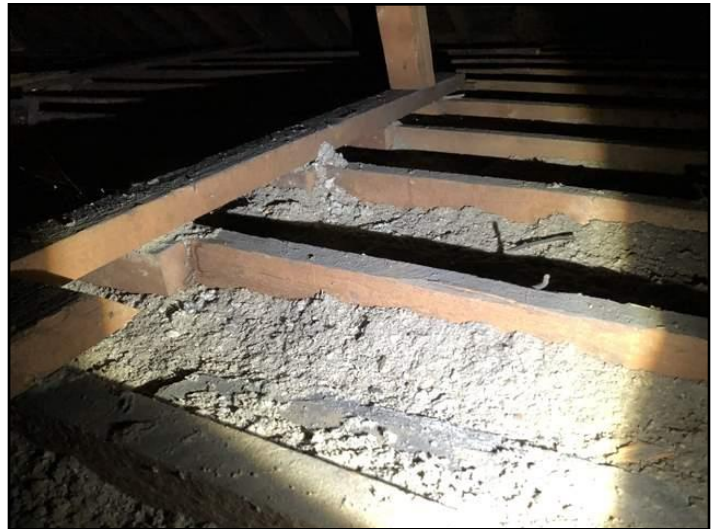
Condition: • [Amount less than current standards](#)

25. Amount less than current standards

26. Amount less than current standards

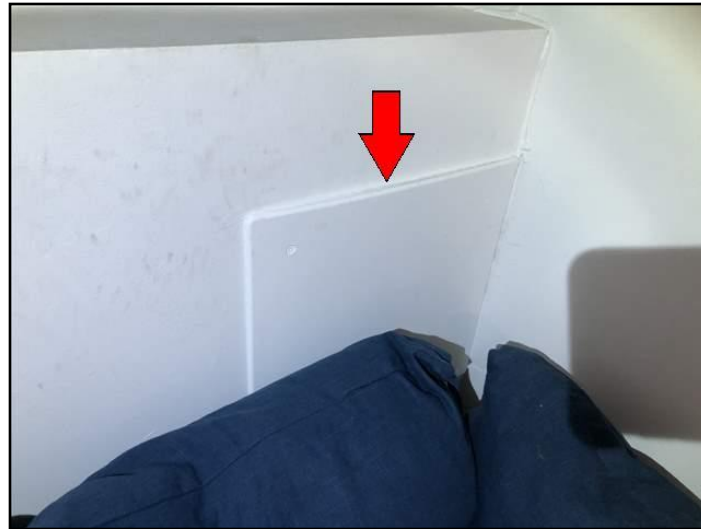
Condition: • [Inaccessible](#)

27. Inaccessible

Task: Provide access to water main shut off

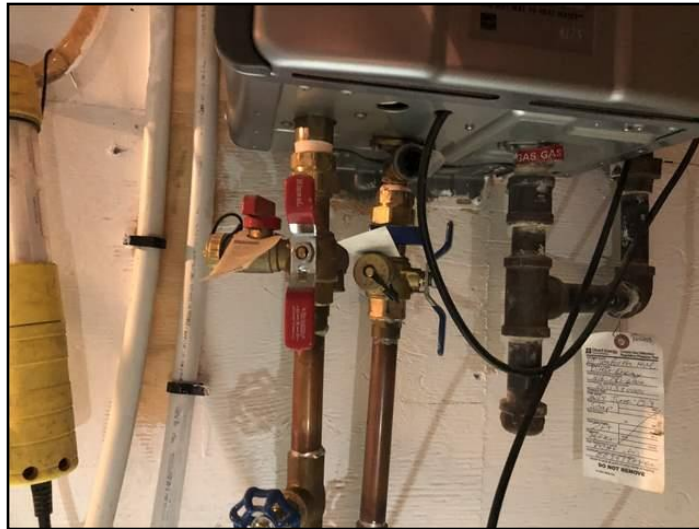
Condition: • [Missing](#)

28. Missing

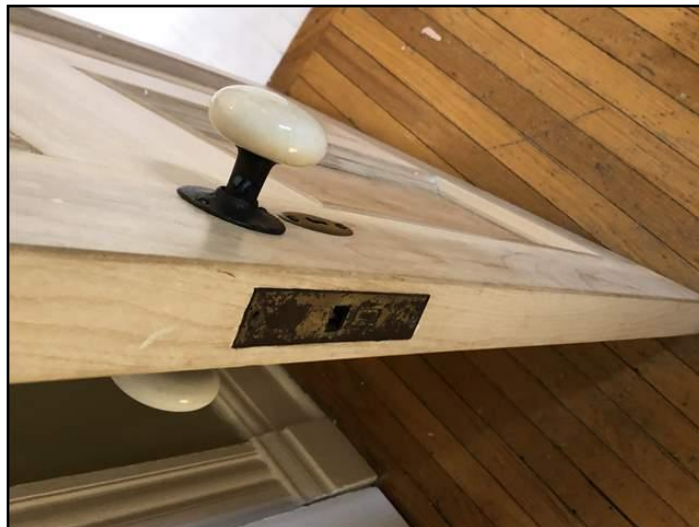
Condition: • [Inoperable](#)

29. Inoperable

Task: Repair

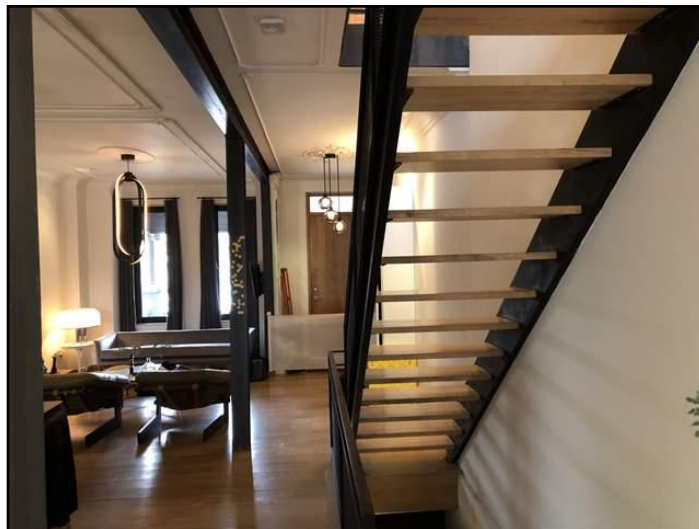
30.

Condition: • Open tread design. Take precautions with small children
