YOUR INSPECTION REPORT

98 Willingdon Boulevard
Toronto, ON M8X 2H7

INSPECTION DATE:
Thursday, January 31, 2019

RE: Report No. 2395
98 Willingdon Boulevard
Toronto, ON
M8X 2H7

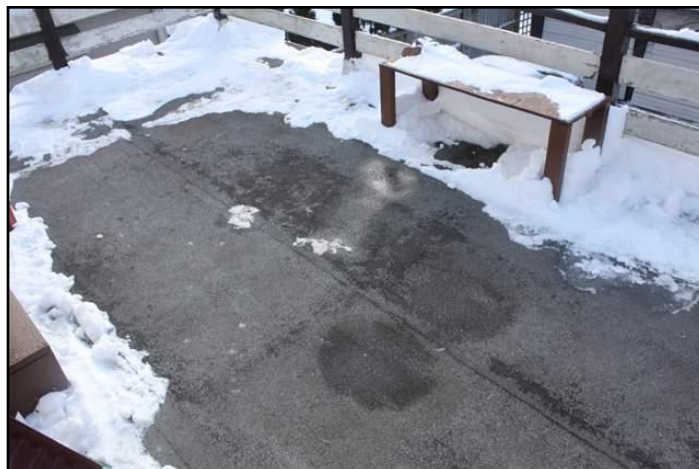
Condition: • [Loss of granules](#)

Granule loss is a normal occurrence as roof covering ages. The flat roof is reported by homeowner to be approx. 10 years old. The granule loss was likely caused by wear and tear from being walked on.

Implication(s): Chance of water damage to contents, finishes and/or structure

1. Loss of granules

Task: Further evaluation

Time: In spring when all snow has melted

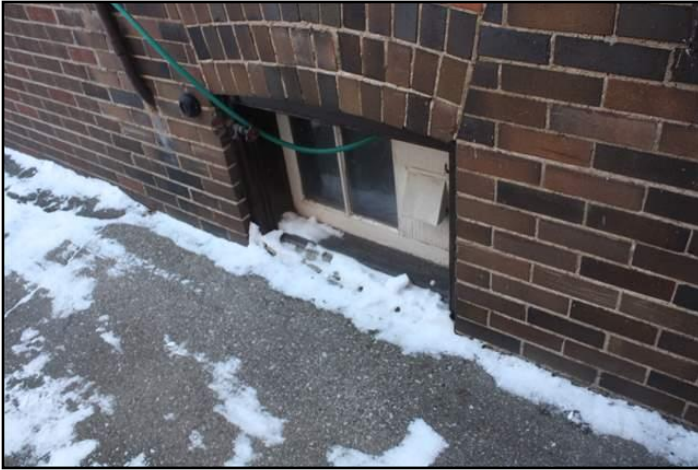
Condition: • Sill - Near or at Grade Level

2. Sill - Near or at Grade Level

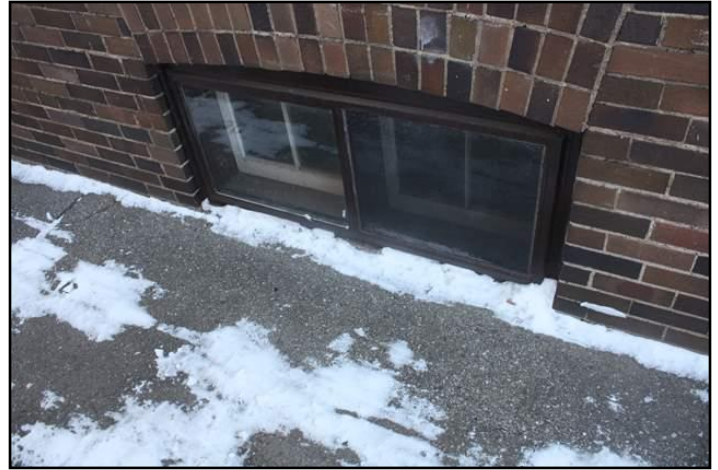
3. Sill - Near or at Grade Level

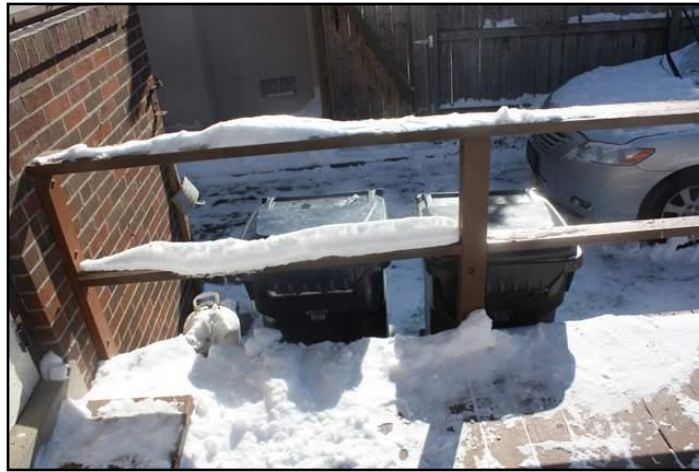
Condition: • [Spindles \(balusters\) climbable](#)

Implication(s): Fall hazard

4. Spindles (balusters) climbable

Time: Less than 1 year

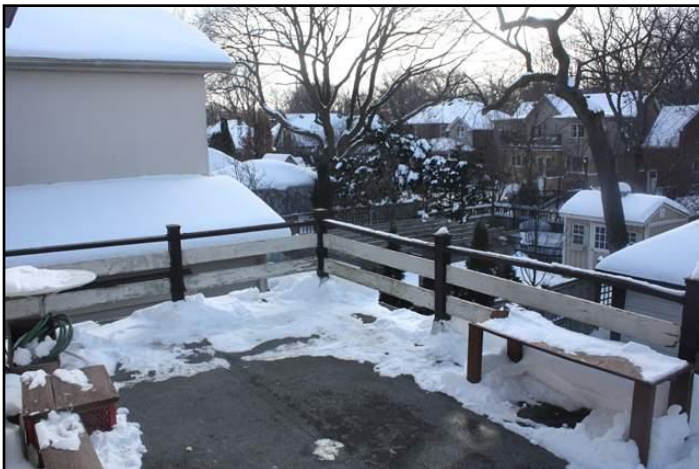
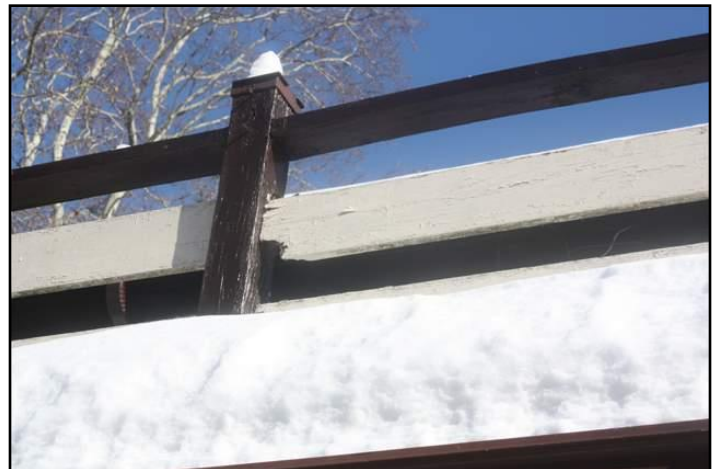
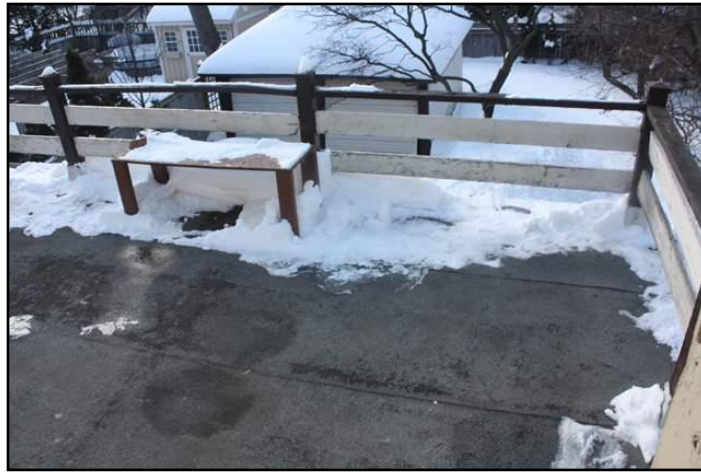
Condition: • Rot

Ineffective guardrails. Weak, rotted and climbable. Unsafe

Implication(s): Fall hazard

5. Rot

6. Rot

7. Rot

Task: Replace

Time: Prior to first use / As soon as possible

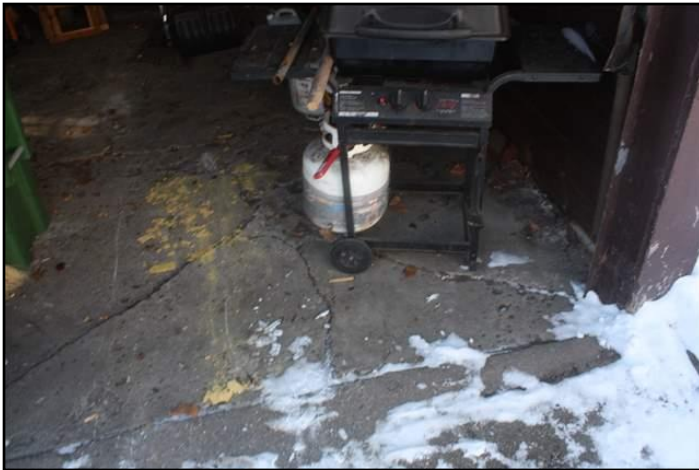
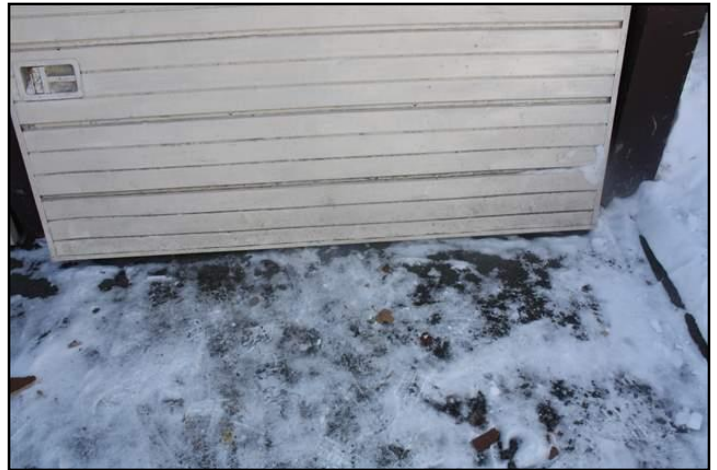
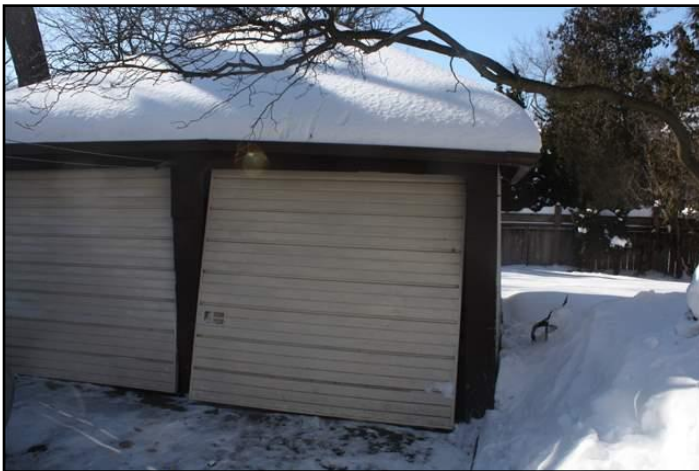
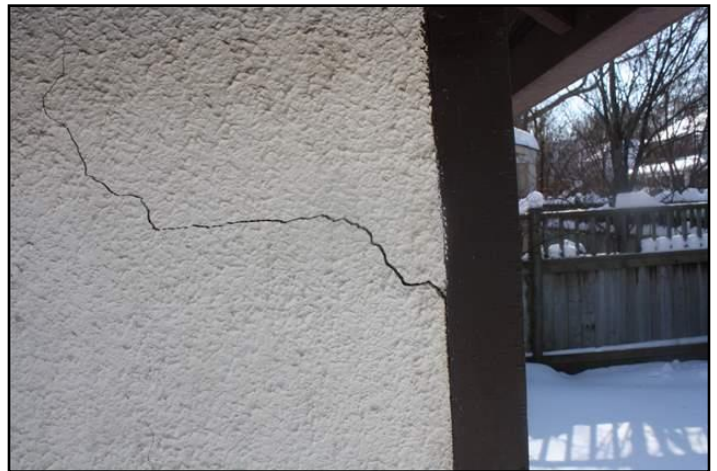
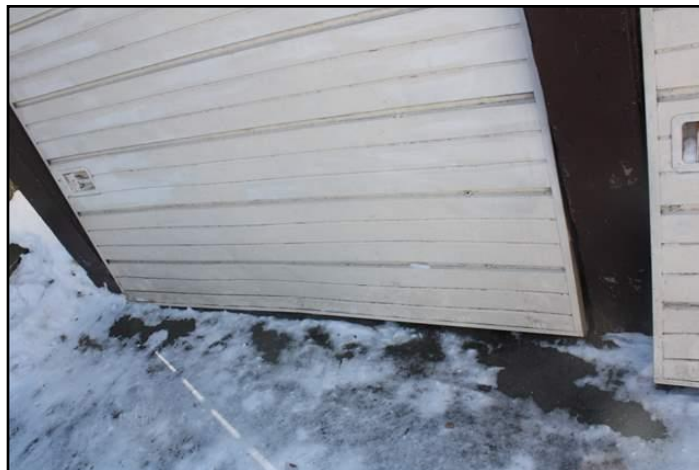
Condition: • Typical low quality structure

This is a typical very old garage commonly found in Toronto. The concrete floor is cracked and displaced. The garage structure has moved / settled / cracked, therefore the garage doors no longer close. Some of the interior studs show rot at the bottom. We also observed prior repairs. We cannot determine on a one-time visit if movement is still active. Replacement garages are expensive, therefore most people choose to repair/reinforce garage ongoing. Consult with a contractor to discuss whether measures are needed to reinforce/stabilize the garage or replace fully

8. Typical low quality structure

9. Typical low quality structure

10. Typical low quality structure

11. Typical low quality structure

12. Typical low quality structure

Task: Repair / Replace

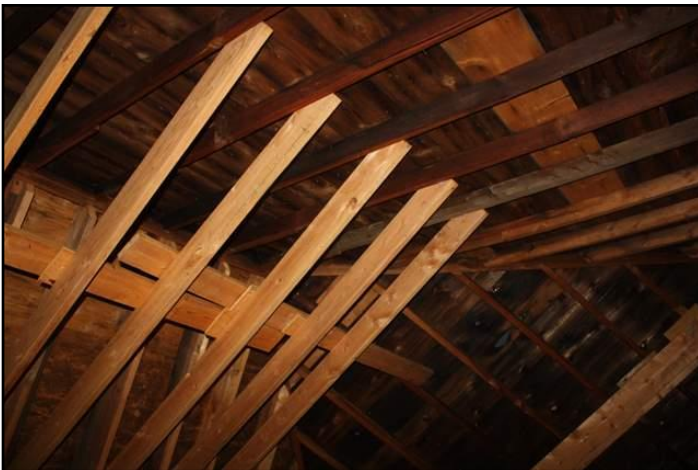
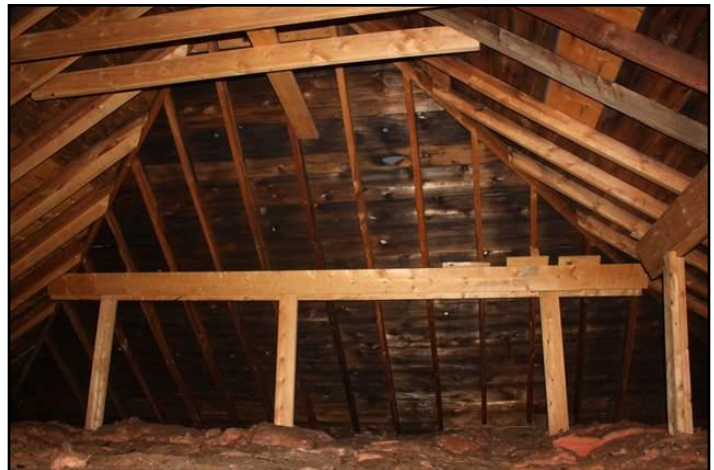
Condition: • Prior repairs noted in attic**Location:** Various Attic**Task:** Monitor**Time:** ongoing

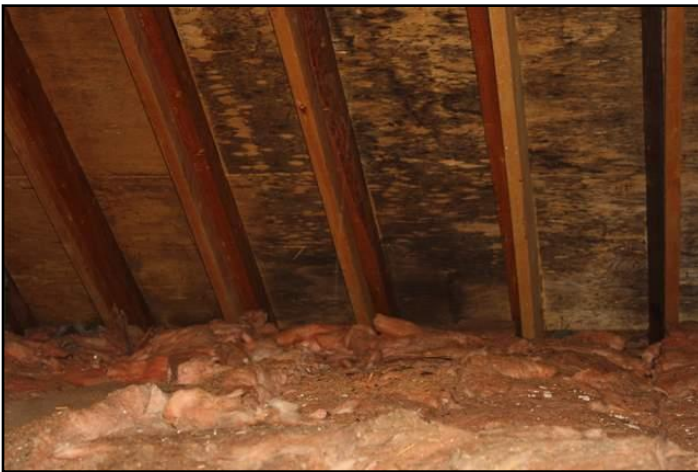
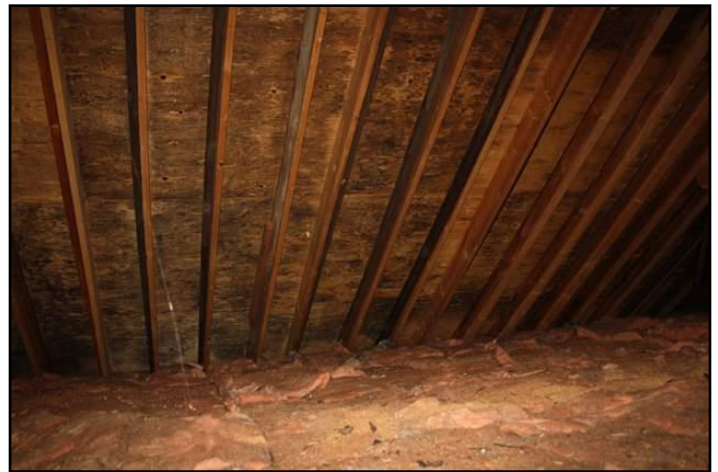
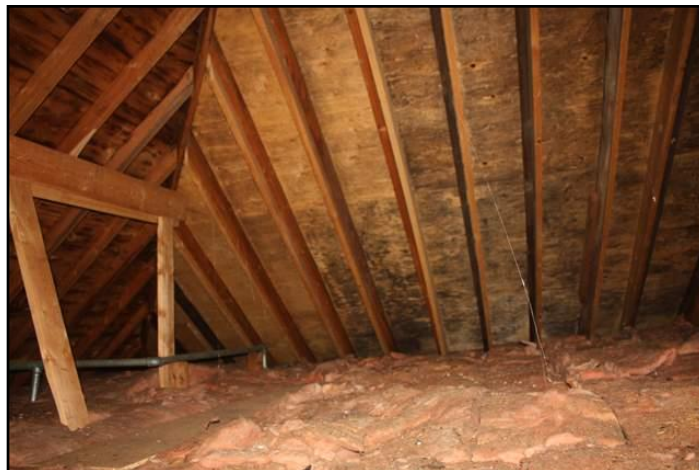
Condition: • [Mold](#)

Mold was noted in attic on the sheathing. Air Quality testing and remediation is beyond the scope of a home inspection. We are not environmental specialists. If you would like to arrange an air quality test which can check the indoor air for mold spores, please call us to make arrangements. We can provide this type of testing. If you like to have the mold remediated by a professional company, contact us for a list service providers.

15. Mold

16. Mold

17. Mold

Time: Discretionary

Cost: Depends on approach \$3000 and up to remove.

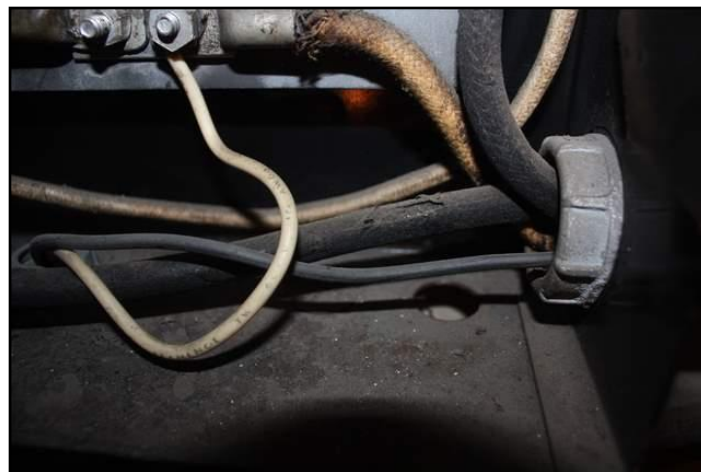
Condition: • [Openings in panel](#)

Implication(s): Fire hazard | Electric shock

18. Openings in panel

any exposed panel openings (that would allow access to the inside of the panel) should be fitted with secure covers

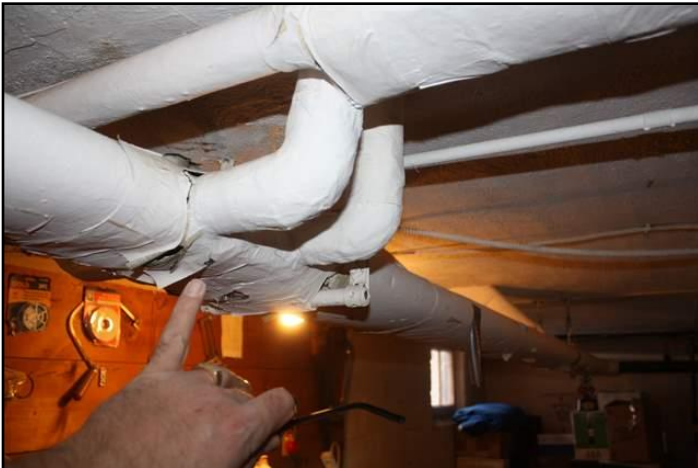
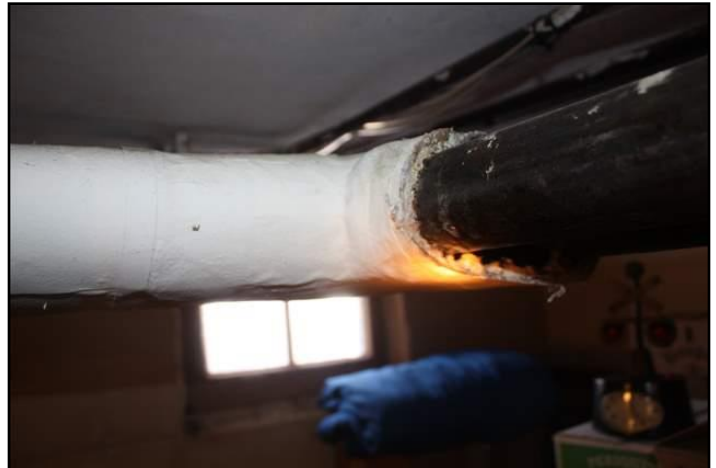
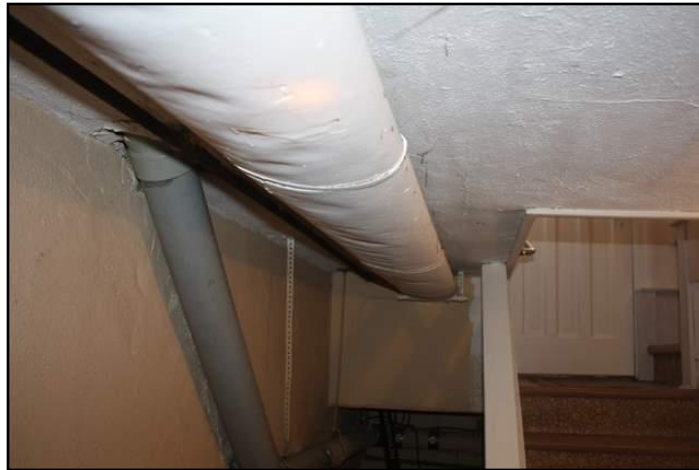
Condition: • The insulation on the boiler or heating pipes may contain asbestos. Health Canada recommends the insulation be left in place undisturbed. If the insulation is damaged or is to be disturbed, and if it contains asbestos (confirm with Laboratory test), precautions should be taken that asbestos fibers are not released into the house air during the work. Please see the Asbestos article in the Supplementary section of the text.

19. The insulation on the boiler or heating...

20. The insulation on the boiler or heating...

21. The insulation on the boiler or heating...

Task: Further evaluation / Remove

Time: before disturbing the wrap.

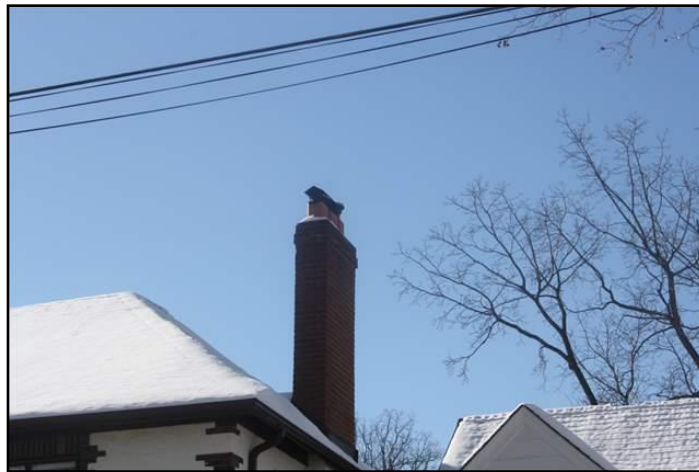
Condition: • [No drip edge on cap](#)

Implication(s): Material deterioration | Shortened life expectancy of material | Chance of water damage to contents, finishes and/or structure

22. No drip edge on cap

Cost: \$500 - \$1,000

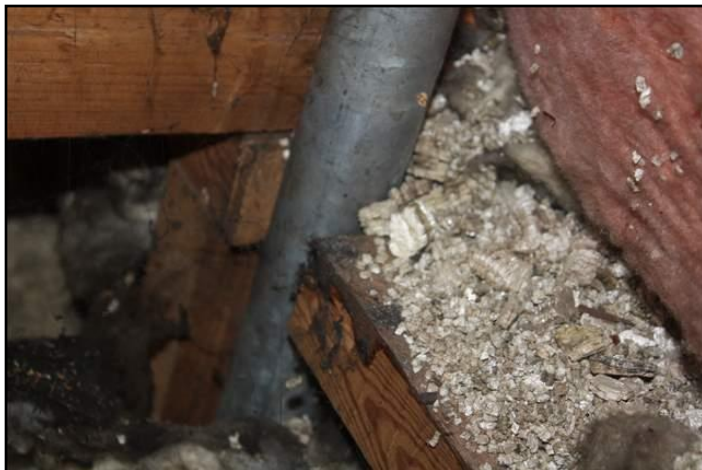
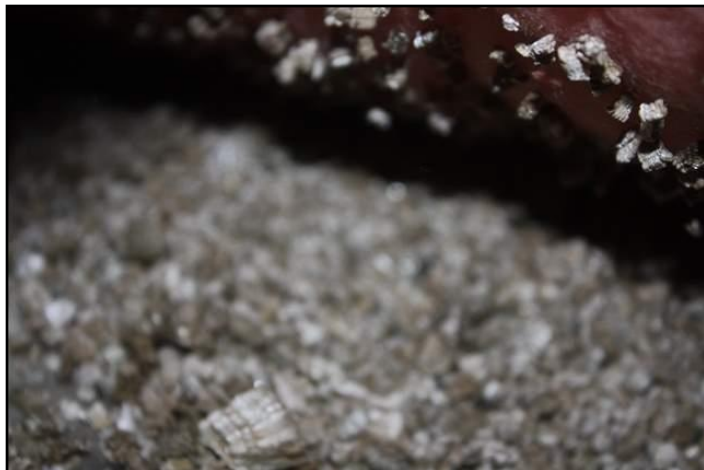
Condition: • [Possible Zonolite](#)

Vermiculite insulation was found in attic. This type insulation may contain asbestos, a material that has been linked to Respiratory disease. Although a home inspection is not an environmental assessment, and we are not health scientists, this is mentioned as a courtesy. Health Canada's position is that vermiculite insulation is best left in place, and health precautions should be taken if working in the attic or disturbing the insulation. More information can be found on Health Canada's website at

23. Possible Zonolite

24. Possible Zonolite

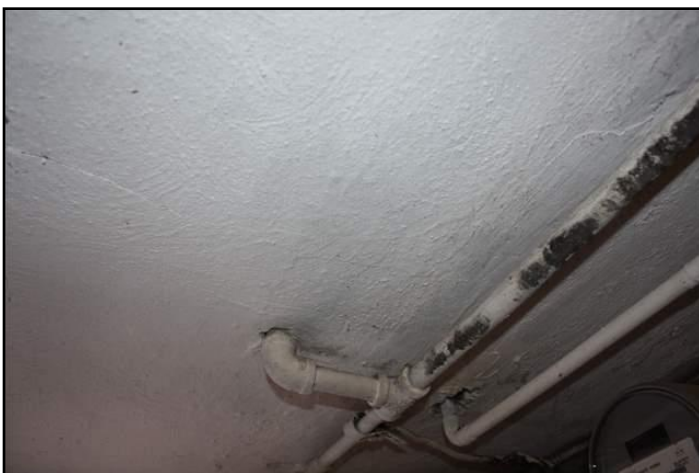
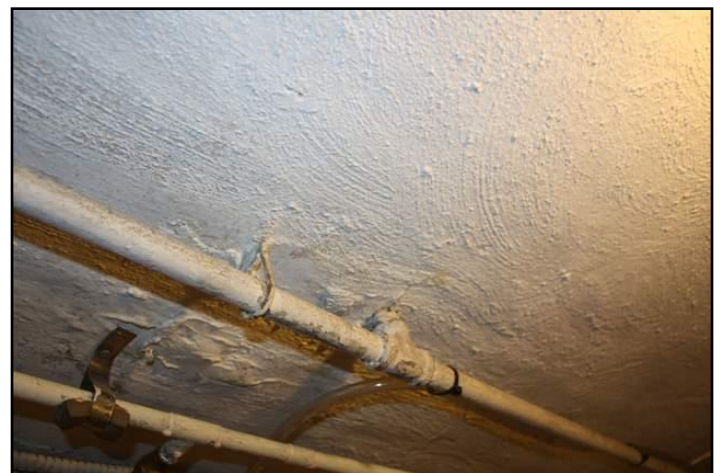
Condition: • [Galvanized steel](#)

Insurance companies will not insure homes with active Galvanized plumbing and therefore replacement is required. The galvanized piping is corroded which affects the pressure / flow and is high leak risk. Click on the blue link for more information.

Task: Replace

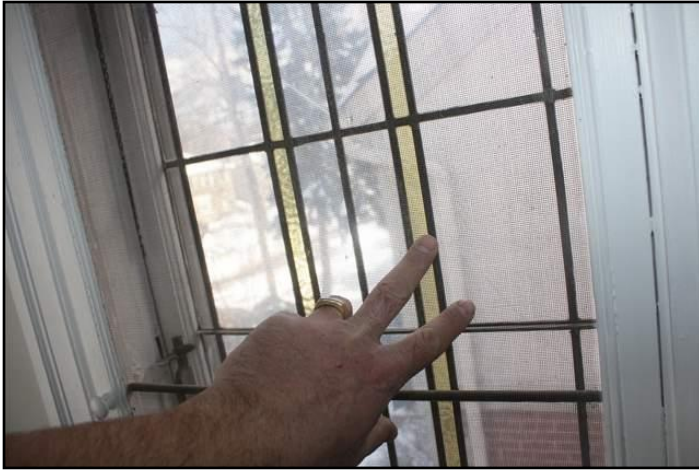
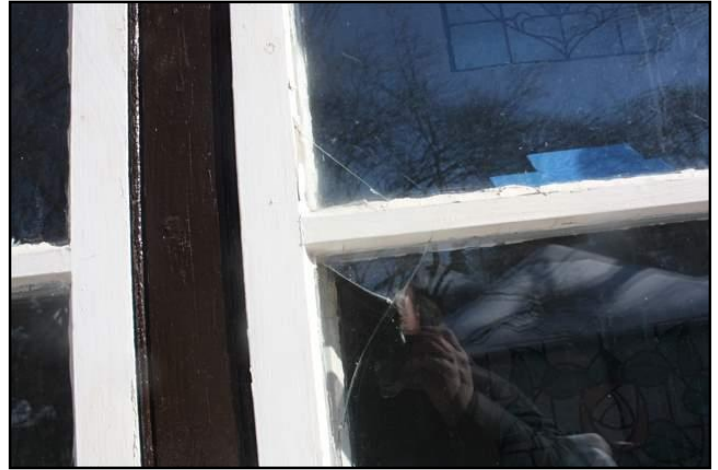
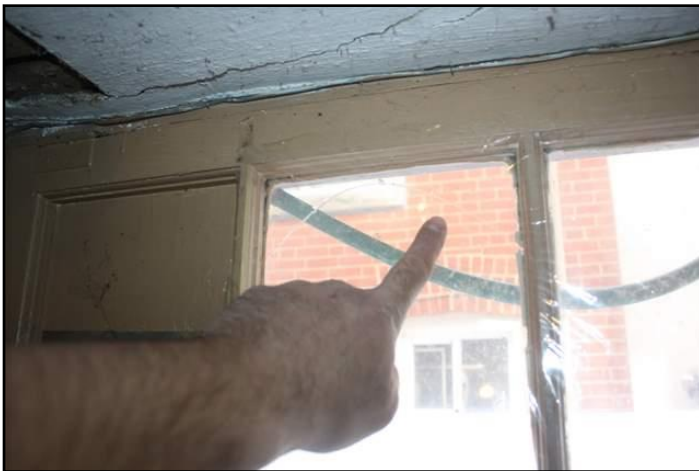
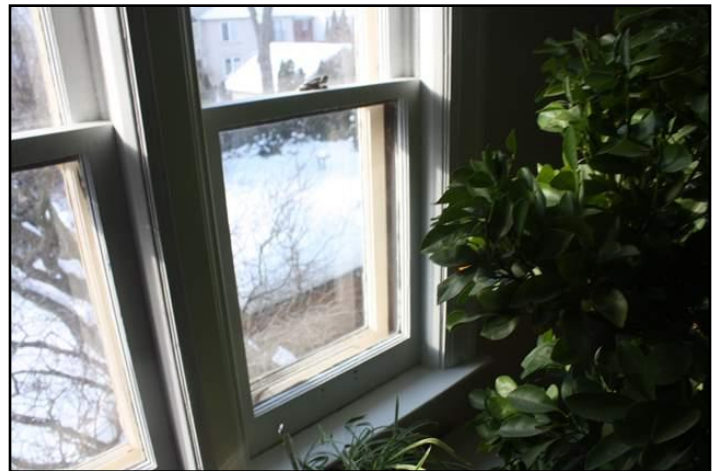
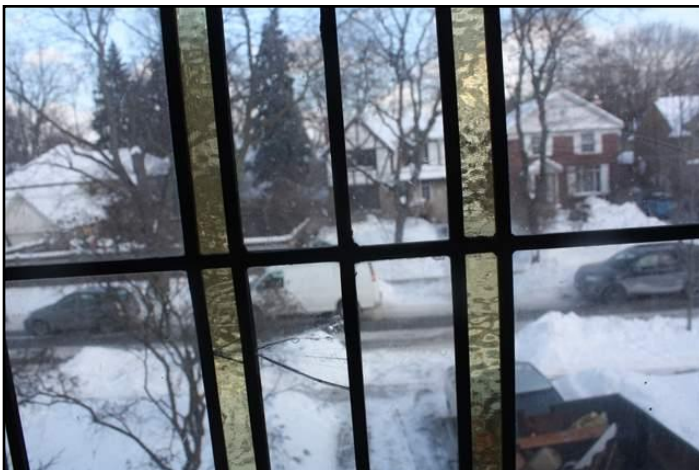
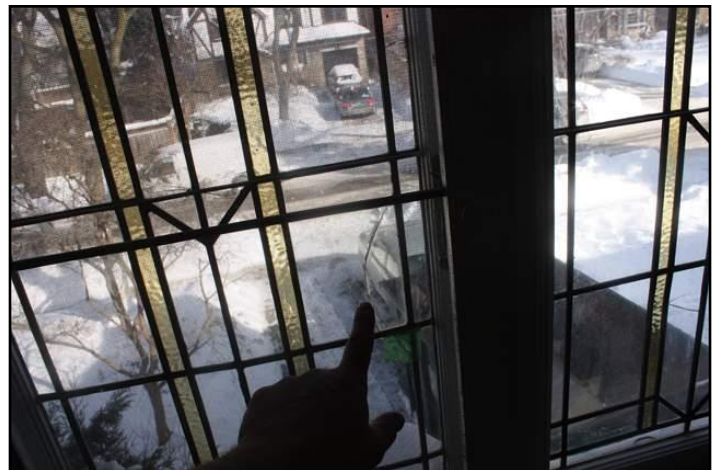
Condition: • The windows throughout the house are very old single pane windows. There are numerous glass cracks throughout and issues with windows that do not function. Overall we recommend that you upgrade to new energy efficient windows throughout. That being said, many homeowner like the charm of the old stained glass windows and choose to repair and restore and use them as a cosmetic feature of the home. Other homeowners choose to sell the stained glass windows. pictures show a very small sampling

Implication(s): Energy efficiency, air drafts, potential leakage, and non functionality.

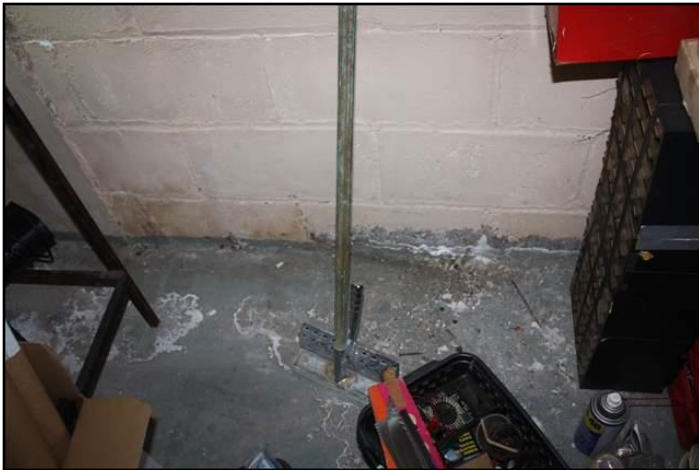
Condition: • [Stains](#)

It is common to find stains in a home of this age. No active water leakage was observed during the inspection. Homeowner noted that the cold room will see a minor amount of moisture after heavy sustained rainfalls.

33. Stains

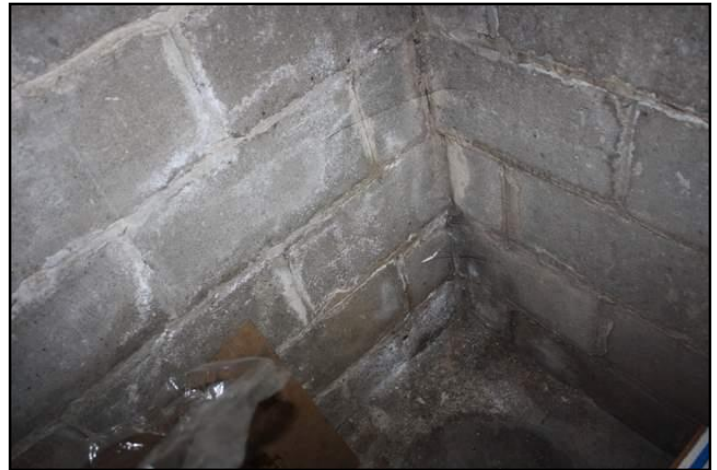
34. Stains / cold room
