YOUR INSPECTION REPORT

426 Armadale Avenue
Toronto, ON M6S 3X8

INSPECTION DATE:
Monday, June 17, 2019

RE: Report No. 2481, v.2
426 Armadale Avenue
Toronto, ON
M6S 3X8

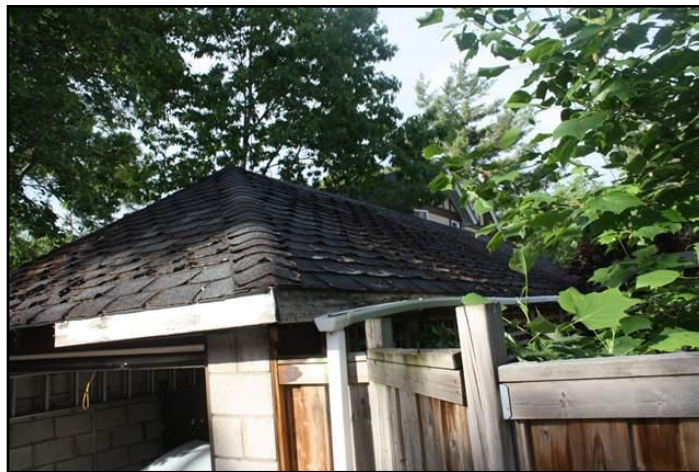
Condition: • [Old, worn out](#)

Implication(s): Chance of water damage to contents, finishes and/or structure

Location: Garage Roof

1. Old, worn out

Task: Replace

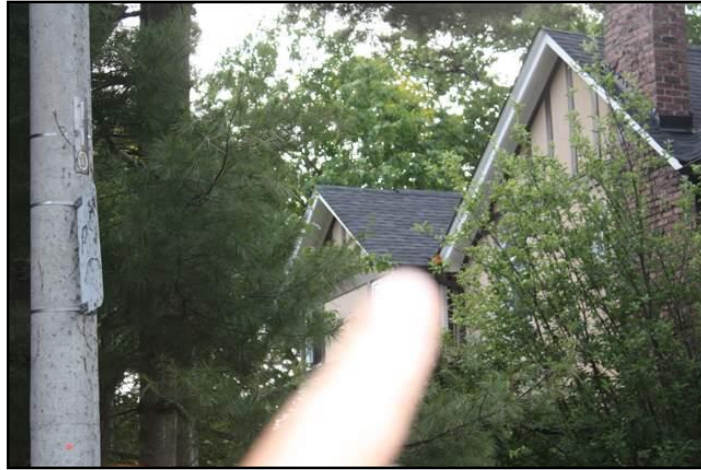
2.

Condition: • Flashing improvement needed - see photo for location

Location: Exterior Roof

Task: Improve

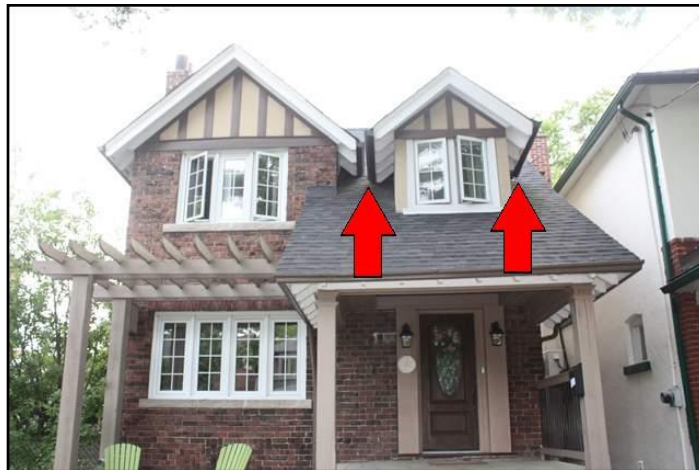
Condition: • [Discharge onto roofs](#)

Implication(s): Material deterioration

Location: Front Exterior Dormers

3. Discharge onto roofs

Improvement recommendation - Provide downspouts from upper gutters to lower gutters to prevent premature wear to Shingles

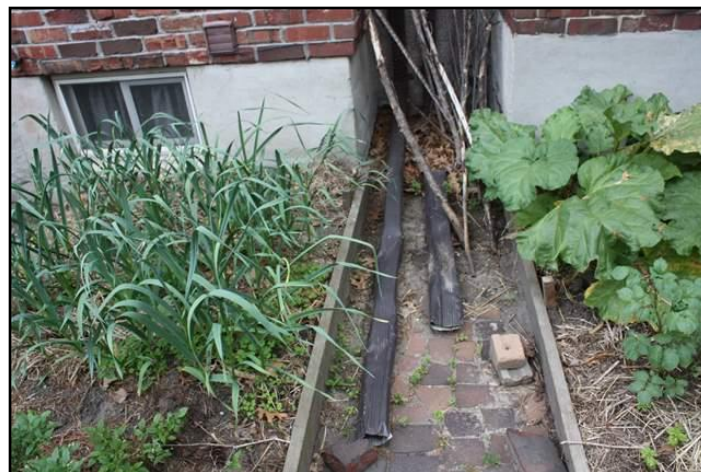
Condition: • [Damage](#)

Implication(s): Chance of water damage to contents, finishes and/or structure

Location: Left Side Exterior

4. Damage

Task: Repair / Replace

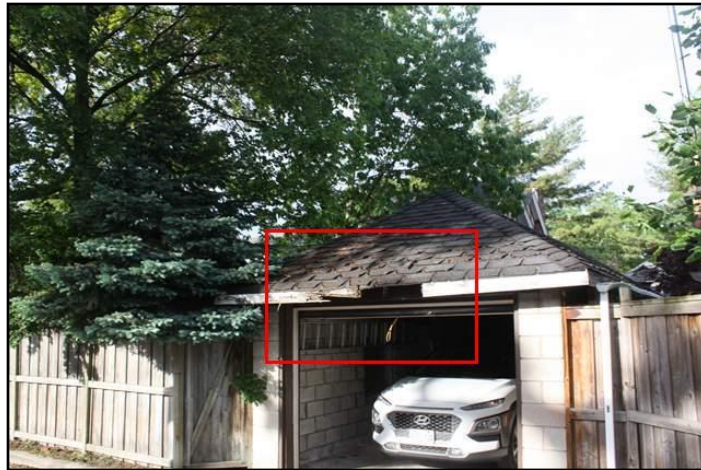
Condition: • [Damage](#)

Seller noted that they would be repairing this.

Implication(s): Chance of water damage to contents, finishes and/or structure

Location: Exterior Garage

5. Damage

Task: Repair

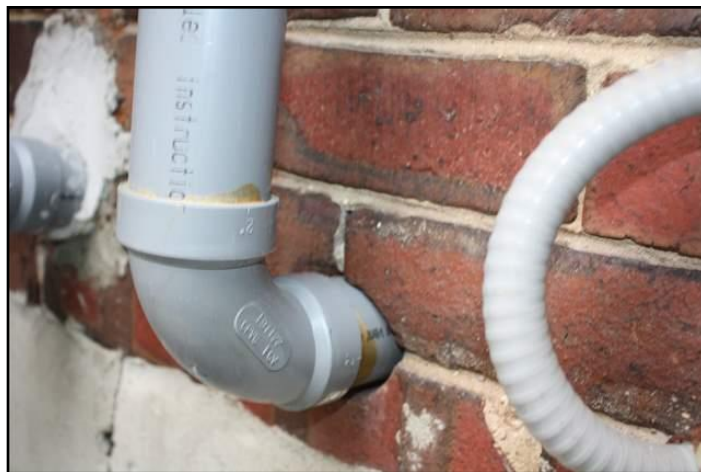
Condition: • [Caulking missing or ineffective](#)

Implication(s): Chance of water damage to contents, finishes and/or structure

6. Caulking missing or ineffective

Task: Provide caulking

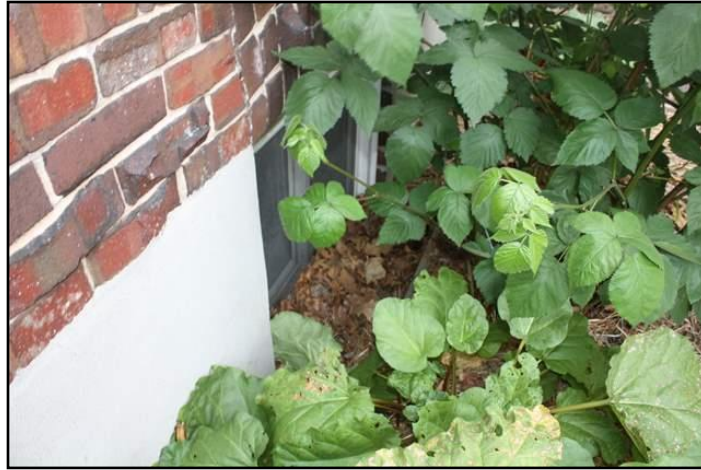
Condition: • Sill - Near or at Grade Level

7. Sill - Near or at Grade Level

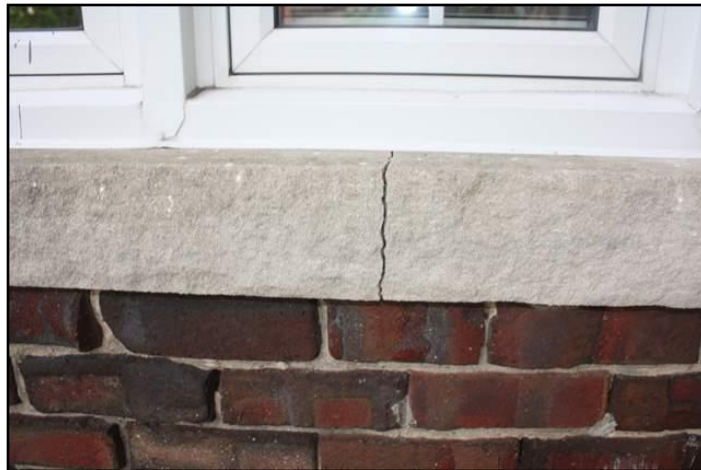
Condition: • [Damage](#)

Implication(s): Chance of water damage to contents, finishes and/or structure

8. Damage

Patch sill crack

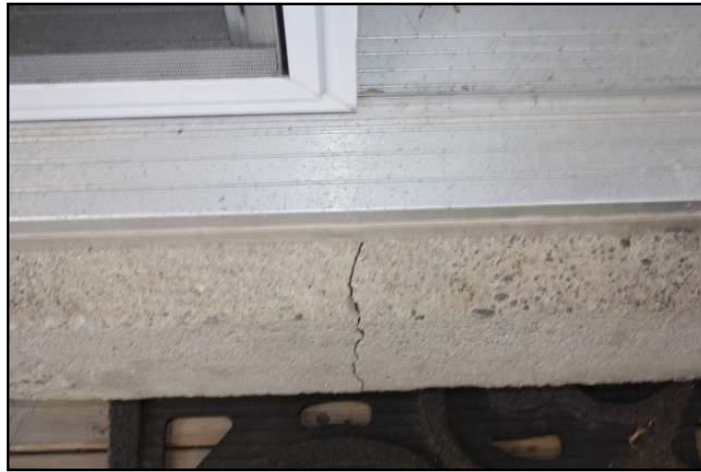
Condition: • [Damaged, cracked or loose](#)

Minor crack at sill

Implication(s): Chance of damage to finishes and structure

9. Damaged, cracked or loose

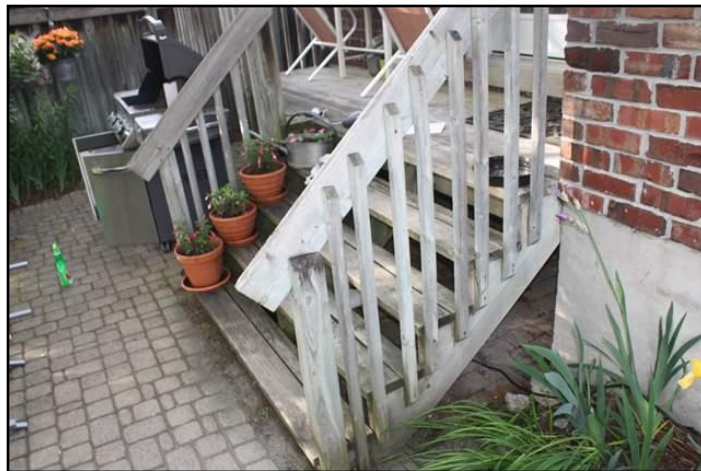
10.

Condition: • Aging - Some areas are old/worn.

Task: Improve / Repair / Replace

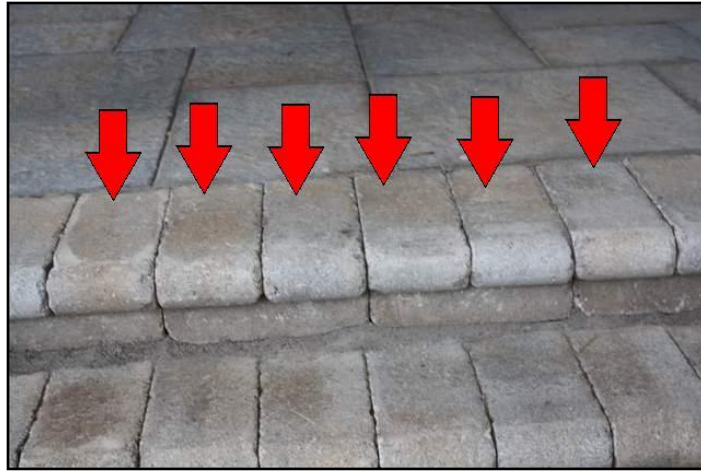
Condition: • Trip hazard

Some parts of the nosing are loose.

Implication(s): Trip or fall hazard

11. Trip hazard

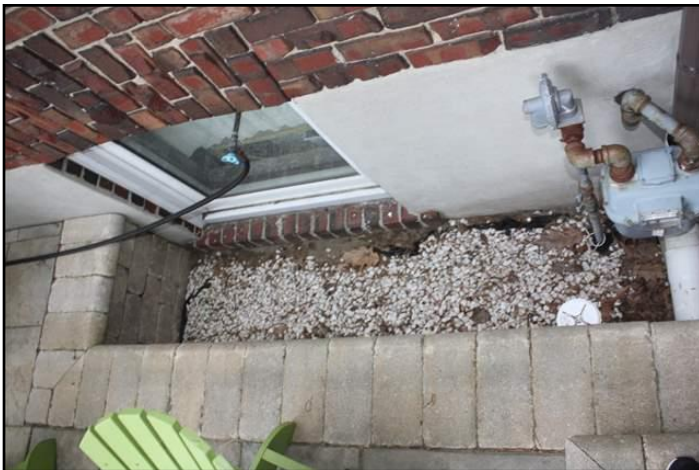
Condition: • [Missing](#)

Implication(s): Fall hazard

12. Missing

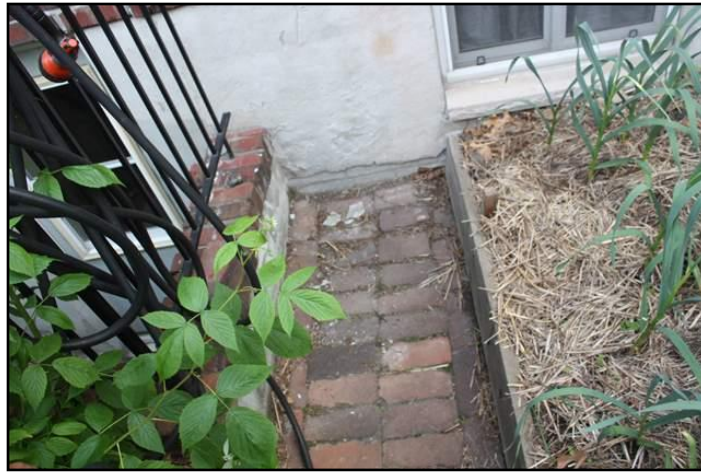
Condition: • Low Areas.

15. Low Areas.

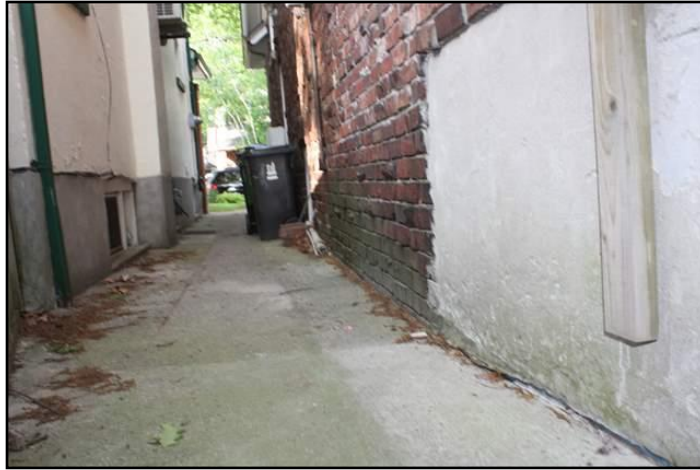
Condition: • [Improper slope or drainage](#)

Implication(s): Chance of water damage to contents, finishes and/or structure

16. *Improper slope or drainage*

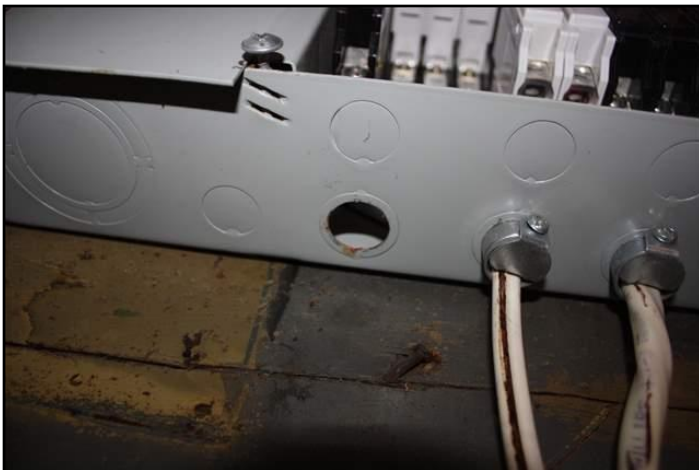
Condition: • [Openings in panel](#)

Implication(s): Electric shock | Fire hazard

17. Openings in panel

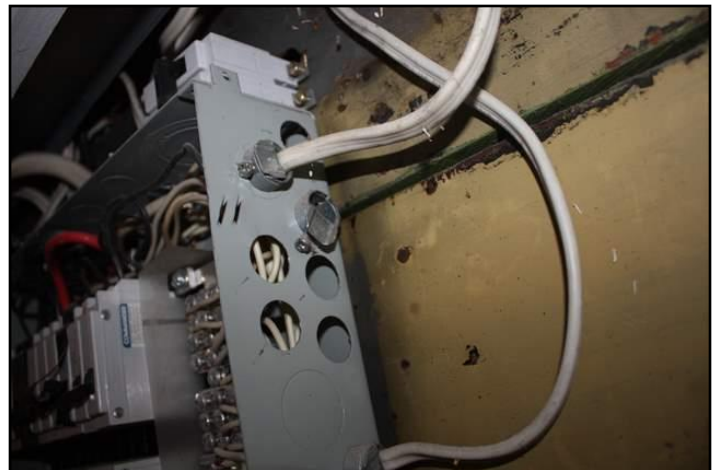
18. Openings in panel

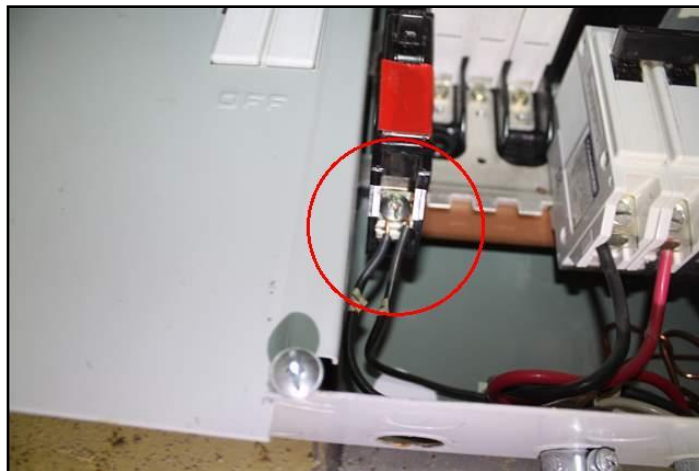
Condition: • [Double taps](#)

Implication(s): Fire hazard

19. Double taps

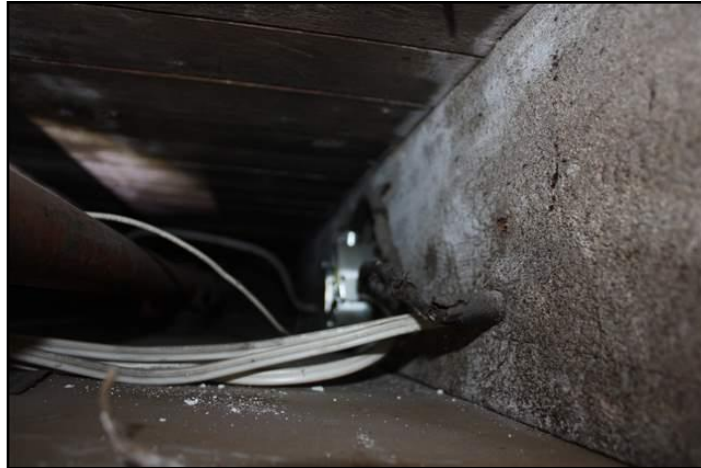
Condition: • [Cover loose or missing](#)

Implication(s): Electric shock | Fire hazard

20. Cover loose or missing

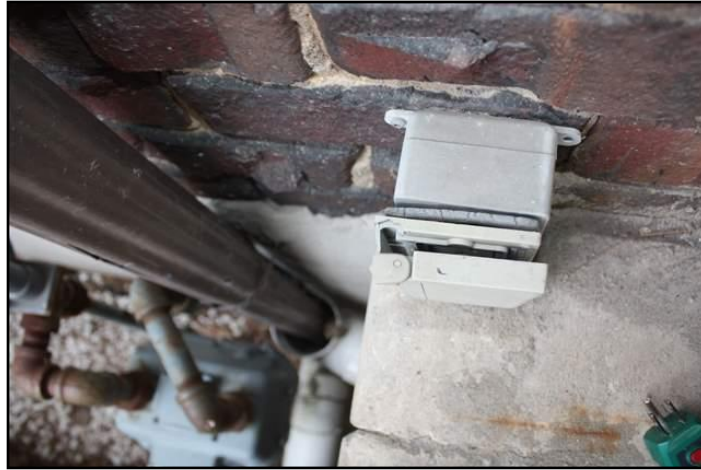
Condition: • [Loose](#)

Implication(s): Electric shock | Fire hazard

21. Loose

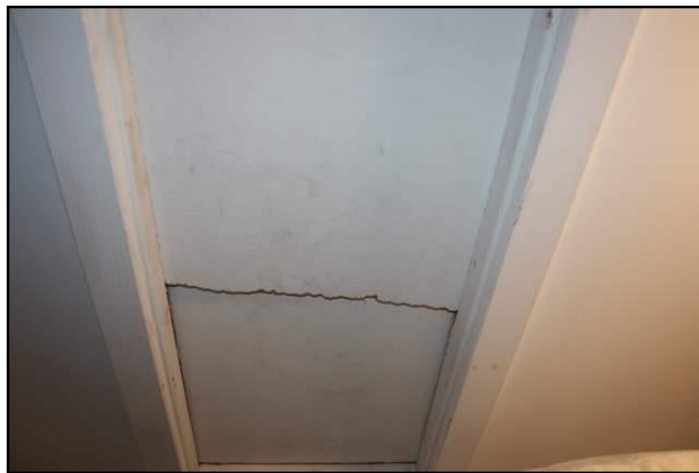
22.

Condition: • Attic hatch damaged

Task: Replace

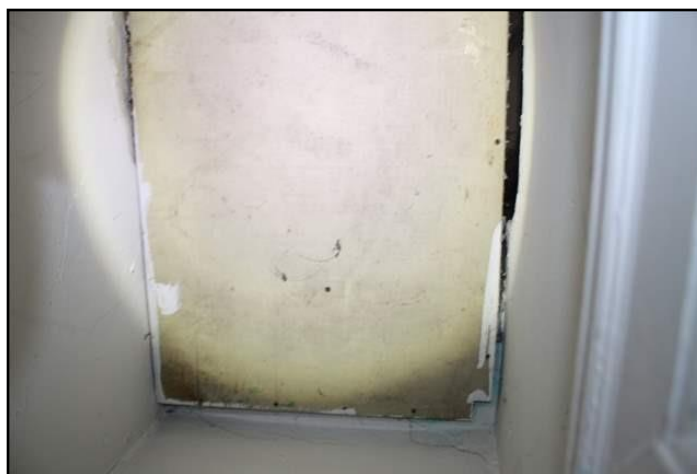
Condition: • [Inaccessible](#)

One of the access hatches to the attic is fastened shut. (We were able to view one of the attics which was accessed from the master bedroom closet) Provide access and inspect. Attics are important areas and should be inspected regular for issues with structure, insulation, ventilation, water damage and mold.

23. Inaccessible

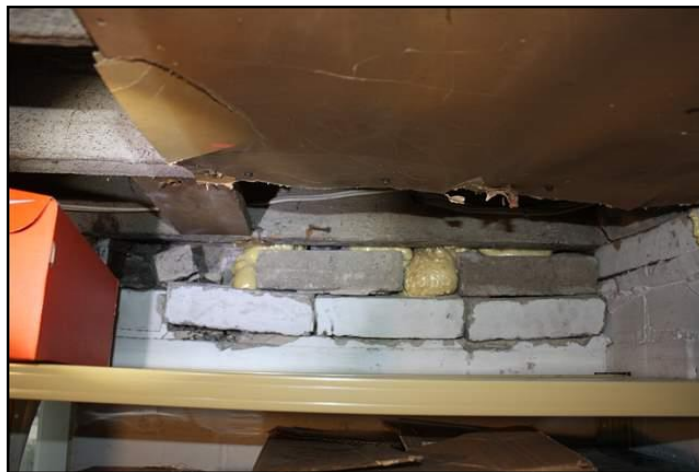
Condition: • [Damage](#)

Implication(s): Material deterioration | Damage or physical injury due to falling materials

24. Damage

Task: Repair loose bricks

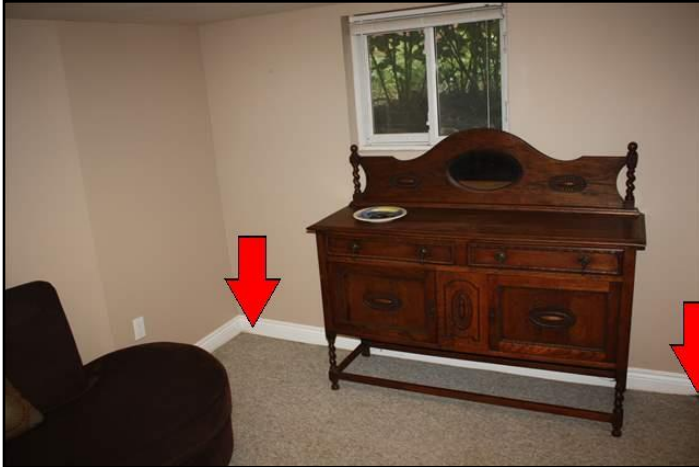
Condition: • [Dampness on floor or walls](#)

Using a moisture meter we noted damp areas of the baseboard at the left side basement. We did not observe any

standing water in this area. Home seller confirms that they have not any any leakage issues. It is very common to find moisture in homes of this age with brick foundations and should be expected from time to time. Determining the source of moisture / condensation is outside the scope of the inspection.

Implication(s): Chance of water damage to contents, finishes and/or structure | Material deterioration

25. Dampness on floor or walls

Task: Monitor / Improve

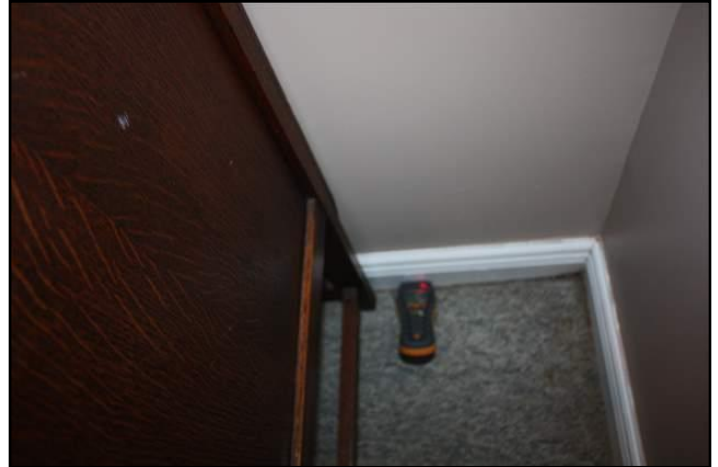
26. Dampness on floor or walls
