YOUR INSPECTION REPORT

33 Vine Avenue
Toronto, ON M6P 1V6

INSPECTION DATE:
Wednesday, November 11, 2020

RE: Report No. 2784, v.4
33 Vine Avenue
Toronto, ON
M6P 1V6

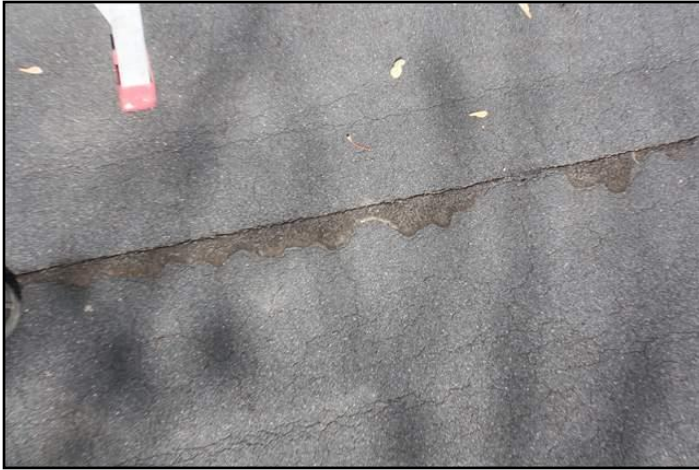
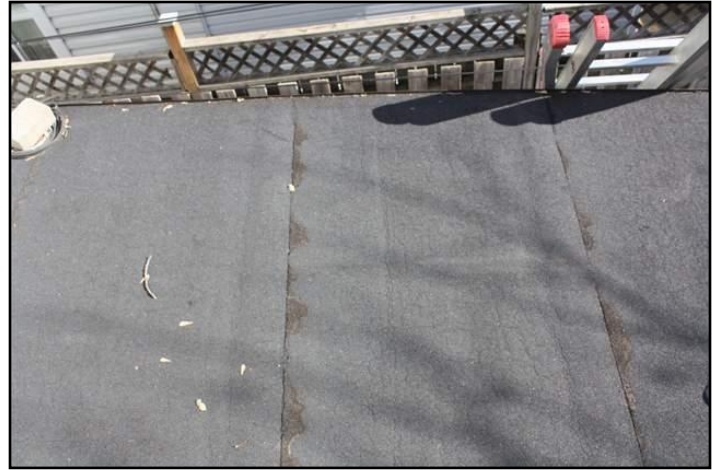
Condition: • [Cracks](#)

Typical lifespan for this type of roof covering is 20-30 years. Surface cracking is a sign of aging / wear / tear. Annual roof inspections are recommended. Flat roofs must be water-tight.

3. Cracks

4. Cracks

Task: Inspect annually / Replace

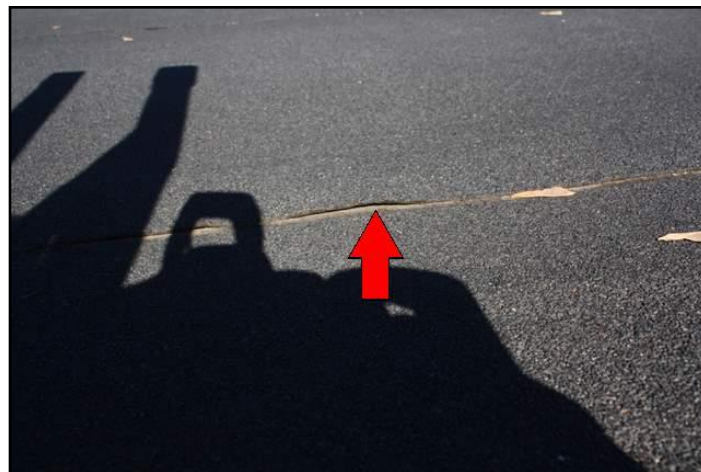
5. Example

Condition: • [Openings at seams or flashings](#)

Task: Repair / Seal

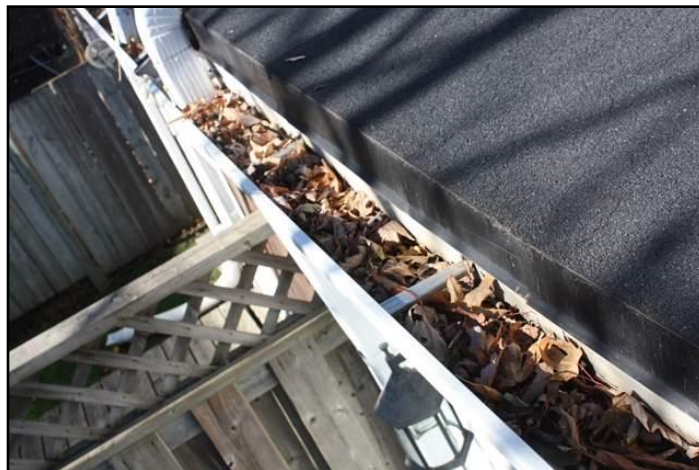
Condition: • Dirty/debris

6. Dirty/debris

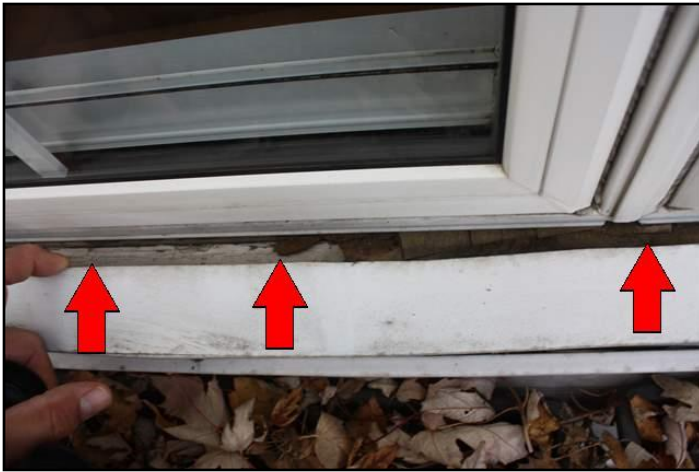
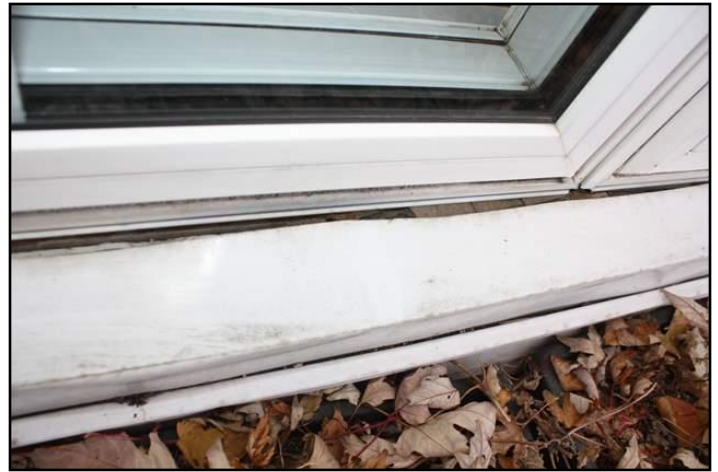
Condition: • [Missing or loose pieces](#)

8. Missing or loose pieces

9. Missing or loose pieces

Task: Repair / Seal

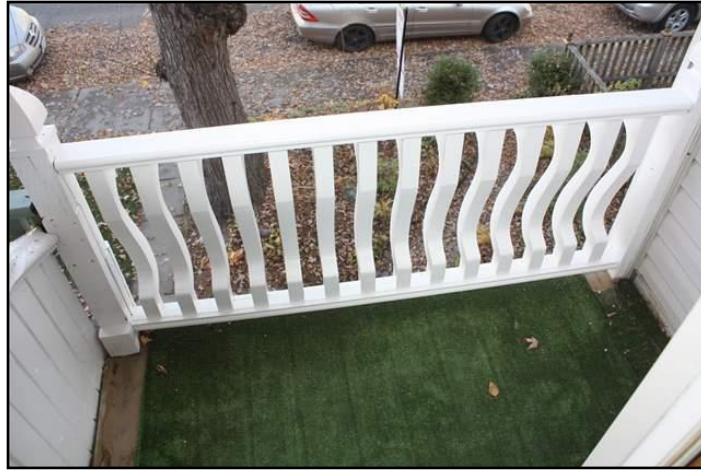
Condition: • [Too low](#)

Below modern standards. Fall hazard

10. Too low

Task: Replace

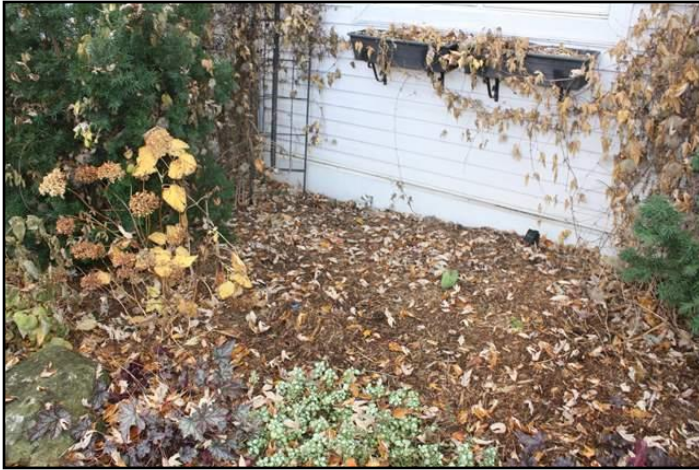
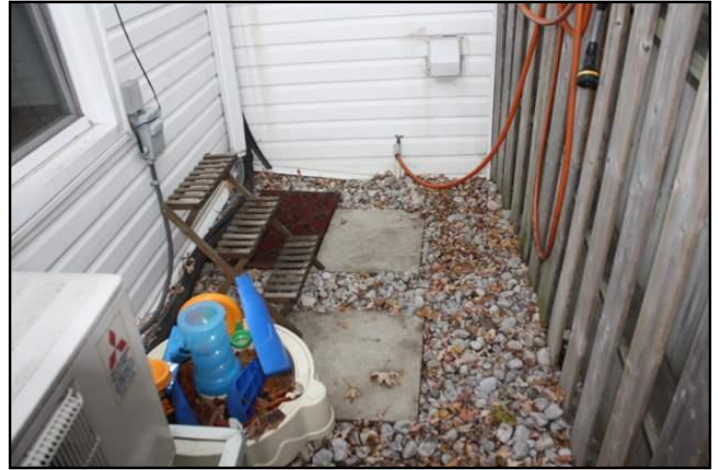
Condition: • Low Areas.

11. Low Areas

12. Low Areas

Task: Correct

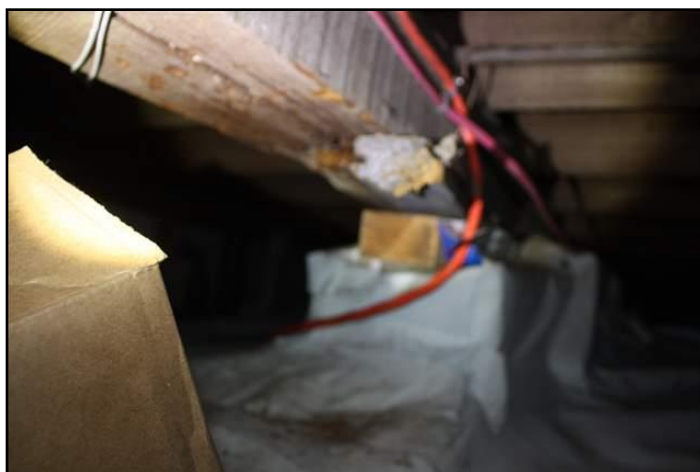
Condition: • [Weak connection to column](#)

13. Weak connection to column

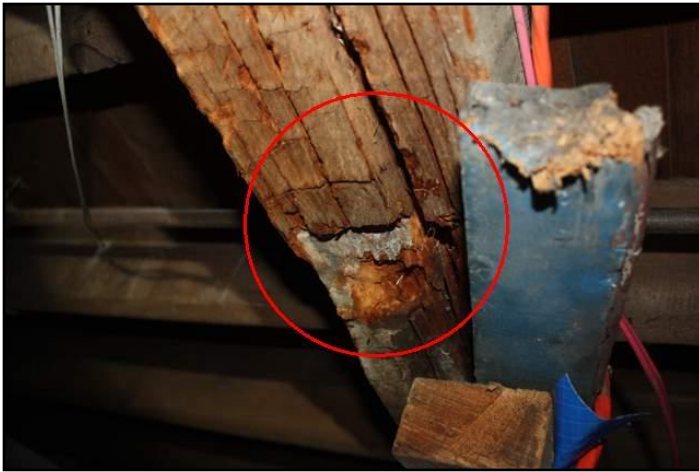
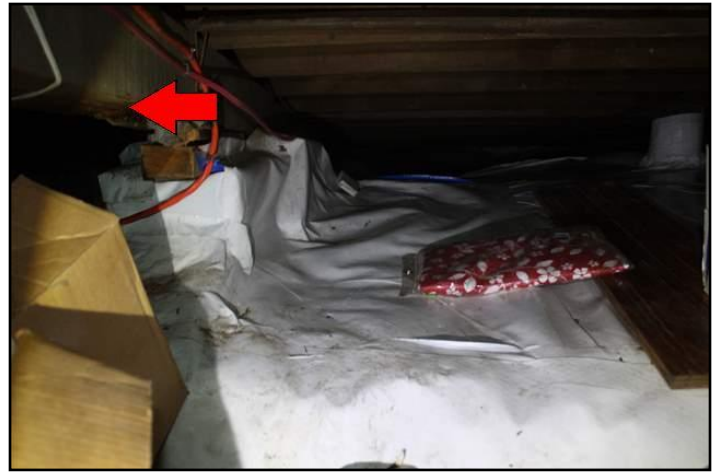
Condition: • [Rot](#)

14. Rot close-up view

15. Rot

Task: Repair

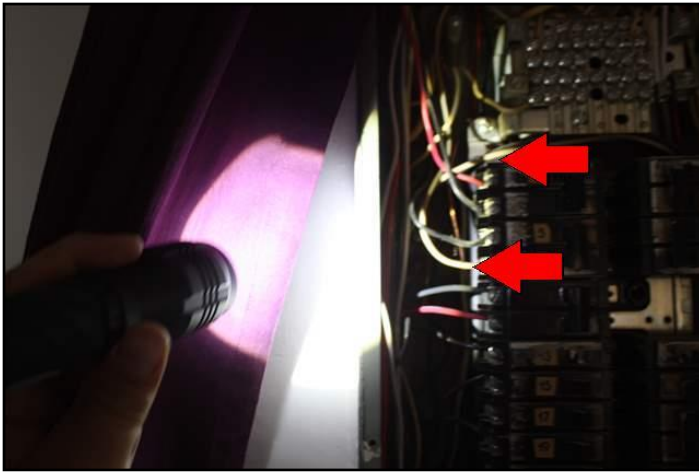
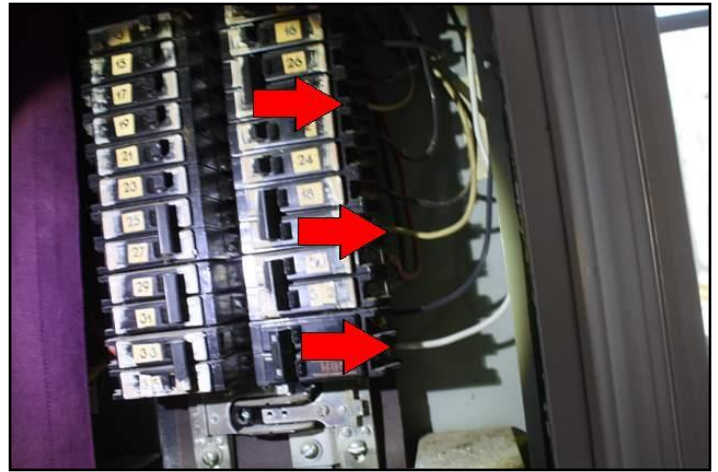
Condition: • White wires connected to breakers not identified as hot/live/ungrounded

17. White wires connected to breakers not...

18. White wires connected to breakers not...

Task: Correct

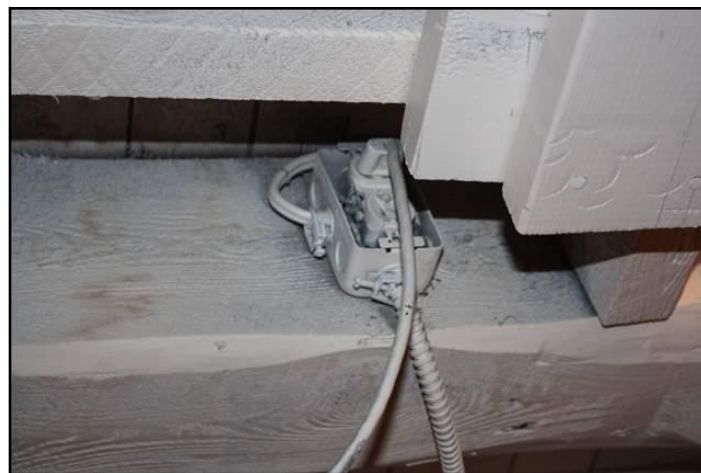
Condition: • For outlet (receptacle) is missing

19. For outlet (receptacle) is missing

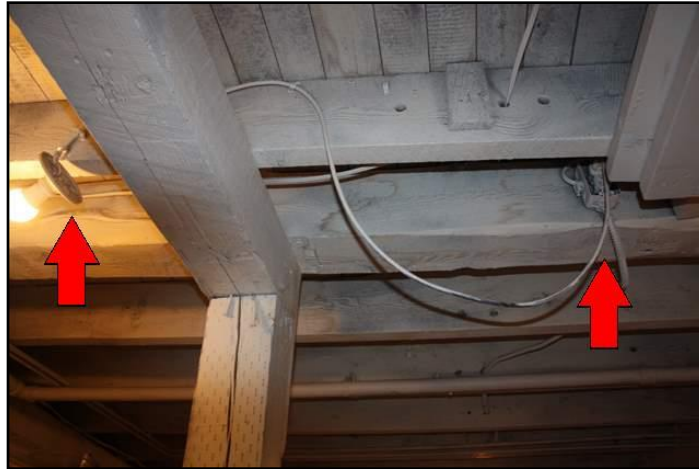
Condition: • [Loose](#)

Improper installation. Temporary light. Missing closed light fixture box.

20. Loose

Task: Correct

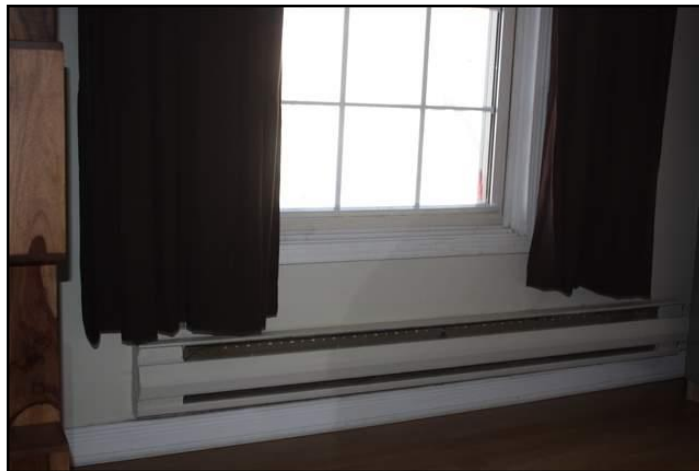
Condition: • [Obstructed heaters](#)

Drape clearance inadequate. If you will be installing drapes, ensure they meet combustible clearances. Click link for more information

21. Drapes too close

Task: Correct

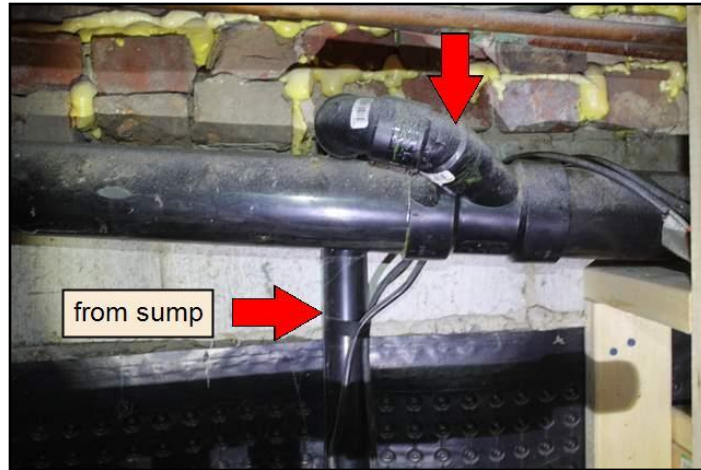
Condition: • [Discharge pipe problems](#)

22. Discharge pipe

Task: Evaluate and correct

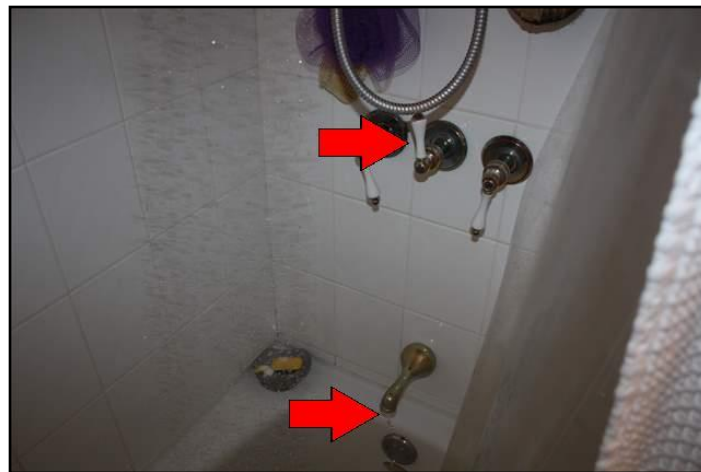
Condition: • [Shower diverter inoperative or defective](#)

The shower diverter operates however water still squirts from the spout when the shower head is engaged. Also the handle is loose.

23. Shower diverter inoperative or defective

Task: Repair / Replace

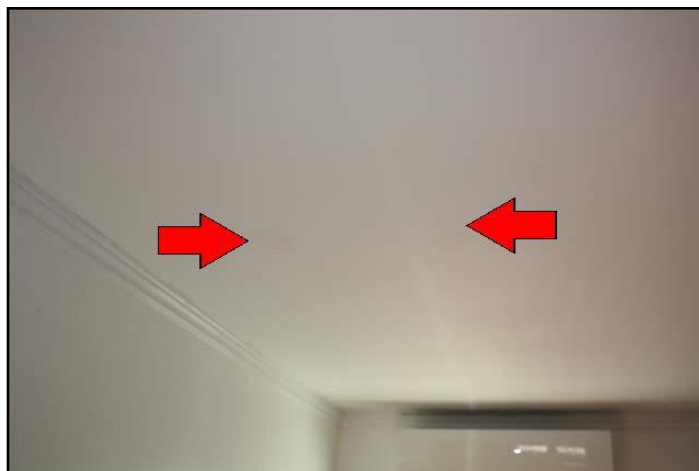
Condition: • Water stains

Small water stains observed. Tested with moisture meter and was dry at time of inspection. These areas are below bathroom. Possible leak in past (or toilet overflow, etc) Monitor area

24. very minor water stains

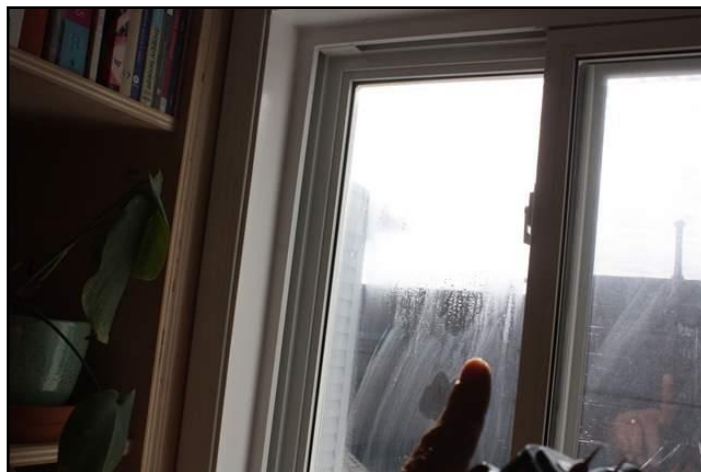
Condition: • [Lost seal on double or triple glazing](#)

25. Lost seal on double or triple glazing

Task: Replace
