INSPECTION REPORT

For the Property at:
ONE LOOPY COURT
COVINGTON, LA 70433

Prepared for: IDA WANTA and LIVE HERE
Inspection Date: Tuesday, November 22, 2016
Prepared by: Turk Schexnayder LHI Lic.10679

RE: Report No. 1589, v.3
One Loopy Court
Covington, LA
70433

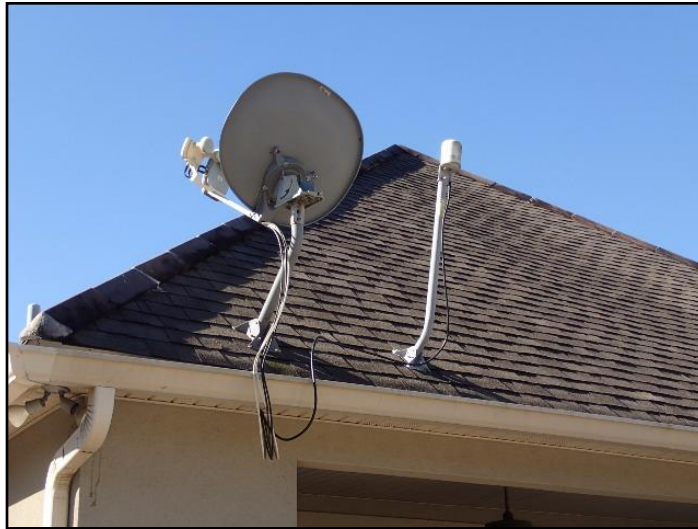
2. Condition: • [Satellite TV dish attached to roof covering](#) These dishes, when attached directly to the roof, are a potential area for leakage or for damage during high winds. It is preferred to attach these to the exterior wall or fascia, or to a pole, where the possibility for damage is reduced.

Implication(s): Roof leak, damage to the structure and/or interior finishes and furnishings

3. Satellite TV dish

Task: Remove if not in use. Improve location if possible. Monitor for leakage or damage.

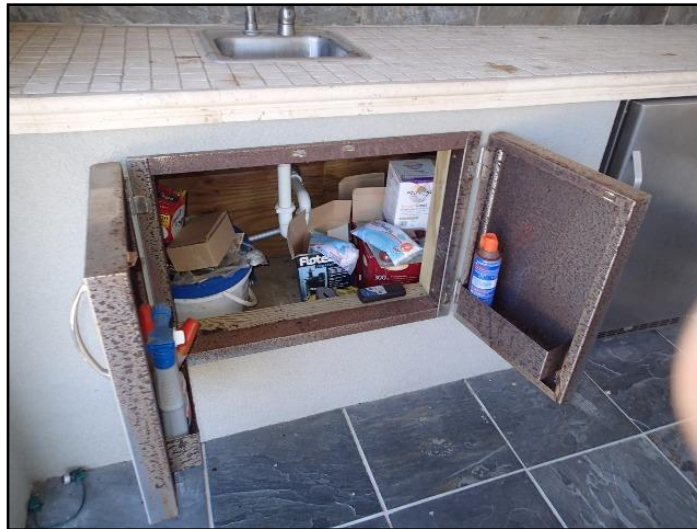
3. Condition: • Stainless steel under counter doors were rusting.

6. Cabinet doors

Task: Clean or replace as needed.

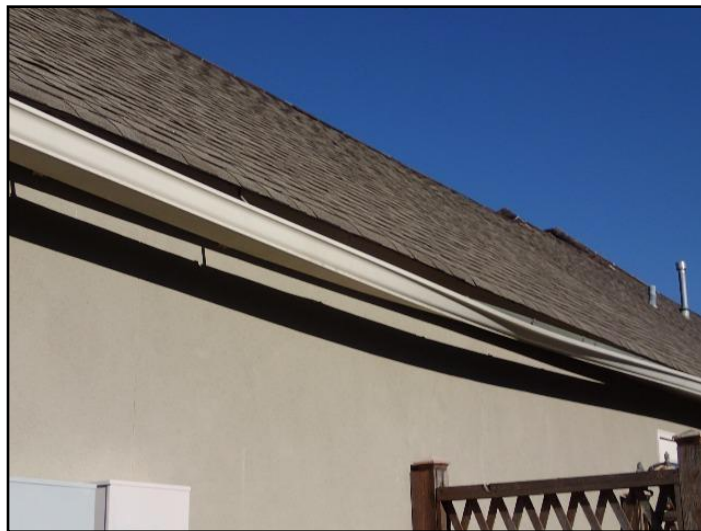
4. Condition: • Loose or damaged

Gutters on rear wall were loose and hanging.

Implication(s): Chance of water damage to structure, finishes and contents

7. Loose or damaged

Task: Repair or replace

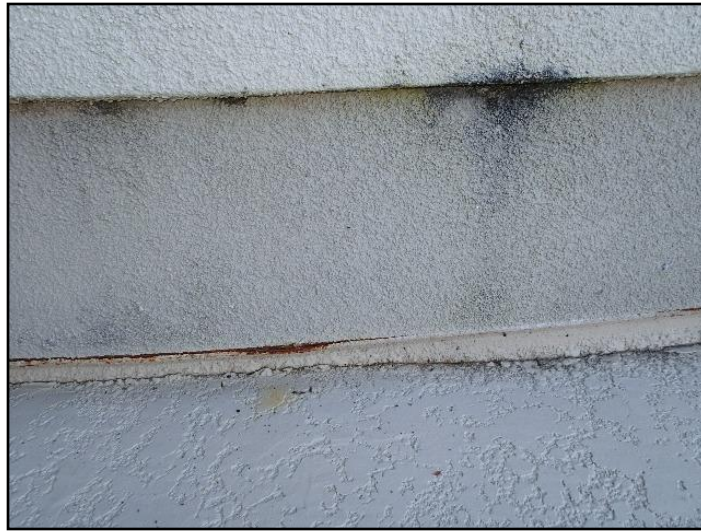
5. Condition: • Rusted weep screed.

8. *Rust*

Task: Repair by a qualified stucco installer.

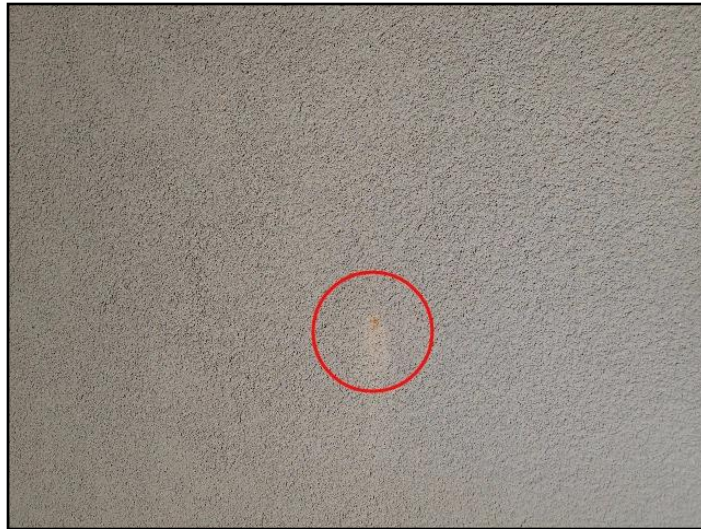
9.

6. Condition: • Rust flecks in stucco. The likely cause of this type of random rust flecks is the source of sand. Most stucco is mixed on site with bulk sand. While the sand is washed and separated by aggregate size, however, it cannot be swept of all impurities. Iron deposits will rust when exposed to water, air and/or stucco cement.

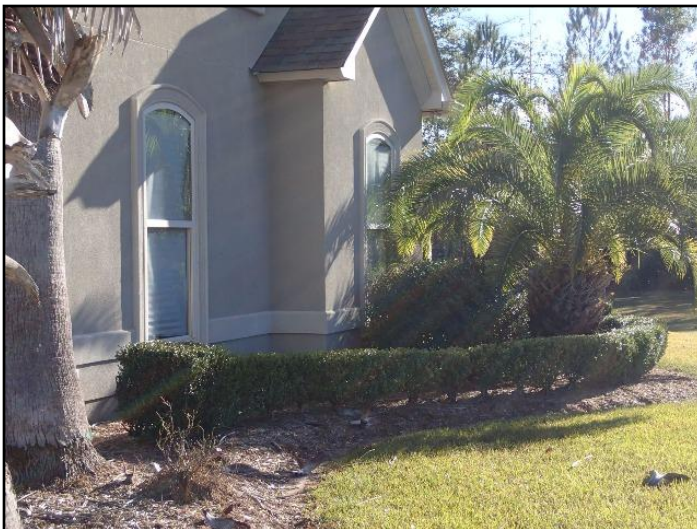
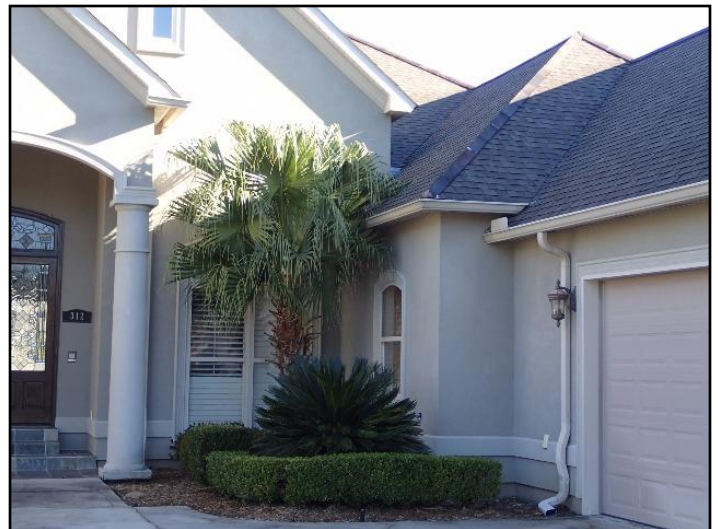
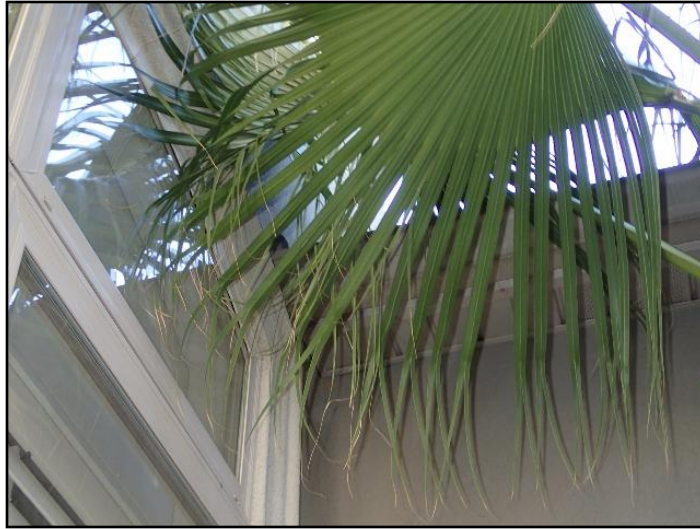
7. Condition: • Trees or shrubs too close to building

Tree branches overhang roof and may prevent proper drying which increases the chance for moisture damage. Branches can cause mechanical damage from scraping or falling. Branches can also provide an access point for pests. Trimming all trees near the home will decrease moisture and allow the structure and grounds to dry more effectively.

Implication(s): Chance of water damage to structure, finishes and contents | Chance of pests entering building | Material deterioration

10. Trees or shrubs too close to building

Task: Trim trees near home.

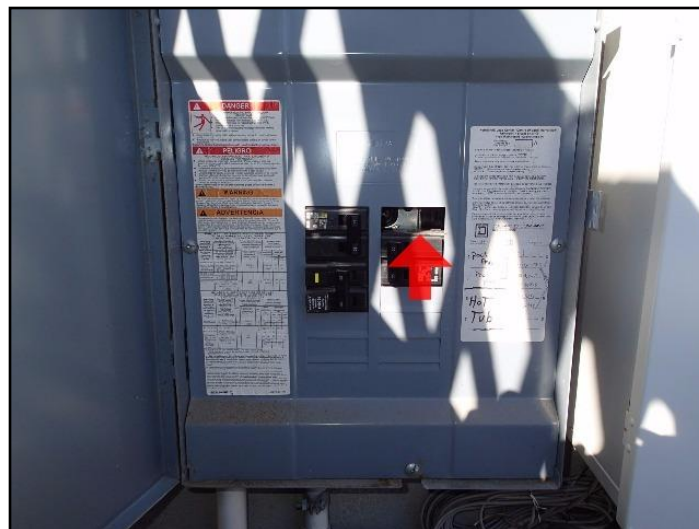
9. Condition: • Openings in panel

Missing knock outs or gaps in sub panel near pool equipment. Replacement with the proper cover/insert is recommended.

Implication(s): Electric shock | Fire hazard

19. Missing knock out.

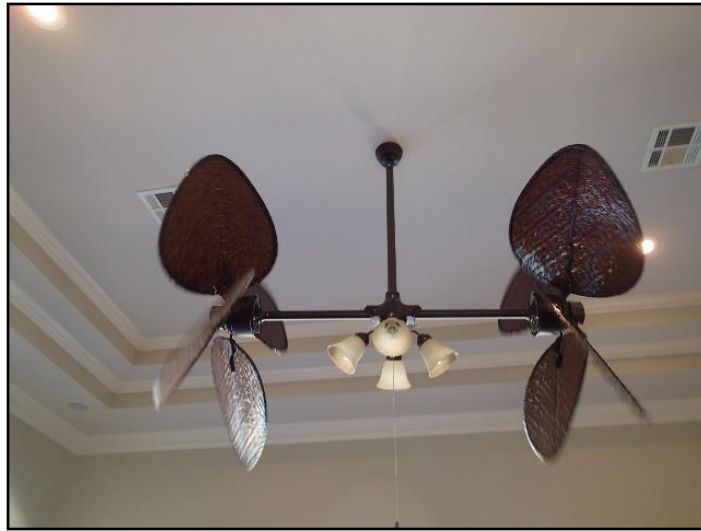
10. Condition: • Ceiling fan wobbled when on.

20. *Ceiling fan*

Task: Improve

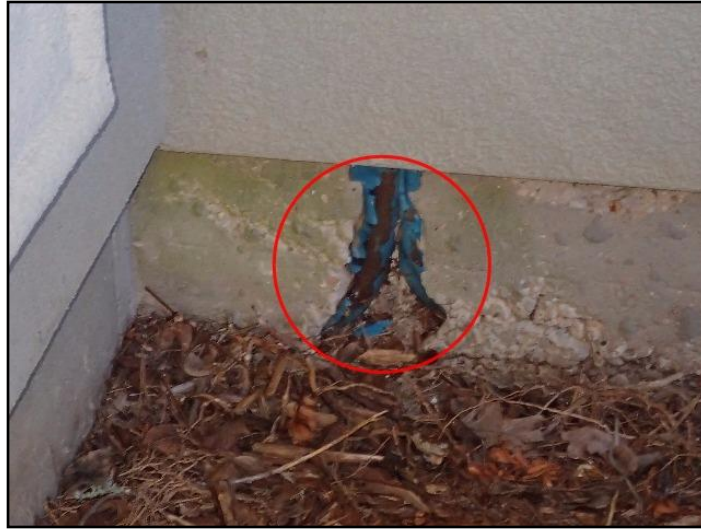
16. Condition: • Water supply line was exposed at edge of slab. Providing insulation or similar material may prevent freezing in colder temperatures.

41. Exposed supply line

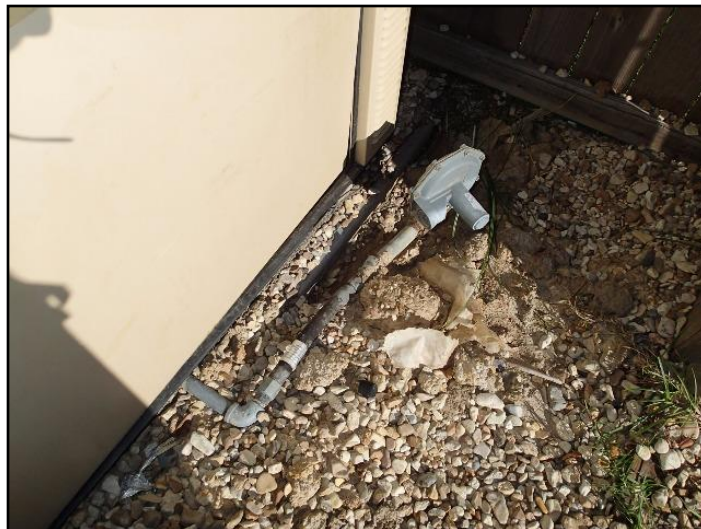
17. Condition: • Missing shut off valve

Missing shut-off valve at generator.

42. Missing shut off valve

Task: Install shut-off valve.

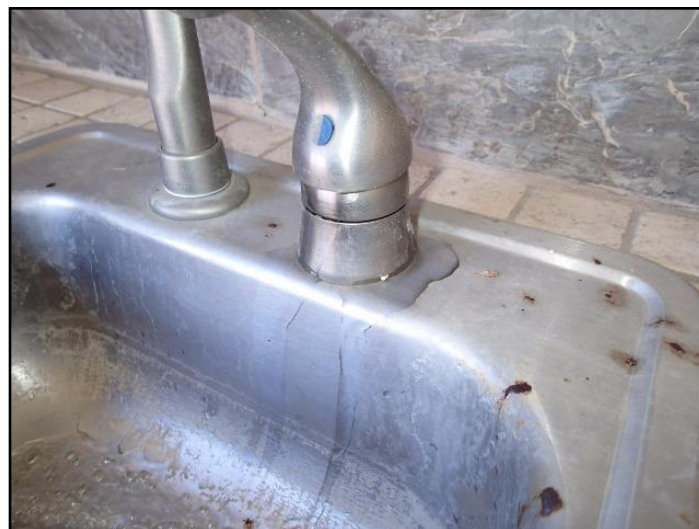
19. Condition: • Drip, leak

Implication(s): Chance of water damage to structure, finishes and contents

45. Drip, leak

Task: Repair

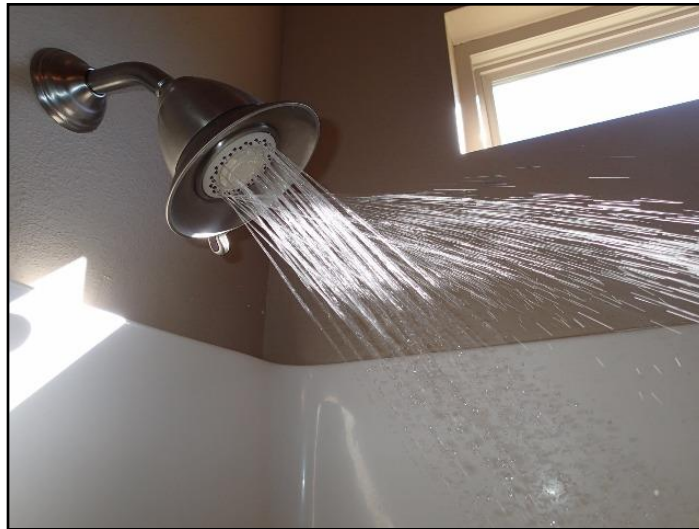
20. Condition: • Aerator - obstructed

46. Obstructed aerator

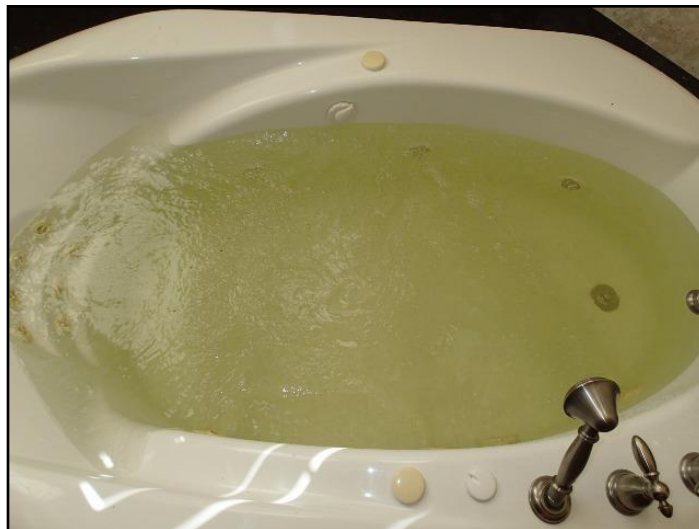
21. Condition: • Whirlpool bath was tested and functioned normally on the day of inspection. However, the water had a shade of green to it when filled.

47. Whirlpool bath

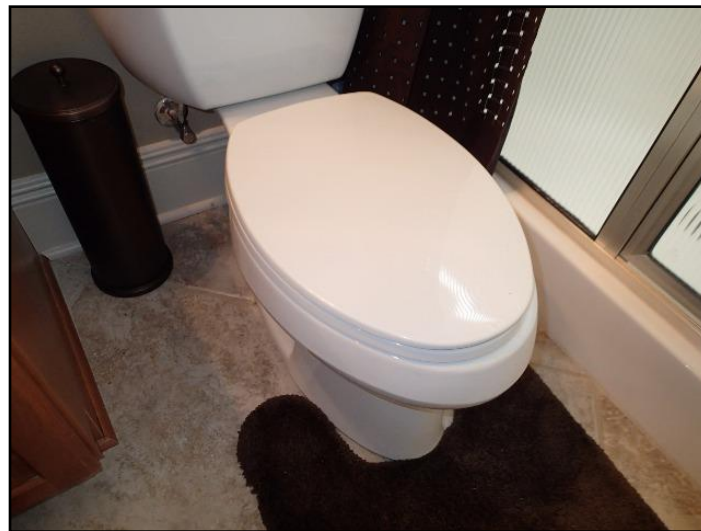
22. Condition: • Loose

Toilet near den was loose. This can result in leakage at the base of the toilet and possible damage to floor over the long term. Care should be taken not to over tighten, as this can crack or damage the porcelain.

Implication(s): Chance of water damage to structure, finishes and contents | Sewage entering the building | Possible hidden damage

48. Loose

Task: Secure

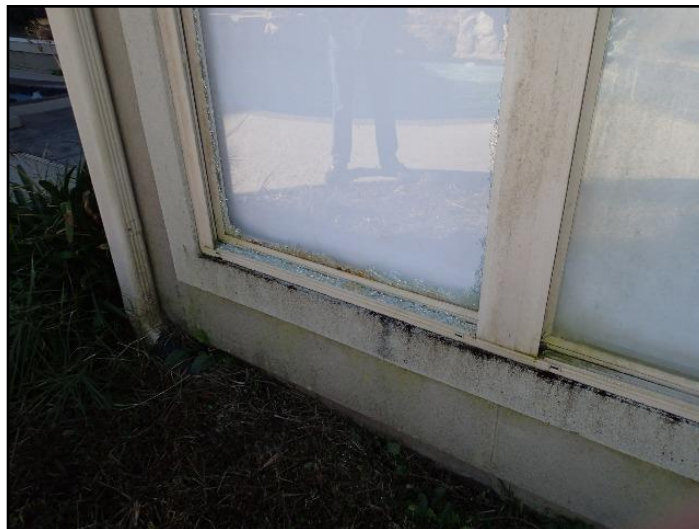
24. Condition: • Broken

Exterior window of master bedroom was broken.

Implication(s): Chance of water entering building | Physical injury | Increased heating and cooling costs | Reduced comfort

50. Broken

Task: Replace broken window

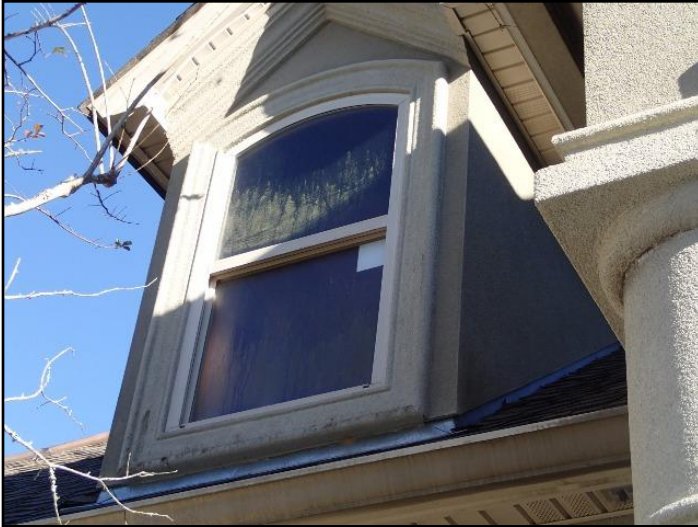
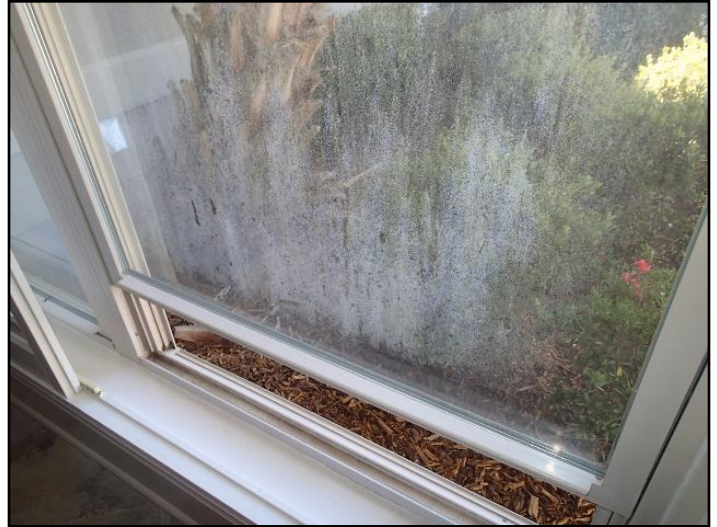
25. Condition: • Lost seal on double or triple glazing

Location: Several other windows with possible lost seal exist, but only two are pictured.

51. Lost seal on double or triple glazing

52. Lost seal on double or triple glazing

The corrective action for these problems is replacement of the glass. Since this is usually considered a condominium association common element, refer to condo documents for responsible party and a course of action to be taken.

Task: Repair or replace

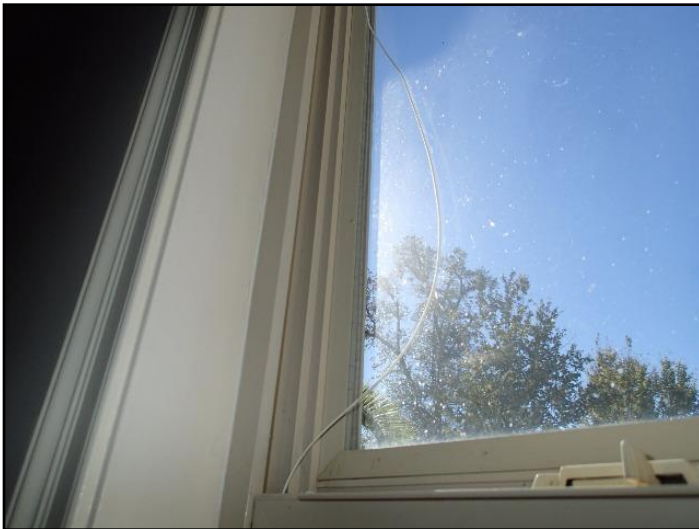
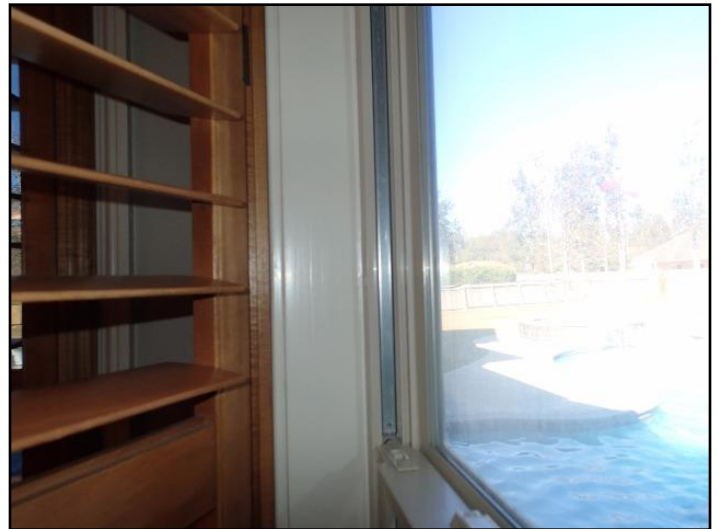
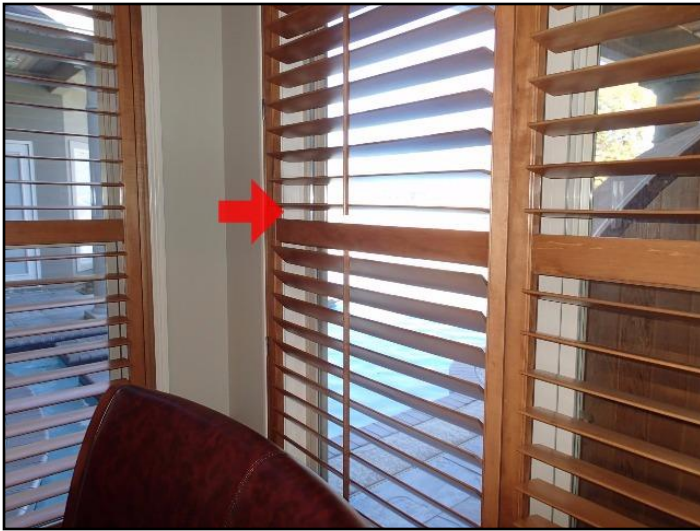
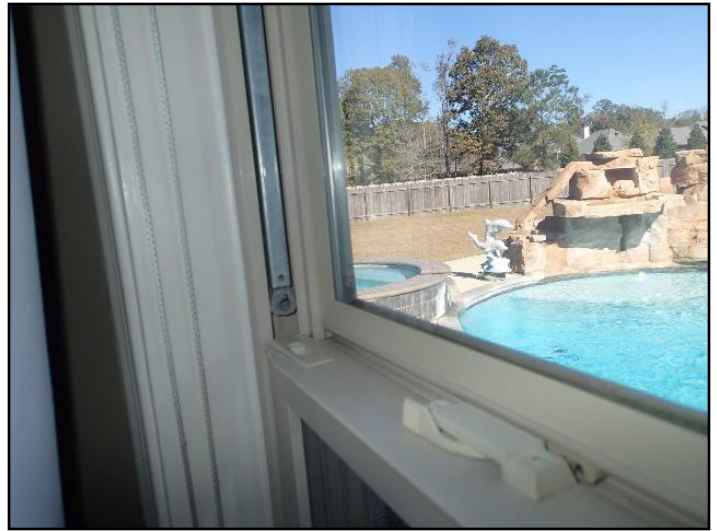
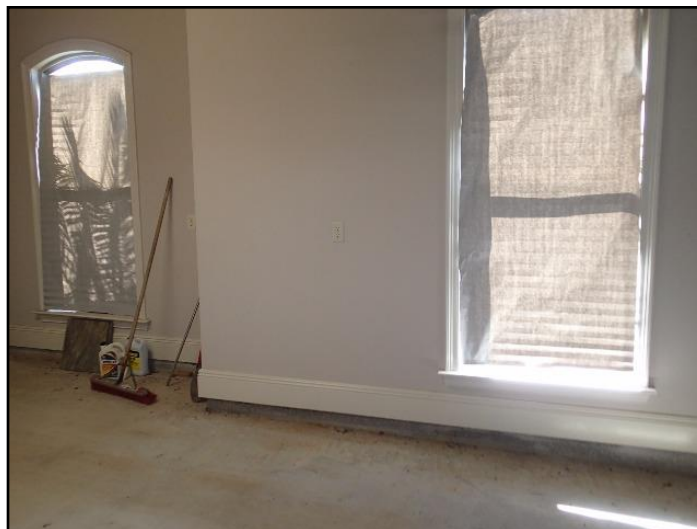
27. Condition: • Broken

Window sash channel balance was broken or inoperable. Unable to open some windows.

Implication(s): System inoperative or difficult to operate

Task: Repair or replace

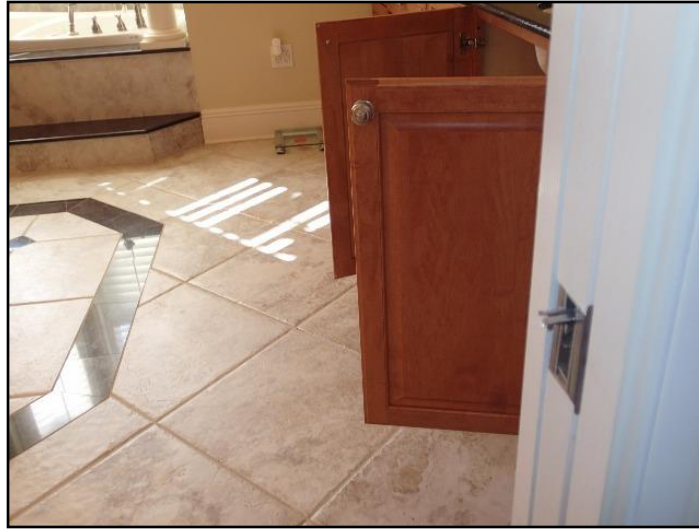
59. Latch

28. Condition: • Latch on pocket door was broken in master bathroom.

Task: Replace broken latch

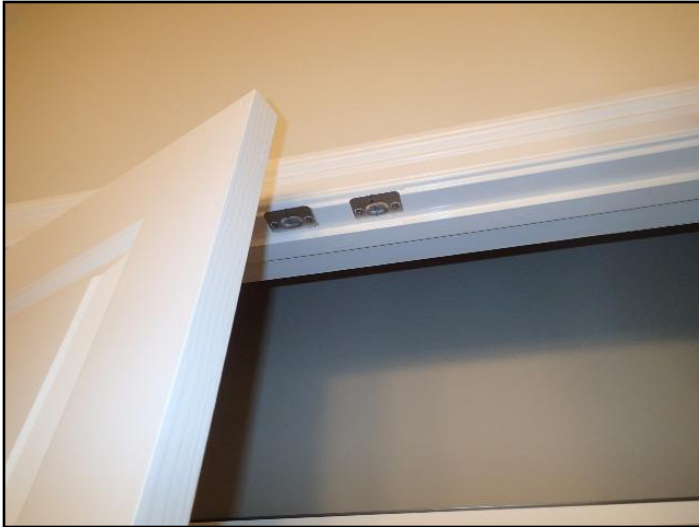
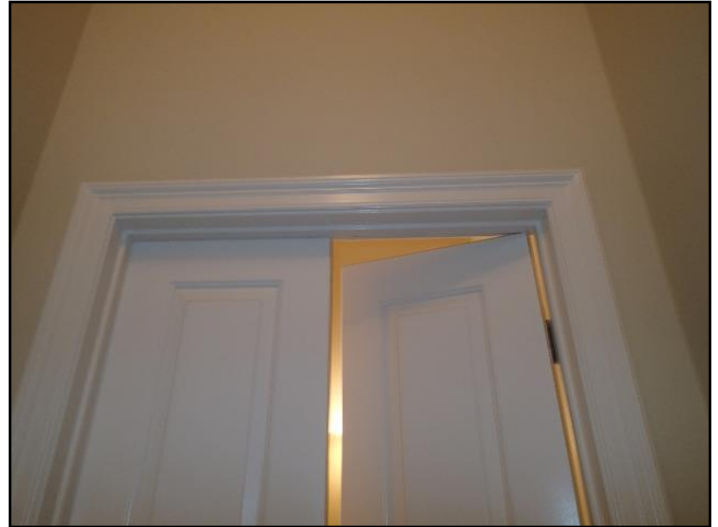
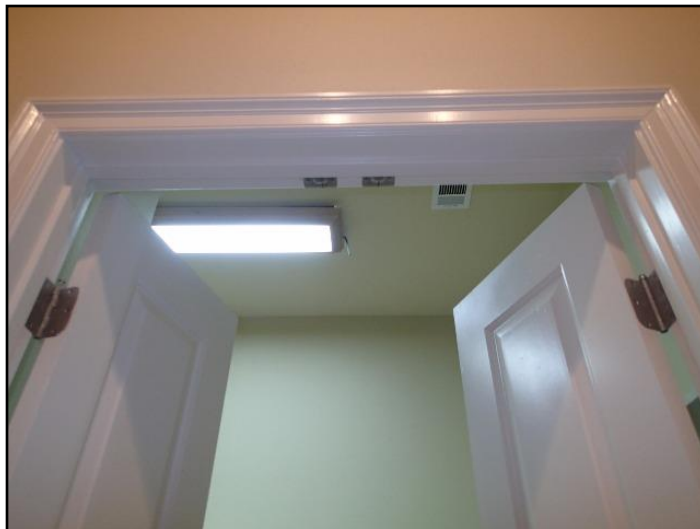
29. Condition: • Ball catch hardware was either too stiff or not stiff enough. Adjust spring tension on ball catch hardware.

Task: Adjust

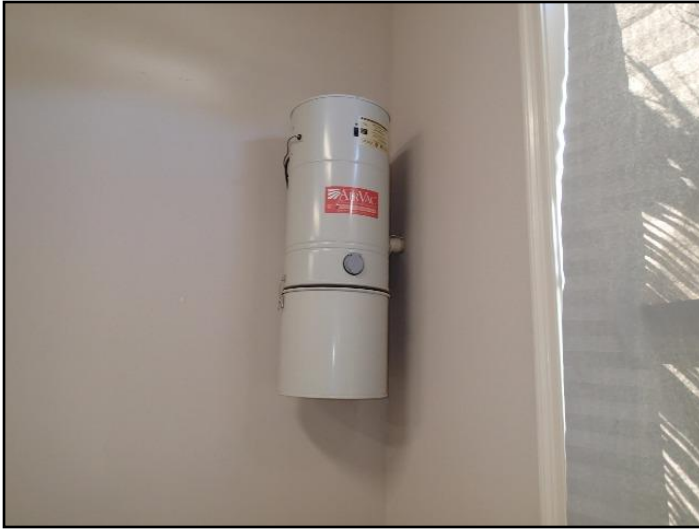
32. Condition: • Inoperative

64. Inoperative

Task: Replace
