# INSPECTION REPORT

For the Property at:  
**100 ANYWHERE**  
AUSTIN, TX

Prepared for: JOHN DOE  
Inspection Date: Wednesday, March 6, 2019  
Prepared by: Chris Nowling

RE: Report No. 3382, v.3  
100 Anywhere  
Austin, TX

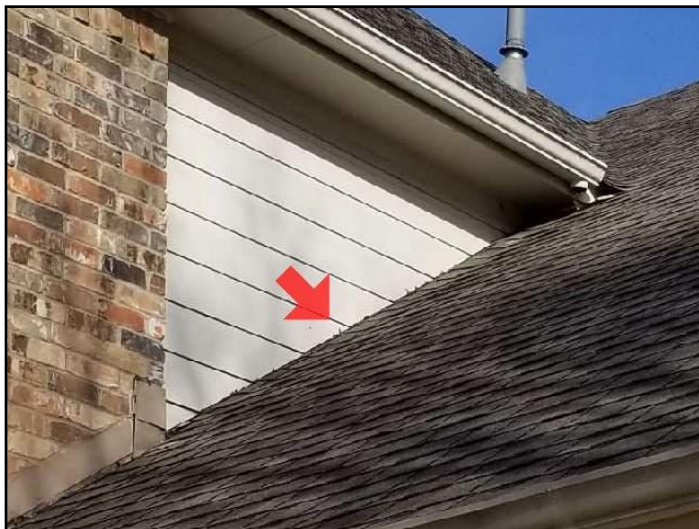
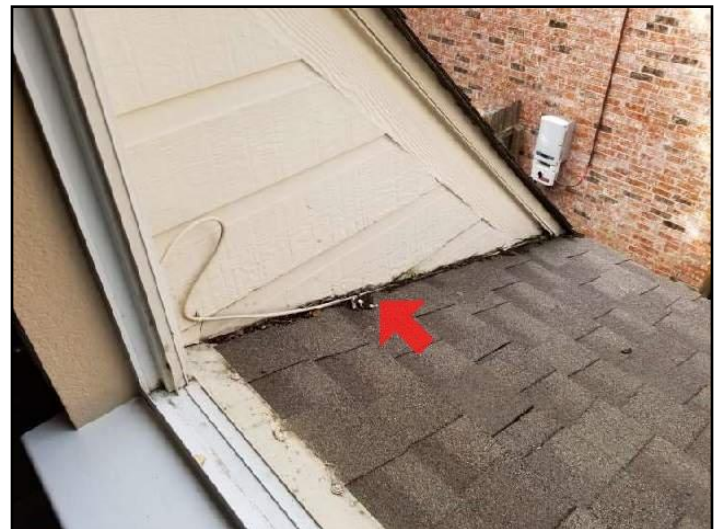
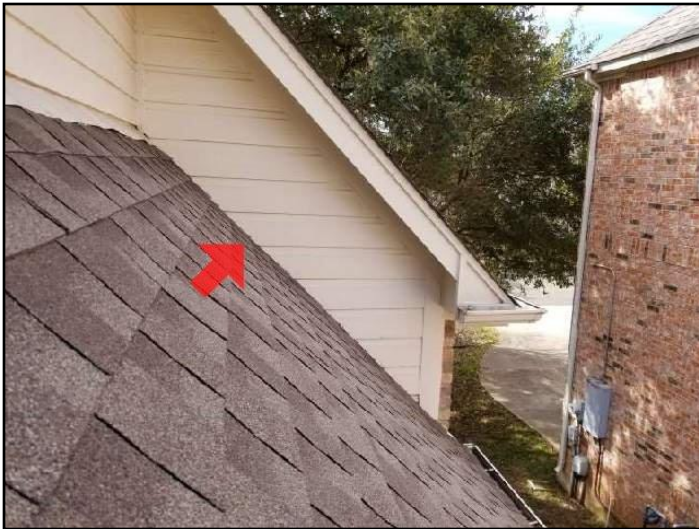
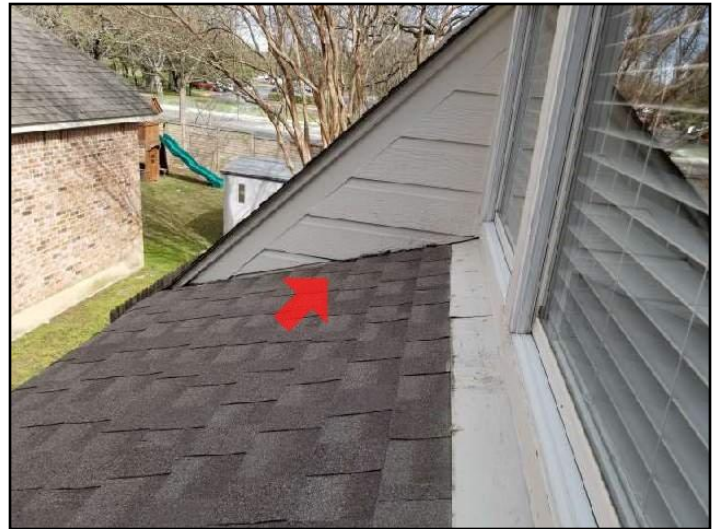
### **2. Condition:** • [Siding not cut back](#)

**Implication(s):** Chance of water damage to contents, finishes and/or structure

6. Siding not cut back

7. Siding not cut back

8. Siding not cut back

9. Siding not cut back

**Task:** Deficiency- Improve

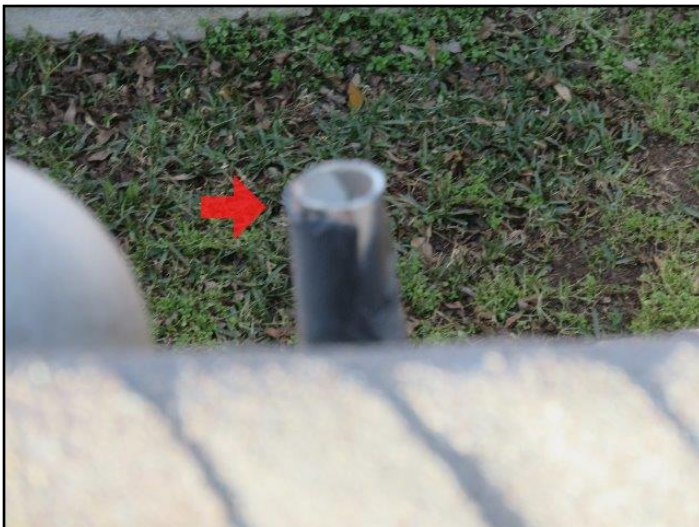
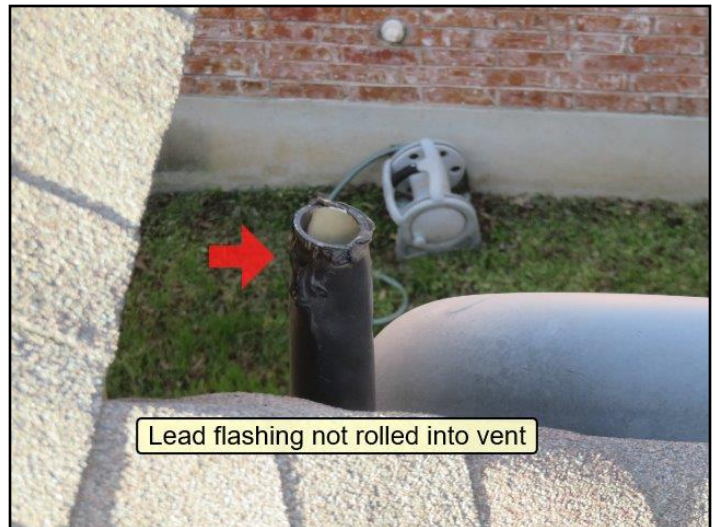
10.

3. Condition: • Lead flashing not rolled into plumbing vents

Implication(s): Leaks

Task: Deficiency- Repair

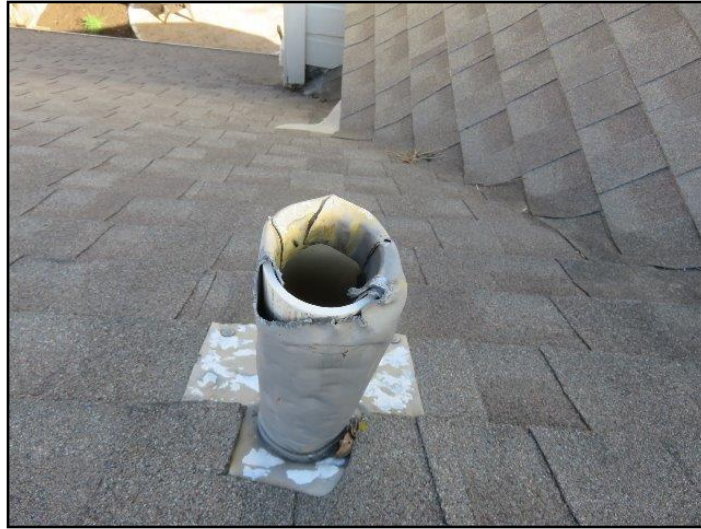
4. Condition: • [Damage](#)

Damaged lead flashing at plumbing vent.

Implication(s): Chance of water damage to contents, finishes and/or structure

12. *Damage*

Task: Deficiency- Repair

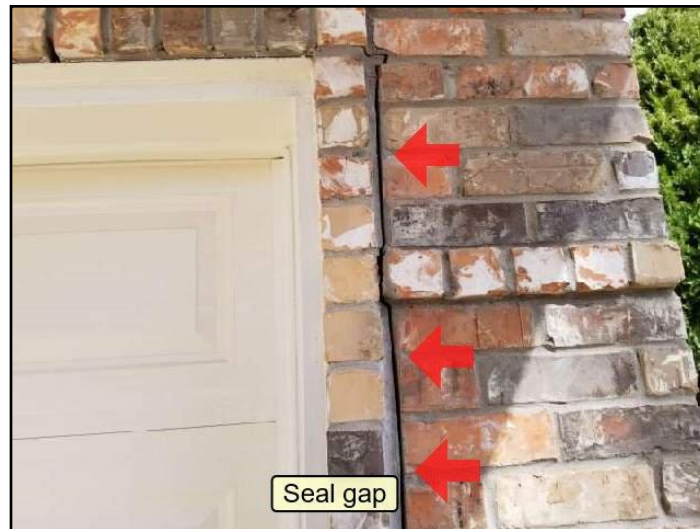
13.

**6. Condition:** • Gap between overhead garage door jamb and brick veneer at the right side of the garage door needs to be sealed.

**Task:** Deficiency- Provide

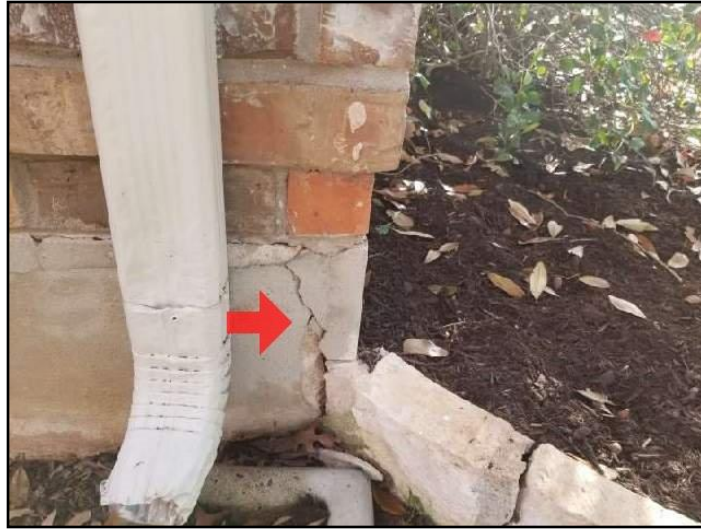
**11. Condition:** • Corner cracks observed at the corners of the foundation. Conditions are typically related to thermal expansion of the brick/masonry veneer where it rests on the slab. Condition is often due to the flashing under the brick/masonry veneer not extending beyond the edge of the foundation.

14. Corner cracks observed at the corners of th...

**Task:** Deficiency- Monitor

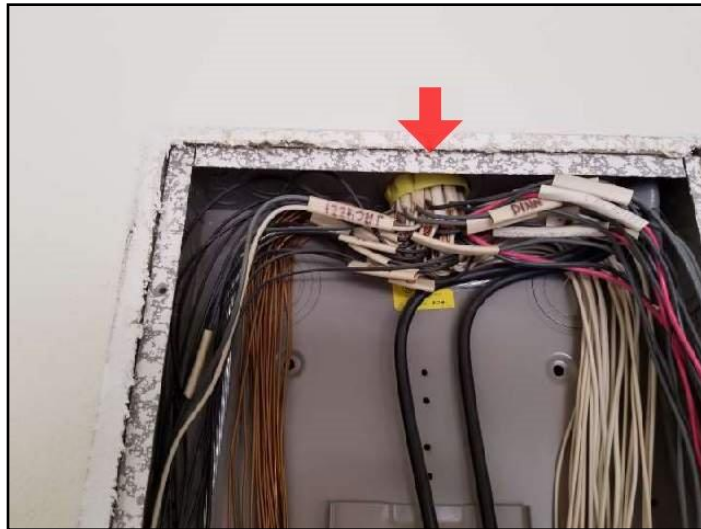
**13. Condition:** • The panel is flush mounted and most cables are bundled and exit the panel through a large opening or

two. As per current applicable standards, the individual cables should be routed through the various small "knock-out" holes at the top, bottom and/or sides of the panel box and secured with approved cable clamps, so that any smoke or fire inside the panel is confined or at least restricted from passing through the knockout openings. What was found here today was generally the method of installation in this region at the time of this home's construction. This installation would not be allowed by current standards. NEC 312.5(C)

19. The panel is flush mounted and most cables...

**Task:** Deficiency- Improve

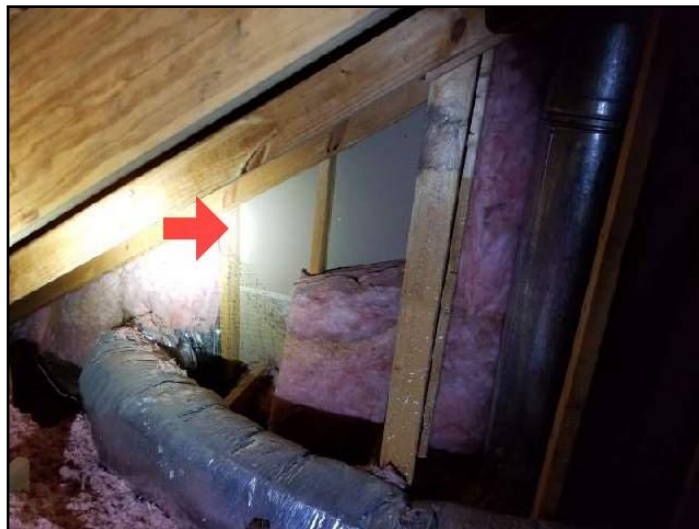
**20. Condition:** • [Gaps or voids](#)

28. Gaps or voids

**Task:** Deficiency- Correct

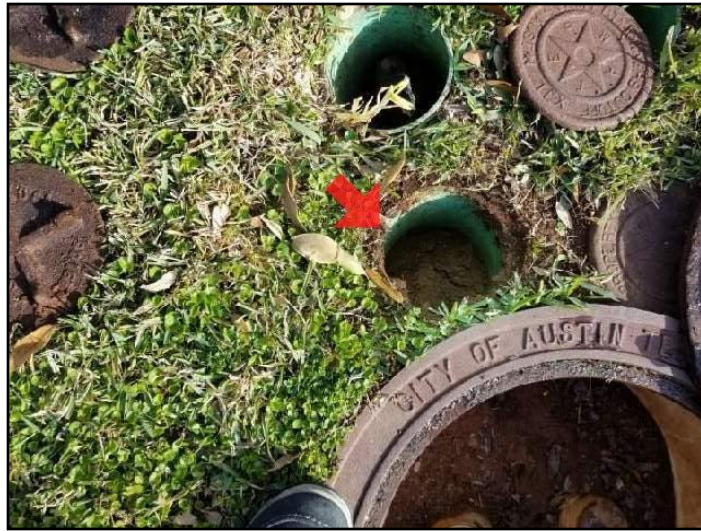
22. Condition: • [Buried](#)

34. Buried

**Task:** Deficiency- Further investigation and repairs recommended

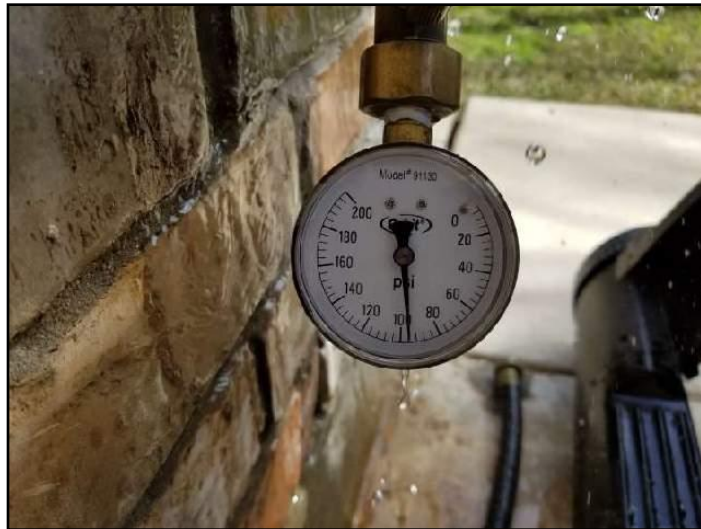
**23. Condition:** • As the static water pressure of the supply plumbing system exceeds 80 pounds per square inch (psi), it would be wise to install a pressure regulator; (if a pressure regulator is present have it serviced/adjusted). Otherwise, the plumbing system may be prone to leaks in piping, fittings or other equipment. Client should be aware that once a "pressure reducing valve" has been installed on the water supply, standards call for the installation of an expansion tank. Consult a licensed plumber for further evaluation and correction.

35. As the static water pressure of the supply...

**Task:** Deficiency- Further investigation and repairs recommended

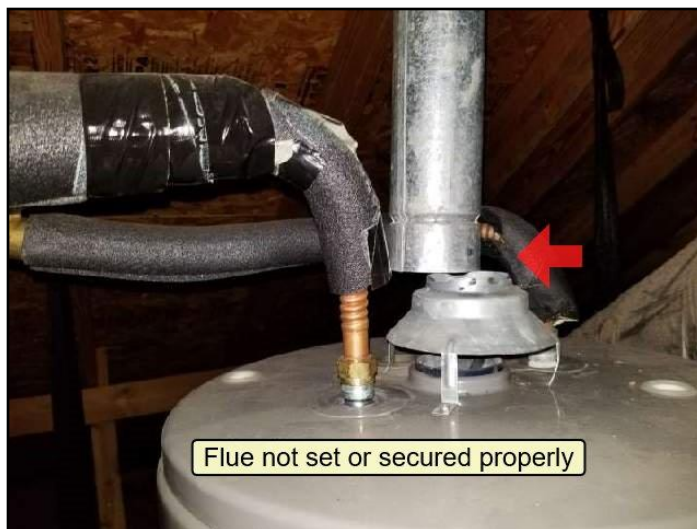
### **25. Condition:** • [Poor connections](#)

**Implication(s):** Equipment not operating properly | Hazardous combustion products entering home

36. Poor connections

**Task:** Deficiency- Repair

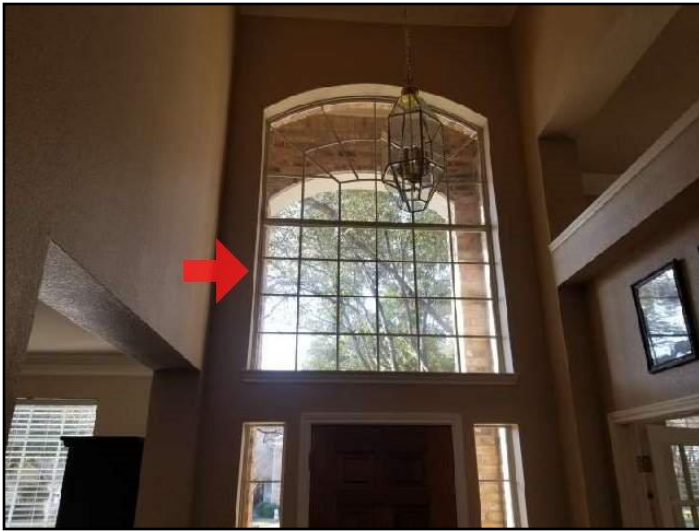
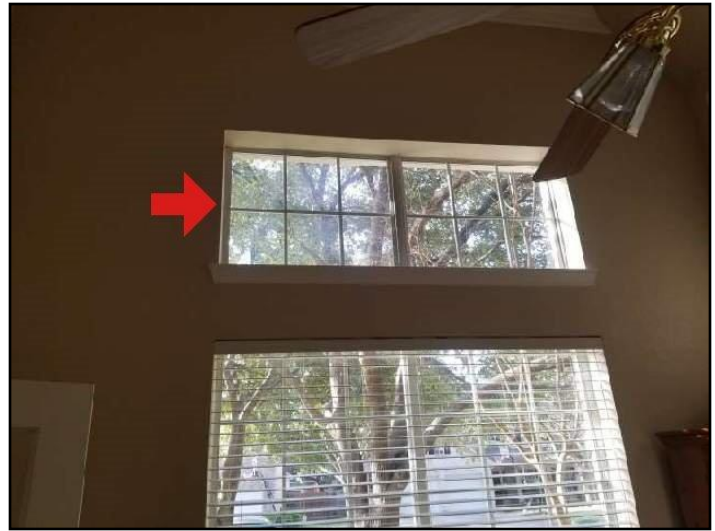
**29. Condition:** • [Lost seal on double or triple glazing](#)

**30. Condition:** • [Lost seal on double or triple glazing](#)

37. Lost seal on double or triple glazing

38. Lost seal on double or triple glazing

**Task:** Deficiency- Repair

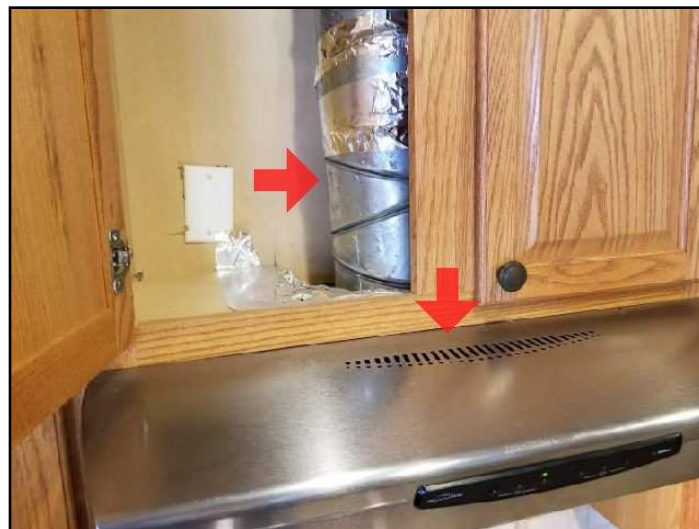
39.

**32. Condition:** • Range exhaust appears to be set up for exterior discharge. However much of the air is blowing inside as if it was a recirculating type and I didn't locate the exterior discharge location.

**Task:** Deficiency- Further investigation and repairs recommended

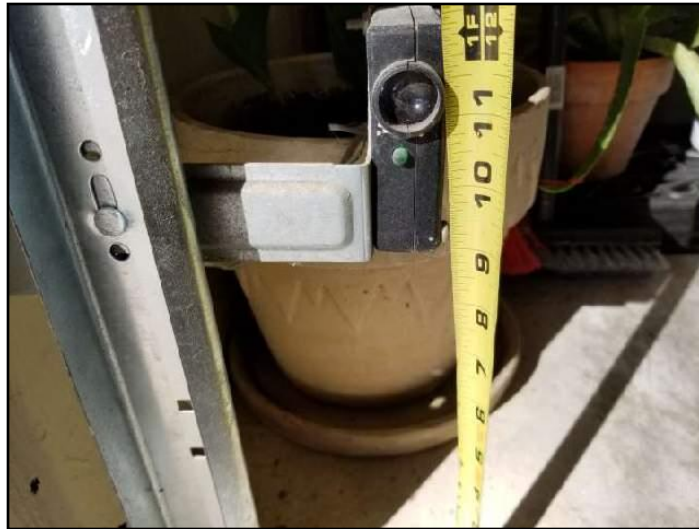
### **34. Condition:** • Sensors poorly located

40. Sensors poorly located

**Task:** Deficiency- Improve

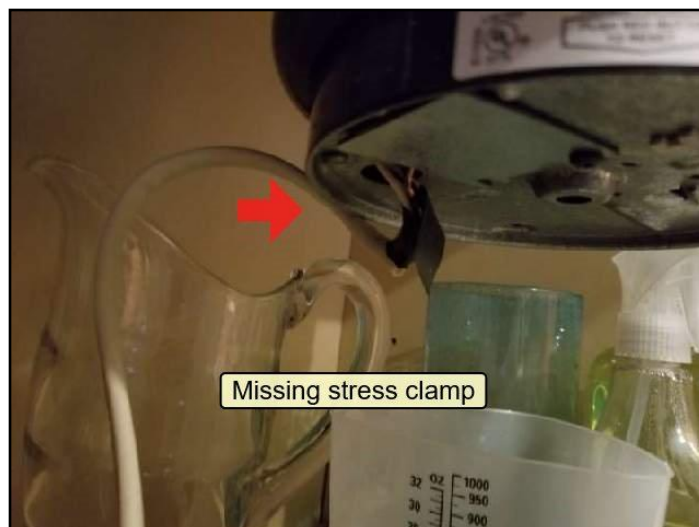
**36. Condition:** • Wiring exposed or loose

41. Wiring exposed or loose

**Task:** Deficiency- Repair

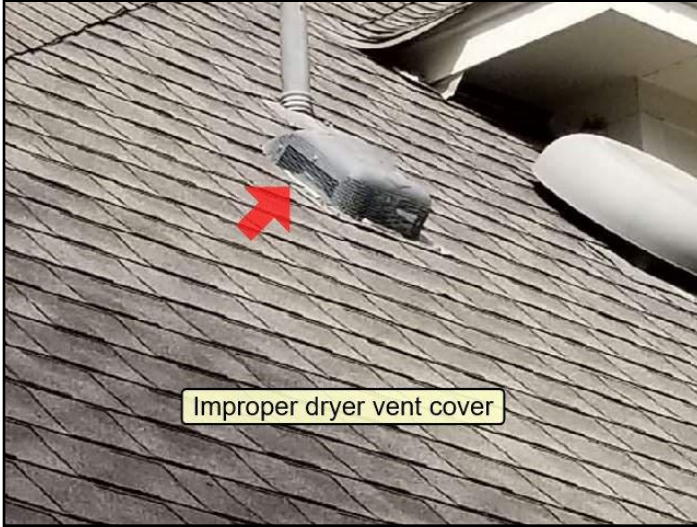
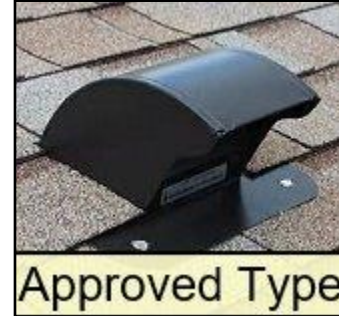
**37. Condition:** • Improper roof top dryer vent discharge and it is not equipped with a damper.

**42. Improper roof top dryer vent discharge and...**

**43. Improper roof top dryer vent discharge and...**

**Task:** Deficiency- Further investigation and repairs recommended
