YOUR INSPECTION REPORT

719 Durie Street
Toronto, ON M6S 3H4

INSPECTION DATE:
Thursday, August 1, 2019

RE: Report No. 2509
719 Durie Street
Toronto, ON
M6S 3H4

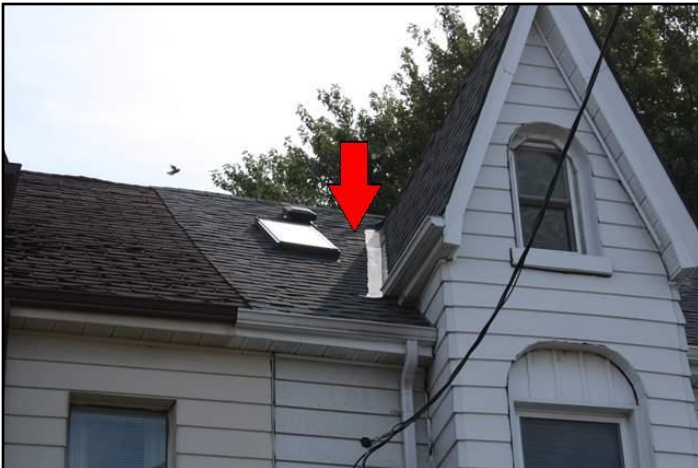
Condition: • [Missing, loose or torn](#)

Implication(s): Chance of water damage to contents, finishes and/or structure

1. Missing, loose or torn

Task: Repair

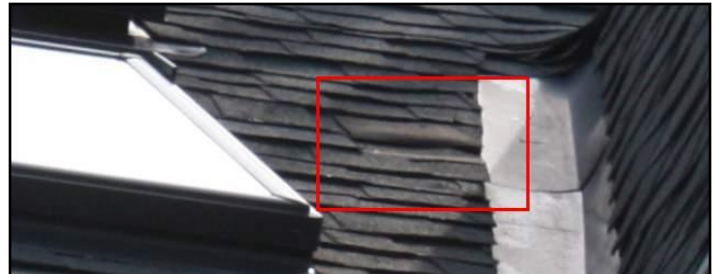
2. Zoomed in view

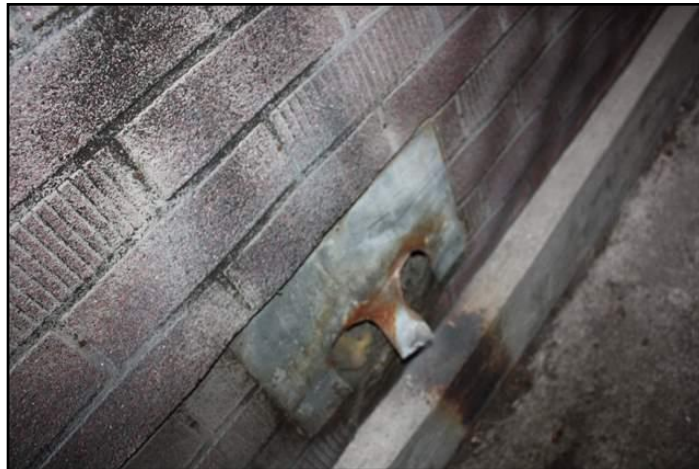
3.

Condition: • Damage

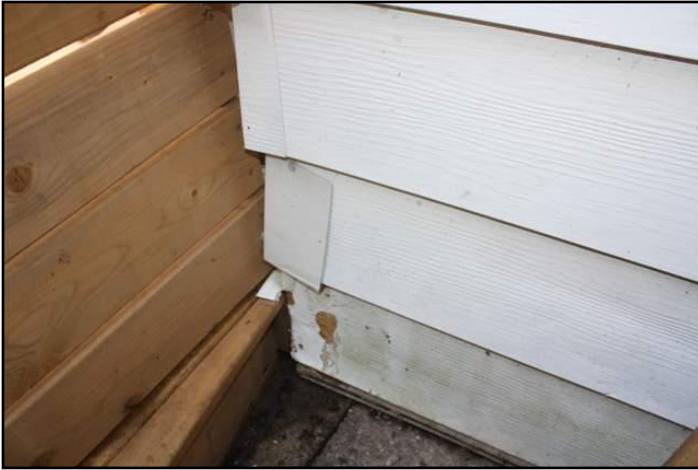
Condition: • [Loose or missing pieces](#)

Implication(s): Chance of water damage to contents, finishes and/or structure

4. Loose or missing pieces

Task: Repair / Replace

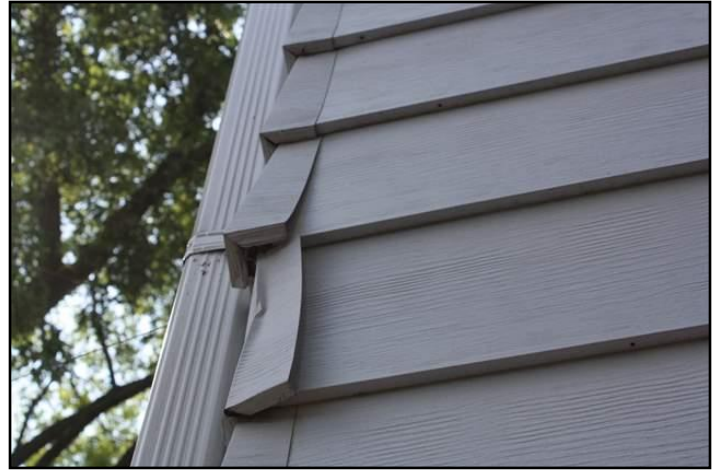
5. Loose or missing pieces

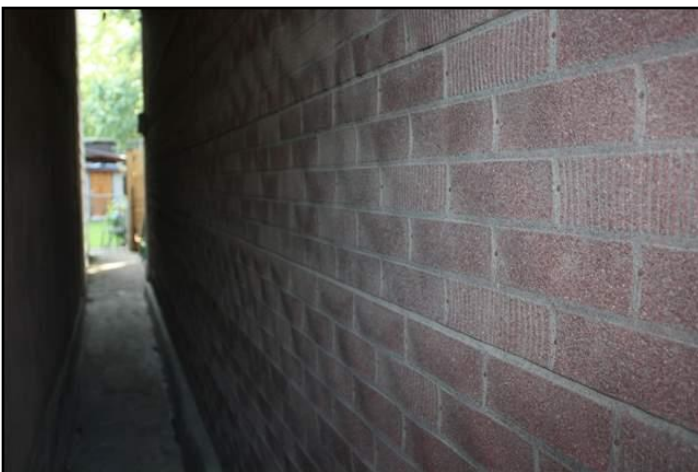
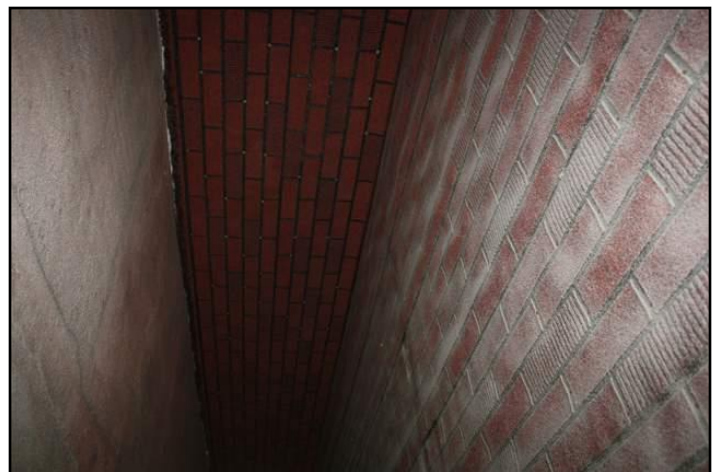
Condition: • Insulbrick has not been manufactured for some time, and installations are quite old, often showing damage or deterioration. Water penetration and damage to the walls behind the siding are potential problems where there are imperfections. Some insurance companies are reluctant to offer insurance for homes with this type of siding.

Task: Consult with your insurer and advise that area is covered

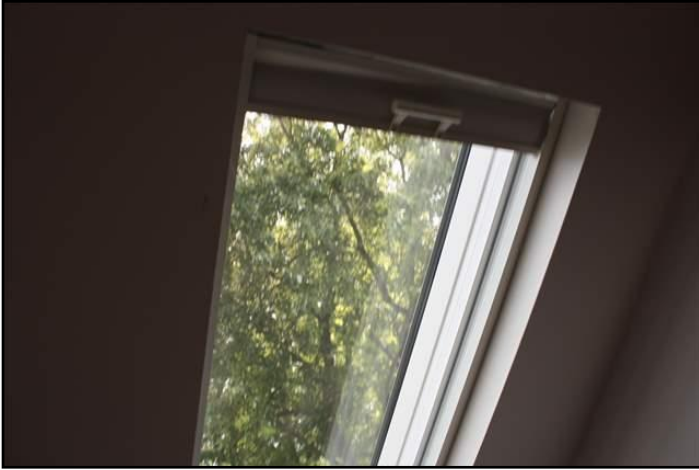
Condition: • Lost seal on double or triple glazing

8. Lost seal on double or triple glazing

Task: Replace

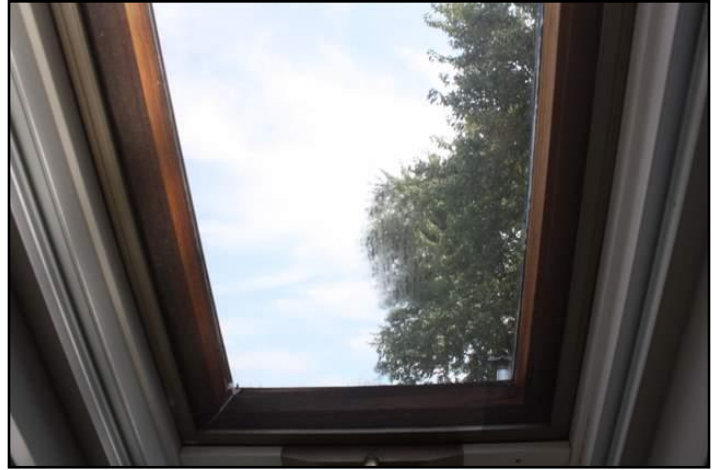
9. Lost seal on double or triple glazing

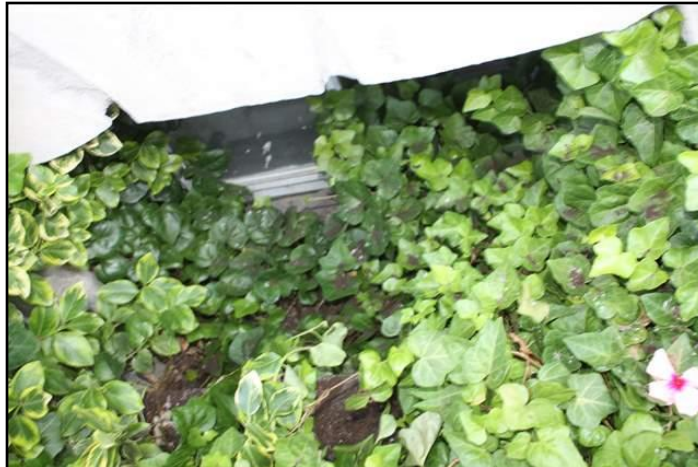
Condition: • Window sill is at or below grade.

10. Window sill is at or below grade.

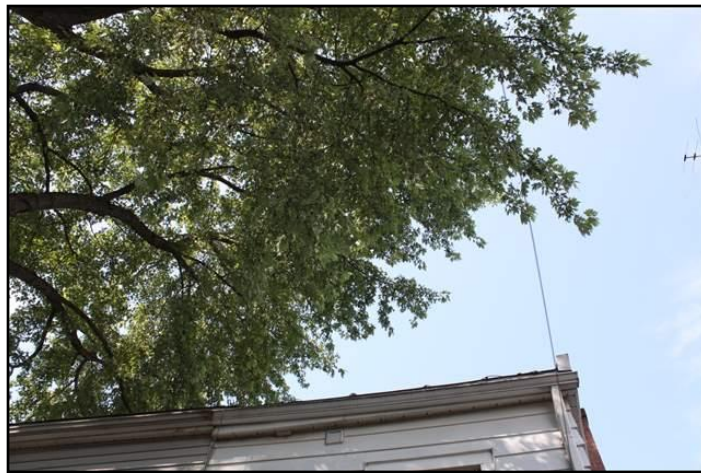
Condition: • [Trees or shrubs too close to building](#)

Implication(s): Chance of water damage to contents, finishes and/or structure | Chance of pests entering building | Material deterioration

11. Trees or shrubs too close to building

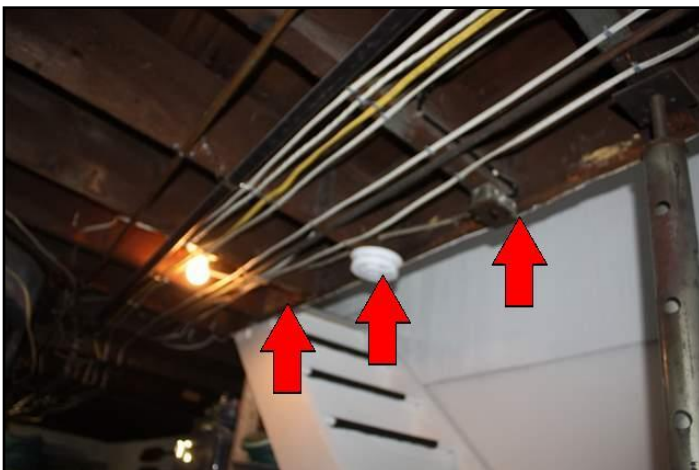
At the joists near the stairs, the end bearing is poor / coming detached. This may have been in this condition for some time. Improve support in this area. This can typically be done by adding joist hangers or wood beam and steel jack posts. Consult with contractor for improvement recommendation

12. Poor end bearing, joist hanger connections

Task: Improve support of joists at stairs

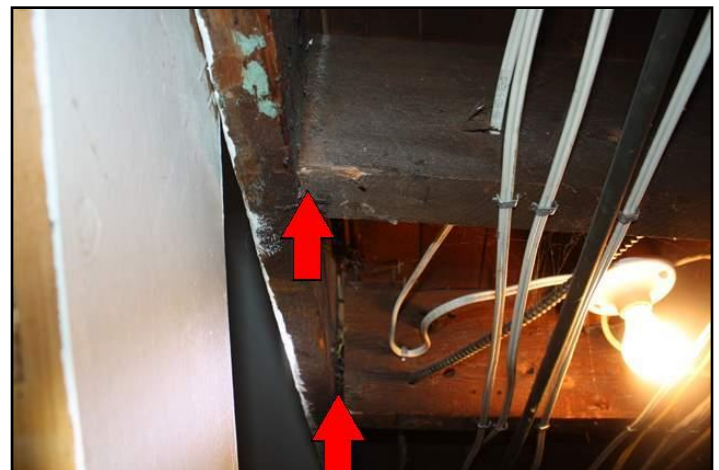
13. Poor end bearing, joist hanger connections

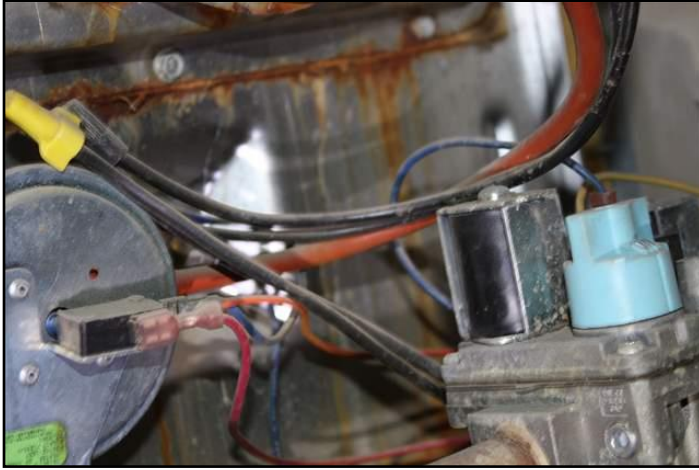
Condition: • [Prior repairs](#)

Very common to find these types of repairs in homes of this age.

14. Prior repairs

Task: For Your Information / Monitor / Improve

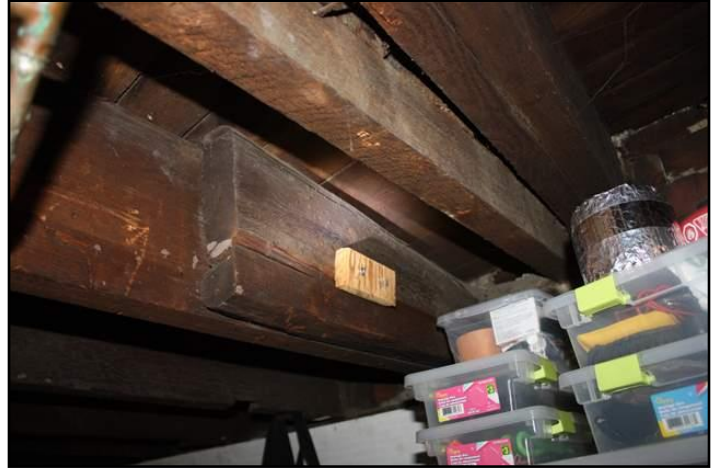
15. Prior repairs example

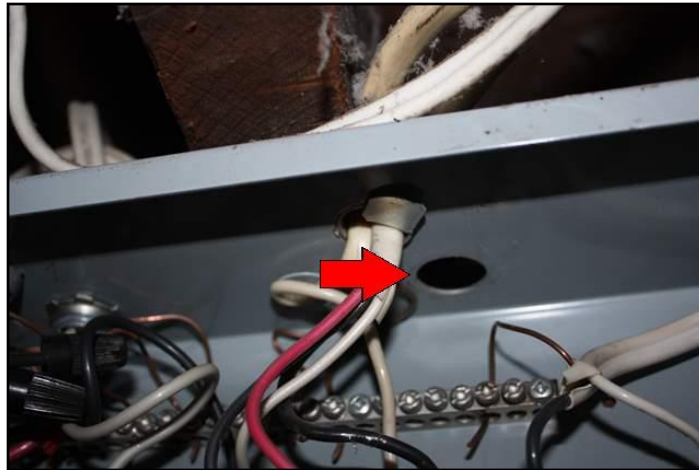
Condition: • [Openings in panel](#)

Implication(s): Electric shock | Fire hazard

16. Openings in panel

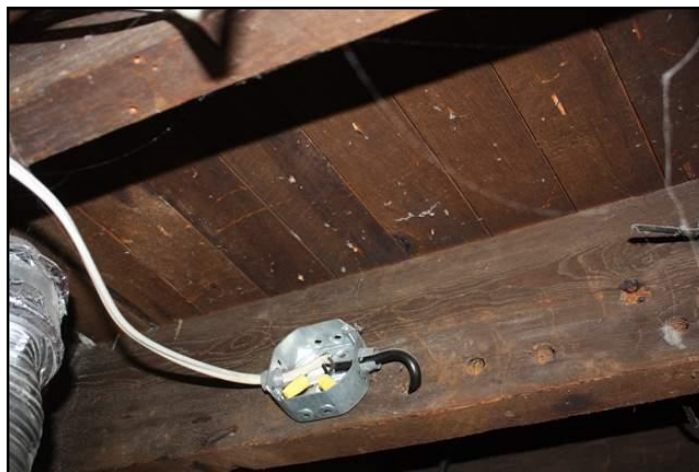
Condition: • [Cover loose or missing](#)

Implication(s): Electric shock | Fire hazard

17. Cover loose or missing

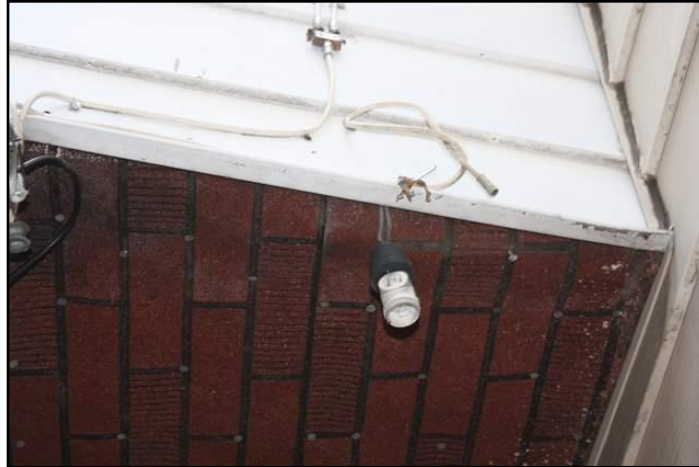
Condition: • [Obsolete](#)

Implication(s): Electric shock | Fire hazard

18. Obsolete

Task: Replace

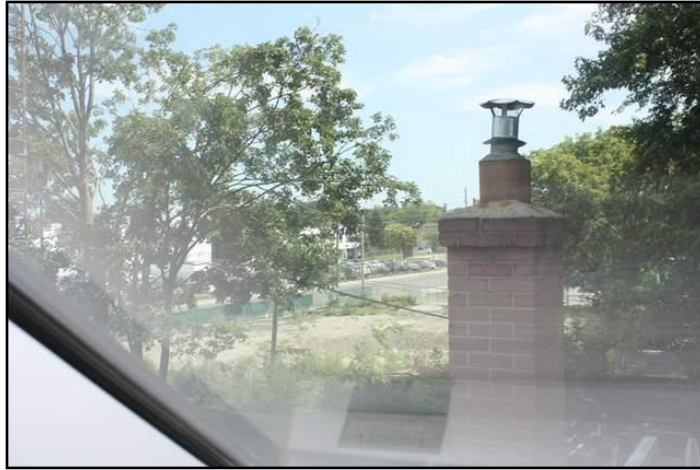
Condition: • [No drip edge on cap](#)

Implication(s): Chance of water damage to contents, finishes and/or structure | Shortened life expectancy of material | Material deterioration

19. No drip edge on cap

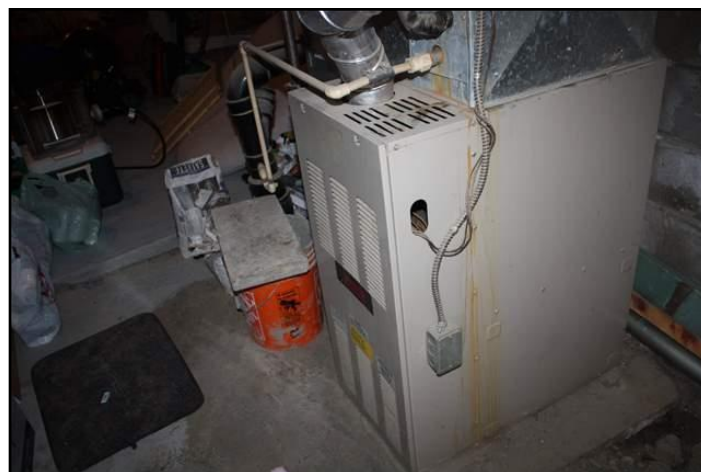
20.

Condition: • Evidence of prior condensate leak. Was not active at time of inspection. May have occurred at any time in the past.

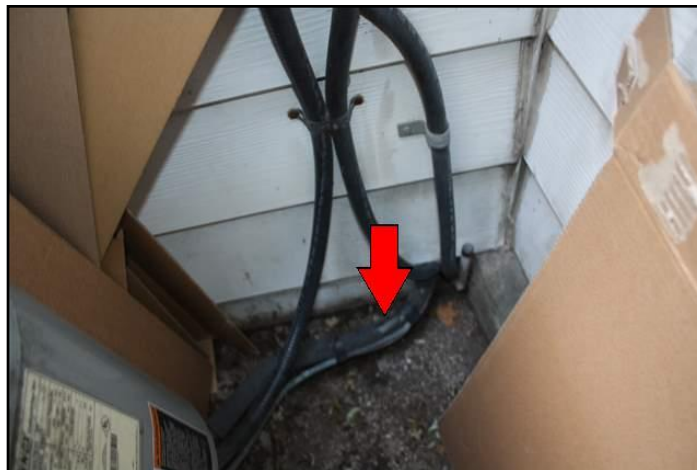
Condition: • [Insulation - missing](#)

21. Insulation - missing

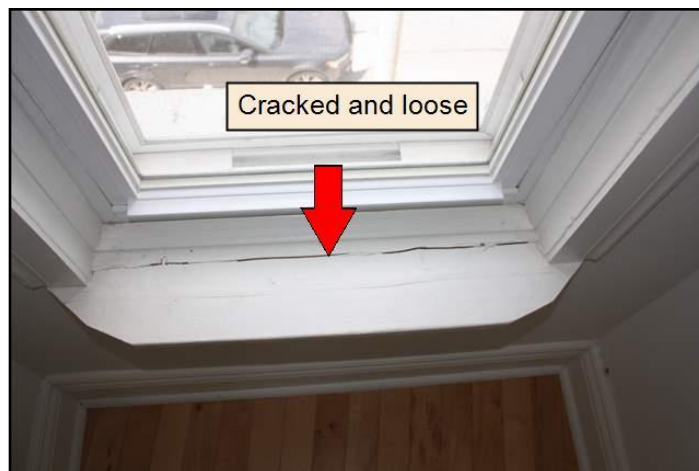
Condition: • [Cracked](#)

Implication(s): Material deterioration | Physical injury

22. Cracked

Task: Repair or replace

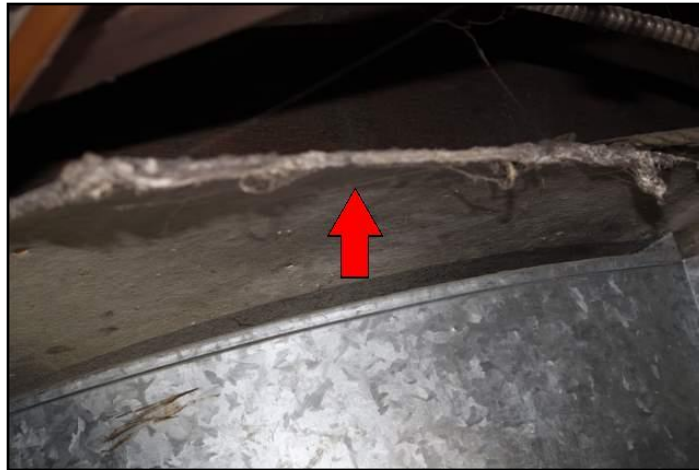
Condition: • Possible asbestos containing materials

During the era when this house was built and up until the 1960s, it was very common to use insulation material that may contain asbestos to shield wood surface from the duct. Determining the material type is outside the scope of this inspection. Health Canada recommends that any asbestos material found should stay in place undisturbed. If you plan to remodel or if this is a concern, consult with a specialist for lab testing to confirm if asbestos is present.

Implication(s): Health hazard

23. Possible asbestos containing materials

Task: Further evaluation
