YOUR Inspection Report

1436 Artesian Ln
Fairborn, OH 45324

RE: Report No. 2680, v.3
1436 Artesian Ln
Fairborn, OH
45324

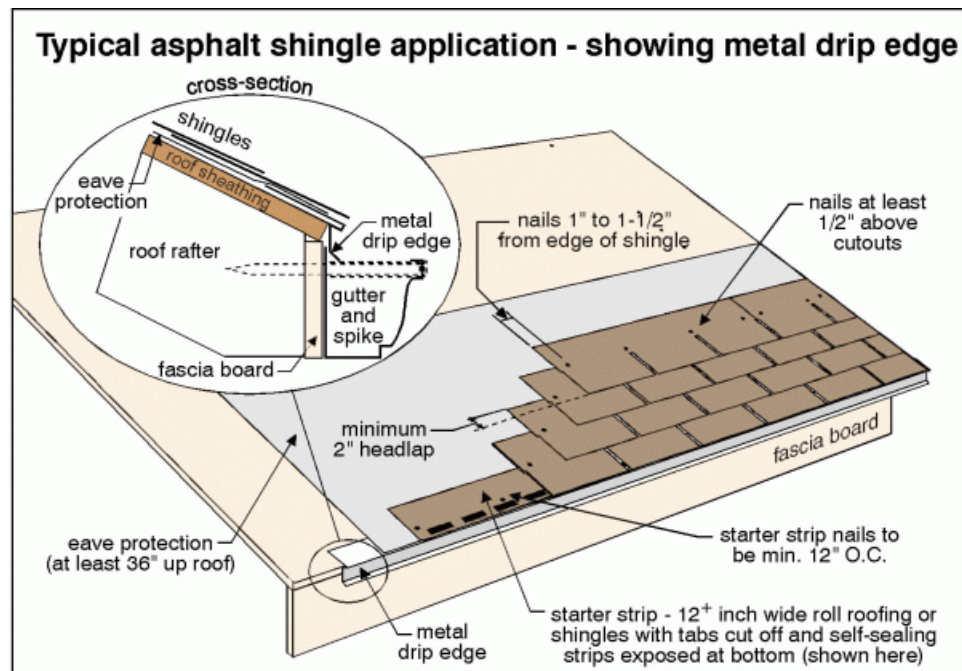
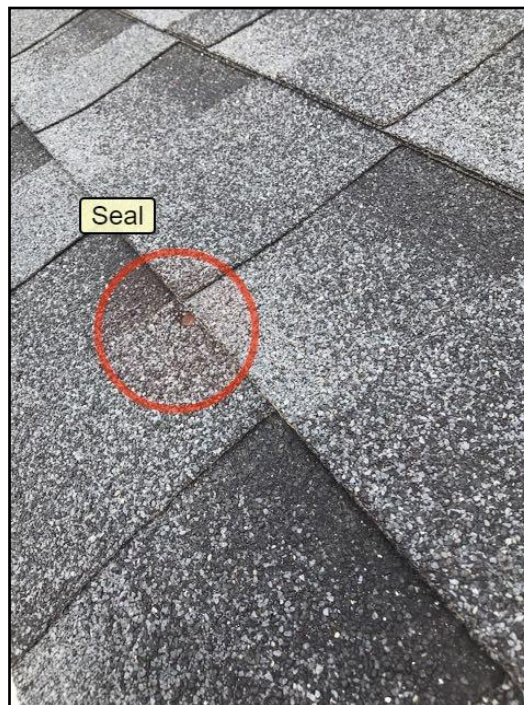
1. Condition: • [Exposed fasteners](#)

Implication(s): Chance of water damage to contents, finishes and/or structure

Location: Front

Exposed fasteners

Task: Seal
