YOUR INSPECTION REPORT

316 Park Lawn Road
Toronto, ON M8Y 3K2

INSPECTION DATE:
Thursday, August 29, 2019

RE: Report No. 2525
316 Park Lawn Road
Toronto, ON
M8Y 3K2

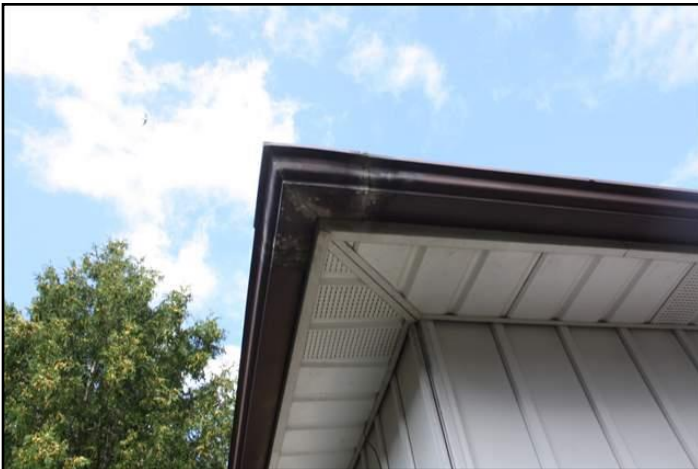
Condition: • Aging - Wear and tear noted. Fasteners loose in some areas

Monitor joints for leakage and seal

1. Aging - Wear and tear noted. Fasteners...

Task: Replace

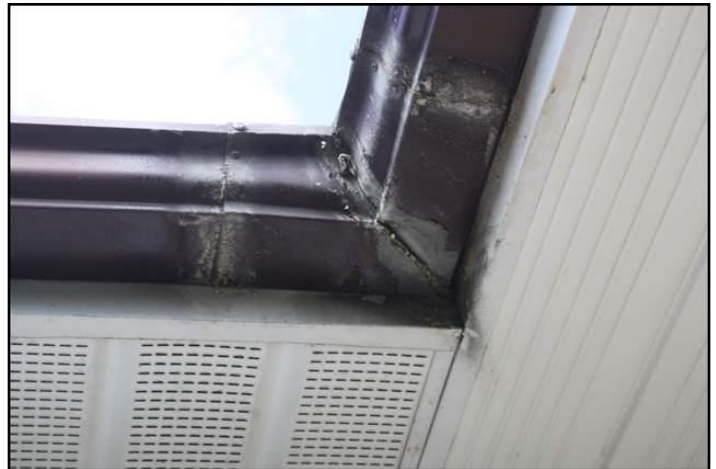
2. Aging - Wear and tear noted. Fasteners...

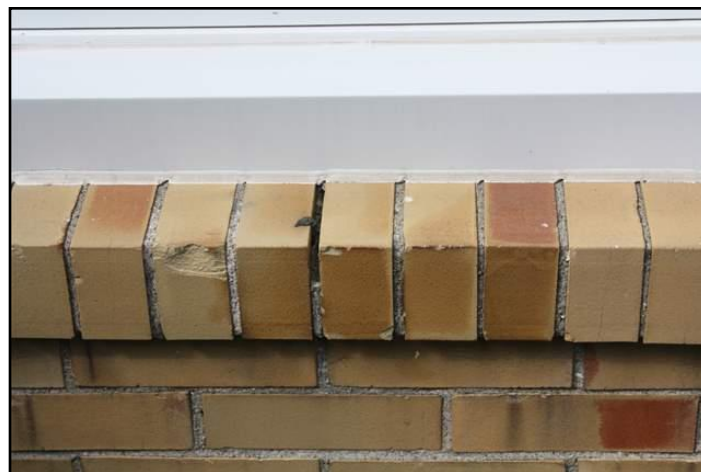
Condition: • [Mortar deterioration](#)

3. Mortar deterioration

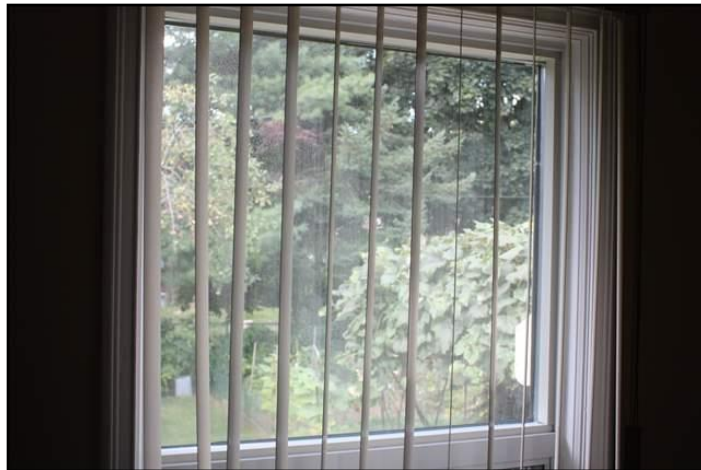
Condition: • [Lost seal on double or triple glazing](#)

4. Lost seal on double or triple glazing

Task: Replace

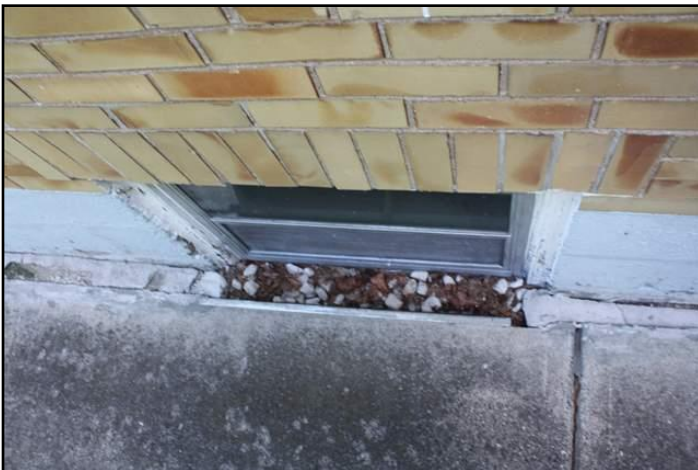
Condition: • Window sill is at or below grade.

5. Window sill is at or below grade.

Window well covers recommended.

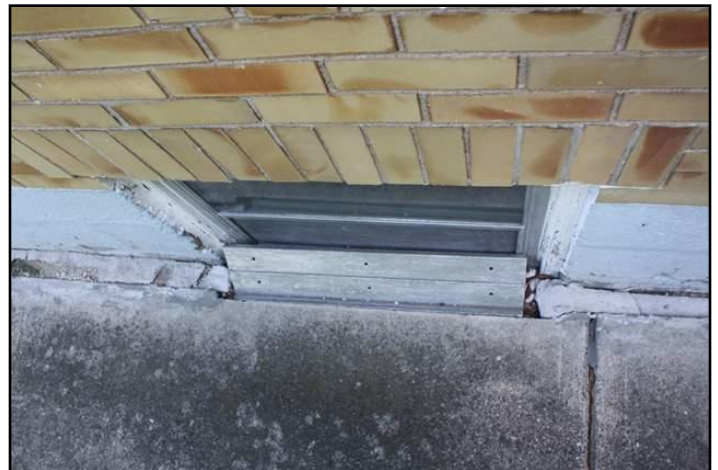
6. Window sill is at or below grade.

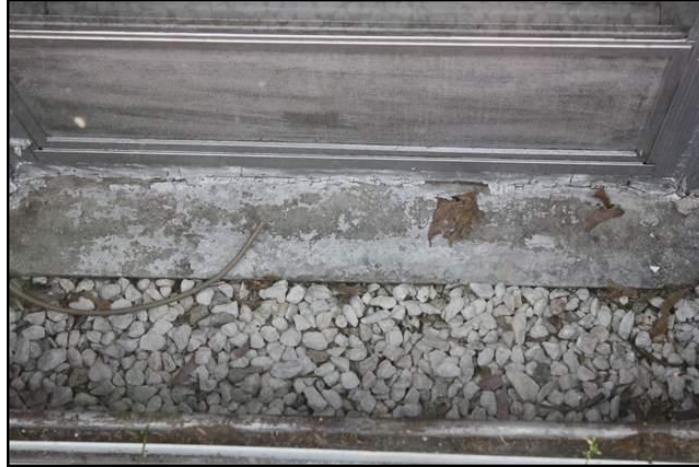
Condition: • Window sill is at or below grade.

7. Window sill is at or below grade.

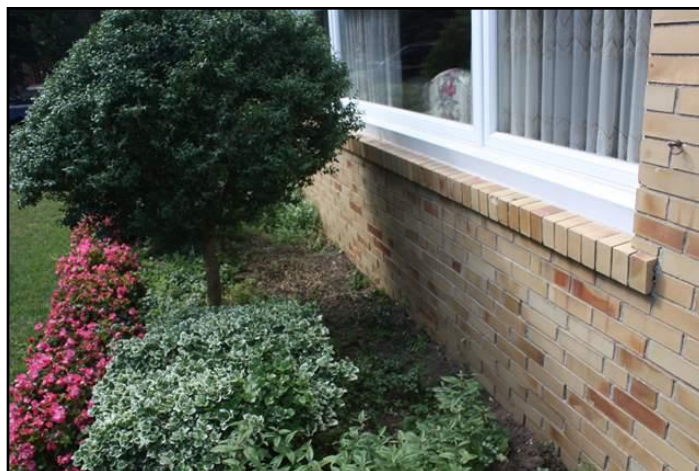
Condition: • [Masonry too close to grade](#)

Click the link to read more information. Some types of brick can be installed at or below grade. We can not distinguish brick type during a home inspection. Considering the masonry is 50+ years old and is in good overall condition it would be prudent to monitor for now.

Implication(s): Chance of damage to structure

8. *Masonry too close to grade*

Task: Click link to read more information / Correct

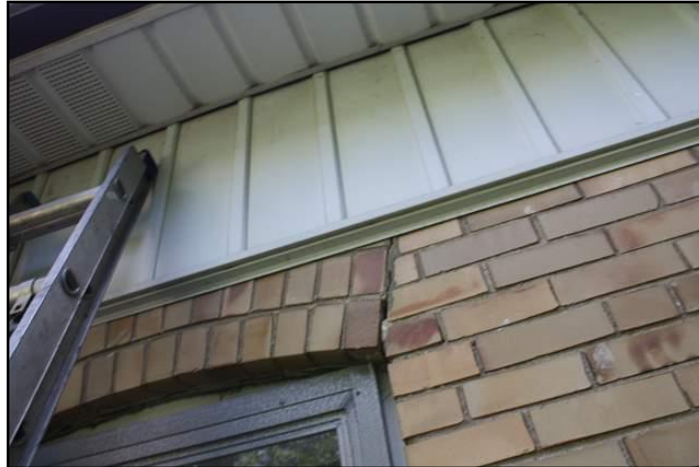
Condition: • [Mortar deteriorated](#)

9. Mortar deteriorated

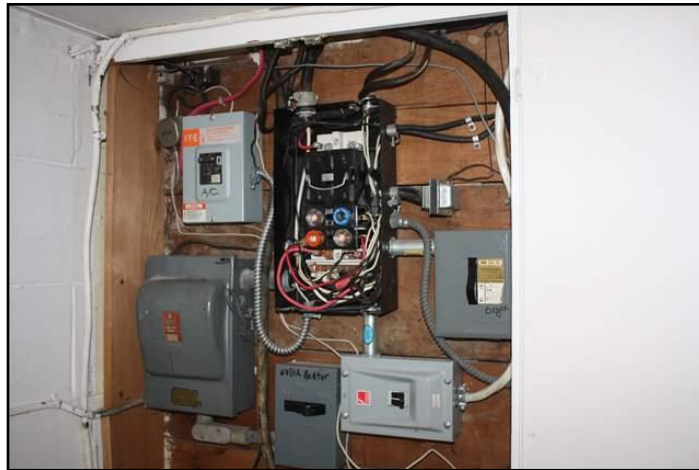
• [Fuses - basement](#)

10. Fuses - basement

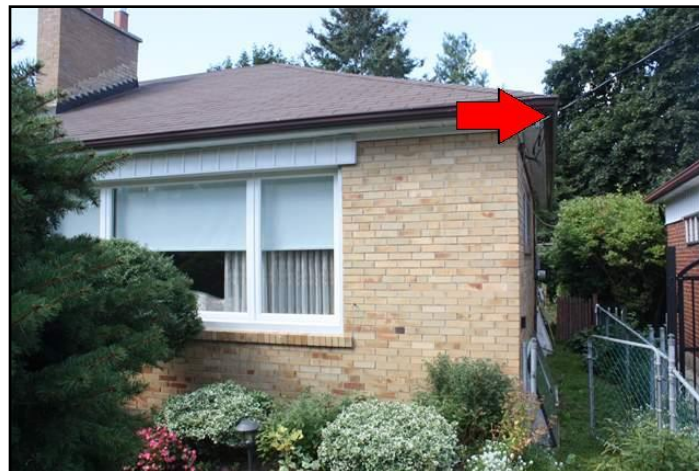
Condition: • [Height over walking area](#)

Implication(s): Electric shock

11. Height over walking area

Task: Correct

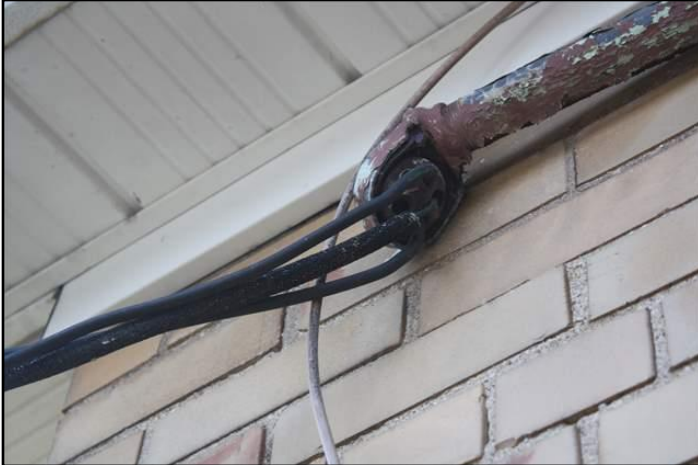
Most Insurance Companies have stopped offering insurance to homes with a 60-amp service size. Depending on the work needed, the cost to upgrade from 60-amp varies from \$1500 - \$3000 (\$3000 would typically include the cost of new 100-panel)

SERVICE DROP AND SERVICE ENTRANCE \ Service size**Condition:** • [Inadequate service size](#)

12. Inadequate service size

Task: Upgrade**Time:** As Soon As Possible**Cost:** \$1500-\$3000

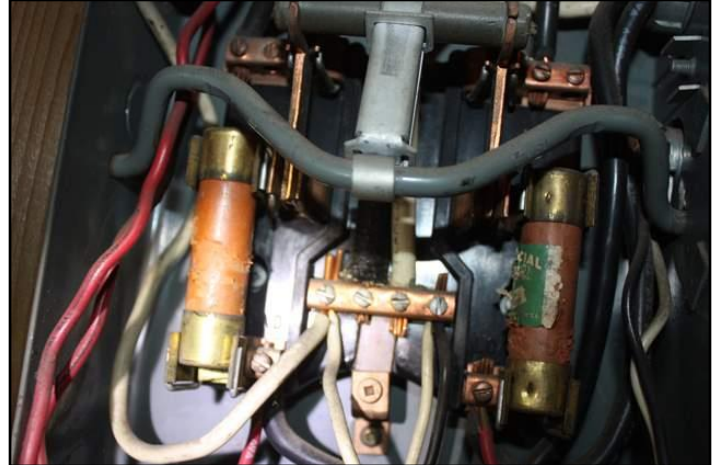
13. Inadequate service size

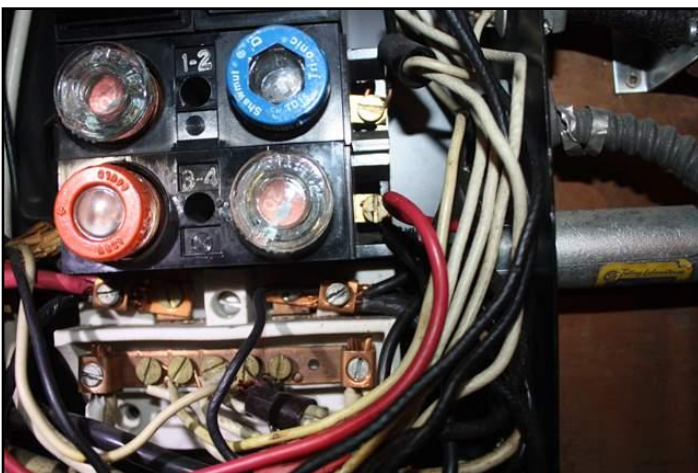
Condition: • [Obsolete](#)

Many Insurance companies have stopped insuring fuse box panels. We noted issues with overfusing, double tapping and overcrowding of both the service box and panel. As noted in Service size inadequate, upgrade service size and panels to new combination breaker panel

Implication(s): Electric shock | Fire hazard**Location:** Basement Panel**Task:** Upgrade**Time:** Immediate**Cost:** See cost note in Service Size Inadequate

14. Double taps and overfusing.

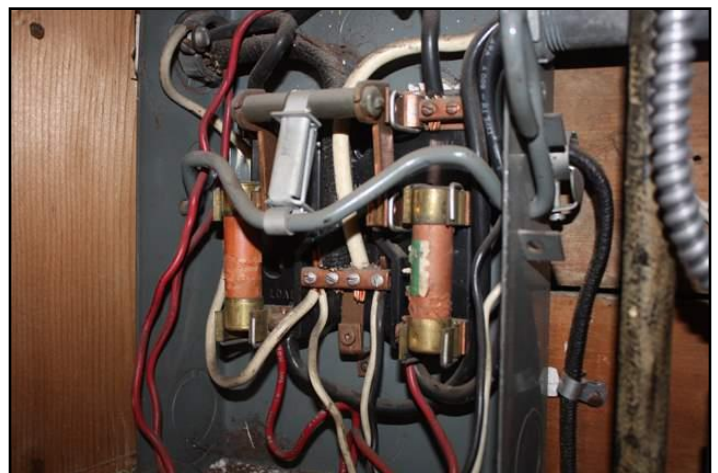
15. double taps

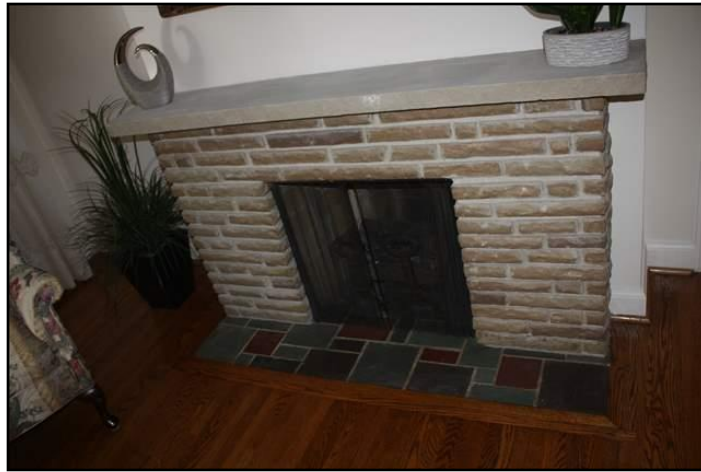
Condition: • Fireplace, flue and chimney should be inspected and swept as needed by a WETT certified technician and any recommended repairs completed before the fireplace is used. (WETT - Wood Energy Technology Transfer Inc. is a non-profit training and education association.) See www.wettinc.ca.

The fireplace on the main floor has not been used in over 30 years. If you plan to use for burning wood, inspect and repair prior.

16. Fireplace, flue and chimney should be...

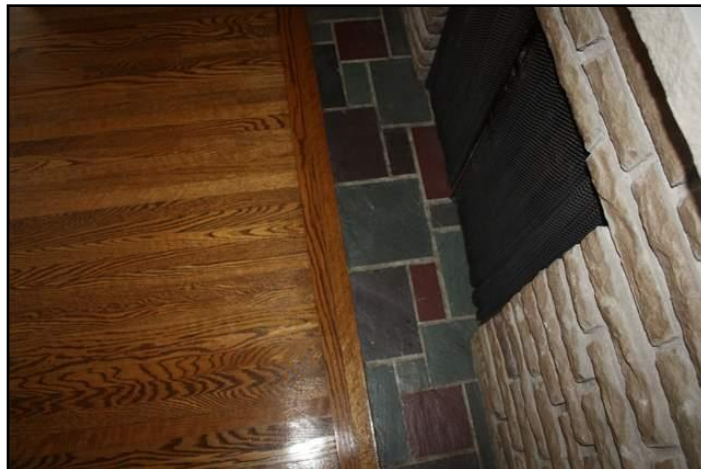
Condition: • [Too small](#)

Implication(s): Fire hazard

17. Too small

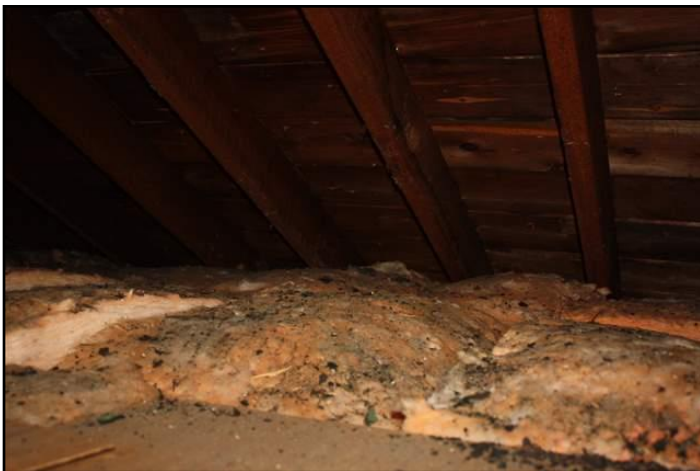
Condition: • [Amount less than current standards](#)

18. Amount less than current standards

Task: Upgrade

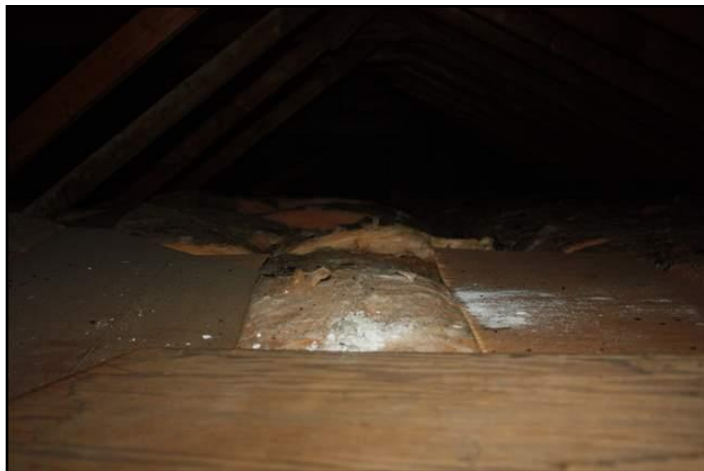
19. Amount less than current standards

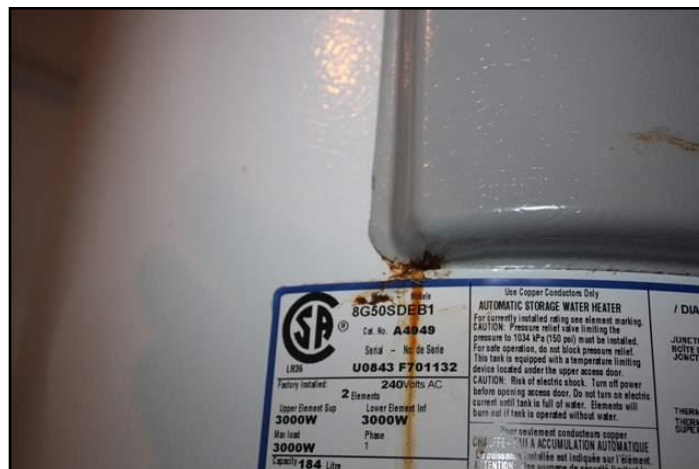
Condition: • [Rust](#)

potential leak

20. Rust

Task: Service

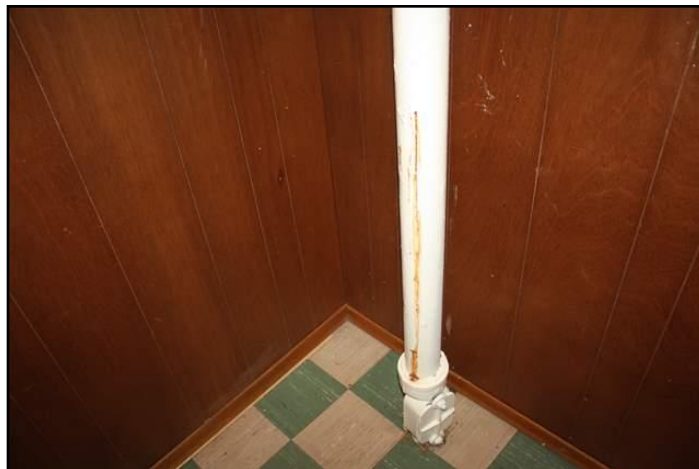
Condition: • The cast iron waste piping is near the end of its normal life expectancy and is prone to rusting through or splitting. Replacement may be required in the near future.

21. The cast iron waste piping is near the end...

Task: Replace

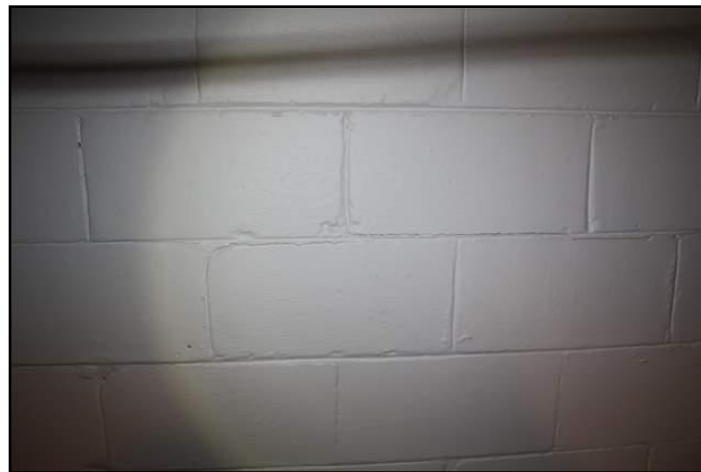
Condition: • Cracks

Hairline cracks noted in block wall. No displacement. Considering the age of the home, these are typical flaws.

Implication(s): Chance of structural movement | Damage or physical injury due to falling materials

22. Minor Cracks

Task: For Your Information / Monitor

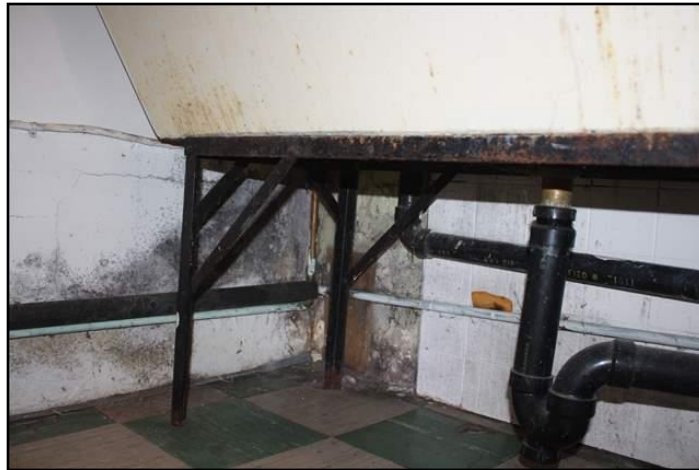
Condition: • [Mildew](#)

Minor dampness and the appearance of Mildew / Mold was noted near the laundry tub. This is fairly common in older homes. Clean area and monitor.

Implication(s): Chance of water damage to contents, finishes and/or structure | Contaminants may enter building air

23. Mildew

Task: Clean

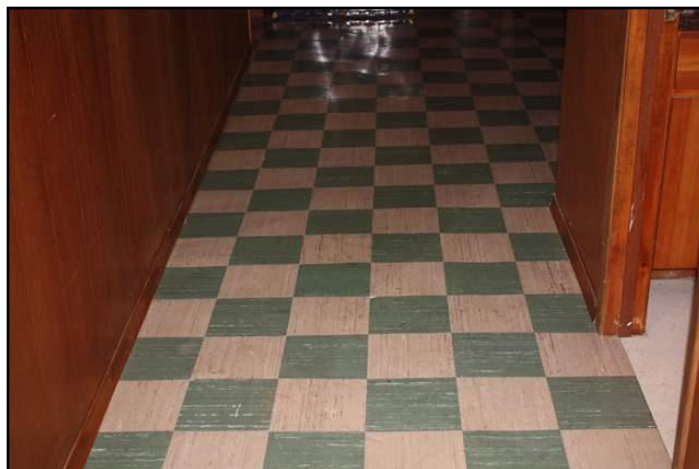
Condition: • Possible asbestos containing materials

Old 9"x 9" resilient floor tiles or the mastic glue may contain asbestos. This type of floor tile is commonly found in older homes. Further evaluation is recommended before removing/disturbing these tiles.

24. Example
