# Your Inspection Report

10 Elora Road  
Toronto, ON M6P 3H6

**INSPECTION DATE:**  
Tuesday, August 18, 2026

RE: Report No. 9747  
10 Elora Road  
Toronto, ON  
M6P 3H6

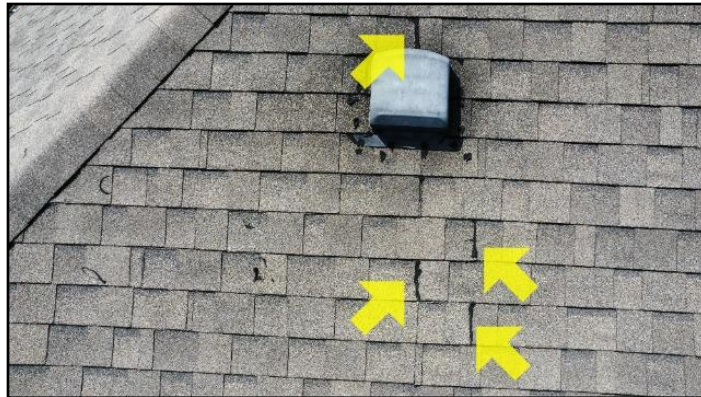
**Condition:** • [Patched](#)

2. Patched

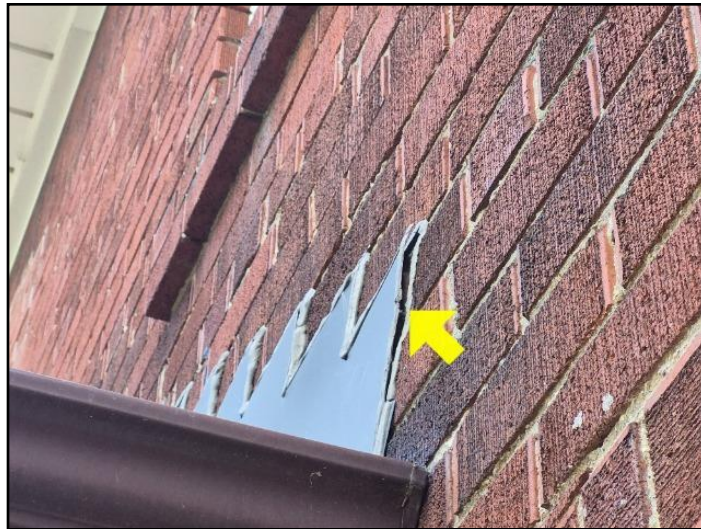
**Condition:** • [Damage, loose, open seams, patched](#)

3. Damage, loose, open seams, patched

**Task:** Seal / Repair

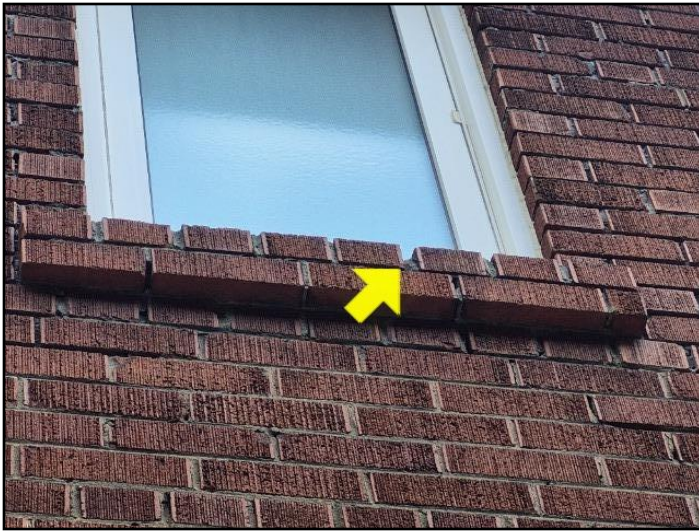
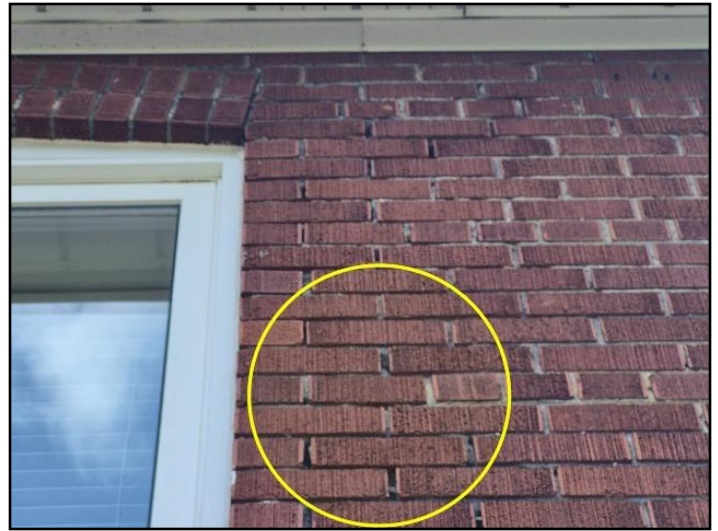
**Condition:** • Masonry and/or mortar deterioration

4. Masonry and/or mortar deterioration

5. Masonry and/or mortar deterioration

Tuckpoint / Repoint mortar and patch/repair spalled masonry. This is typical maintenance for a home of this age.

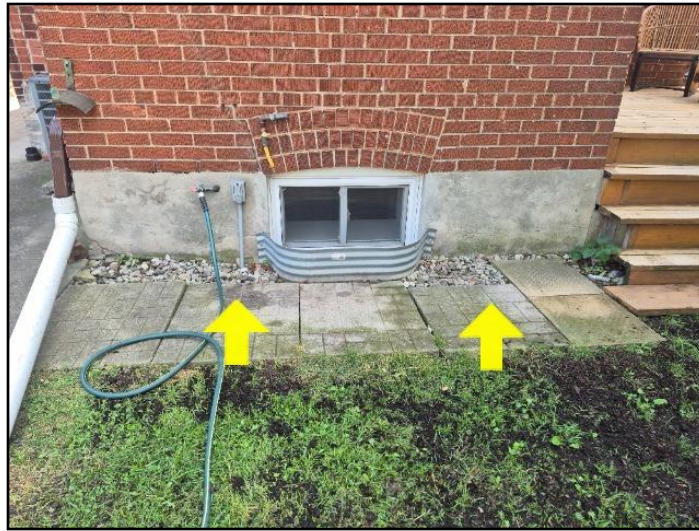
**Condition:** • [Improper slope or drainage](#)

Areas of grading near the home were sloping toward the foundation. Proper grading near the home is important to help reduce the risk of moisture intrusion. Improve low areas and grading so that water drains away from the home.

6. Improper slope or drainage

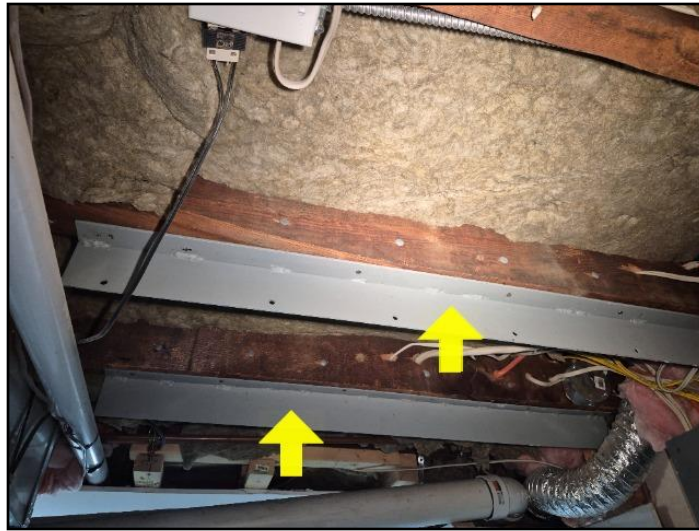
**Condition:** • Prior repairs

Evidence of prior structural repairs was observed. This may include sistered joists, joist hangers, and localized reinforcement. These types of repairs are commonly found in older homes and are often installed to address historic damage, sagging, settlement, or deflection over time.

7. Prior repairs

**Task:** Monitor for movement

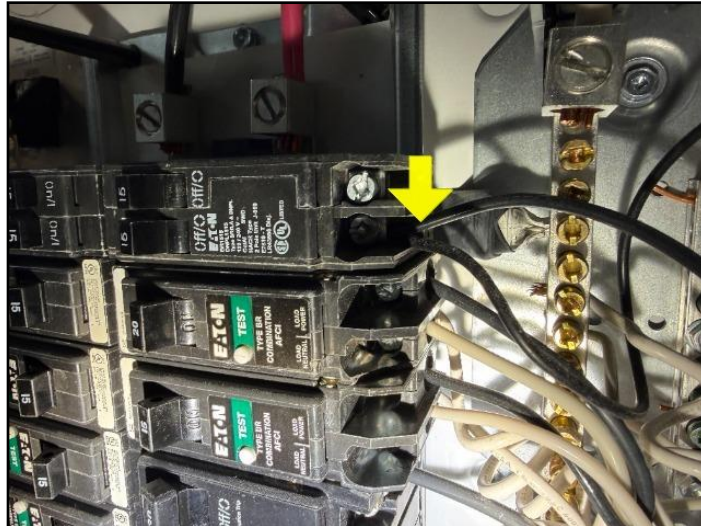
**Condition:** • [Double taps](#)

10. Double taps

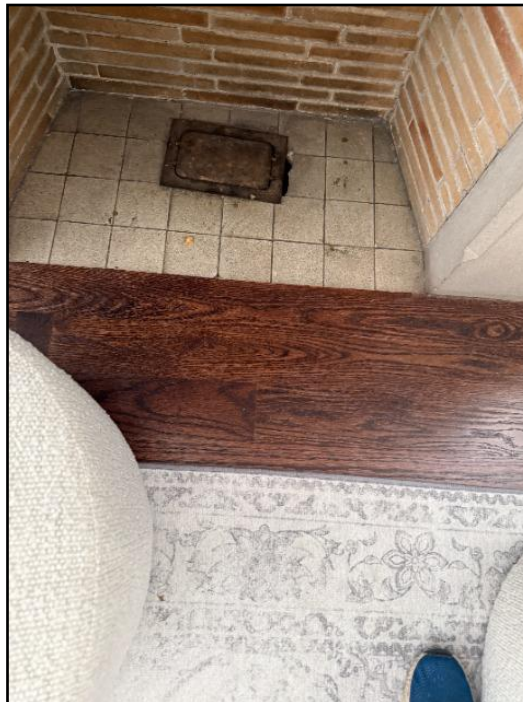
**Condition:** • [Too small](#)

**Implication(s):** Fire hazard

11. Too small

**Task:** Correct

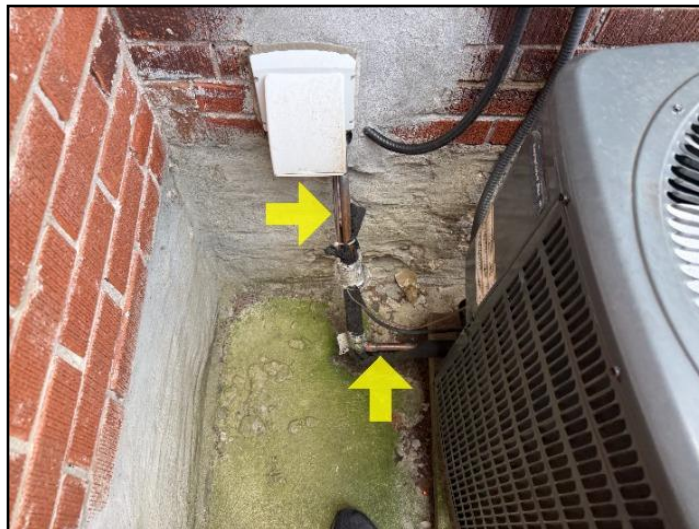
**Condition:** • Insulation - missing or damaged

12. Insulation - missing or damaged

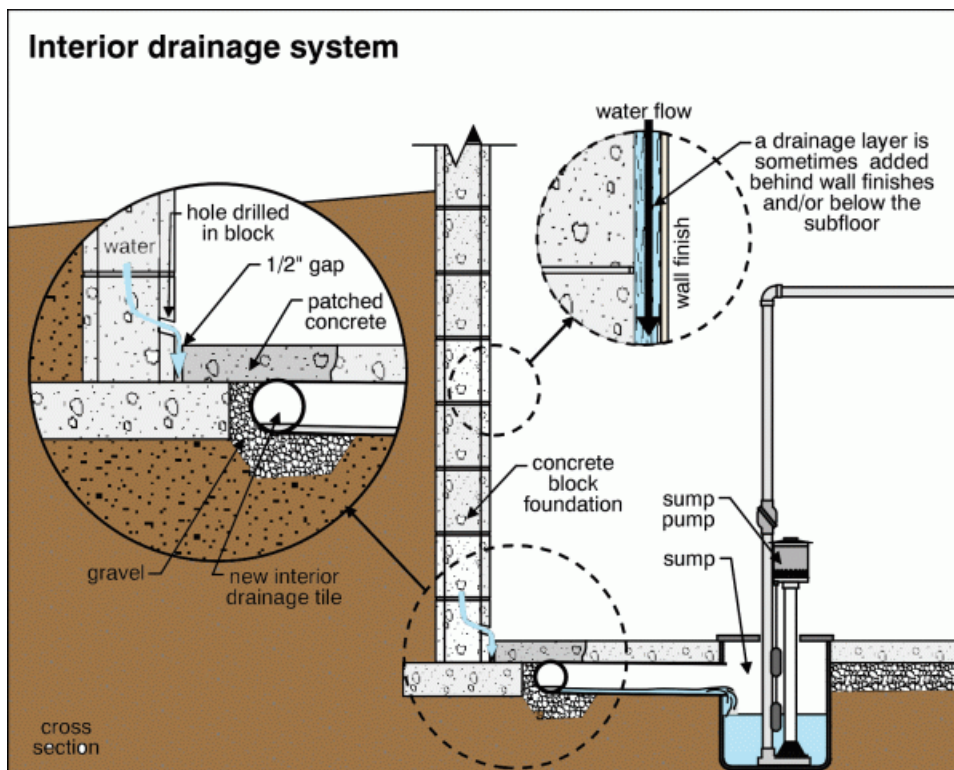
**Condition:** • [Interior drainage system](#)

An interior drainage membrane was visible at a limited area of the basement foundation, and a sump pump was present. The extent of the system could not be determined. Consult seller / agent if further information is desired.
