YOUR INSPECTION REPORT

468 Beresford Avenue
Toronto, ON M6S 3B7

INSPECTION DATE:
Tuesday, September 18, 2018

RE: Report No. 2332, v.3
468 Beresford Avenue
Toronto, ON
M6S 3B7

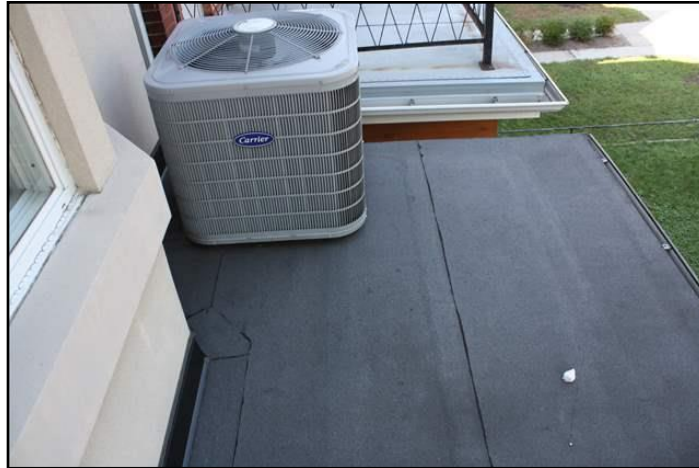
1. Modified bitumen membrane

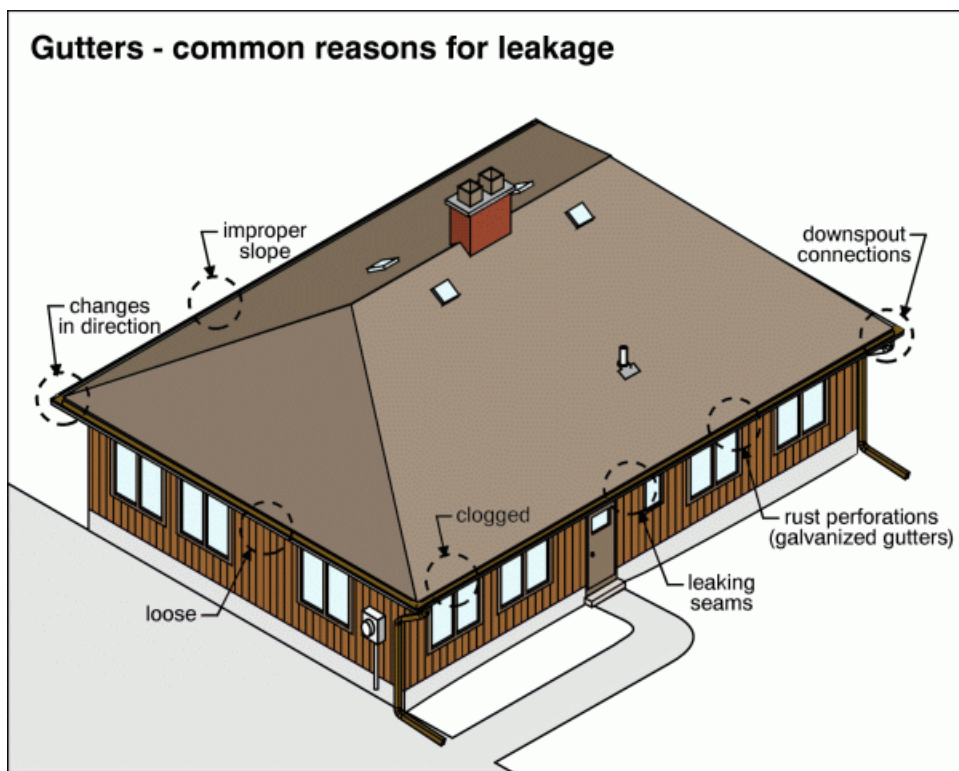
Condition: • [Clogged](#)

Implication(s): Chance of water damage to contents, finishes and/or structure

Location: Various Exterior

Task: Clean

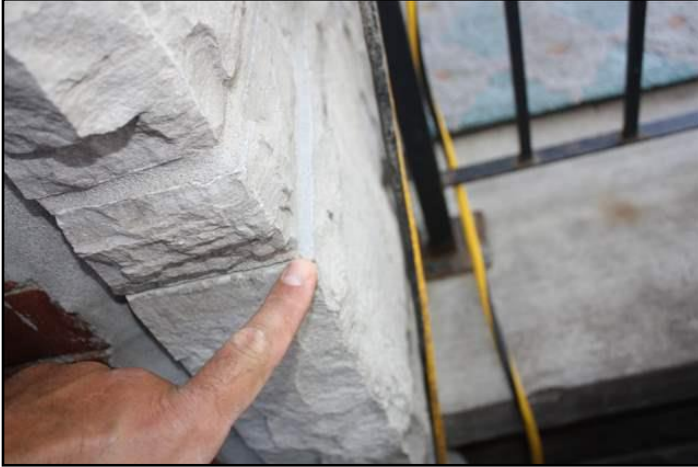
Stone cladding mortar cracks and loose in one area

Implication(s): Chance of water entering building | Weakened structure | Chance of movement

Location: Various Front Exterior Wall

2. Loose stone

Task: Repair

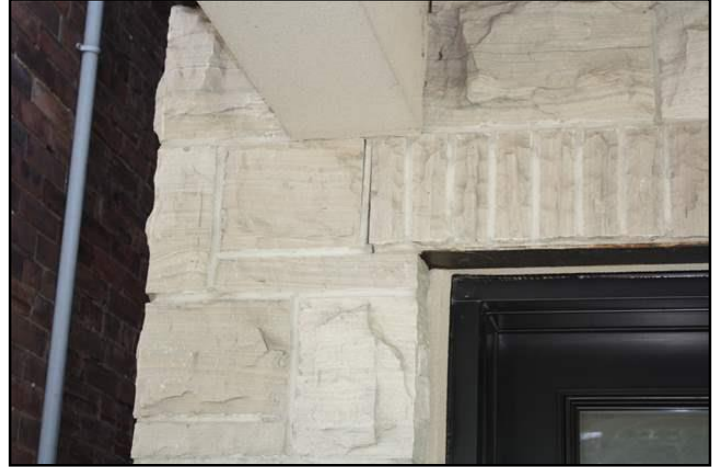
3. Cracked

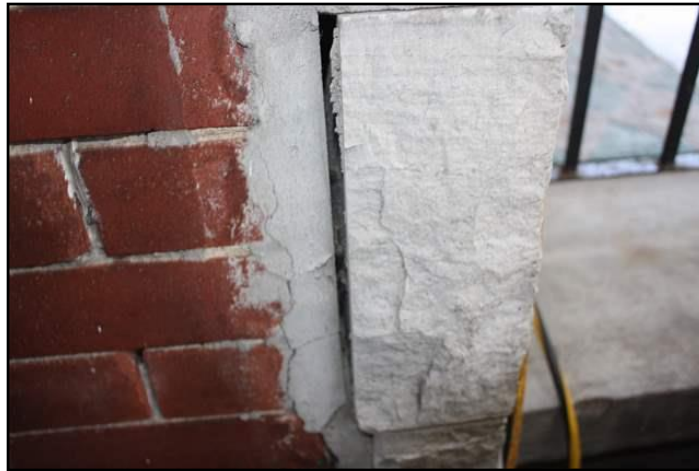
4. same loose stone

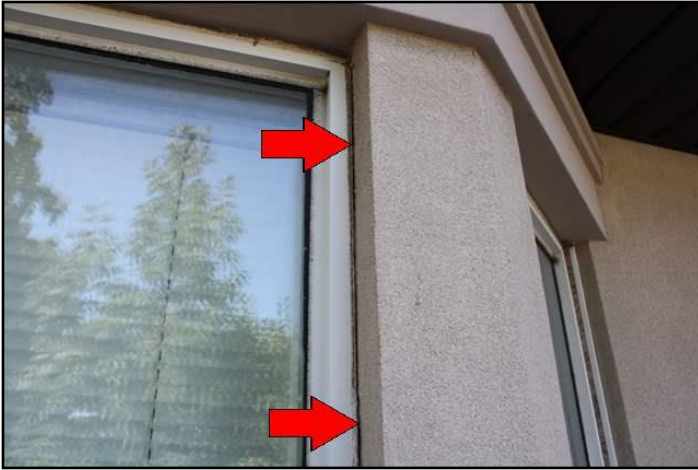
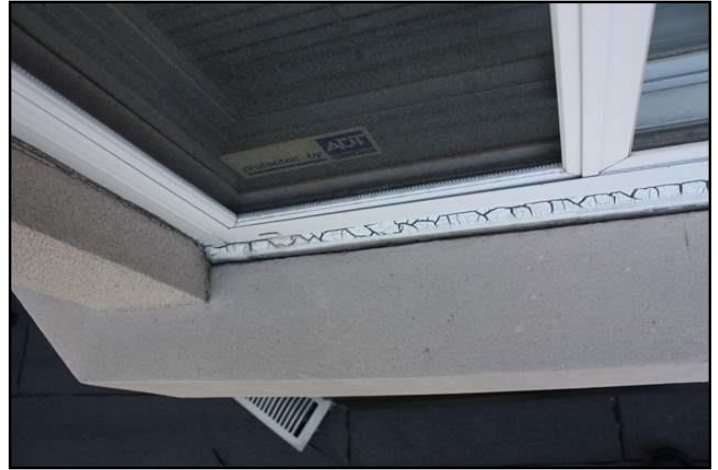
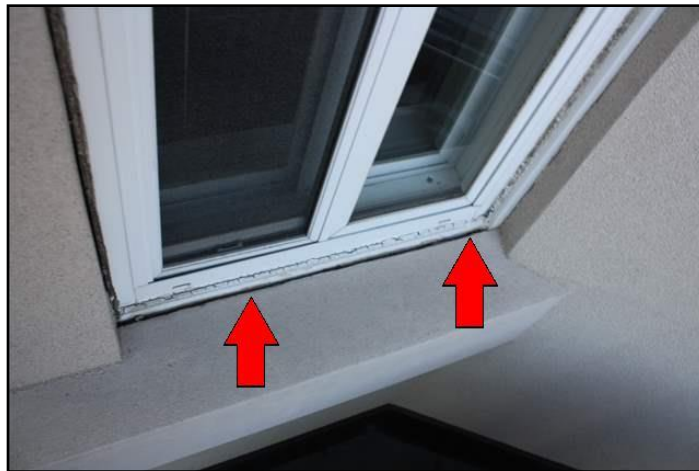
Condition: • [Caulking missing, loose or deteriorated](#)

Implication(s): Chance of water damage to contents, finishes and/or structure

Location: Various Front Exterior

Task: Improve

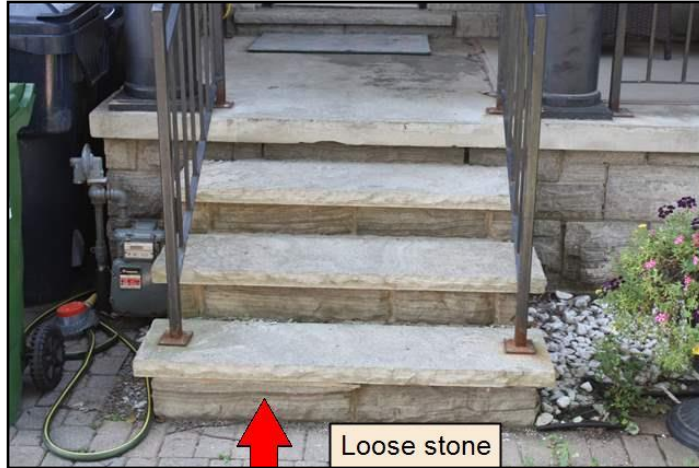
Condition: • [Masonry or concrete cracking](#)

Implication(s): Weakened structure

Location: Front Exterior Staircase

8. Masonry or concrete cracking

Task: Repair

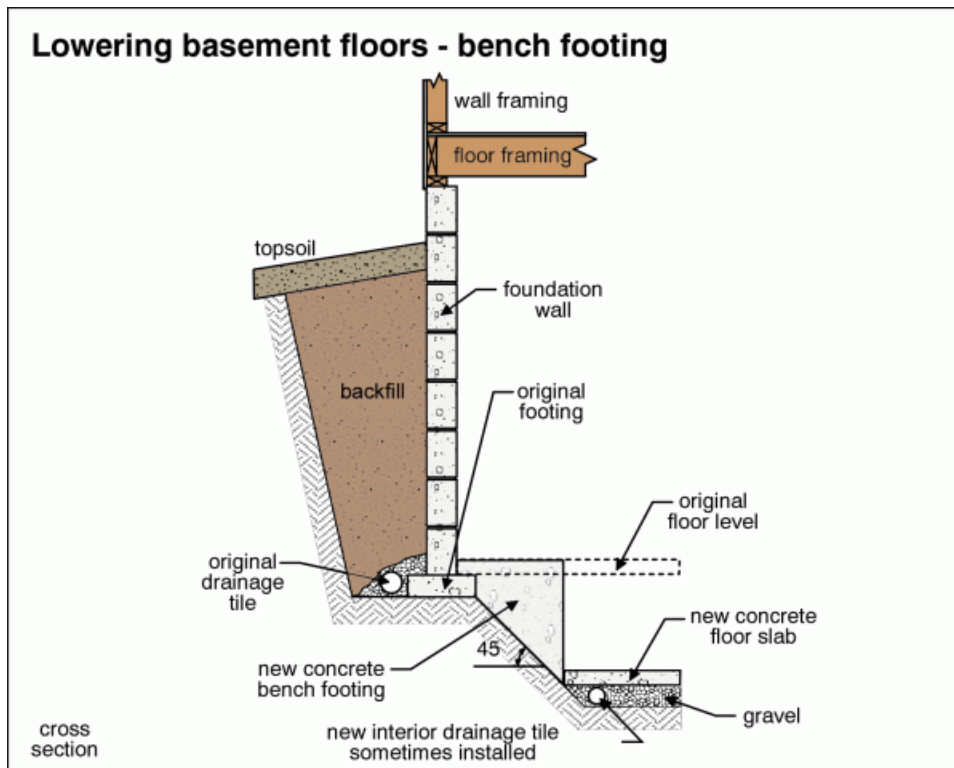
Condition: • [Basement lowered](#)

Implication(s): Chance of structural movement

Lowering basement floors - underpinning

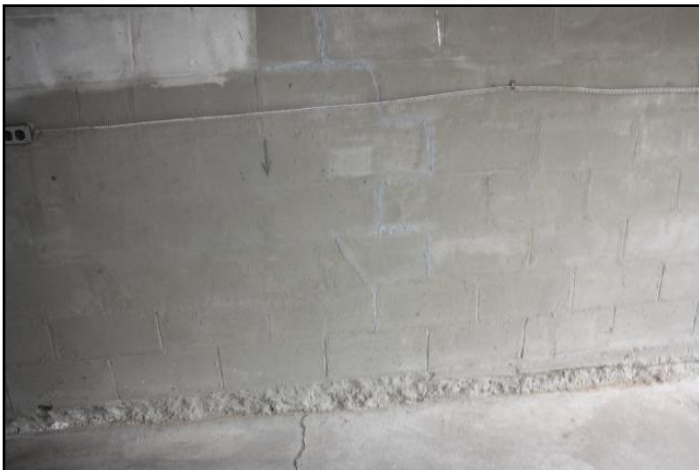
Garage wall structural crack. Gap appears sealed with caulking/sealant. repair with masonry.

Implication(s): Weakened structure

Location: Right Side Exterior Wall Garage

9. Interior view

Task: Repair

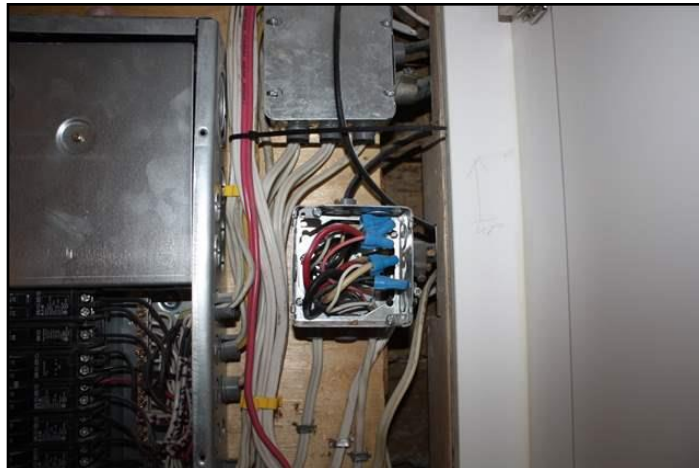
Condition: • [Cover loose or missing](#)

Implication(s): Fire hazard | Electric shock

Location: Basement

11. Cover missing

Task: Cover

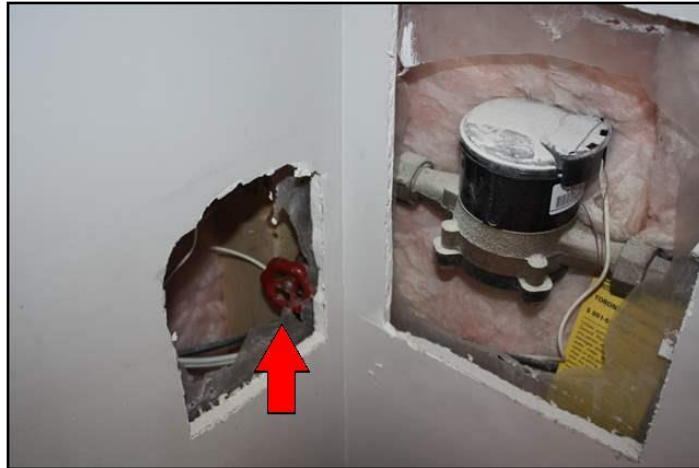
12. Front of the basement

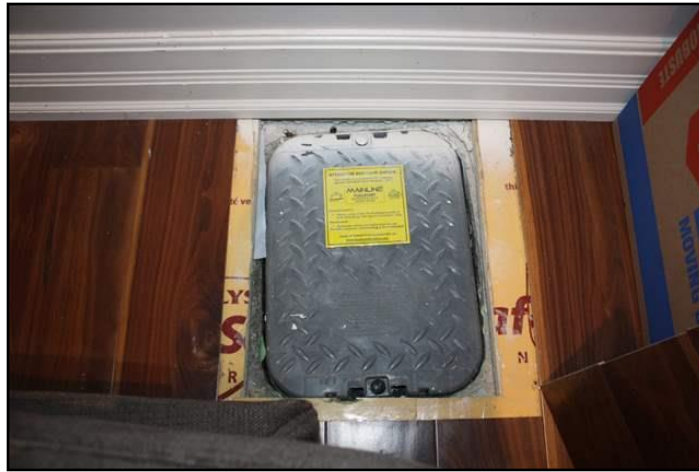
- Present. These valves help prevent sewer backup. Many insurance companies insist these be installed before they will offer a sewer backup endorsement, which we strongly recommend you obtain.

13. Present. These valves help prevent sewer...
