# YOUR INSPECTION REPORT

FOR THE PROPERTY AT:  
85 Prince Edward Drive South  
Toronto, ON M8Y 3V5

INSPECTION DATE:  
Wednesday, May 23, 2018

RE: Report No. 2277  
85 Prince Edward Drive South  
Toronto, ON  
M8Y 3V5

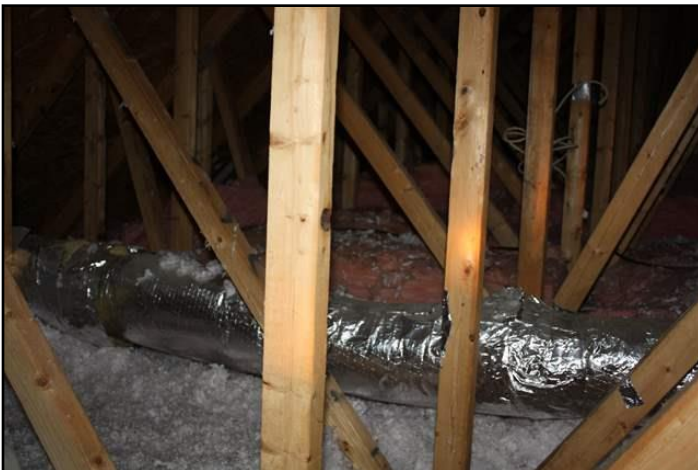
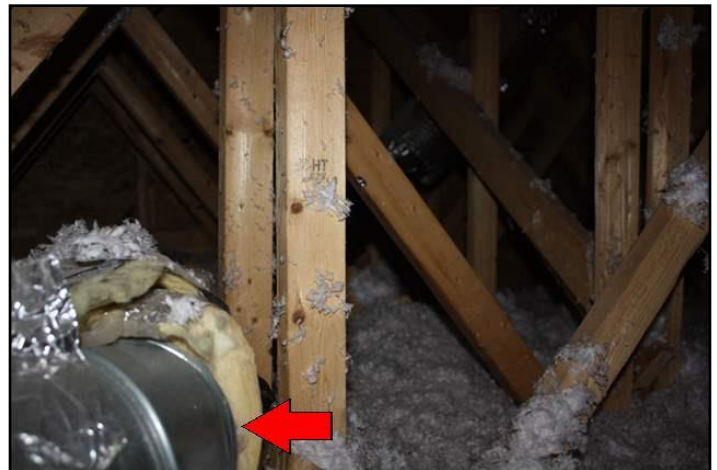
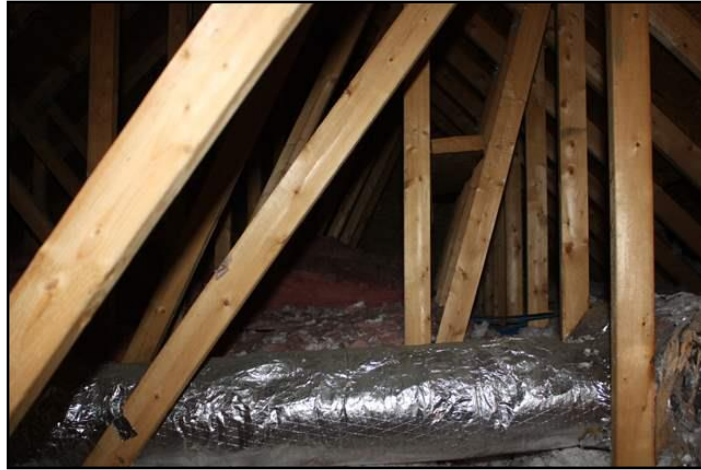
1.

**Condition:** • [Vulnerable to ice damming](#)

Heating ducts in attic. Ensure heating ducts in attic are insulated in all areas. Heat escaping from ducts can cause snow on roof to melt and cause ice damming.

**Implication(s):** Chance of water damage to contents, finishes and/or structure

**Task:** Monitor/Improve

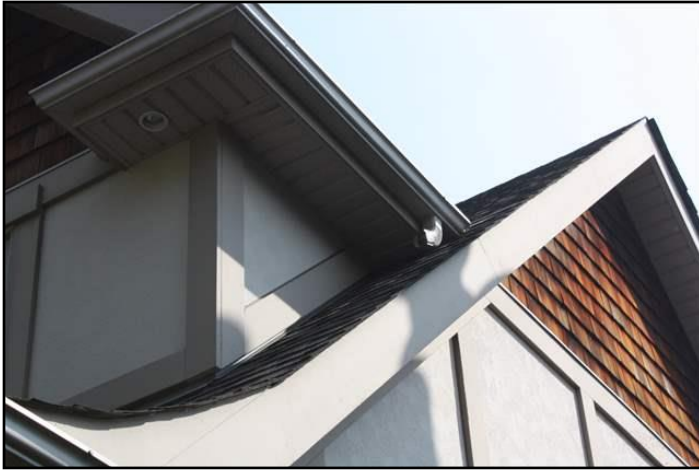
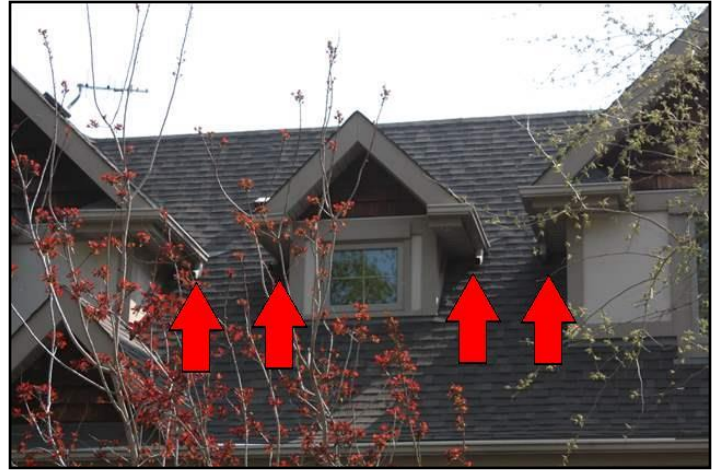
Condition: • [Discharge onto roofs](#)

**Implication(s):** Chance of water damage to contents, finishes and/or structure

4. Discharge onto roofs

5. Discharge onto roofs

Improvement recommendation. Extend Downspouts to lower gutter to protect roof from premature wear.

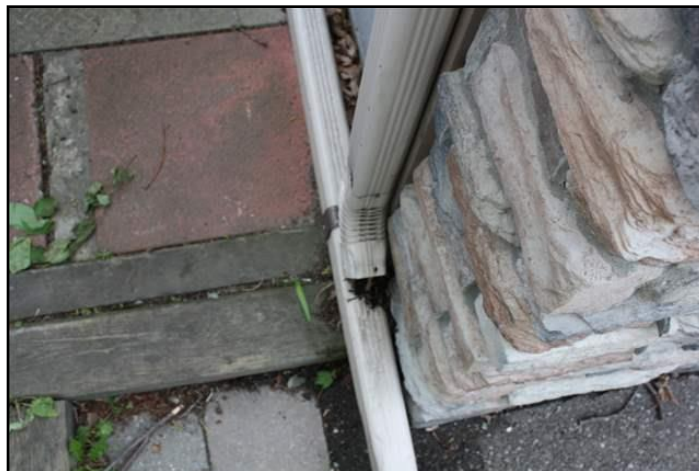
**Condition:** • [Discharge too close to building](#)

**Implication(s):** Chance of water damage to contents, finishes and/or structure

6. Discharge too close to building

**Task:** Improve

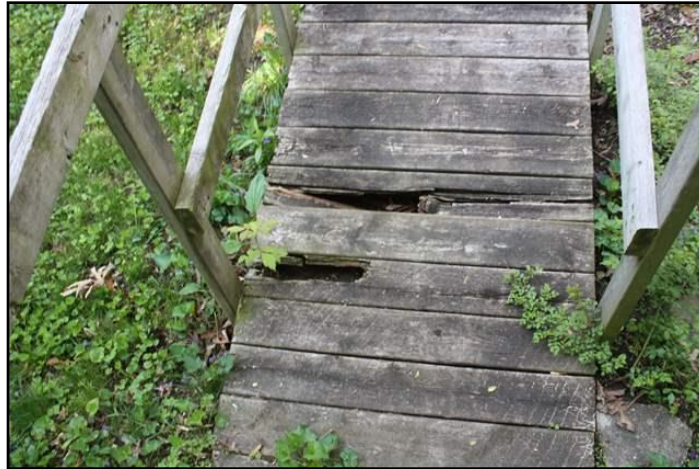
**Condition:** • [Damage](#)

**Implication(s):** Weakened structure | Chance of movement

7. Damage

**Task:** Replace

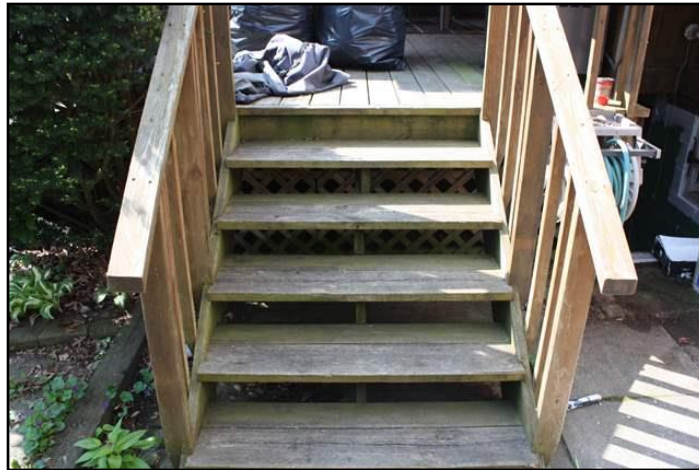
**Condition:** • [Steps springy, loose or sagging](#)

**Implication(s):** Trip or fall hazard

8. Steps springy, loose or sagging

**Task:** Repair / Replace

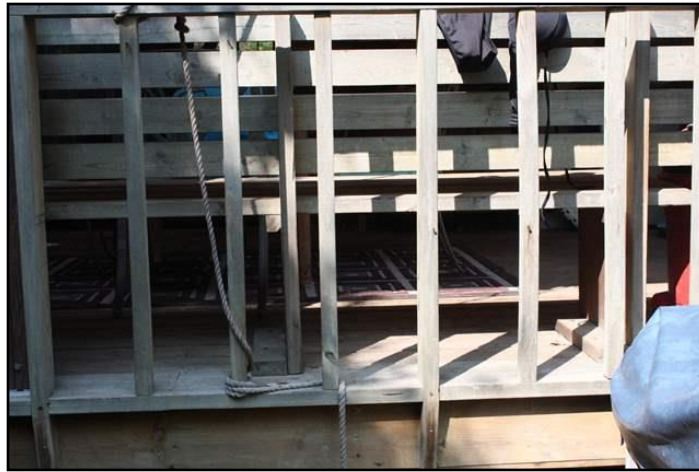
**Condition:** • [Spindles \(balusters\) too far apart](#)

**Implication(s):** Fall hazard

9. Spindles (balusters) too far apart

**Task:** Improve

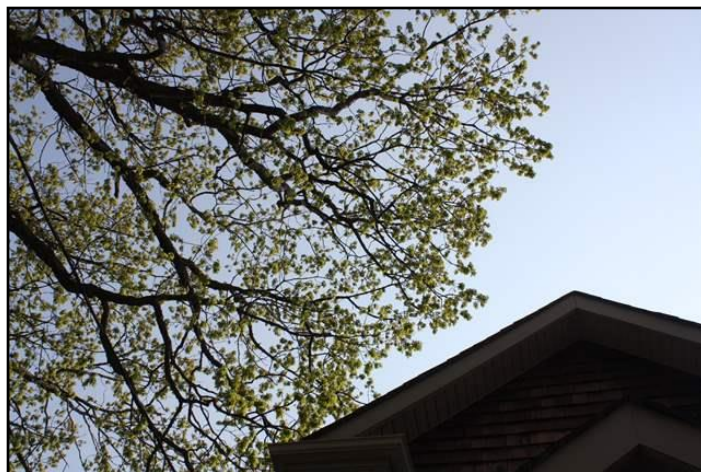
**Condition:** • [Trees or shrubs too close to building](#)

**Implication(s):** Chance of water damage to contents, finishes and/or structure | Chance of pests entering building | Material deterioration

10. Example

Keep tree branches trimmed back 3 feet from roof line.

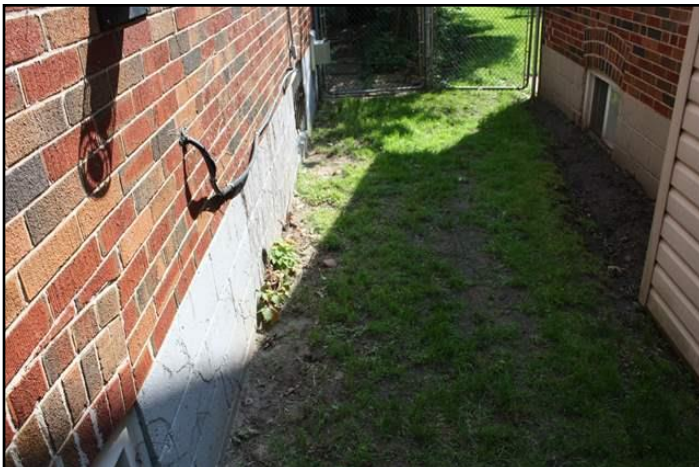
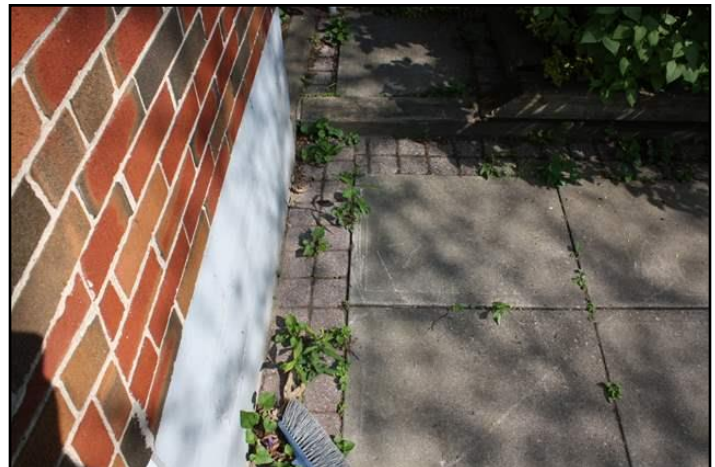
**Condition:** • Low Areas.

11. Low Areas.

12. Low Areas.

**Task:** Monitor / Improve

**Condition:** • During rainfall, walk the exterior to view if any water is draining towards the home. Improve these areas as needed

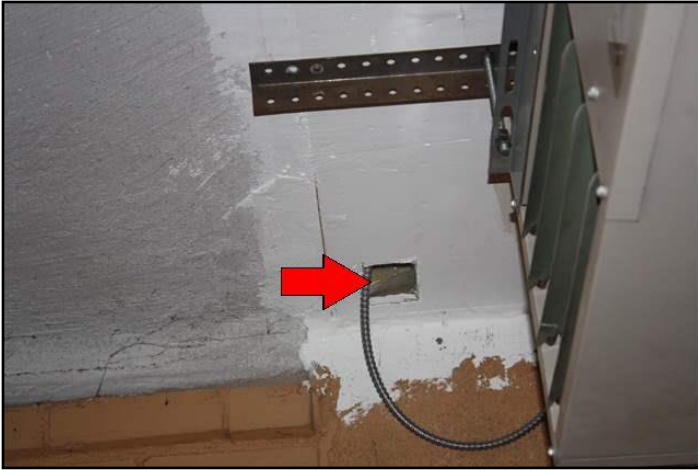
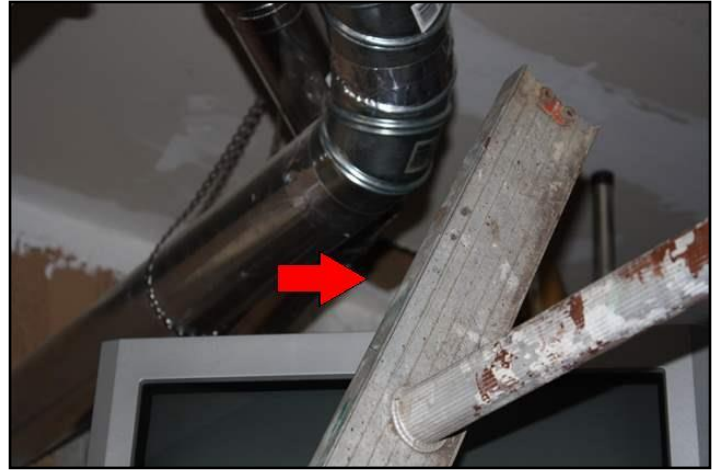
**Condition:** • Not gastight

**Implication(s):** Hazardous combustion products entering home

13. Not gastight

14. Not gastight

Seal / Repair all openings, including screw holes. The garage walls that are adjacent to the house must be gastight. (for carbon monoxide and other possible chemicals that might be present in the garage)

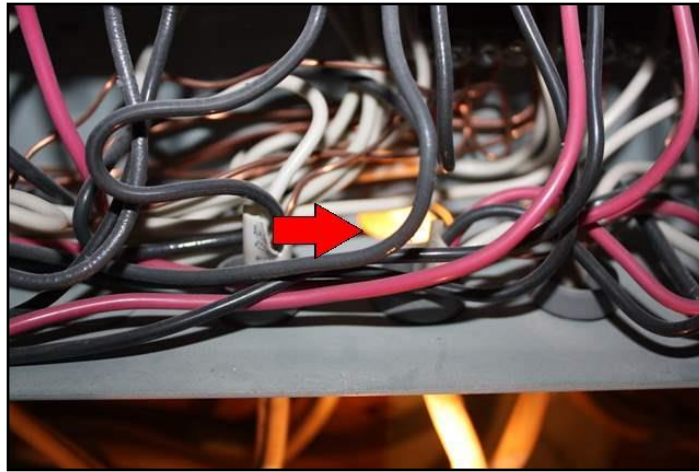
**Condition:** • [Openings in panel](#)

**Implication(s):** Electric shock | Fire hazard

15. Openings in panel

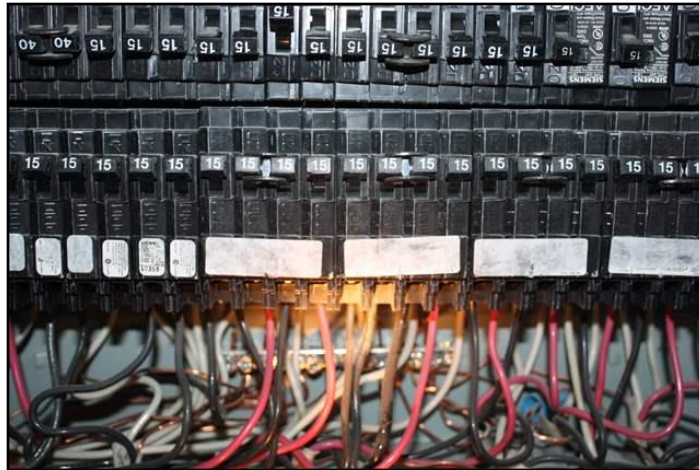
**Condition:** • [No links for multi-wire circuits](#)

16. No links for multi-wire circuits

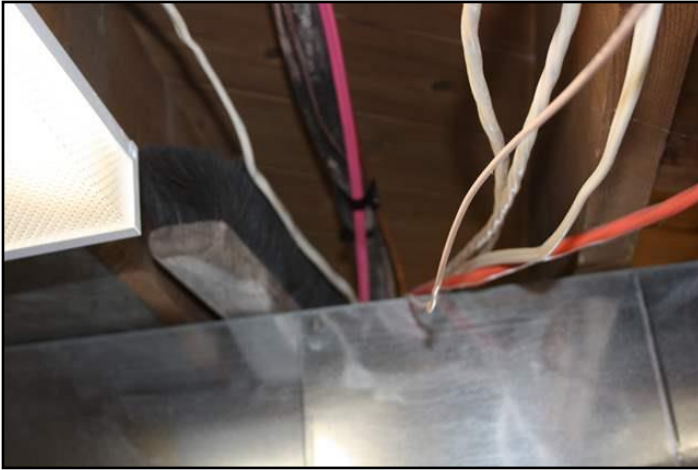
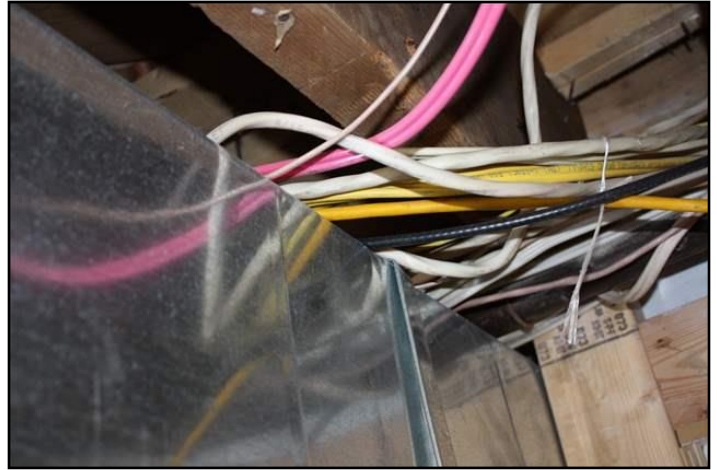
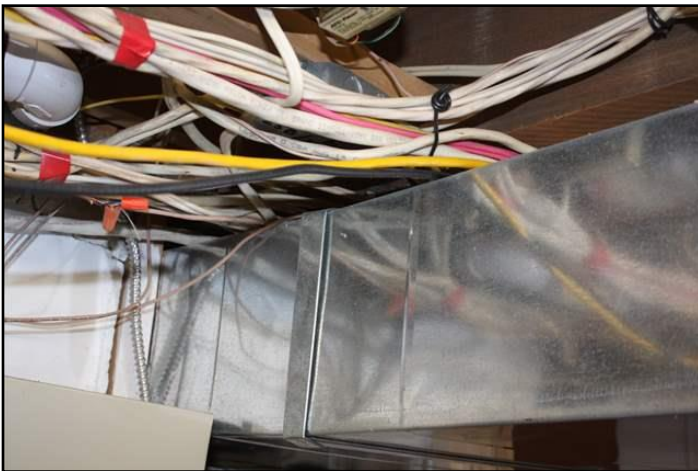
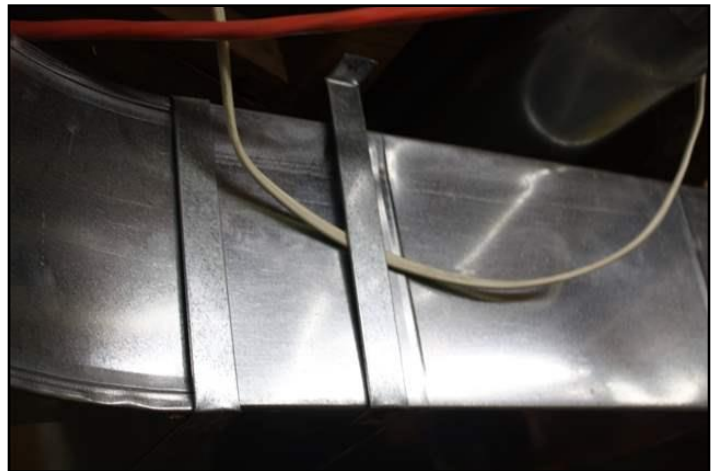
**Condition:** • [Too close to duct, pipe, vent or chimney](#)

**Implication(s):** Electric shock | Fire hazard

17. Too close to duct, pipe, vent or chimney

18. Too close to duct, pipe, vent or chimney

19. Too close to duct, pipe, vent or chimney

20. Too close to duct, pipe, vent or chimney

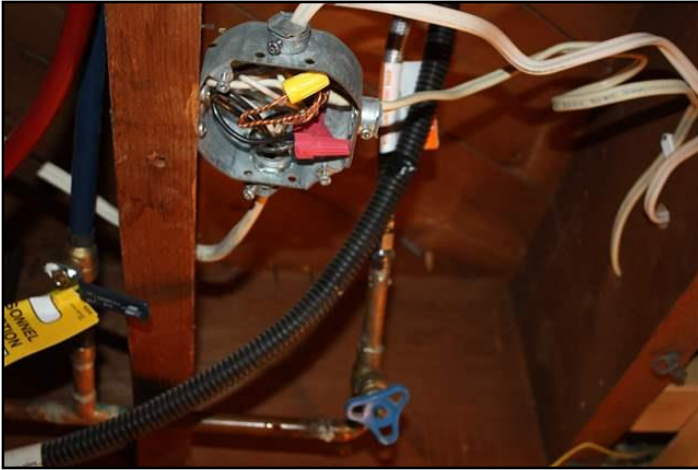
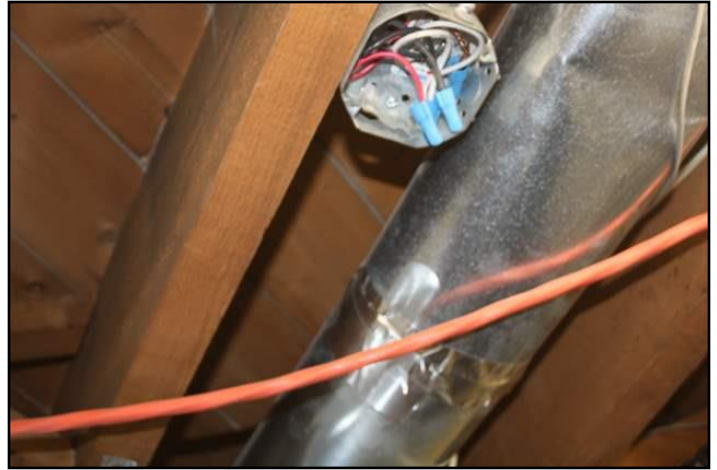
**Condition:** • [Cover loose or missing](#)

**Implication(s):** Electric shock | Fire hazard

21. Cover loose or missing

22. Cover loose or missing

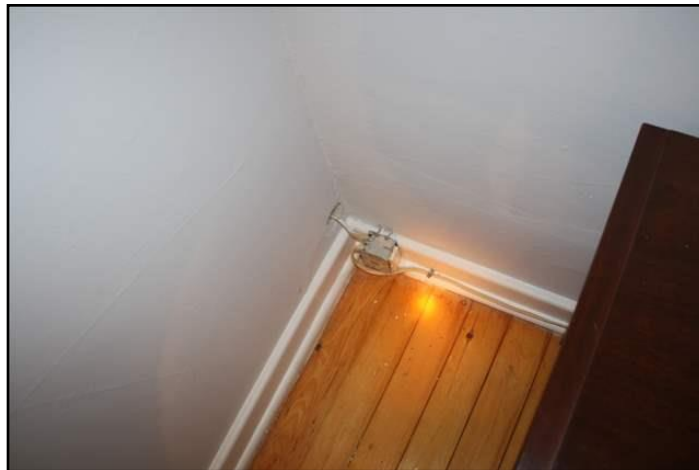
23.

**Condition:** • Improper installation of outlet

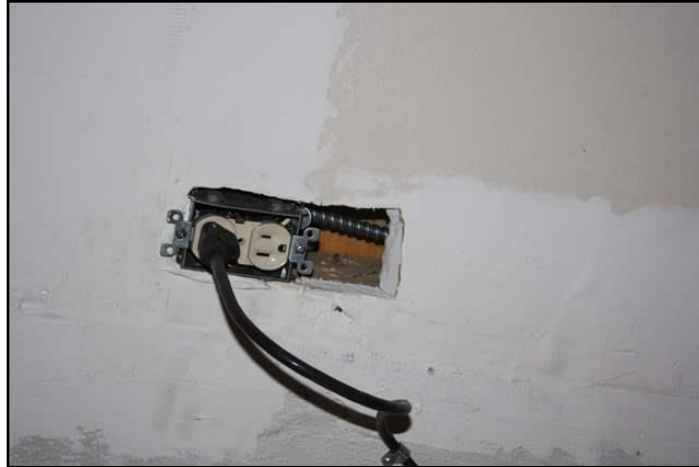
**Condition:** • [Missing](#)

24. Missing

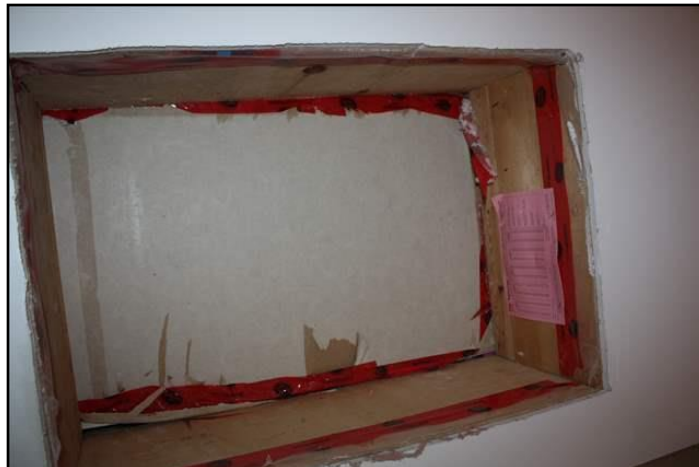
25.

Condition: • Poor installation of attic hatch

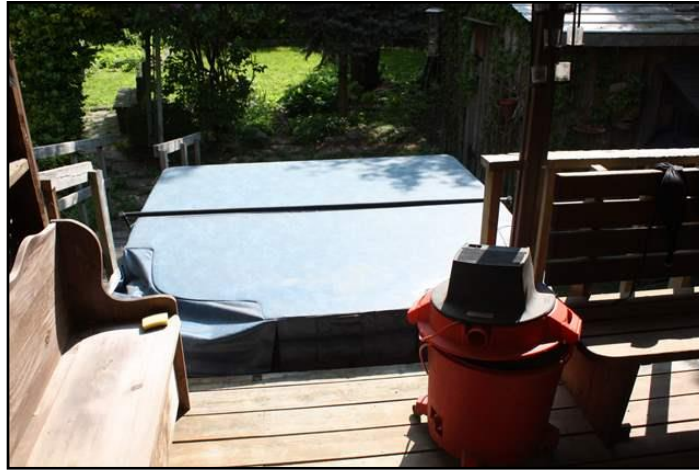
Outside the scope of a home inspection

26. Hot tub

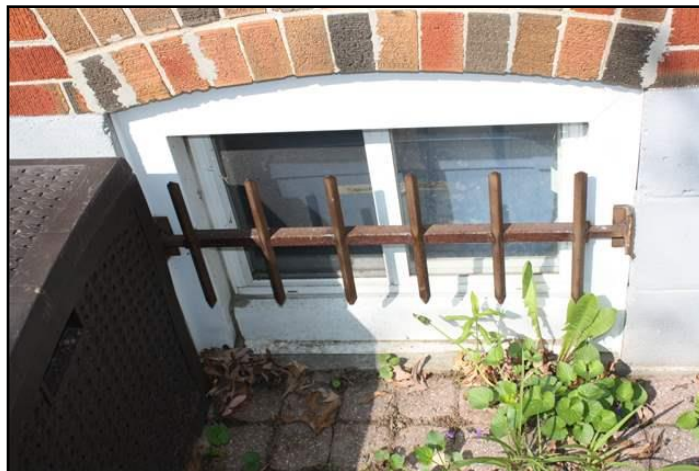
**Condition:** • [Burglar bars not operable without keys](#)

27. Burglar bars

**Task:** Remove

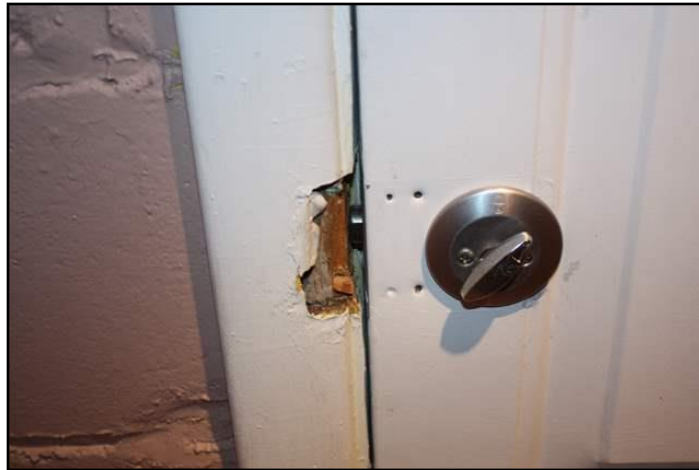
**Condition:** • Lock not effective on exterior door

28. Lock not effective on exterior door
