YOUR INSPECTION REPORT

FOR THE PROPERTY AT:
708 Willard Avenue
Toronto, ON

INSPECTION DATE:
Friday, April 14, 2023

RE: Report No. 7184, v.2
708 Willard Avenue
Toronto, ON

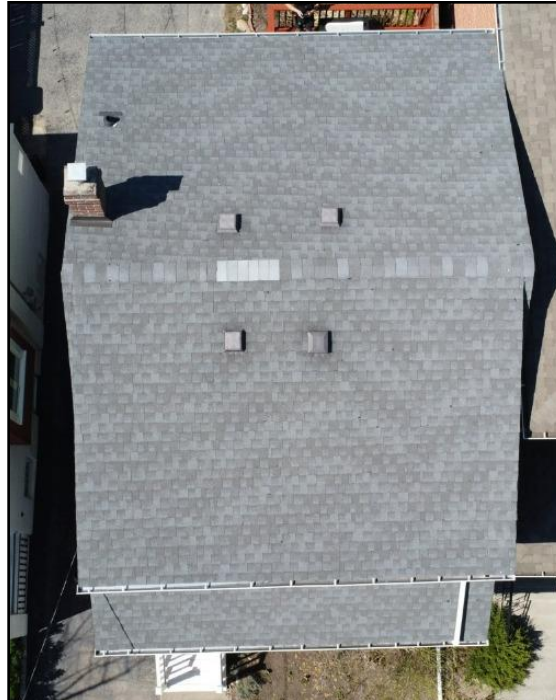
1. Roof view from drone

Condition: • [Granule loss](#)

Normal wear for the age. Age unknown but estimated to be in final third of lifespan. Inspect annually.

Task: Inspect annually / Replace

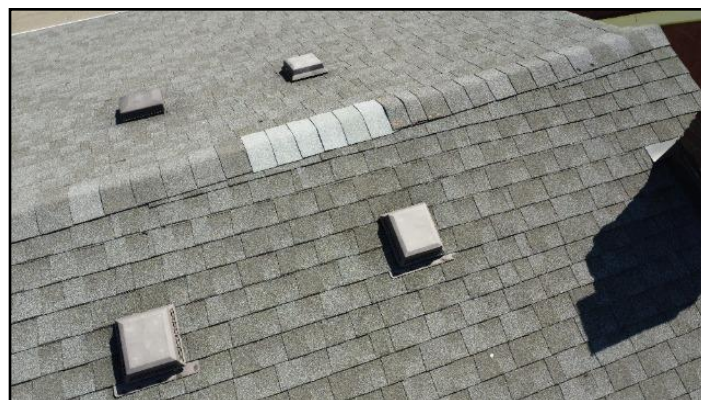
2. Patched

Condition: • [Patched](#)

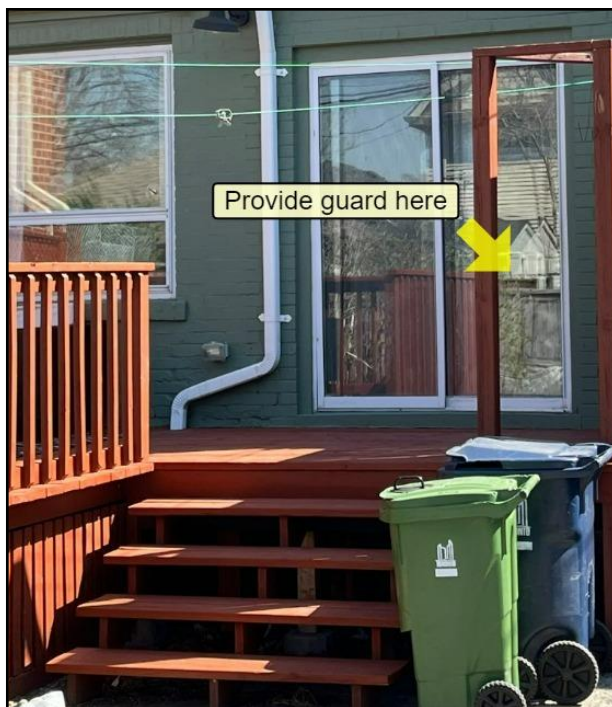
3. Missing

Condition: • [Missing](#)

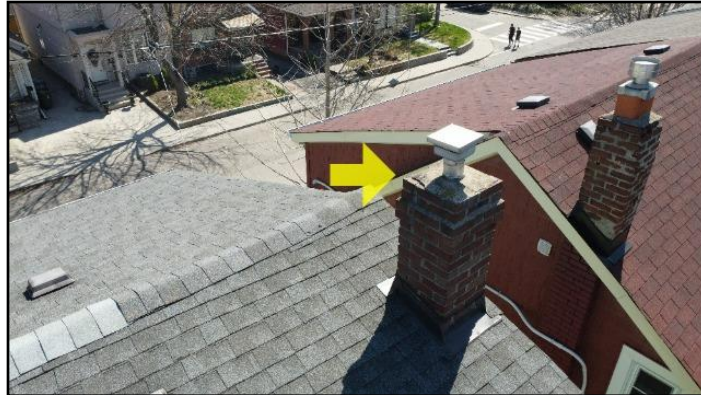
5. No drip edge on cap (crown)

Condition: • [No drip edge on cap \(crown\)](#)

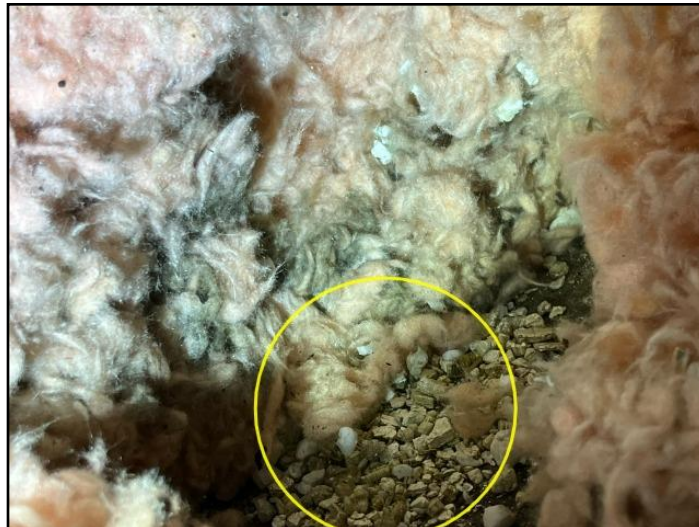
6. vermiculite insulation

Condition: • [Possible Zonolite \(vermiculite\)](#)

Vermiculite was found below the Fiberglas. We always recommend testing for asbestos prior to disturbing this insulation type.

***The home seller had the vermiculite tested for asbestos in 2016 and has shared the report with us. The lab report noted that no asbestos was found. For your reference the lab report is included in the APPENDIX section of this inspection report.

Task: For Your Information / See Appendix tab

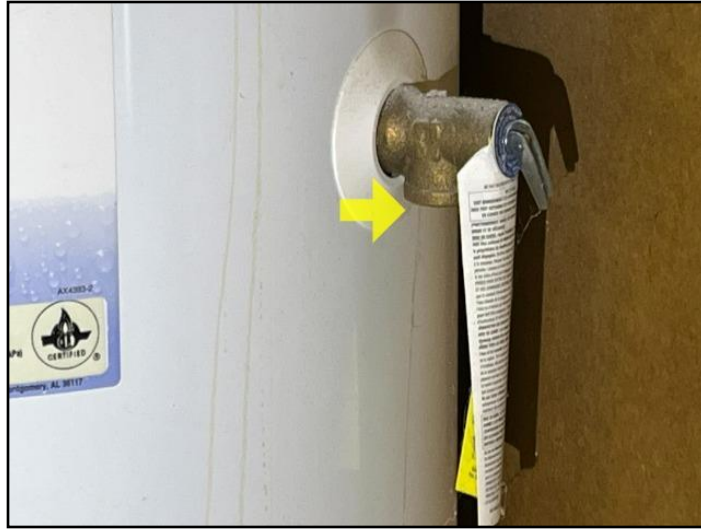
8. Discharge tube missing

Condition: • [Discharge tube missing](#)

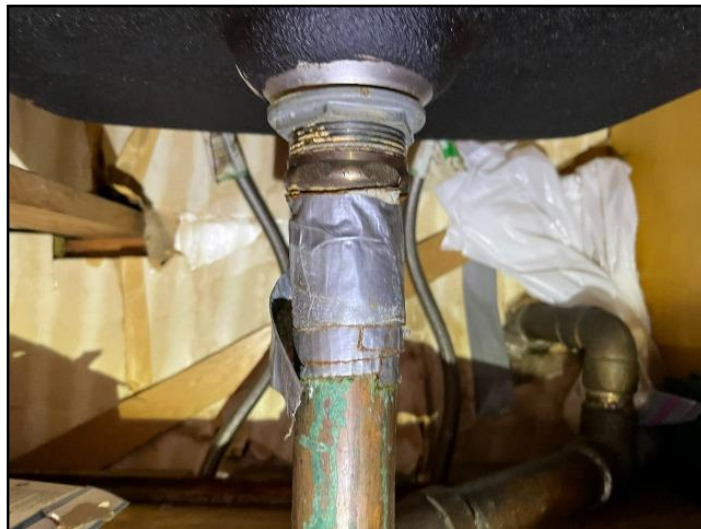
9. Nonstandard materials and patches

Condition: • [Nonstandard materials and patches](#)

Task: Repair / Replace

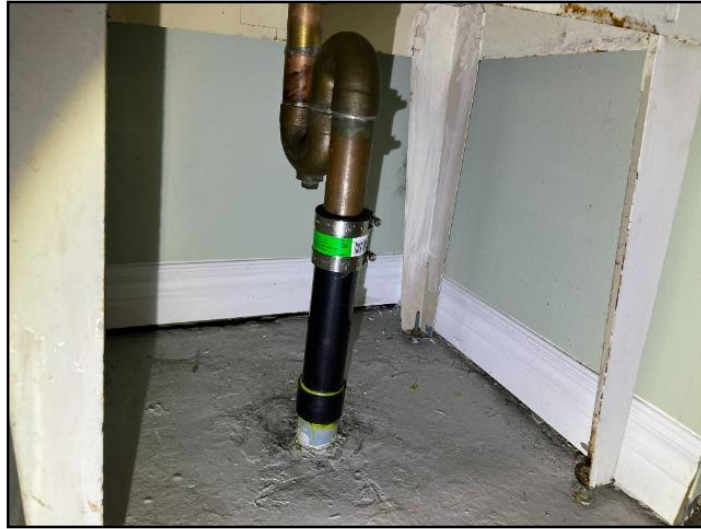
10. Wrong type

Condition: • [Wrong type](#)

Task: Correct

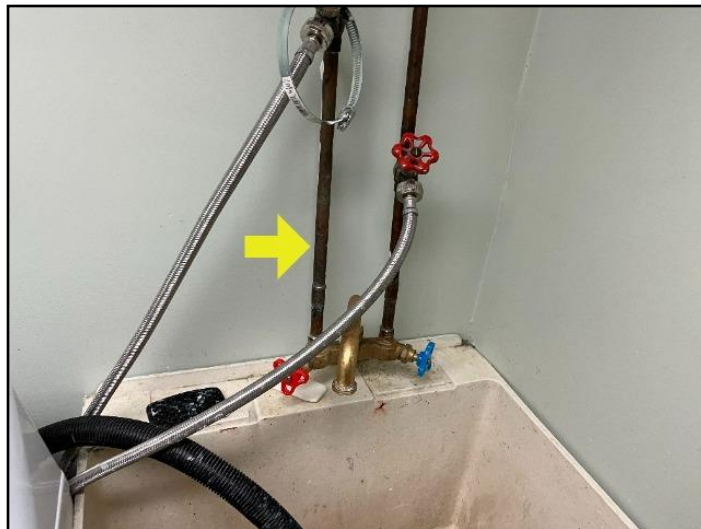
11. Loose

Condition: • [Loose](#)

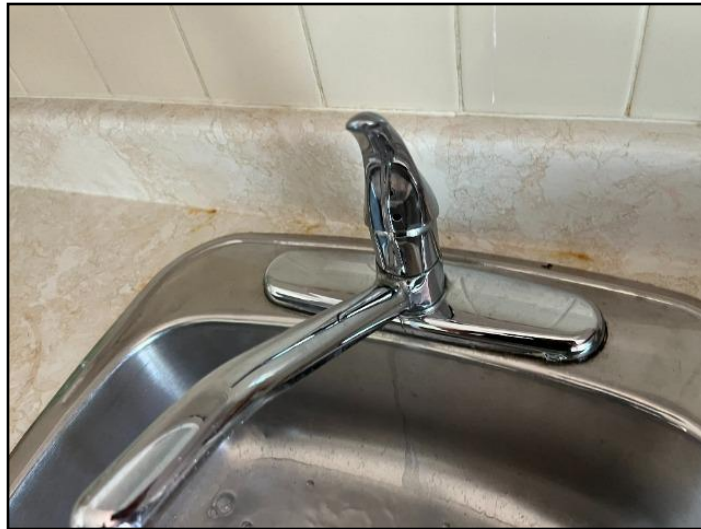
12. Loose

Condition: • [Loose](#)

Task: Repair / Replace

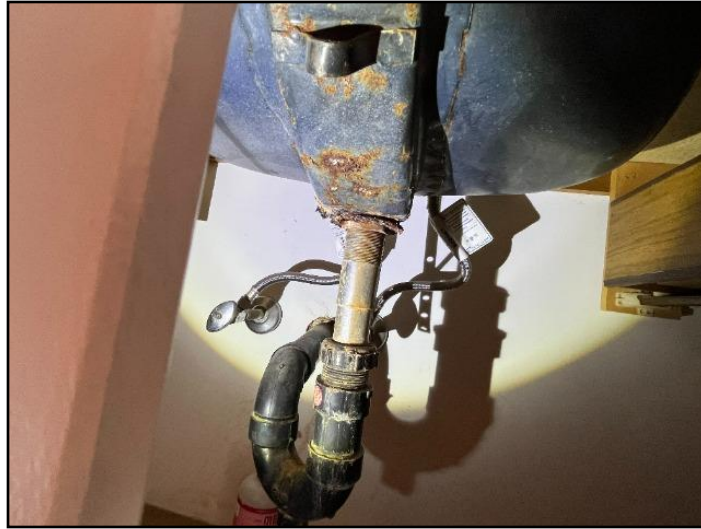
13. Rust

Condition: • [Rust](#)

Task: Replace

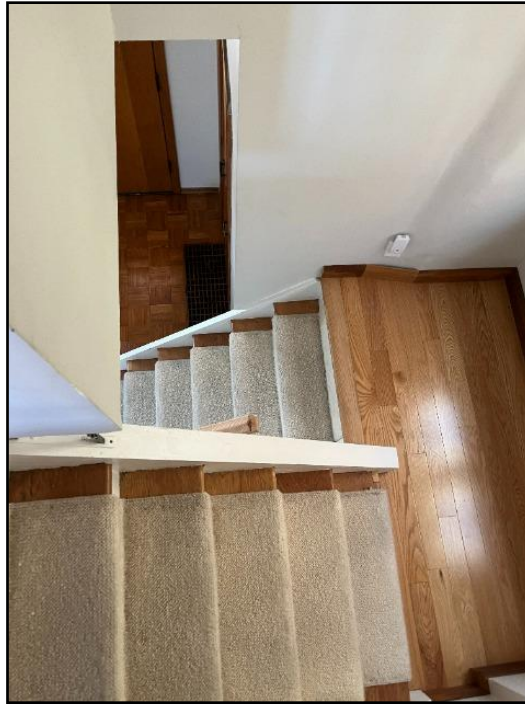
14. Missing

Condition: • [Missing](#)

Location: First Floor Staircase

Task: Provide handrails on open side

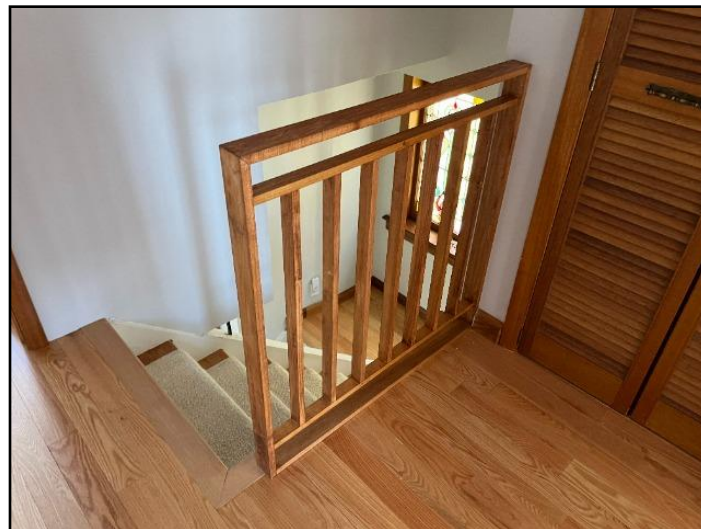
15. Loose

Condition: • [Loose](#)

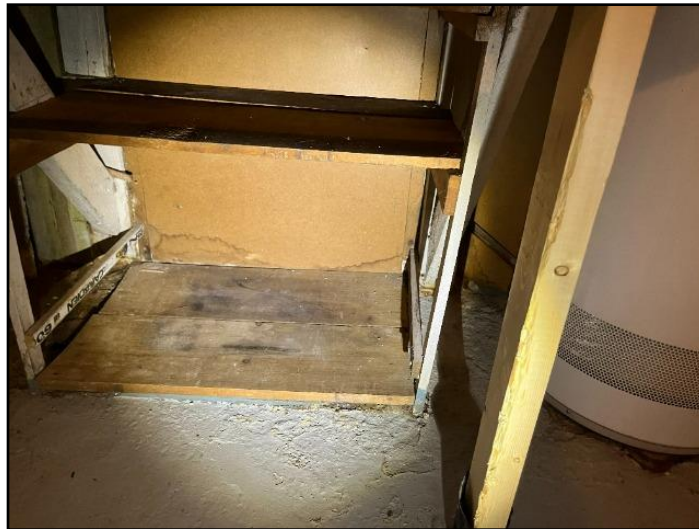
16. Example of water stains/marks

Condition: • [Water marks](#)

It is very common to find water marks in some areas of the basement, particularly in older properties. We tested these water marks with a moisture meter and were dry at time of inspection. There was no standing water observed during the inspection. Stains are likely remnants of prior leaks or sewer backups.

Task: For Your Information / Monitor
