# YOUR INSPECTION REPORT

1 Nottinghill Gate  
Toronto, ON M9B 3H4

INSPECTION DATE:  
Wednesday, June 12, 2019

RE: Report No. 2477, v.2  
1 Nottinghill Gate  
Toronto, ON  
M9B 3H4

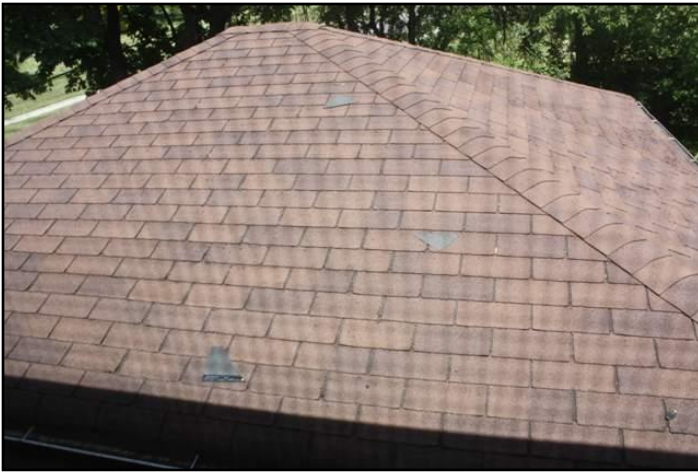
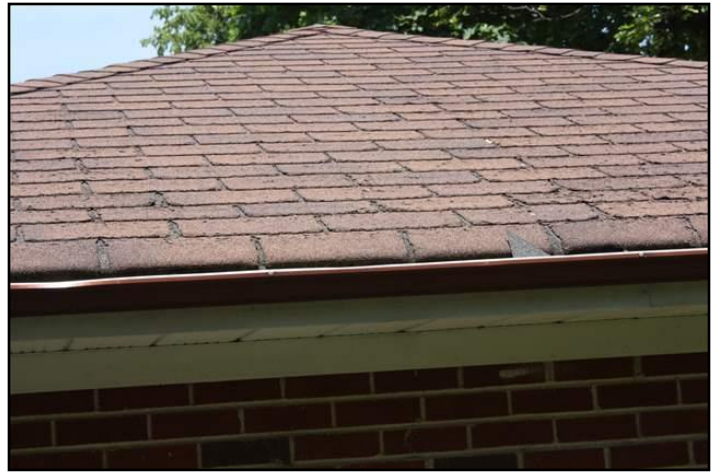
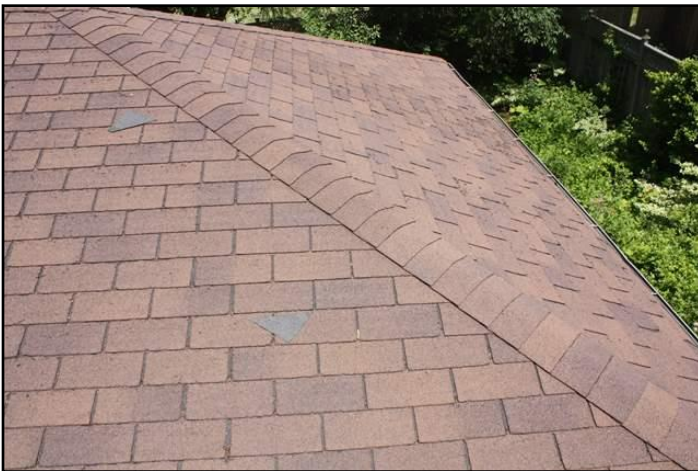
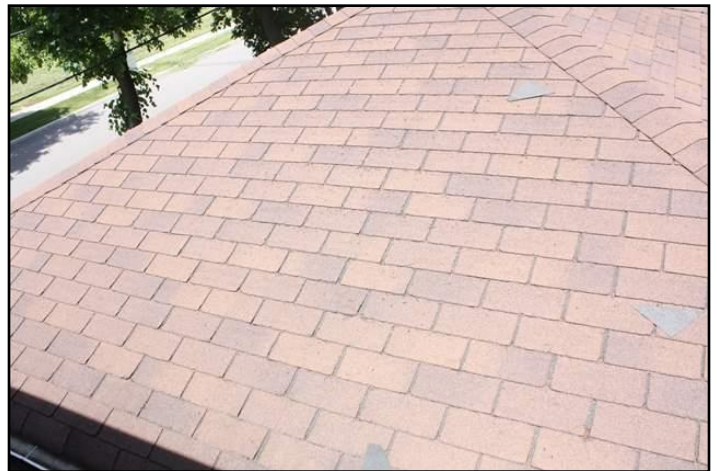
**Condition:** • [Old, worn out](#)

**Implication(s):** Chance of water damage to contents, finishes and/or structure

3. Old, worn out

4. Old, worn out

5. Old, worn out

6. Old, worn out

**Task:** Replace

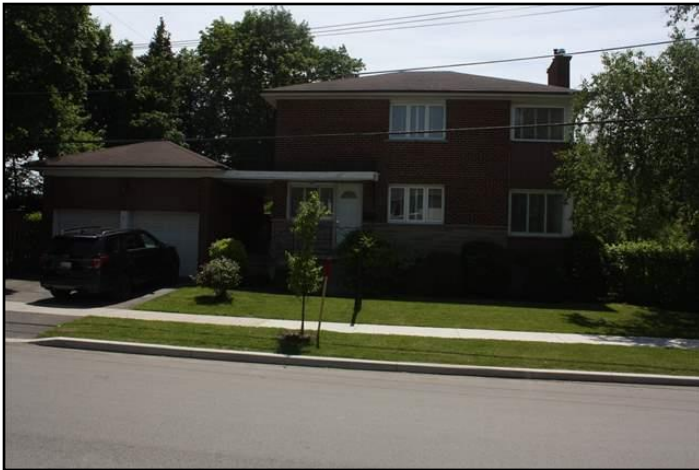
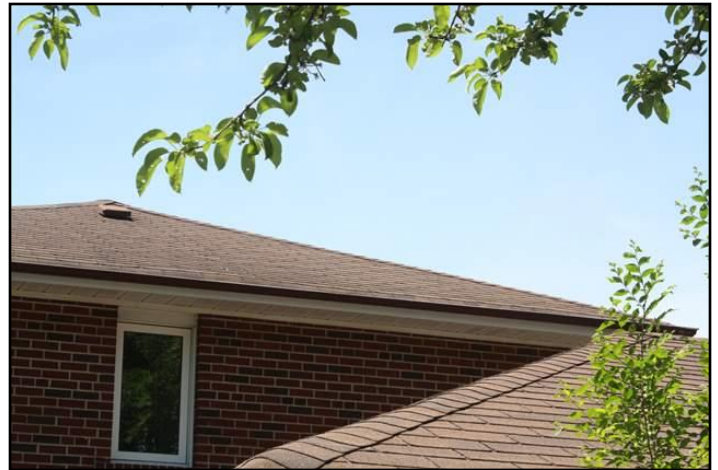
## Condition: • [Near end of life expectancy](#)

We noted that the Southwest and Southeast sides of the roof covering have been more recently replaced with premium shingles. The Northwest and Northeast sides have NOT been replaced and are showing signs of aging - Curling, granule loss, widening slots due to shingles shrinking with age. The south and west sides of a roof typically wear out faster due to sun exposure and sometimes homeowners replace these areas first.

7. Northwest side

8. Northeast side

**Task:** Replace

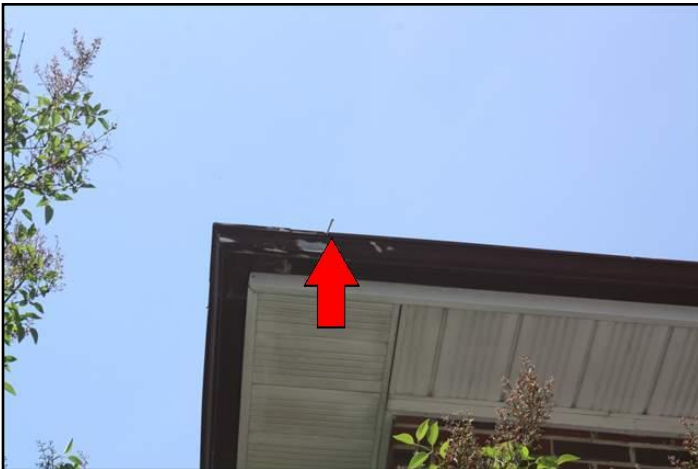
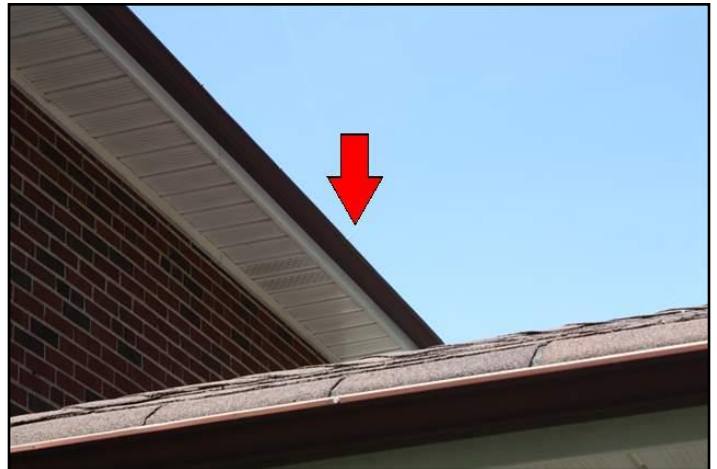
**Condition:** • Aging - Wear and tear noted. Fasteners loose in some areas

9. Aging - Wear and tear noted. Fasteners...

10. Aging - Wear and tear noted. Fasteners...

**Task:** Repair / Replace

**Cost:** For replacement \$5-\$10 per linear foot

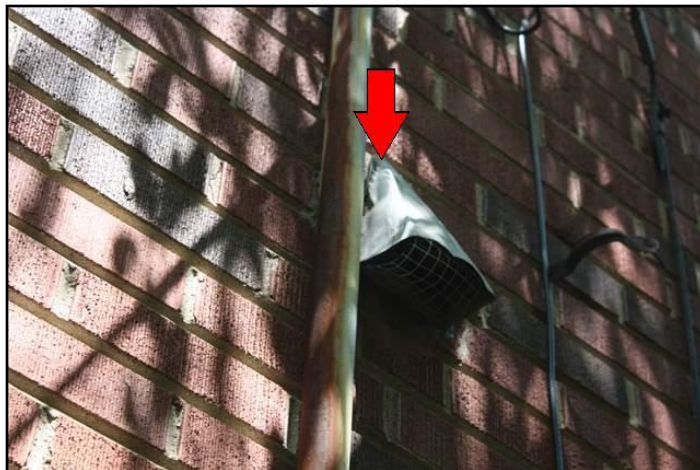
**Condition:** • [Caulking missing or ineffective](#)

11. Caulking missing or ineffective

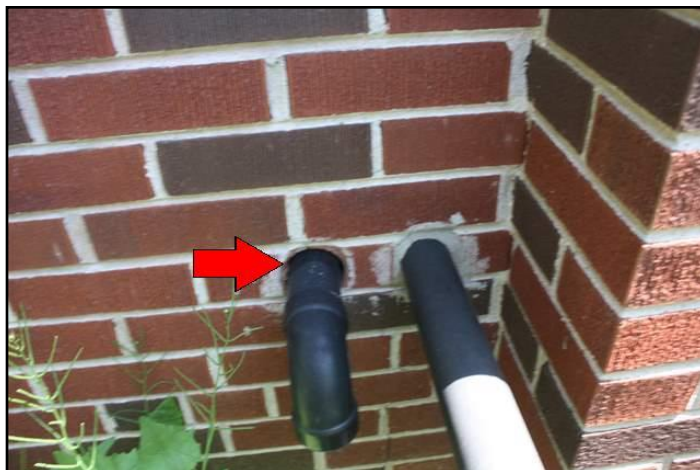
**Condition:** • [Caulking missing or ineffective](#)

12. Caulking missing or ineffective

**Time:** Regular maintenance

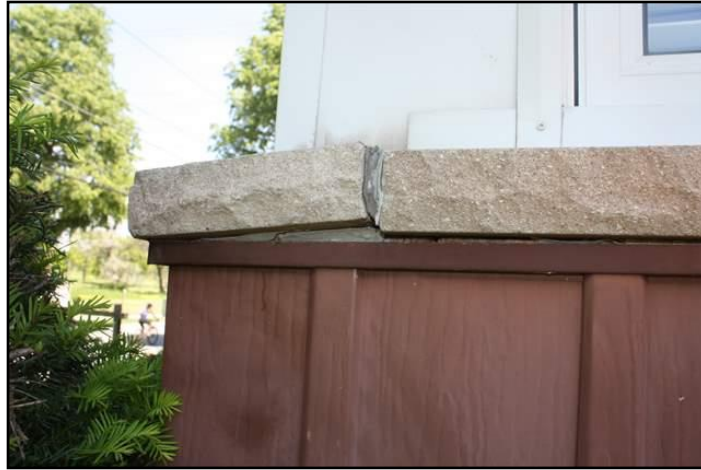
13.

**Condition:** • Prior movement at stone

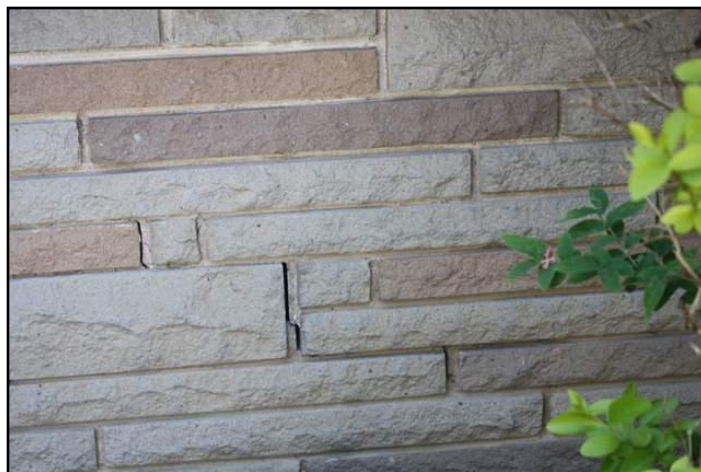
**Condition:** • [Cracked](#)

It is common to see differential settlement type cracks on walls below and above windows. Patch cracks to prevent water entry and damage. It is not possible on a one-time visit to know if cracks are active. Repair / Patch and monitor for activity. (Provide tuckpointing / repointing of mortar. Use professional masonry company)

14. *Cracked*

**Task:** Repair

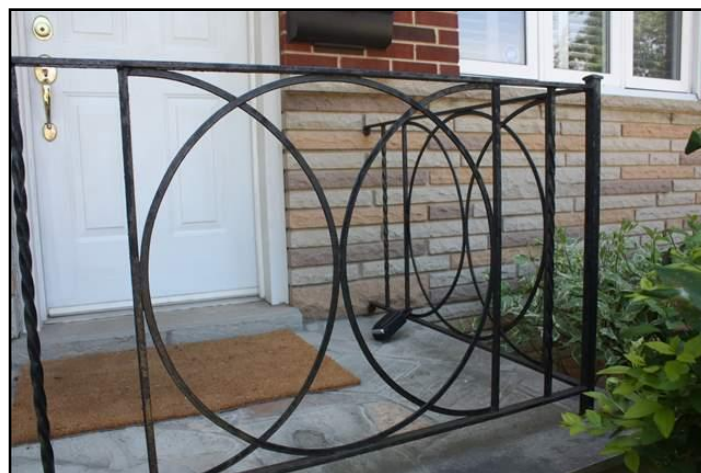
**Condition:** • [Too low](#)

**Implication(s):** Fall hazard

16. Too low

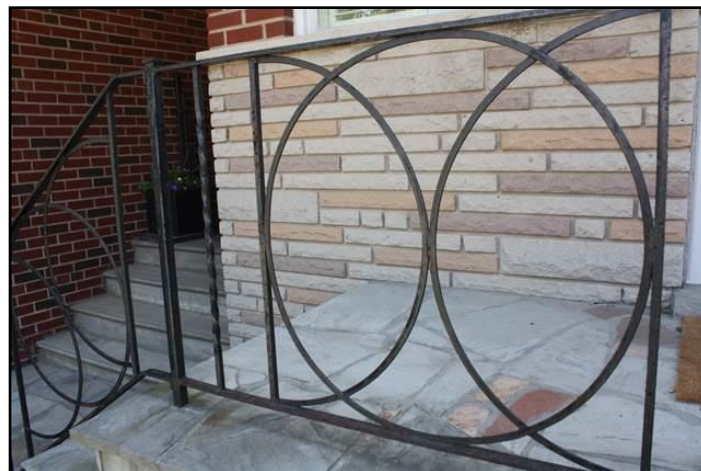
**Condition:** • [Spindles \(balusters\) too far apart](#)

**Implication(s):** Fall hazard

17. Spindles (balusters) too far apart

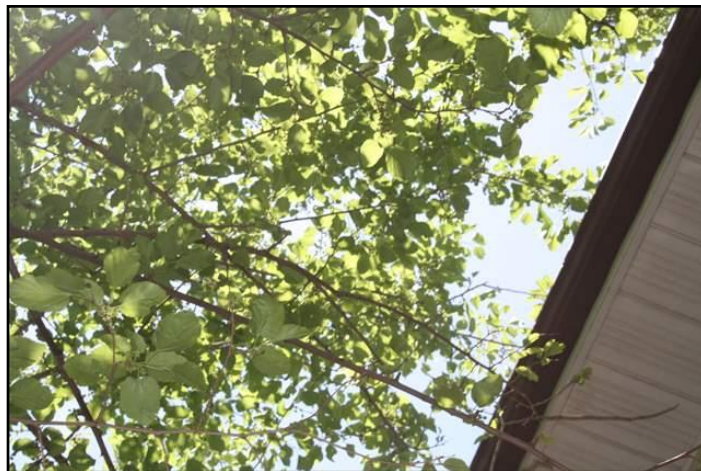
**Condition:** • [Trees or shrubs too close to building](#)

**Implication(s):** Chance of pests entering building | Material deterioration | Chance of water damage to contents, finishes and/or structure

**18.** *Trees or shrubs too close to building*

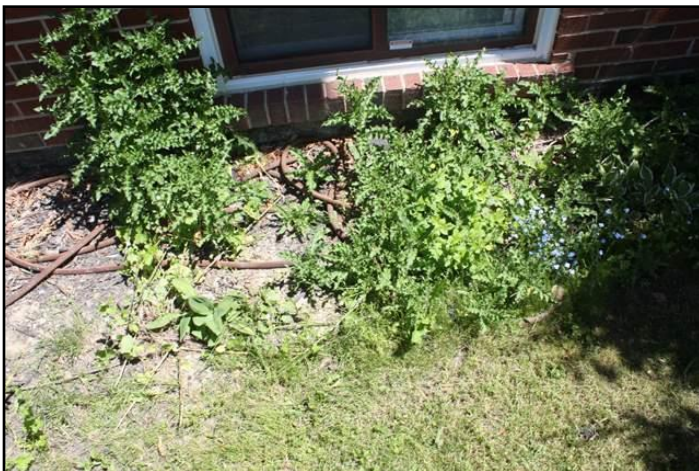
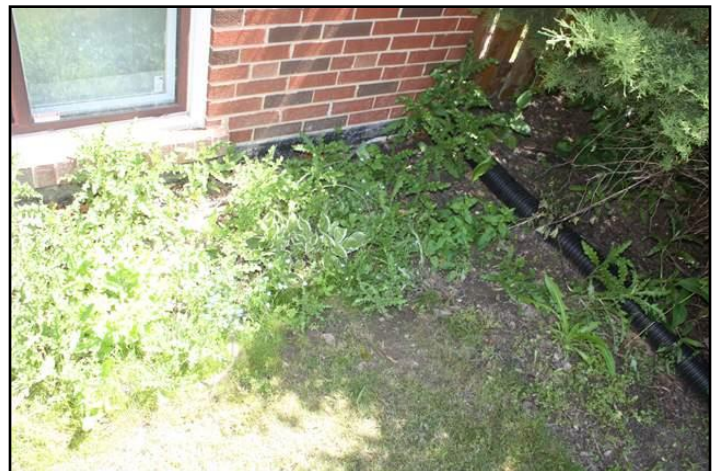
**Condition:** • Low Areas.

19. Low Areas.

20. Low Areas.

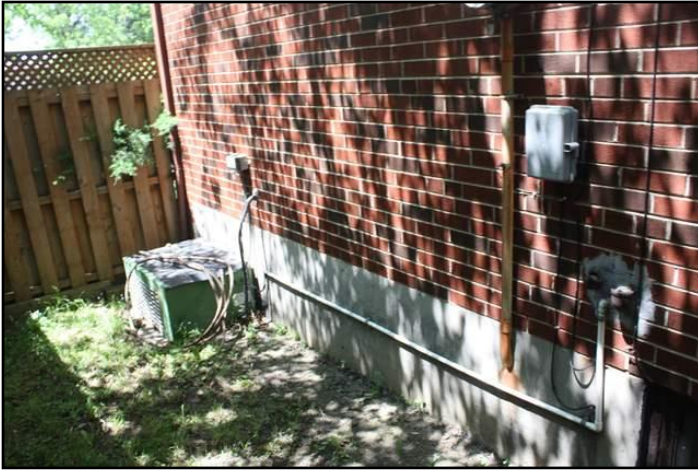
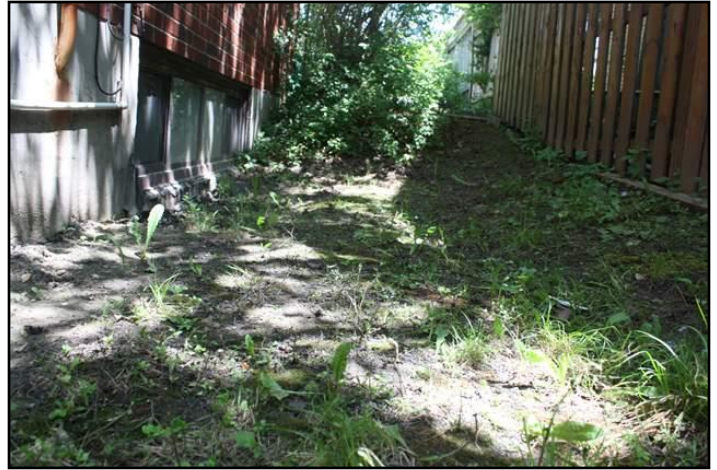
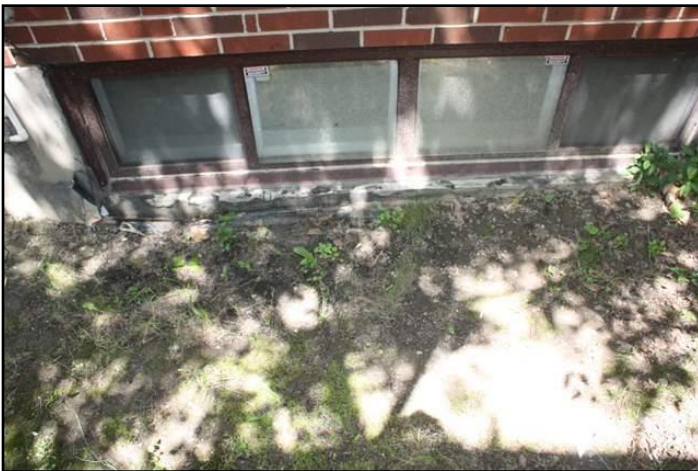
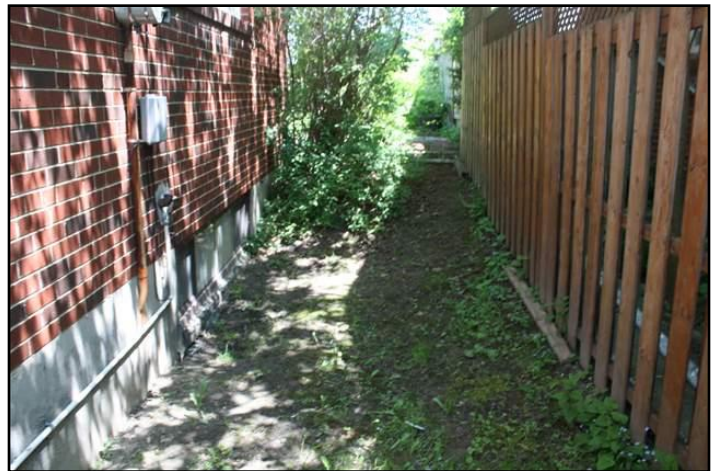
### Condition: • [Improper slope or drainage](#)

The Southwest side grading slopes downward toward the home. This creates a vulnerable area for potential basement leakage, although no leakage was observed during the inspection. It also appears that prior waterproofing has been performed below the window. We could not determine the extent of the waterproofing below grade. It is recommended to improve the drainage in this area through grading improvements and/or providing a drain. Consult with specialist.

21. Improper slope or drainage

22. Improper slope or drainage

23. Improper slope or drainage

24. Improper slope or drainage

**Cost:** This is labor intensive work. - consult landscaper

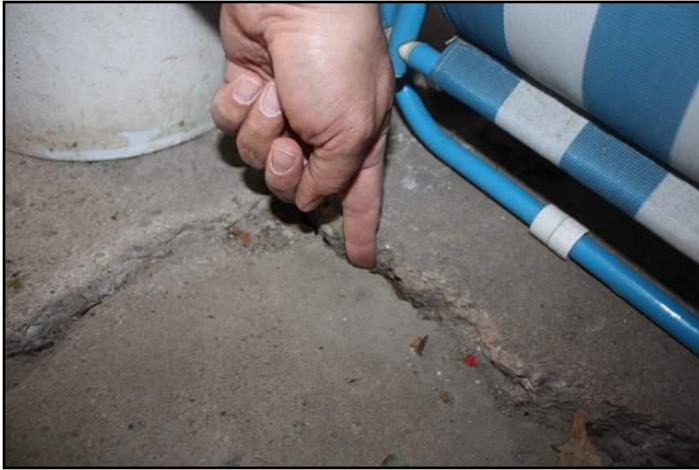
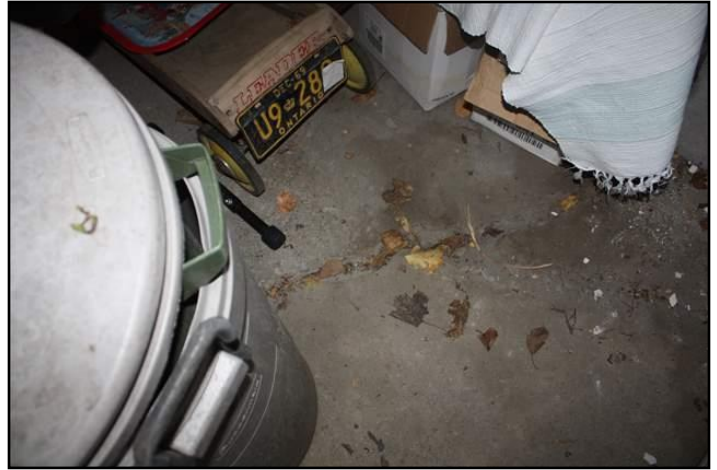
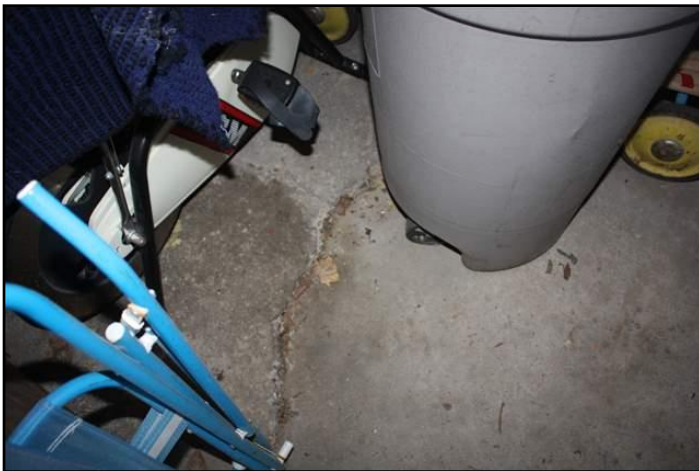
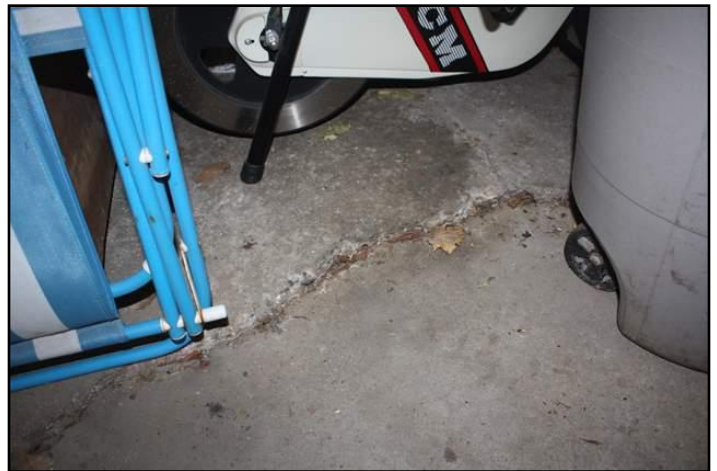
**Condition:** • [Cracked](#)

Cracking and Settlement or Heaving Observed. It is common for a concrete garage floor of this age to contain cracks. This is not part of the structure. Repair/replace as needed.

25. Cracked

26. Cracked

27. Cracked

28. Cracked

**Task:** Repair / Replace

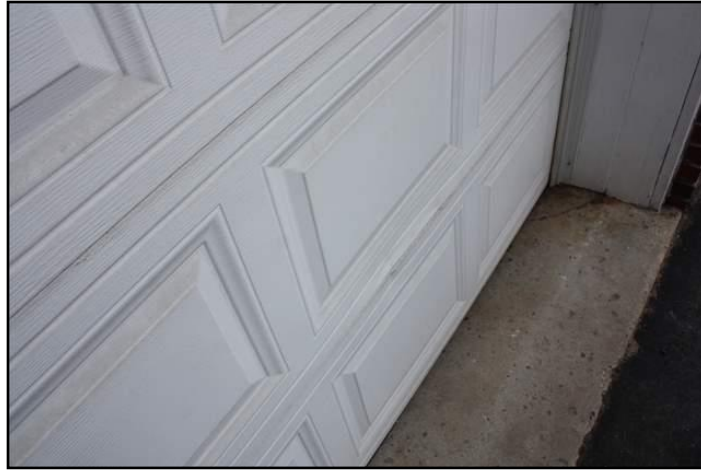
**Condition:** • Dented

**Implication(s):** Damage to equipment

29. Dented

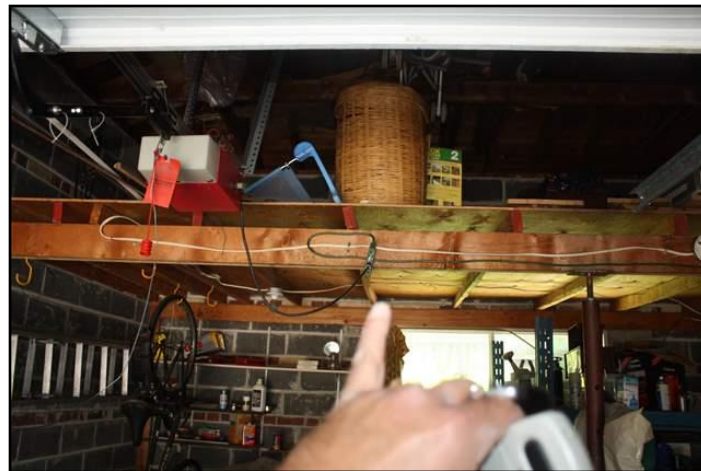
**Condition:** • [Extension cord for opener](#)

30. Extension cord for opener

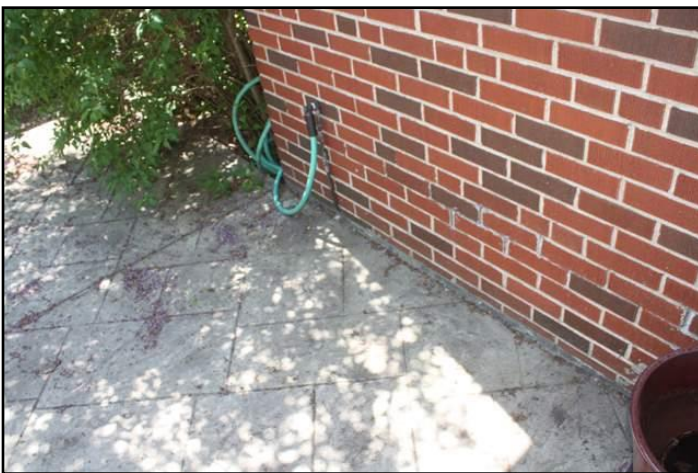
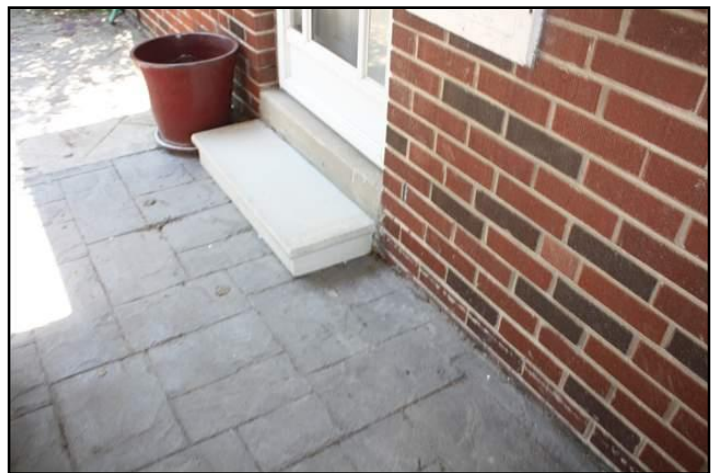
**Condition:** • [Masonry too close to grade](#)

Click the link to read more information. Some types of brick can be installed at or below grade. We can not distinguish brick type during a home inspection. Considering the masonry is 50+ years old and is in good overall condition it would be prudent to monitor for now.

**Implication(s):** Chance of damage to structure

31. Masonry too close to grade

32. Masonry too close to grade

**Task:** Click link to read more information / Correct

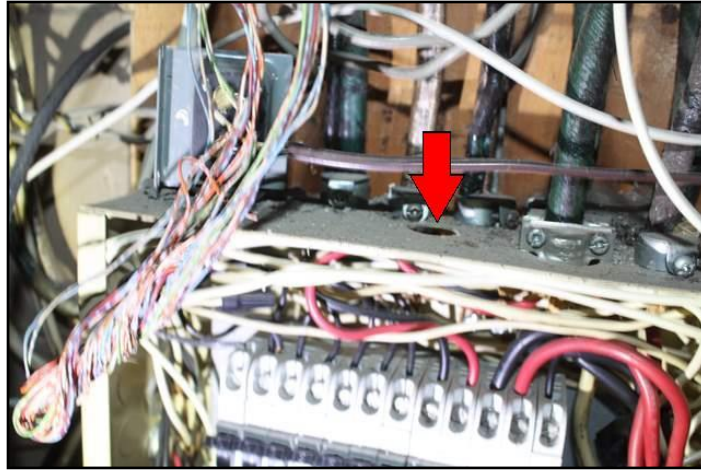
**Condition:** • [Openings in panel](#)

**Implication(s):** Fire hazard | Electric shock

33. Openings in panel

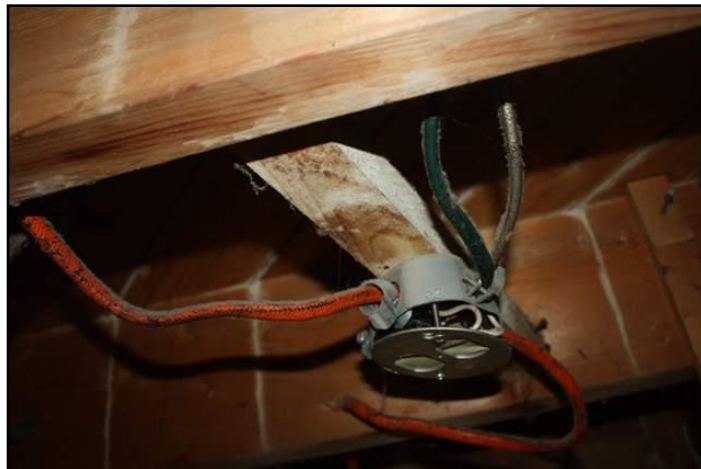
**Condition:** • [Cover loose or missing](#)

**Implication(s):** Fire hazard | Electric shock

34. Cover loose or missing

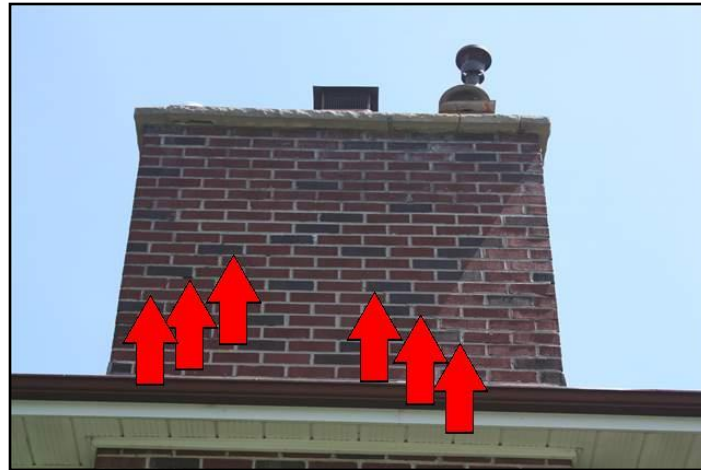
**Condition:** • [Cracked](#)

**Implication(s):** Shortened life expectancy of material | Chance of water damage to contents, finishes and/or structure

35. Cracked

**Task:** Repair

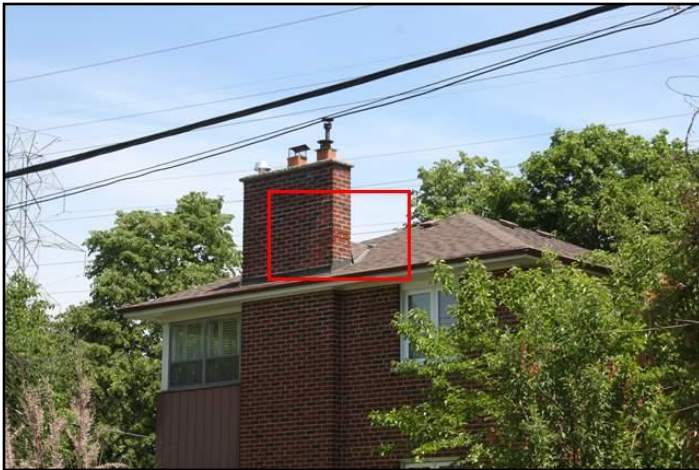
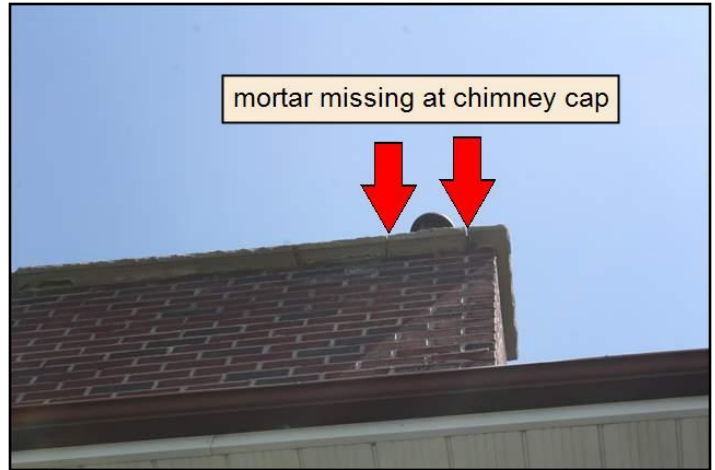
**Condition:** • [Loose, missing or deteriorated mortar](#)

**Implication(s):** Material deterioration

36. Loose, missing or deteriorated mortar

37. Loose, missing or deteriorated mortar

**Task:** Repair

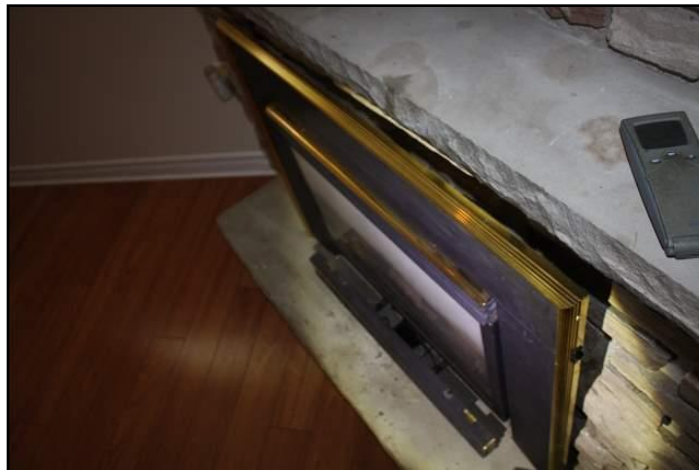
38.

**Condition:** • Check installation with gas fireplace specialist before using.

**Task:** Service

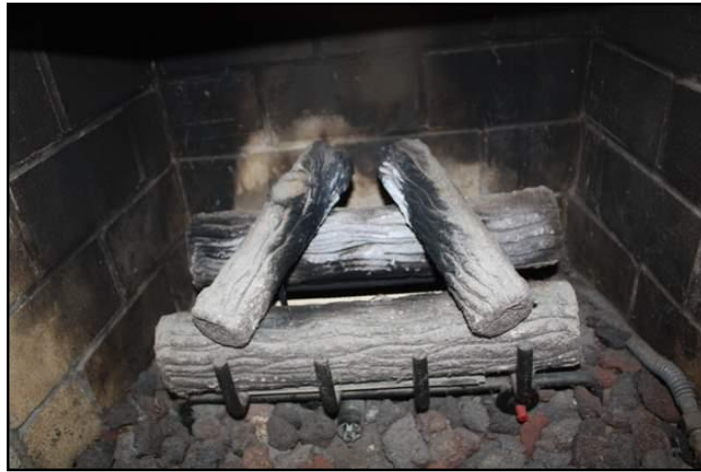
39.

**Condition:** • [Inoperative](#)

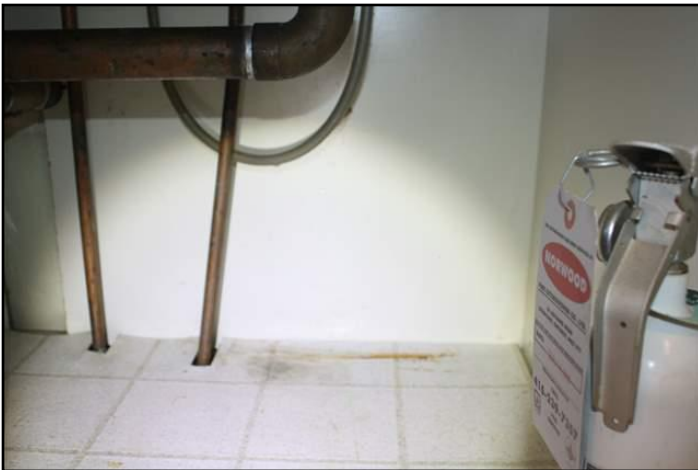
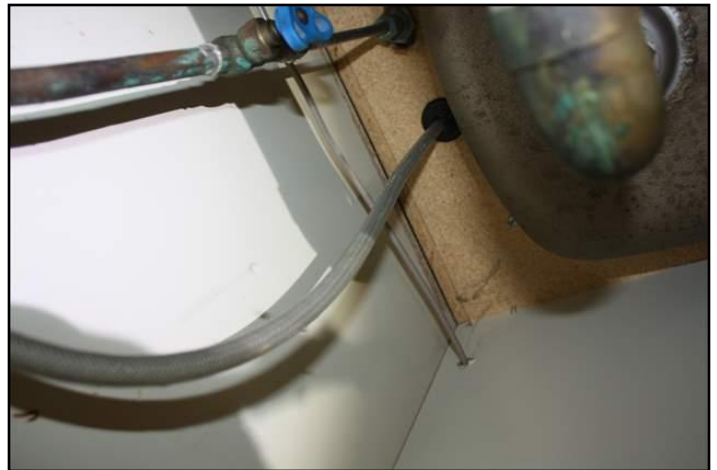
**Condition:** • [Leak](#)

**Implication(s):** Sewage entering the building | Chance of water damage to contents, finishes and/or structure

41. Leak

42. Leak

**Task:** Repair

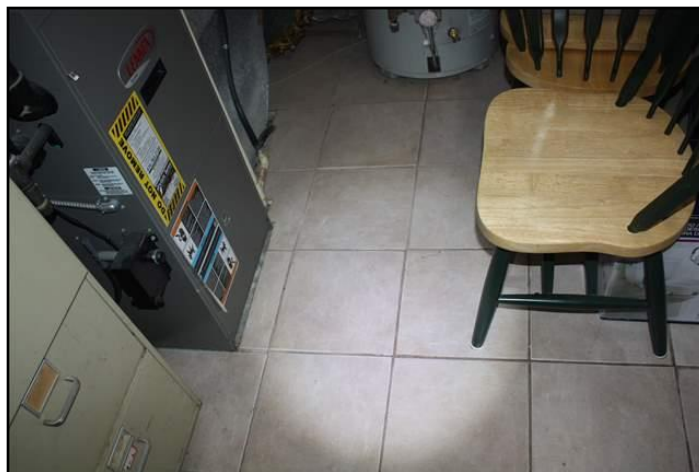
**Condition:** • [Tiles cracked](#)

Tiles loose, cracked and the floor is uneven

**Implication(s):** Trip or fall hazard

43. Tiles cracked

**Task:** Replace

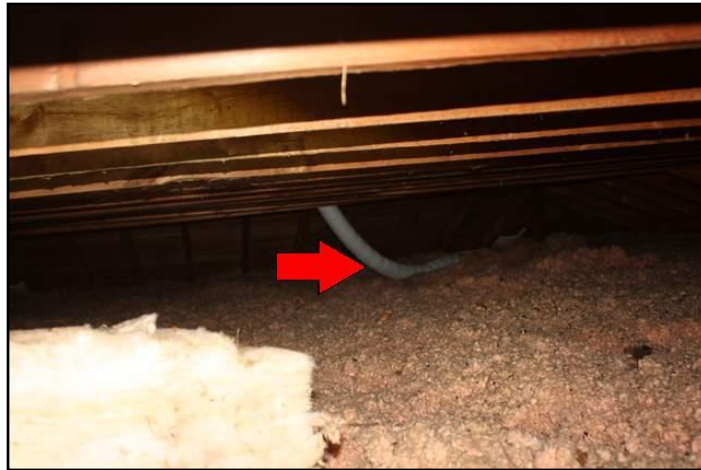
**Condition:** • [Not insulated in unconditioned space](#)

**Implication(s):** Chance of condensation damage to finishes and/or structure

**44.** *Not insulated in unconditioned space*

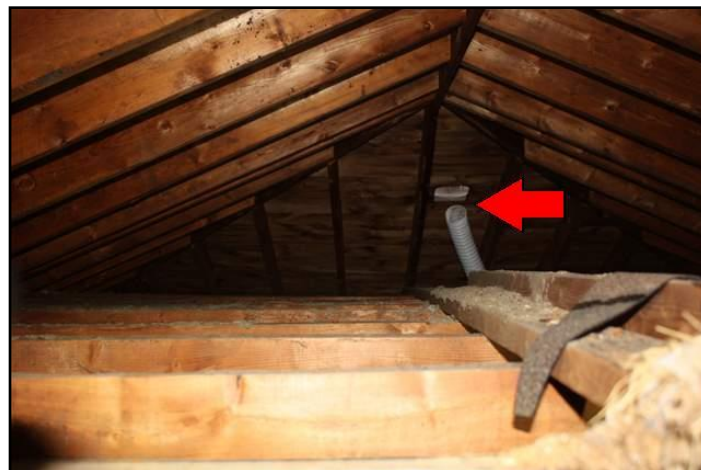
**Condition:** • [Poor termination location](#)

**Implication(s):** Chance of condensation damage to finishes and/or structure

45. Poor termination location

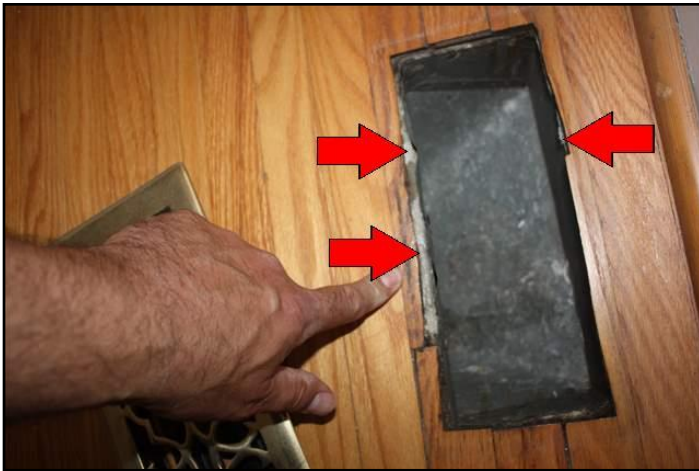
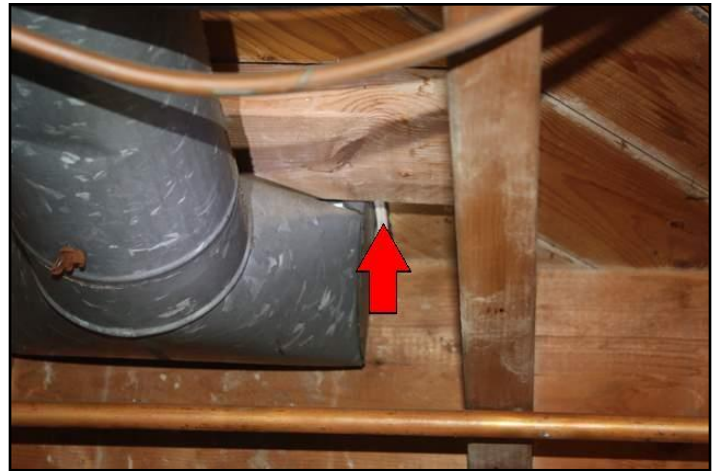
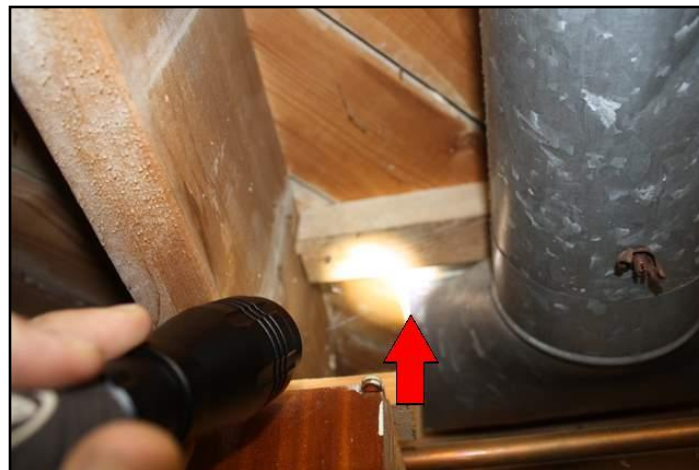
**Condition:** • Possible asbestos containing materials

During the era when this house was built, it was very common to wrap registers in asbestos type insulation to protect the floors from overheating. Determining the material type is outside the scope of this inspection. Health Canada recommends that any asbestos material found should stay in place undisturbed. If you plan to remodel or if this is a concern, consult with a specialist for lab testing to confirm if asbestos is present.

**Task:** Evaluate before disturbing or if desired
