YOUR INSPECTION REPORT

771 Indian Road
Toronto, ON M6P 2E4

INSPECTION DATE:
Tuesday, October 9, 2018

RE: Report No. 2347
771 Indian Road
Toronto, ON
M6P 2E4

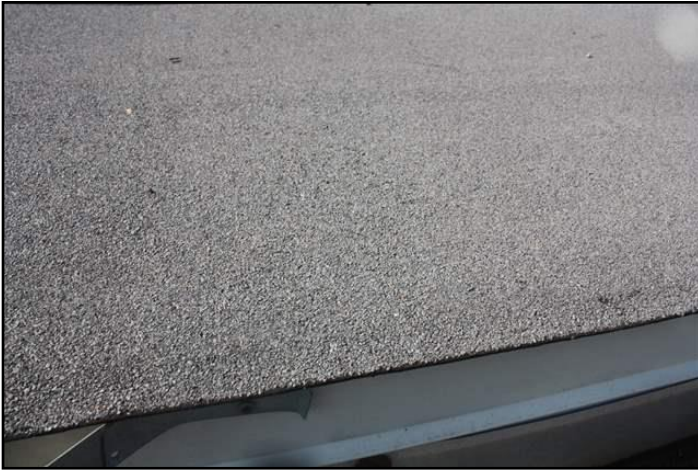
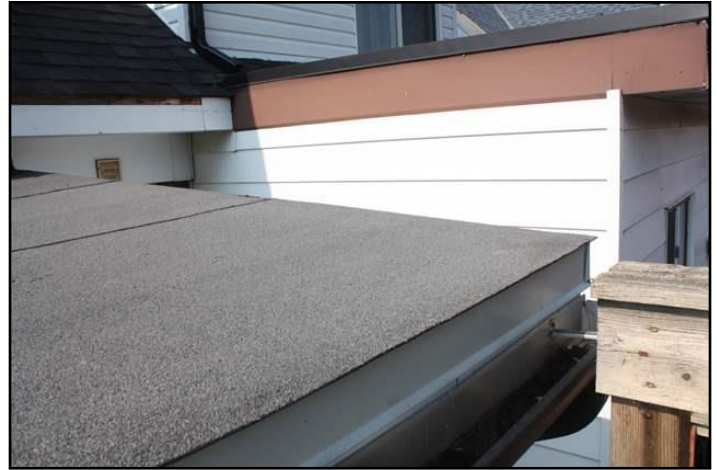
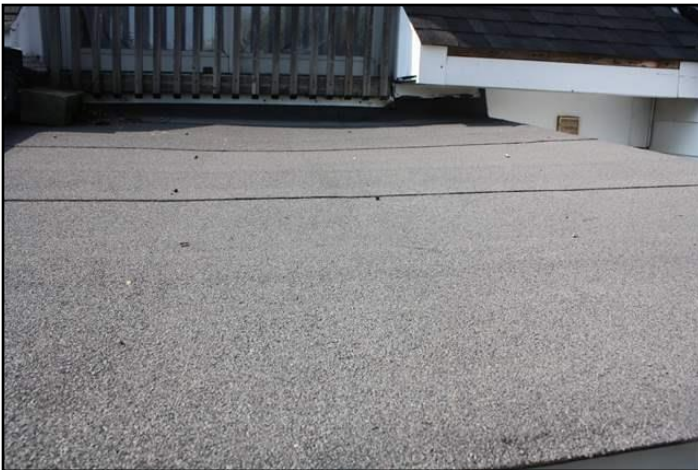
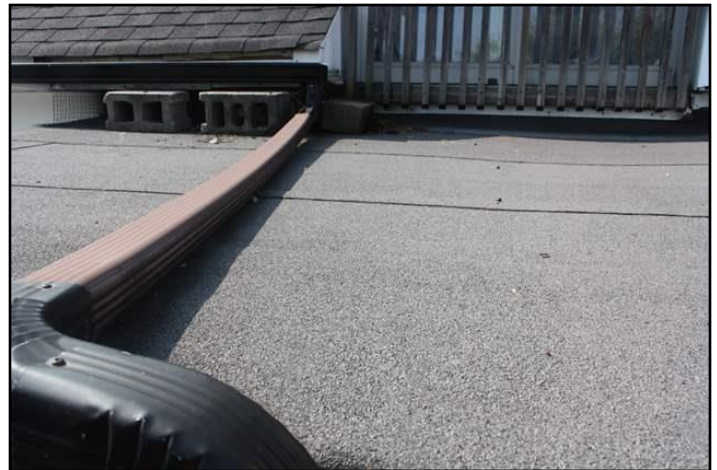
Condition: • For Your Information - Professional roofer onsite noted that the flat roof was in good condition. We also observed roof from roof edge and determined that there are several years of service remaining. With flat roofs it is recommended to inspect annually

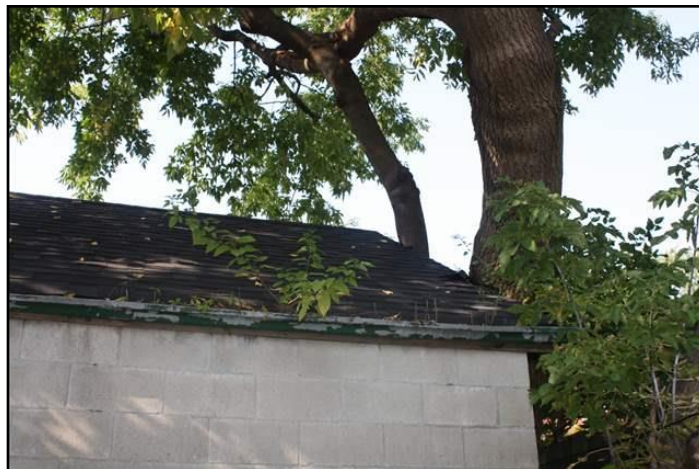
5. Clogged

Condition: • [Clogged](#)

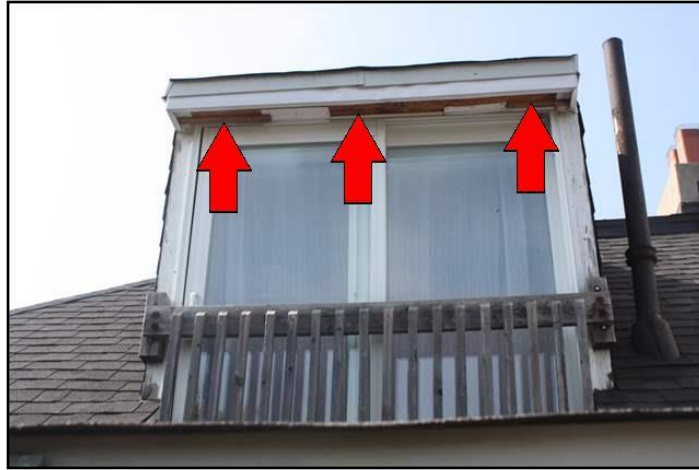
6. Flashings incomplete or ineffective

Condition: • [Flashings incomplete or ineffective](#)

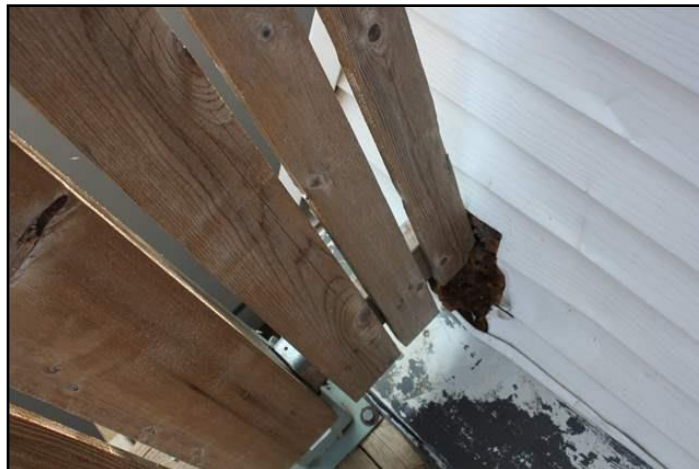
7. Loose or missing pieces

Condition: • [Loose or missing pieces](#)

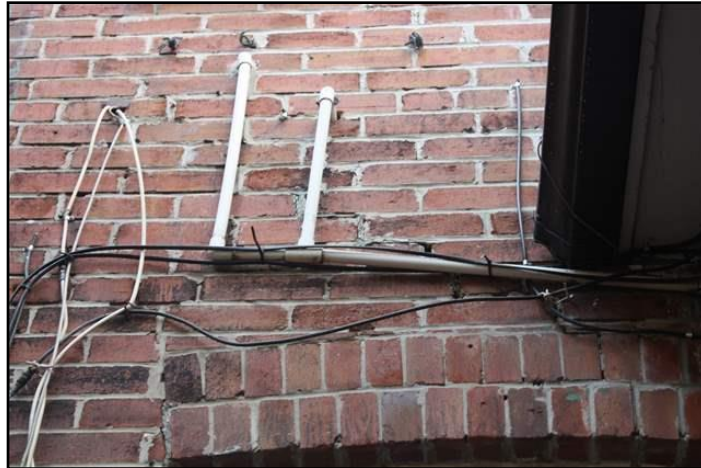
8. Minor cracking

Condition: • [Cracked](#)

It is common to see differential settlement type cracks on walls below and above windows. Patch cracks to prevent water entry and damage. It is not possible on a one-time visit to know if cracks are active. Repair / Patch and monitor for activity.

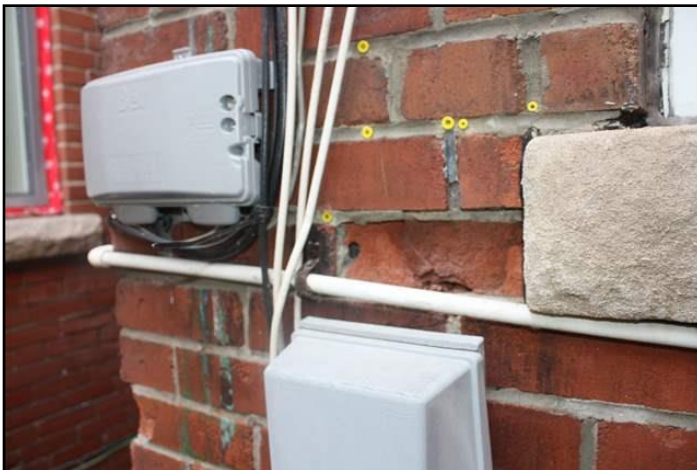
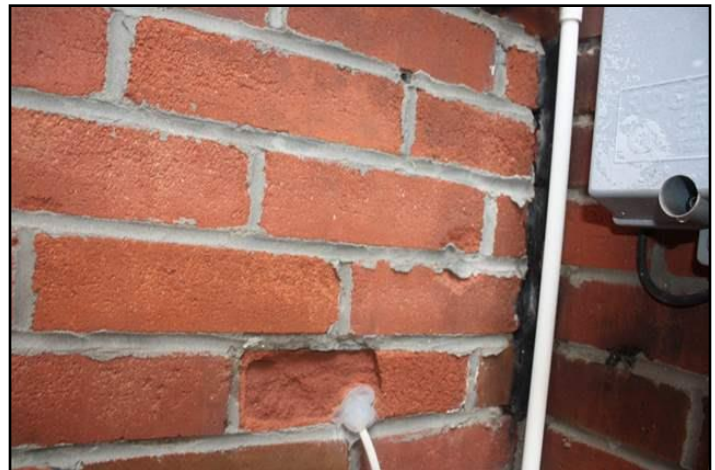
Condition: • [Spalling](#)

Spalling/ masonry deterioration noted at various areas. Repair / Replace / Tuck point masonry. This is regular maintenance for a home of this age.

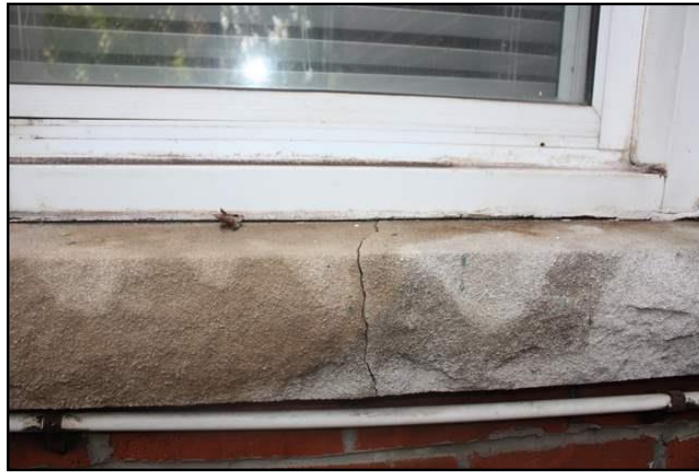
11. Sill deteriorated

Condition: • [Sill deteriorated](#)

Minor crack at sill noted. Patch to prevent further damage. Typical Maintenance

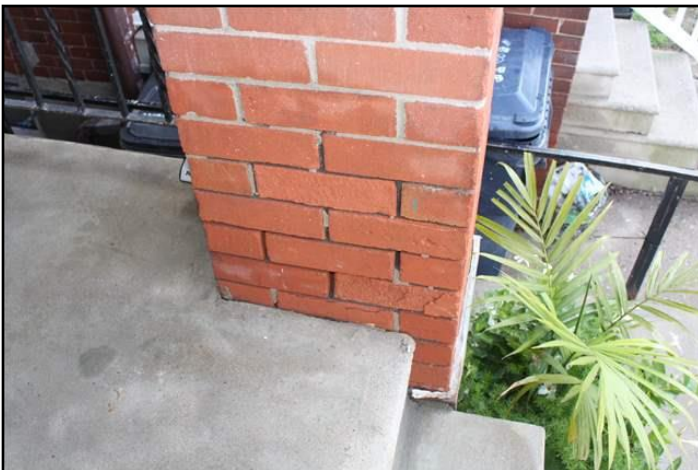
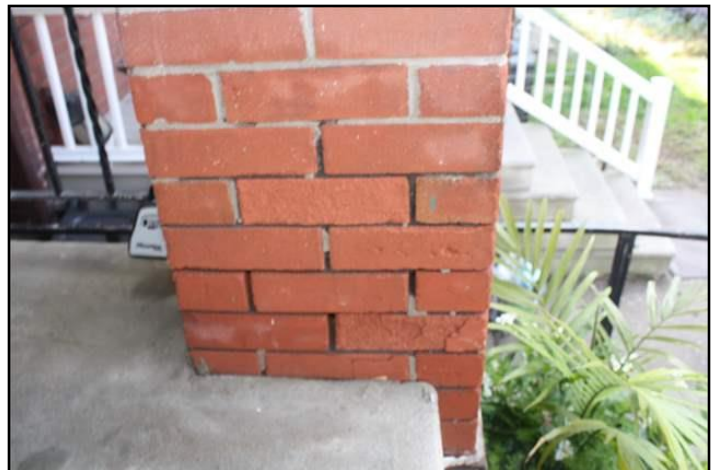
Condition: • [Spalling](#)

Spalling bricks and mortar deterioration. Tuckpoint mortar and repair/replace bricks.

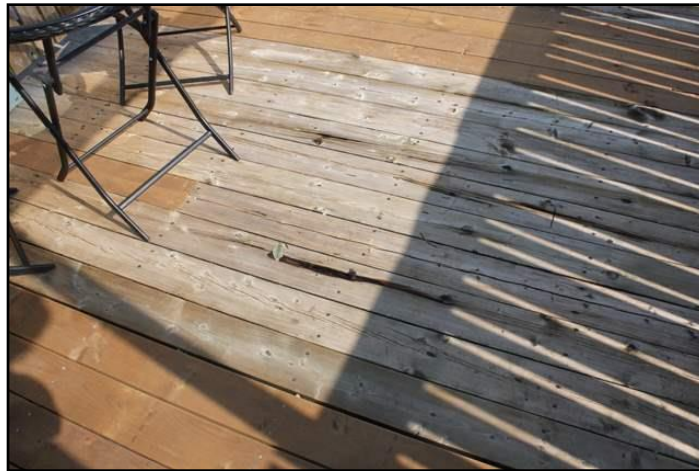
14. Rot

Condition: • [Rot](#)

Some of the boards have already been replaced.

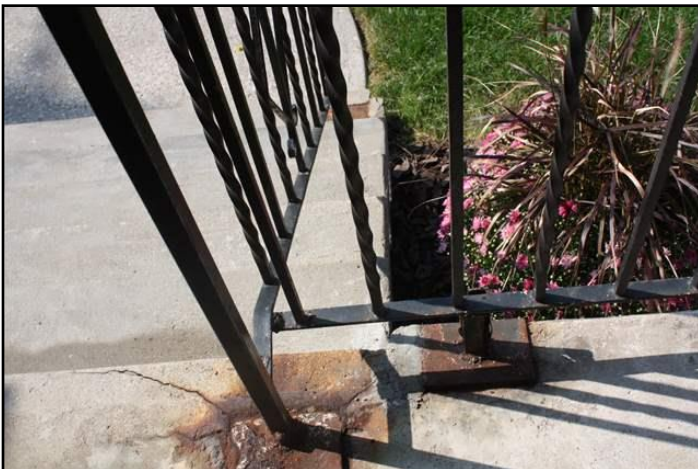
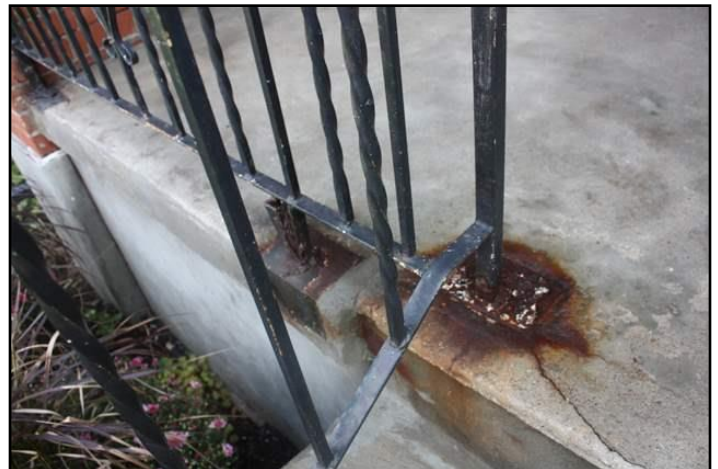
Condition: • [Rust](#)

Old Railings. Rusted at bottom of railings.

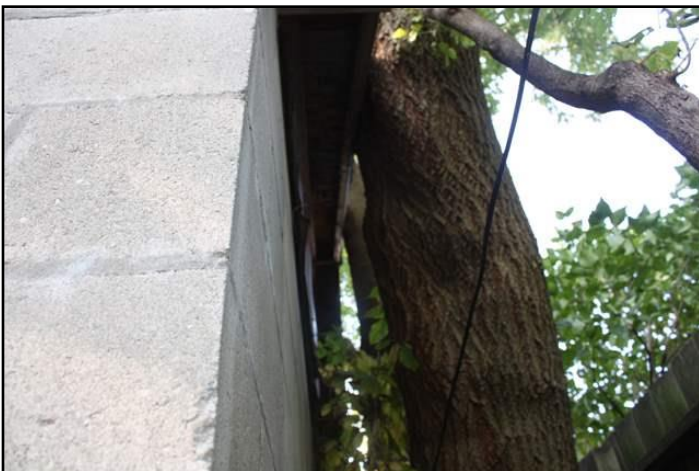
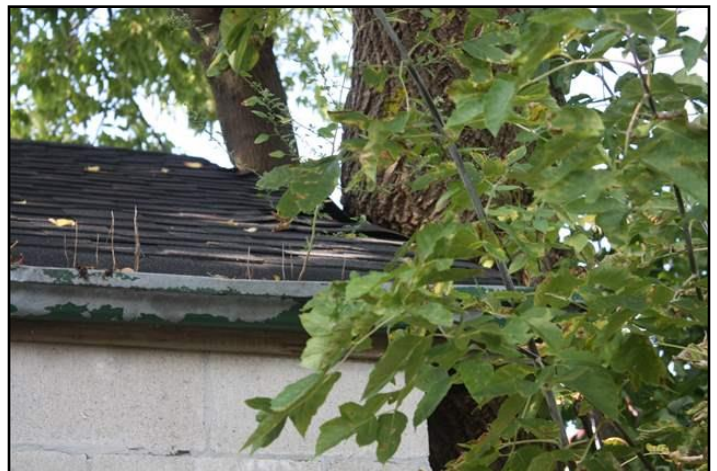
Condition: • [Trees or shrubs too close to building](#)

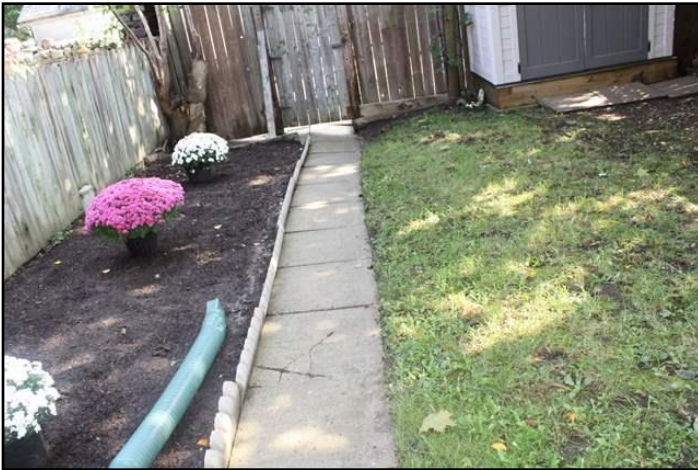
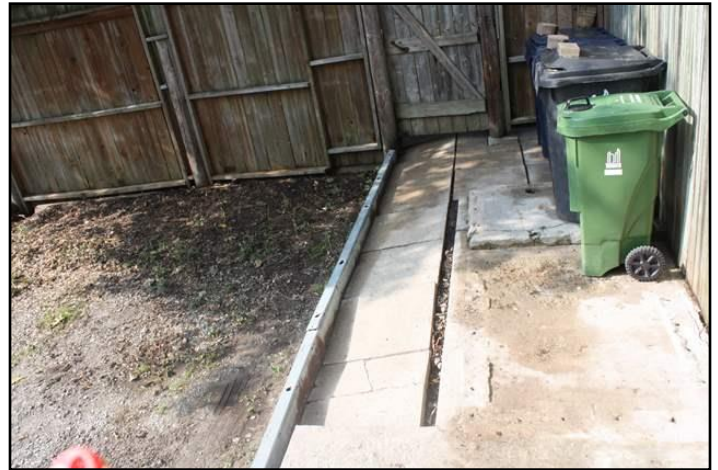
Condition: • [Uneven \(trip hazard\)](#)

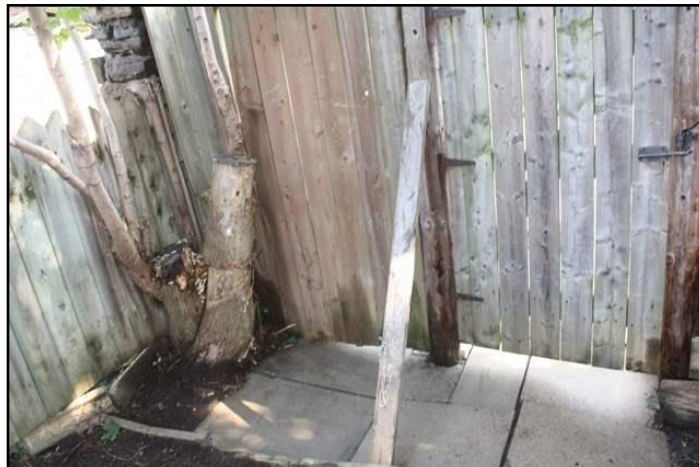
Condition: • Leaning

21. Prior temporary repair

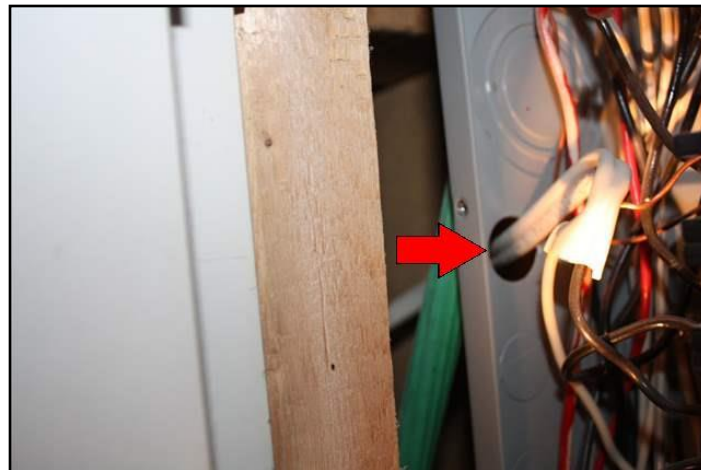
23. Openings in panel

Condition: • [Openings in panel](#)

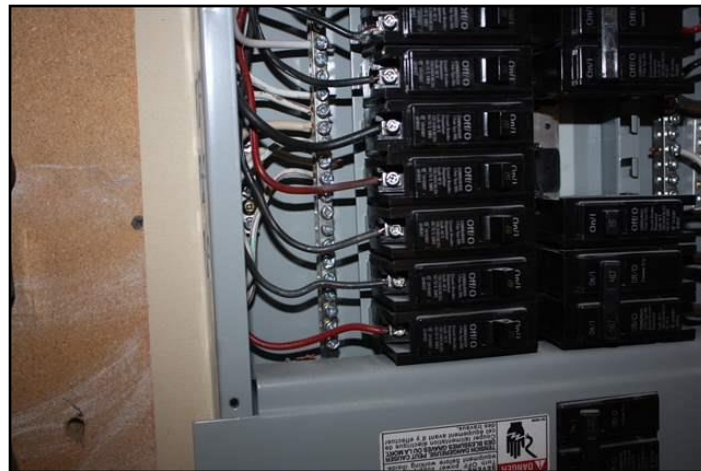
24. No links for multi-wire circuits

Condition: • [No links for multi-wire circuits](#)

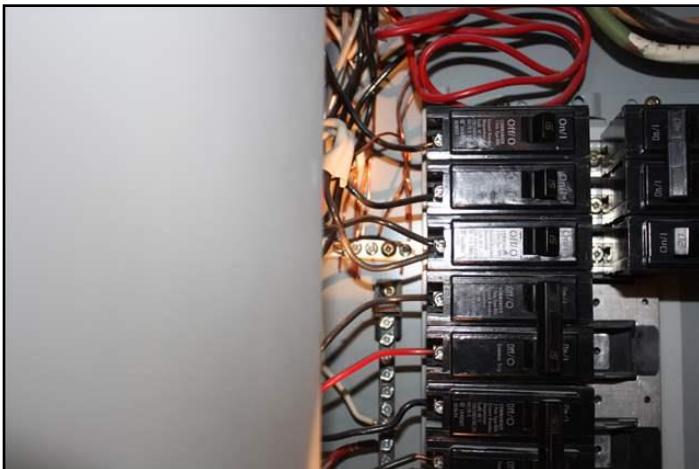
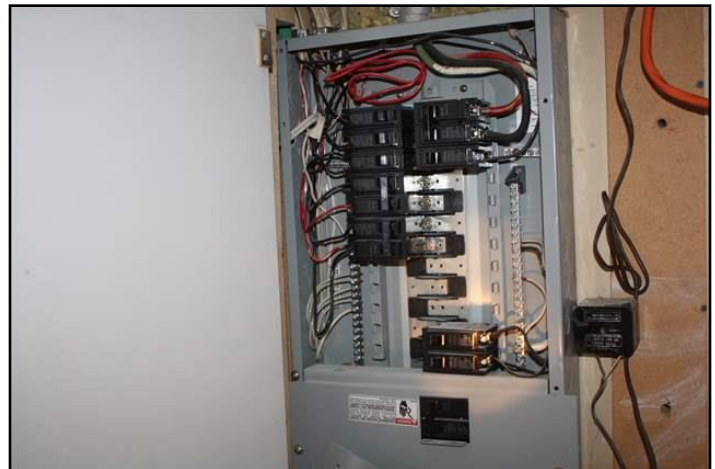
Condition: • [Double taps](#)

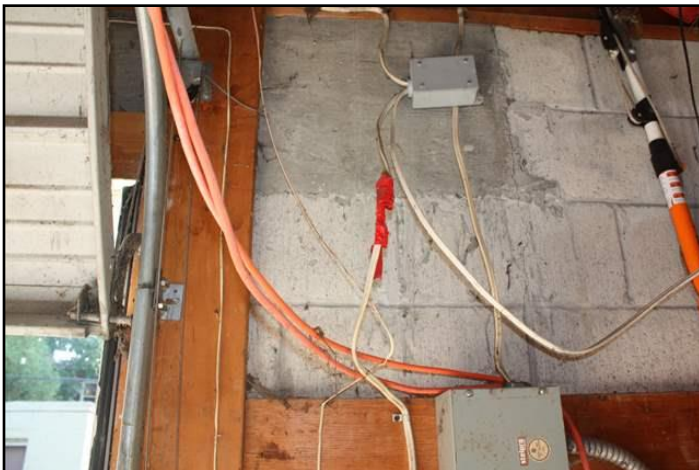
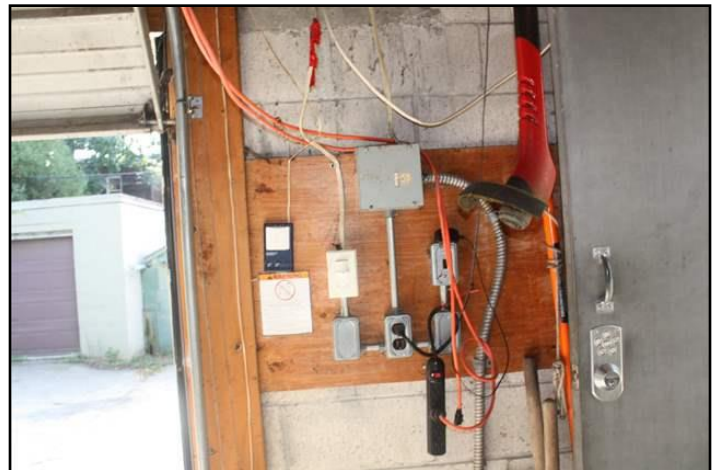
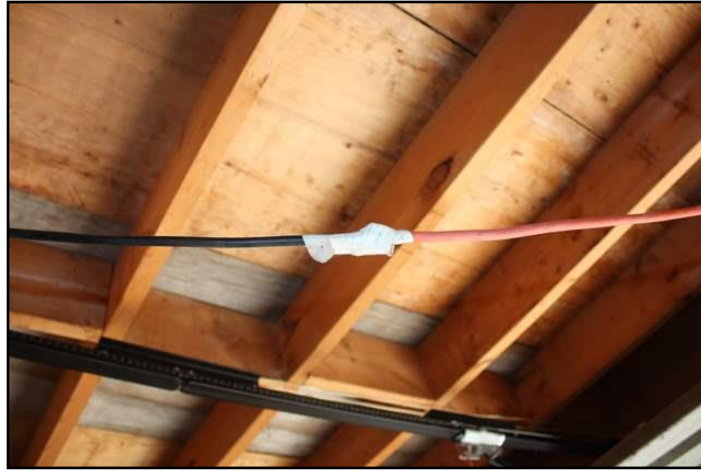
**DISTRIBUTION SYSTEM \ Wiring - installation****Condition:** • [Open splices](#)

Various electrical issues noted in Garage. Have electrician clean up connections, and provide junction boxes.

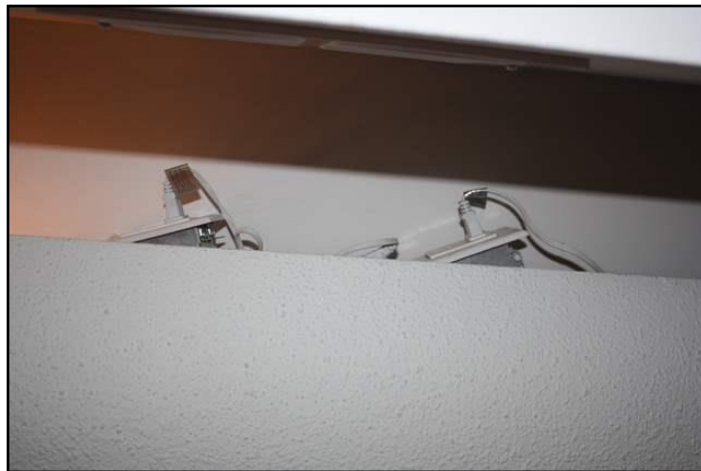
Condition: • [Not well secured](#)

30. Outlets not well secured

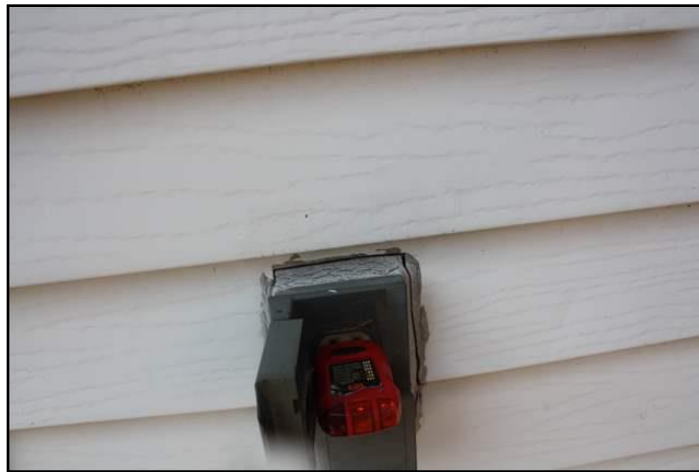
31. GFCI/GFI needed (Ground Fault Circuit...

Condition: • [GFCI/GFI needed \(Ground Fault Circuit Interrupter\)](#)

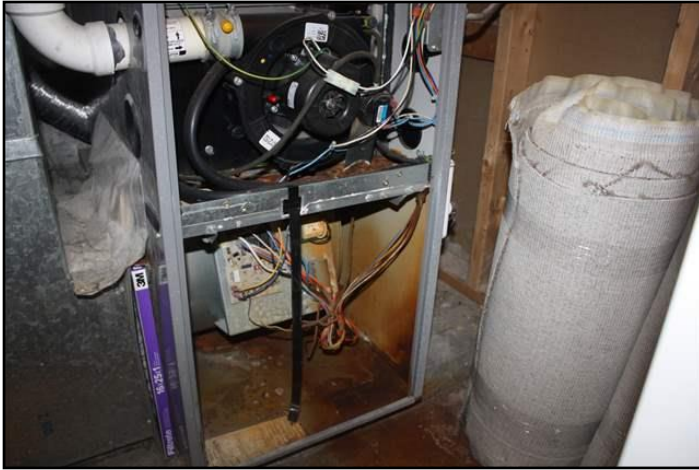
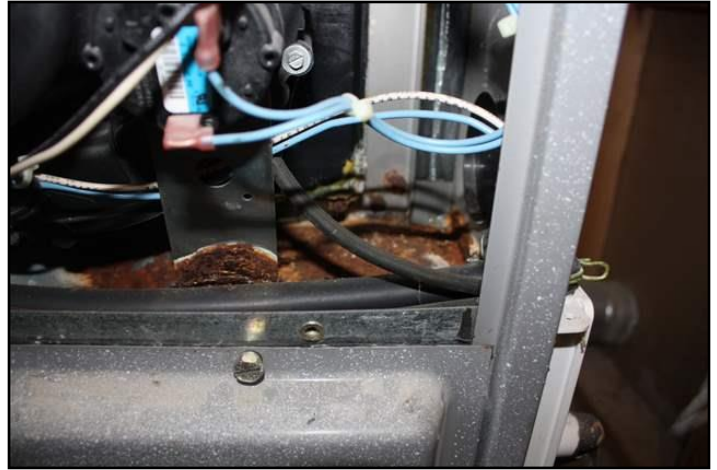
Condition: • [Rust](#)

Rust noted inside furnace cabinet. Evidence of prior leakage noted on the inside and exterior of furnace. Unknown if condensate leak is still active or intermittent. Dry at time of inspection. Service furnace and have HVAC technician check heat exchanger for rust.

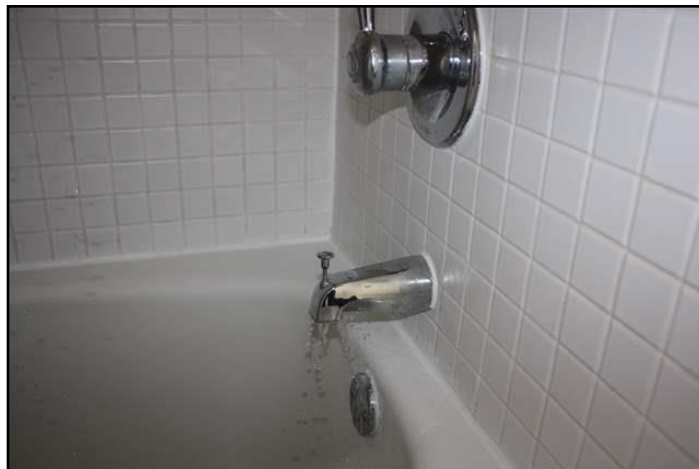
35. *Shower diverter inoperative or defective*

Condition: • [Shower diverter inoperative or defective](#)

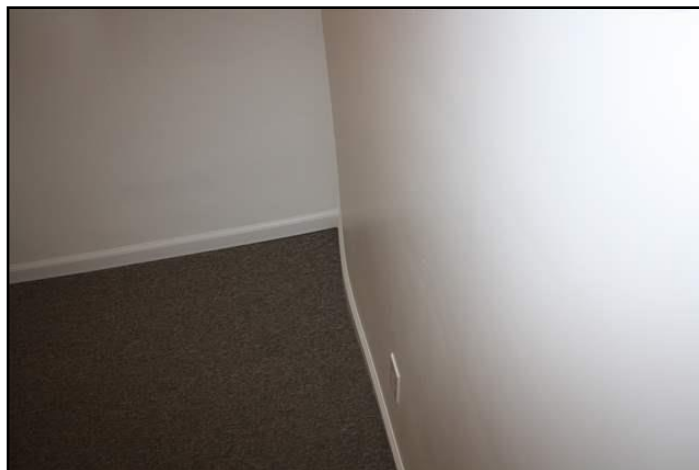
36. *Bulging*

Condition: • [Bulging](#)

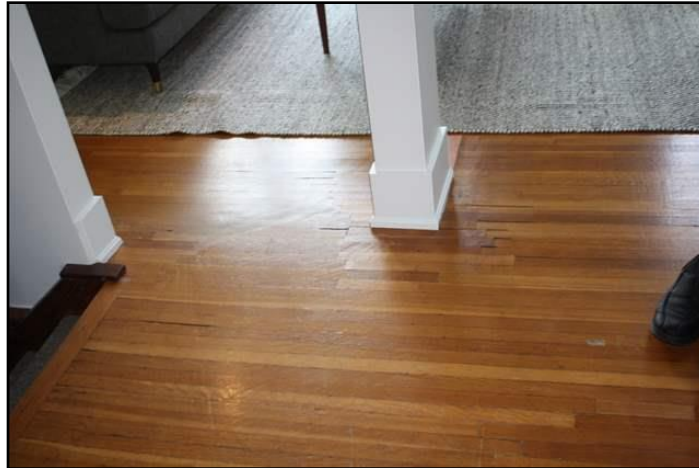
37. Worn

Condition: • Worn

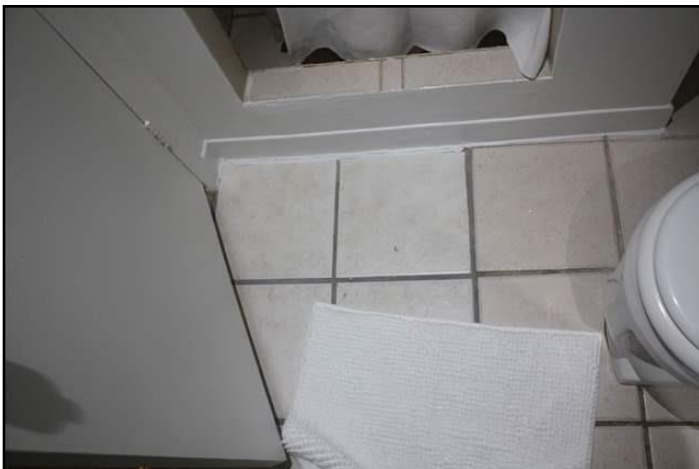
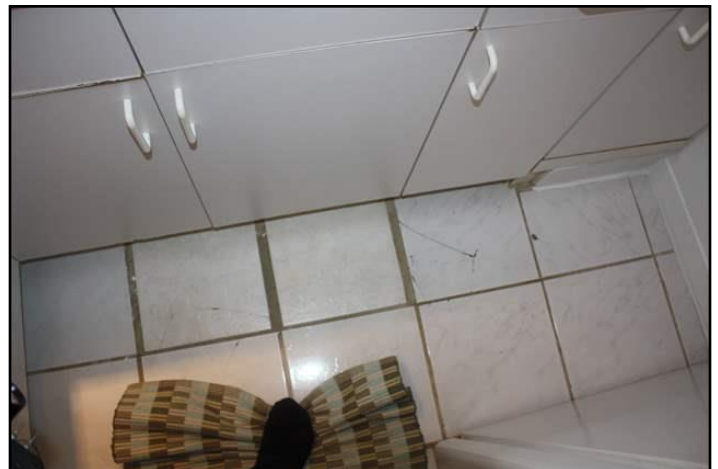
Condition: • [Tiles cracked](#)

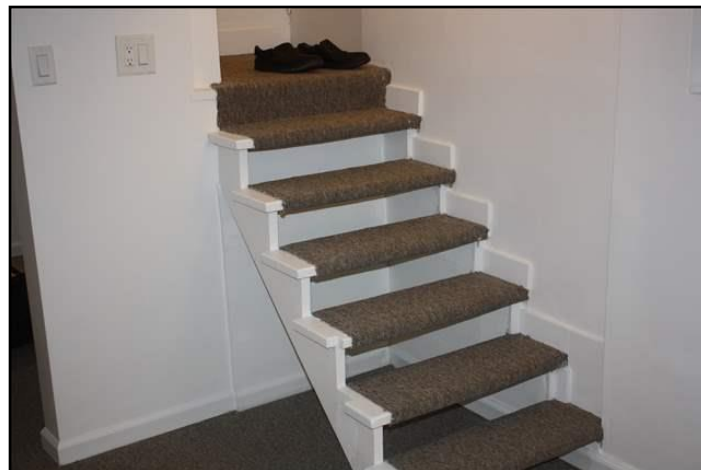
40. Missing

Condition: • [Missing](#)
