INSPECTION REPORT

For the Property at:
123 SAMPLE WAY
FLOWERY BRANCH, GA 30542

Prepared for: SAMPLE HOME INSPECTION
Inspection Date: Monday, August 3, 2020
Prepared by: Keith Kerr

RE: Report No. 1015, v.2
123 Sample Way
Flowery Branch, GA
30542

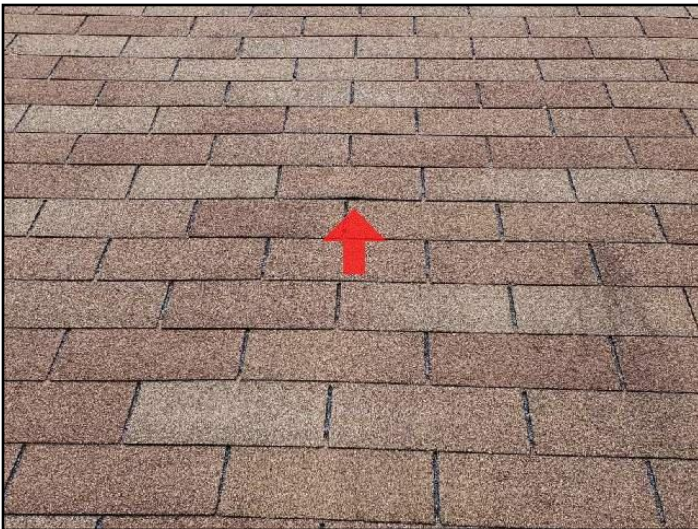
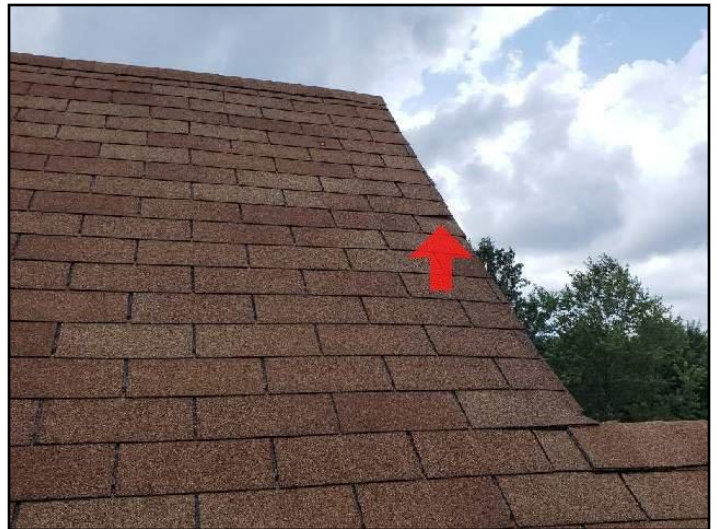
Location: Front

1. Condition: • [Cupping, curling, clawing](#)

Several shingles cupping or curling on front portion of roof. Recommend replacing damaged shingles and further evaluation by licensed roofing contractor.

Implication(s): Chance of water damage to structure, finishes and contents

Cupping, curling, clawing

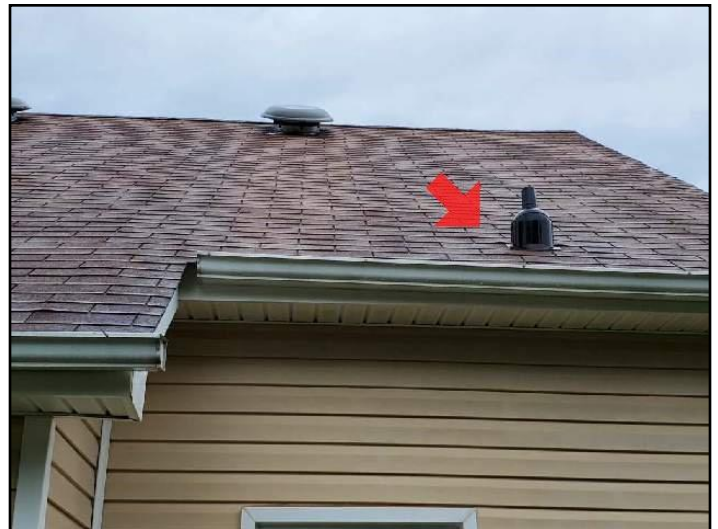
2. Condition: • [Cupping, curling, clawing](#)

Numerous shingles cupping or curling on rear portion of roof. Recommend replacing damaged shingles and further evaluation by licensed roofing contractor.

Implication(s): Chance of water damage to structure, finishes and contents

Cupping, curling, clawing

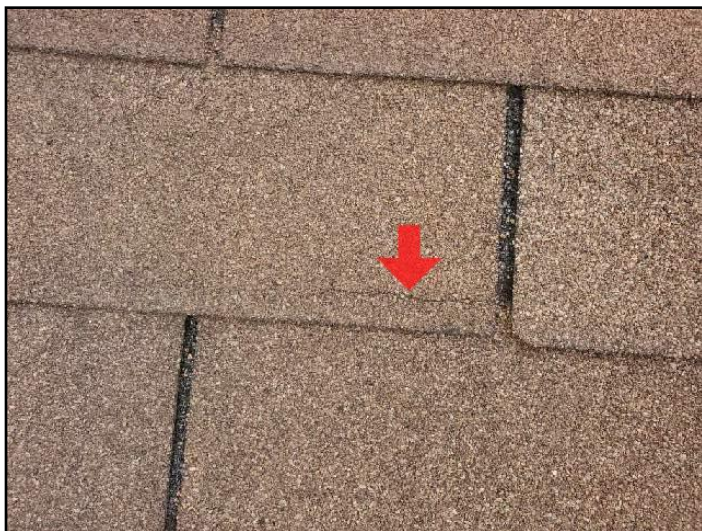
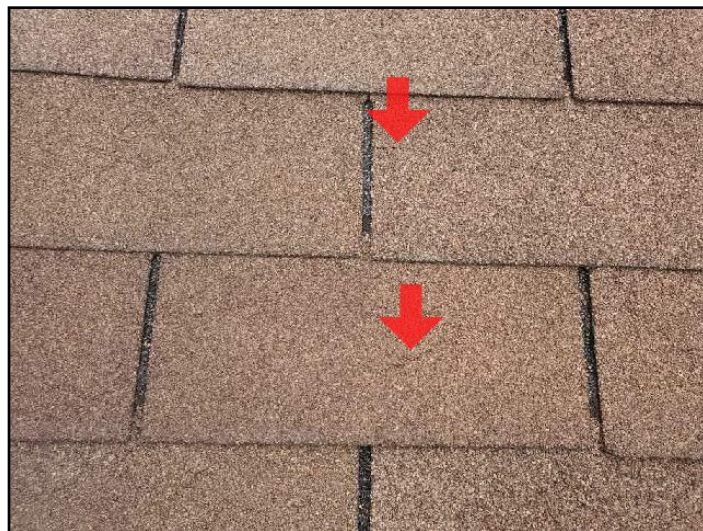
3. Condition: • [Cracks](#)

Shingles cracked on roof at front of structure. Recommend further evaluation and replacement by licensed roofing contractor.

Implication(s): Chance of water damage to structure, finishes and contents

Cracks

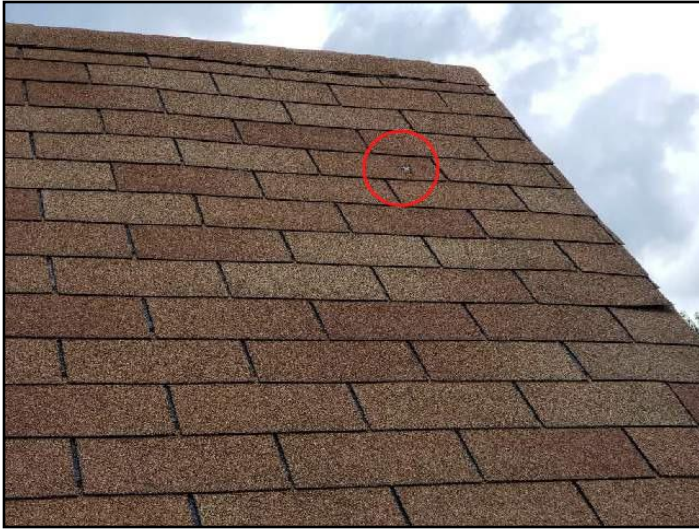
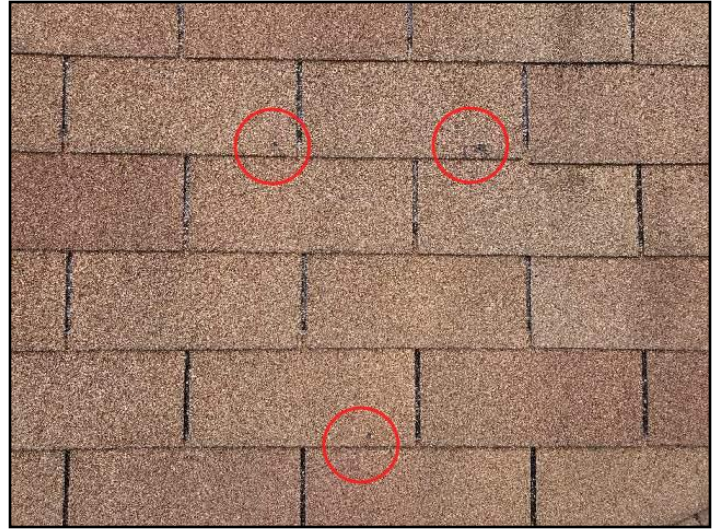
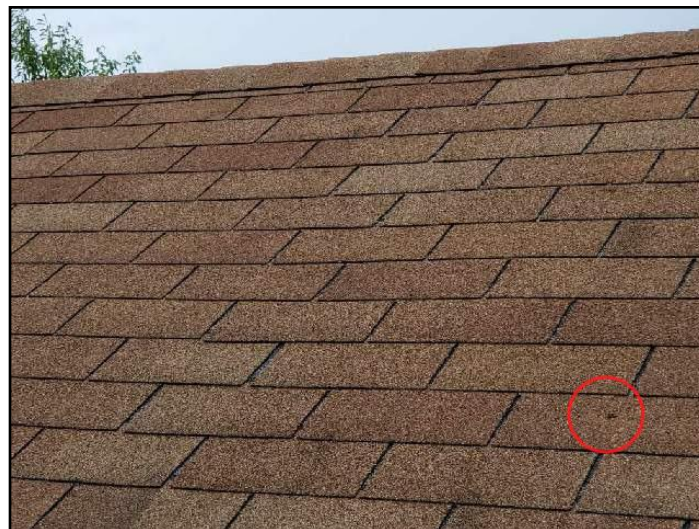
4. Condition: • [Damage](#)

Shingles damaged in several areas. Recommend replacing damaged shingles and further evaluation by licensed roofing contractor.

Implication(s): Chance of water damage to structure, finishes and contents

Damage

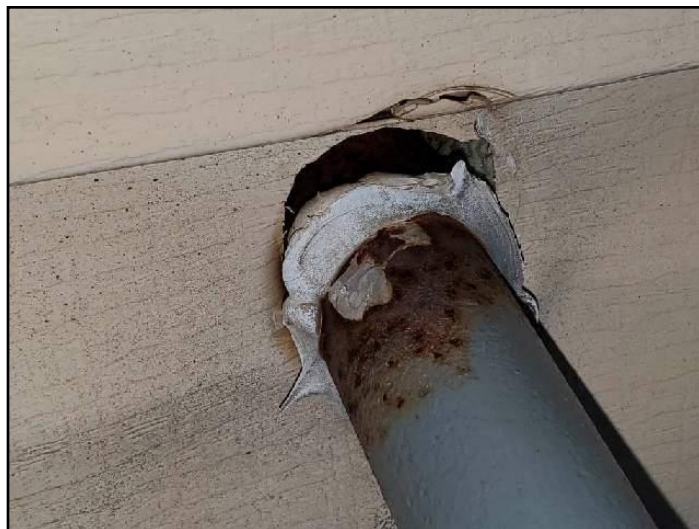
Location: Right Side

6. Condition: • Other

Recommend sealing where gas line enters structure to prevent water and pest intrusion.

Other

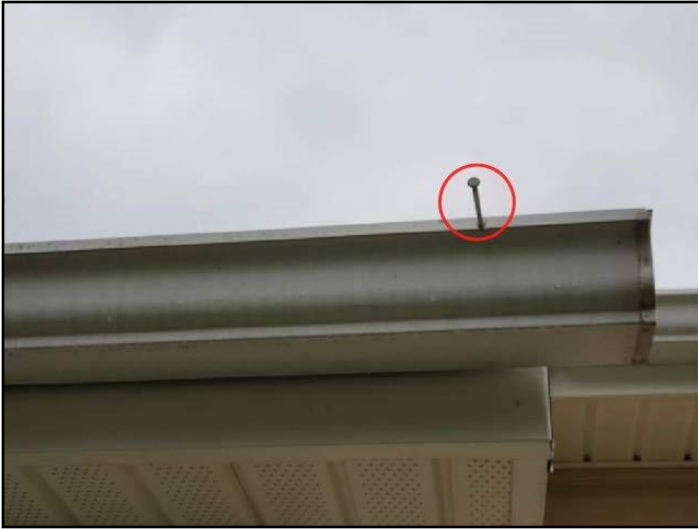
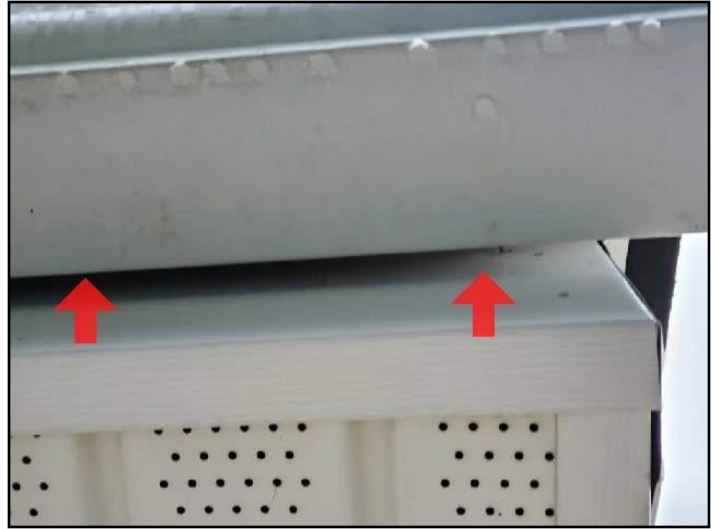
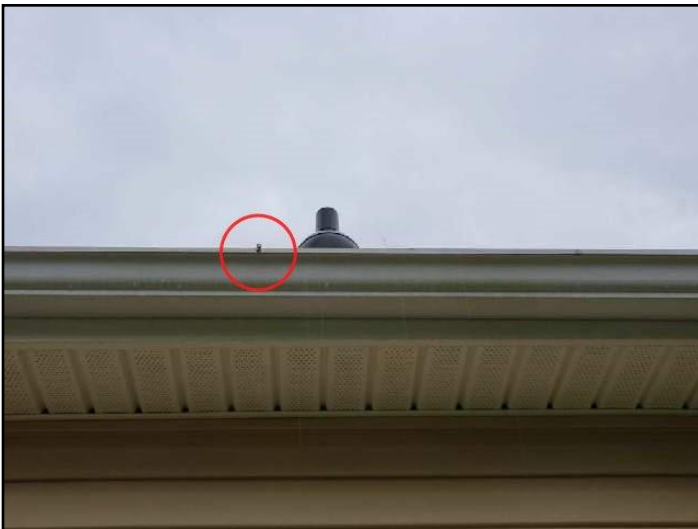
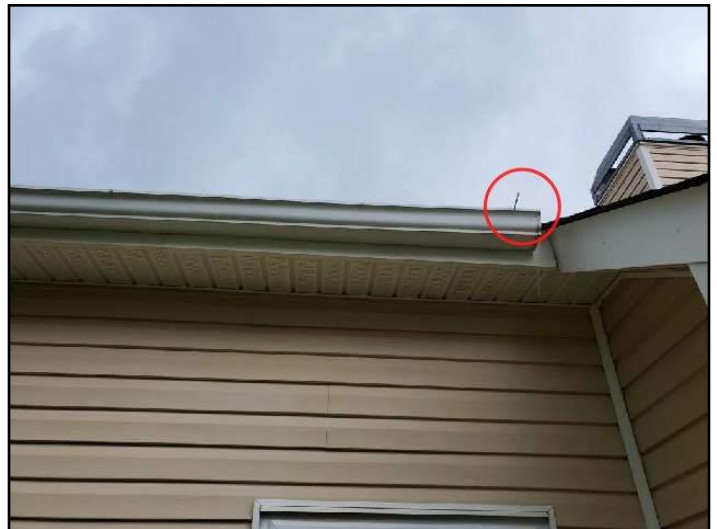
7. Condition: • Loose

Nails backing out of gutters causing them to be loose and sag. Recommend qualified professional re-secure gutters to allow water to properly drain into gutter system. If gutters are not re-secured, there is a potential for water damage and rot to the fascia board.

Loose

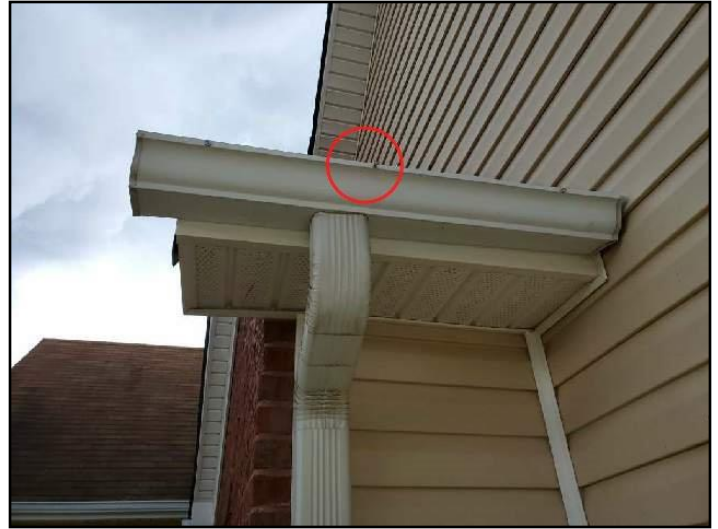
8. Condition: • Loose

Nails backing out of gutters causing them to be loose and sag. Recommend qualified professional re-secure gutters to allow water to properly drain into gutter system. If gutters are not re-secured, there is a potential for water damage and rot to the fascia board.

Loose

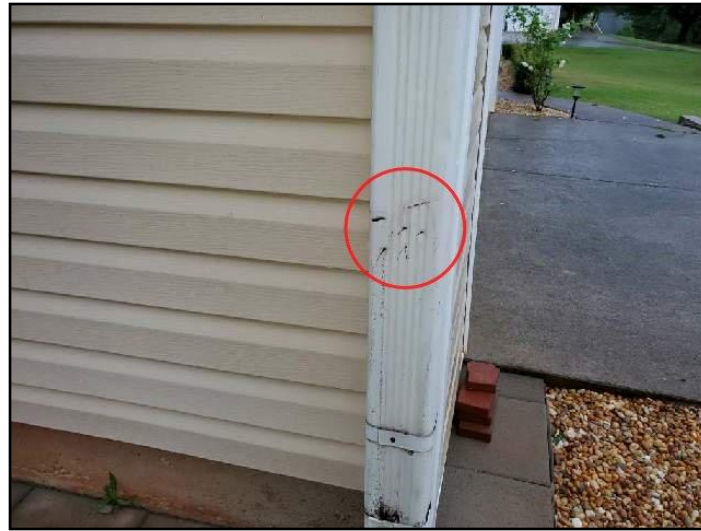
Location: Front Left

9. Condition: • [Damage](#)

Several cuts and holes observed on gutter downspout on left side near garage. Recommend replacing damaged portion of gutter.

Implication(s): Chance of water damage to structure, finishes and contents

Damage

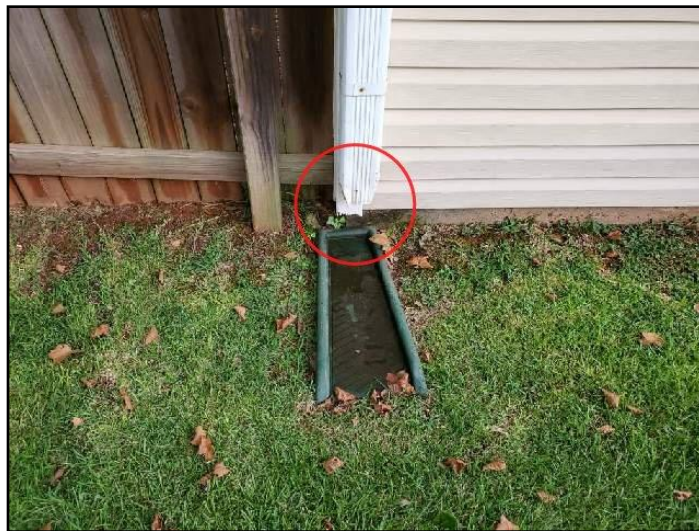
Location: Rear Left Side

10. Condition: • [Discharge too close to building](#)

Recommend connecting down spout extender to shed water 5 to 6 feet away from foundation.

Implication(s): Chance of water damage to structure, finishes and contents

Discharge too close to building

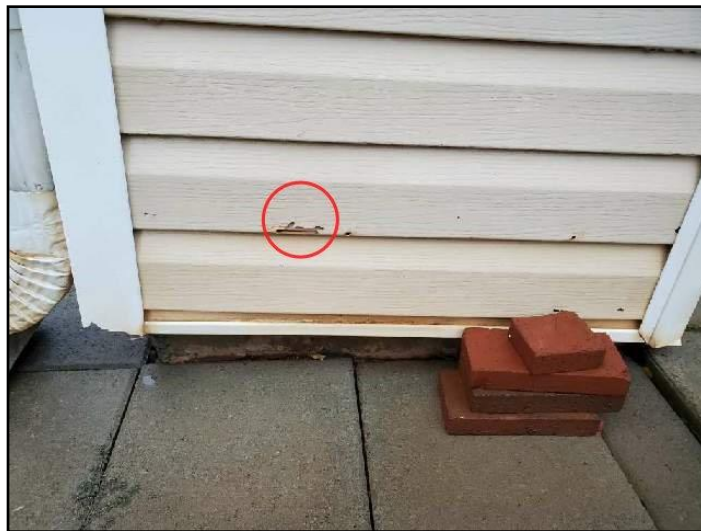
Location: Front

12. Condition: • [Mechanical damage](#)

Siding damaged on front of structure. Recommend replacing damaged pieces to prevent water intrusion.

Implication(s): Chance of water damage to structure, finishes and contents

Mechanical damage

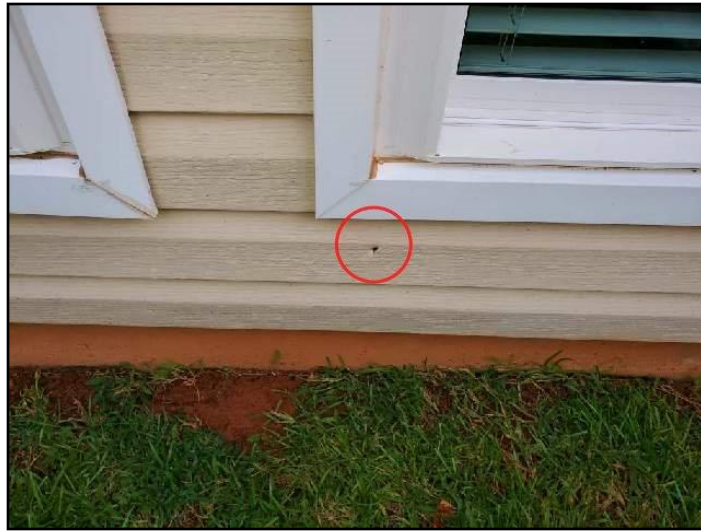
13. Condition: • [Mechanical damage](#)

Siding damaged on rear of structure. Recommend replacing damaged piece to prevent water intrusion.

Implication(s): Chance of water damage to structure, finishes and contents

Mechanical damage

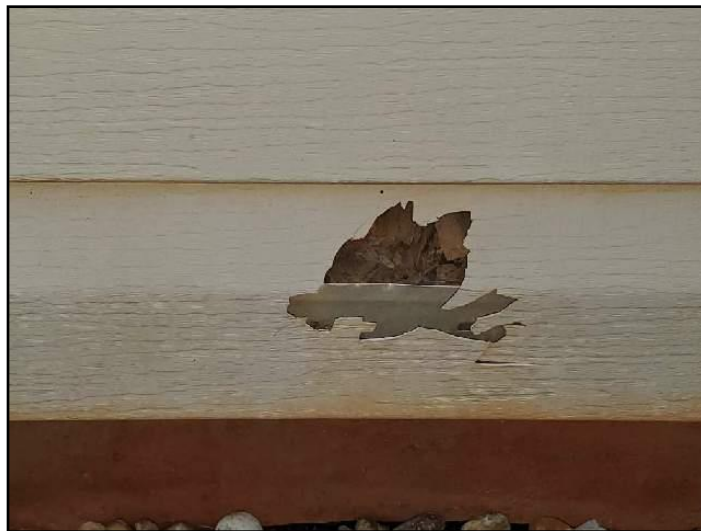
Location: Right Side

14. Condition: • [Mechanical damage](#)

Siding damaged on right side near HVAC compressor. structure. Recommend replacing damaged pieces to prevent water intrusion.

Implication(s): Chance of water damage to structure, finishes and contents

Mechanical damage

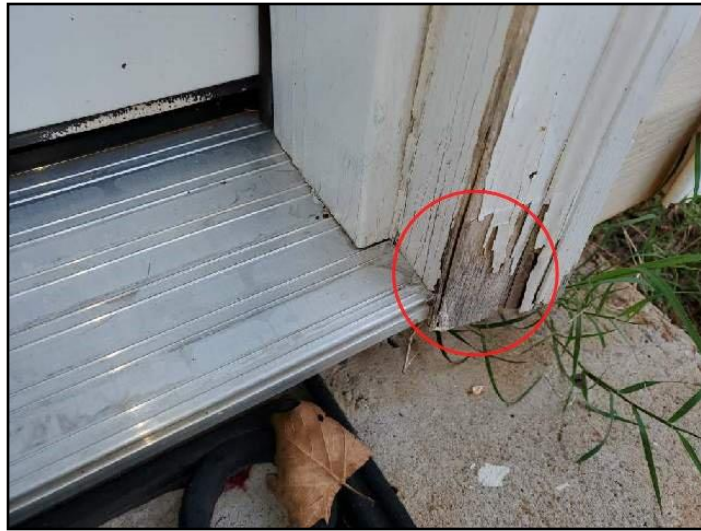
15. Condition: • [Rot](#)

Rot observed at base of deck door frame. Recommend qualified professional replace door frame.

Rot

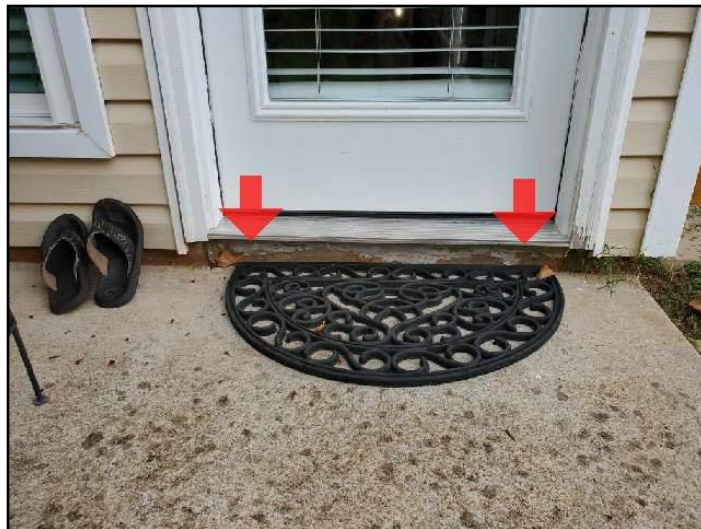
Location: Rear Patio Door

16. Condition: • Rear patio door missing threshold support. Recommend adding threshold support to prevent damage to threshold.

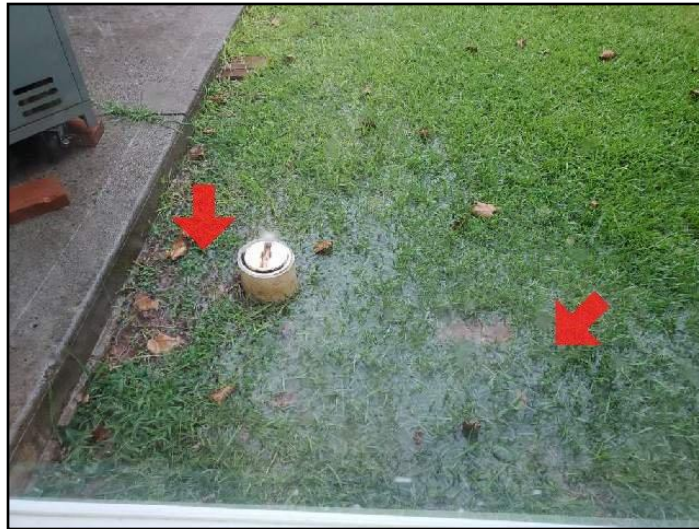
17. Condition: • [Improper slope or drainage](#)

Improper slope or drainage

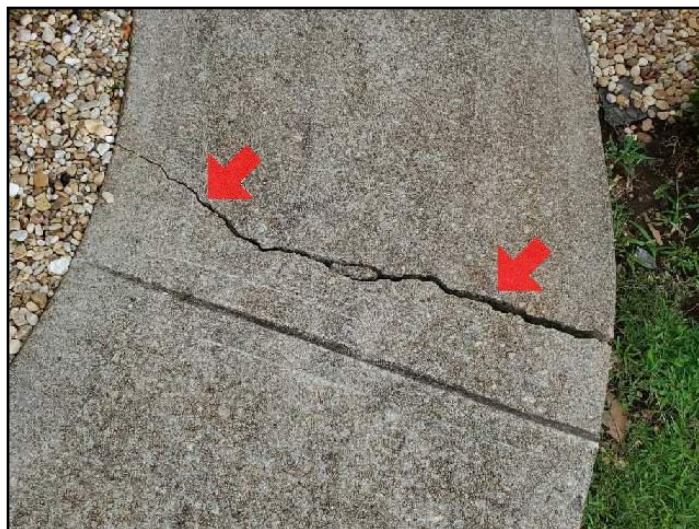
Location: Front

Implication(s): Trip or fall hazard

Cracked or damaged surfaces

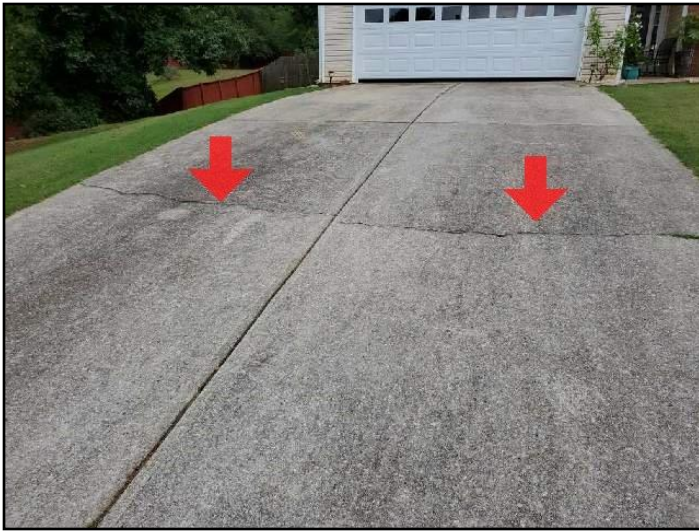
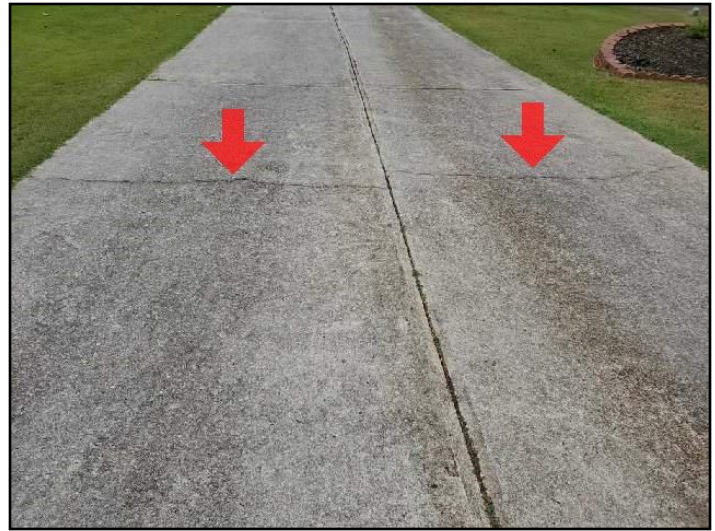
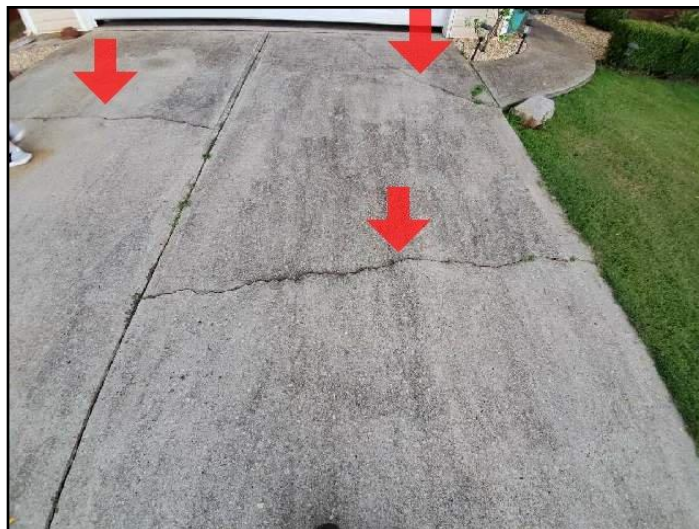
Cracked or damaged surfaces

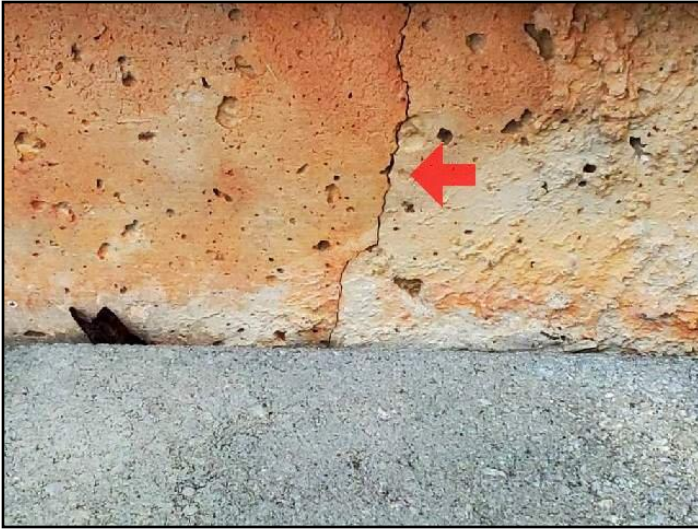
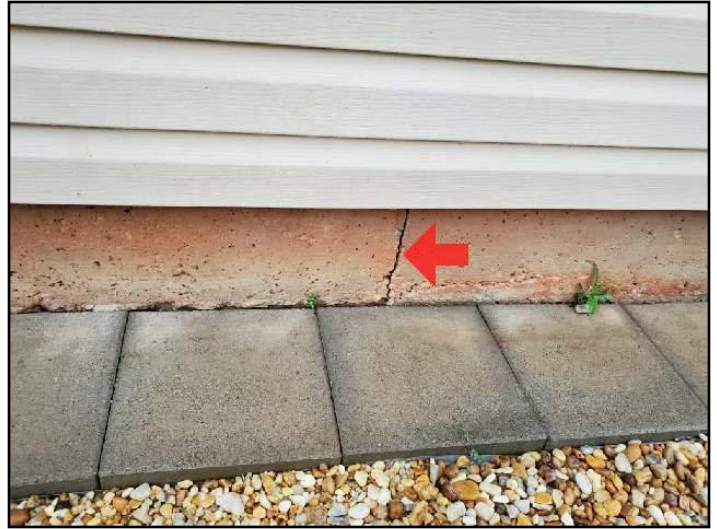
Location: Left Side

Implication(s): Chance of water damage to structure, finishes and contents | Weakened structure

Cracked

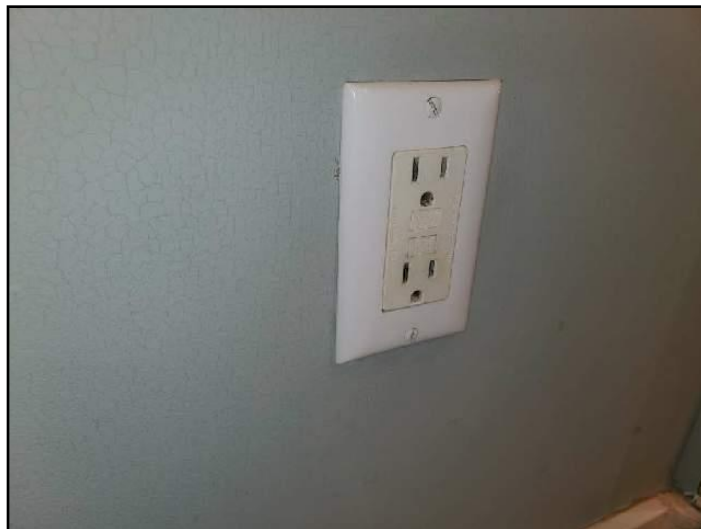
Location: Master Bathroom

Loose

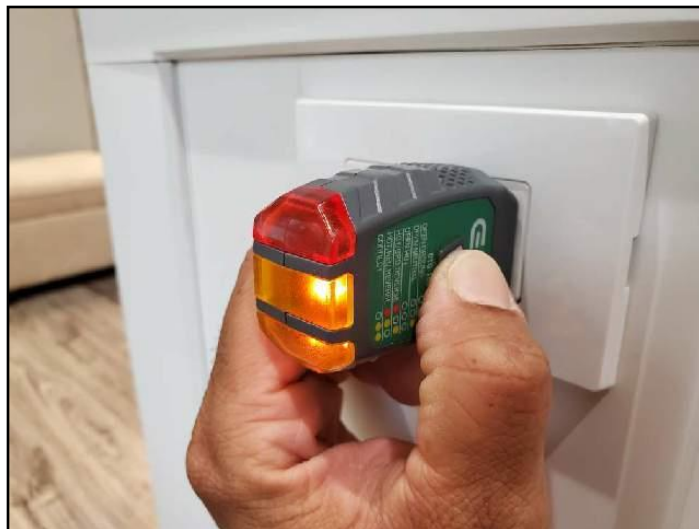
Location: Kitchen

22. Condition: • [GFCI/GFI needed \(Ground Fault Circuit Interrupter\)](#)

Implication(s): Electric shock

GFCI/GFI needed (Ground Fault Circuit...

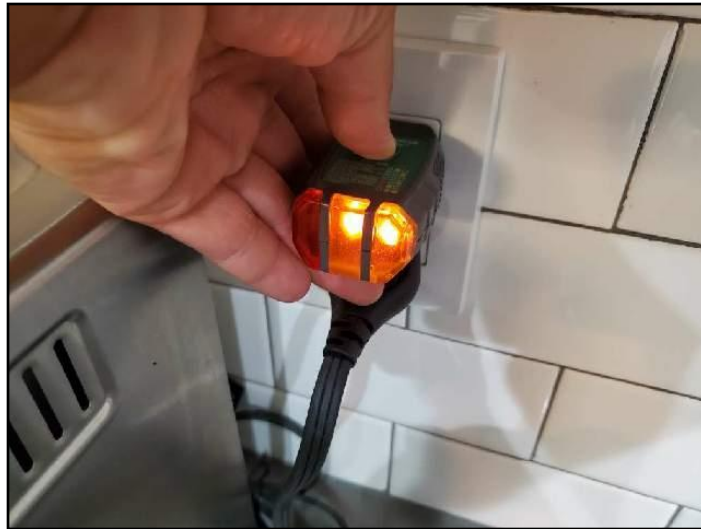
Location: Kitchen Countertop

23. Condition: • [GFCI/GFI needed \(Ground Fault Circuit Interrupter\)](#)

Implication(s): Electric shock

GFCI/GFI needed (Ground Fault Circuit...

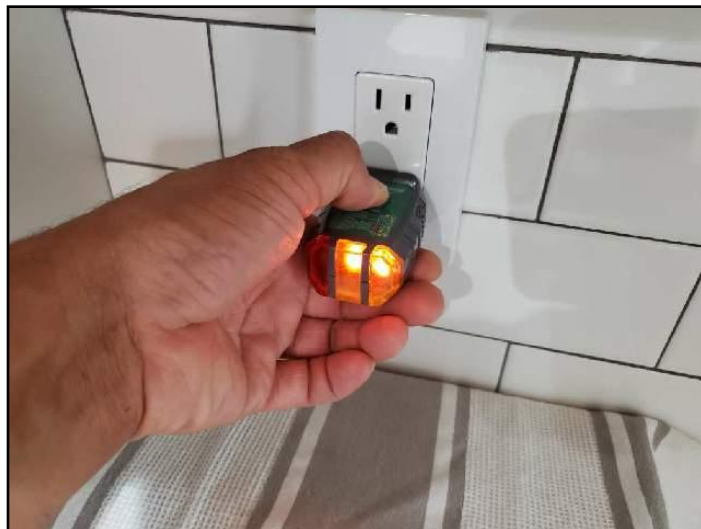
Location: Kitchen Butler's Pantry

24. Condition: • [GFCI/GFI needed \(Ground Fault Circuit Interrupter\)](#)

Implication(s): Electric shock

GFCI/GFI needed (Ground Fault Circuit...

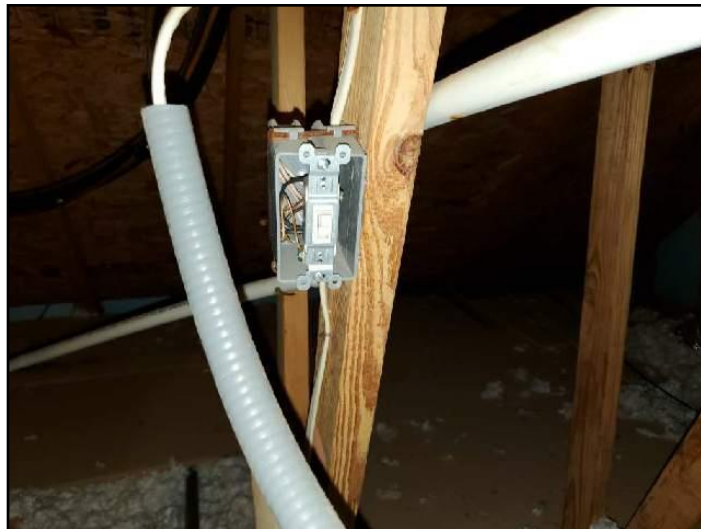
Location: Attic

Missing

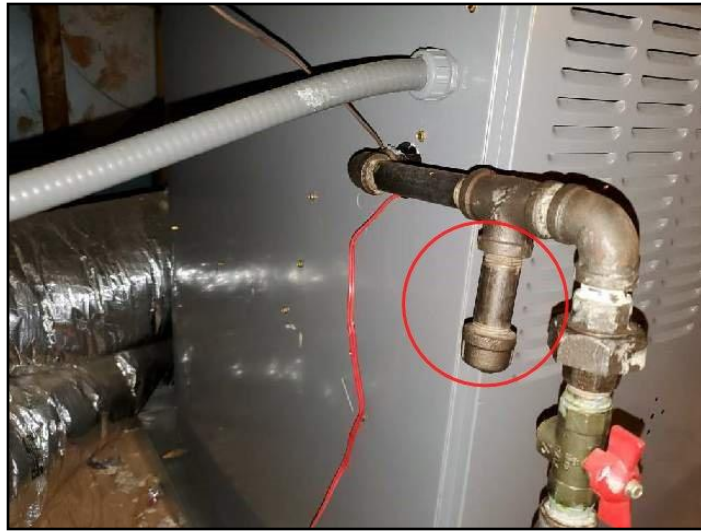
Improper sediment trap

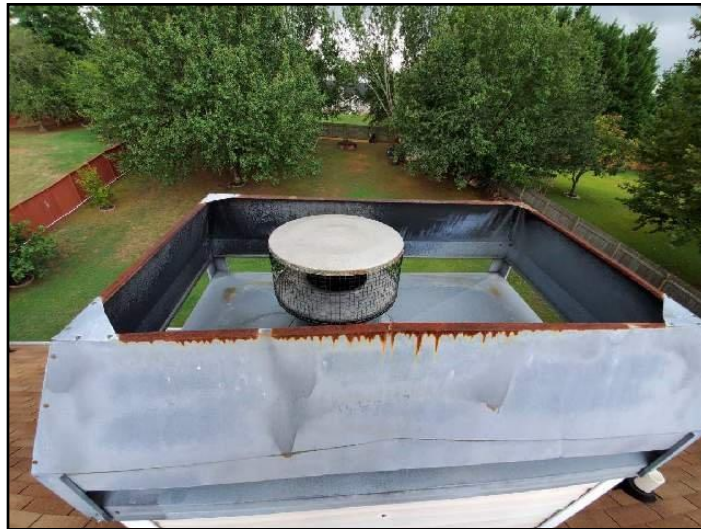
Location: Rear

Rust

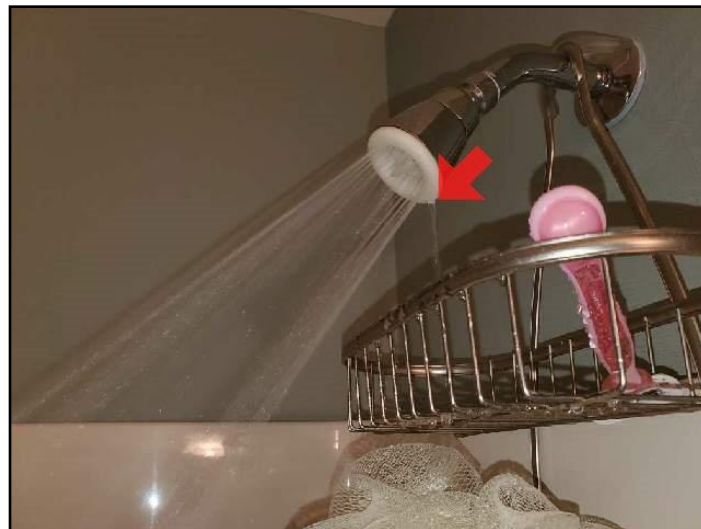
Location: Hallway Bathroom

Implication(s): Chance of water damage to structure, finishes and contents

Leak

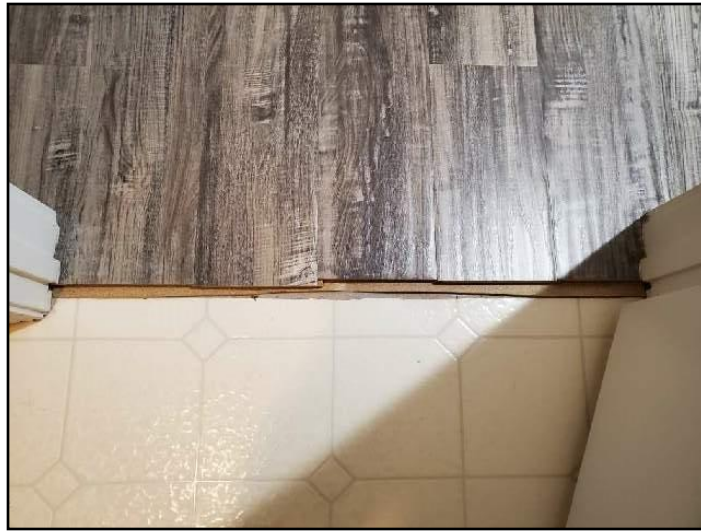
Location: Laundry Area

Implication(s): Trip or fall hazard

Improper installation

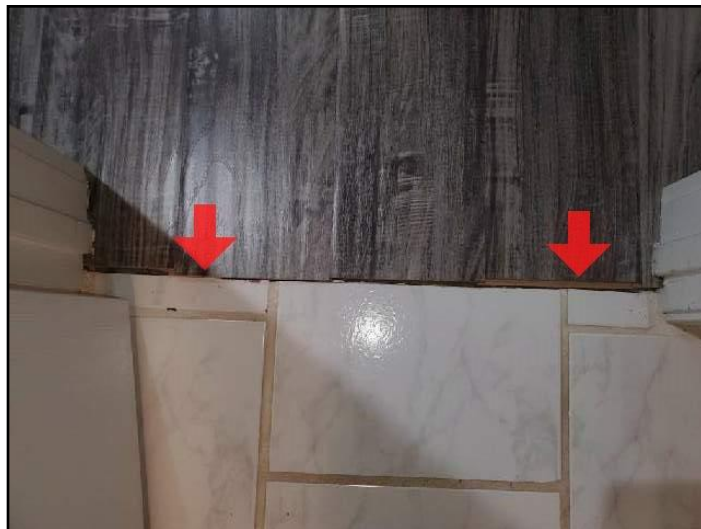
Location: Hallway Bathroom

37. Condition: • Improper installation

Implication(s): Trip or fall hazard

Improper installation

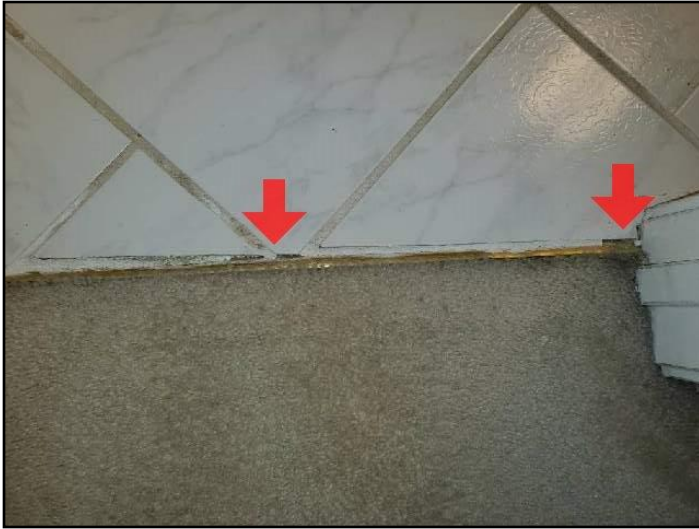
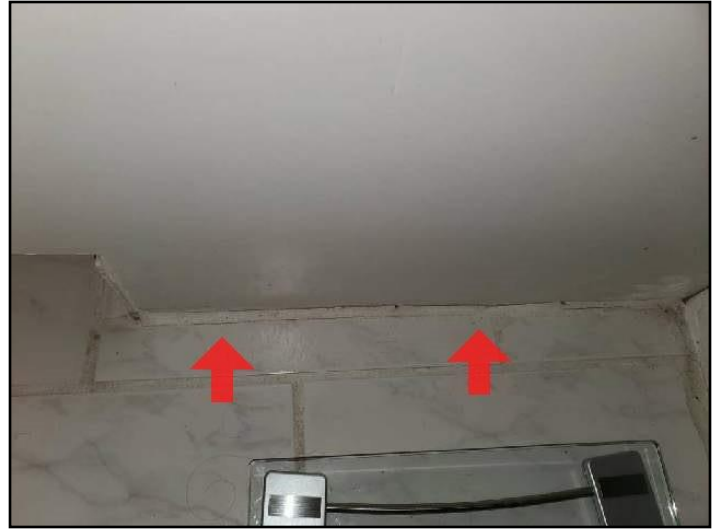
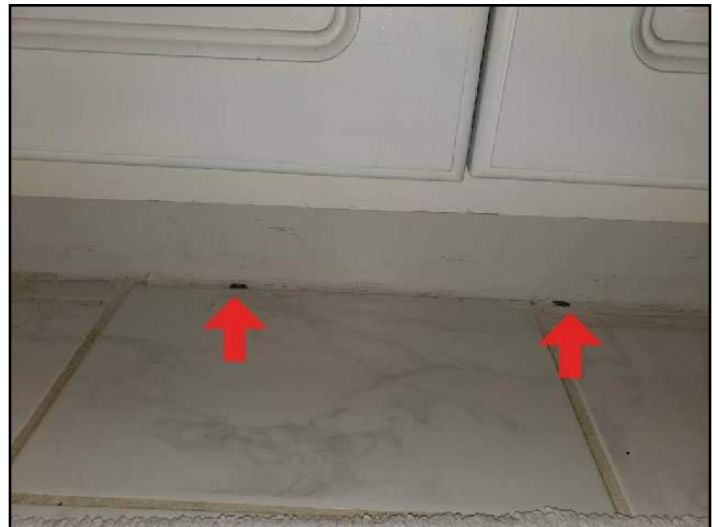
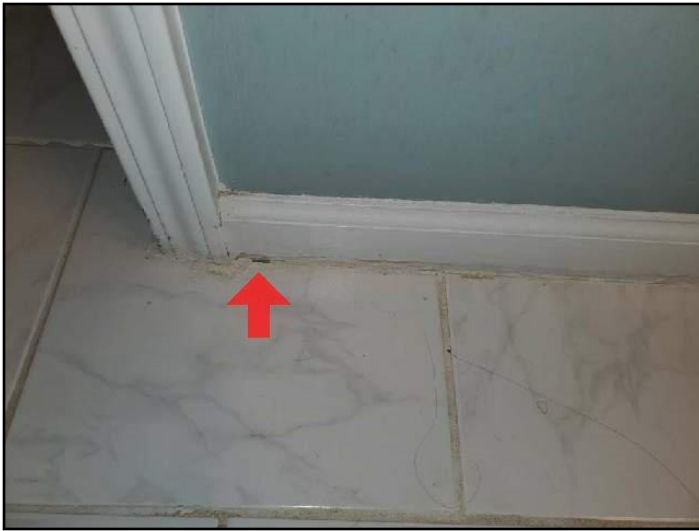
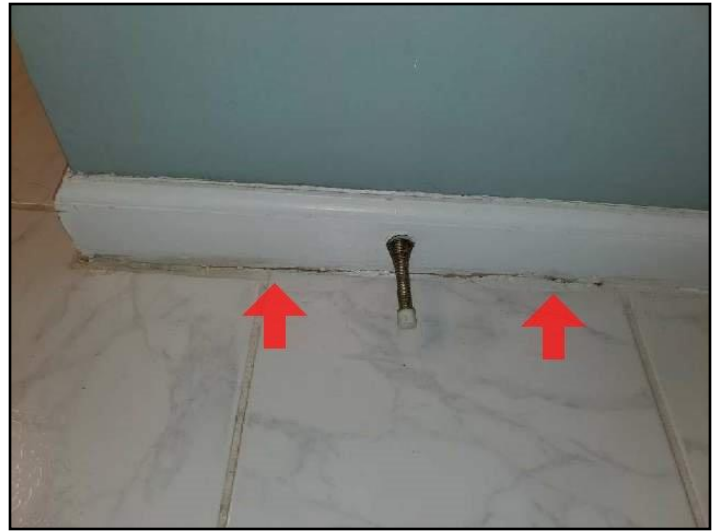
Grout missing

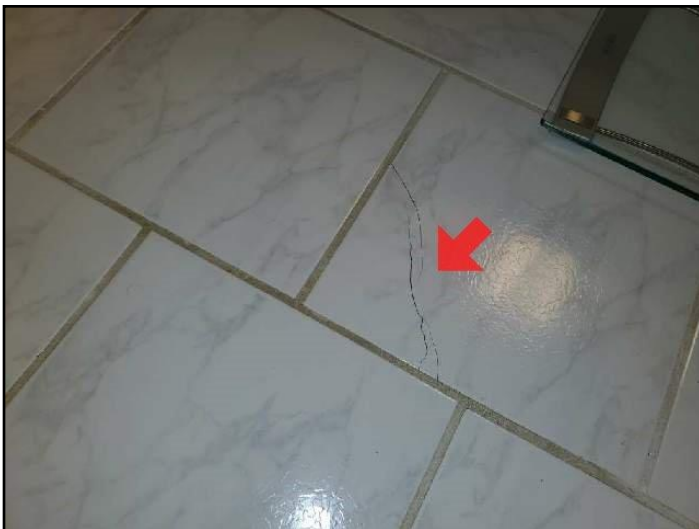
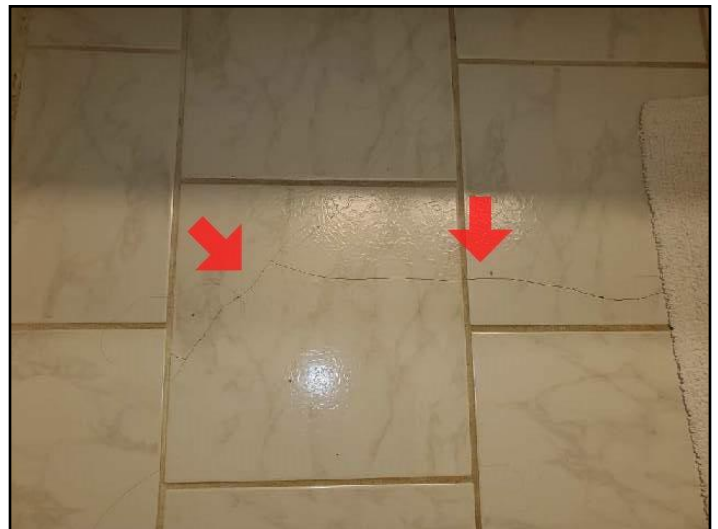
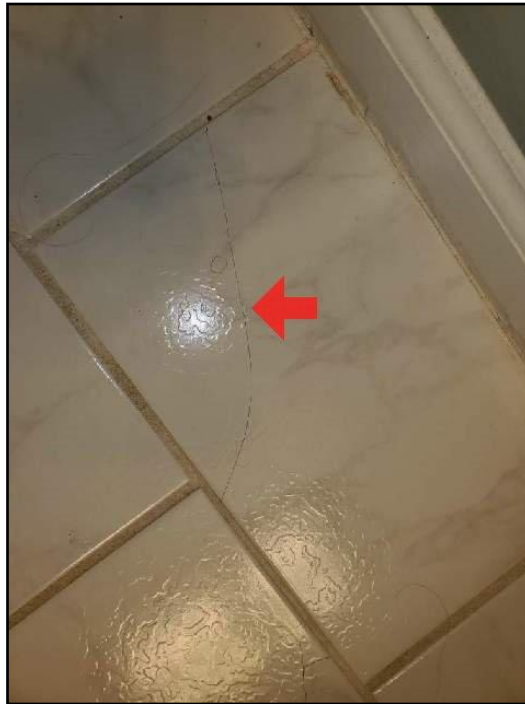
Location: Master Bathroom

39. Condition: • [Tiles cracked](#)

Implication(s): Trip or fall hazard

Tiles cracked

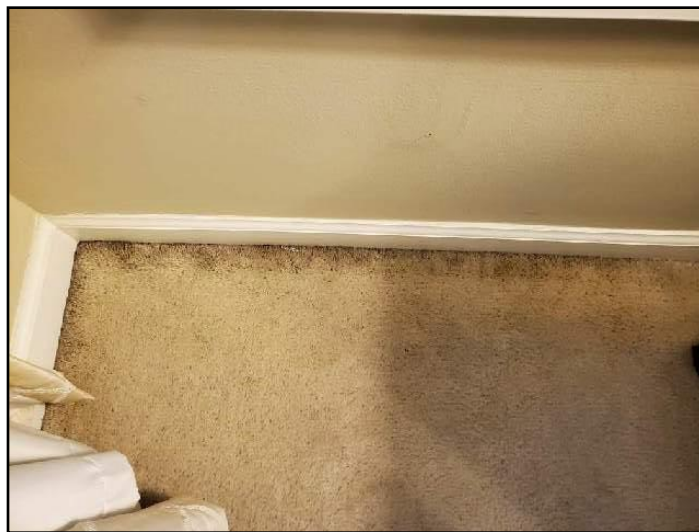
Location: Master Bedroom

Implication(s): Chance of water damage to structure, finishes and contents

Stains

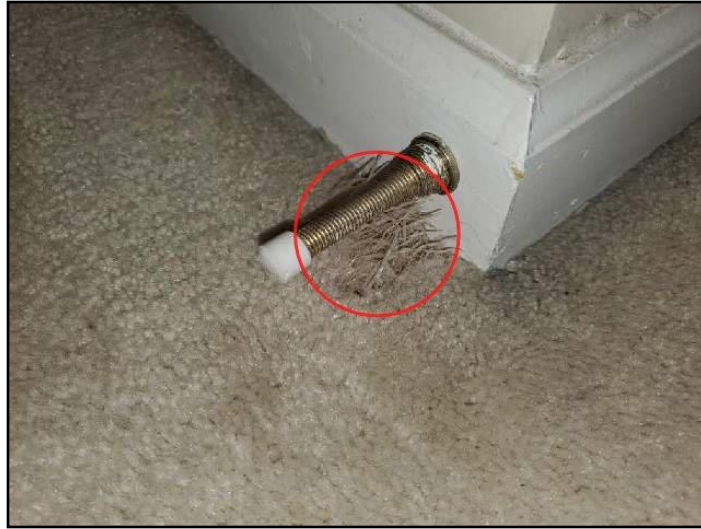
41. Condition: • Carpet damaged in master bedroom. Recommend having carpet repaired or replaced.

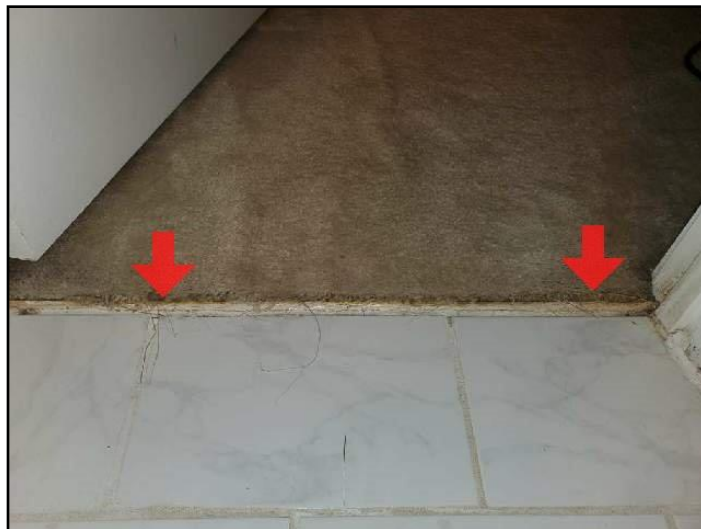
Location: Master closet

42. Condition: • Carpet damaged in master closet. Recommend having carpet repaired or replaced.

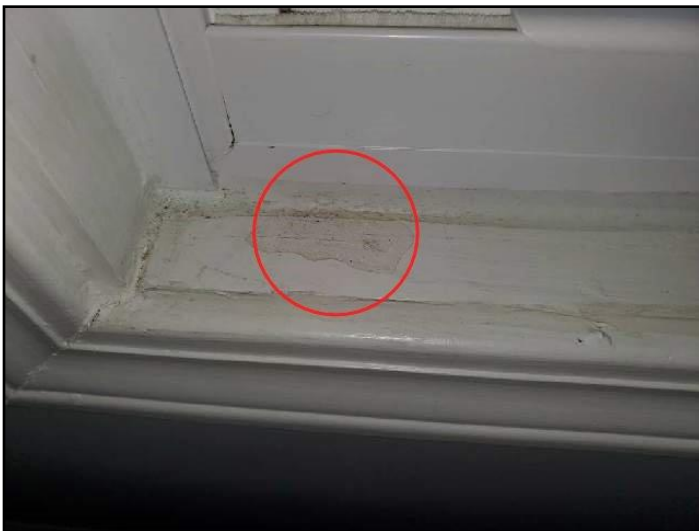
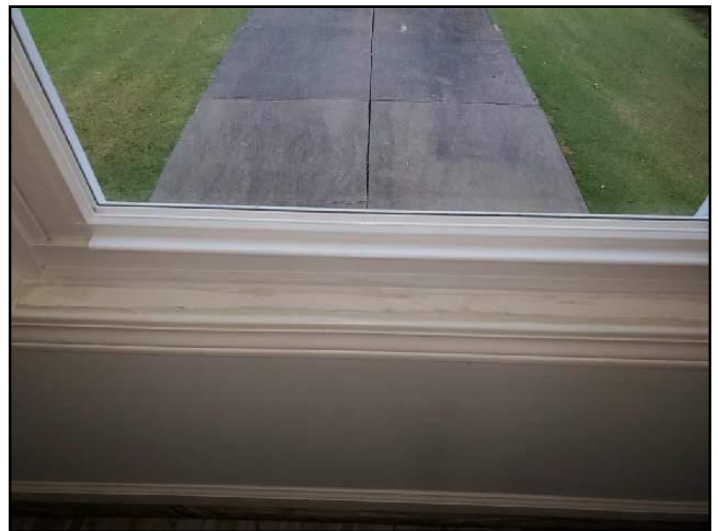
Location: Finished Room Over Garage

43. Condition: • [Water leaks](#)

Water leaks

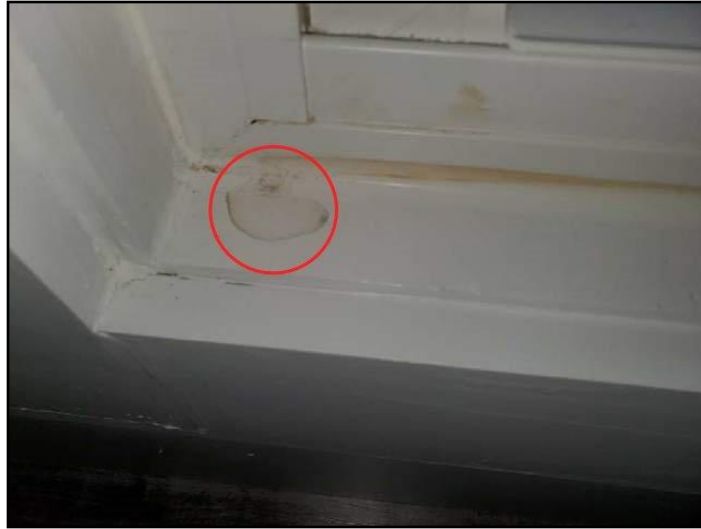
44. Condition: • [Water leaks](#)

Water leaks

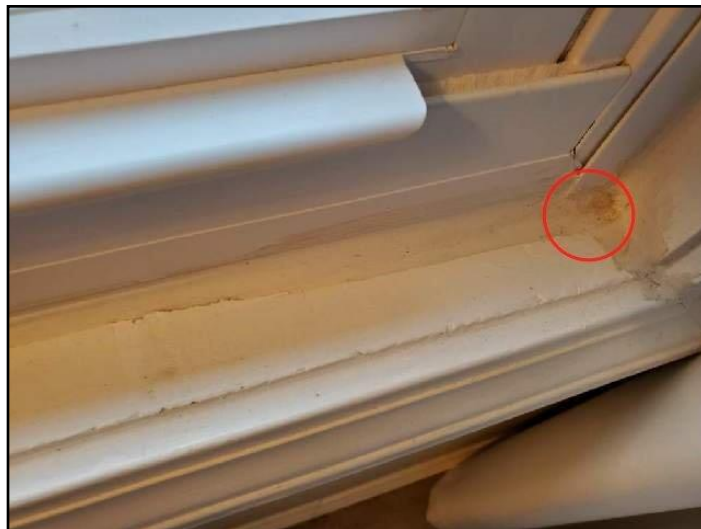
Location: Master Bedroom

45. Condition: • [Water leaks](#)

Implication(s): Chance of damage to finishes and structure | Chance of damage to structure

Water leaks

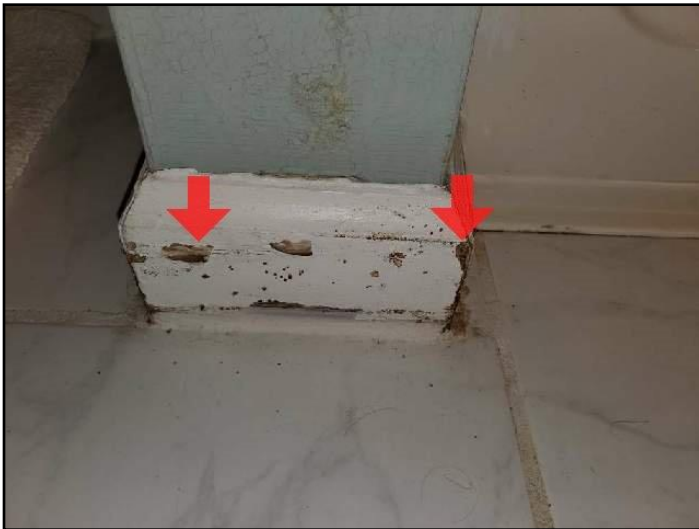
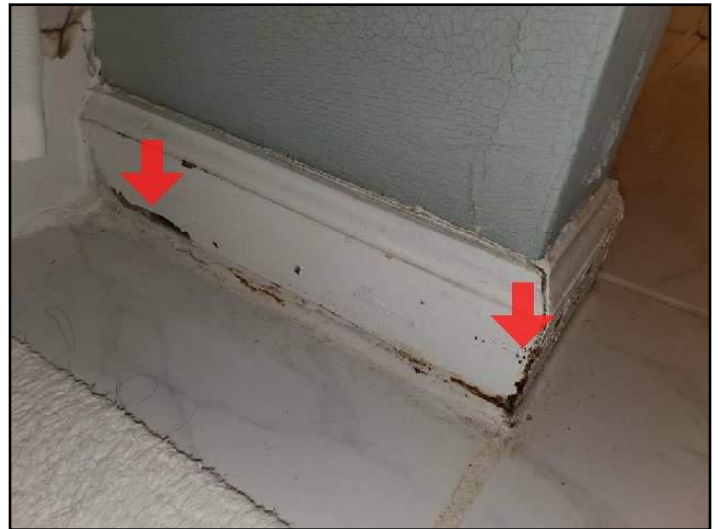
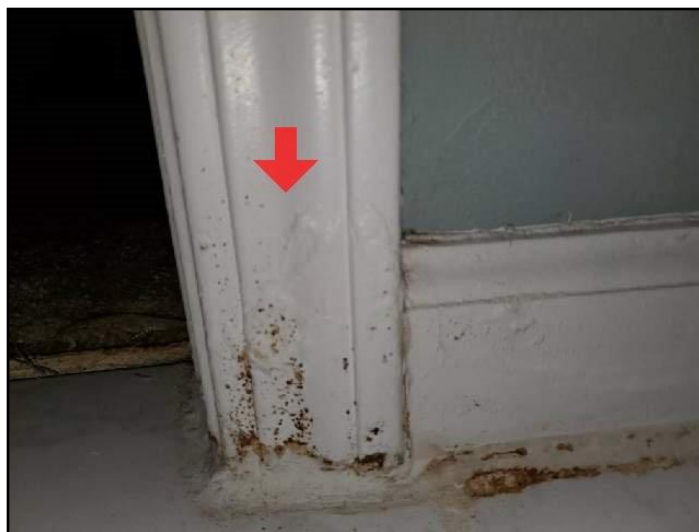
Location: Master Bathroom

Implication(s): Material deterioration

Rot
