INSPECTION REPORT

For the Property at:
123 SAMPLE WAY
FLOWERY BRANCH, GA 30542

Prepared for: SAMPLE HOME INSPECTION
Inspection Date: Monday, August 3, 2020
Prepared by: Keith Kerr

RE: Report No. 1015, v.2
123 Sample Way
Flowery Branch, GA
30542

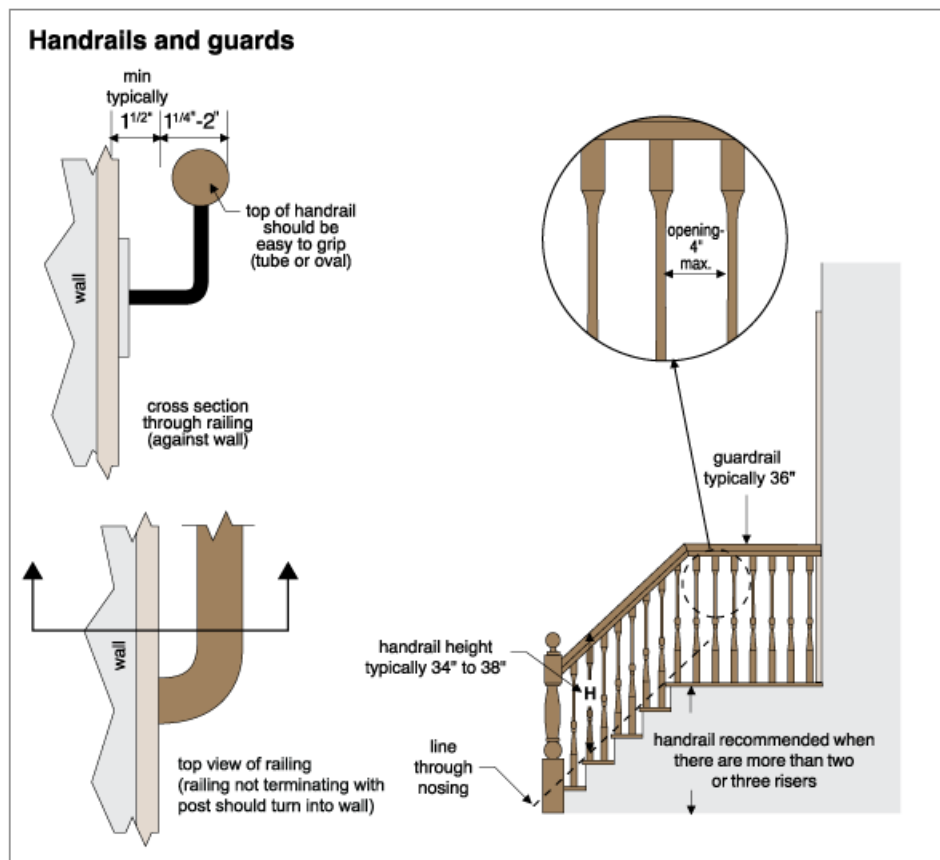
Location: Finished Room Over Garage

Implication(s): Fall hazard

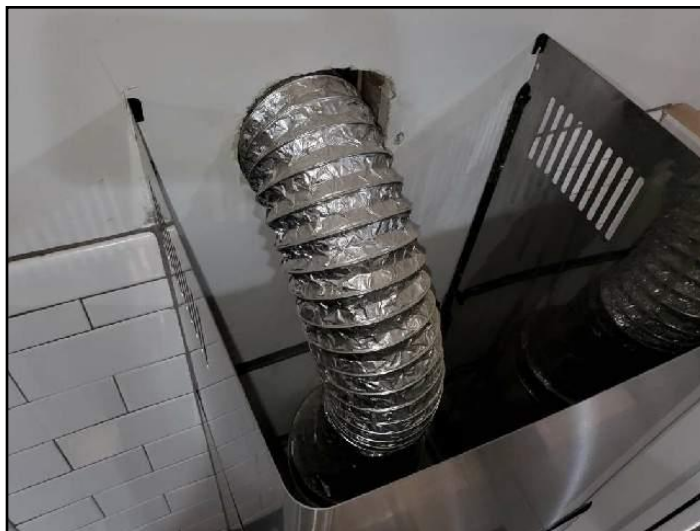
Location: Kitchen

Venting arrangement poor
