# INSPECTION REPORT

For the Property at:  
**234 WAVERLEY ROAD**  
TORONTO, ON M4L 3T3

RE: Report No. 2715  
234 Waverley Road  
Toronto, ON  
M4L 3T3

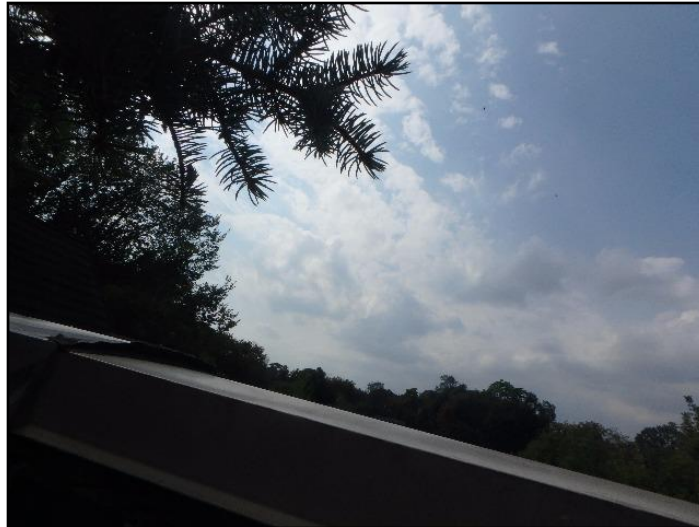
1. Lack of access (too high/steep)

**Roof inspection limited/prevented by:**

- Lack of access (too high/steep)

Limited access to roof

1. • Service/ Inspect bi- annually

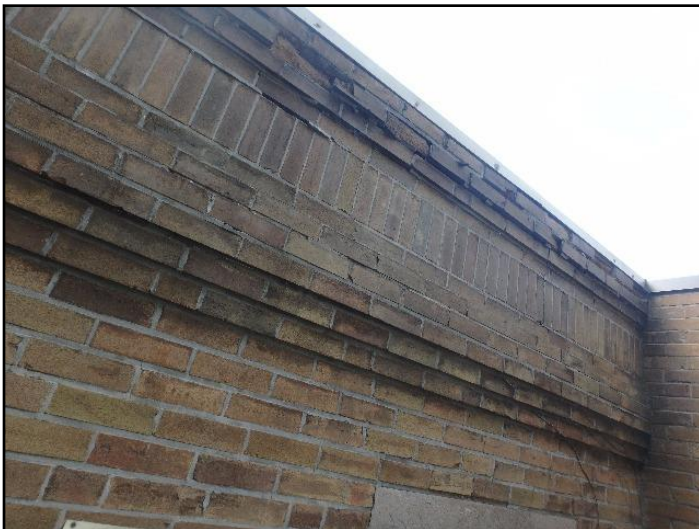
2. Spalling

**2. Condition:** • [Spalling](#)

**Location:** Front

freezing temperatures, saturated brick and a susceptible type of brick are required for spalling to occur

**Task:** Repair

**Time:** When necessary

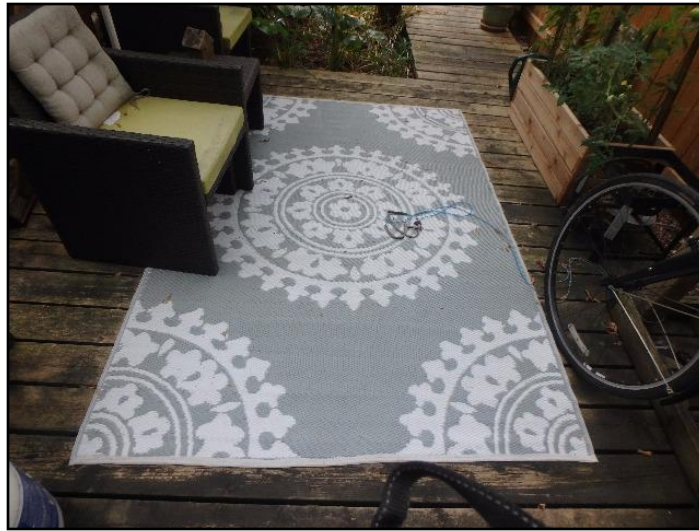
4. Rot

3. Condition: • [Rot](#)

Task: Service

Time: Ongoing

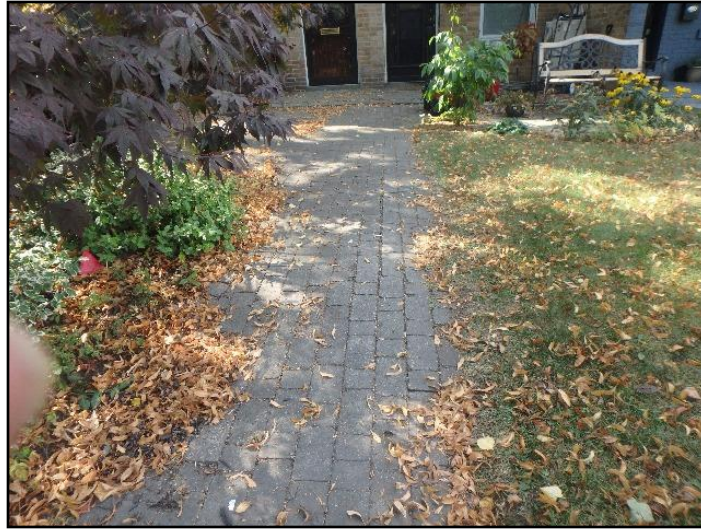
*5. Improper slope or drainage*

4. Condition: • [Improper slope or drainage](#)

Task: Improve

Time: If necessary

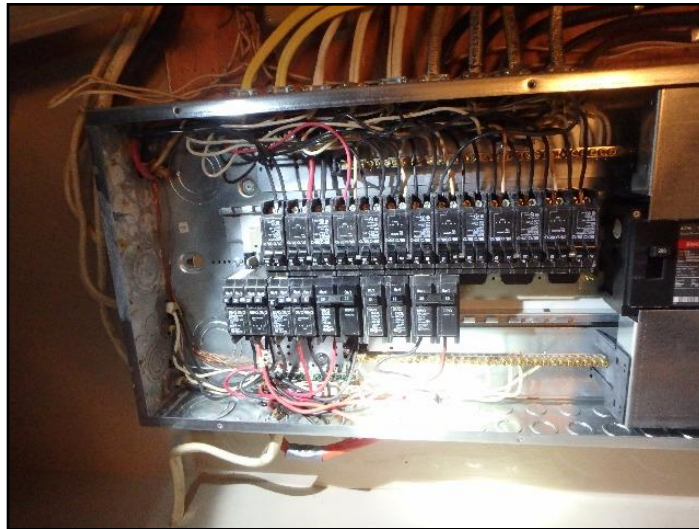
6. Breakers - basement

• [Breakers - basement](#)
