INSPECTION REPORT

For the Property at:
211 MILL POND RD
ROSWELL, GA 30076

Prepared for: SAMPLE CONDO
Inspection Date: Monday, November 26, 2018
Prepared by: John Watson

Report No. 1011, v.2

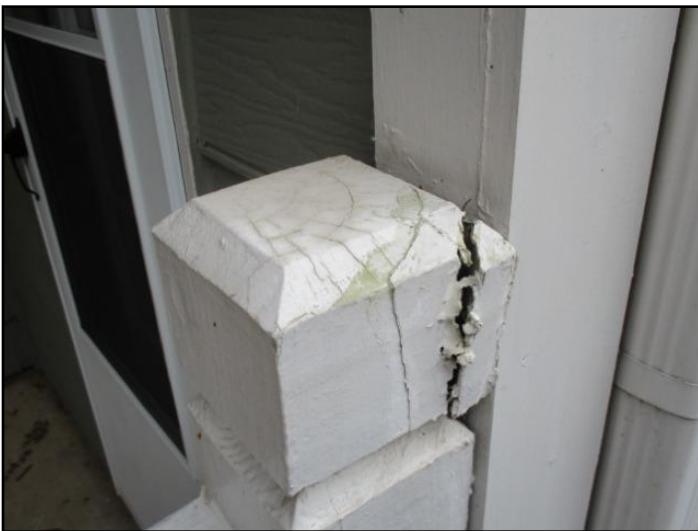
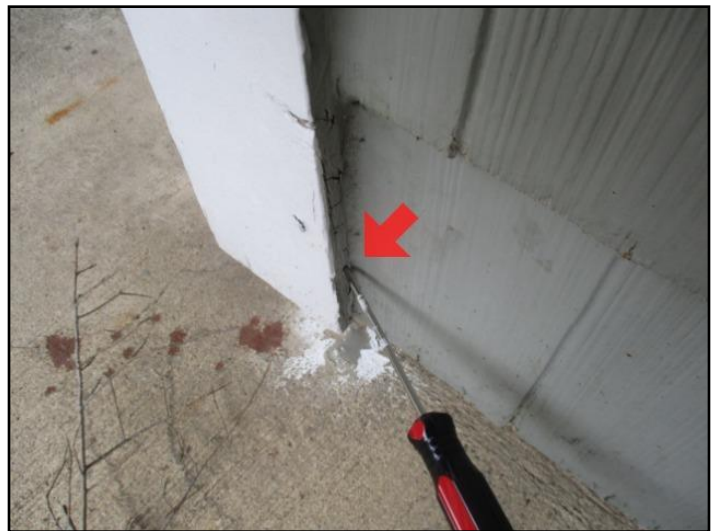
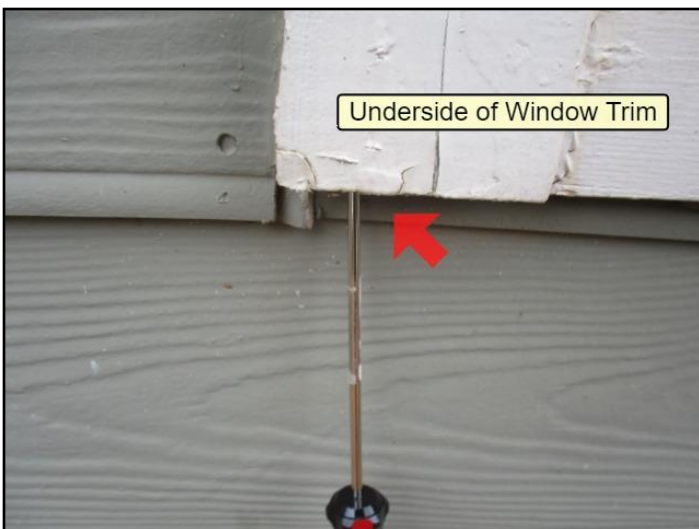
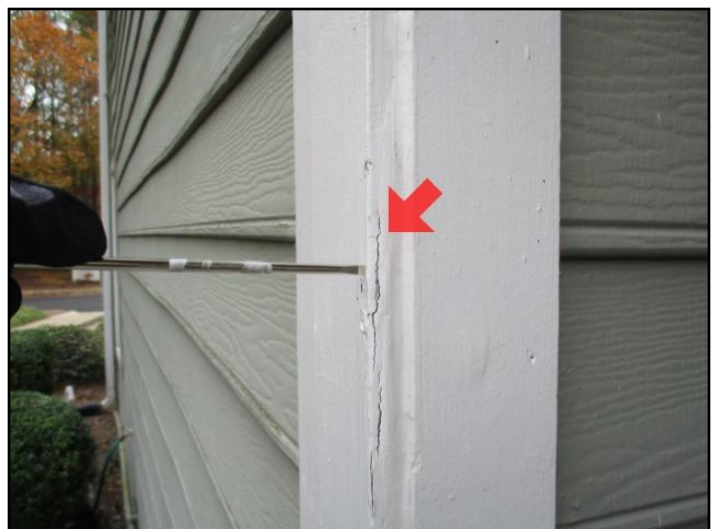
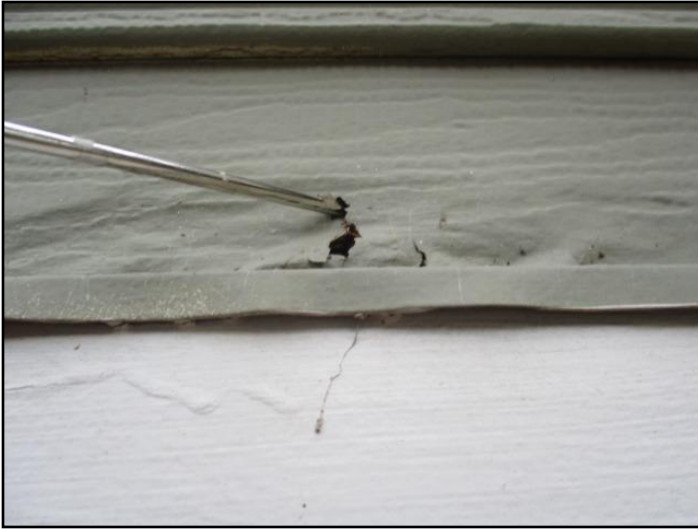
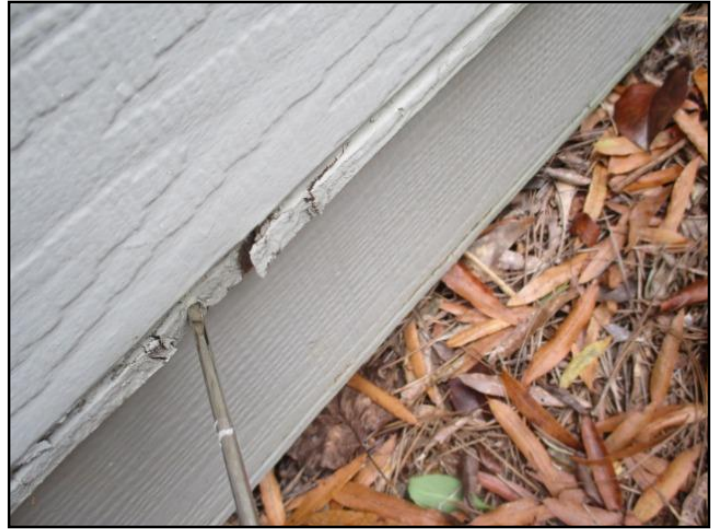
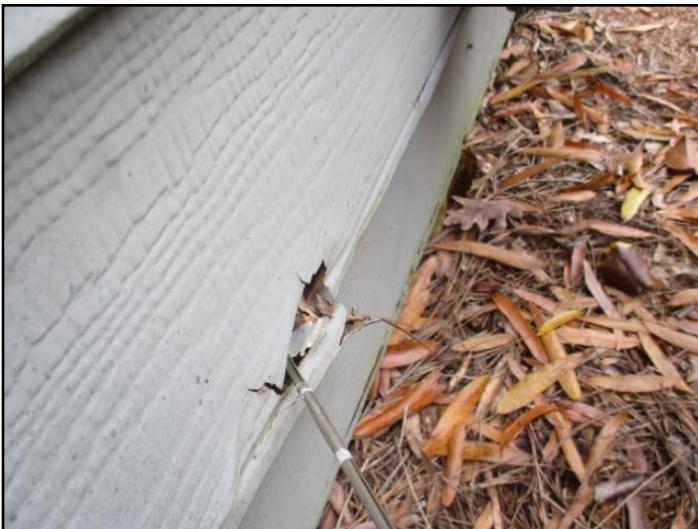
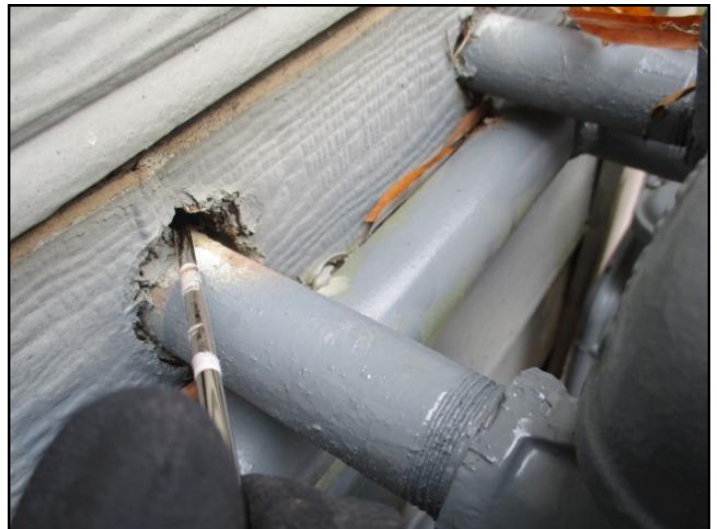
2. Condition: • Rot or insect damage

Various locations on the exterior of the home contain rot and/or insect damage. It is recommendation that a qualified contractor be hired to remove rotted trim, siding and/or fascia boards, treat all areas and replace with new trim, caulk and paint.

Implication(s): Chance of water damage to contents, finishes and/or structure | Material deterioration

Rot or insect damage

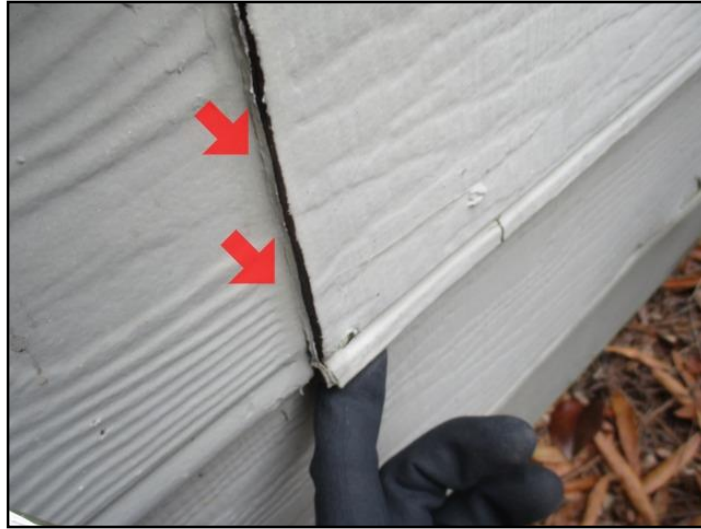
3. Condition: • Loose

Small area of siding loose. It is recommended that a qualified contractor secure siding with approved fasteners for the application, caulk and paint.

Loose

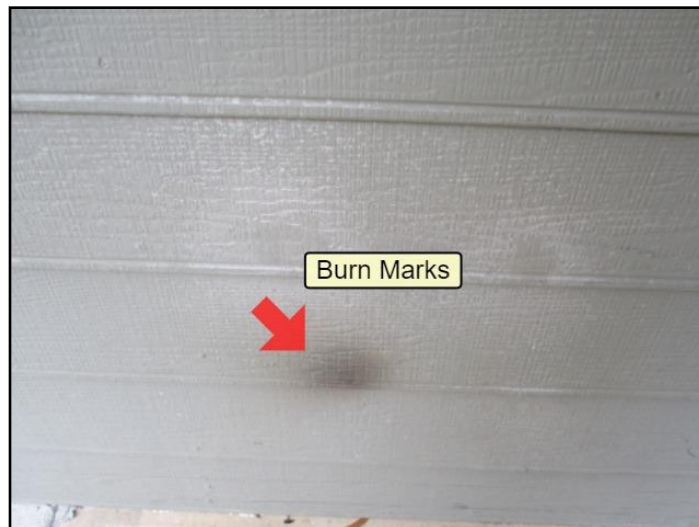
4. Condition: • Paint or stain needed

Damage to the exterior paint near front entry way seems to have been caused by a heat source (charcoal or gas grill). It is recommended that this area be repainted to prolong the life of the siding.

Paint or stain needed

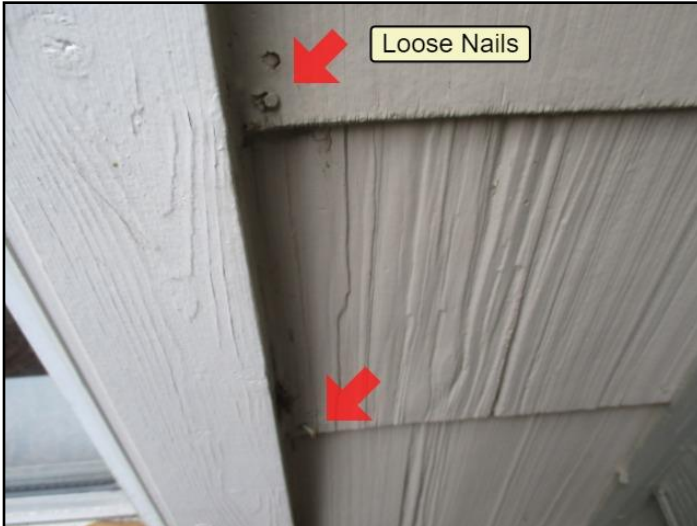
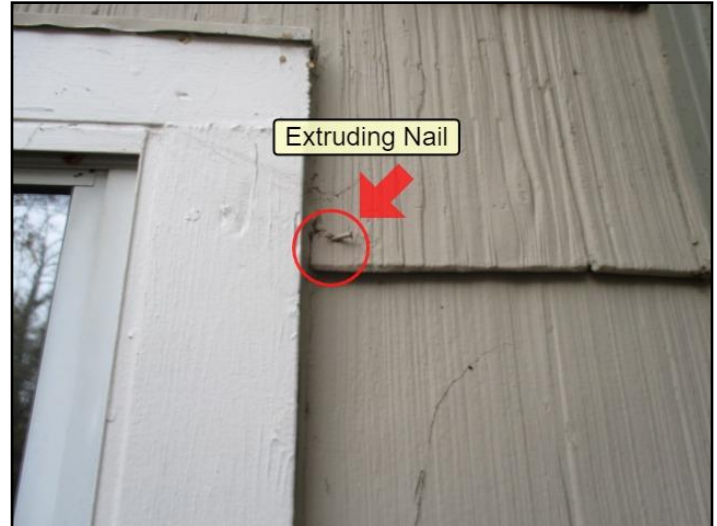
5. Condition: • Nailing problems

Various areas on exterior of home have nails that have become loose over time. It is recommended that a qualified contractor be contacted to repair all areas containing nailing defects.

Nailing problems

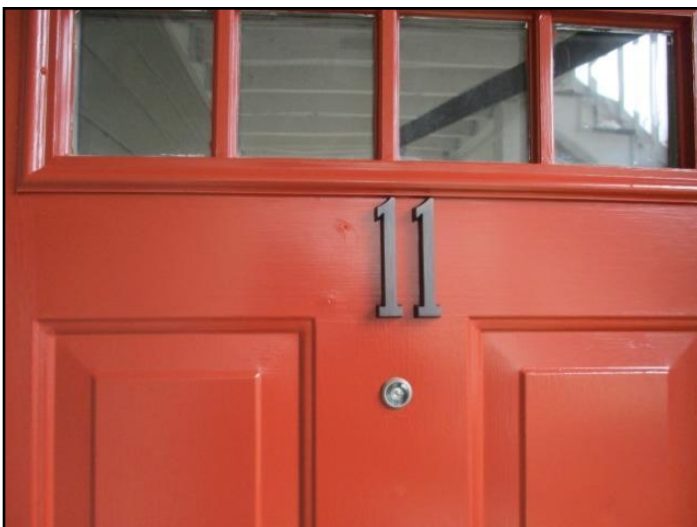
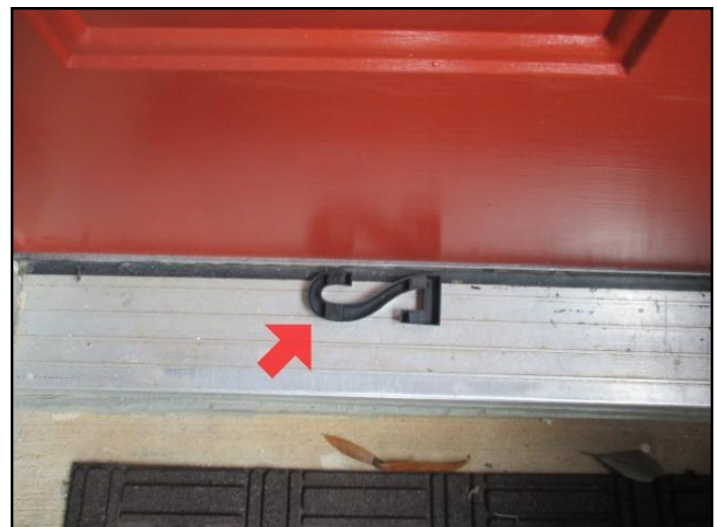
6. Condition: • Front entry door has missing address numbers. It is recommended that the number be replaced/secured to the door.

Fallen Address Number

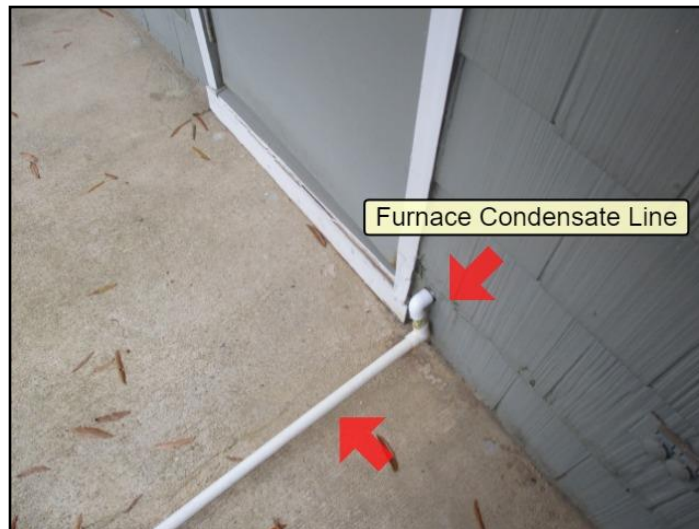
7. Condition: • Trip hazards

Condensate line from the furnace runs perpendicular across the patio. It is recommended that the PVC be rerouted to go under the door way onto the ground instead of directly across the main walk way.

Trip hazards

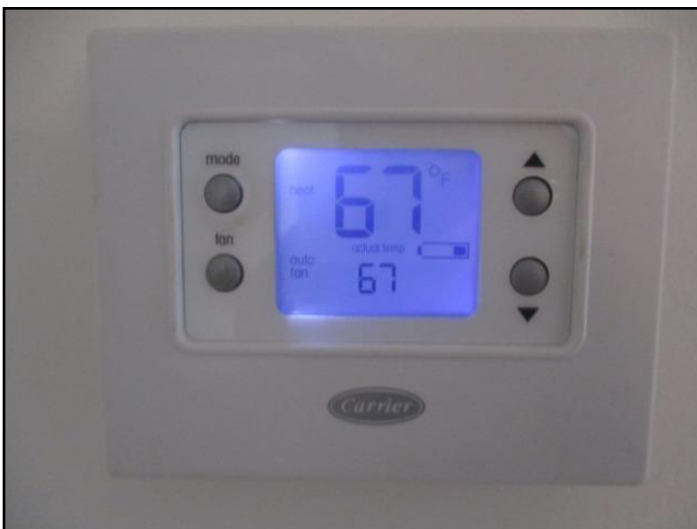
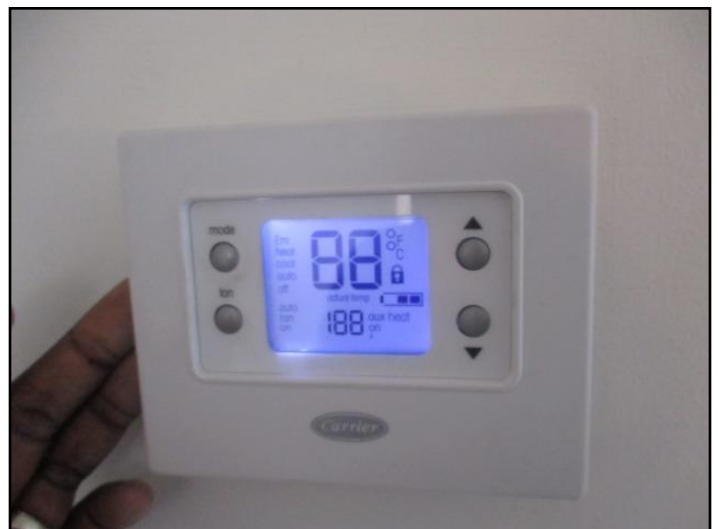
10. Condition: • Loose

Wall thermostat loose causing the unit to constantly reset and not fully charge the internal batteries, which can lead to poor calibration and operation. It is recommended that a qualified HVAC contractor repair the thermostat to improve heating efficiency and operation of the unit.

Loose

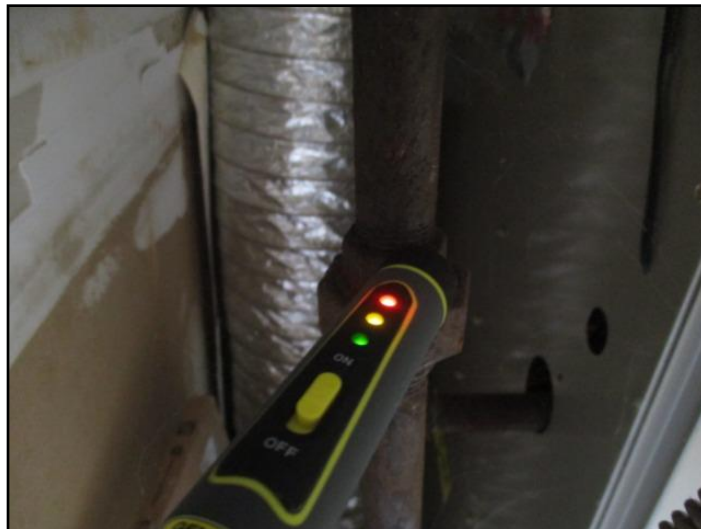
11. Condition: • Rust

Gas pipes in HVAC closet contain rust due to them being exposed to the exterior elements. The rust has caused gas leaks which creates a safety issue for anyone living in the home. It is recommended that the pipe work to the HVAC unit be further evaluated to better understand if it can be corrected by sanding off the rust or if the pipes need to be completely replaced.

Rust

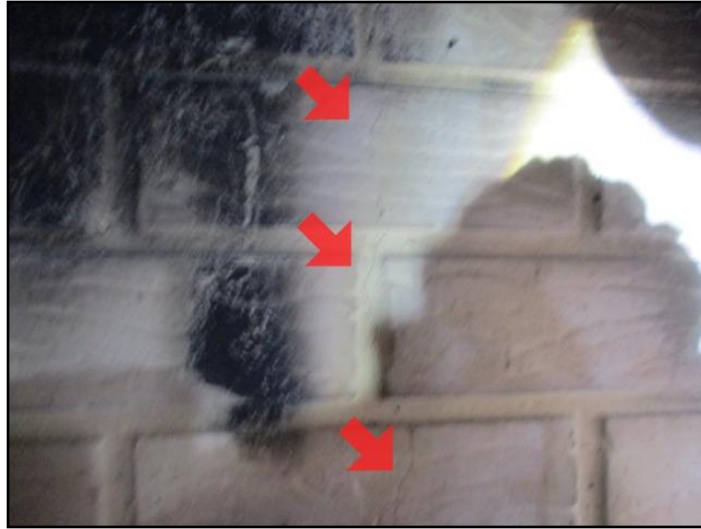
12. Condition: • Cracked masonry or refractory

Noticeable cracks found in the masonry of the fireplace. It is recommended that a qualified contractor repair the cracks to prevent further damage.

Cracked masonry or refractory

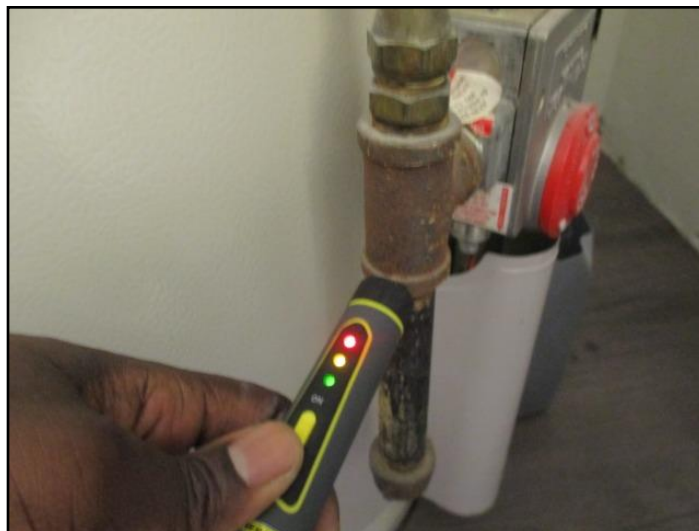
15. Condition: • Leak

Due to rust at the drip leg, a gas leak was detected. It is recommended that a qualified contractor evaluate the drip leg cap, clean off rust and tighten to prevent further leaking.

Leak

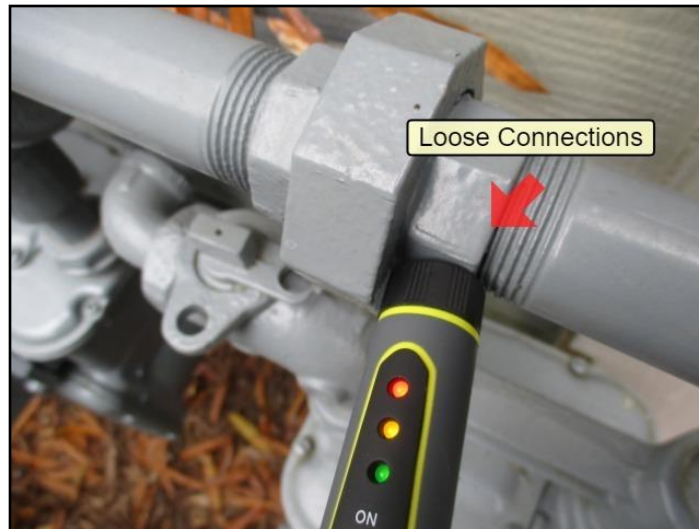
17. Condition: • Leak

While inspecting the outside of property, a gas leak was detected at one of the connections. It is highly recommended that the buyer contact the City of Roswell to remedy the situation, by sending a qualified technician to the property to test and tighten the gas connections to the meter.

Leak

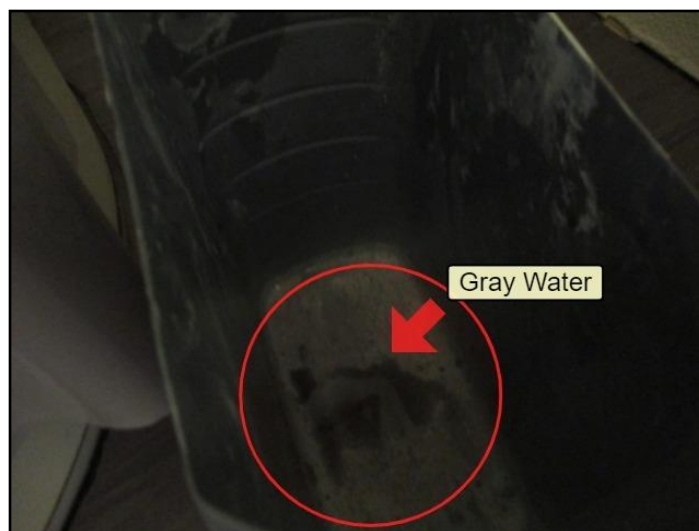
18. Condition: • Near end of life expectancy

Based on the current age of the hot water heater, it is recommended that the unit be serviced by a qualified professional. While the bottom of the unit was not found to be rusted, grayish/black water exited the tank at the location of the drain valve during the time the water pressure was being tested. This indicates that the tank has not been flushed recently as all sediment has settled to the bottom of the tank which can reduce the efficiency of the unit and cause continuous heating of the tank.

Near end of life expectancy

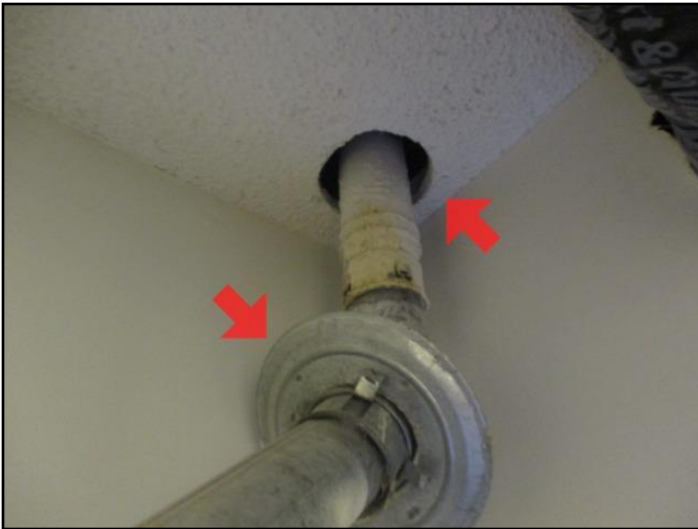
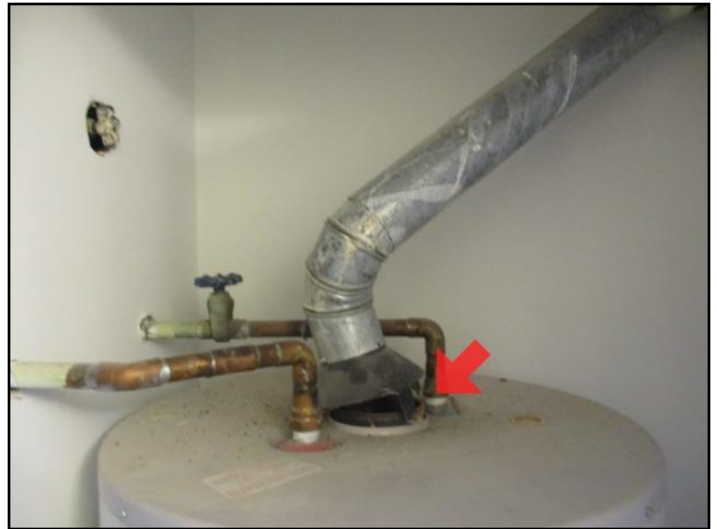
19. Condition: • Spillage or backdraft at the draft hood

Spillage or backdraft at the draft hood

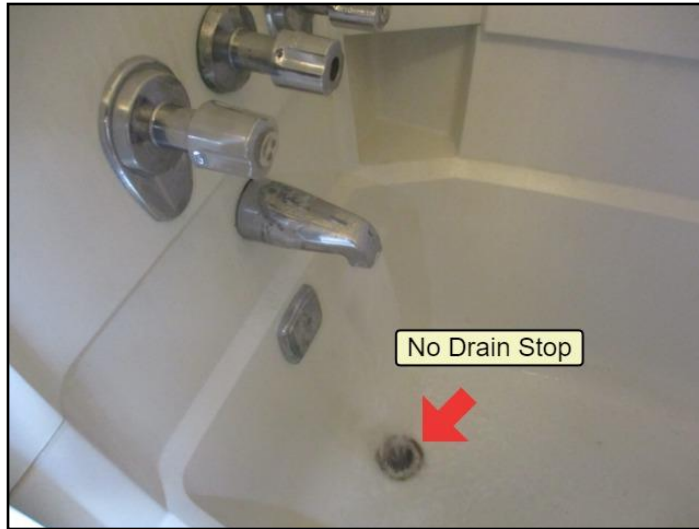
20. Condition: • Drain stop missing

Drain stop missing in 1 of bathrooms. Recommend replacing drain stop.

Drain stop missing

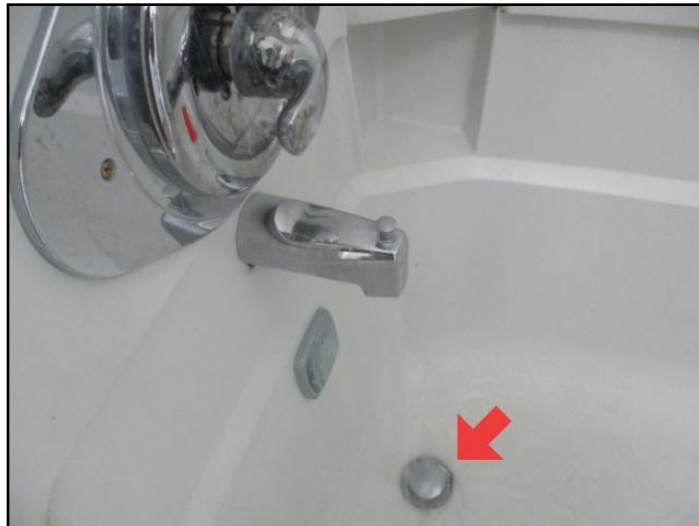
21. Condition: • Drain stop ineffective

2nd bathroom has drain stop, but it is ineffective in terms of keeping water from draining. Recommend tightening the current drain stop or replacing with newer drain stop.

Drain stop ineffective

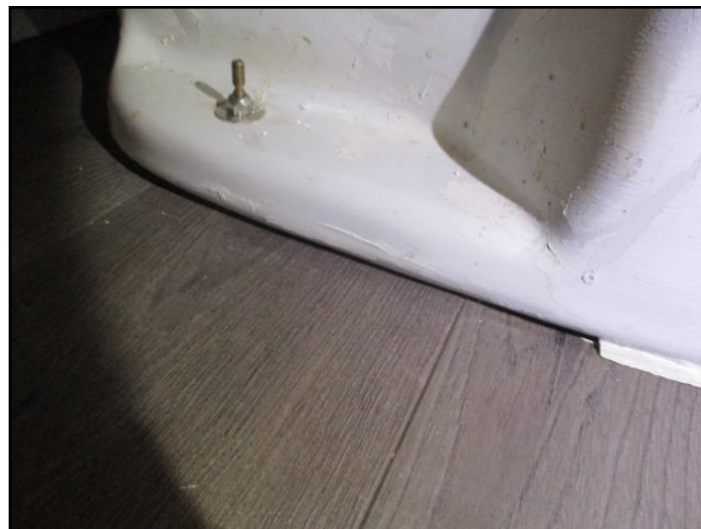
22. Condition: • Loose

Caulking missing from toilet base. Recommend that caulking be applied around the toilet to prevent movement, improve stability and stop sewer gases from entering the living space.

Loose

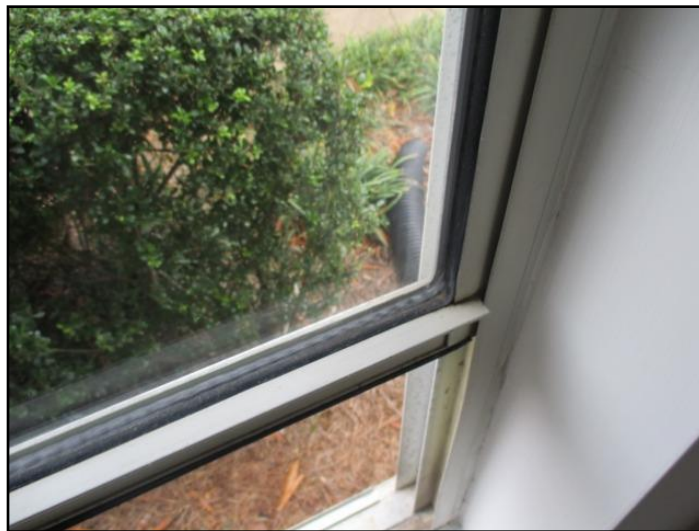
23. Condition: • Difficult to operate

Multiple windows throughout property were either inoperable, broken or damaged due to being the original metal frame windows. Recommend a qualified contractor provide estimate on replacing all windows as they are beyond their usable life, creating increased utility bills and lower level of comfort throughout the home.

Difficult to operate

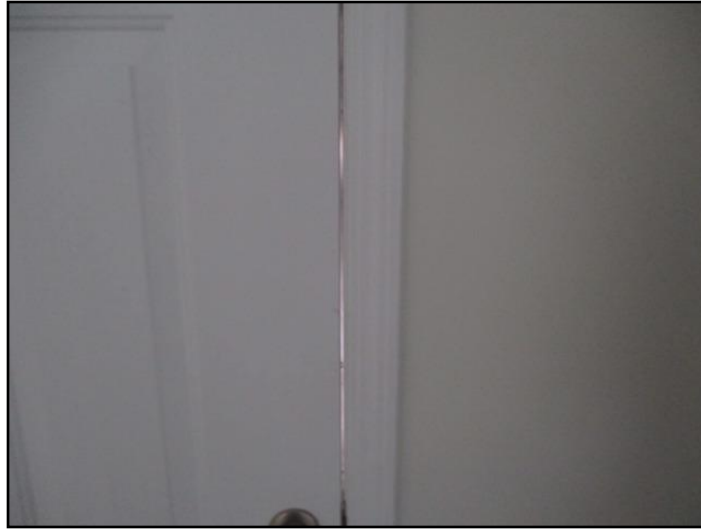
25. Condition: • Weatherstripping missing or ineffective

Although weather stripping is present at the front entrance, it has become ineffective overtime and daylight can be seen between the door and the casing when the door is fully closed. Indicating that the weather stripping needs to be replaced.

Weatherstripping missing or ineffective
