# Your Inspection Report

15940 Sample Street  
Your City, CA

**INSPECTION DATE:**  
Wednesday, September 5, 2012

Santa Cruz Property Inspections

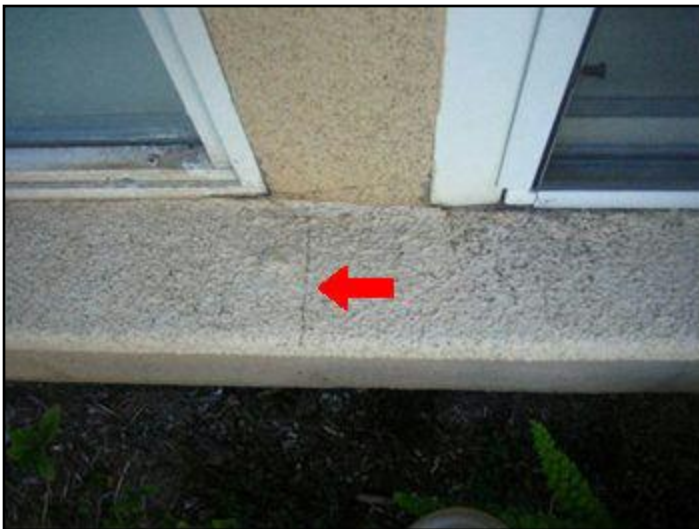
**6. Condition:** • Cracked and/or damaged. Any cracks or damage may allow water to enter the wall cavity which may cause fungal growth (mold) or wood deterioration. The inspector cannot determine the condition behind the wall covering. Further study advised

2. Cracked

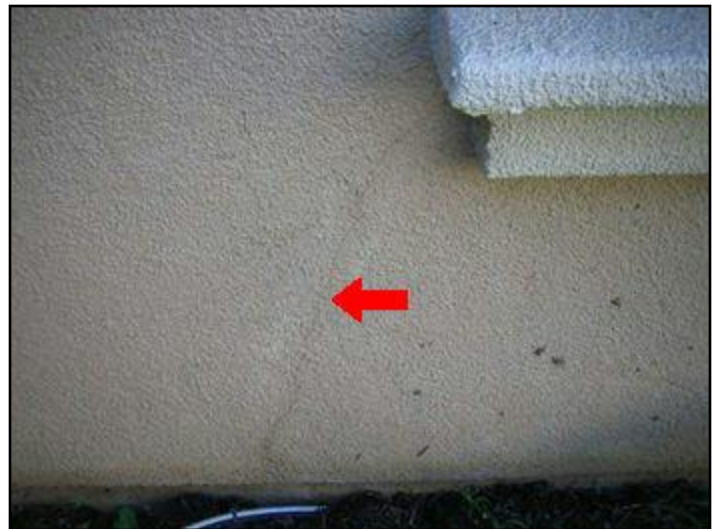
3. Cracked

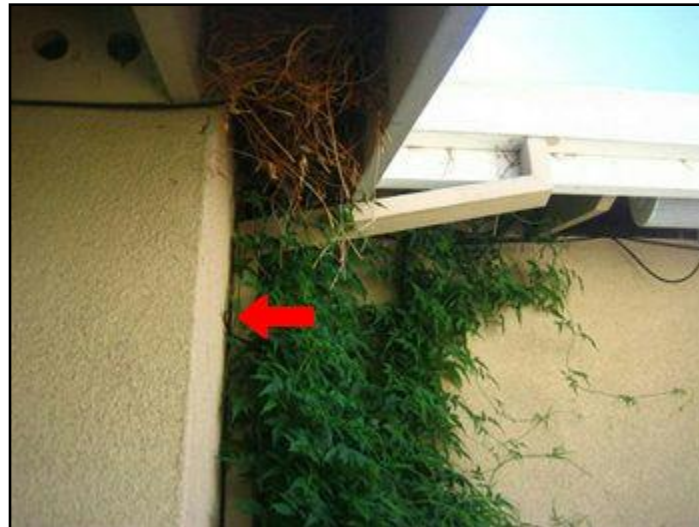
**7. Condition:** • [Trees or shrubs too close to building](#)

**Implication(s):** Chance of water damage to contents, finishes and/or structure | Chance of pests entering building | Material deterioration

4. Trees or shrubs too close to building

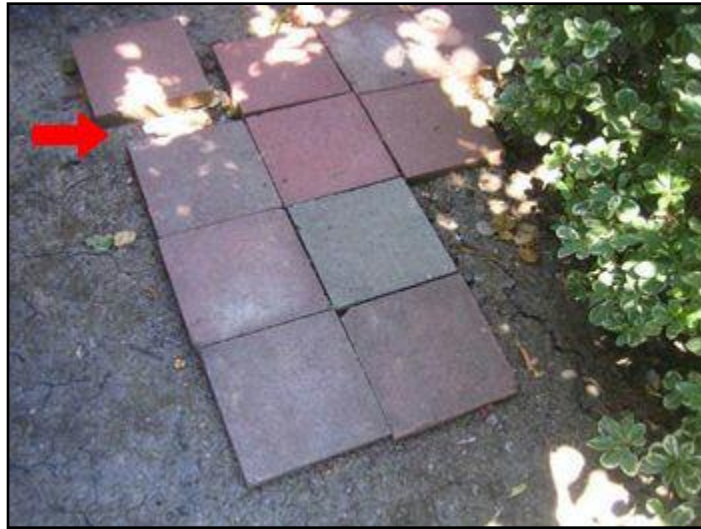
8. Condition: • [Uneven \(trip hazard\)](#)

Implication(s): Physical injury

5. Uneven (trip hazard)

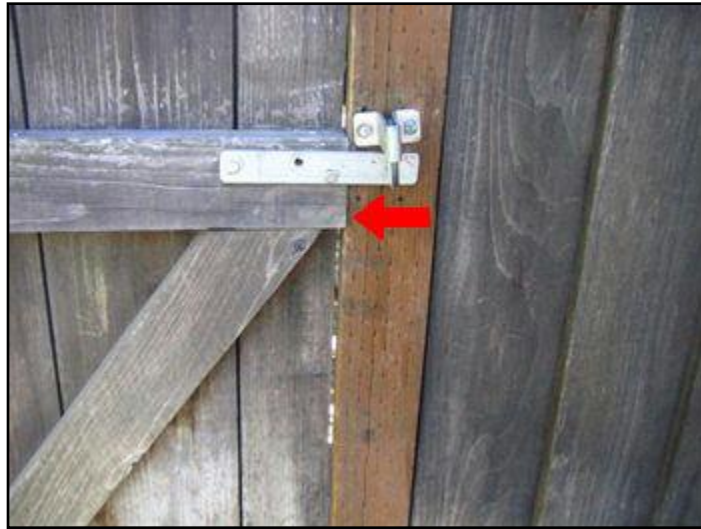
**10. Condition:** • Gate - adjustment needed

7. Gate - adjustment needed

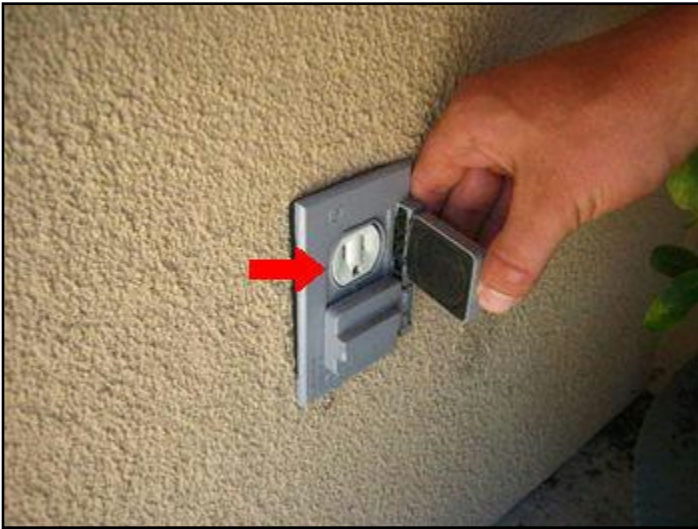
**12. Condition:** • Ground Fault Circuit Interrupters (GFCI): GFCI protection is recommended for any electrical outlet located at the exterior, bathrooms, kitchens, laundry areas, garages, unfinished basements, crawl spaces and/or within 5' of any water source. These safety devices should be tested regularly in accordance with the manufacturer's specifications. The inspector does not determine if areas are protected up/downstream by outlets hidden from view

10. No GFCI apparent-Exterior

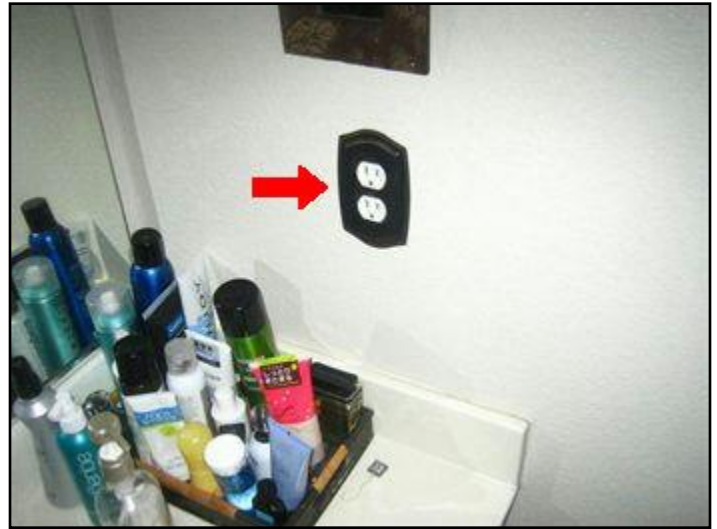
11. No GFCI apparent-Bathroom

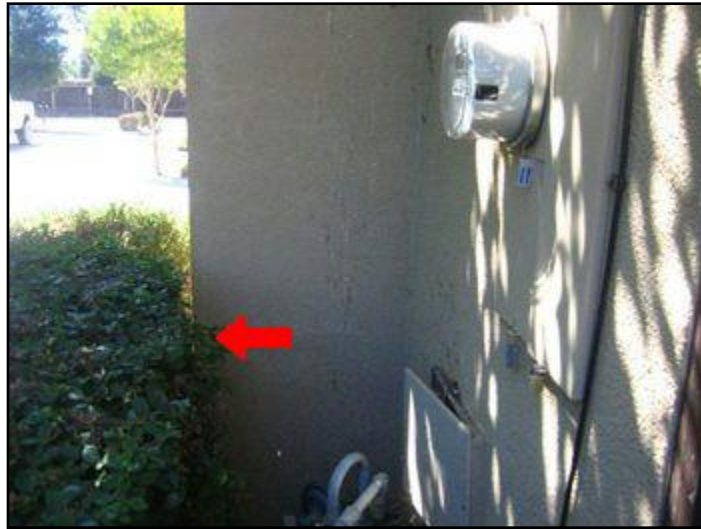
### 13. Condition: • [Poor access](#)

12. *Poor access*

Recommended cutting back plants/shrubs to provide adequate access

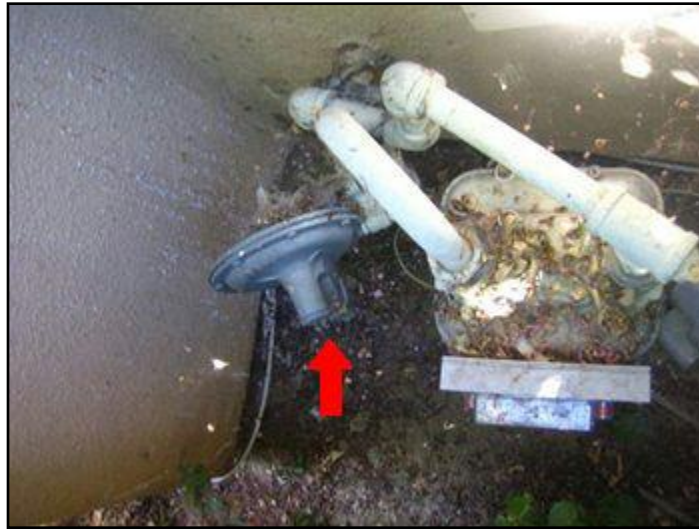
**18. Condition:** • No wrench for gas meter shutoff valve: A wrench for the gas meter shutoff valve was not located in the vicinity of the gas meter as recommended in seismically active zones. Securing a properly sized wrench to the gas meter or nearby piping to provide a convenient means of shutoff in an emergency is suggested.

13. No wrench for gas meter shutoff valve

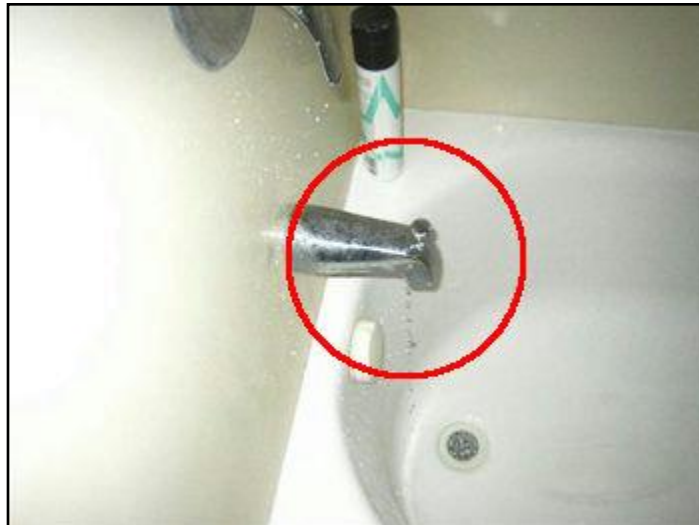
19. Condition: • [Shower diverter inoperative or defective](#)

14. Shower diverter inoperative or defective

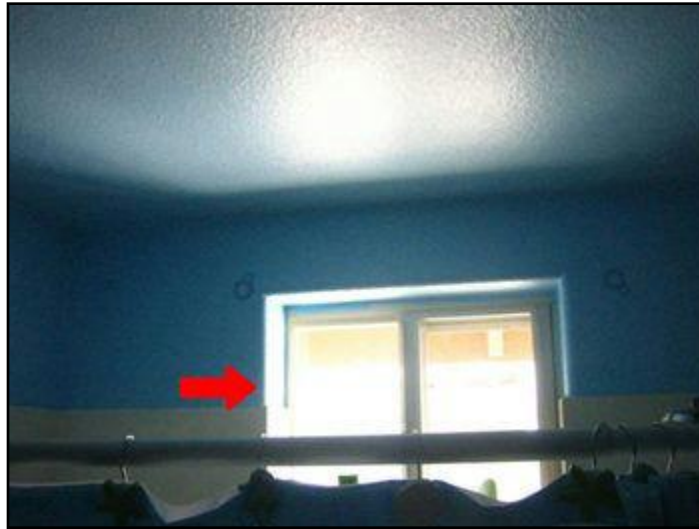
20. Condition: • Shower head above window. This type of construction can allow moisture intrusion into the wall if this area is not properly sealed and maintained

15. Shower head above window

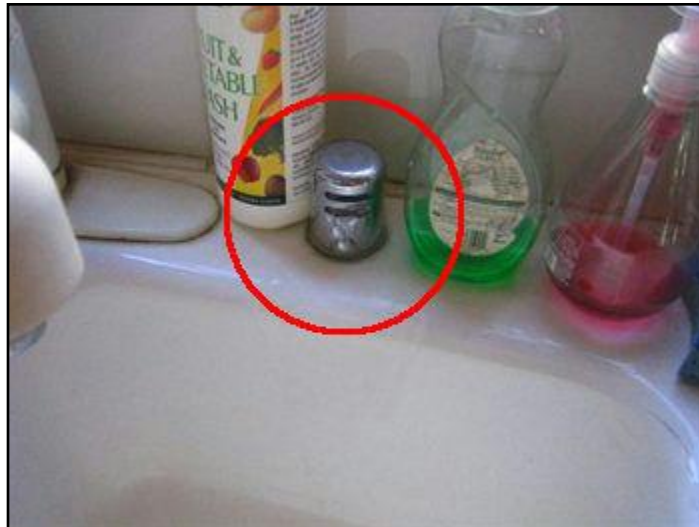
21. **Condition:** • Dishwasher airgap leaks

**Implication(s):** Chance of water damage to contents, finishes and/or structure, Contaminated dishwater

16. Backflow prevention defective

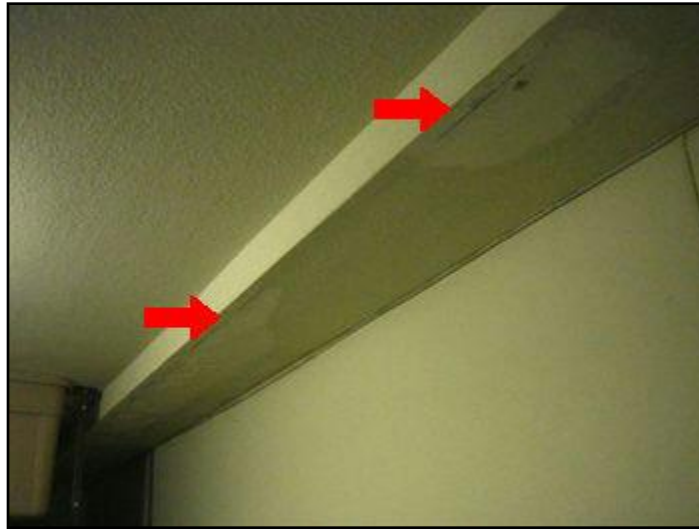
**23. Condition:** • Water stain(s) noted on interior surface This condition may indicate active roof leakage. Further study advised

18. Water stain(s) noted

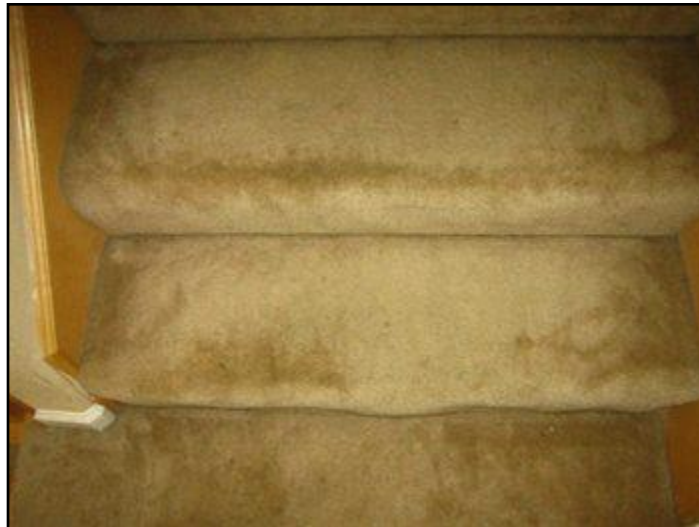
24. Condition: • Buckled

Implication(s): Trip hazard

19. Buckled

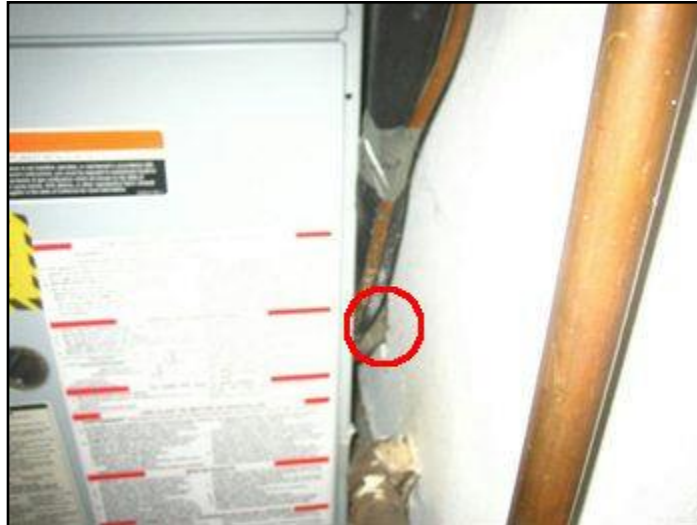
**28. Condition:** • Fire resistant wall or ceiling damaged / holed / not properly sealed / firestopped

**Implication(s):** Increased fire risk, Chance of hazardous combustion products entering living space

**22.** *Wall holed*

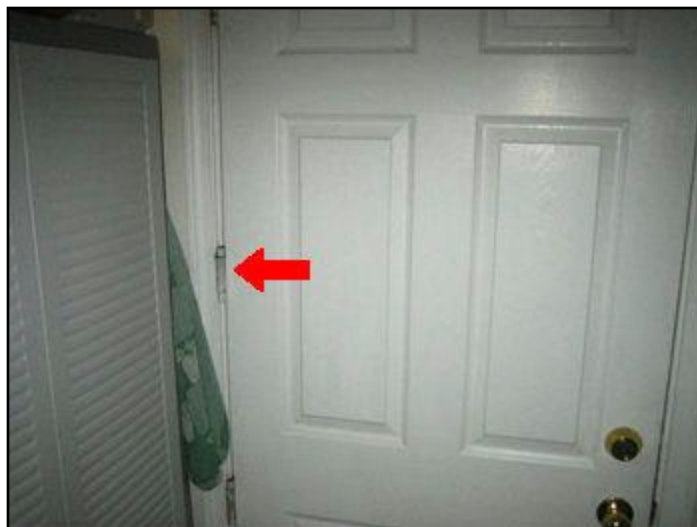
**29. Condition:** • No self closer

**Implication(s):** Increased fire risk, Chance of hazardous combustion products entering living space

**23.** *No self closer*
